**STAFF REPORT:** 8/9/2023 REGULAR MEETING

**APPLICATION NUMBER:** #23-8485

**ADDRESS:** 2405 BURNS

**SCOPE:** REPLACE WINDOWS AND DOORS, REMOVE PAINT, REPAIR STUCCO AND EAVES (WORK COMPLETED WITHOUT APPROVAL)

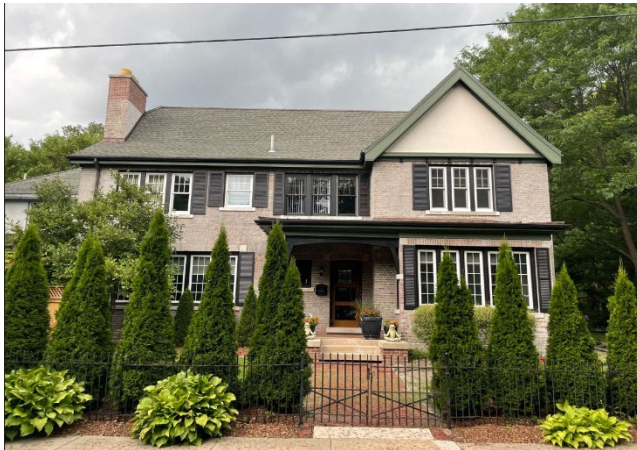
*Site Photo 1, by Staff July 20, 2023: (Southeast) front elevation, showing vinyl windows from a previous owner and some wood windows.*

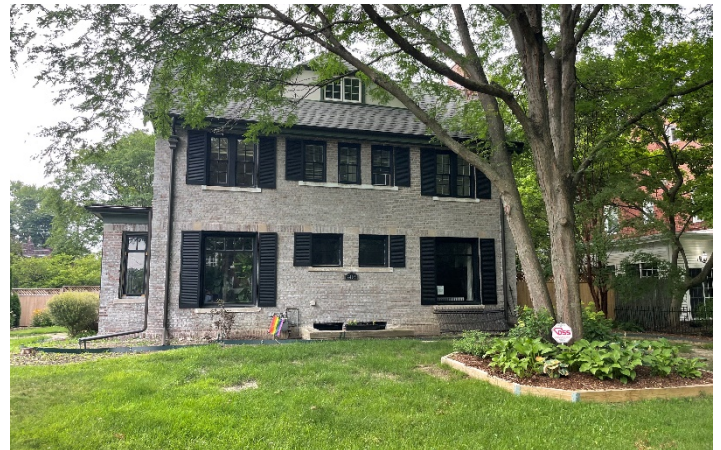
*Site Photo 2, by Staff July 20, 2023: (Northeast) side elevation, showing two fixed picture windows that replaced vinyl windows. These windows received a Denial from the previous application in June 2023. Vinyl windows on the 3<sup>rd</sup> floor were installed by a former owner.*

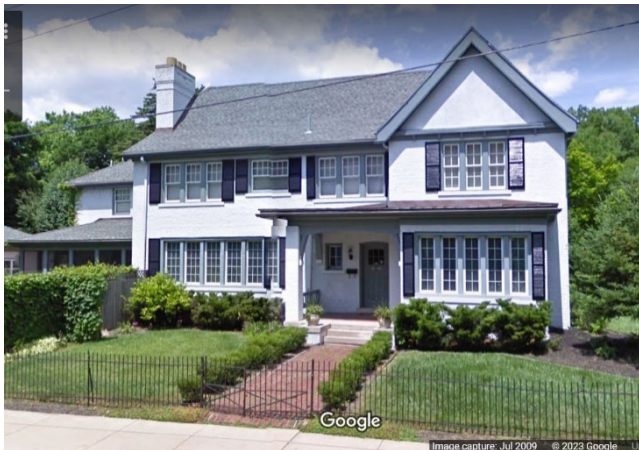
*Site Photo 3, by Google Streetview, July 2009: (Southeast) front elevation, showing original and vinyl windows (by previous owner), painted brick, and original front door.*

- The designation slides of both 1975 and 1980 show that the Southeast and Northeast elevations had some windows replaced, particularly on the first floor. It is not clear their material, but they have been since replaced with vinyl windows, which was done before 2009. (See site photos 3 & 4).

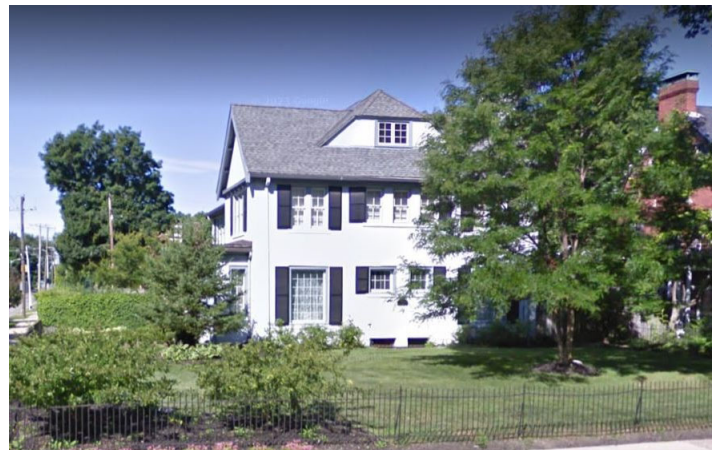
*Site Photo 4, by Google Streetview, July 2009: (Northeast) side elevation, showing original and vinyl windows (by previous owner), and painted brick.*

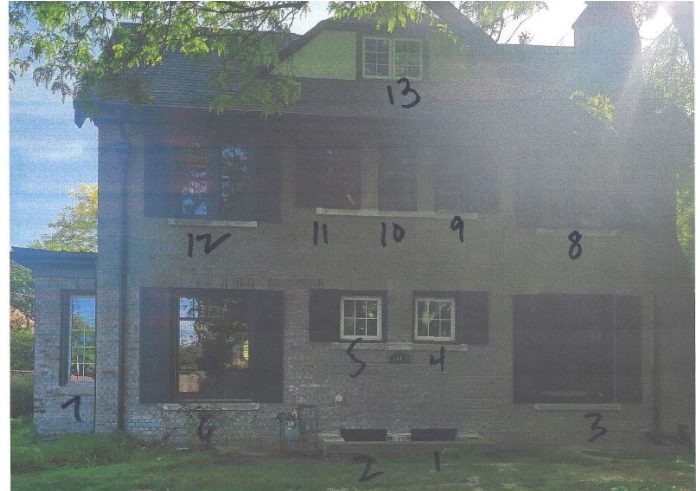
Figure 1, by Applicant: (Northeast) side elevation, picture windows #3 and #6, and replaced vinyl window #7.

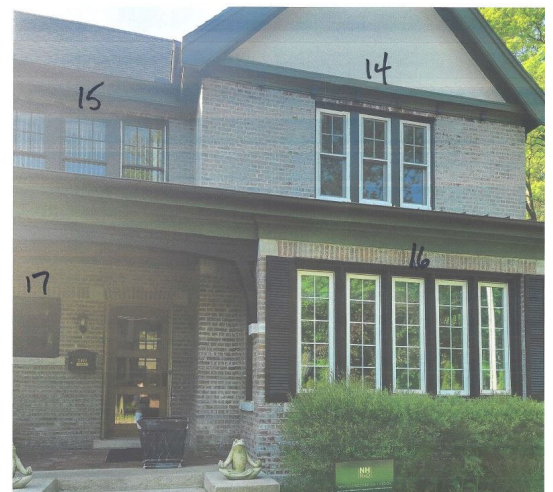
Figure 2, by Applicant: (Southeast) front elevation, showing existing vinyl windows #16.

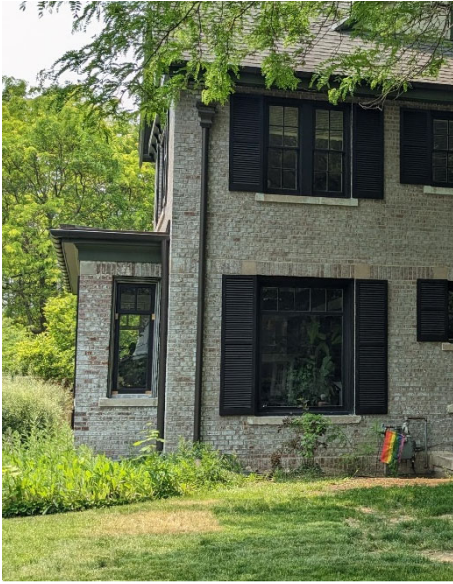
Site Photo 5, by Staff June 5, 2023:  
(Northeast) side elevation, detail of window #7  
a newly constructed 2/1 wood window.

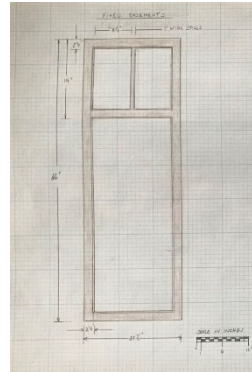
- Staff observed that the applicant has matched the configuration of the historic windows with the exception of the front elevation casement windows: instead of a casement of 2x5 divided light, the applicant proposes to introduce 2/1 divided light per casement window on the first floor casement windows. These would be located on the first floor bay, and two windows have already been installed. (See figures 1-3, Site photo 5). These windows are currently vinyl, previously installed by a previous owner and were present at the time of historic designation. It is staff's opinion that the original configuration was more likely to resemble the 2x5 layout, but it is staff's opinion that the proposed 2/1 configuration is not demonstrably inappropriate.

Figure 3, by Applicant:  
Proposed 2/1 casement  
window for front elevation  
bay.

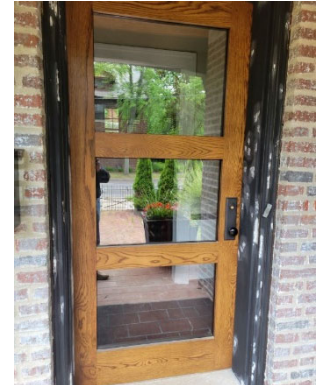
- The existing doors for the front screened in porch and rear door were of steel or composite materials and are not historic doors. Staff observed that both doors are not publicly visible, as one is located inside a screen porch behind a privacy fence (front porch) and the other is at the rear elevation. It is staff's opinion that the proposed replacement doors are of a design and material that is appropriate. Although not publicly visible, it is staff's opinion that the exterior doors would be more appropriate as painted with a color selected from HDC Color System D, rather than natural stained wood. (See photo 6.)

Site Photo 6, by Applicant  
2023: (Southeast) front  
elevation, showing newly  
installed front door, which is  
not in this application but  
demonstrates the design of  
the other proposed doors.

- Although the two proposed replacement doors would not be publicly visible, it is staff’s opinion that the exterior of the doors should be painted rather than stained. An appropriate color could be selected from Color System D.

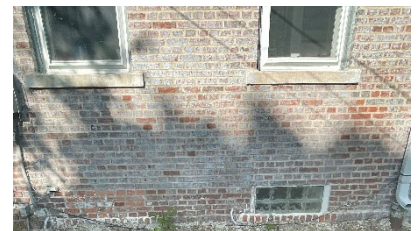
- Staff observed that the brick still has a noticeable amount of paint remaining, giving the appearance of a washed rather than a natural brick color look.
- Upon receipt and review of the Grunwell-Cashero letter supplied by the applicant, several staff members visited the site to inspect the brick. Staff observed that the brick exhibits minor and sporadic areas of loss at the surface of the brick that was likely caused by the power washing. Staff observed that because the house was already painted at the time of designation, a repainting of the brick with an appropriate paint would likely have been the most historically appropriate approach. However, it is staff's opinion that the removal of paint did not cause significant

Site Photo 7, by Staff, August 2, 2023:  
(west) side elevation, showing paint  
removal work.

damage and any further removal of the remaining paint should be follow National Park Service Preservation Brief #1 “Assessing Cleaning and Water-Repellent Treatments for Historic Masonry Buildings” and use the gentlest means possible. Staff would not advise re-painting the brick, as it may lead to accelerated deterioration, particularly in the areas where the brick fire skin was lost. Therefore, staff would support the proposal to leave the house unpainted.

- Staff recommends that any further spot treatment for paint removal follow National Park Service Preservation Brief #1 “*Assessing Cleaning and Water-Repellent Treatments for Historic Masonry Buildings*” and use the gentlest means possible.
