ADDRESS: 2010 EDISON**APPLICATION NO: #23-8479****HISTORIC DISTRICT: BOSTON-EDISON****APPLICANT: CLIFFORD TERRY****OWNER: DEBORAH VINSON****DATE OF STAFF SITE VISIT: 7/18/2023****DATE OF PROVISIONALLY COMPLETE APPLICATION: 7/10/2023****SCOPE: REPLACE BUILT-IN/BOX GUTTERS WUTH HUNG GUTTERS****EXISTING CONDITIONS**

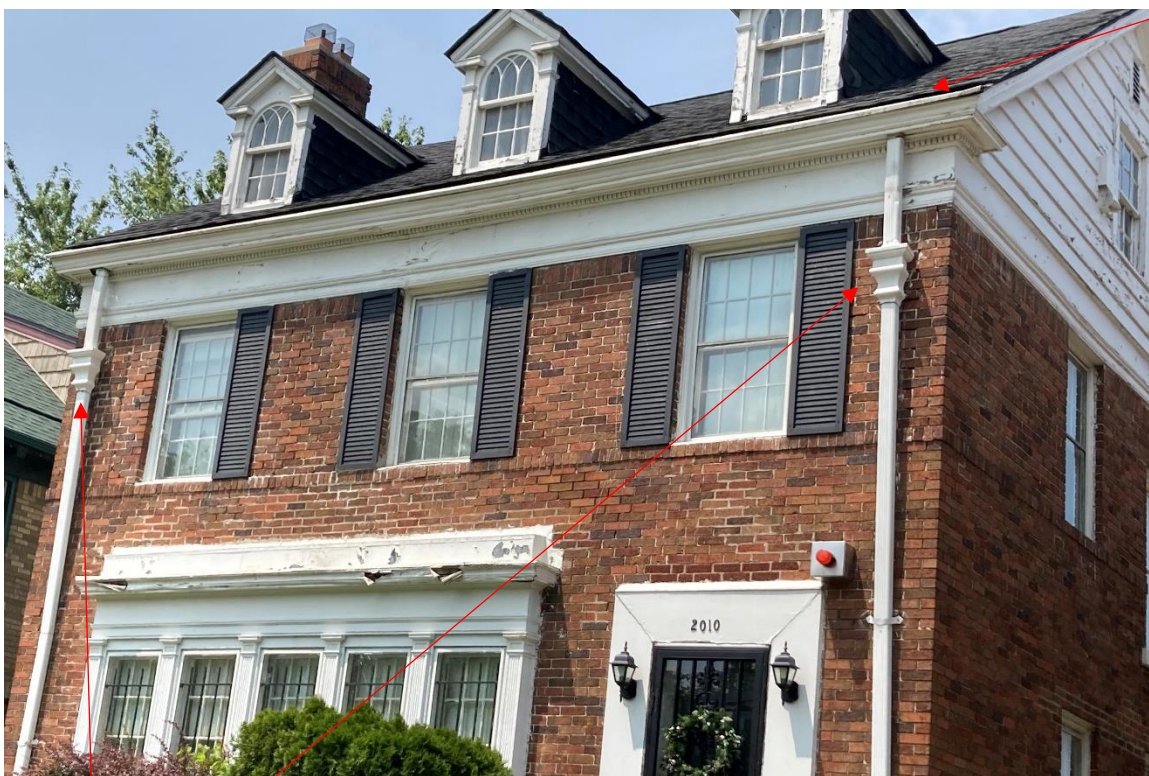
Current appearance. Staff photo taken on 7/18 /2023

Original built-in /box gutters (not visible). See below section drawing

Classical detailing

Original collector boxes

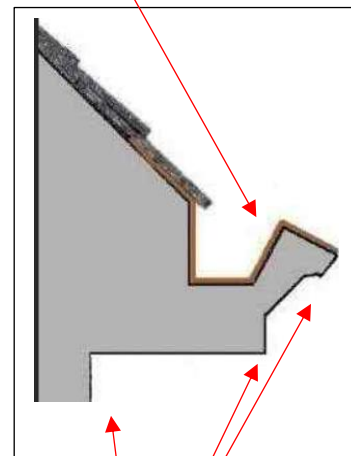
Section drawing showing hidden location of built-in gutters

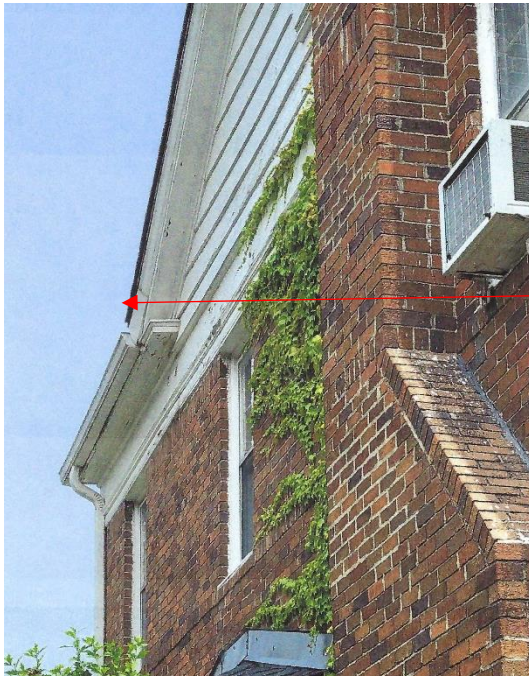
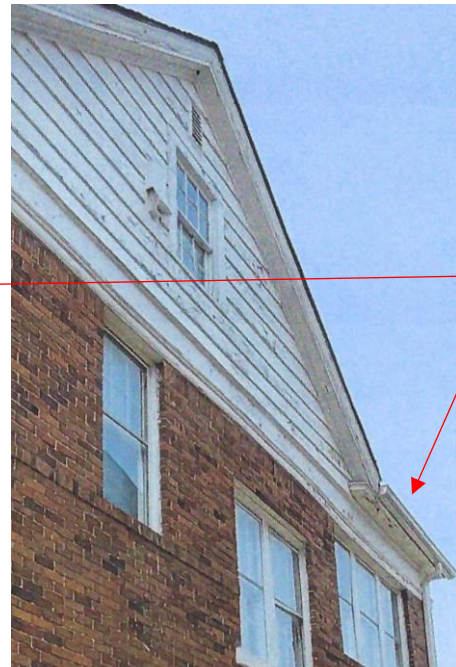
Non-historic hung aluminum gutters at side elevations

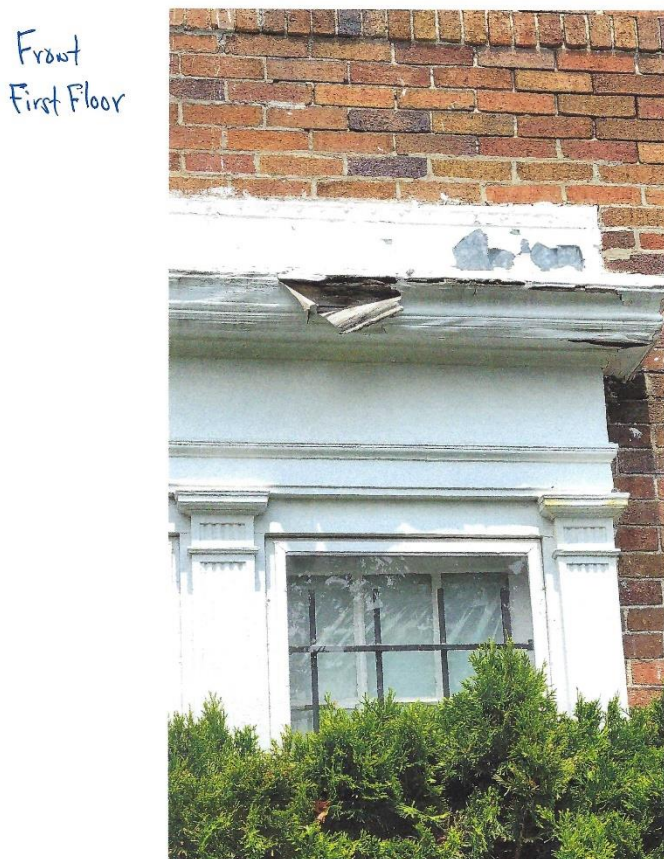
- The submitted documents include a detail photo of the cornice of the bay window which is located at the front elevation, first story (see the below). As the specific locations of the new gutters and downspouts have not been indicated in the current application, staff is unclear if the applicant included this photo because he is seeking to install new hung gutters and downspouts at this location. It is staff's opinion that the location of new hung gutters in this location would not meet the Standards because the work would obscure or possibly lead to the removal of portions of the fascia and will change the geometry of the distinctive character-defining element.

Applicant photo of bay window cornice at front elevation, first story
