STAFF REPORT: 9/13/2023 REGULAR MEETING

APPLICATION NUMBER: #23-8523

ADDRESS: 4325 FULLERTON

SCOPE: REMOVE WINDOWS (WORK COMPLETED WITHOUT APPROVAL), INSTALL ALUMINUM CLAD WOOD WINDOWS

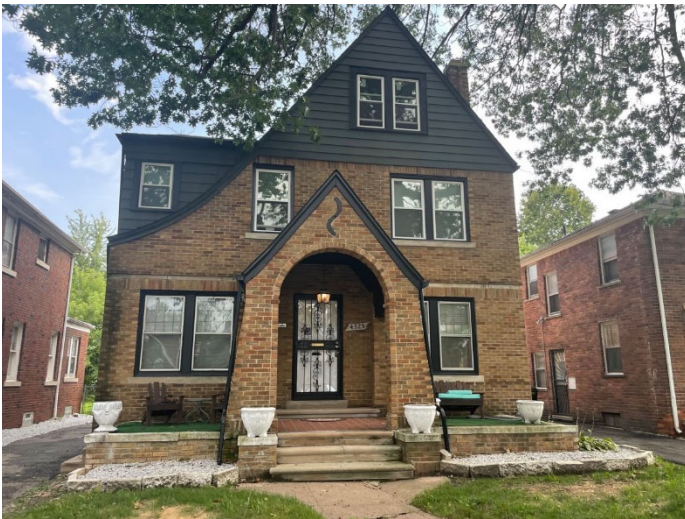
Site Photo 1, by Staff August 24, 2023: (North) front elevation showing replaced windows on 2nd & 3rd floors.

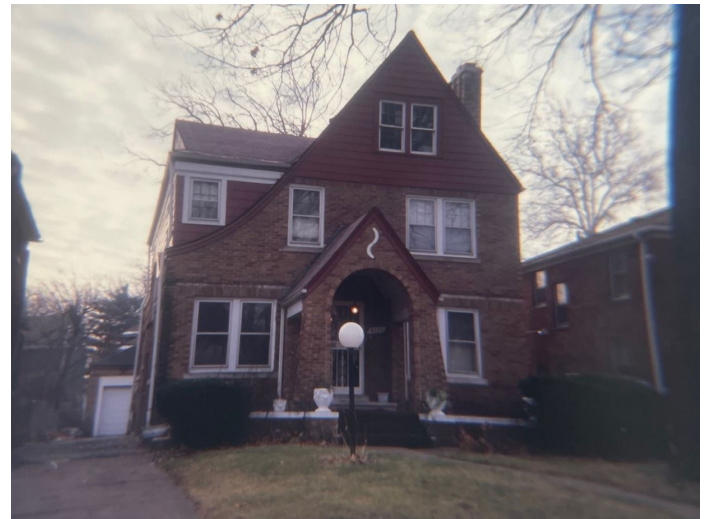
Designation Slide, 1999: (North) front/side elevation showing original windows.

- Staff confirmed with the applicant that the original windows have been removed and destroyed by the window contractor.
- From the designation slide, it is staff's observation that the original windows were wood, double-hung with a 6/1 configuration on the upper floors. It is staff's opinion that these original wood windows, their double-hung

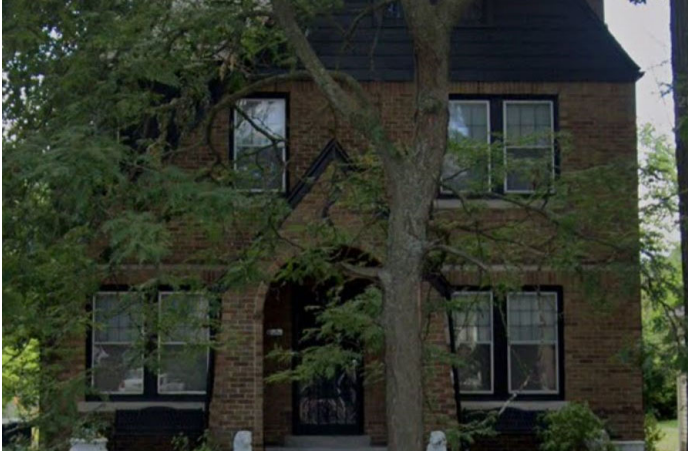
Site Photo 2, Google Streetview June 2022: (North) front/side elevation showing windows before work.

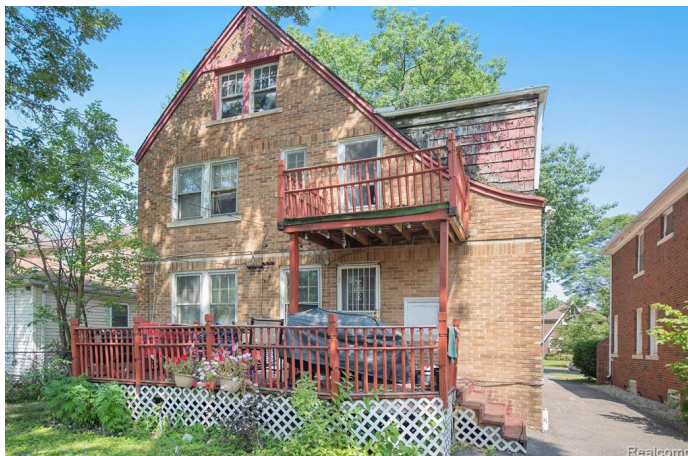
Site Photo 3, by Applicant (unknown date) March 22, 2023: (South) rear elevation, showing original windows.

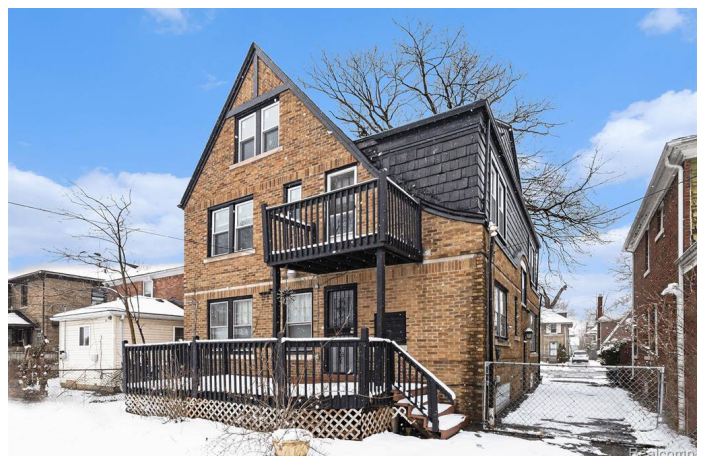
Site Photo 4, by Applicant 2022: (South) rear elevation showing replaced windows (unapproved) and approved repaired siding, new railings, and trim/siding paint work. Notice windows on 2nd and 3rd floor have been replaced, while the original first-floor windows remain.

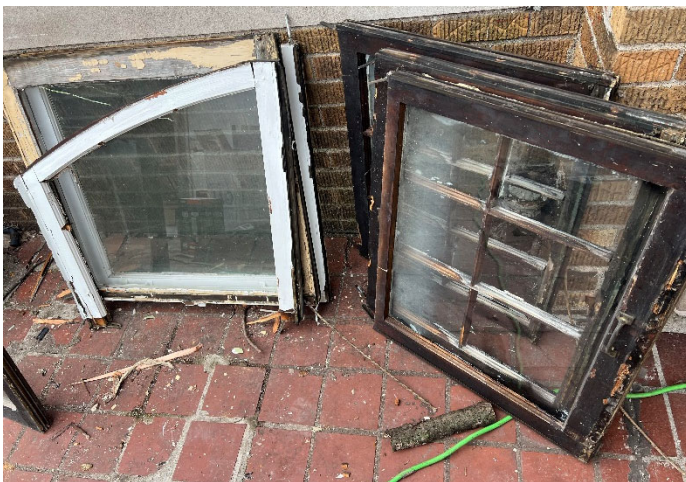
- In the previous, May 2023 Staff Report, staff received a sample photo of the original windows' condition (*see Site Photo 5*) and the following description: *“When I purchased the home, it was completely derelict and had been occupied by squatters. After removing them from the property, we discovered that the second-floor windows had at some point been replaced, and were non-functioning/rotted through. At first, we attempted to repair the windows, but after continual breakage, degradation, and a repair specialist telling me they weren't able to be fixed, we were forced to use Mulligan Windows in Farmington to replace them”*.

Site Photo 5, by Applicant, showing conditions of original windows removed. The archtop window shown here may be from the window pair discussed on the next page.

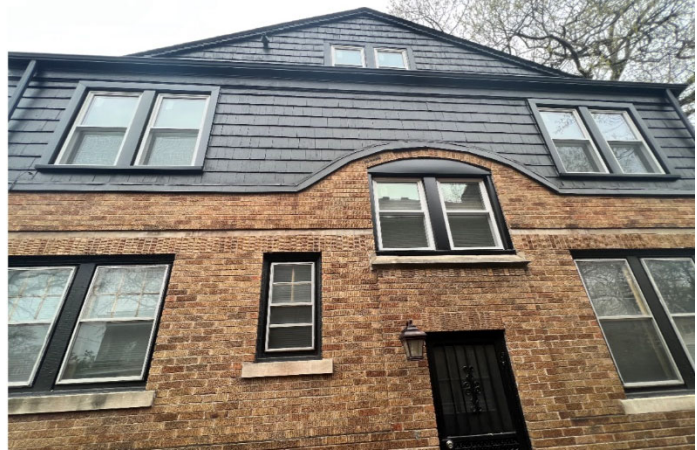
- Staff observed that above the side entrance (east elevation), a pair of double hung windows with a curved top rail were replaced with a pair of rectilinear vinyl windows with what appears to be a vinyl cover at the remaining arch of the former windows. It is staff's opinion that this pair of windows is a distinctive character defining feature that was altered without approval. Vinyl is not an appropriate material in the Russell-Sullivan Historic District, given its inability to faithfully replicate historic profiles, its detracting color/sheen, and its poor detailing. Staff also observed that this pair of windows were missing from the window schedule, but present as double-hung rectangular windows in the window order. Staff received an update from the applicant, which states that the window order will be updated later to include this window pair, as arched upper railings, which has not been received at the time of this staff report. *(See Site Photos 5, 6 & 7.)*

Site Photo 6, by Applicant, showing vinyl cover arch over vinyl window pair, located over the side entrance.

- It is staff's opinion that the removal of the original arch over the east elevation window and proposed replacement with a vinyl cover alters the original *scale*, *design*, and *materiality* and that is incompatible and inappropriate for this historic property, and therefore does not meet the Secretary of the Interior's Standards for Rehabilitation and Elements of Design.

- The applicant provide HDC staff with the dimensions and description of method to install the windows and restore the brick moulding of the window openings.
- The applicant provide 6/1 simulated divided lites, 4/1 for the two smaller bathrooms.
- The east elevation vinyl windows be removed and replaced with an appropriate curved top rail design with double-hung, aluminum clad wood or wood windows and a 6/1 configuration.
- The applicant provide a window trim color selected from Color System D of the HDC color chart guidelines.
- HDC staff shall review and approve these submissions before their application/installation.

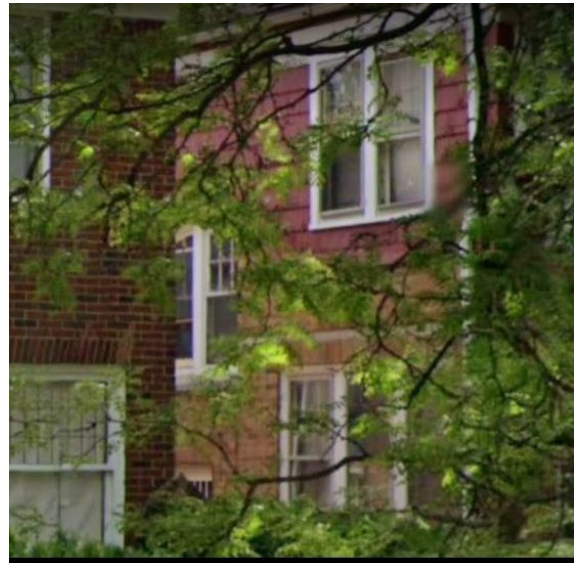
Site Photo 7, by Google Streetview 2019, showing original curved top rail of the double hung window pair, located over the side entrance.
