STAFF REPORT: 9/13/2023 REGULAR MEETING

ADDRESS: 1405 CHICAGO BOULEVARD

APPLICATION NO: 2023-8519

SCOPE: REPLACE WINDOWS, FENCE, LANDSCAPING (WORK COMPLETED WITHOUT APPROVAL)

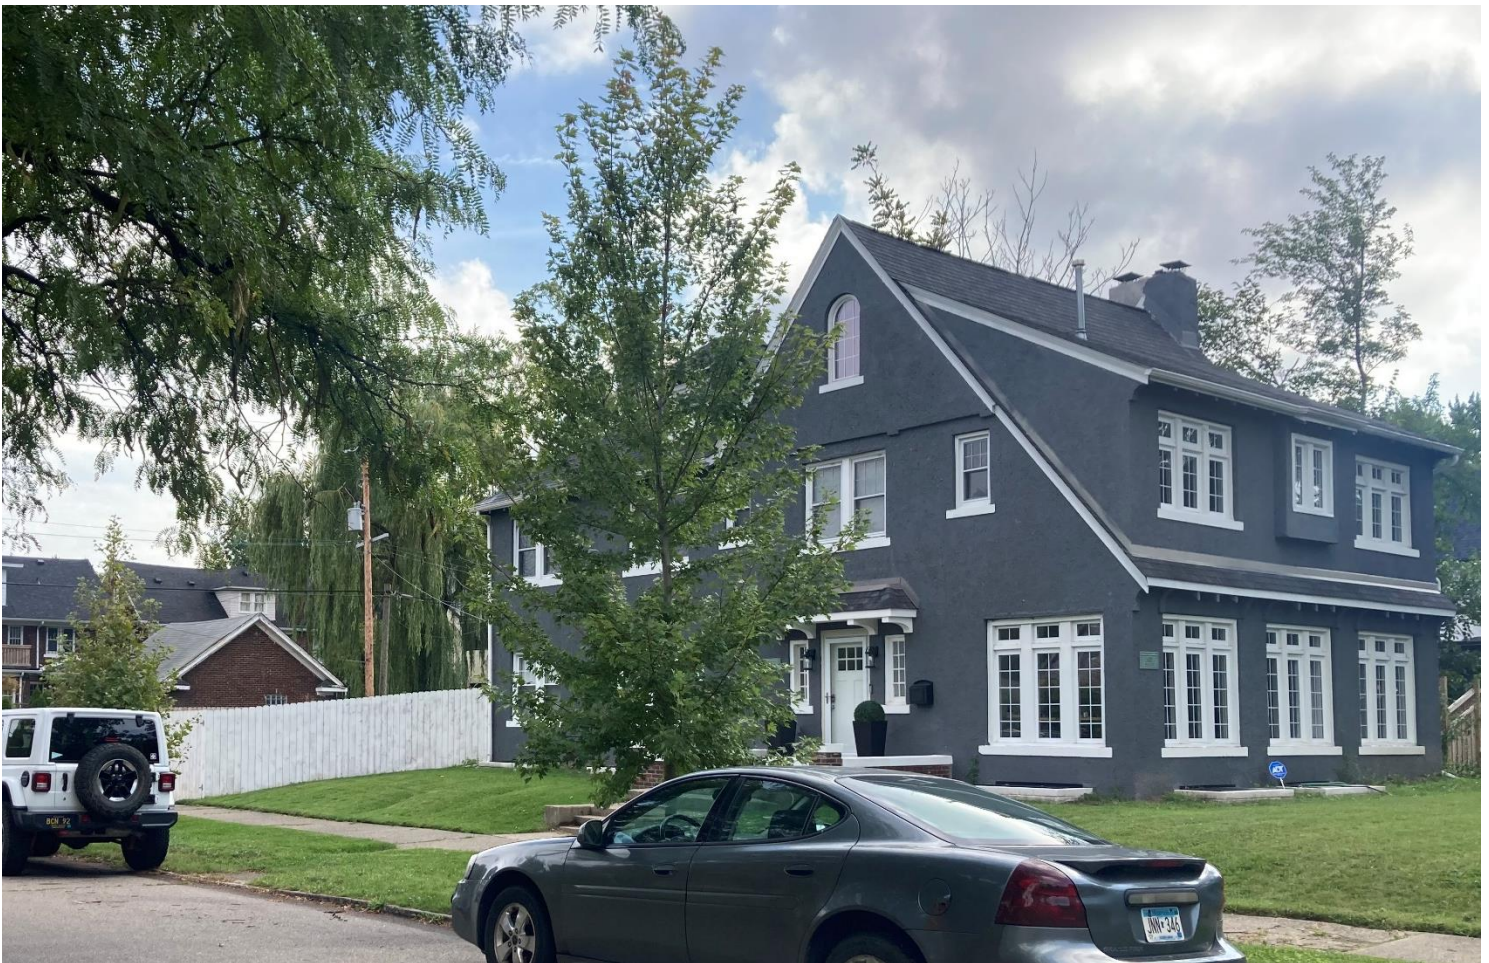
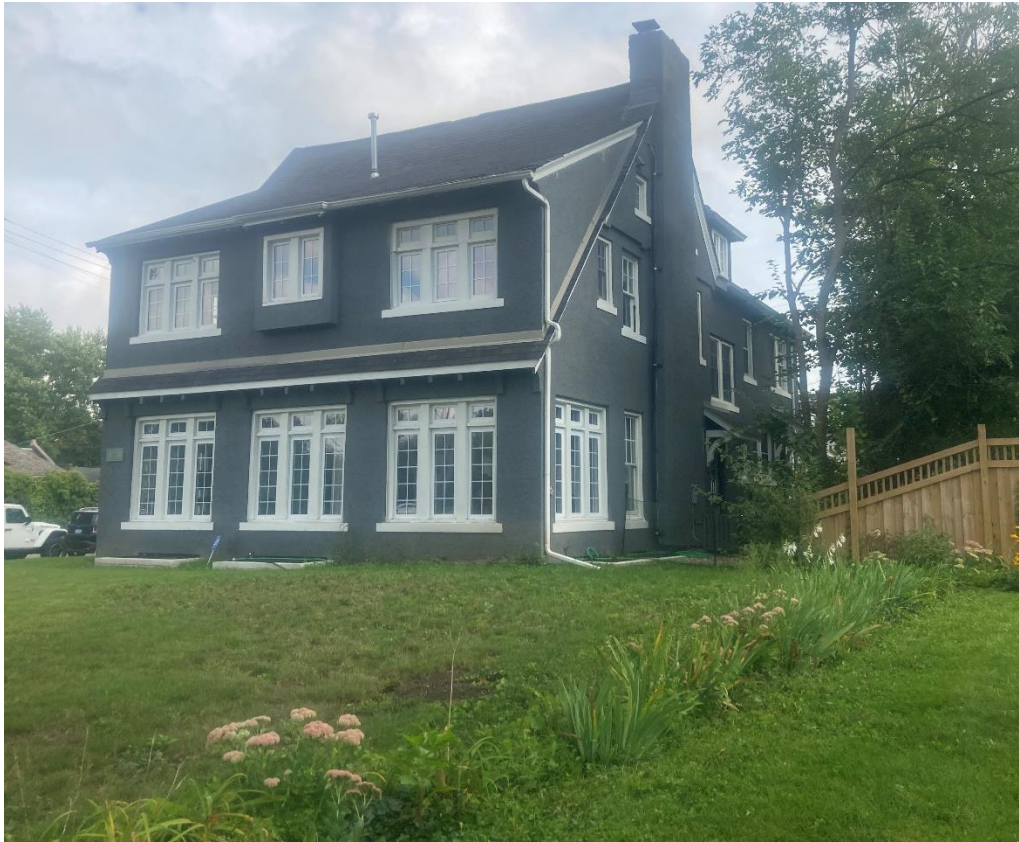
1405 Chicago Blvd., current appearance. Staff photos taken on 8/31/2023

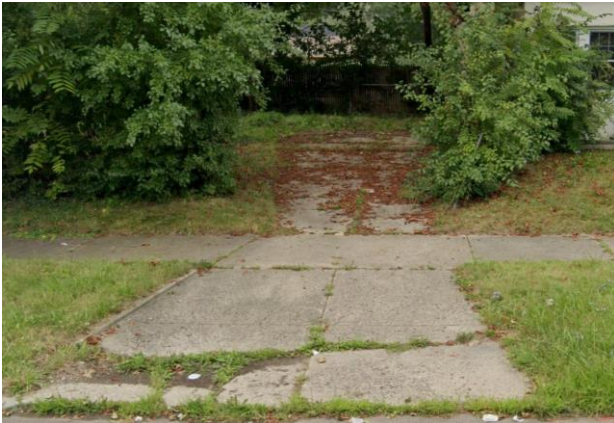
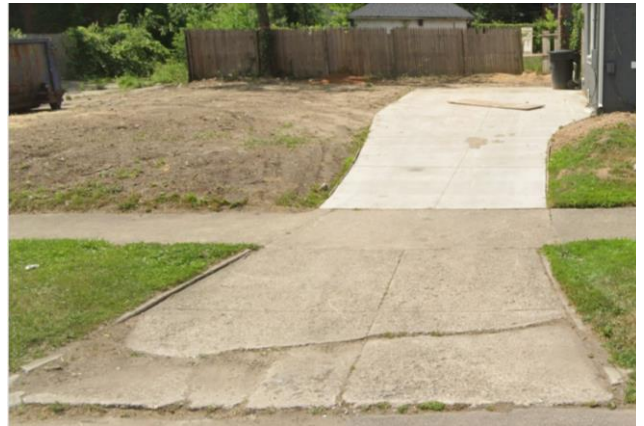
- As noted above, a former owner replaced the original driveway with a new driveway. See the below photos which indicate that the footprints of both driveways are similar. Also, and the materiality (concrete) and location of both driveways are the same. Staff has no issue with this scope item and recommends its approval.

Google Streetview, 2019

Google Streetview, 2022

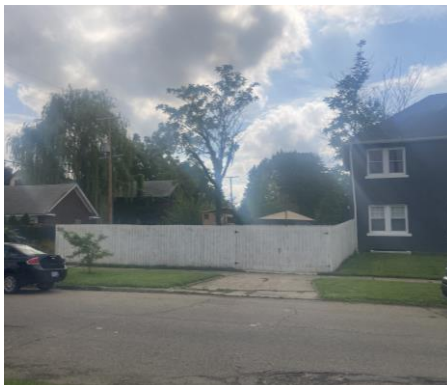
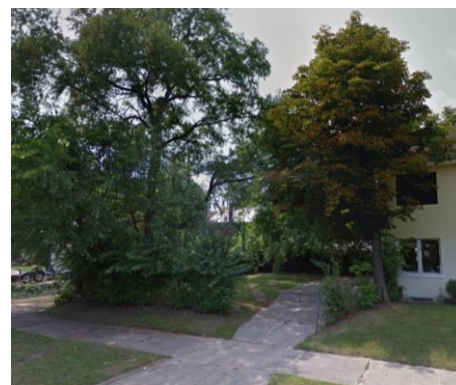
- As noted above, the existing fencing was erected in 2022 without HDC approval. It is a dog-eared style, 6'-0" high wood fence that is painted white. The fence is located at the southern and western perimeter of the parcel and encloses the property's south side/front yard, along Byron Street. The fencing located at the along Byron Street was installed adjacent to the sidewalk, pushing forward of/to the east of the home's front façade. While the placement does not conform to the guidelines, staff does note that a chain link fence was once extant at that location (see below). Also, two other fences within the block are similarly located because all other yards in the bear vicinity are rear yards. Also, please note that the fence guidelines are not requirements. Rather, they outline the conditions under which staff can issue an administrative approval. The Commission can approve fence proposals which do not conform to the guidelines if they determine that the proposal meets the Standards and conform to the Elements of Design for the district. It is staff's opinion that the work is appropriate and recommends it's approval.

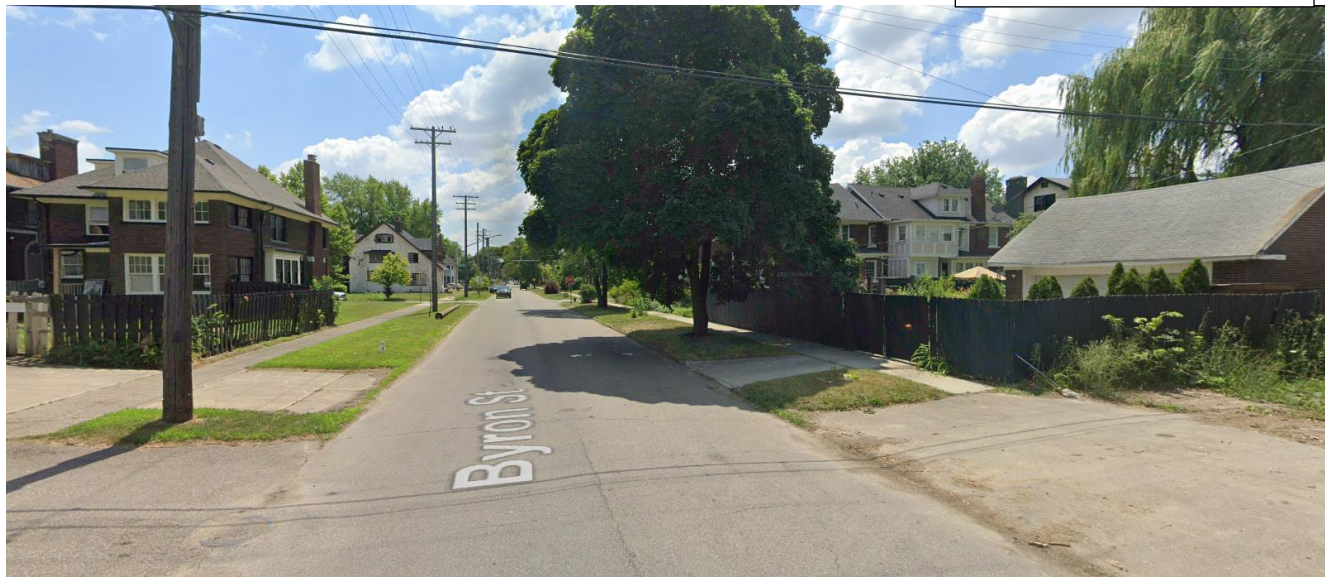
Additional fences located at the sidewalk, within the same block on Byron. Google Streetview 2022

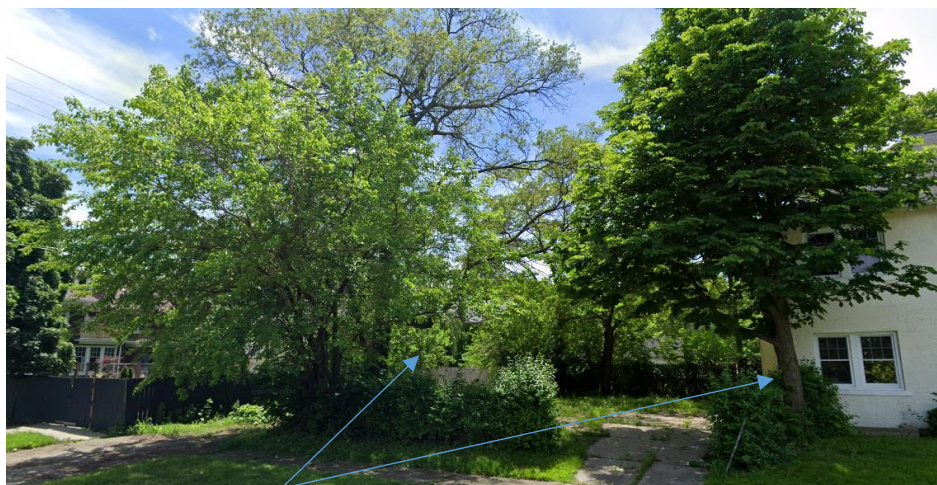
These mature shade trees removed at side yard along Byron. Also all of the shrubs were removed. Google Streetview, 2019

without HDC approval were present in 1980. The HDC staff landscape architect reviewed the designation slides and found that the trees and shrubs were likely historic age. Staff does support the remove of the one shade tree which was close to the front/east façade because it's root system would likely damage the house. However, it is staff's opinion that the recent removal of the shade tree that was removed from the southeast corner of the parcel, the removal of the line of shrubs along the western edge of the property (at the side yard along Chicago Blvd.), and the removal of the shrub at the northeastern corner of the property (at the side yard along Chicago Blvd) was inappropriate to the property's historic character. Staff recommends that these elements be replaced with like landscaping and a new shade tree to support the district's historically-significant tree canopy.

- A new shade tree shall be planted in the side/south yard to replace the shade tree that was removed from the southeast corner of the parcel. Also new shrubs shall be planted along the western edge of the property (at the side yard along Chicago Blvd.), and at the northeastern corner of the property (at the side yard along Chicago Blvd) to replace the landscaping that was removed without HDC approval. The applicant shall submit a landscape plan to HDC staff for review and approval prior to initiating the work.

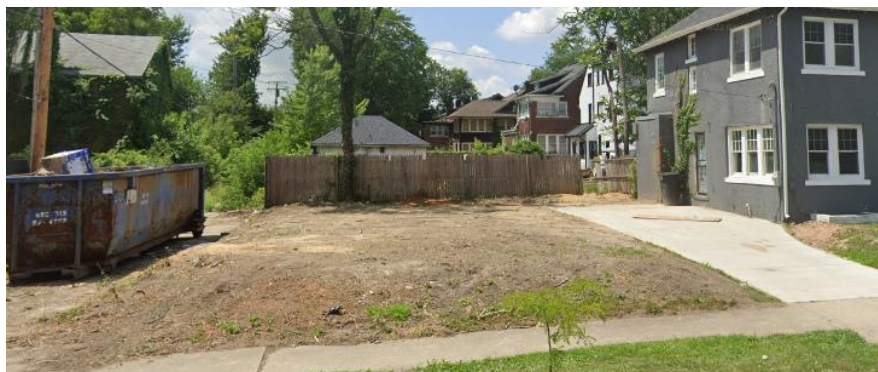
Side yard along Byron, taken immediately after landscape removal. Google Streetview, 2022.

Compare to above photo

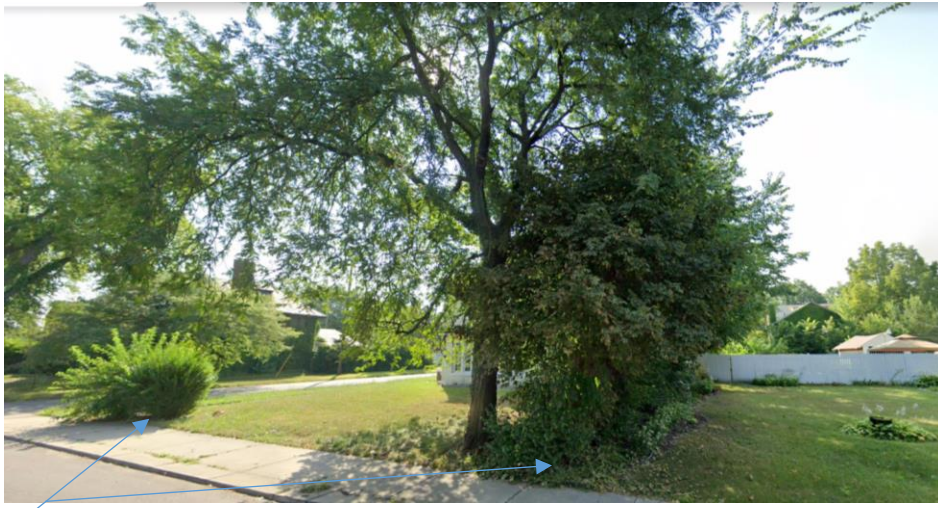
These shrubs removed in side yard along Chicago Blvd. Google Streetview, 2019

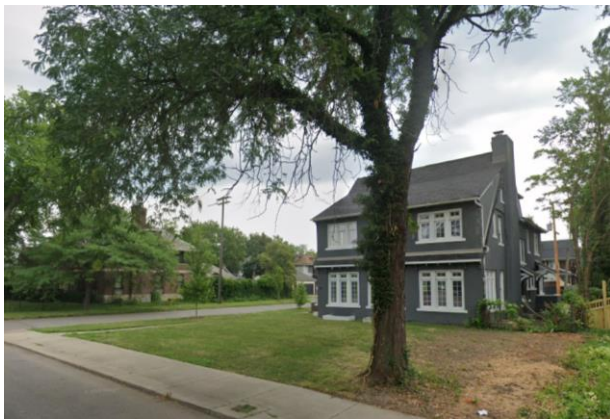
Property's appearance of side yard, along Chicago post landscape removal. Google Streetview, 2022

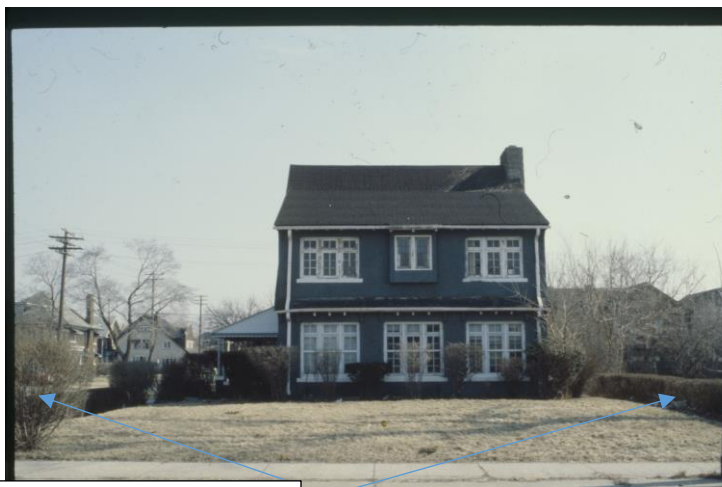
Appearance in 1980. Note presence of shrubs

- As demonstrated in the above photos, the two shade trees in the southern side yard (along Byron) and the shrubs in the northern side yard (along Chicago) that were recently removed

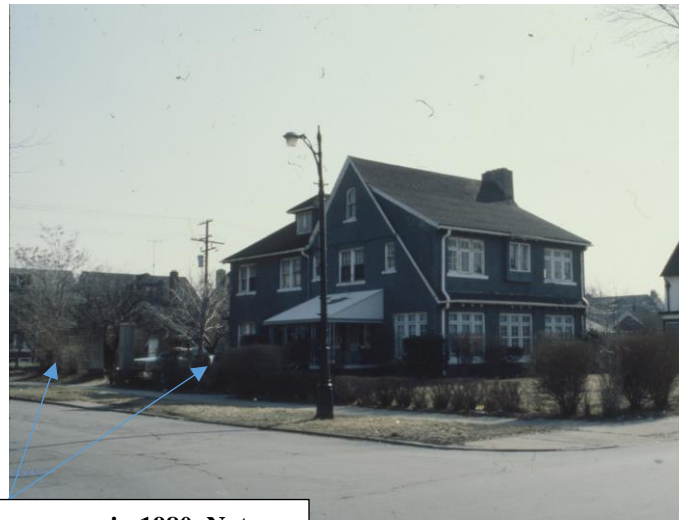
Appearance in 1980. Note presence of shade trees

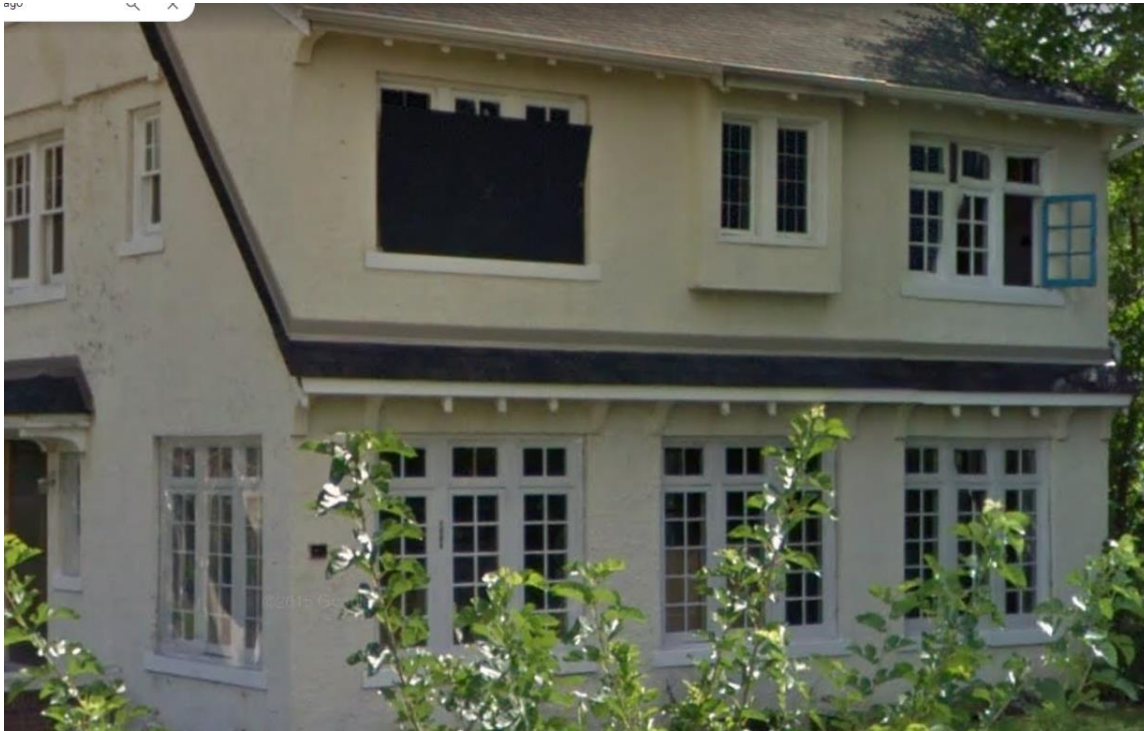
North side, 2016 conditions

- A review of the images of the home windows from 2016 indicate that the original windows were distinctive character defining features of the home. They also did not appear to be deteriorated beyond repair. It is not clear to staff why the former owner reinstalled the windows in 2016, only to remove them in 2017. Also, please note that SOI Standard # 6 requires that new elements “match the old in design, color, texture, and other visual qualities and, where possible, materials” if an historic element is deteriorated beyond repair to an extent that requires it’s replacement. It I staff opinion that the new vinyl windows are not an adequate match for the historic windows that were removed without HDC approval for the following reasons:

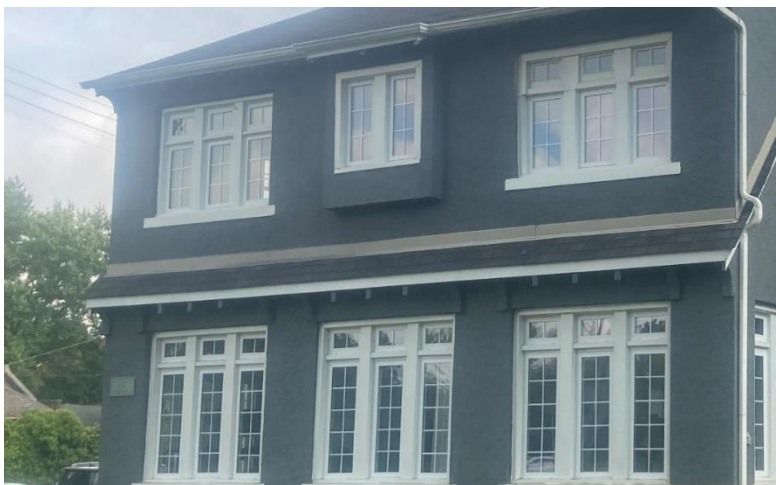
North side, current conditions

Note muntins between the glass and boxy aluminum coilstock casing and mullions at current windows. Lite configuration matches with the originals with the exception of the windows in the 2nd story bay. Operation appears to match the original windows

- The current vinyl units include muntins between the glass which is not an adequate replication for the former true divide lite windows as the current muntins portray a flat appearance

- The current vinyl windows and wrapped brickmould offer a plasticity and flat/thick appearance that does not adequately match the profile/dimensionality and appearance of the original historic wood windows and associated trim/brickmould.

Staff therefore recommends that the Commission denial the current proposal to retain the existing vinyl window units.

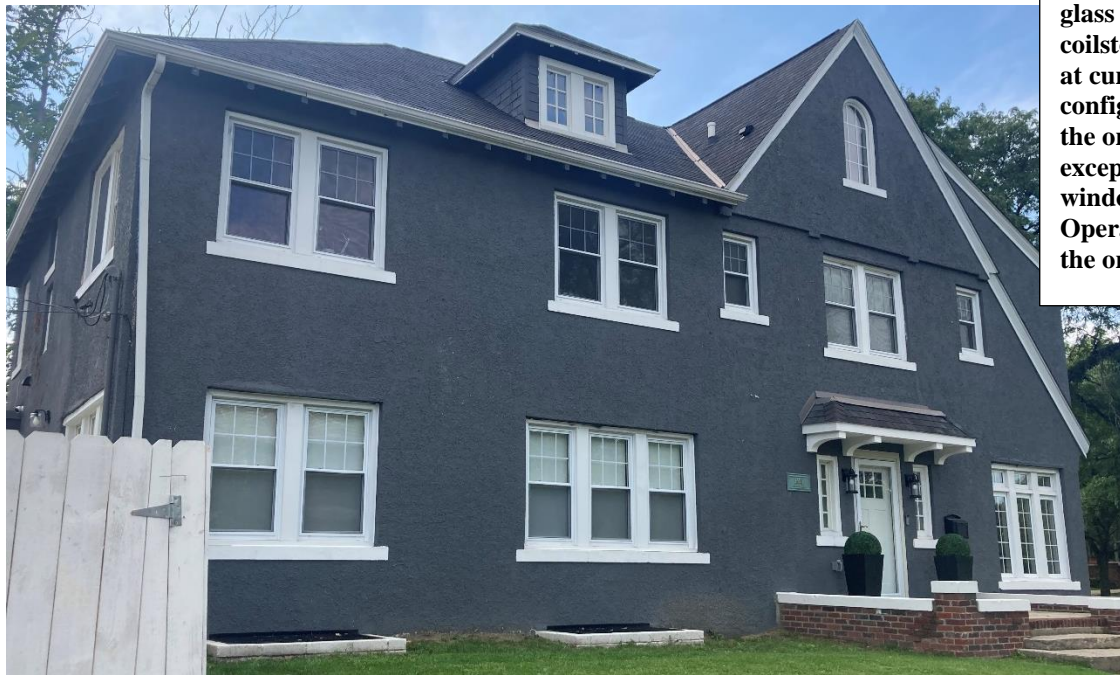
Note muntins between the glass and boxy aluminum coilstock casing and mullions at current windows. Lite configuration matches with the originals with the exception of the arched window in the gable end. Operation appears to match the original windows
