STAFF REPORT: OCTOBER 11, 2023 MEETING

APPLICATION NUMBER: HDC2023-00043

ADDRESS: 4201 GLENDALE

SCOPE: *REPLACE WINDOW SASH, REMOVE TREE AND LANDSCAPING*

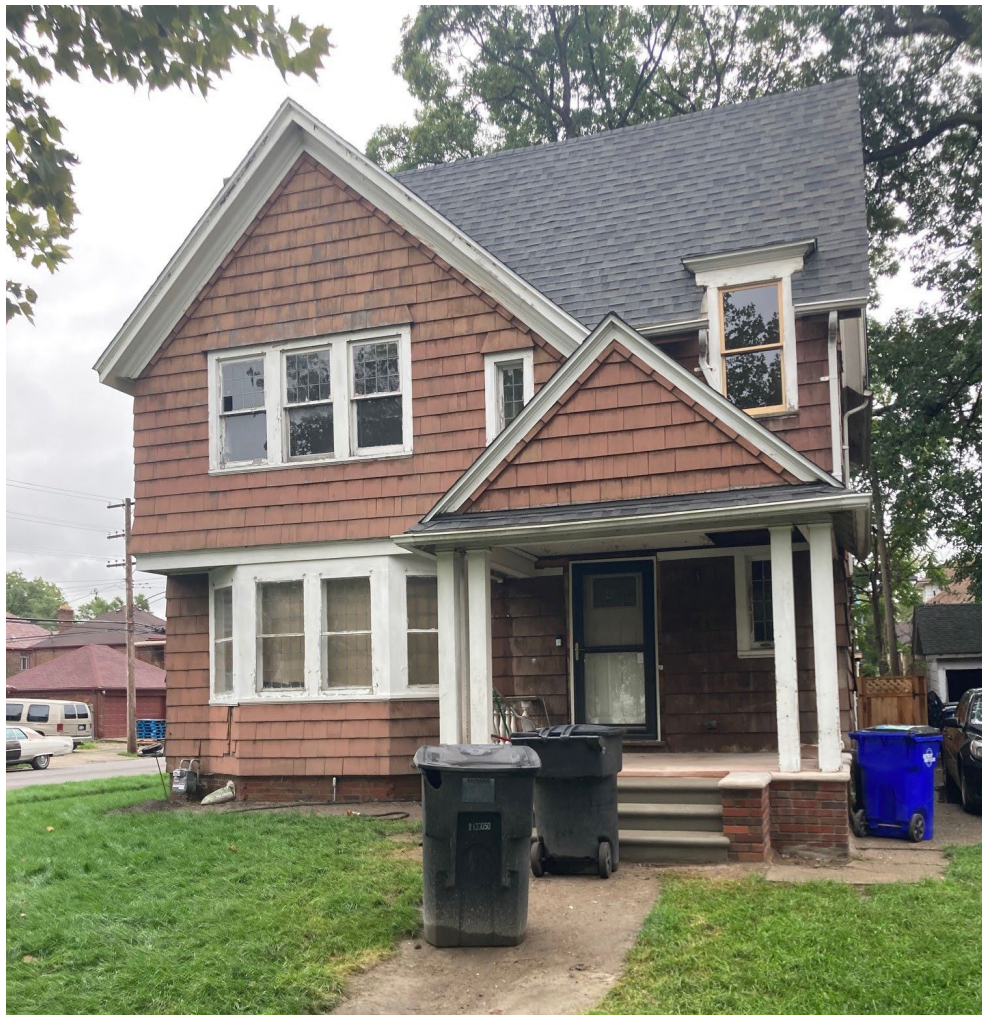
Figure 1: 4201 Glendale, looking southeast.

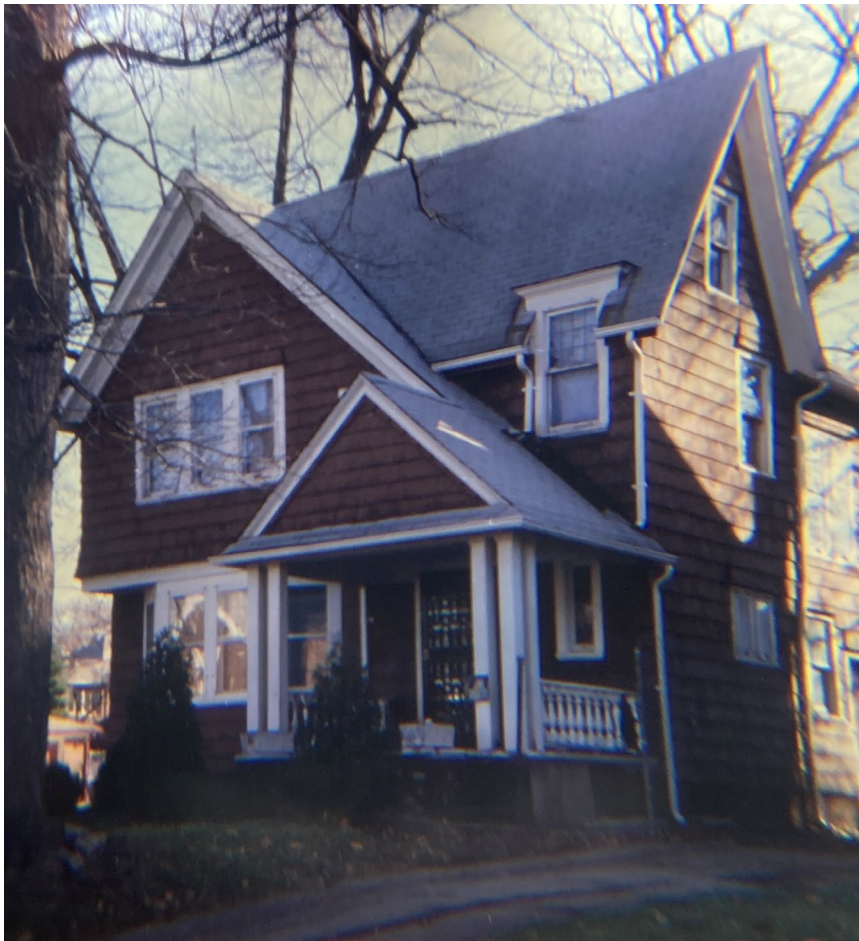
Figure 2: 4201 Glendale ca. 1999, looking southwest. HDAB

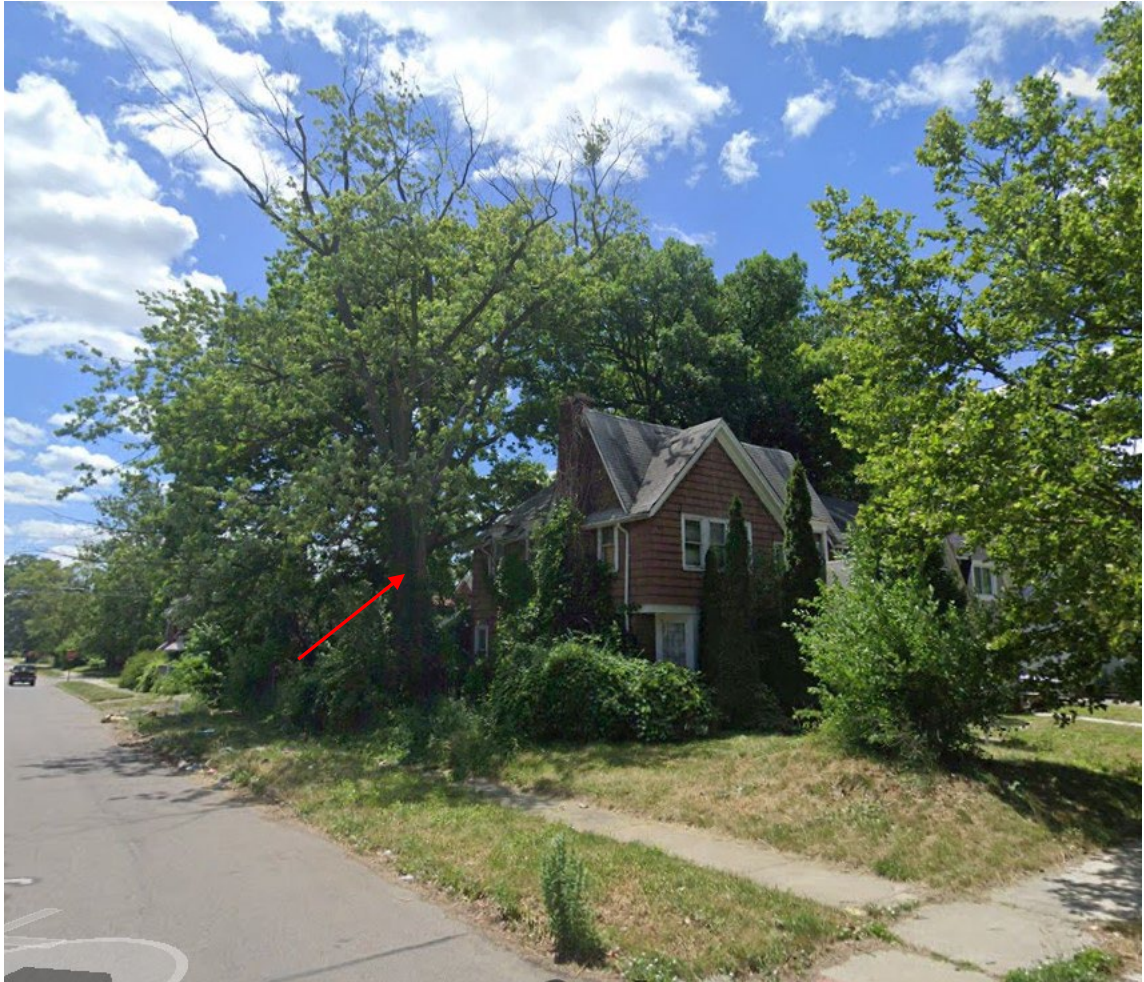
- The Russell Woods-Sullivan Historic District was established in 1999.
- In September, 2023, HDC staff issued a COA for work completed or in progress that included the following work items.
 - Replacement of front door
 - Rehabilitation of front porch
 - Installation of glass block windows at basement window openings
 - Repair of wood shingle siding in kind
 - Installation and staining of rear fence
 - Repair of fascia on board on house and garage
- Images available from Google Street View indicate that the mature tree removed by the applicant was diseased, leaning, overgrown for its location, and had the potential to cause damage to the foundation of the home.

▪ **Figure 3: View of 4201 Glendale from Google Street View, 2022. The red arrow indicates the tree that was removed from the property by the applicant.**

- Available photographs show the shade tree was deteriorating, overgrown, and presented a threat to the historic dwelling. Likewise, the landscape plantings were overgrown and had the potential to damage historic materials on the dwelling. Staff recommends approval for this portion of the application.

Recommendation Two – COA – Removal of mature shade tree, landscape plantings, and replacement of lower window sash with new wood sash.

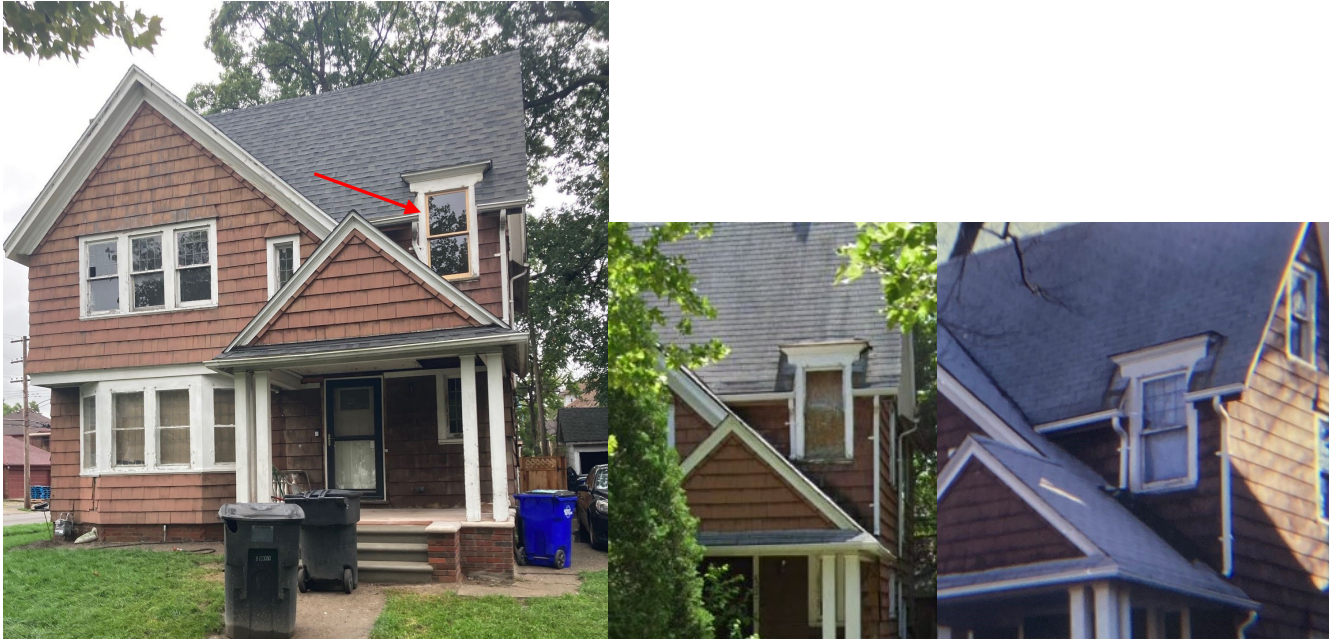
North Wall (Façade): One double-hung, wood sash window has been installed on the façade. This window was missing at the time the applicant purchased the home, but originally featured a leaded-glass upper sash with 12 lights.

Recommendation One – Denial – Replacement of Leaded Glass Window Sash

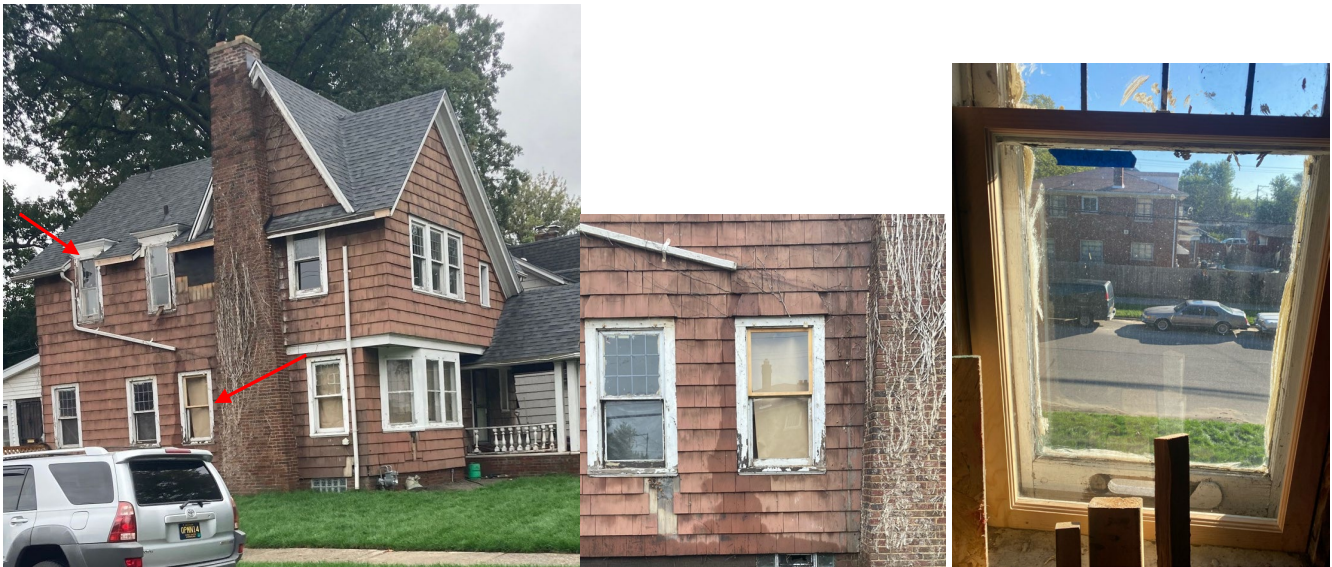
East Wall: One upper sash of a window on the lower story, and one lower sash at the second story have been replaced with new custom wood sash. The prior condition of the window is not visible due to extensive vegetation.

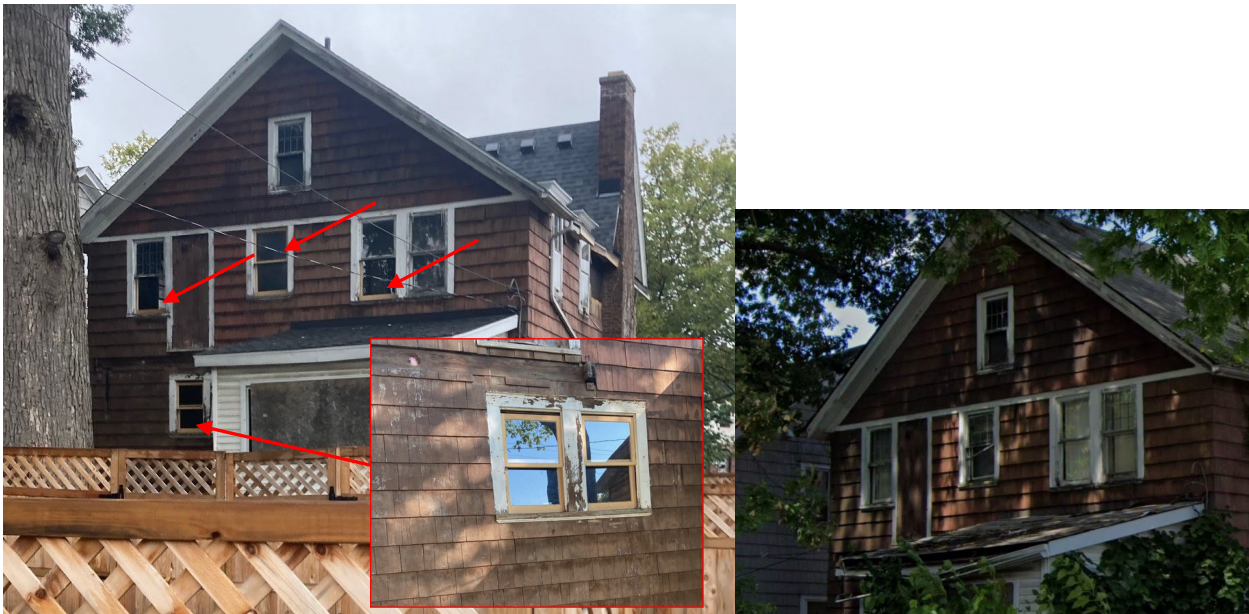
South Wall (Rear): Three double-hung windows and two lower sashes were replaced with new wood sashes. Google Street View photographs indicate all three replaced upper sashes once contained leaded glass, however the central window on the second story was in poor condition.

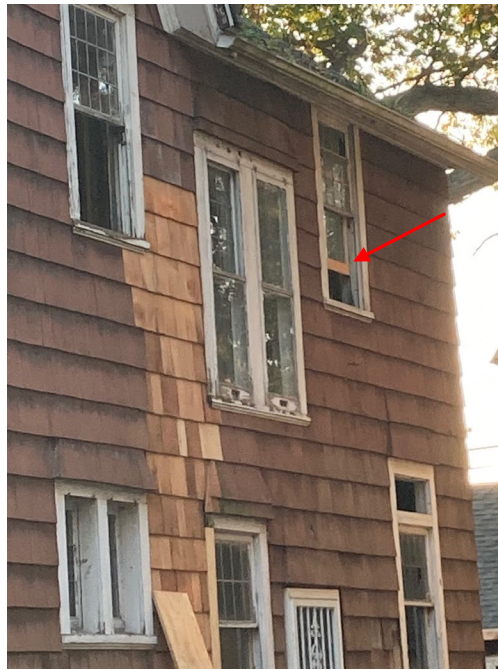
West Wall: The lower sash of a single window was replaced on the north wall.
