**STAFF REPORT: OCTOBER 11, 2023 MEETING**

**APPLICATION NUMBER: HDC2023-00053**

**ADDRESS: 3747 TYLER**

**HISTORIC DISTRICT: RUSSELL WOODS-SULLIVAN**

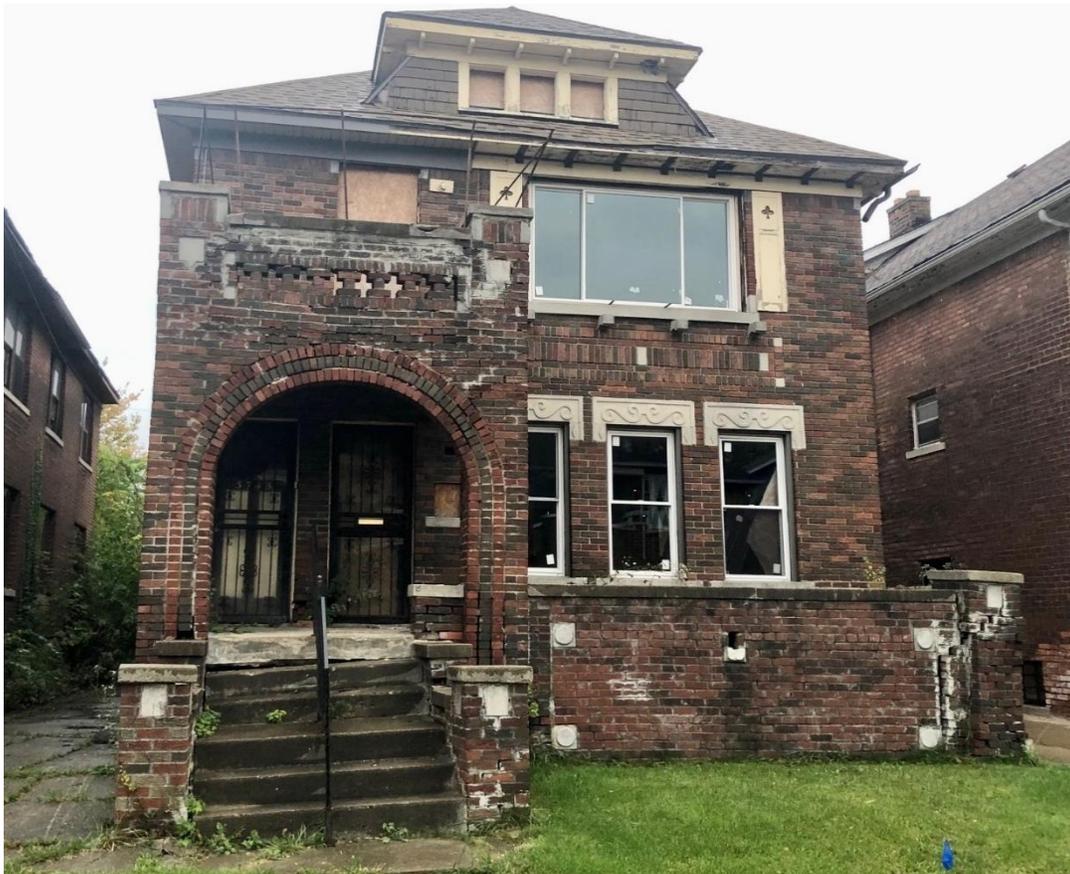
Erected ca. 1927, the property at 3747 Tyler is a 2 ½ story, duplex residence facing north, flanked on either side by concrete driveways, the east driveway reaches the garage at the rear of the property. The hipped, dark asphalt-shingled roof has a low shed dormer at the east elevation and a dominant hip roof dormer at the front elevation which features wood shingle-covered sloping walls, bracketed eaves and three, square mullied window openings. The house is clad in dark brown brick and cast stone details, including the first story window hoods and sills, and unadorned square pieces topping each masonry pier/wall. The side-by-side front doors are accessed through an arched masonry opening that is accentuated by alternating dark red and brown brick. A single door at the second floor opens to the porch above the main entrance where cross-shaped openings offer a spatial relief to the massing of the covered entry porch. An elevated open front porch extends across the front wall and stepped brick wing walls enclose the front stairs. It appears one historic door is present at the front entrance, vinyl windows fill the openings at the first and second floor, and the windows within the dormer and the porch door are covered or missing.

*Staff photo, September 26, 2023.*

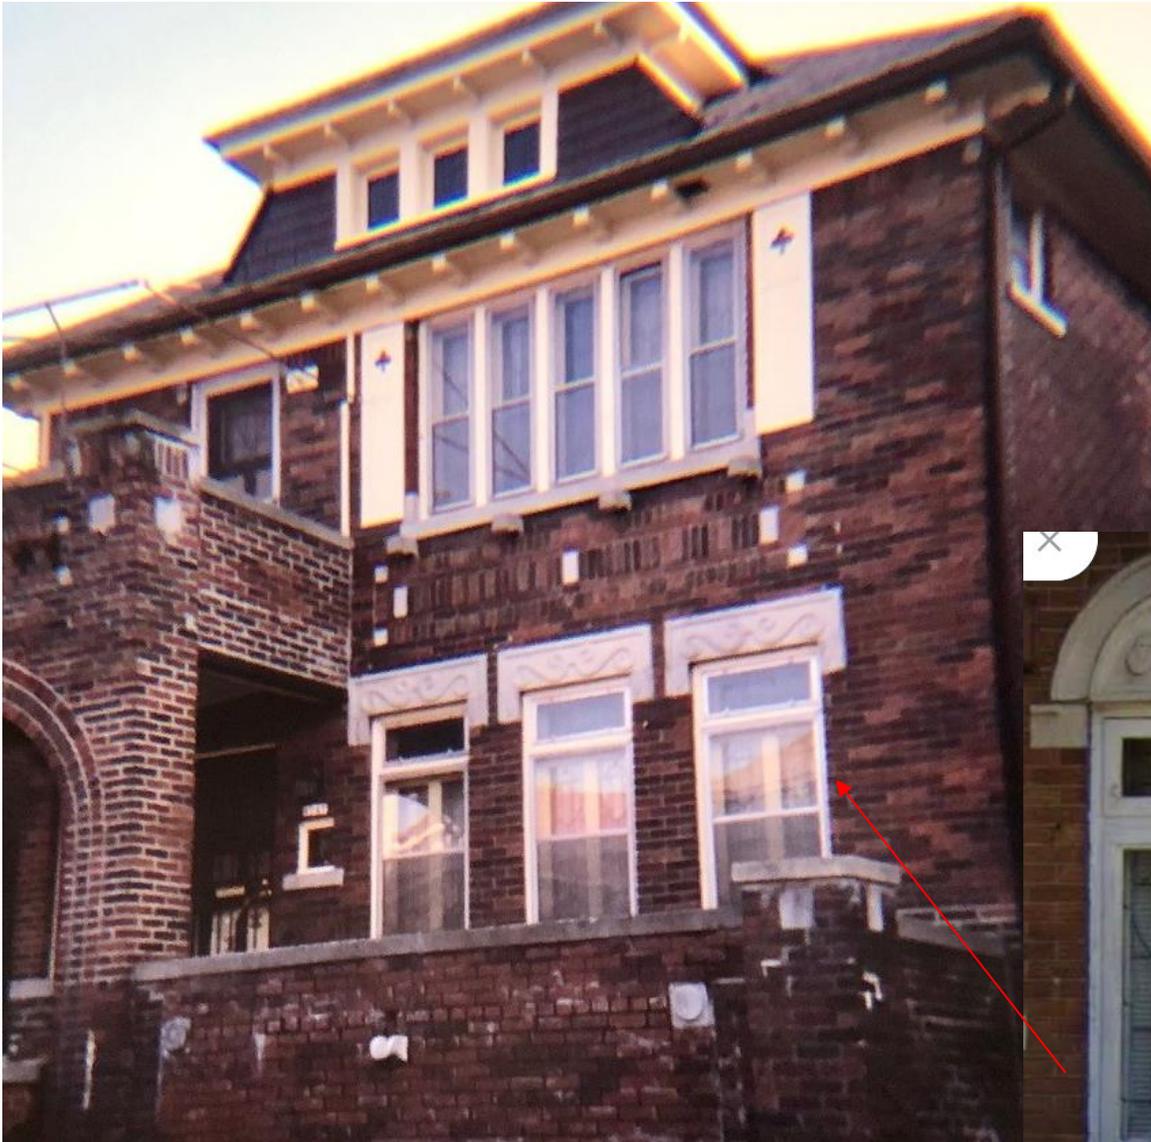
- The Russell Woods-Sullivan historic district was established in 1999.
- The designation photo shows leaded glass windows within each front elevation window opening, including a matching glass panel in the door leading to the porch. It appears the front doors had a similar panel/glass design. The first and second floor windows were vertically oriented, while the third-floor square windows echoed the square leaded glass panels in the doors. The windows and doors were distinctive character-defining features. All original windows were replaced, without HDC approval, between 2013 and 2022.

*Designation photo, HDAB.*

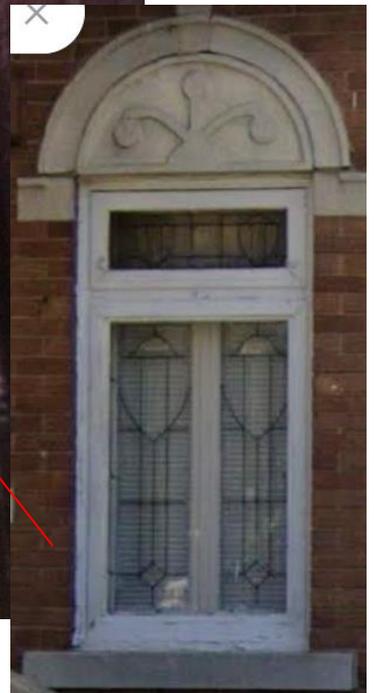
*Right: 3755 Tyler, Google street view, June 2022.*

- The window shown at right is in the neighboring house (3755 Tyler) and appears to staff to be an identical pattern to what had been in place at 3747 Tyler.

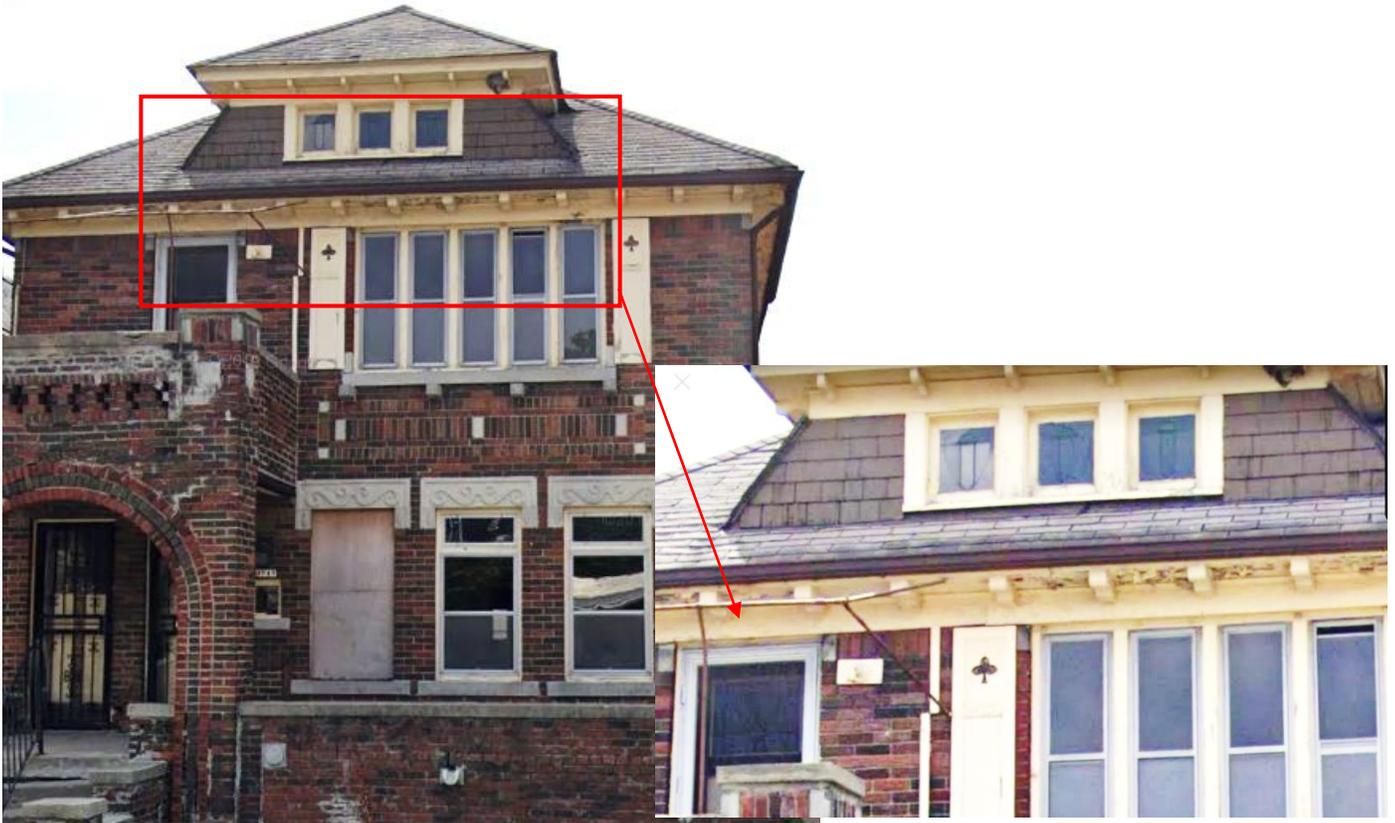
- According to Google street view, the leaded glass windows and doors were all in place as of August 2013. The next available image is from August 2018 and shows the windows at the first floor and second floor had been removed (but the double-hung storm windows remained in place), the leaded glass windows in the dormer remained, as did the front entry doors and second floor door leading to the porch. The 2019 image below shows visual clarity of the 2018 conditions.

*Google street view, August 2019.*

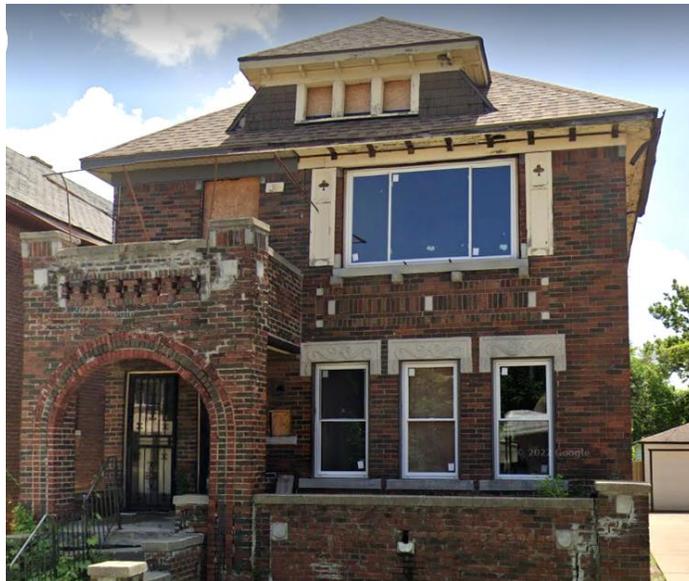
- Reviewing additional Google street view images, the remaining windows and upper porch door were removed (or covered) between June 2019 and June 2022 and the existing vinyl windows were installed.

*Google street view, June 2022.*

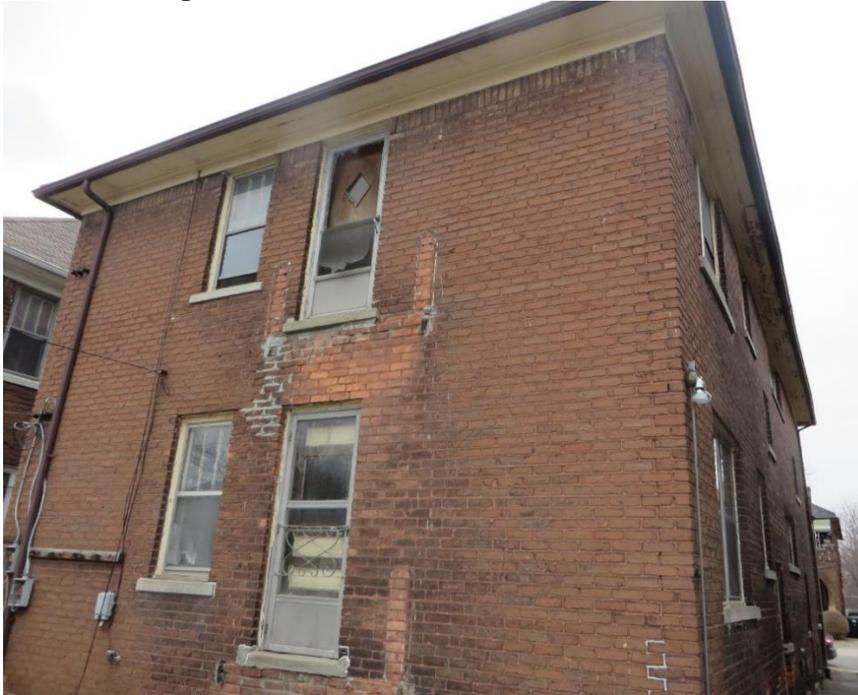
*These two photographs were in a folder from a previous (incomplete) application and offer a clear before and after comparison of the rear elevation.*

*Photo at left - January 2018. The window openings have wood double-hung windows with three vertical glass panels in the top sash. The first floor paneled/glass door may be original, while the second floor door design reflects a later replacement door.*

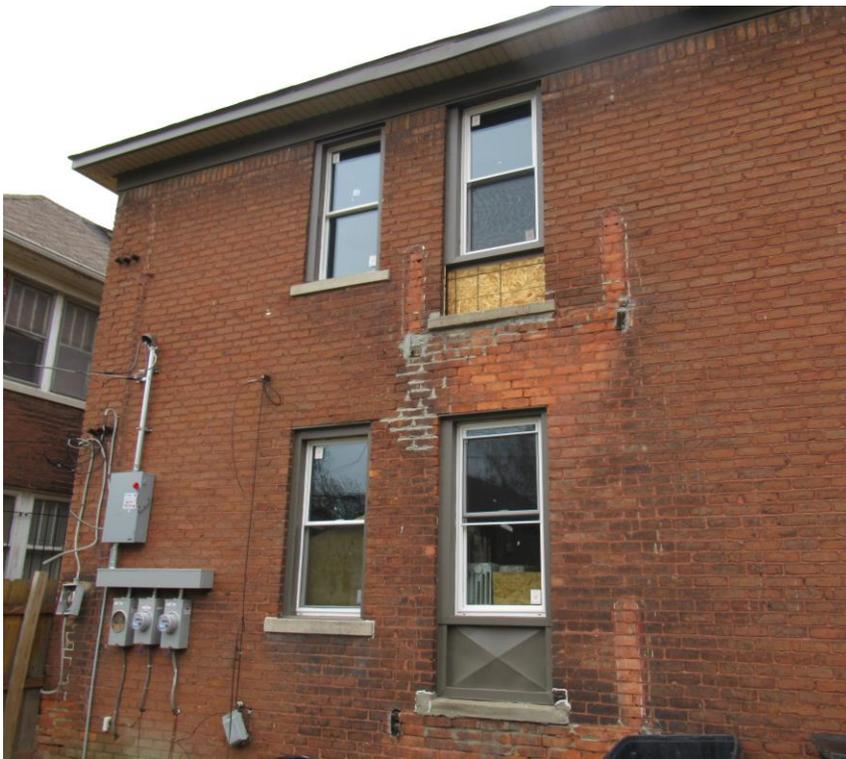
*Photo at lower left – November 2021. The window openings have one-over-one vinyl windows, the wood brick mould has been capped, and the door openings have been resized/infilled to accommodate one-over-one vinyl windows.*

*Staff doesn't know when the two-story porch was removed.*

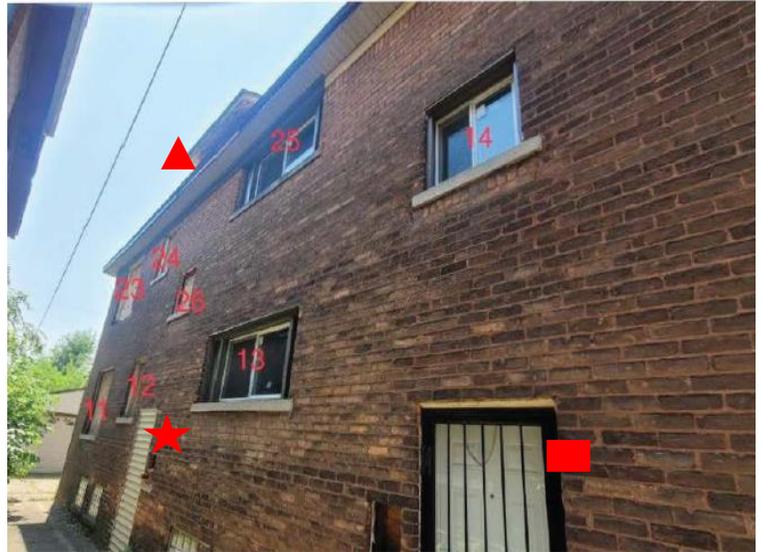
Above - 2022 application photo.

Staff noticed the east elevation rear door opening (★) has been covered with vinyl siding, and the door closer to the front of the house (■) has been replaced with a solid paneled door.

Staff believes there are windows in this east elevation dormer (▲). The dormer window(s) and east elevation doors are not included with this application.

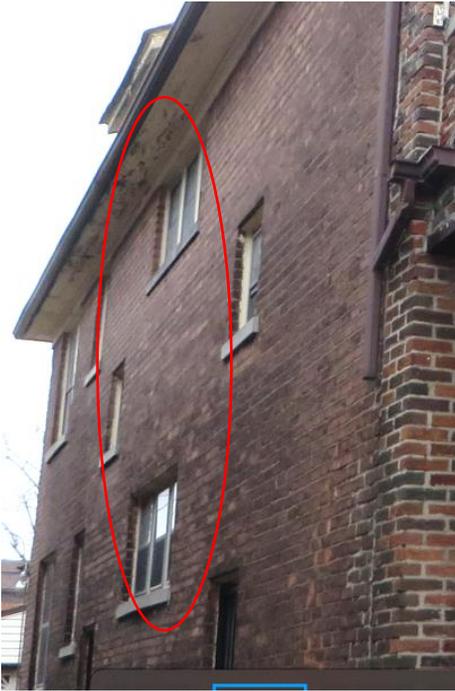
- Neither a project review request form nor a written scope of work were submitted. The applicant has not replied to staff communication requests related to this project. Staff listed the proposal scope of work based on the submitted materials.
- The 2018 east elevation photo of 3747 Tyler shows mullied units in the wider than tall window openings, the 2018 rear elevation photo of 3747 Tyler shows three-over-one double-hung units, and the 2022 photo of 3755 Tyler shows three-over-one double-hung mullied units in a similar wider than tall opening, therefore it is staff's opinion the side and rear elevation windows at 3747 were consistently three-over-one double-hung units in single and mullied window openings.

*3747 Tyler, 2018 east elevation.*

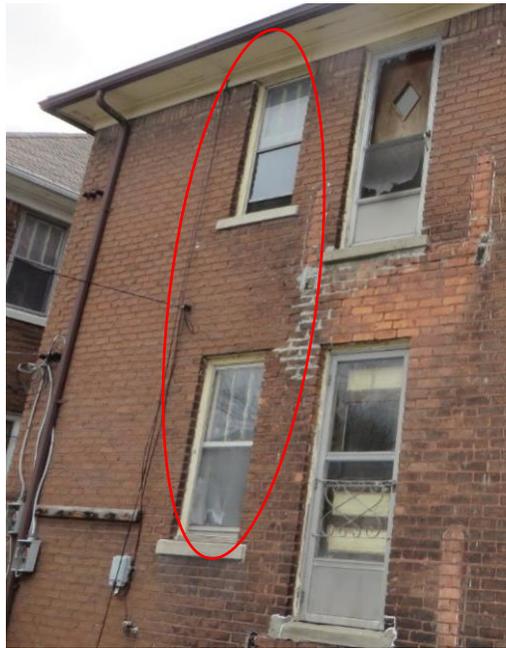
*3747 Tyler, 2018 rear elevation.*

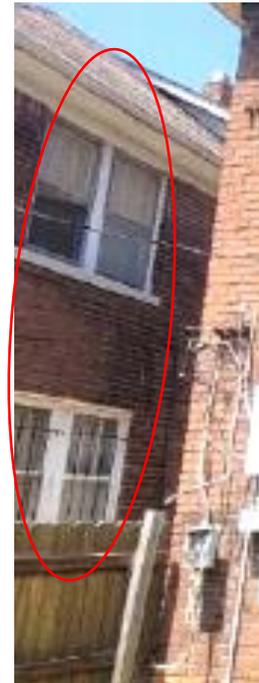
*3755 Tyler, east elevation.*

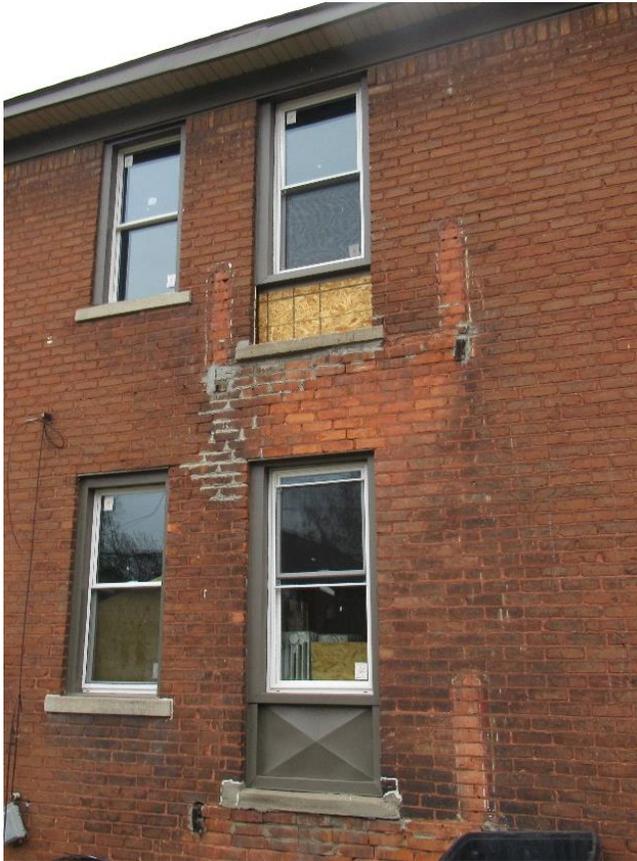
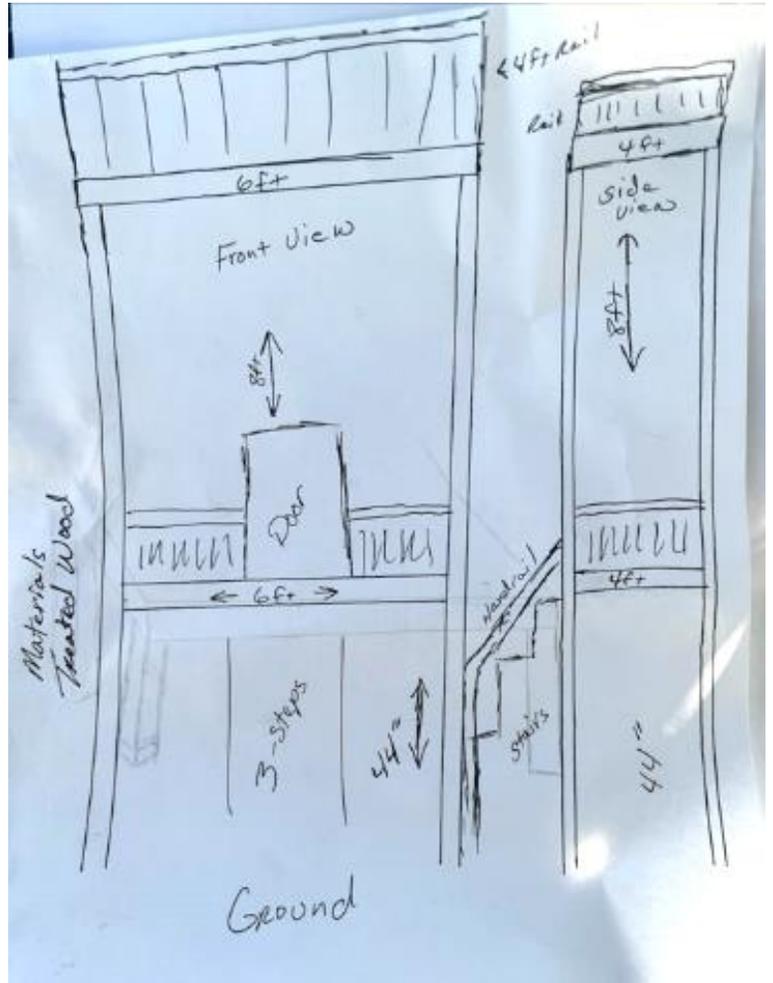
- The two-story rear porch has been gone since at least 2009. The submitted drawing offers an idea of what is proposed, but the applicant must submit a detailed dimensioned drawing that clearly shows the design, dimensions and finish of the proposed porch, railing, and steps. The porch and step railing should have defined corner posts and balusters/spindles should fill the area between the top and bottom rails. All porch components must be painted after the wood dries out; a paint color will be selected and included on the revised drawings to be submitted to staff for review.
- The current proposal is to retain windows within the door openings that lead to this porch. It is staff's opinion doors should be installed within these openings.

*Applicant photo and drawing*

- The submitted drawings for the rear porch do not offer clarity of dimensions, design, and finish for this two-story element. Additionally, the applicant proposes to retain windows within the door openings leading to the porch. This is not an appropriate solution for these openings; doors should be reintroduced to the door openings as part of the porch design.
