**STAFF REPORT: NOVEMBER 8, 2023 MEETING**

**APPLICATION NUMBER: HDC2023-00082**

**ADDRESS: 1257 LONGFELLOW**

**SCOPE: REMOVE WOOD WINDOWS (WORK COMPLETED WITHOUT APPROVAL), INSTALL VINYL WINDOWS**

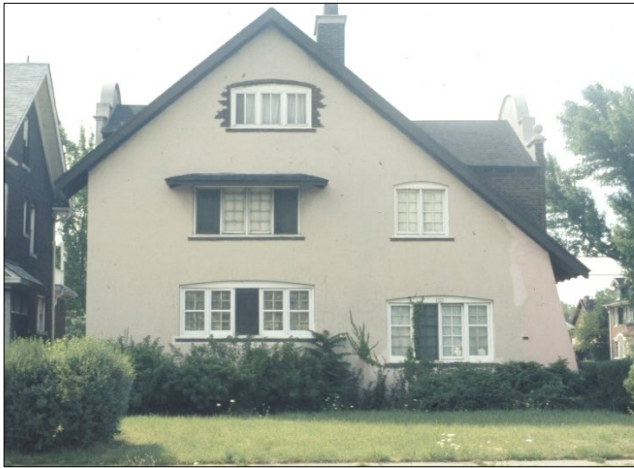
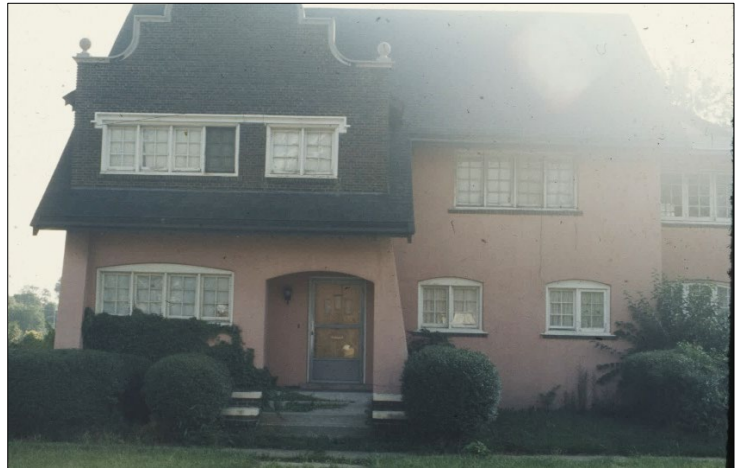
*Designation photos, 1974. HDAB. These photos capture the west/Byron elevation (above right) painted a different color than the north/Longfellow elevation (above left). The two colors remained in place through at least 1980, the house current has a uniform off-white paint color on the house and garage.*

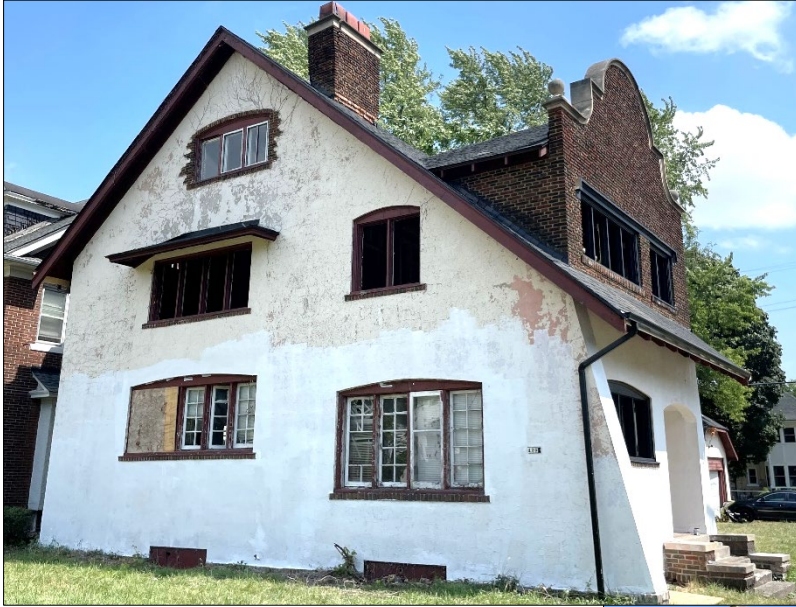
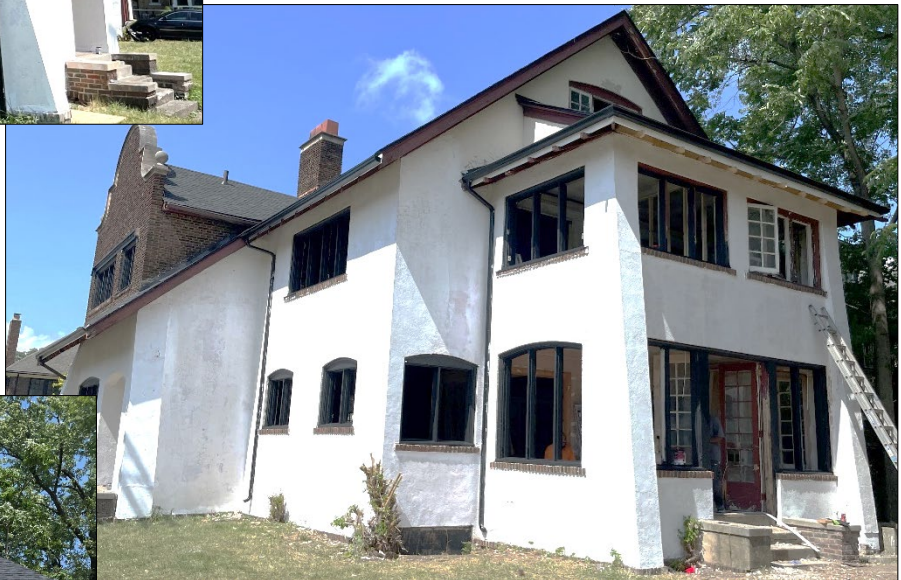
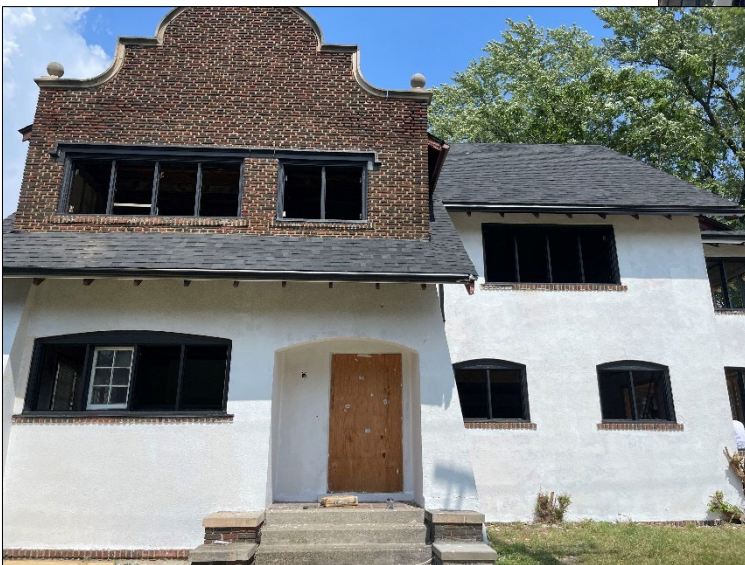
Staff photos, August 1, 2022.

*Above: Longfellow elevation – Windows at the second floor had been removed.*

*Right: South elevation faces the garage; most of the windows have been removed.*

*Below: Byron elevation – All but one window had been removed.*

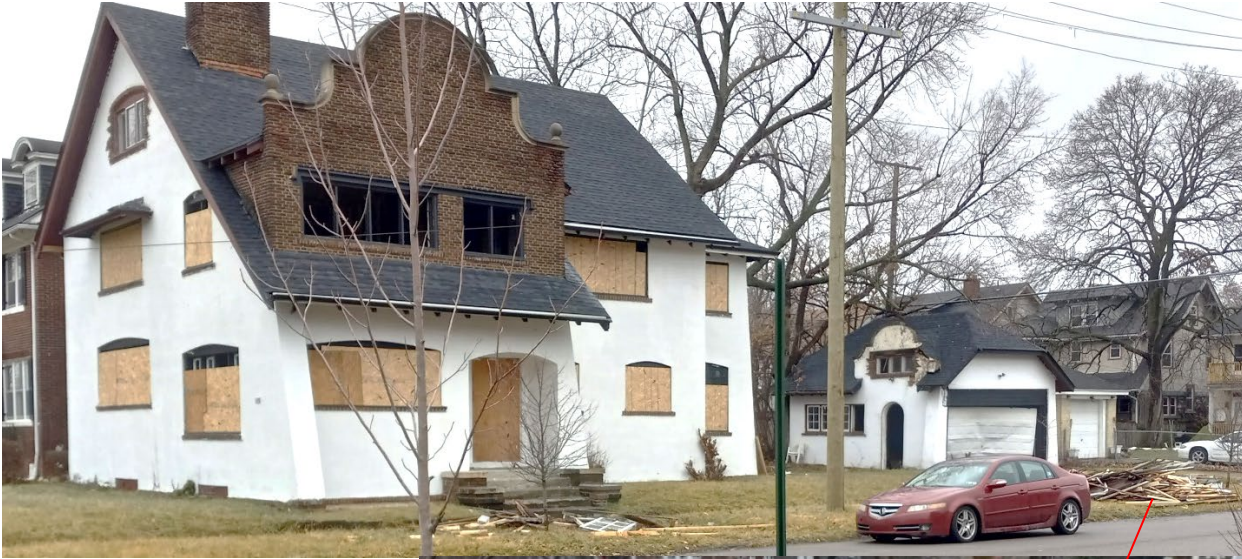
*Undated photos that accompanied the January 3, 2023 email to HDC staff.*

- Based on images that showed the windows within the openings prior to removal, as well as the photo of the discarded windows at the curb, it is staff’s opinion the visual documentation showed the window sash were intact and the wood frames and glass panes appeared to be in repairable condition.

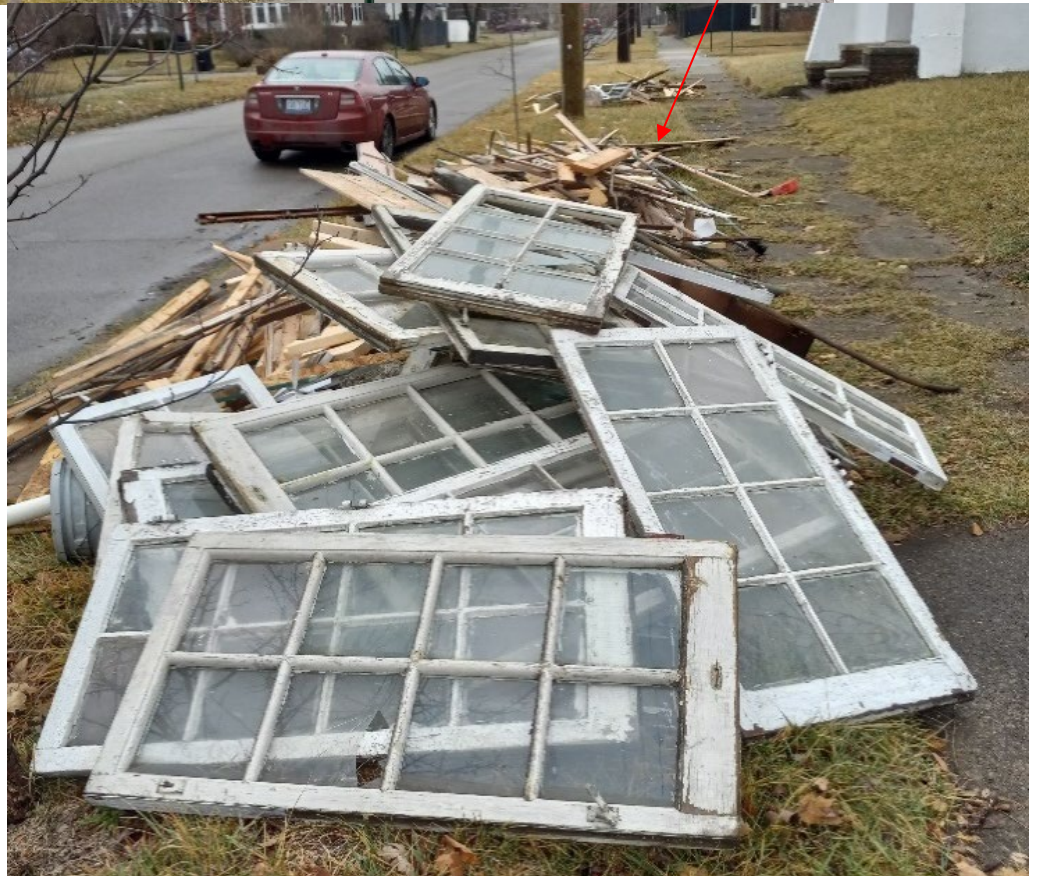
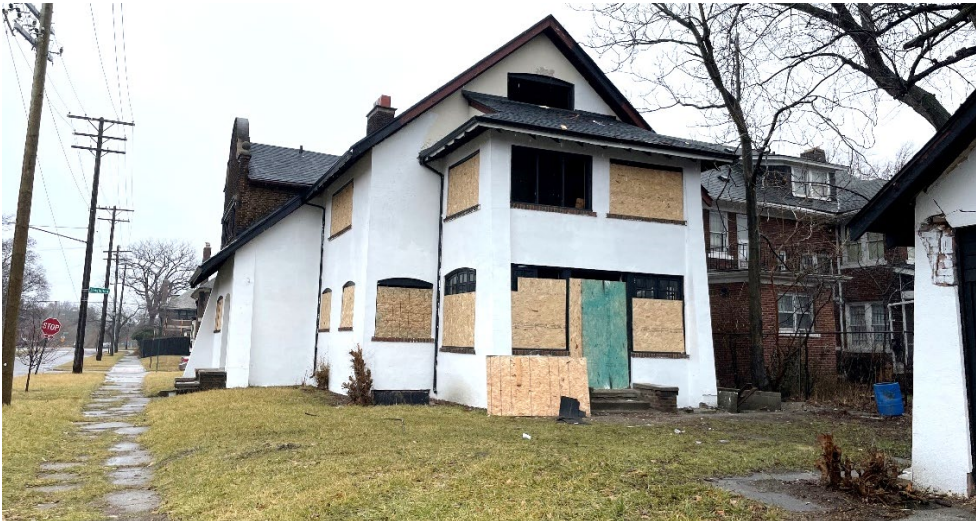
- January 3, 2023 –HDC staff visited the site and noted that the windows were gone, only shards of glass remained.

*Staff photo, January 3, 2023.*

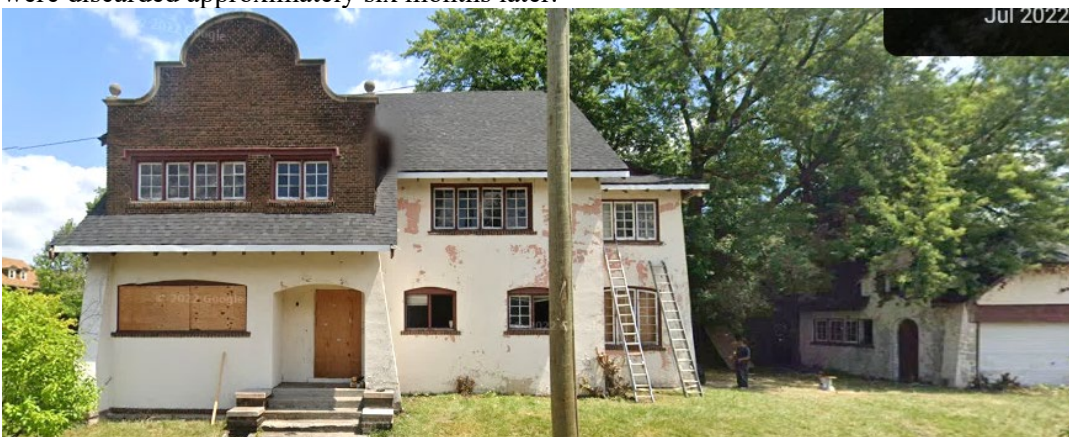
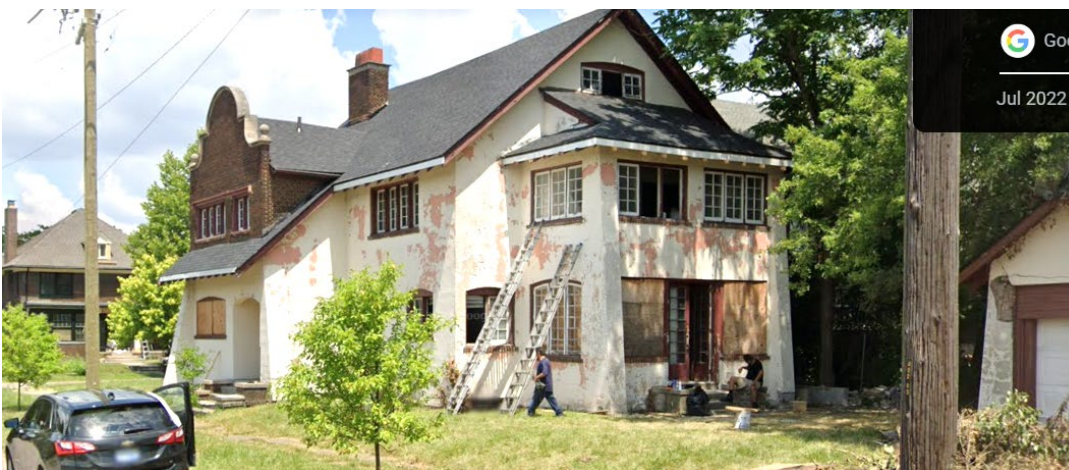
- During the drafting of this report, staff reviewed the house’s visual timeline on Google Maps. The July 2022 street view images captured people working at the property and the windows being removed. This is the activity led to the August 2022 SeeClickFix notification. As noted in the above timeline, the windows were discarded approximately six months later.

*Google street view, July 2022.*
