STAFF REPORT: 12/13/2023 REGULAR MEETING

APPLICATION NUMBER: HDC2023-00046

ADDRESS: 4750 CORTLAND

SCOPE: REPLACE WOOD WINDOWS

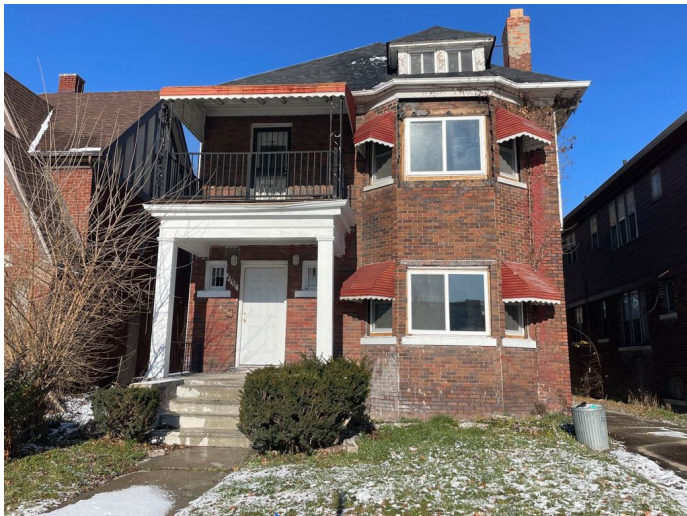
Site Photo 1, by Staff November 28, 2023: (South) front elevation.

- Some unapproved work, such as the removal of the windows, may have been done by a previous owner. As described under existing conditions, Staff observed that the following work was completed without approval (*See photos 1 & 3*). Other than the 12 windows listed above, these items are not included in this application at this time:
 - Replacement of west elevation and rear elevation windows with vinyl windows
 - Replacement of wood panel front door with steel door
 - Removal of window awnings
 - Removal of brick cladding and window sill from front elevation.

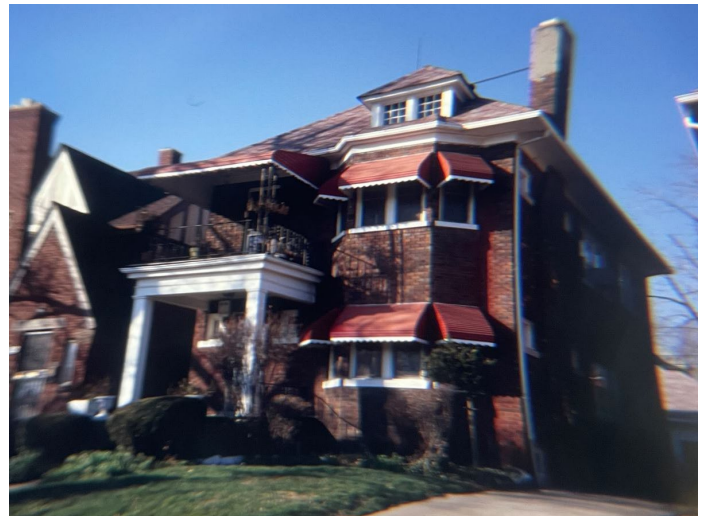
Designation Slide, 1999: (South) front/side elevation showing original windows, porch, entrance, and roof. Note chimney support.

- From the designation slide, it is staff's observation that most original windows were wood, double-hung with a 9/1 true divided-light configuration. Some remains of these wood frame windows were recently partially or fully present in the house prior to replacement with vinyl windows. It is staff's opinion that these remaining windows could have been potentially repaired and did not require replacement. (Staff has not received a report on the condition of these windows, or if they are still available to be repaired.) It is staff's opinion that these original wood windows, their double-hung operation, and formation are distinctive character-defining features that have been either removed or neglected.

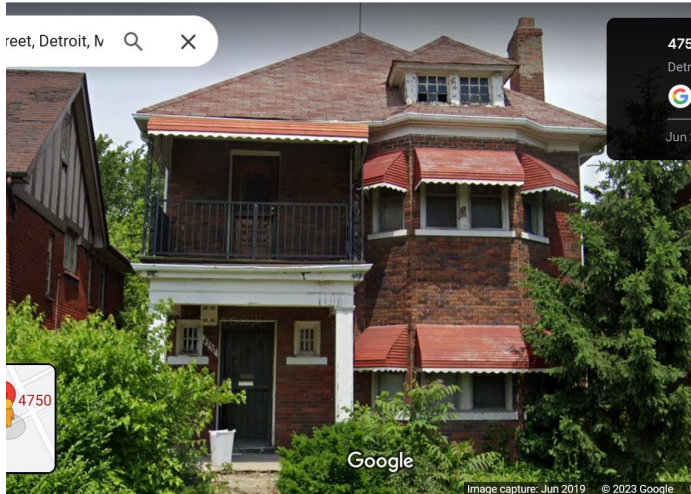
Site Photo2, Google Streetview June 2019: (South) front/side elevation showing conditions before current owner work.

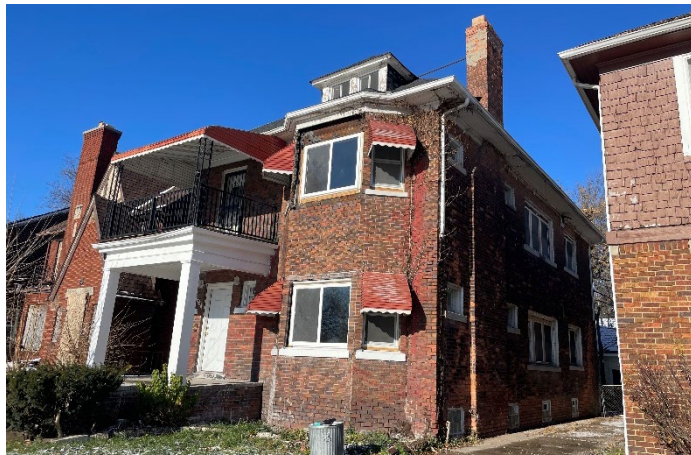
Site Photo 3, by Staff November 28, 2023: (South) front elevation, showing side wood windows replaced with vinyl windows.

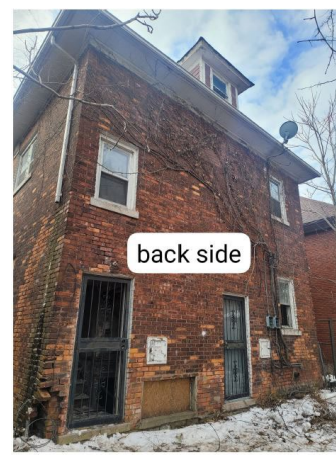
Site Photo 4, by Applicant 2023: (North) rear elevation.

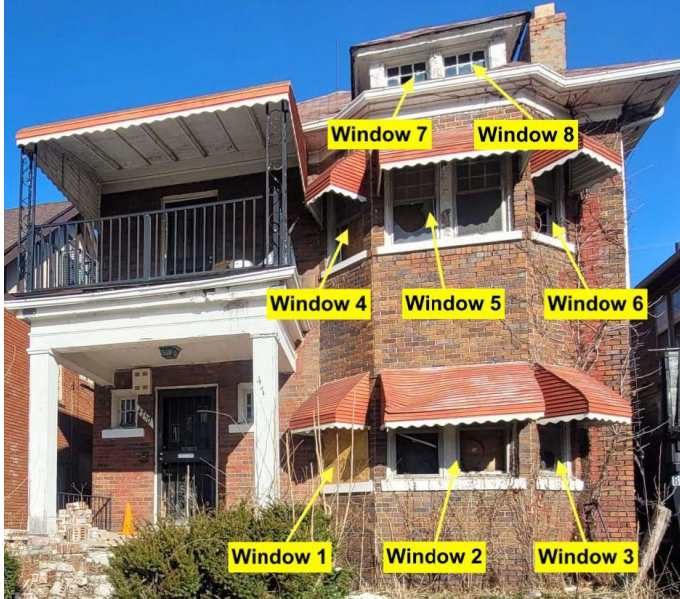
Windows 1-6, single-hung wood windows, no sashes
Windows 7-8, “sashes windows”

Site Photo 5, by Applicant 2023: (South) front elevation, showing proposed replacement locations of windows 1-8.

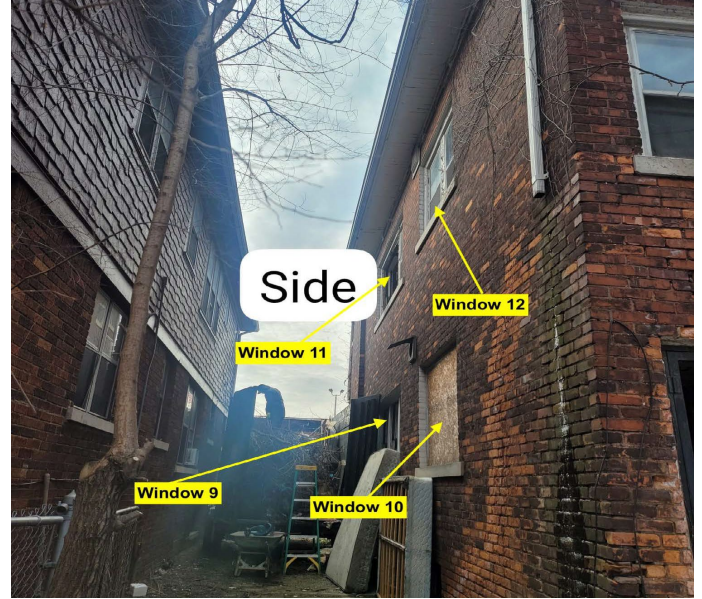
Windows 9-12, single-hung wood windows

Site Photo 6, by Applicant 2023: (East elevation, looking southward) side elevation, showing proposed replacement locations of windows 9-12.

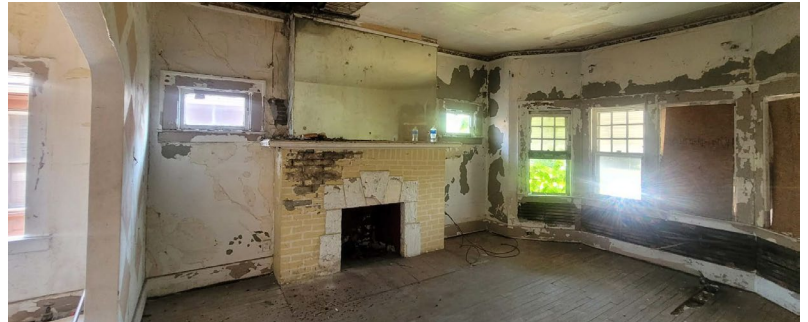
Site Photo 7, by Applicant 2023: Interior, looking towards front bay and east side of the house, showing original windows by fire place and 9/1 configuration of wood windows in the front bay.

- Installation of porch sconces.
- The applicant states wooden windows were missing or broken. However, staff sees in the applicant photos that some wood windows remained until recent replacement with vinyl windows. Staff requested the applicant to provide photos of showing evidence that the original window were beyond repair, but have not received this information at the time of this report. (See site photo 7.)
