STAFF REPORT: DECEMBER 13, 2023 MEETING

APPLICATION NUMBER: HDC2023-00139

ADDRESS: 19245 PARKSIDE

SCOPE: REPLACE ORIGINAL WINDOWS WITH VINYL WINDOWS, REHABILITATE EXTERIOR (WORK COMPLETED WITHOUT APPROVAL)

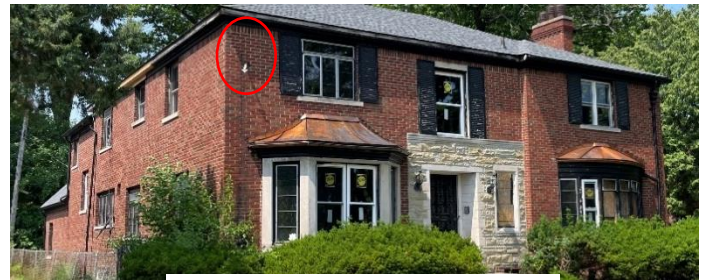
- While writing the staff report, staff noticed that the collector box and downspout at the left/south end of the front elevation were removed between June 2022 and June 2023. *The collector box, and its accompanying downspout bracket, are a distinctive character-defining feature. Although small in size, when compared against the massing of the front façade, their profile and detailing are an impactful and interesting component to the otherwise utilitarian-designed downspout. The applicant stated in a 12/10 email that the collector box was damaged after a fire and removed, and there is no plan to repair or replace it.*

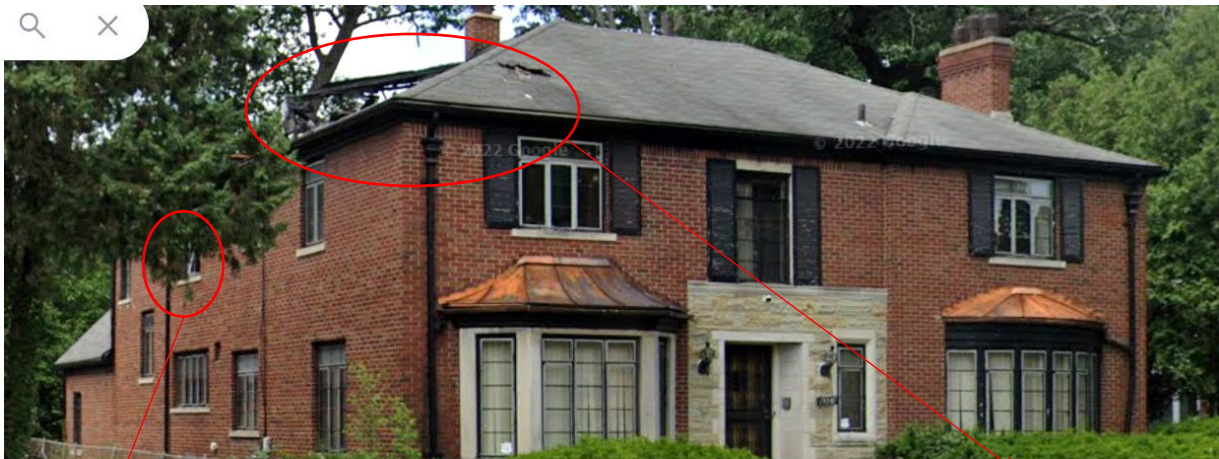
- BSEED’s electronic permit system, Accela, notes a fire insurance claim was made in the summer of 2022. Evidence of a fire is circled in the below photo. The south-facing dormer is gone, a small hole is in the front roof, and it appears one of the casement windows units at the south-side elevation was severely damaged.

Above and left: Google street view, June 2022. The damaged window is partially visible, and the roof dormer is destroyed.

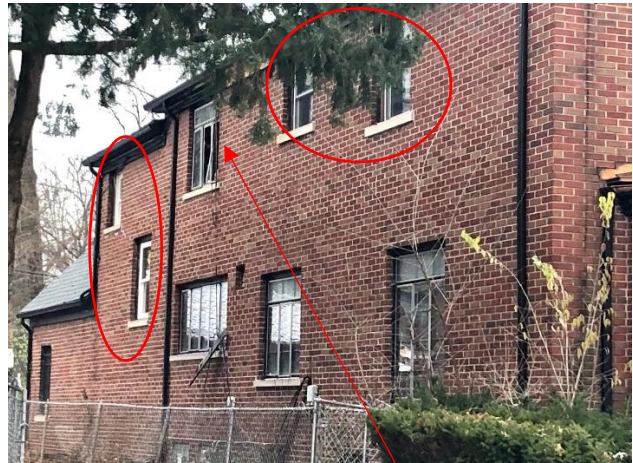
South-side elevation

Staff photo, November 2023. The damaged casement, shown on the previous page, is visible here. Installed vinyl windows are circled.

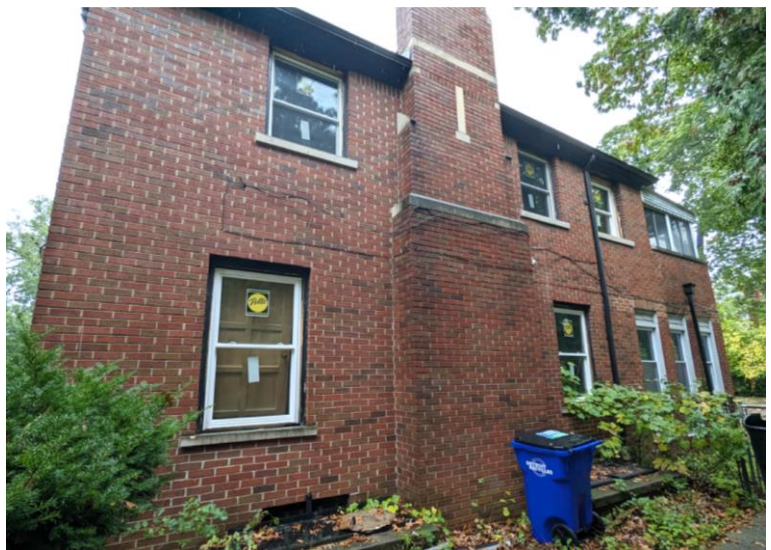
North-side elevation

Applicant photo. All the historic window sash on this elevation have been replaced with vinyl windows.

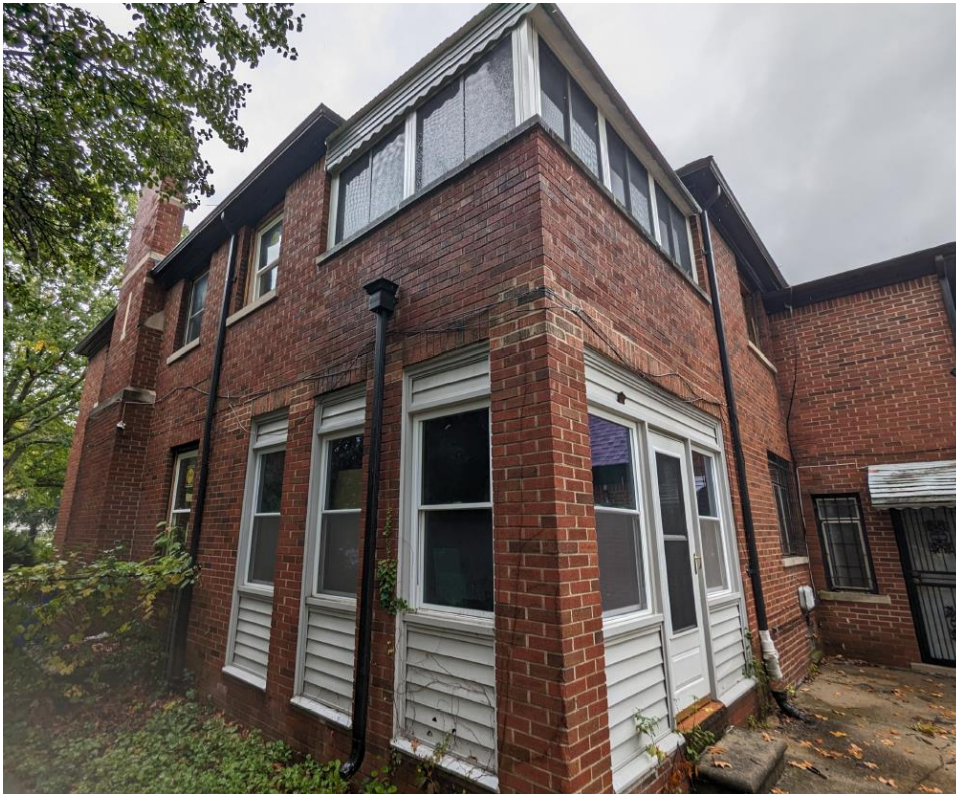
South-side and partial rear elevations

Applicant photo. Based on the masonry design of this rear corner, staff believes the upper area was possibly an open porch originally, and the lower area was possibly a screened enclosure. The vinyl window units within the first floor openings appear to be newer than the siding enclosure; the 2018 image on the preceding page shows vinyl units and the enclosed openings were in place at that time. Staff doesn't have earlier photo documentation of this area, but enclosures of porches in the 1950s-1980s were very common, so it is possible these enclosures pre-date district designation.

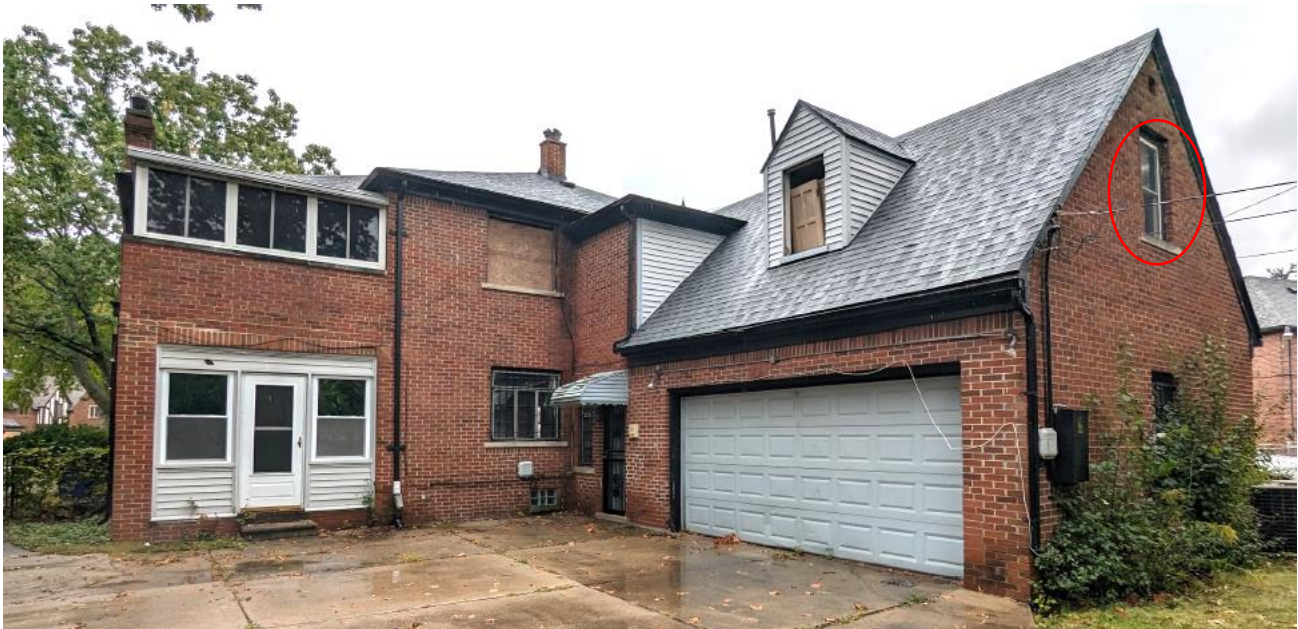
Rear elevation

Applicant photo. At the second floor of the garage, one vinyl window has been installed, and two openings (one at garage, and one at house) have had window sash removed. Historic sash remains at the first floor of the house and garage.

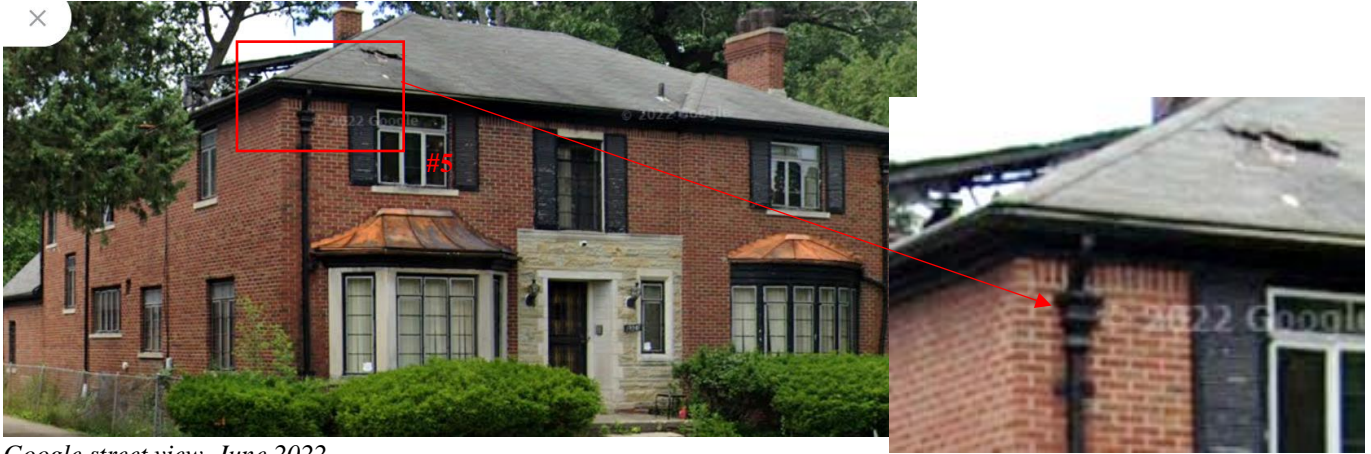
- *The applicant stated the collector box was removed due to it being damaged by the fire. However, the below June 2022 post-fire Google street view images show the collector box and decorative downspout bracket intact. Standard Six states, “Deteriorated historic features shall be repaired rather than replaced. Where the severity of deterioration requires replacement of a distinctive feature, the new feature shall match the old in design, color, texture, and other visual qualities and, where possible, materials. Replacement of missing features shall be substantiated by documentary, physical, or pictorial evidence.” Even if the bracket and collector box were damaged beyond repair, Standard Six requires in-kind replacement of historic features.*

Google street view, June 2022.

- *The collector box/bracket and windows were removed without Historic District Commission approval. Therefore, based on the Standards, new windows and a collector box and downspout bracket should be reinstalled and should match all the details of the historic components that were removed.*

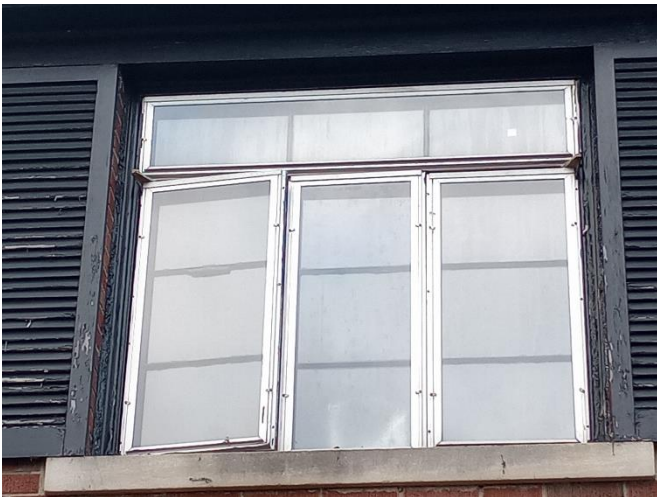
Applicant photos. This is Window #5, and is located on the front elevation, second floor, far left (as seen in the photo at the top of the page).

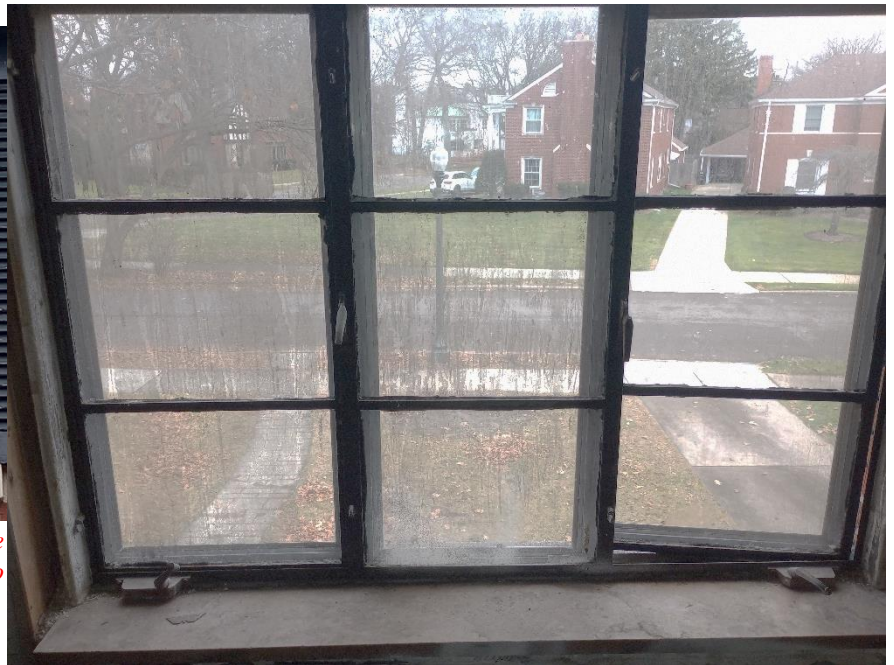
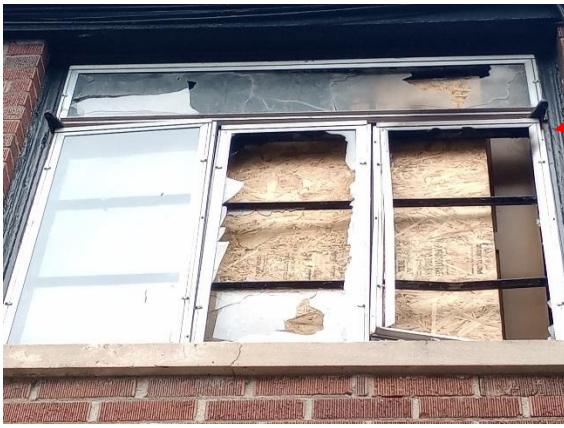
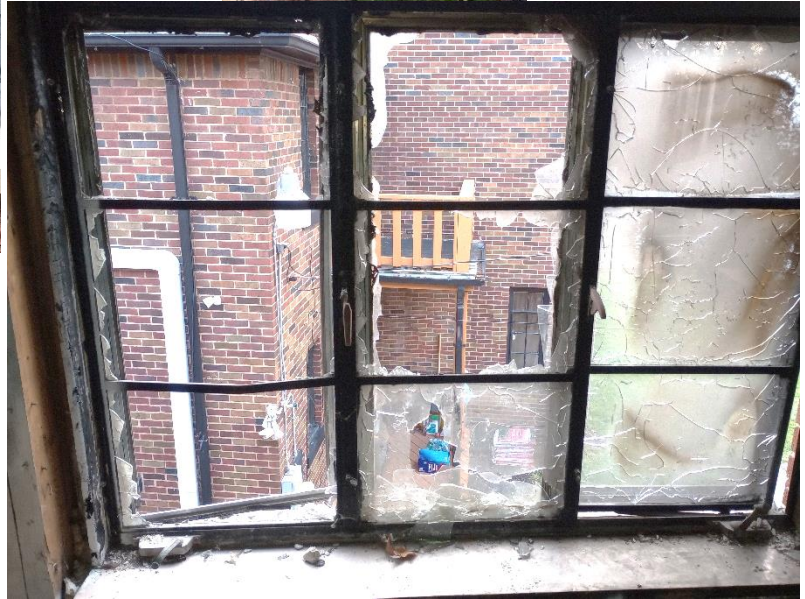
Above right: South elevation, severely damaged opening is #8.

Above and right: Close-up views of damaged window opening, which includes a bent window frame. Staff believes the damage of the windows in this opening is severe and is beyond feasible repair.

Recommendation Two – Certificate of Appropriateness – Replacement of damaged steel windows (opening #8), installation of new front entry door and entry lights

- *The replacement windows for opening #8 will sufficiently replicate the aesthetic and physical characteristics of the original window as determined by staff.*
