**STAFF REPORT: 9/13/2023 MEETING**

**APPLICATION NUMBER: HDC2023-8524**

**ADDRESS: 4138 LINCOLN**

# 4138 Lincoln St. Renovation Historic District Commission Review

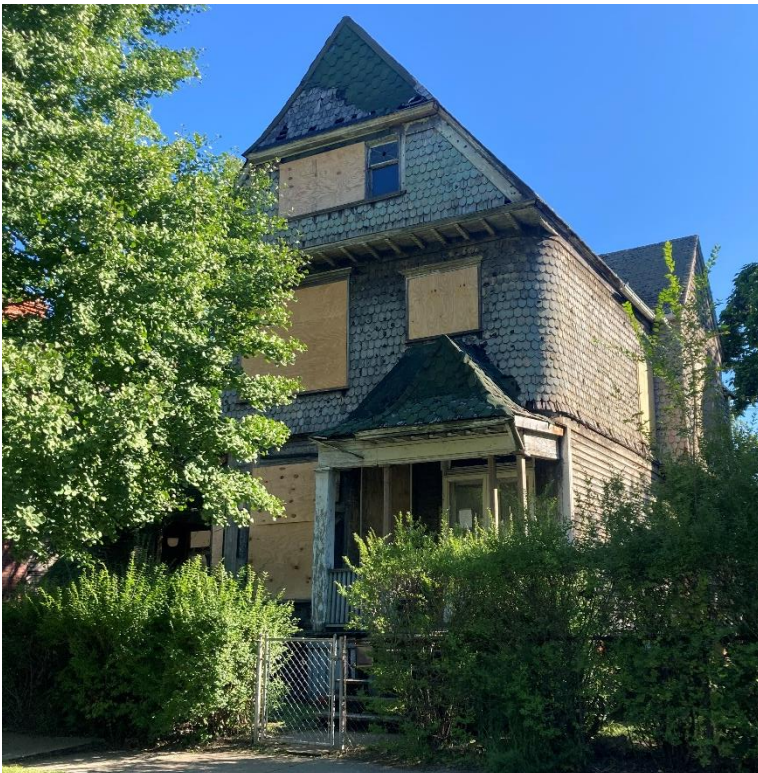
**4138 Lincoln, current appearance. Staff photo, taken 8/31/2023**

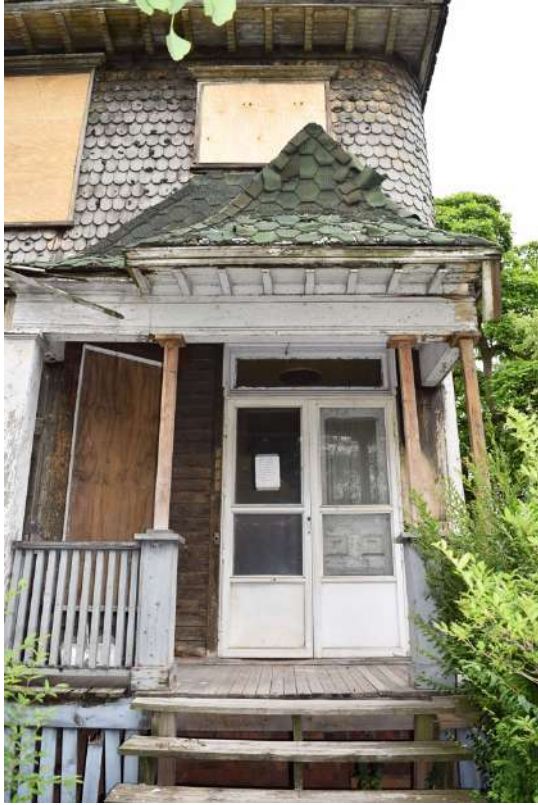
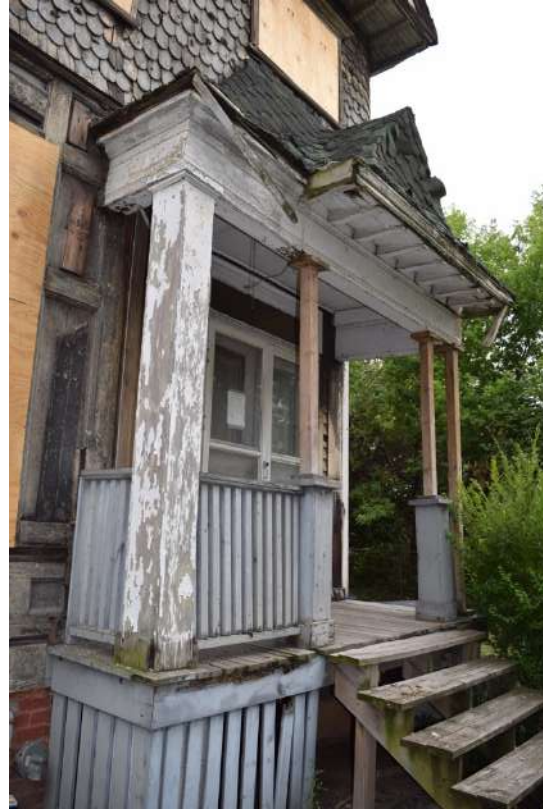
The house features a gabled roofline at the front and hipped roof at the rear. The coatings of the existing roof shingle are degraded and require replacement. The existing front porch roof is in repairable condition, but visibly detaching from the main house structure. The existing porch columns, guardrail, decking, and skirting are not original to the structure and have significant portions missing or deteriorated beyond repair due to improper connections and general neglect. The original wood lap-siding that wrapped the majority of the house and wood scallop shingle cladding at the second story of the front and partial side facades was uncovered by the

The proposed rebuilt front porch will not deviate from that approved within the COA issued in March 2021. The original porch roof structure will remain and be stabilized/reinforced as necessary, and the porch posts and base will be completely rebuilt per the attached drawings. The original double-swing panel front door is to remain and be refinished with a dark stain, and the existing aluminum storm door will be removed. The roof shingle covering will be replaced with new asphalt shingles to match those of the main roof.

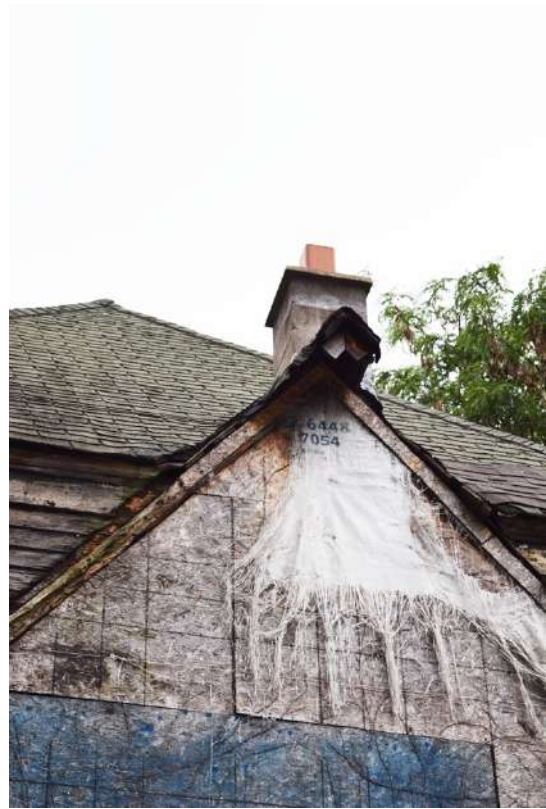
Rear coal chimney proposed for removal

- Remove existing CMU coal chimney at rear wall.
  - Remove existing chain-link fence at front yard/sidewalk.
- Exterior Improvements:
  - Install new roof membrane, shingles, flashing, gutters, and downspouts

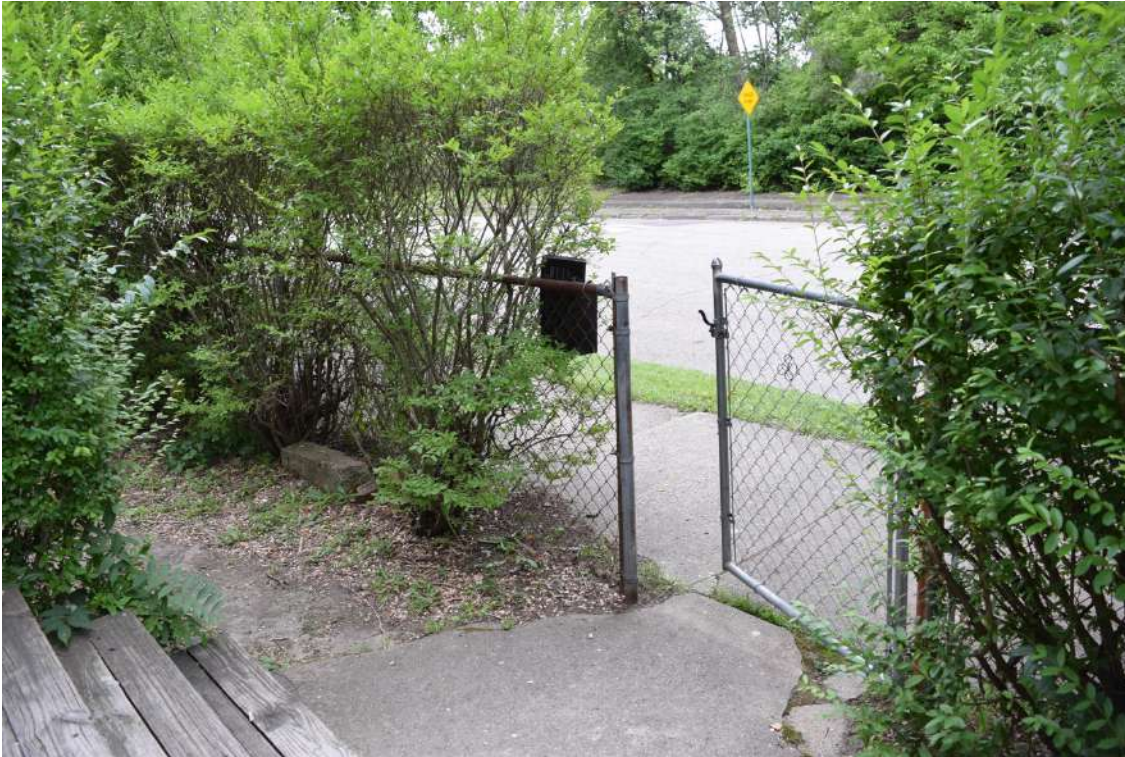
Front chain link fence proposed for removal

- Remove existing chain link fence
- Replace concrete walkway in front yard with new concrete walkway.
- Retain existing hedgerow plants at front yard, adjacent to existing fence
- Install a new HVAC condenser in rear yard

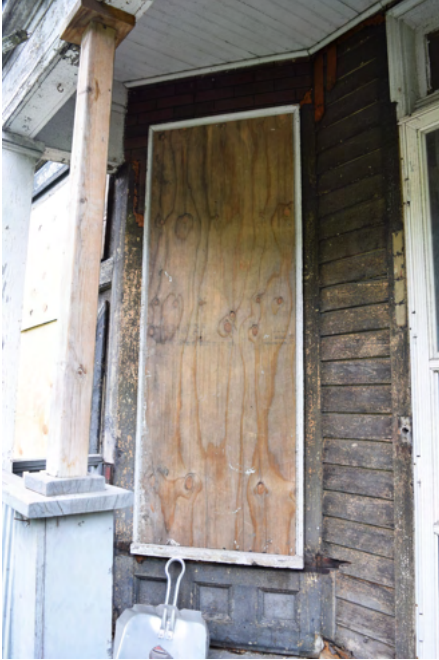
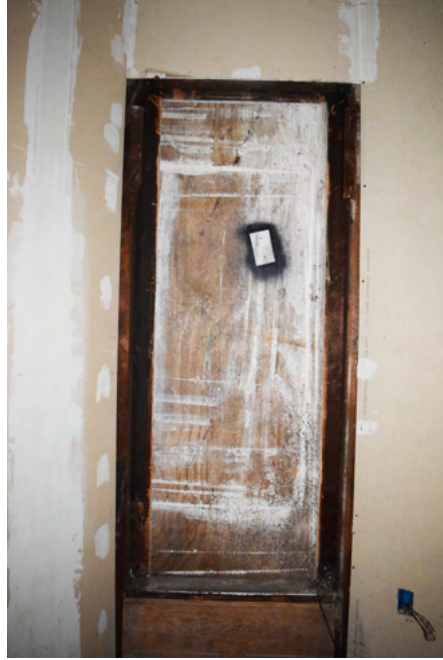
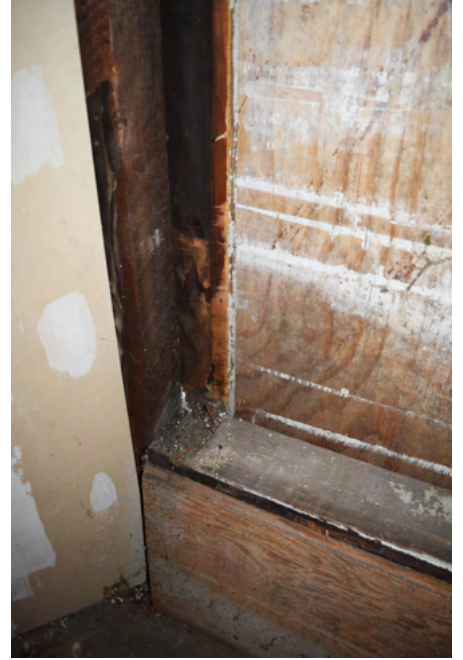
### Window 1.0

Location First Level, Front Facade  
Operation Double Hung  
Condition Missing

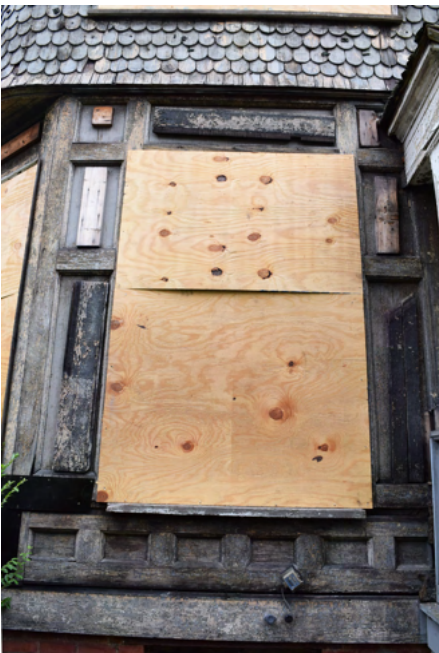
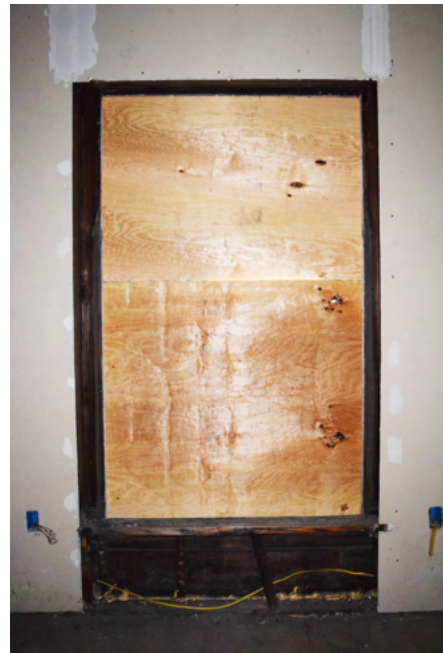
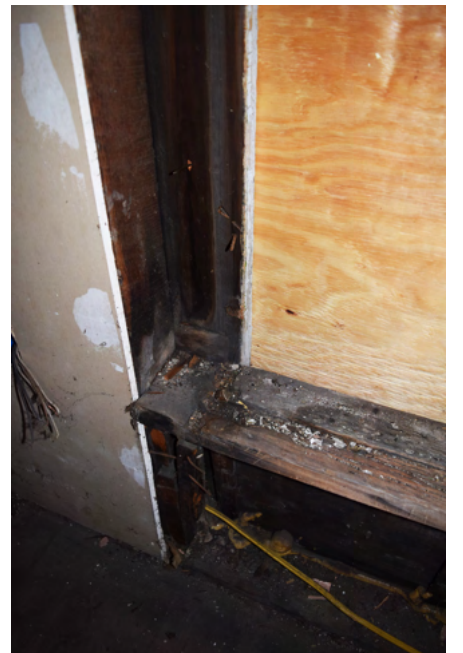
### Window 1.1

Location First Level, Front Facade  
Operation Fixed Picture with Transom  
Condition Missing

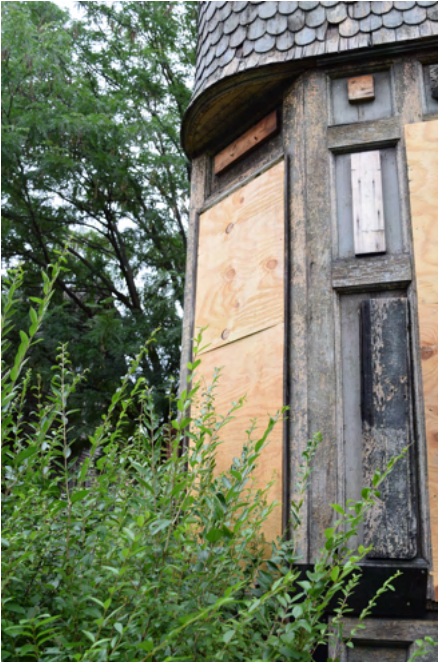
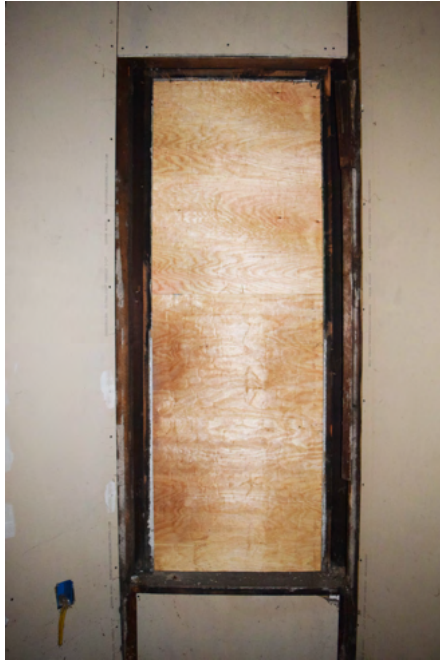
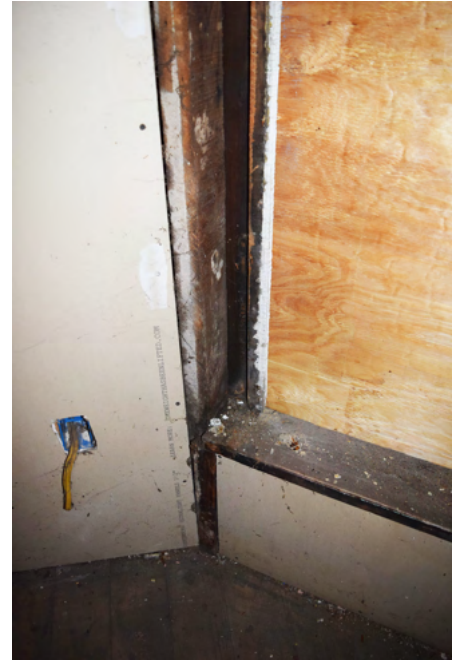
## Window 1.2

Location First Level, Front Facade  
Operation Double Hung  
Condition Missing

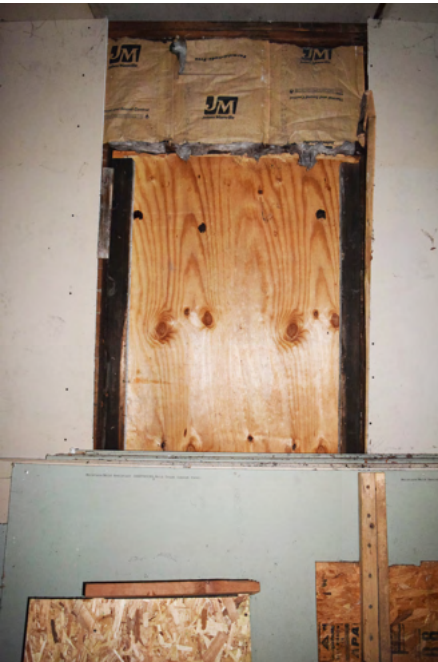
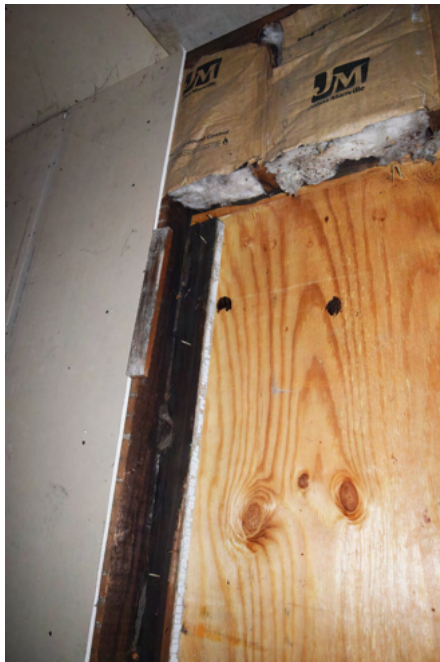
## Window 1.3

Location First Level, Side Facade  
Operation Double Hung  
Condition Missing

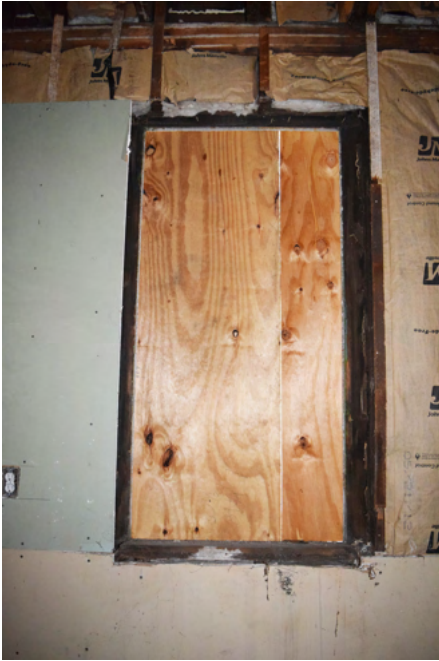
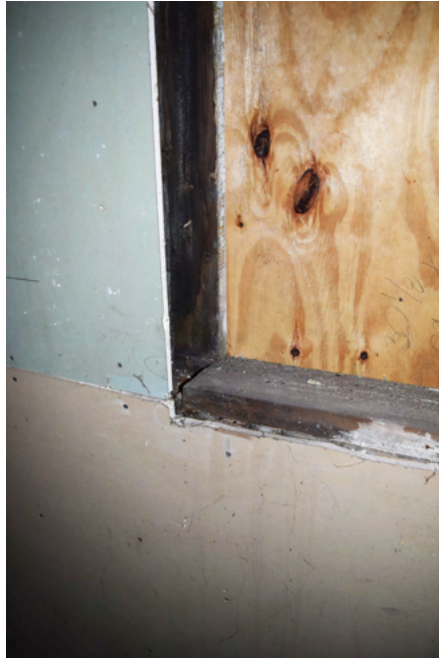
## Window 1.4

Location First Level, Side Facade  
Operation Double Hung  
Condition Missing

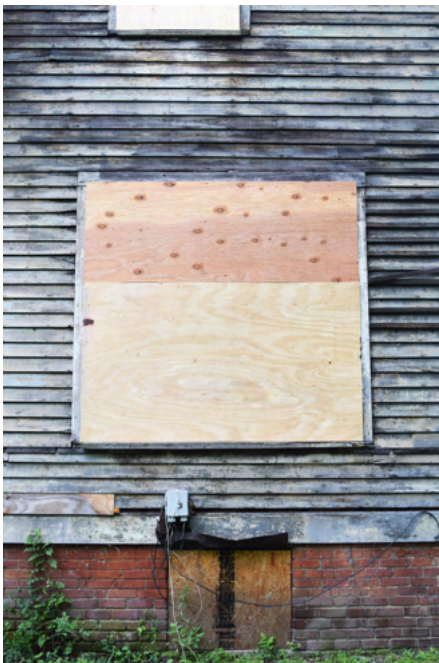
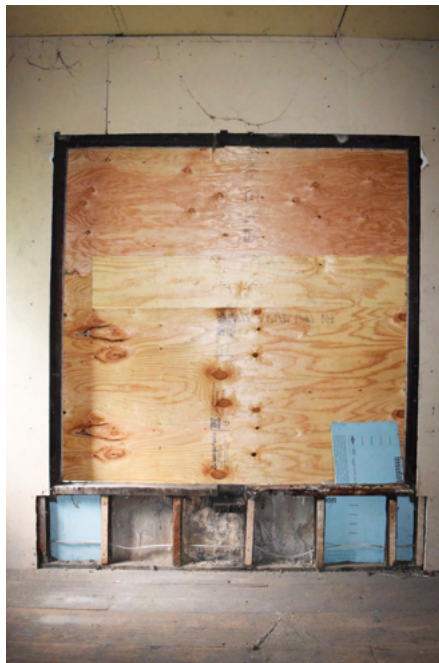
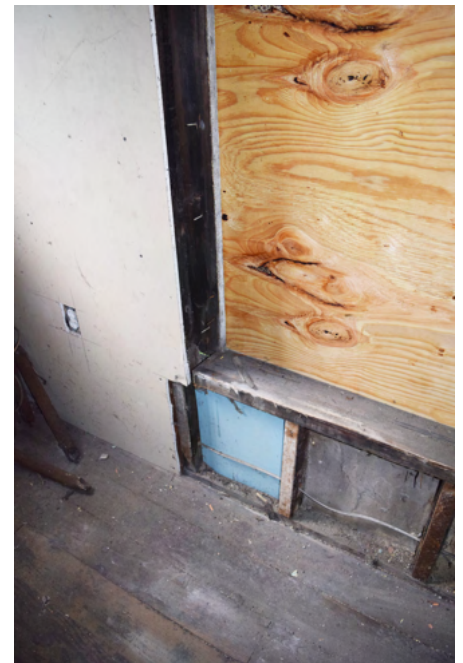
## Window 1.7 / 1.8

Location First Level, Side Facade  
Operation Double Hung  
Condition Missing

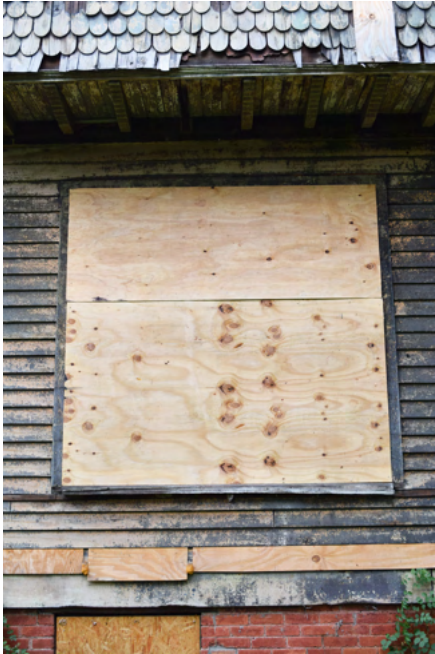
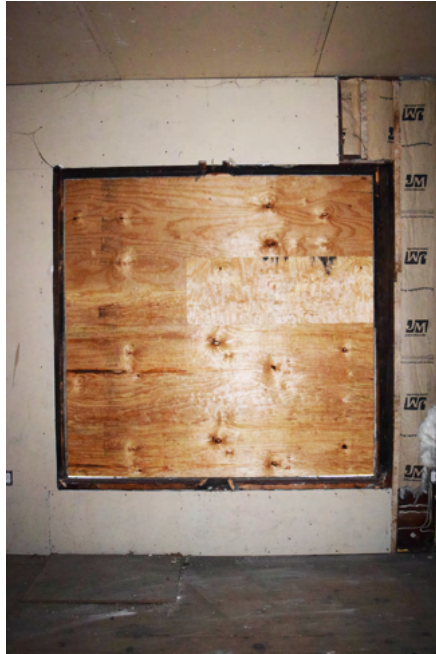
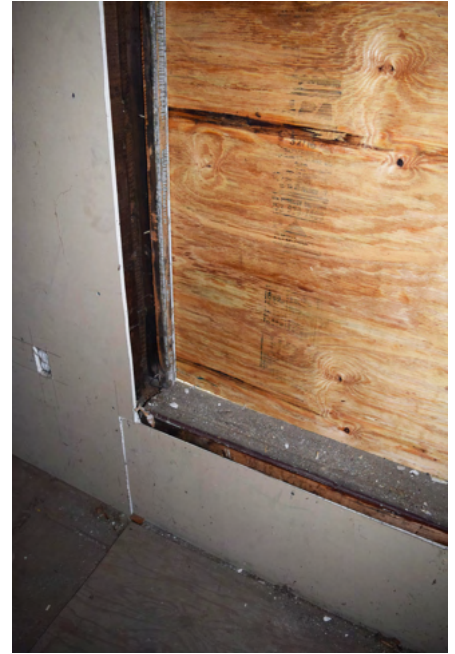
## Window 1.9

Location First Level, Side Facade  
Operation Double Hung  
Condition Missing

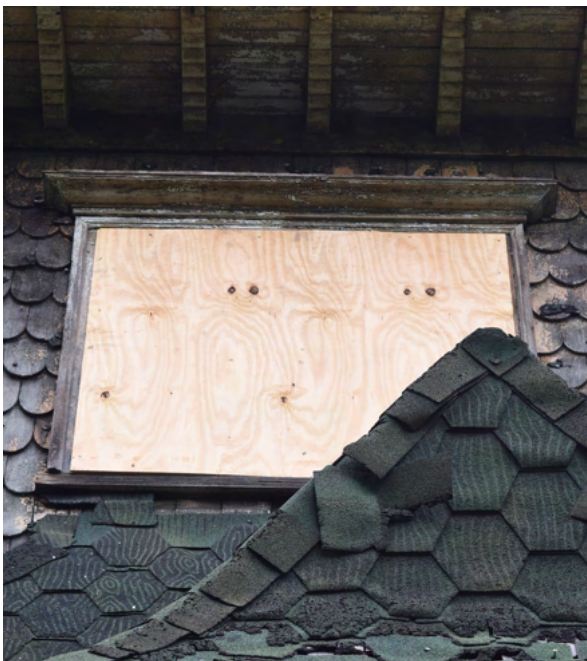
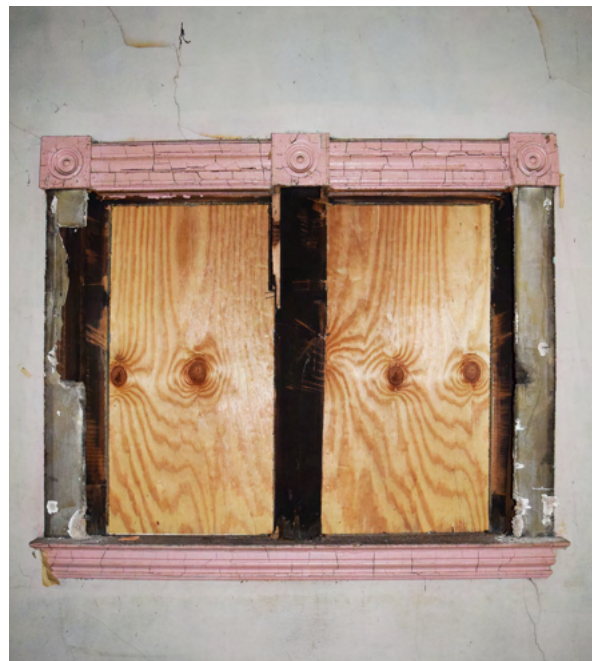
## Window 2.0 / 2.1

Location Second Level, Front Facade  
Operation Single Hung  
Condition Missing

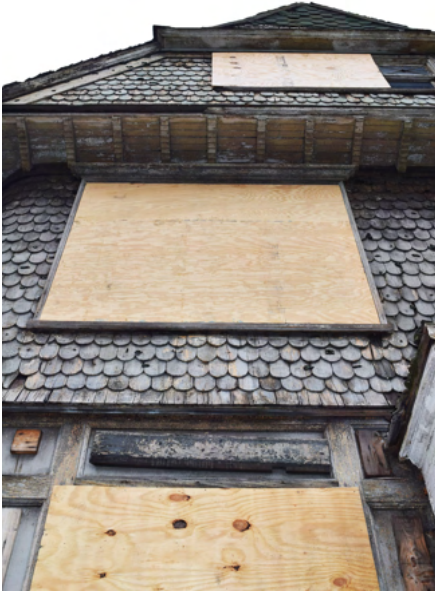
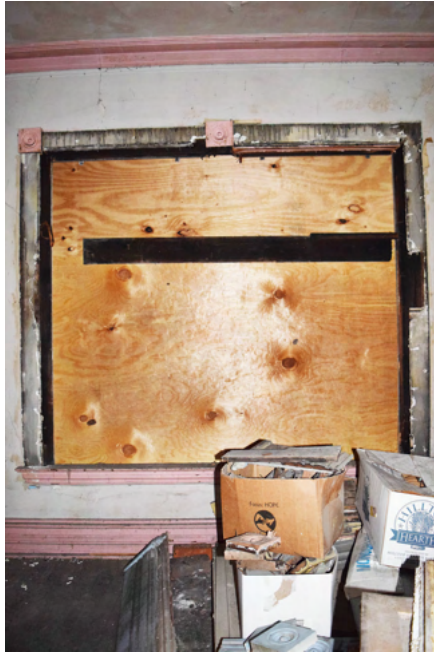
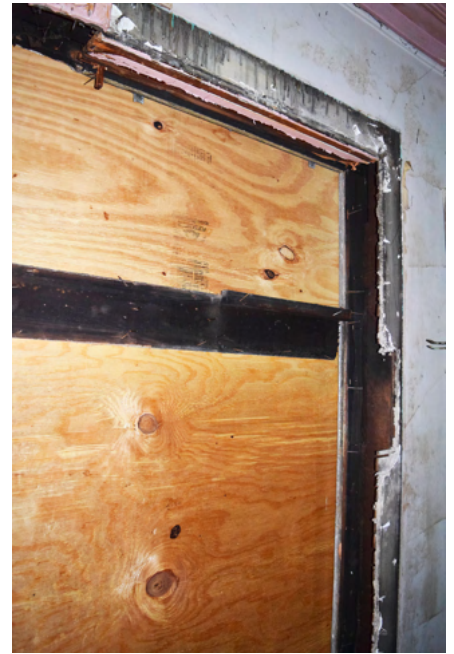
## Window 2.2 / 2.3

Location Second Level, Front Facade  
Operation Double Hung with transom  
Condition Missing

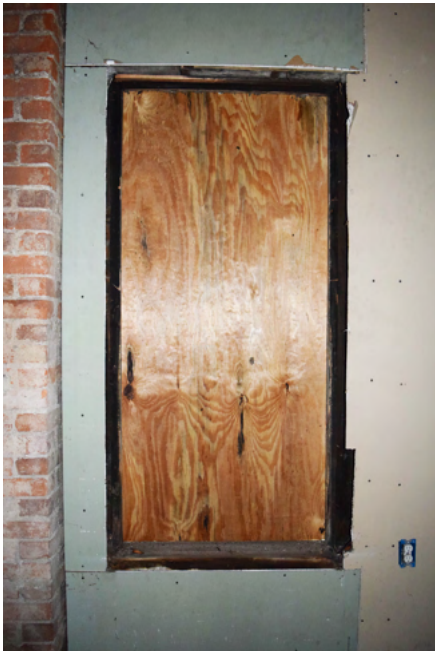
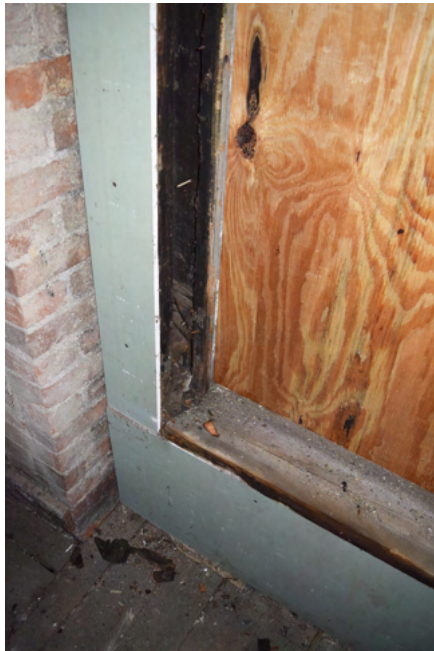
## Window 2.4

Location Second Level, Side Facade  
Operation Double Hung  
Condition Missing

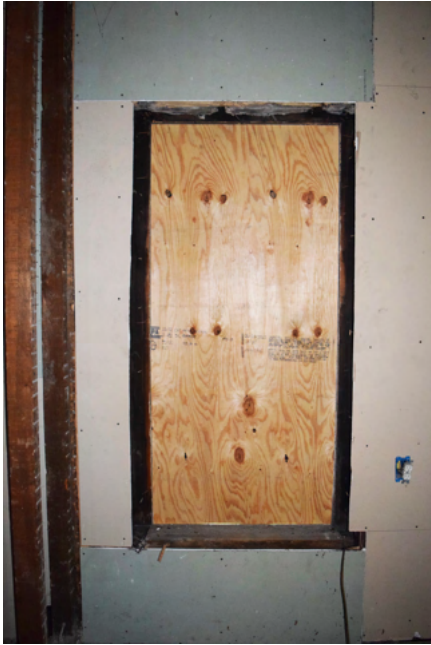
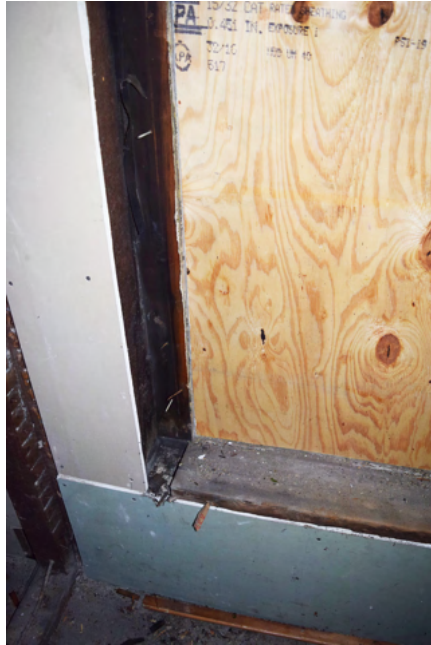
## Window 2.5

Location Second Level, Side Facade  
Operation Double Hung  
Condition Missing

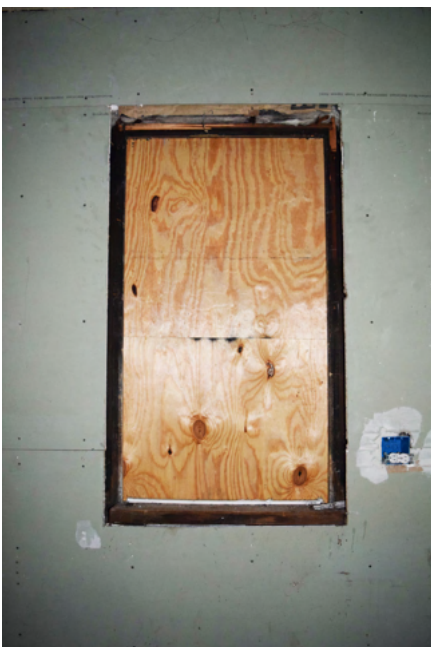
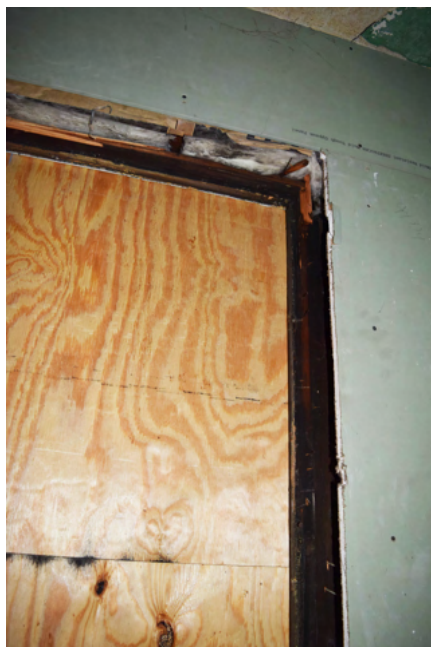
## Window 2.6

Location Second Level, Side Facade  
Operation Double Hung  
Condition Missing

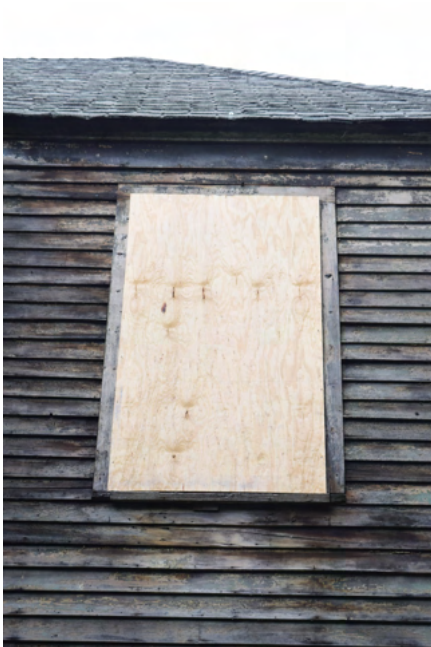
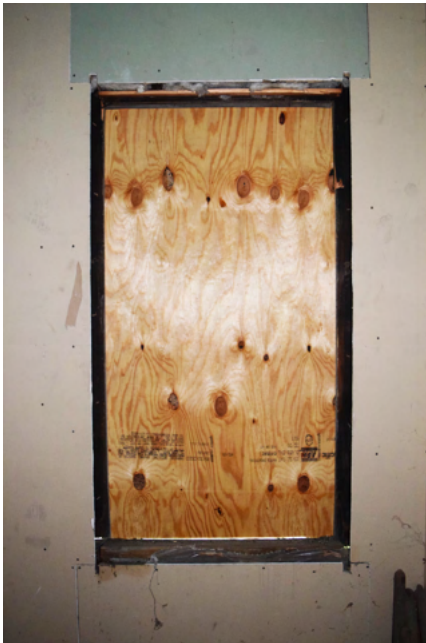
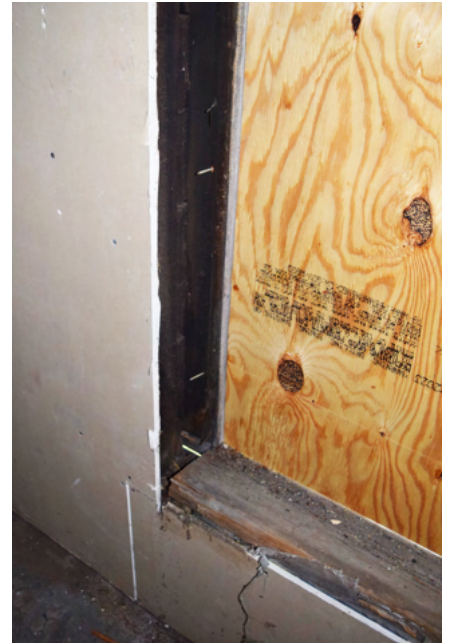
## Window 2.7

Location Second Level, Side Facade  
Operation Double Hung  
Condition Missing

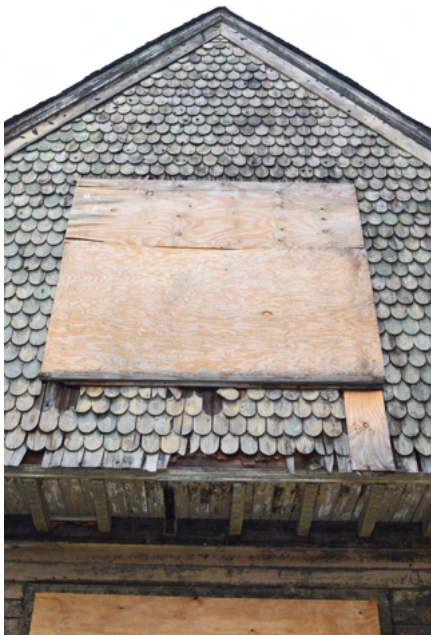
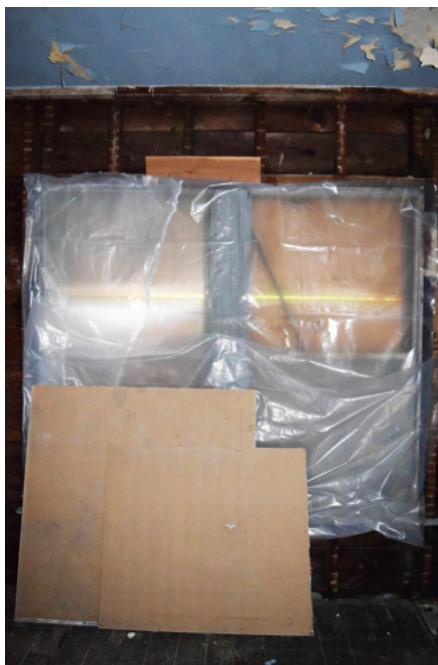
## Window 2.8 / 2.9

Location Second Level, Side Facade  
Operation Double Hung  
Condition Missing

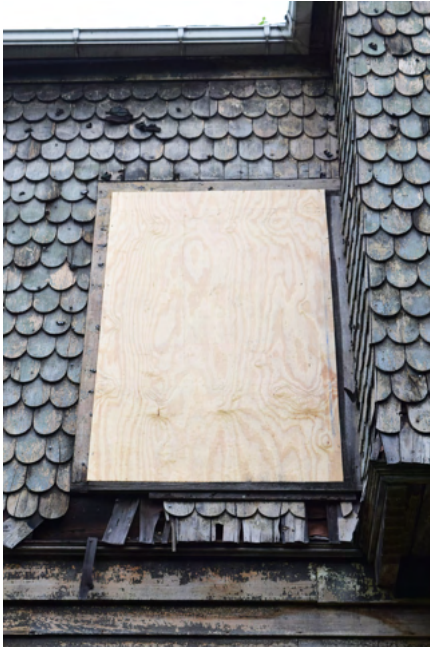
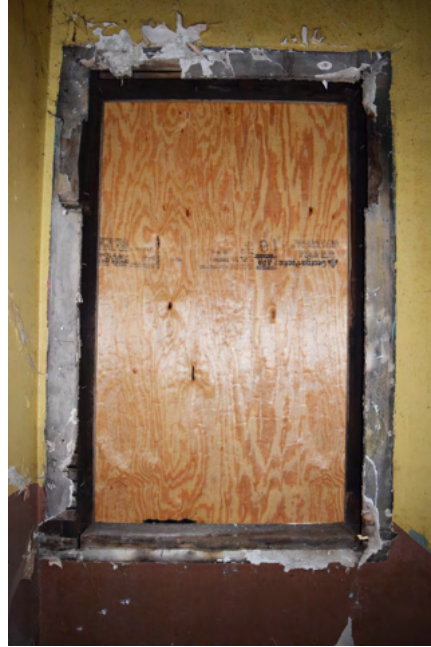
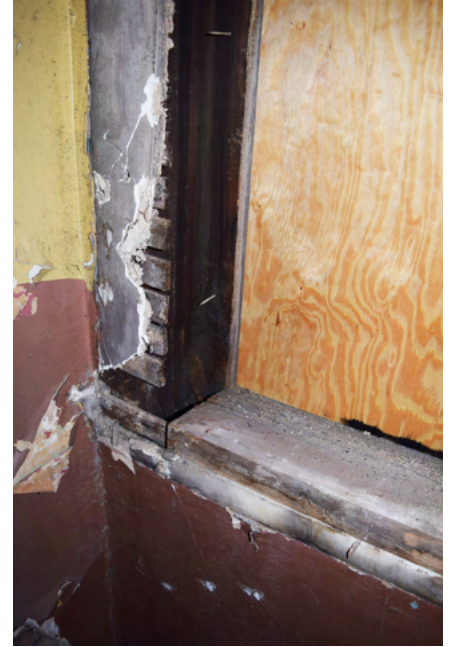
## Window 2.10

Location Second Level, Side Facade  
Operation Double Hung  
Condition Missing

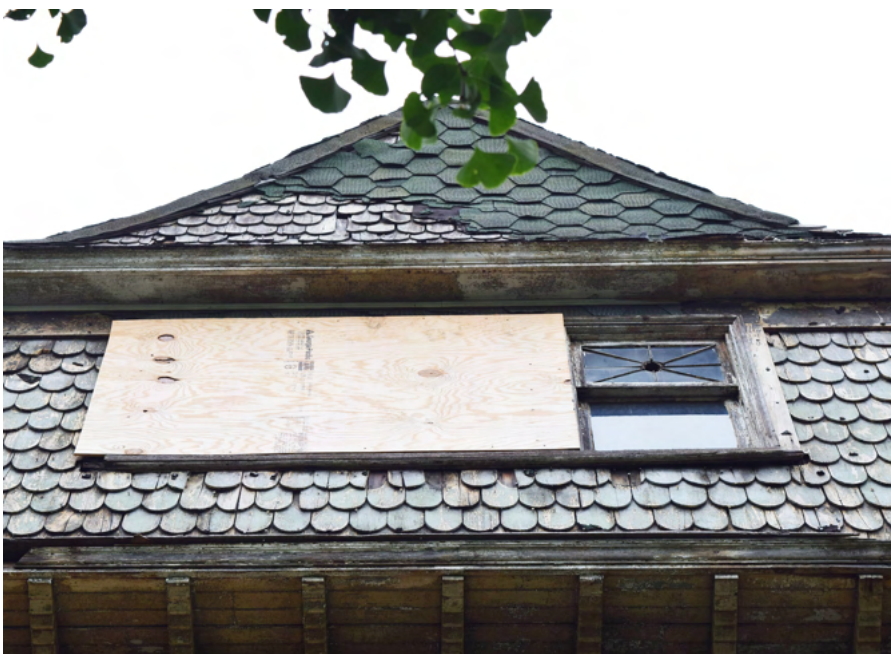
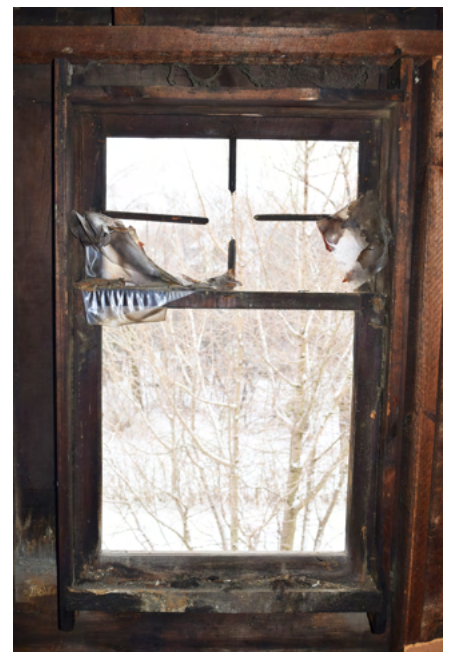
## Window 3.0

Location Third Level, Front Facade, Attic  
Operation Single Hung  
Condition Water damage to frame, glass missing from both sashes, broken and missing muntins

- Replace all missing window units with proposed new aluminum-clad wood units
  - Repair three existing single-hung window units at front gable attic-level including divided-lite sunburst motifs in kind to their original construction

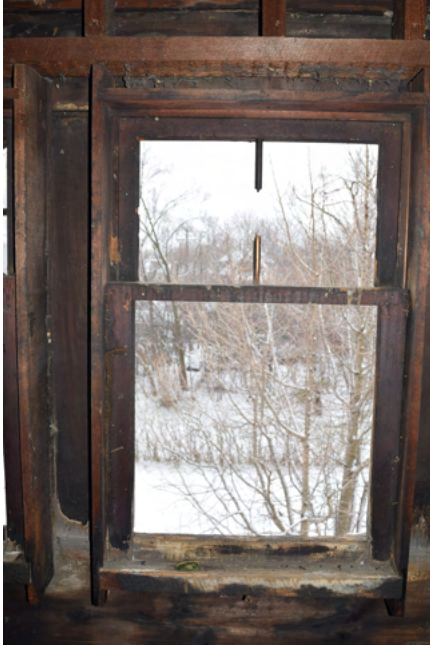
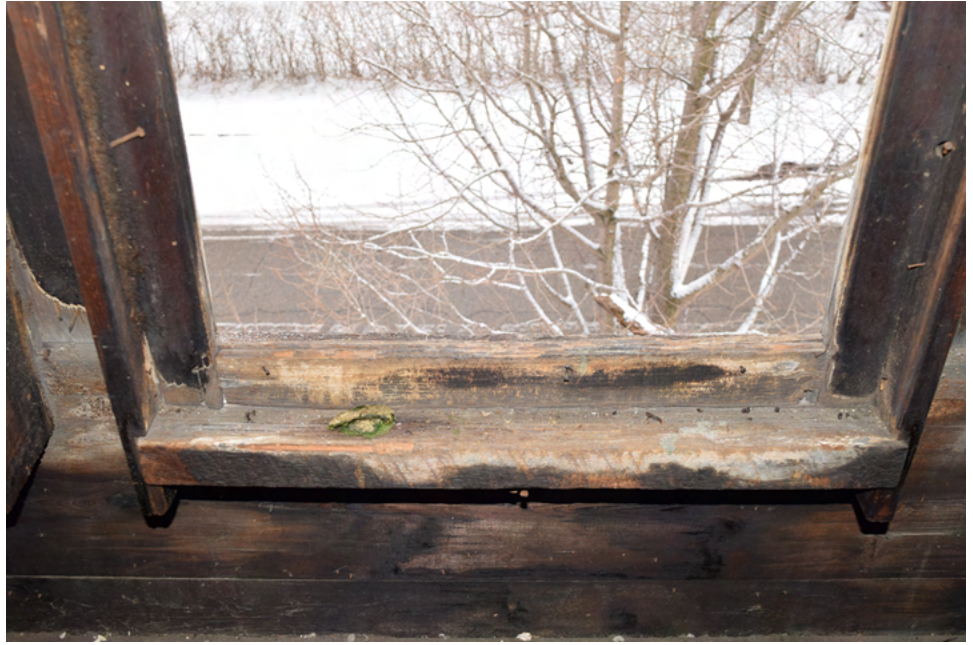
### Window 3.1

Location Third Level, Front Facade, Attic  
Operation Single Hung  
Condition Broken and missing muntins, glass missing

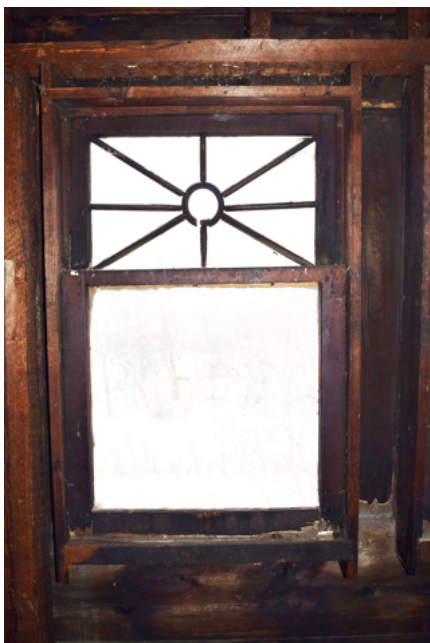
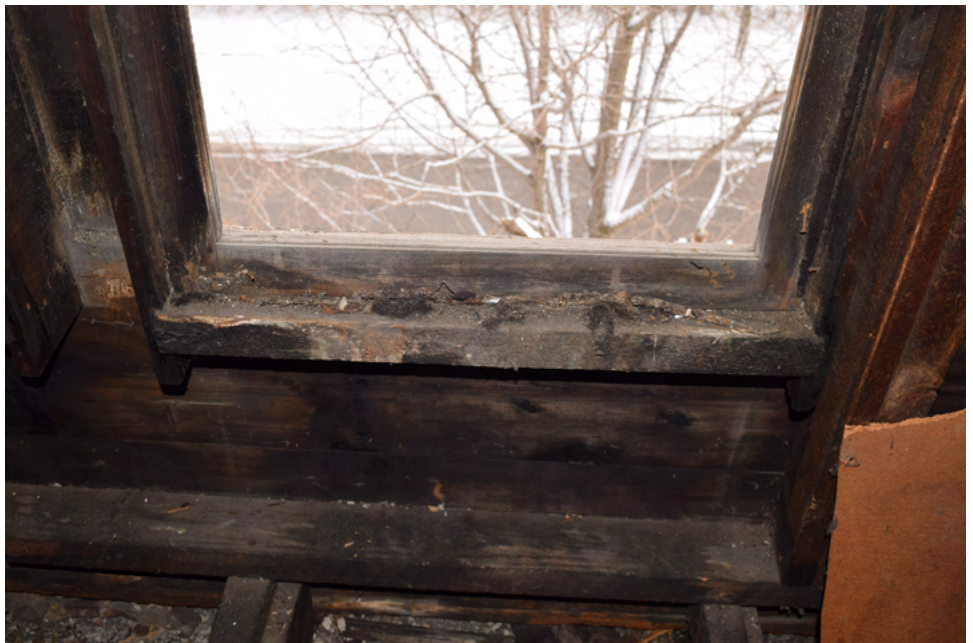
### Window 3.2

Location Third Level, Front Facade, Attic  
Operation Single Hung  
Condition Water damage to frame and sash, broken muntins
