STAFF REPORT: FEBRUARY 7, 2024 MEETING

APPLICATION NUMBER: HDC2024-00004

ADDRESS: 15123 ARTESIAN

SCOPE: REPLACE ORIGINAL WINDOWS WITH COMPOSITE WINDOWS

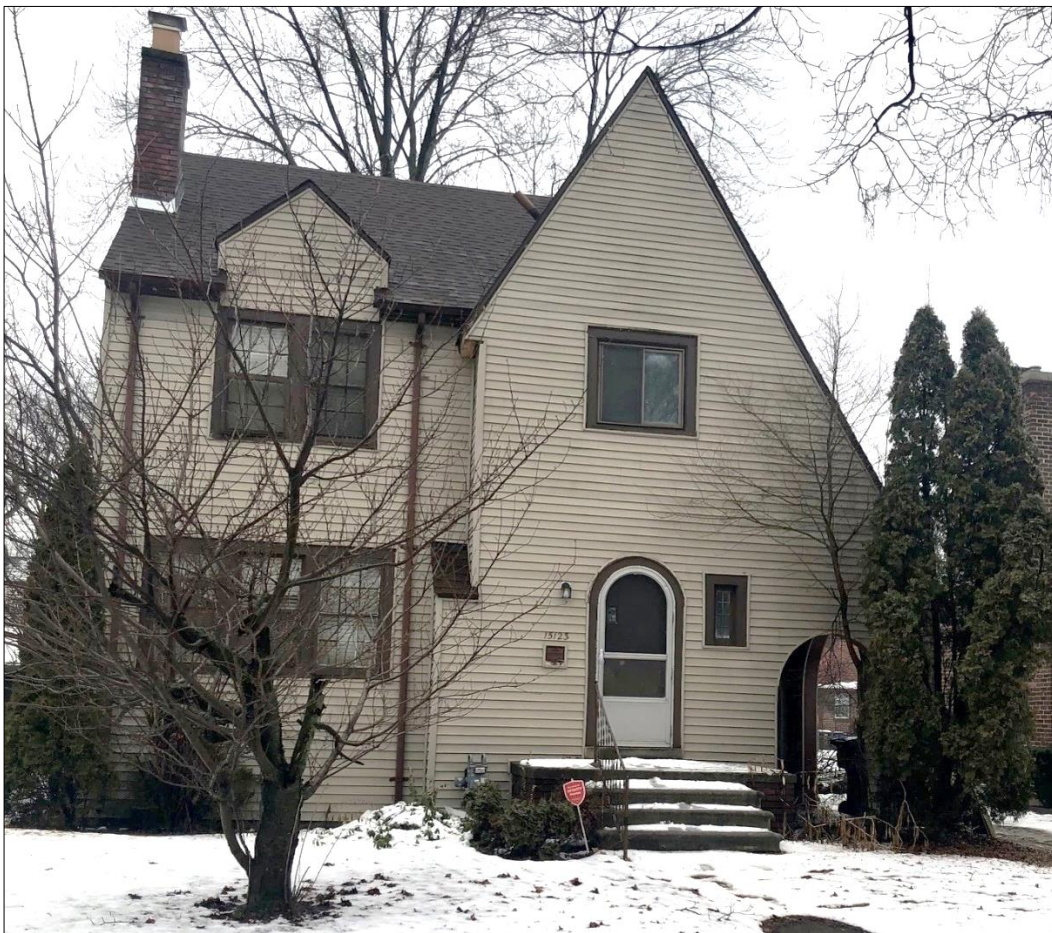
Staff photo, January 25, 2024.

The two-story dwelling at 15123 Artesian was erected in 1927. The front elevation is dominated by a front-facing, two-story gable, whose extended wall and roof created an open, at-grade corner porch. The arched porch openings repeat the arch of the front door. Grouped double-hung windows are at the first and second floors of the recessed wall of the front façade, directly below a small gable that extends past the eave of the reverse gable roof. A small decorative leaded glass window emulates the small leaded glass opening in the front door.

Seventeen (17) of the 22 window openings retain the historic wood framed windows, which are fixed or double-hung in operation. Five (5) openings have vinyl replacement units; three are sliders and two are double-hung.

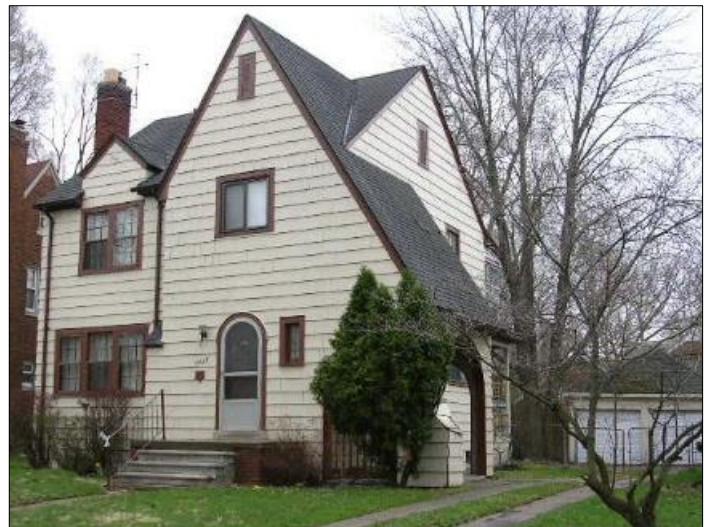
North-Side Elevation

Two wood double-hung windows, 6-over-6 pattern
 Four fixed windows, 2 high-3 wide pattern
 Comment: All original windows remain in place

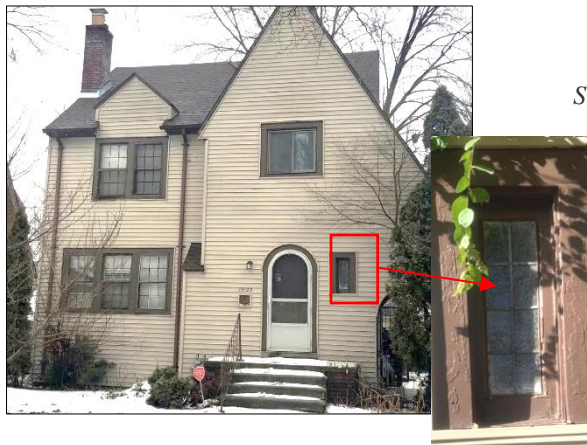
Front Elevation

Five wood double-hung windows, 6-over-6 pattern
 One wood, leaded glass fixed window, 4 high-2 wide pattern
 One vinyl sliding window, no grid
 Comment: Historic windows remain intact within most window Openings.

- The windows on the front elevation, north-side elevation, and single casement at the south-side elevation are on primary and highly visible elevations of the building.

- The majority of the historic wood windows on the front and north elevations remain in place.
 - The single casement on the south-side elevation, while not highly visible now, would become more visible through the trimming or removal of the arborvitae. Additionally, it is staff’s opinion that this side porch is a distinctive character-defining feature and the window that opens to this outdoor area is an important element of this feature; it is also separated from the remaining windows on this elevation.

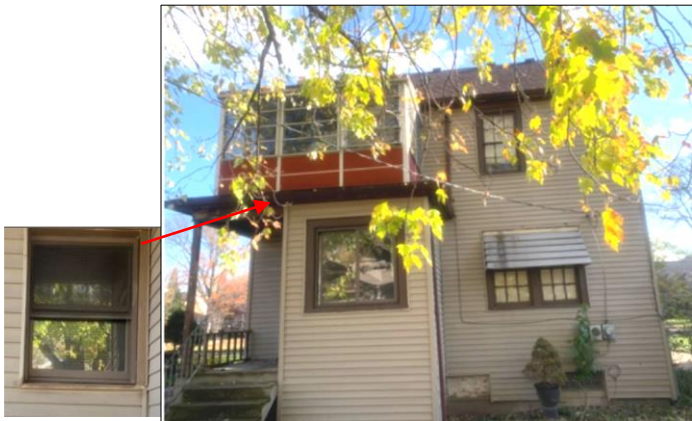
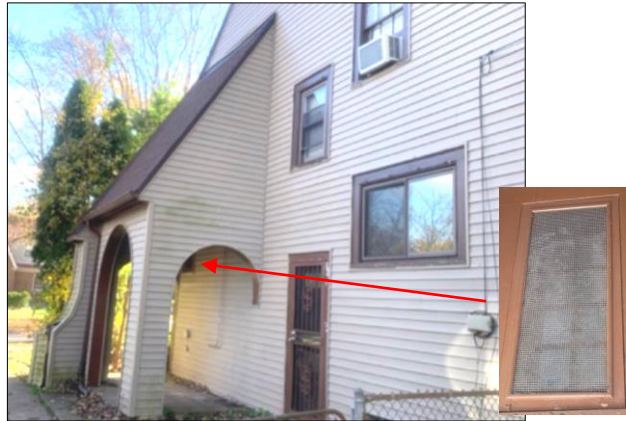
South-Side Elevation

One wood double hung window, 6-over-6 pattern
 One vinyl sliding window, no grid
 One vinyl double-hung window, 1-over-1 pattern
 One casement window, 5 high-2 wide pattern
Comment: Only two original windows remain on this elevation. The casement window is under the porch roof, but is located at the front corner of the house.

- The three window openings on the south-side elevation (two of which have vinyl windows) are all mostly hidden from public view due to the sloping, extending roof structure that covers the at-grade side porch.

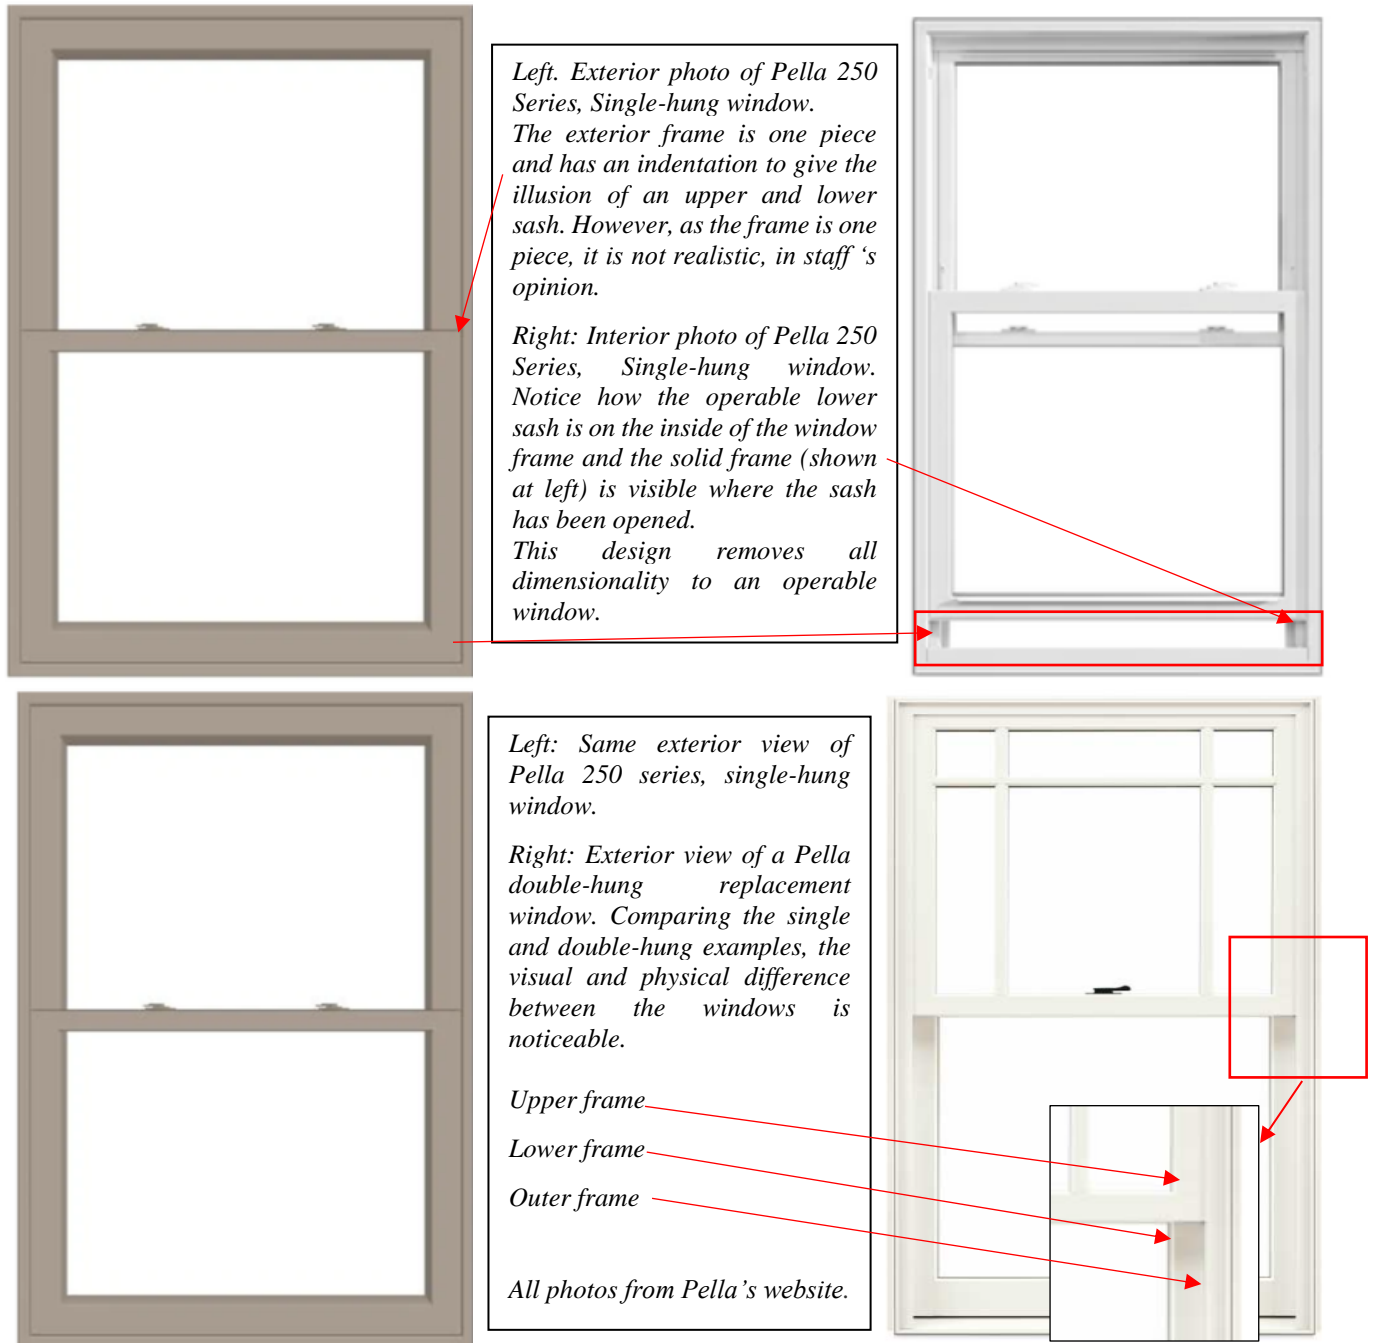
- The applicant proposes to replace the wood windows with vinyl windows. In addition to the material change (which also includes dimensional and profile changes to the window frames), the double-hung windows would be changed to single hung, and the muntin (or grille/grid pattern) would be replaced with clear glass.
- According to the Pella estimate, the cost for 14 replacement windows is \$23,073.35; this creates an average price of \$1,648 per window (a reduction of \$1,110 per window when compared to the restoration/storm window fabrication estimate).

- The selected replacement does not match the existing historic windows in materiality, dimensionality, operation, and finish.

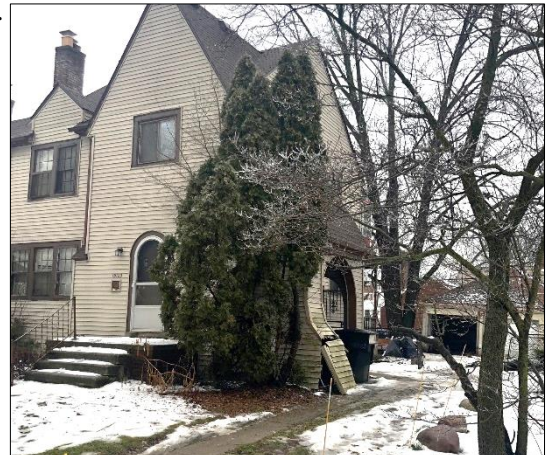
Staff photo taken at sidewalk adjacent property’s driveway.
