**STAFF REPORT: FEBRUARY 7, 2024 MEETING**

**APPLICATION NUMBER: HDC2024-00023**

**ADDRESS: INDIAN VILLAGE BRICK ALLEYS (BETWEEN SEMINOLE AND IROQUOIS FROM E. JEFFERSON TO ST. PAUL**

**SCOPE: REPAIR BRICK ALLEYWAYS**

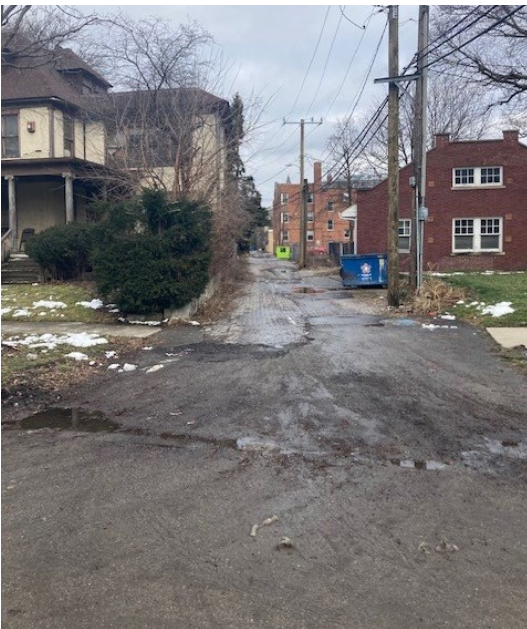
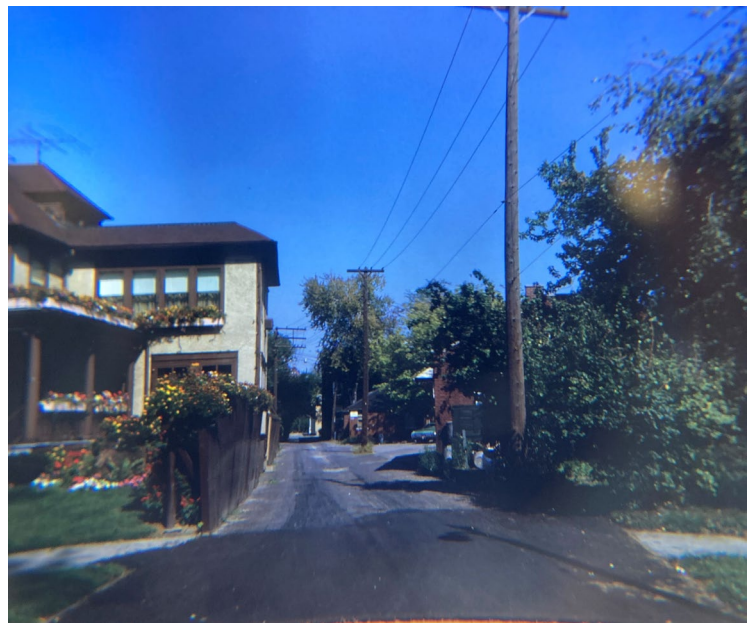
The geographic scope of this project, as received from the applicant, encompasses the brick paved alleyways between Seminole and Iroquois Streets from Jefferson Avenue to St. Paul Streets. The alleyways are paved with gray, vitrified brick pavers south of Lafayette, and red vitrified brick pavers between Lafayette and St. Paul. HDC staff could not locate records indicating when the existing brick pavers were laid, but proprietary markings visible on paving units indicate they were produced around the beginning of the 20<sup>th</sup> century and are likely the original paving material. Numerous infrastructure repairs conducted over the 20<sup>th</sup> century, and into the 21<sup>st</sup> century, have introduced patches of concrete, asphalt, and dissimilar bricks to the alleys.

**Figure 1: Current view looking east down the alley between Seminole and Iroquois (left), and the same view from ca. 1970. (right, HDAB)**

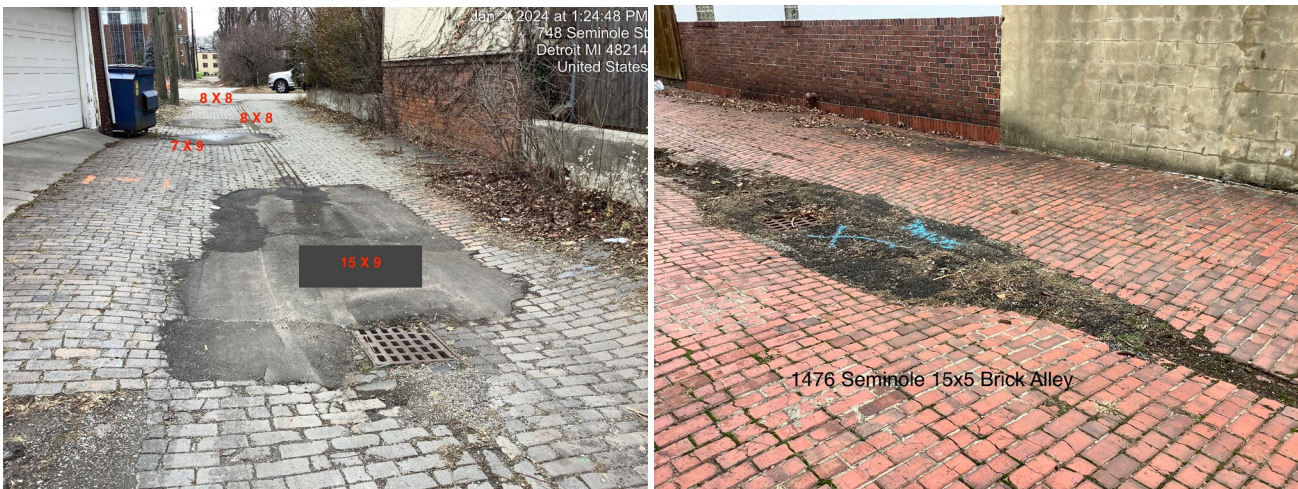
Figure 4: Examples of typical repair locations provided by the applicant.

The applicant proposes to reinstall brick pavers in alleyways located between Seminole and Iroquois, from E. Jefferson Ave. to St. Paul Street. The repair includes the removal of bituminous patching materials installed by the Detroit Water and Sewerage Department (DWSD) when conducting repairs of water infrastructure in the alleys and laying of new brick pavers on a concrete bed.

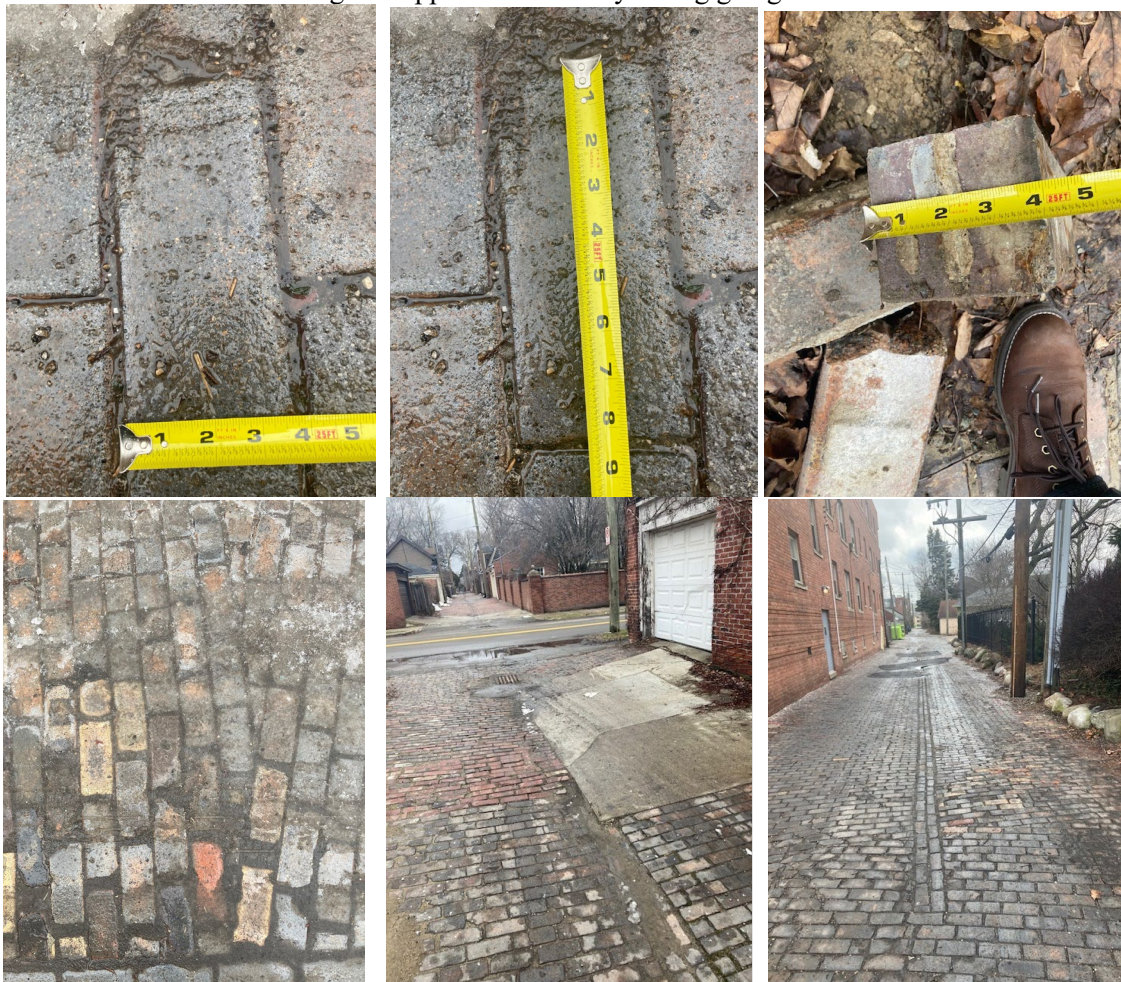
- The alleys running south of Lafayette are paved primarily with gray colored vitrified paving block measuring approximately 8 inches long, 3.75 inches wide, and 3.75 inches tall. However, numerous bricks of different sizes and colors have been used as replacement for the repairs over time, giving the paving a patchwork appearance in some locations. In addition to municipal and utility repairs, adjacent property owners have also replaced or covered the paving materials in order to address water infiltration concerns or grade approaches to alley facing garages.

**Figure 5: Images showing the dimensions and conditions of the paving in the alleys south of Lafayette.**

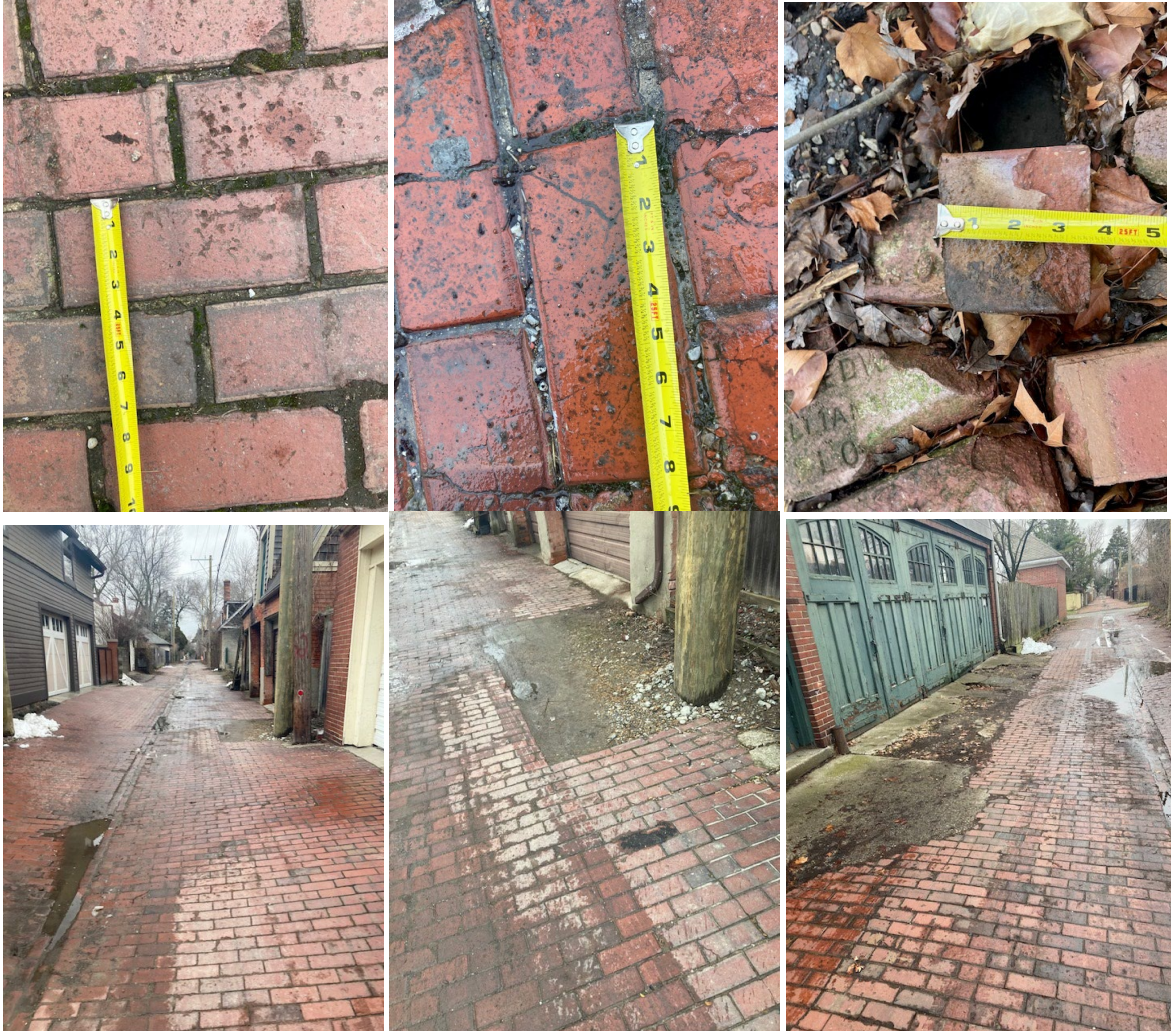
- The alleys north of Lafayette are paved primarily with red colored vitrified paving block measuring approximately 8 inches long, 3.75 inches wide, and 3.75 inches tall. The blocks in this area of the project are more uniform in color than the southern alleys, but still display a slight variation in edge treatment and color.

**Figure 6: Images showing the dimensions and conditions of the paving in the alleys north of Lafayette.**

- The applicant submits photographs and dimensions of newly sourced brick pavers that are of a sufficient match to the existing paving in the areas in which they are to be installed, to be approved by staff.
