**STAFF REPORT:** 03/13/2024 REGULAR MEETING

**APPLICATION NUMBER:** HDC2024-00054

**ADDRESS:** 1665 W BOSTON

**SCOPE:** DEMOLISH GARAGE, INSTALL FENCING, REPAIR HOUSE

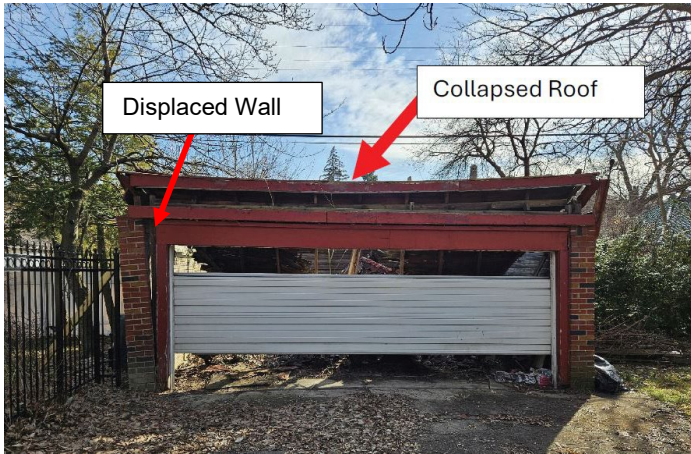
Site Photo 2, by applicant October 2023: (facing south) north elevation of garage, showing collapsed roof and displaced wall.

- The applicant provided photos to show the condition of the garage. The applicant also allowed staff to visit the site and observe the conditions. The roof has caved into the garage. There are structural cracks and displacement of the brick masonry on all sides of the surrounding walls. It is staff’s opinion that the structure has suffered severe damage and is beyond feasible repair, showing signs that the exterior walls are in state of collapse.

- It is staff's opinion that the garage's structure is severely compromised, and the building has lost its historic integrity. Given these conditions, staff finds it reasonable to approve demolition.
- Staff have no issues with the proposed remaining work in this application.

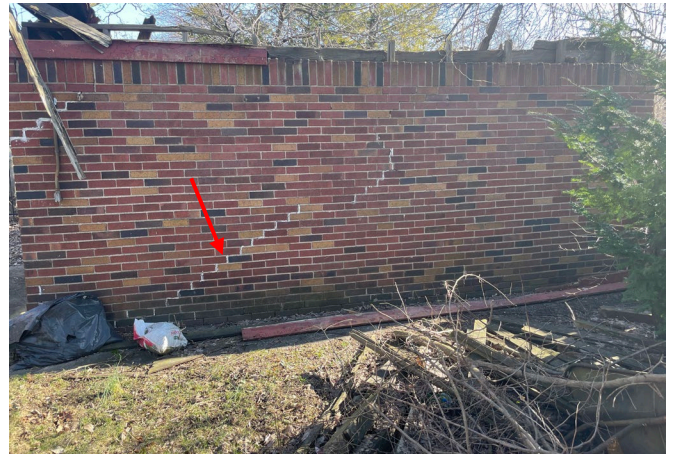
Site Photo 3, by Staff February 23, 2024: (facing east) west wall of garage, showing brick displacement and cracking along the wall.

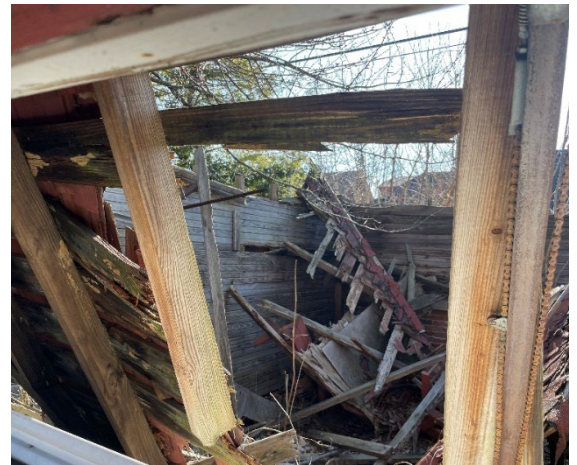
Site photo 4, by Staff February 23, 2024: (facing south) interior of garage showing collapsed roof.

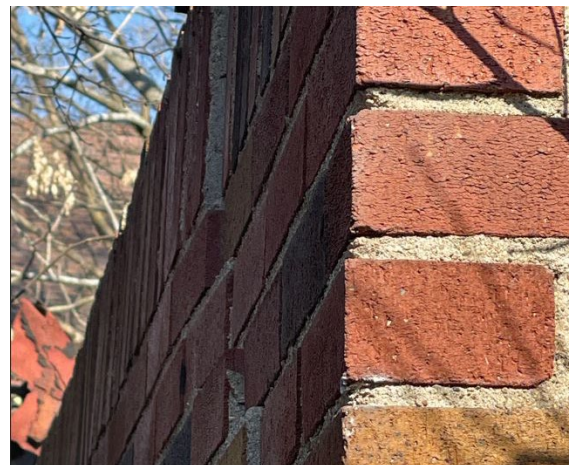
Site photo 5, by Staff February 23, 2024: (facing north) showing brick displacement along west wall.
