STAFF REPORT: MAY 10, 2024 MEETING
APPLICATION NUMBER: HDC2024-00170
ADDRESS: 4428 SECOND AVENUE

HISTORIC DISTRICT: WILLIS SELDEN LOCAL
APPLICANT: MARC GRASSI, PUSH DESIGN
PROPERTY OWNER: SCOTT LOWELL, LOWELL CONSTRUCTION MANAGEMENT
DATE OF PROVISIONALLY COMPLETE APPLICATION: APRIL 15, 2024
DATE OF STAFF SITE VISIT: APRIL 19, 2024

SCOPE: REPLACE WINDOWS, INSTALL FIBER CEMENT SIDING AT REAR

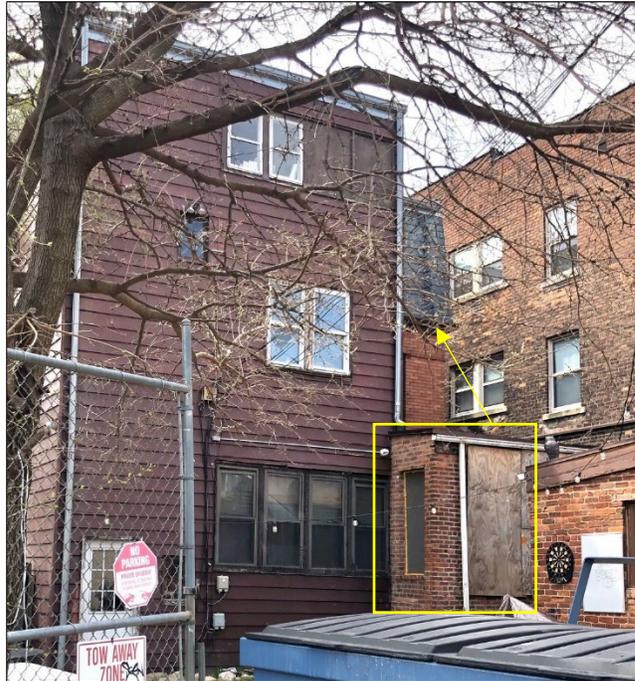
East-rear elevation. A single-story masonry extension is visible. The rear wall of the main house is partially visible above the masonry extension.

The extension at the rear is recessed slightly from the rear corner of the brick wall and extends about half-way across the width of the rear wall. Aluminum siding wraps the walls and each of the large window openings held four windows (two windows at the second floor have been covered over).

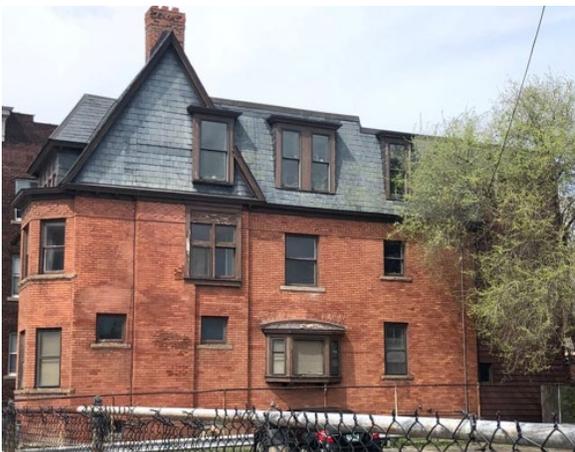
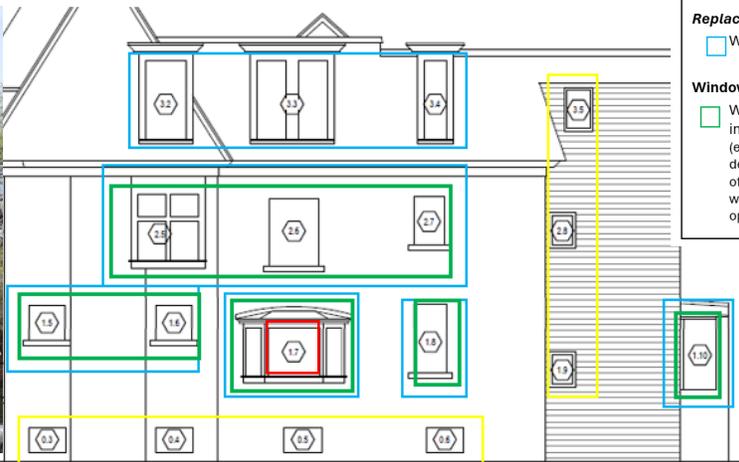
ELEVATION EXISTING CONDITIONS (STREET FACADE) ...

Applicant will retain the wood basement windows.

Applicant proposes to replace remaining wood windows on facade.

Staff determines the windows on the facade to be character-defining features and appear to be repairable. Notable exception is window 1.4 – staff recommends a new wood window be built for this opening.

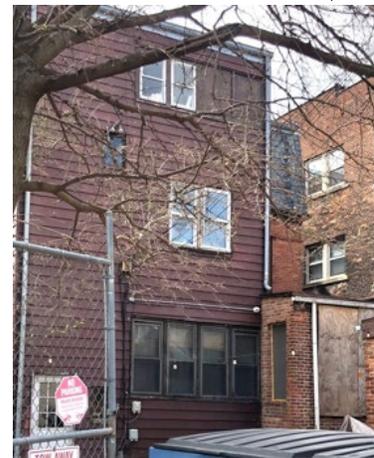
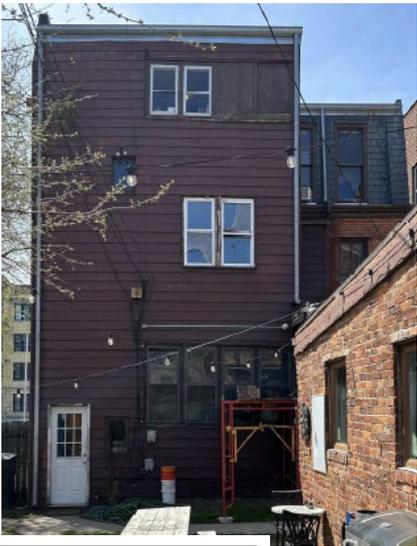
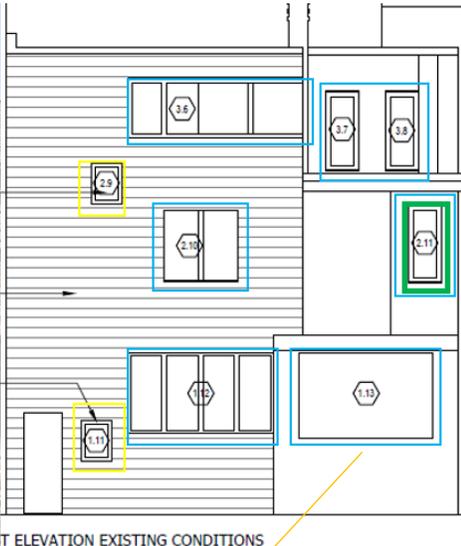
SOUTH ELEVATION EXISTING CONDITIONS

Applicant will retain the wood basement windows, as well as the single windows in the rear enclosure.

Applicant proposes to replace remaining windows on side wall.

Staff determines the wood windows on the first and second floor are character-defining features. Based on applicant photos, the windows are intact and most appear to have solid, repairable frames. Notable exception is the middle window of opening 1.7 – staff recommends a new wood window be built for this opening.

Staff confirmed the windows at the third floor are contemporary replacement units and can be replaced, per the applicant's proposal.

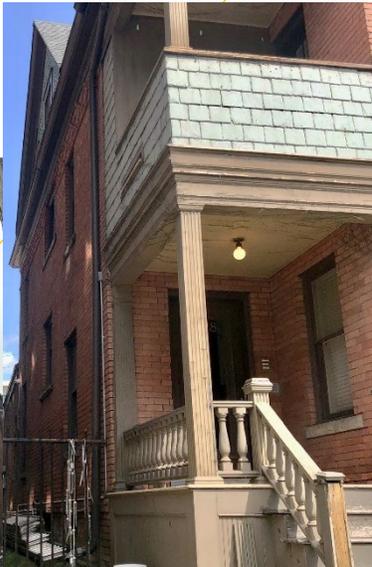
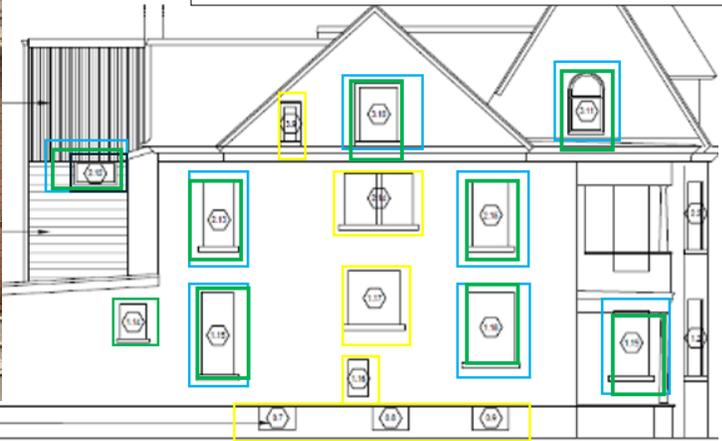
REAR ELEVATION EXISTING CONDITIONS

Applicant will retain the single wood windows at the three-story extension.

Applicant proposes to replace remaining windows on both rear walls.

The window units within the grouped window openings at the rear extension are not historic age, some are vinyl replacement units and opening 1.13 doesn't have any windows. Staff agrees replacement units can be installed at these locations.

The remaining three wood windows on the masonry wall of the house are historic age. Window 2.11 is intact and repairable. Window 3.7 has additional deterioration due to exposure from an a/c unit. Due to the rear and recessed location of these openings, and their location in the roof (meaning the windows aren't deeply recessed within their openings) and minimal dimensional change of the proposed replacement units, staff feels that the proposed replacement units in this location, meets the criteria of the National Park Service document [Replacement Windows that meet the Standards](#).

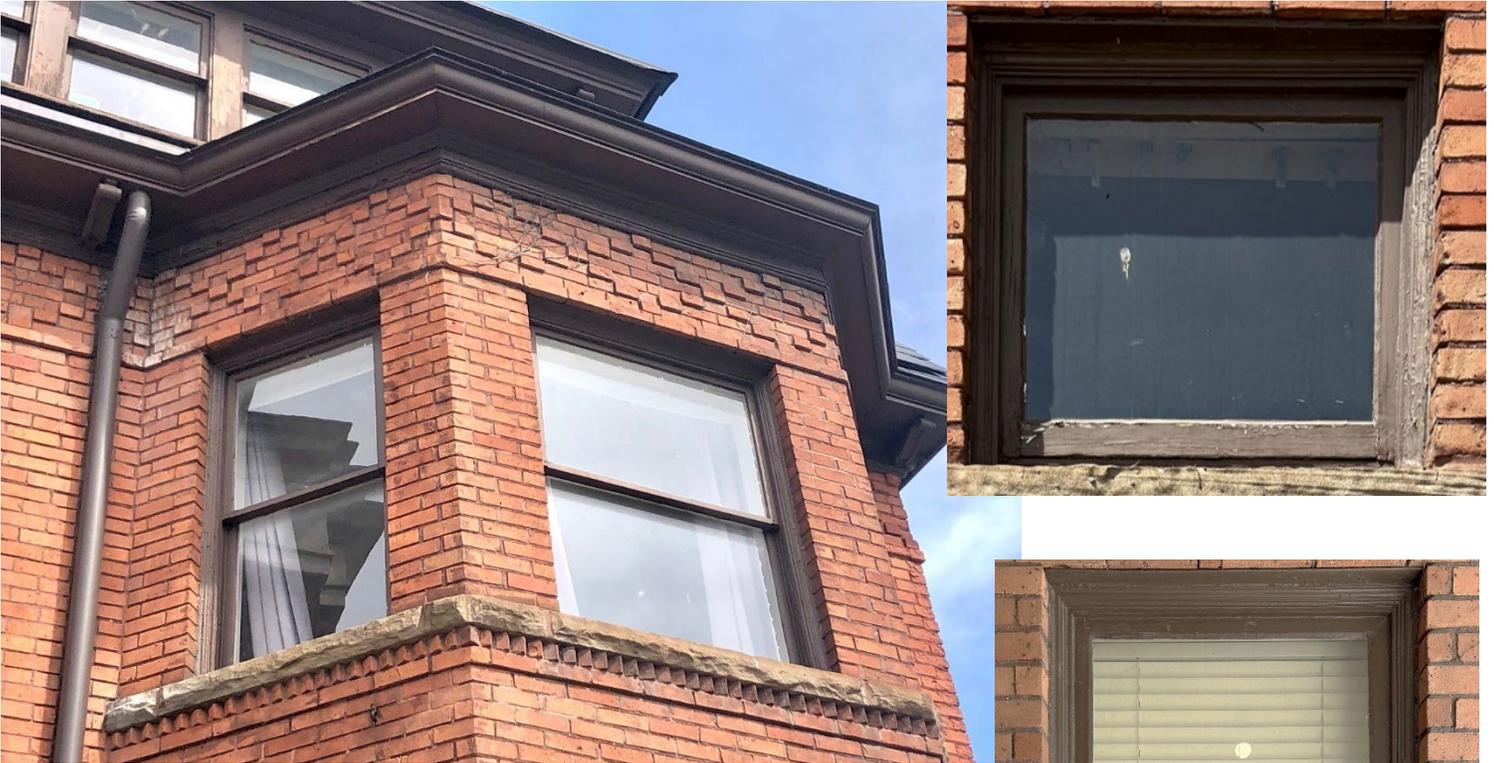
- The placement of windows within the openings is an equally important visual component to consider. This house has thick brick walls and the windows are recessed within the windows openings; and a few windows are exceptionally deeply recessed. Should the Commission consider replacement products for window openings with recessed windows, dimension of the setbacks must be documented and a drawing confirming the setback dimension for the new windows must be submitted for staff review.

The recessed windows are an additional detail to the architectural composition of the house.
