Front/West Wall

Elevations with window numbers, interior photos and close-up exterior photos provided by applicant. Windows in yellow indicate applicant will retain them.

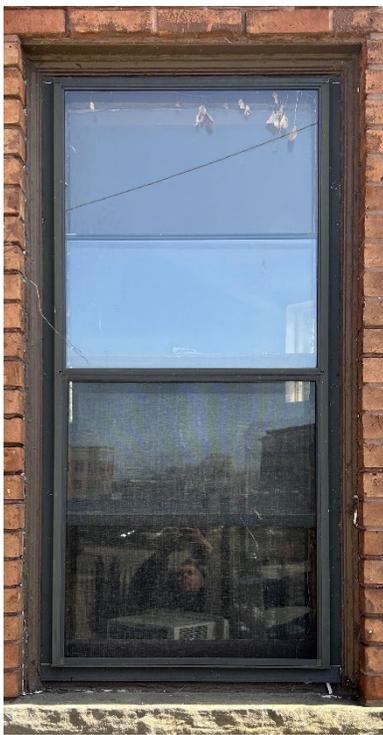
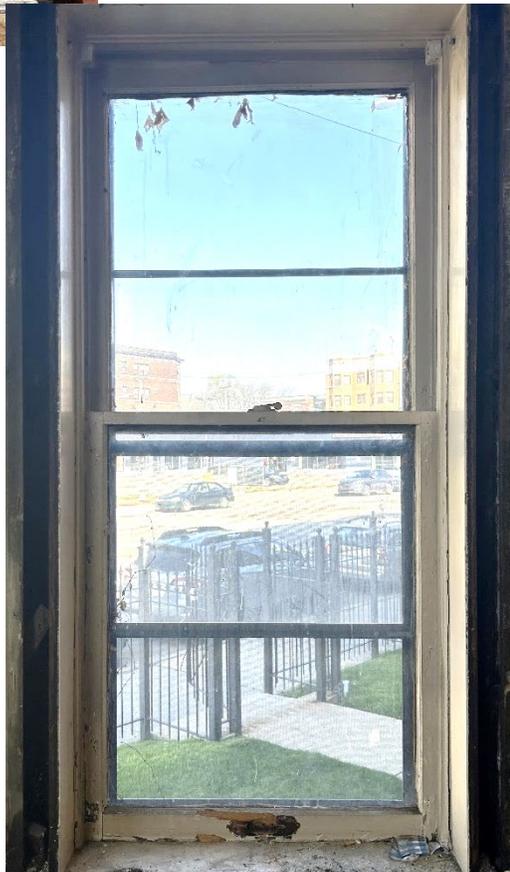
Window 1.1
First floor, single window opening
Window 1.2
North-side window in first floor bay window
Applicant requests replacement.
Staff recommends repair.

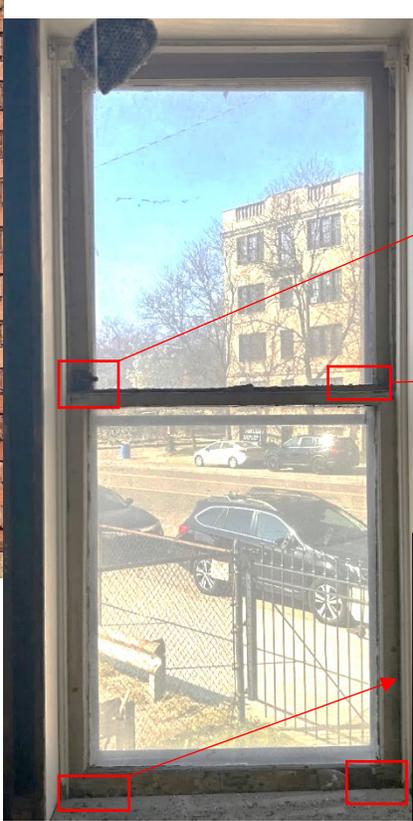
1.3

Central (1.3) and south-side windows (1.4) in first floor bay window.

Applicant requests they be replaced. Staff recommends #1.3 be retained and #1.4 be replaced with custom-fabricated wood window.

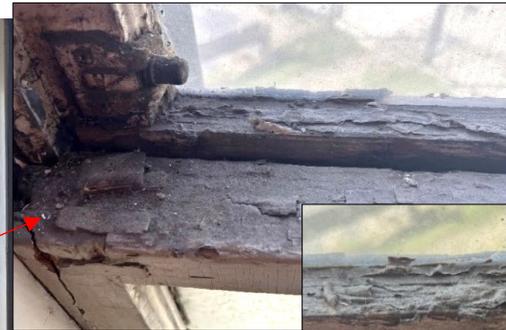
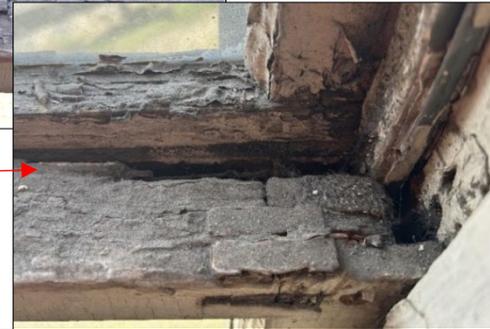
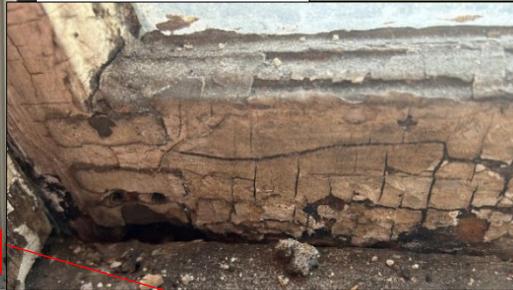
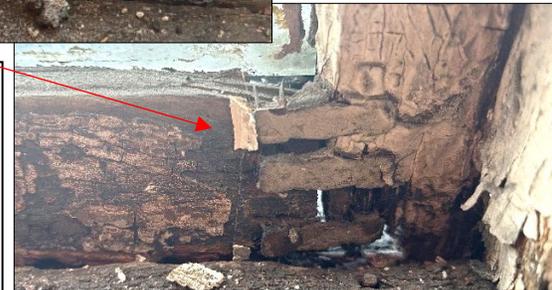
1.4

The above image shows an a/c unit installed, which was in place a minimum of six years. But due to time gaps in Google photos, it could have been in place longer. The exposure to the elements from the open window and a/c unit may be the main factor why this window sash is significantly more deteriorated than the other two bay window units.

It is staff's opinion this window may be deteriorated to the level of replacement. However, a new wood double-hung window, matching the sash dimensions and profile (and all other details) should be fabricated. This window opening is one part of the two-story bay window; a standard replacement window within this composition would stand out too strongly and would alter this distinguished character-defining feature on the façade.

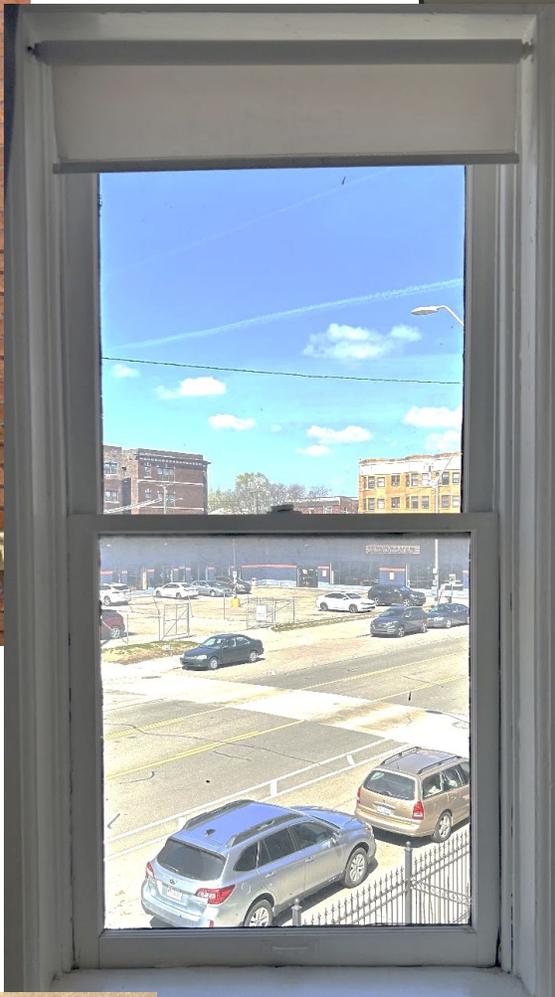
Windows 2.1 and 2.2–
 Front-facing single opening window at second floor.
 North-side window of second floor bay window.
 Applicant requests both windows be replaced.
 Staff recommends they be retained and repaired.

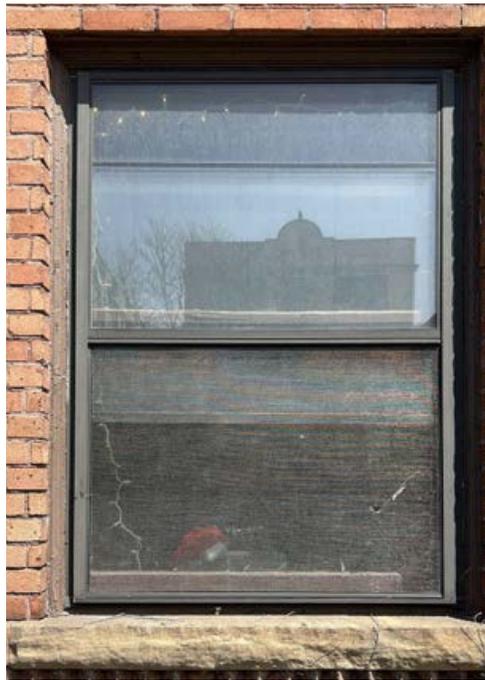
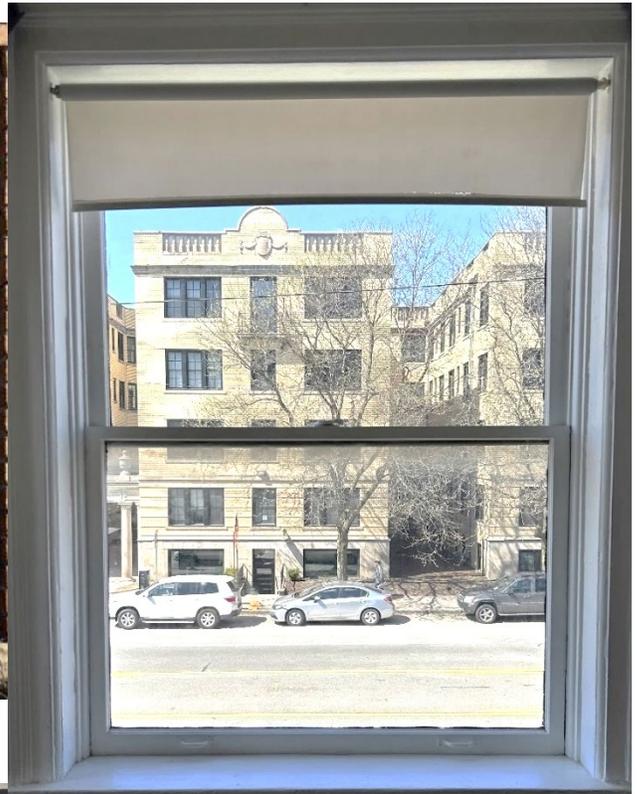
Windows 2.3 and 2.4 –
Center window and south-side
window of second floor bay
window.
Applicant requests they be
replaced.
Staff recommends they be
retained and repaired.

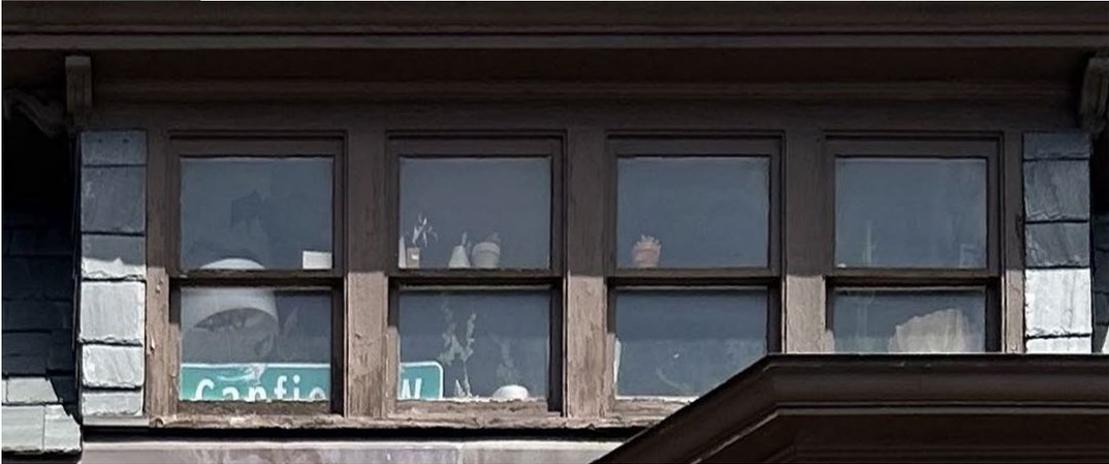
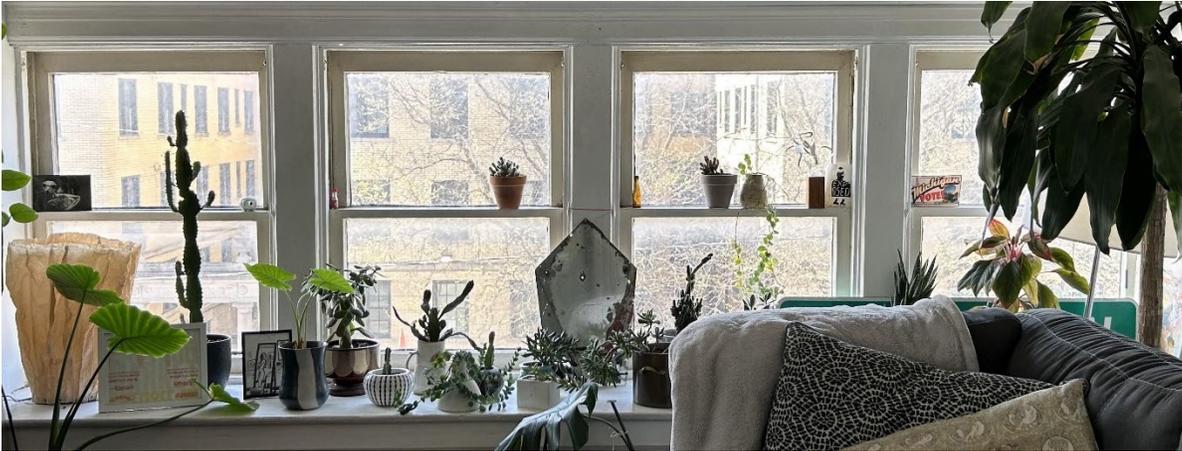
Window 3.1 –
Mulled windows in façade dormer.
Applicant requests they be replaced. Staff recommends they be retained and repaired.

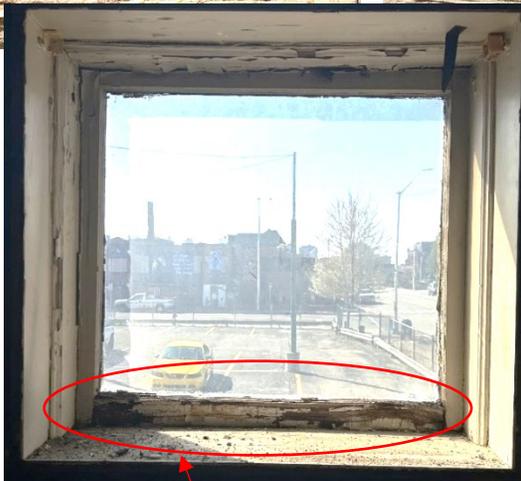
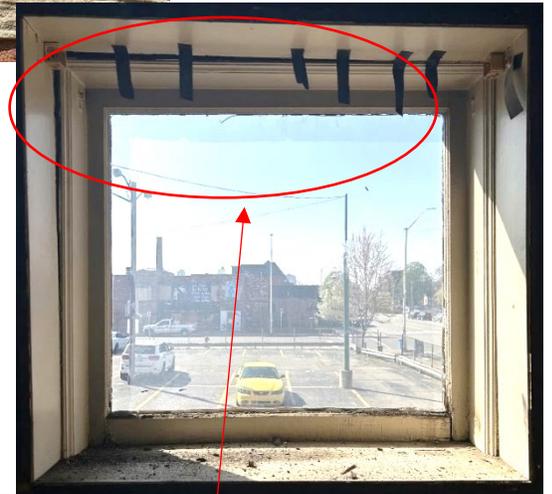
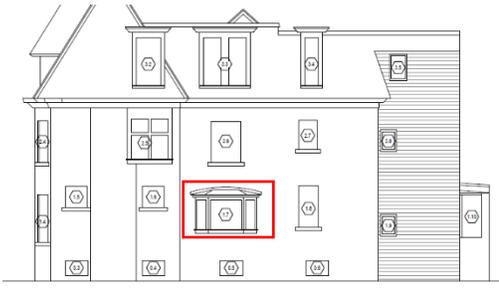
Windows 1.5 and 1.6 –
Small windows flanking chimney.
Applicant requests they be replaced.
Staff recommends they be retained and repaired.
Additional analysis by owner of conditions of window openings can be helpful to fully assess condition.

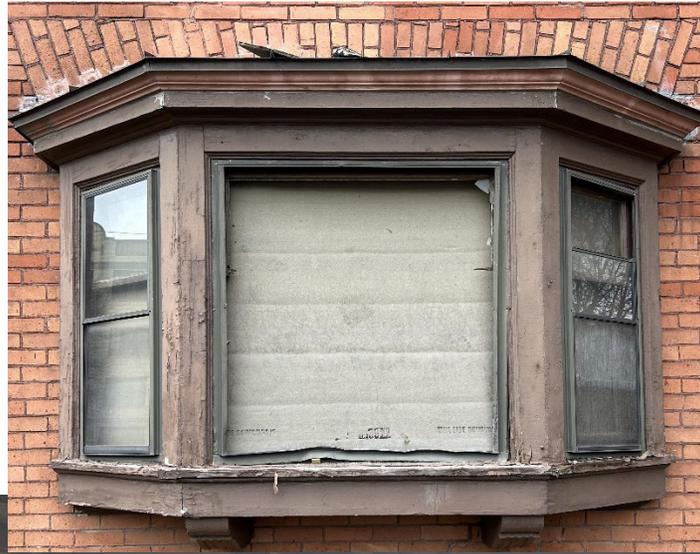
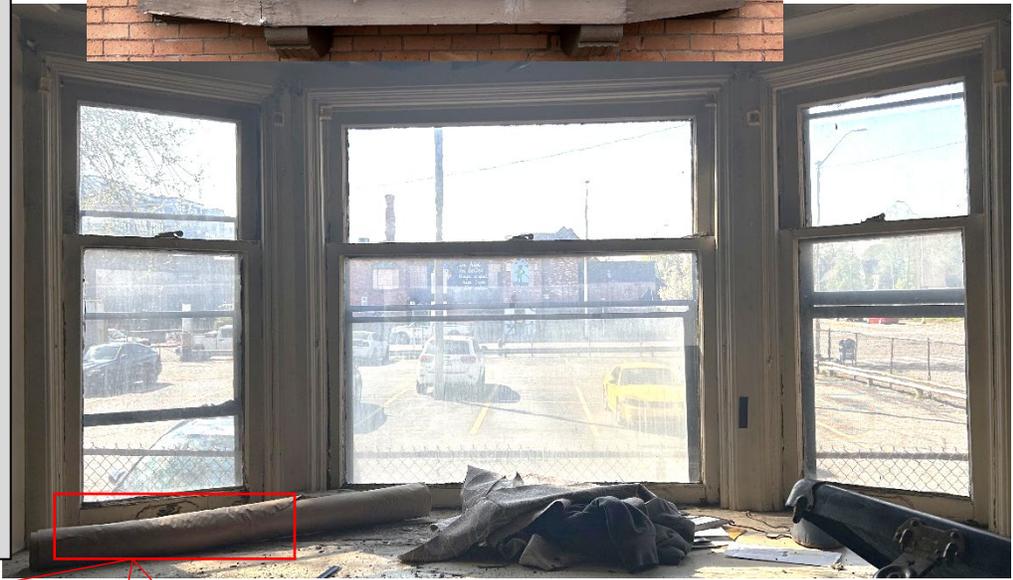
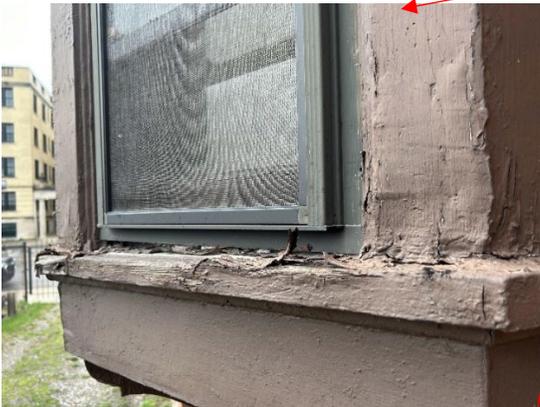
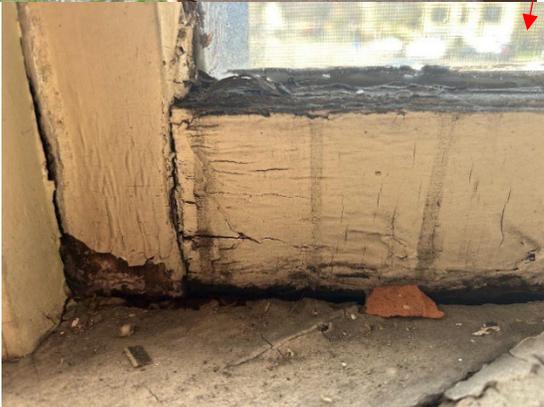
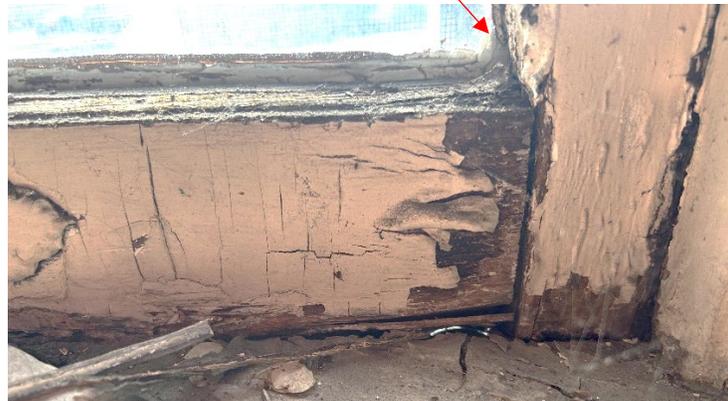
Windows (3) 1.7 –

Applicant requests the windows be replaced.

Staff recommends they be retained and repaired.

The bottom sill of the west-facing window shows a higher level of deterioration, but the remaining sash appears intact.

Confusion over existing conditions: Exterior photo appears to show missing central unit, and applicant documents state the same. However, the interior photo shows it intact.

Central unit at minimum has missing glass, and staff doesn't know if the sash is present and if it is there, its condition due to exposure from missing glass. Staff recommends a new wood window matching all details of adjacent windows be fabricated for this opening. **These are oriel windows.**

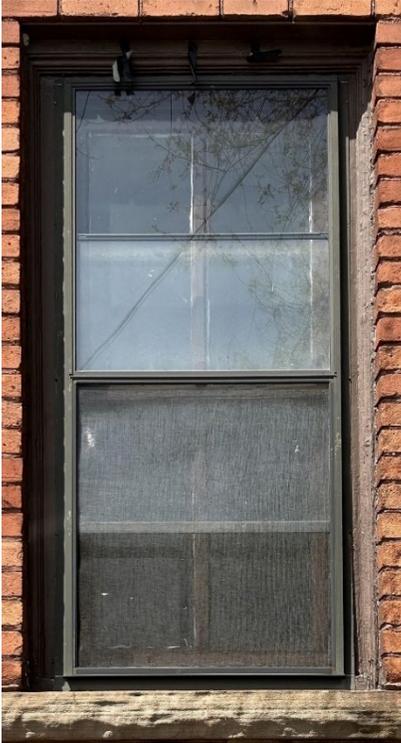
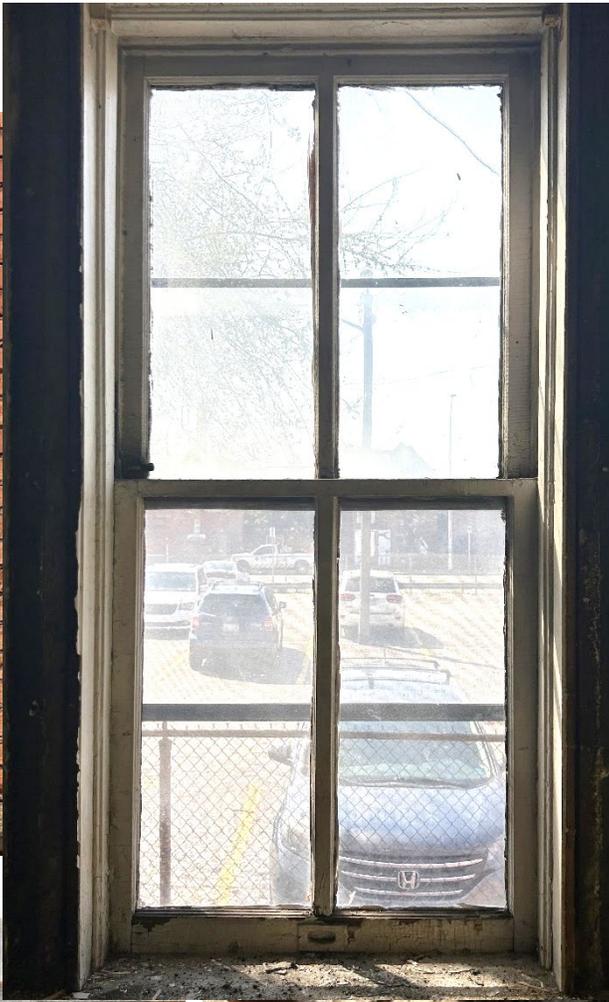
Window 1.8 – Different design that the remaining windows at the first and second floor, the 2-over-2 double-hung (which at first appears to be 4-over-4 due to the interior moveable bottom storm window that is partially open) is also found in the same location on the north wall, as well as one window on the east wall.

This window pattern was popular from the mid-1850s to the beginning of the 20th century. It is possible, but can't be proven, that this window sash was from the original (pre-1897) dwelling and wasn't replaced in the 1913 remodeling.

Regardless, it is a window of historic age, and not a total outlier as there are two other identical windows in similar locations. The window is intact and appears to be in repairable condition.

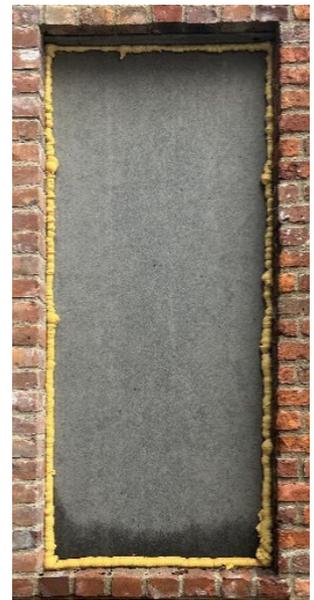
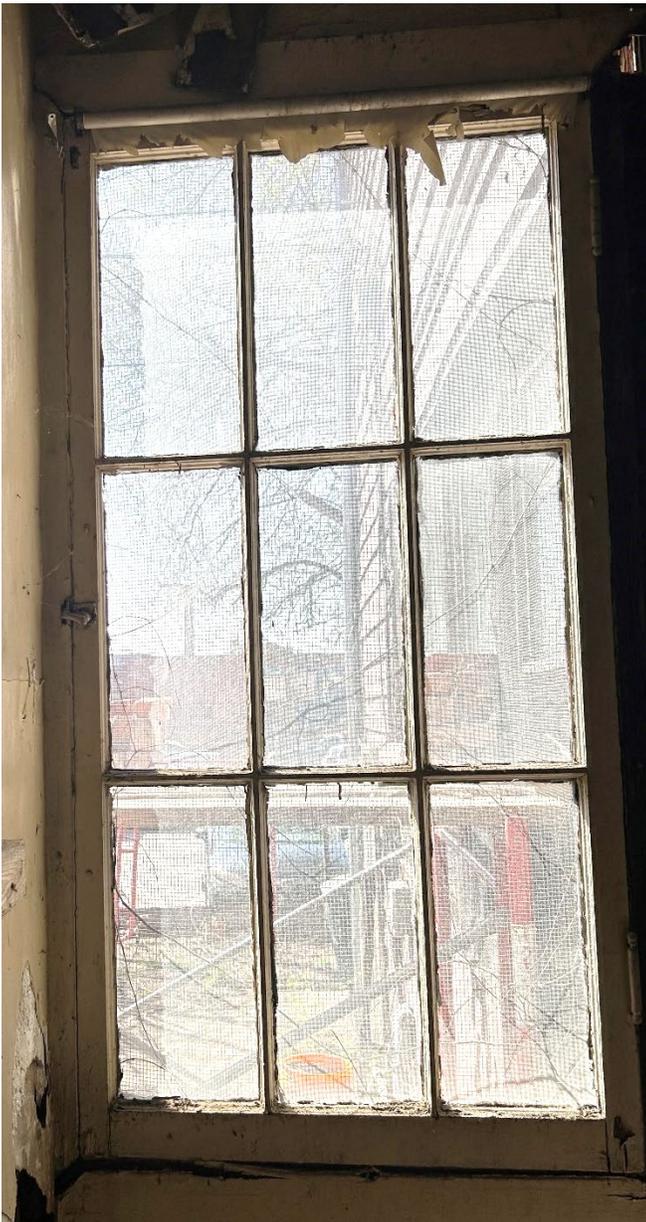
Windows 1.10 –

Applicant requests the window be replaced. Staff recommends it be retained and repaired.

This window is in the one-story addition, erected in 1920. The nine-light casement was a common window design for that period. While the surrounding walls appears to require a substantial amount of repair work, the window itself appears to be fully intact and repairable condition.

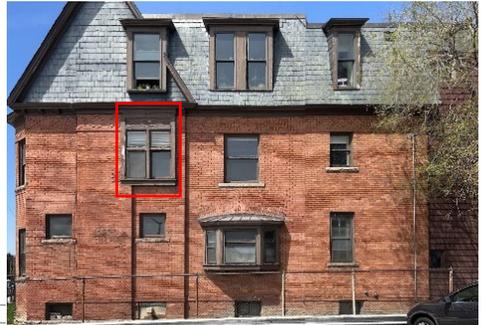
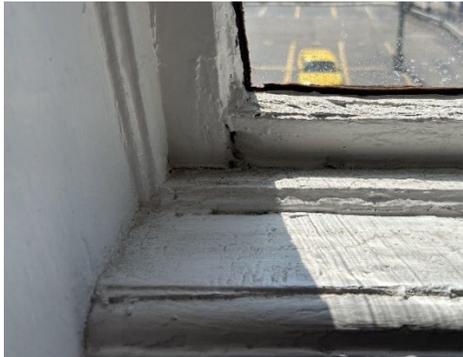
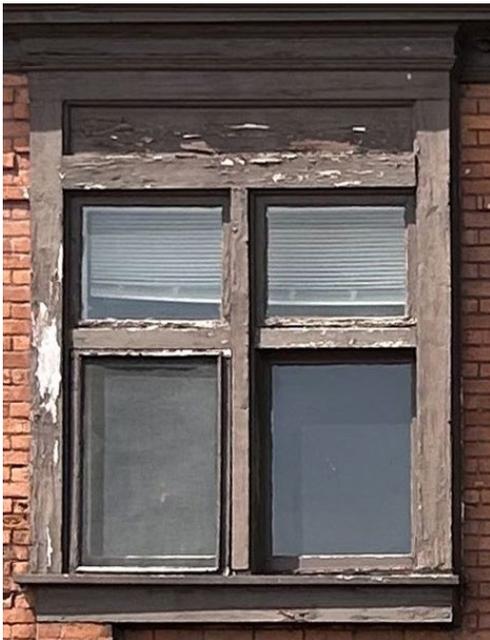
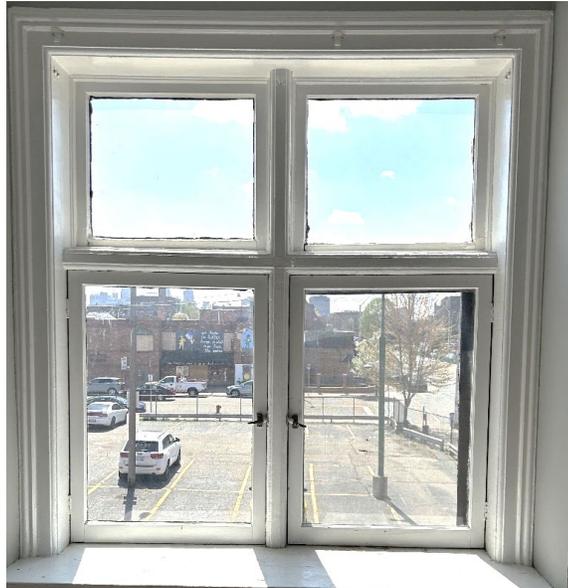
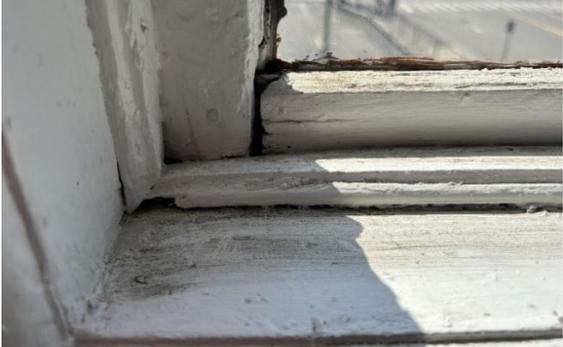
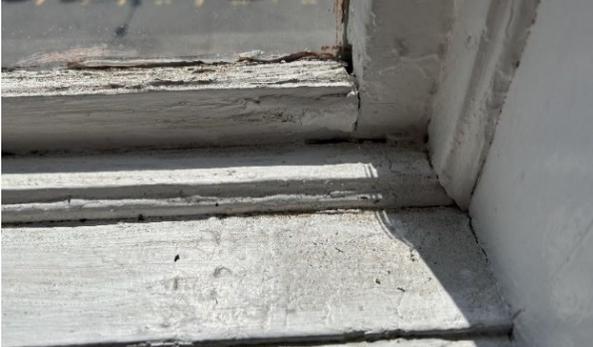
Windows 2.5
 The applicant requests these units be replaced. Staff recommends they be retained and repaired
 Staff isn't clear as to what appears to be open space between the interior wall of the house and outer window frame (bottom left photo), but inserting a replacement window would not fix this issue.

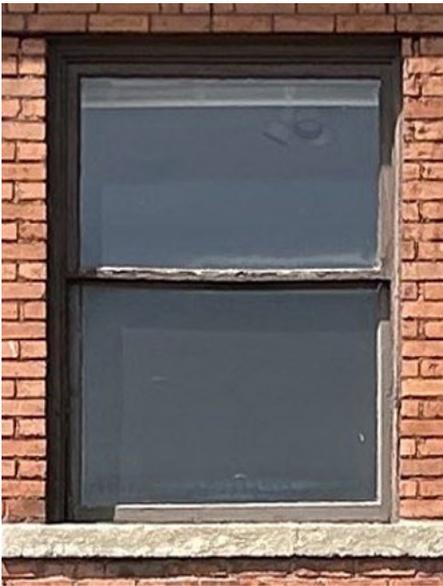
2.6

Applicant requests it be replaced. Staff recommends it be retained and repaired.

This window appears to be a newer window (there is no open area on side of window frame for a sash cord), but the frame dimensions visually appear to be similar to the older double-hung windows.

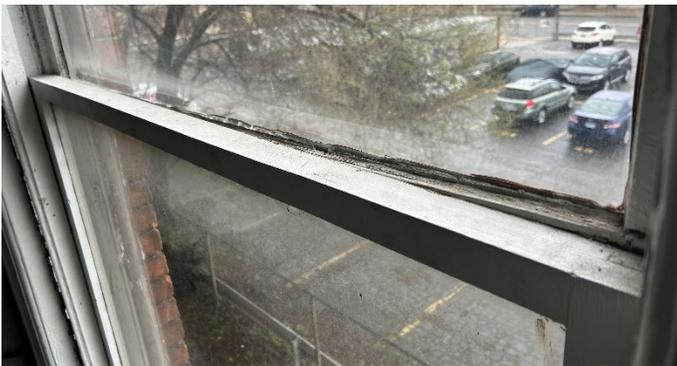
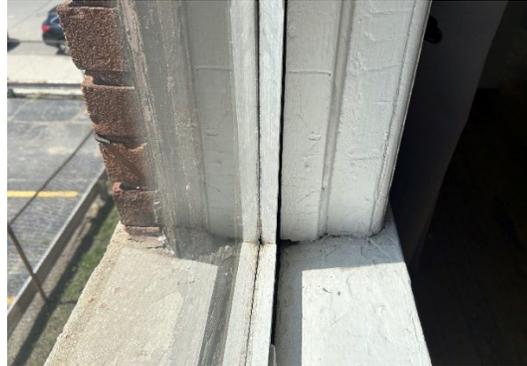
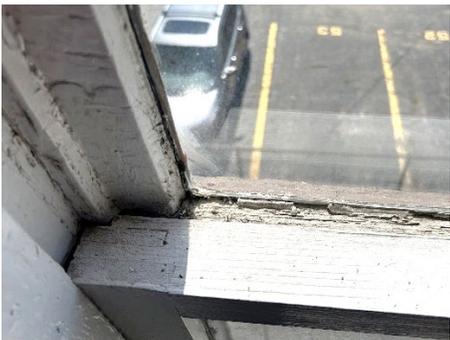
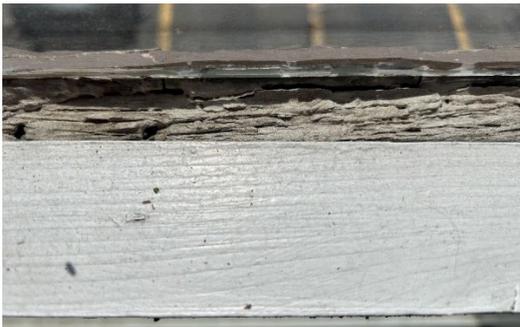
2.7

Applicant requests it be replaced. Staff recommends it be retained and repaired. However, detailed photos to confirm its condition were not available at the time of writing the report.

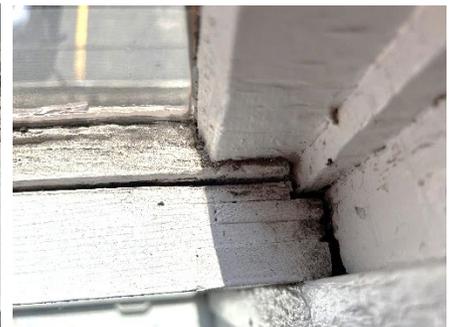
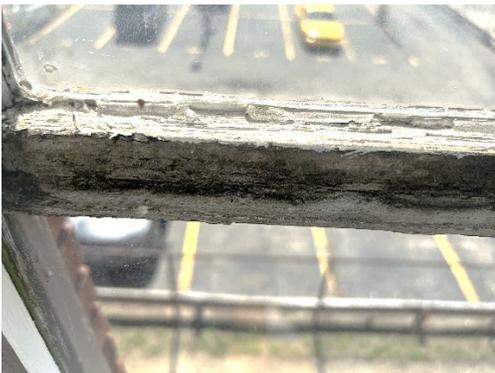
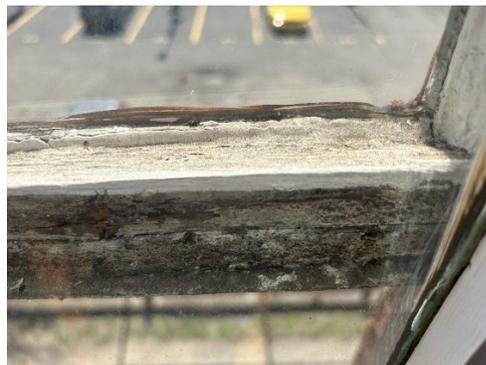
1.10

Appears to be original to the 1920 rear addition construction. Applicant requests replacement. Staff recommends retention and repair.

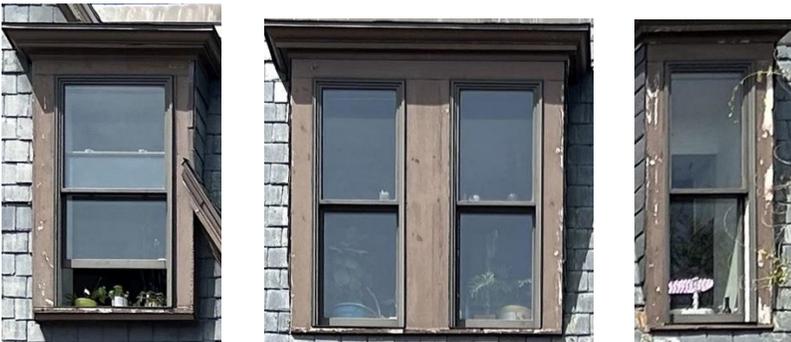
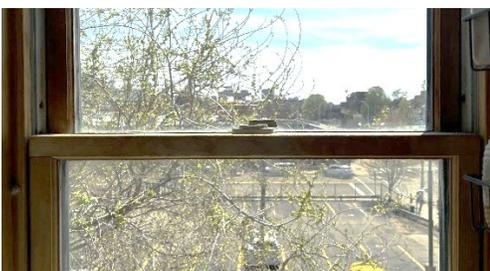
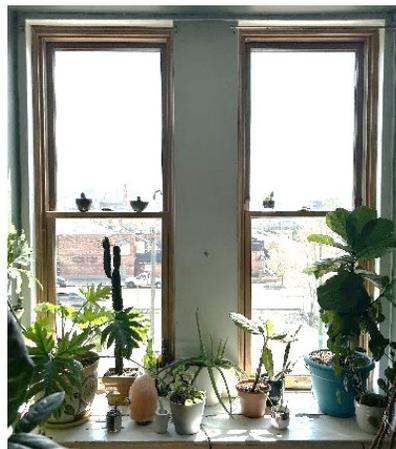
Windows 3.2, 3.3 and 3.4
Existing windows are contemporary replacement units. Installation of new aluminum-clad wood windows is compatible within the parameters of the Standards.

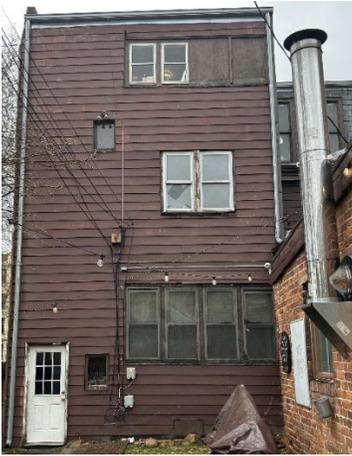
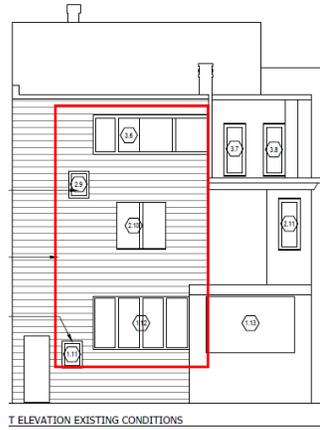
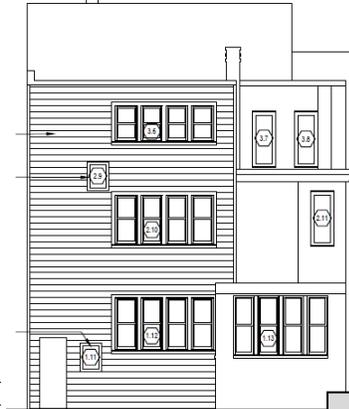
Window openings 1.12, 2.10 and 3.6

The existing openings do not contain historic window sash, and 2 of the 3 openings have been heavily altered.

The proposal, as shown in the "after" elevation (top right), will return a uniformity to this elevation.

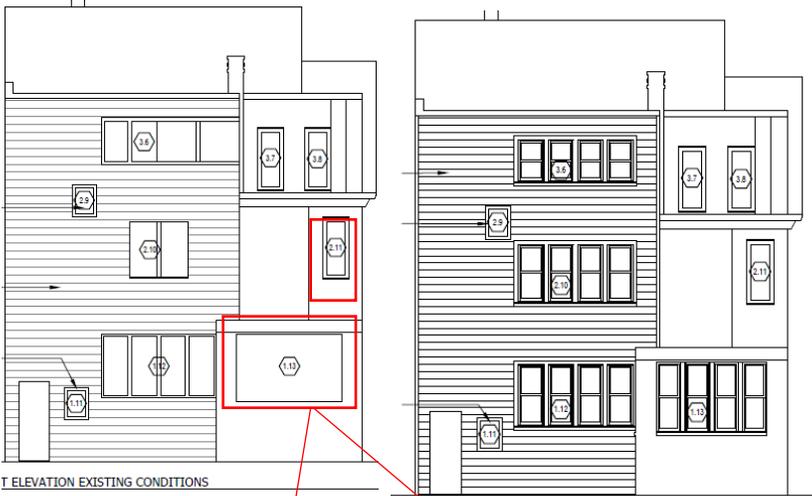
Window opening 1.13
 The existing openings do not contain historic window sash the opening has been heavily altered.
 The proposal, as shown in the “after” elevation (at left), will return a uniformity to this elevation.

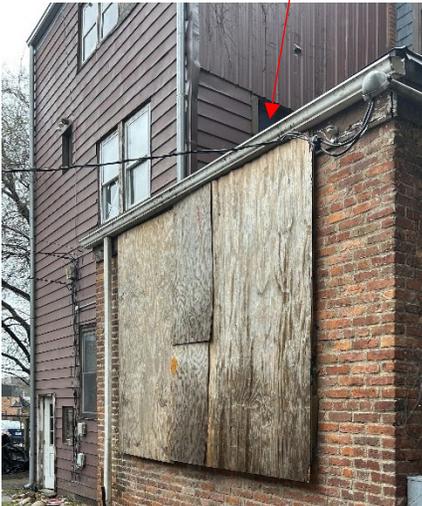
Window 2.11
 As discussed under Window 1.8, this is one of three historic age 2-over-2 double-hung windows within the house.
 Applicant requests replacement; staff recommends repair.

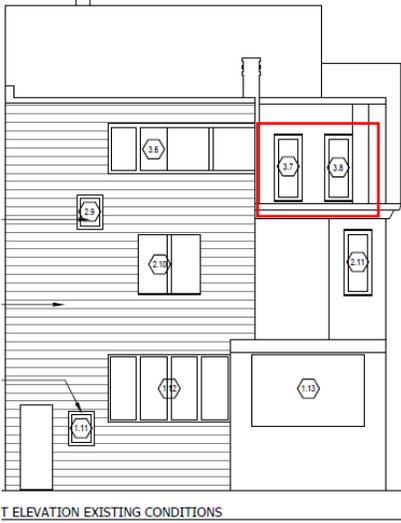
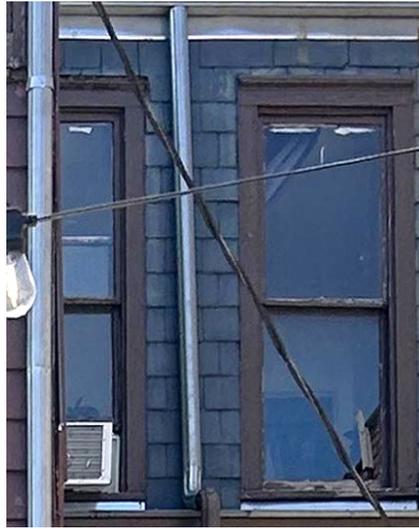
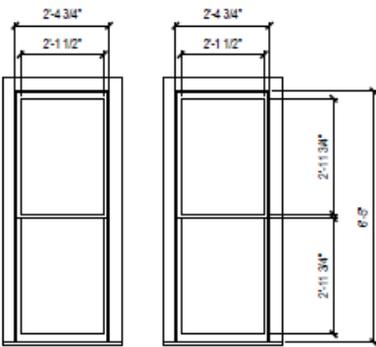
Windows 3.7 and 3.8

Similar to the façade window 1.4, window 3.7 suffers from additional deterioration due to long term exposure caused by a window a/c unit (although additional photos could help the assessment). The adjacent window, 3.8, appears to be in repairable condition.

However, as the windows are adjacent each other, it's staff's opinion they should be considered with the same action-repair or replacement. As these openings are on the rear elevation and recessed behind the three-story addition; they are not publicly visible.

The dimensions of the proposed windows are close to the historic units. And at the recessed second floor location, staff doesn't believe the replacement units will be noticeable, won't alter the historic features of the property and believes the replacement meets the National Park Service guidelines document [Replacement Windows that meet the Standards](#).

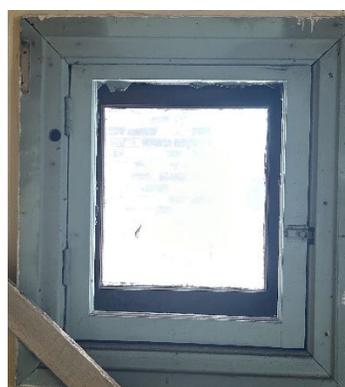
Applicant requests to replace 2.12 (on north wall of enclosed rear three-story porch).

Applicant requests to replace 1.14.

These windows are not visible from any public view. Both windows appear to be repairable, therefore, staff determines that the replacement proposal doesn't meet Secretary of the Interior Standard 6.

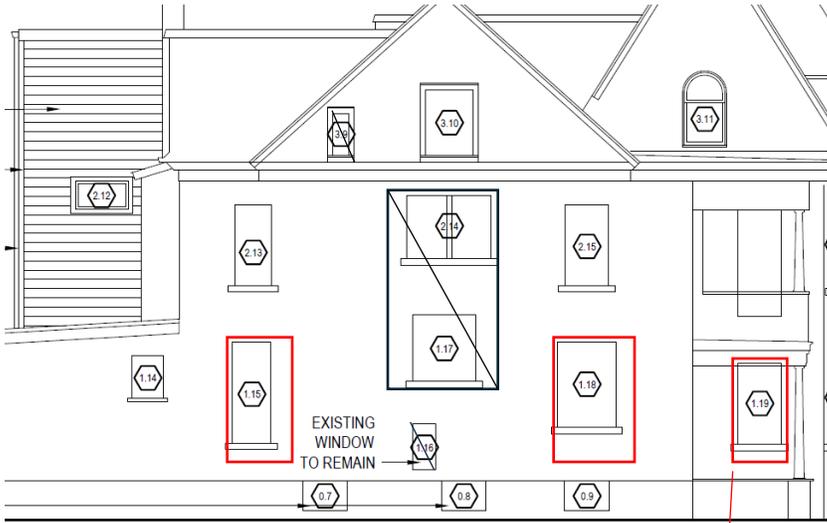
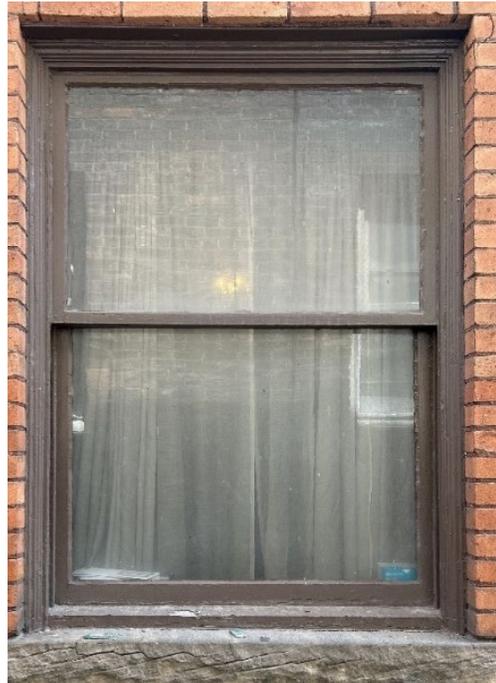
1.18

It is staff's opinion that they all appear to be in good condition (likely due to their limited exposure) and can be repaired.
