STAFF REPORT: 07/10/2024 REGULAR MEETING
APPLICATION NUMBER: HDC2024-00289
VIOLATION NUMBER: 912
ADDRESS: 677 W. CANFIELD
HISTORIC DISTRICT: WEST CANFIELD
APPLICANTS/ PROPERTY OWNER: MATTHEW ALLEN FLESZAR
DATE OF PROVISIONALLY COMPLETE APPLICATION: 06/17/2024
DATES OF STAFF SITE VISITS: 06/26/2024

SCOPE: ERECT REAR STAIRWELL ENCLOSURE (WORK COMPLETED WITHOUT APPROVAL)

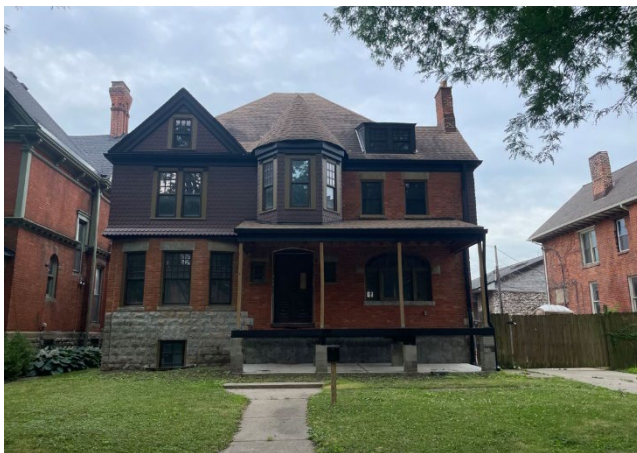
Site Photo 1, by Staff June 26, 2024: (North) front elevation showing current conditions.

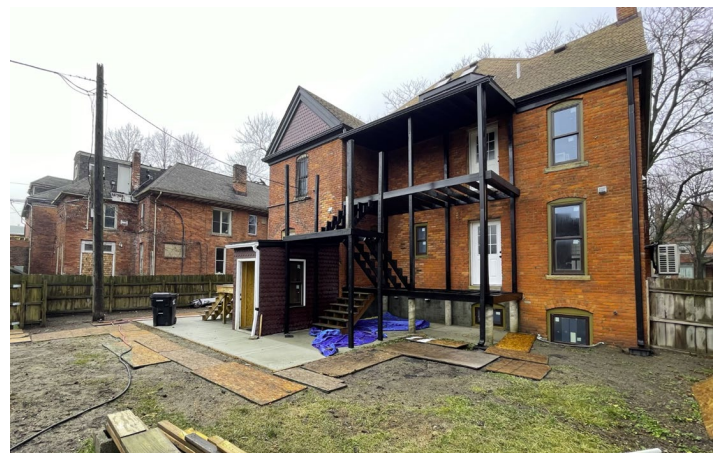
Site Photo 2, by Applicant June 2024: (South) rear elevation showing current conditions.

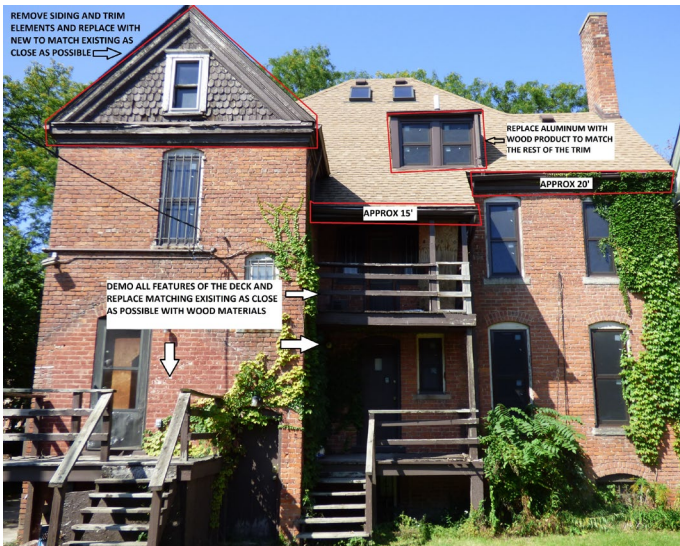
Site Photo 3, from 2020 application, date unknown: (South) rear elevation showing previous conditions of rear deck/balconies and their original footprint locations, which were approved for rebuild within these footprints. Note the scalloped siding in the gable that is reflected in the proposed stairwell enclosure.

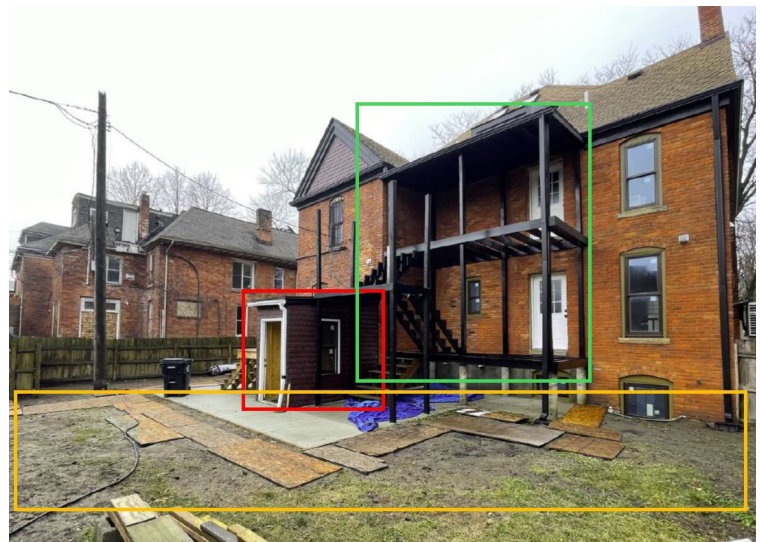
Site Photo 4, by Applicant, June 2024: (South) rear elevation location showing locations of work: red and gold boxed areas are included in this proposal, the green box is for a future application.

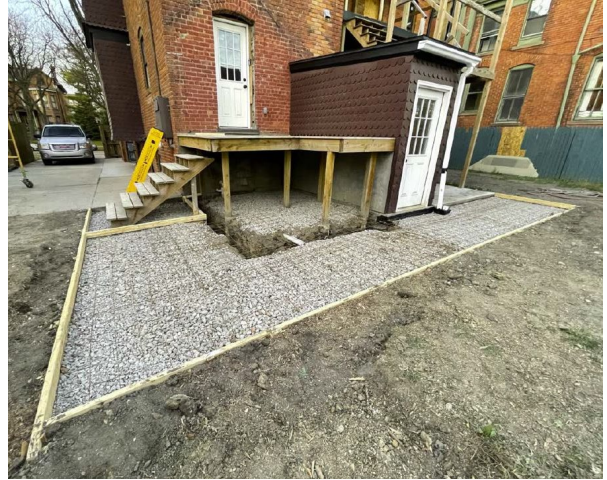
Site Photo 5, by Applicant, June 2024: (Southwest) rear elevation, showing rear stairwell enclosure, which has not yet been fully painted, and the extent of the proposed concrete paved areas.

- Work in this application was completed without the Commission's approval.
- Staff has no other issues with the proposal.

It is staff's opinion that the construction of the rear stairwell enclosure, concrete paving work, and installation of the French drains are appropriate. Staff therefore recommends the Commission issue a Certificate of Appropriateness for the work as proposed because it meets the Secretary of the Interior Standards for Rehabilitation and the West Canfield Historic District's Elements of Design.
