STAFF REPORT: 7/10/2024 MEETING

ADDRESS: 1480 SHIPHERD

APPLICATION NO: #HDC 2024-00086

SCOPE: ERECT NEW ADDITION, ALTER EXTERIOR OF BUILDING

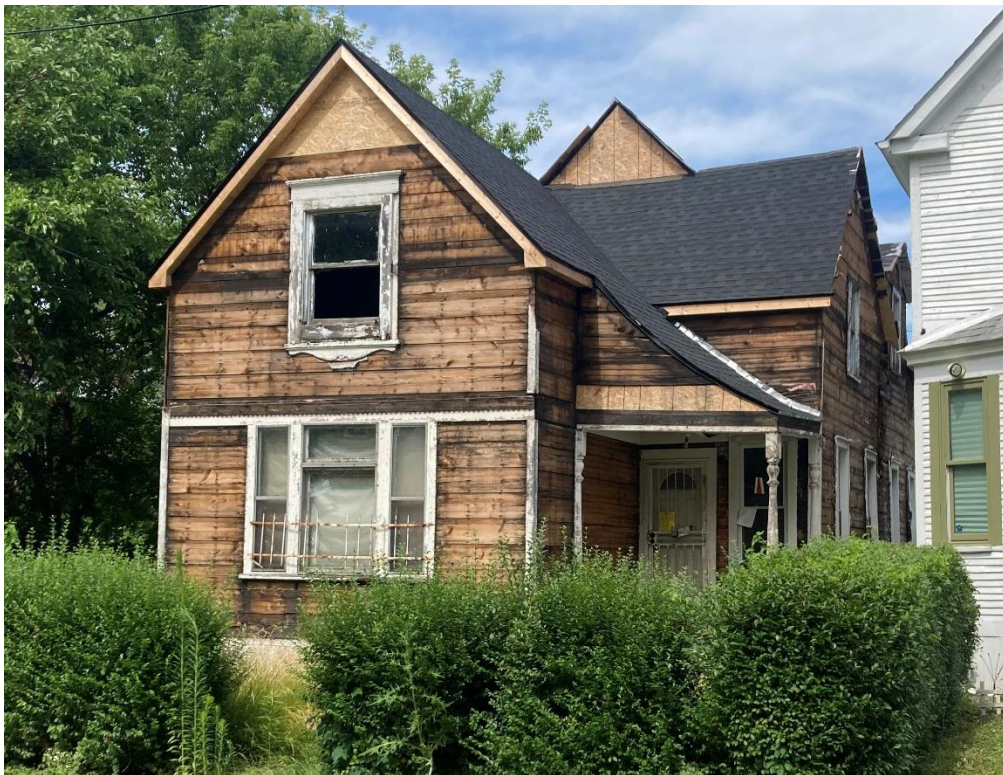
1480 Shipherd, current condition after the removal of most historic features. Compare to images on page 4. Staff photo taken on 6/25/2024

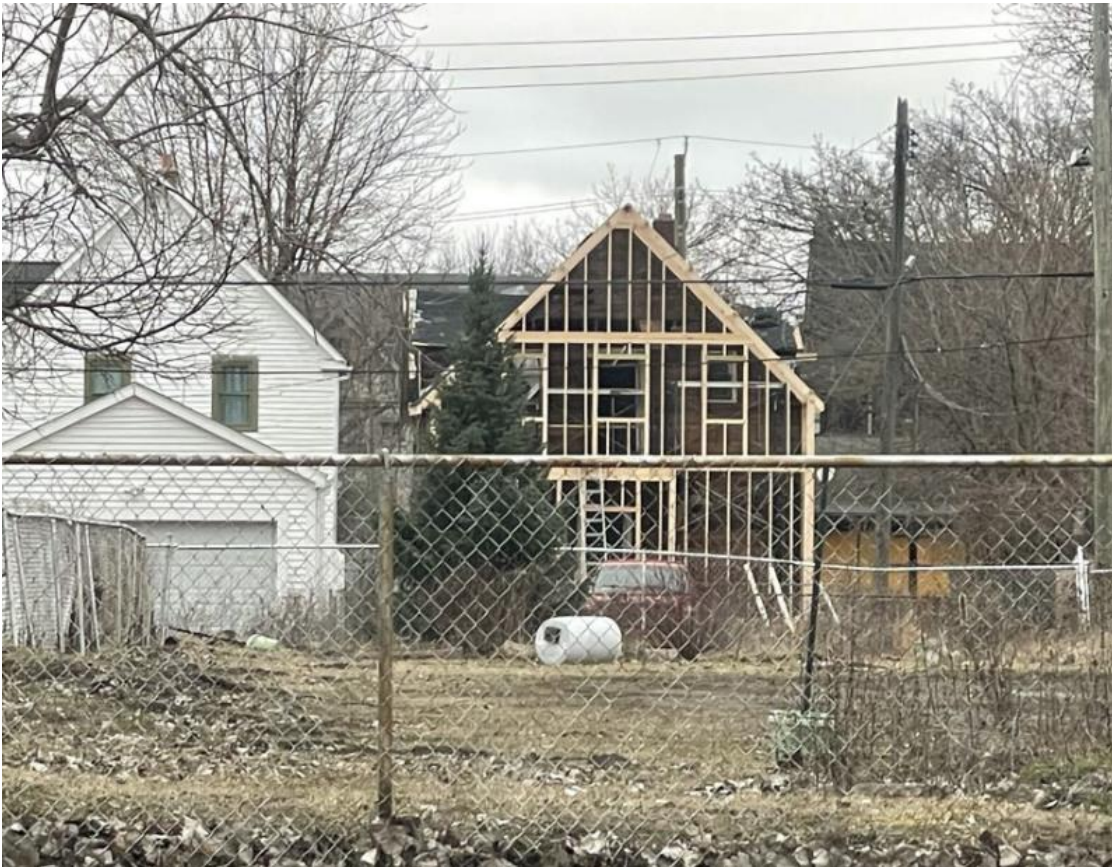
1480 Shipherd, rear addition. Photo taken by HDC staff on 2/28/2024

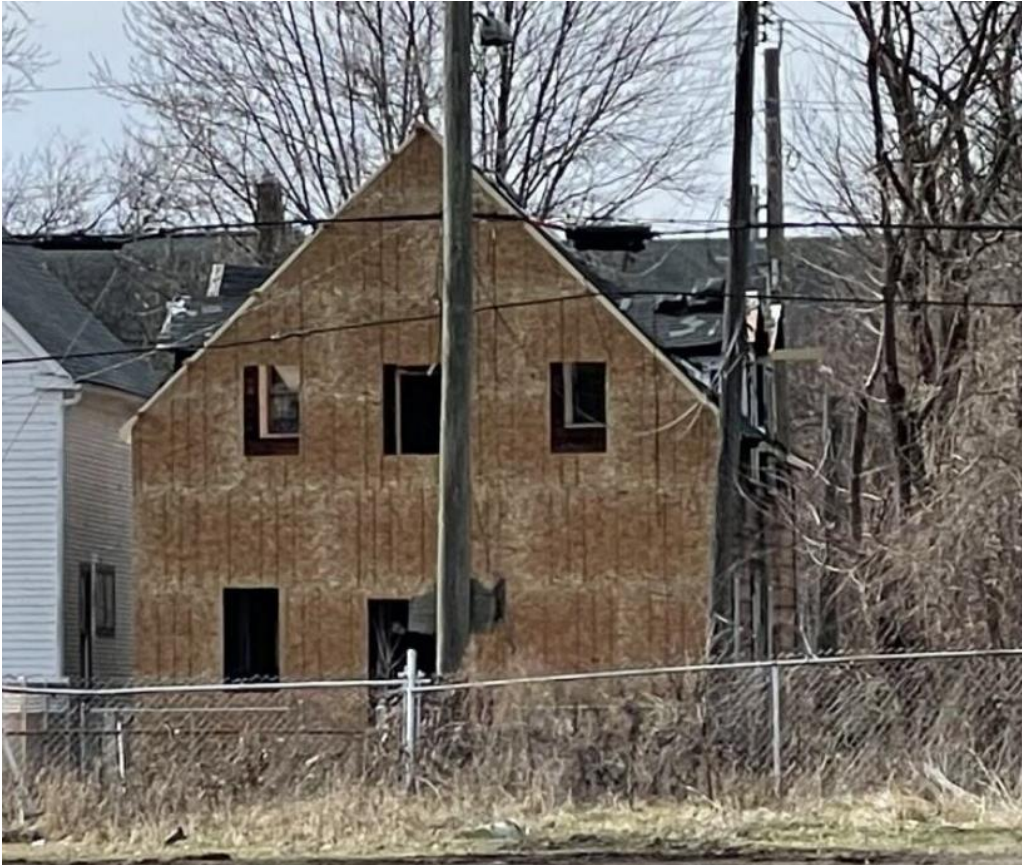
1480 Shipherd, rear addition. Photo taken by HDC staff on 3/1/2024

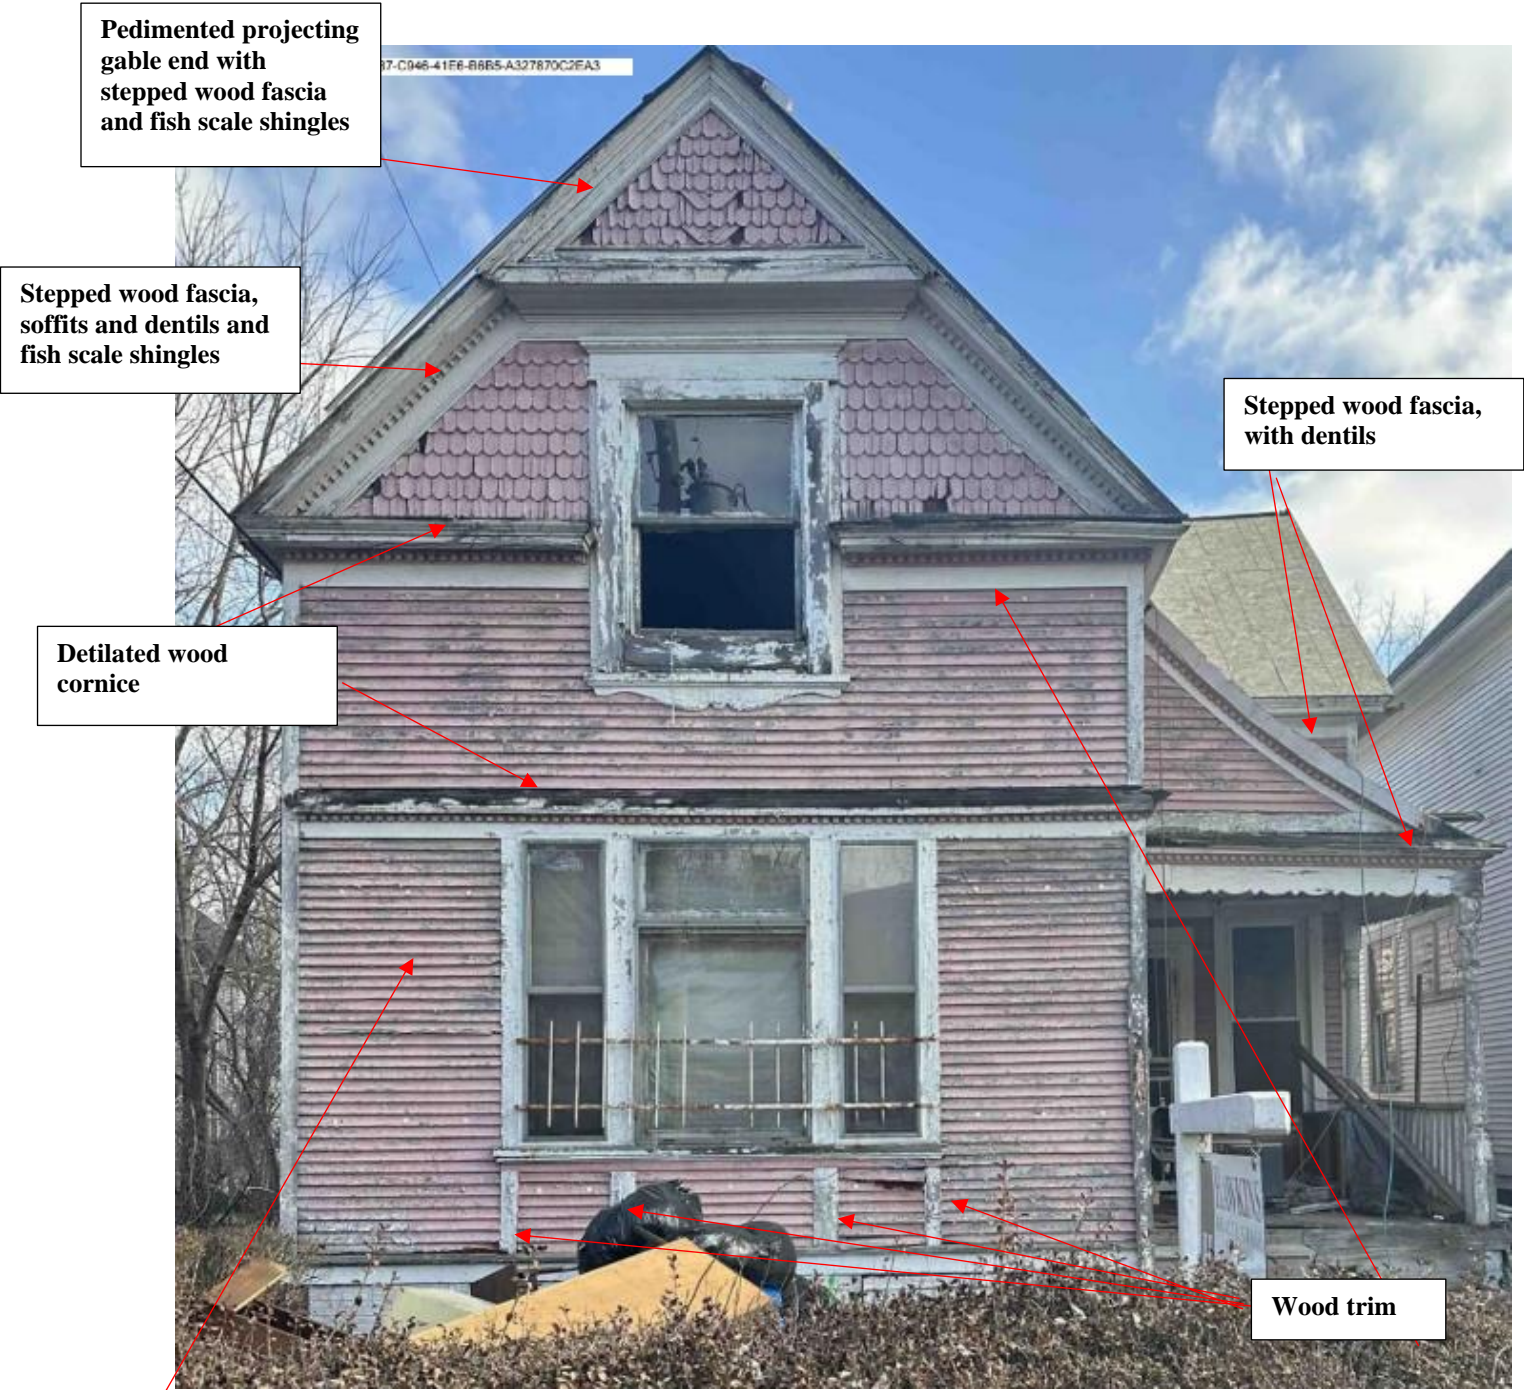
1480 Shipherd, prior to unapproved work. Photo provided by applicant

Narrow exposure wood clapboard siding

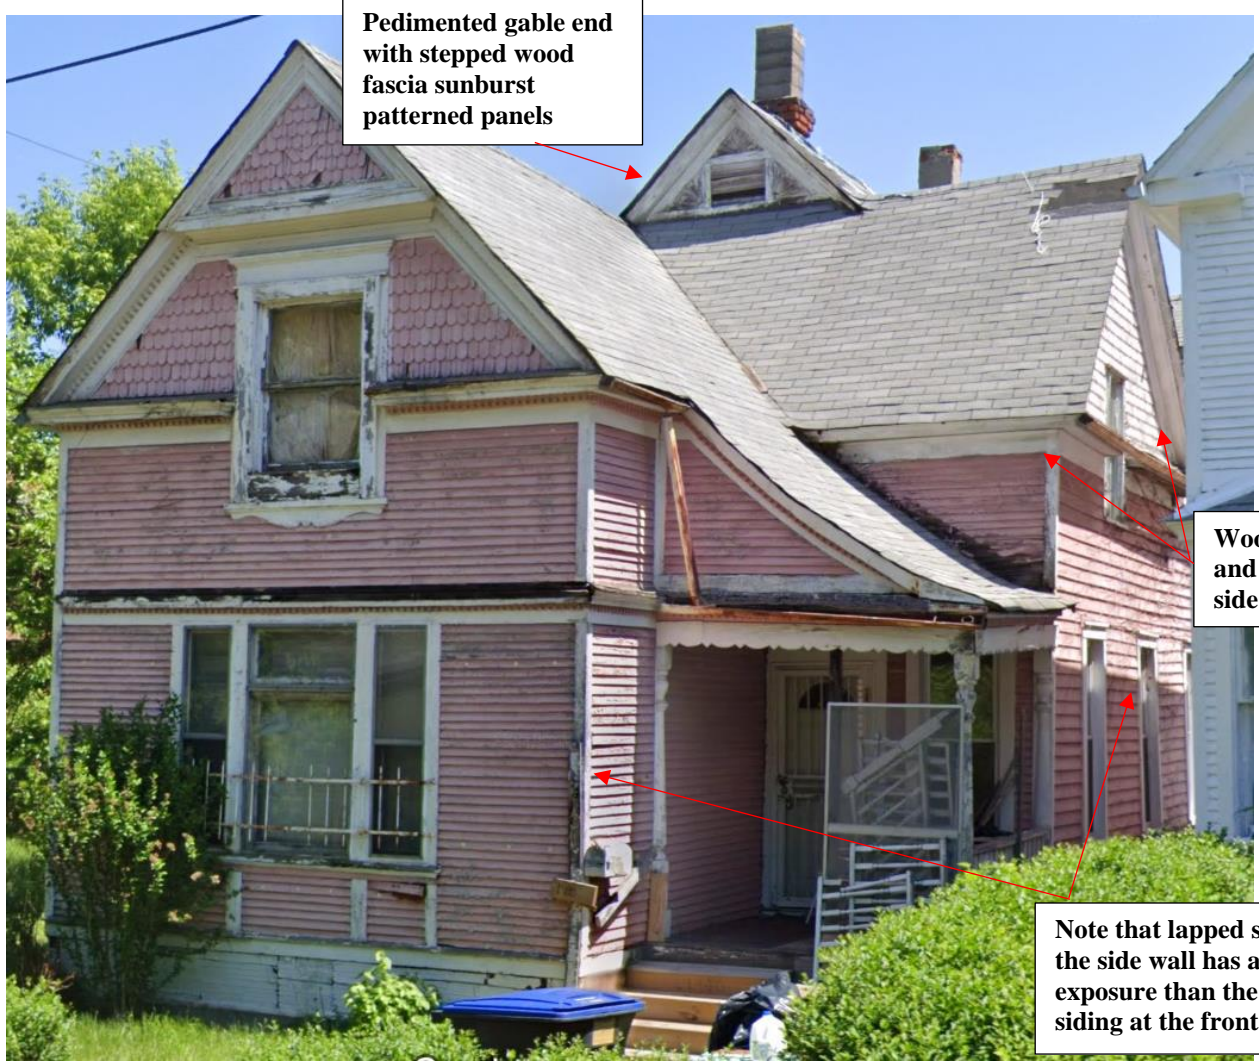
1480 Shipherd, Google Streetview 2019

Pedimented gable end with stepped wood fascia sunburst patterned panels

Wood trim and soffits at side wall

Note that lapped siding at the side wall has a wider exposure than the lapped siding at the front facade

- The fish scale shingle treatment proposed for the east gable is not accurate to the sunburst panel siding that was historically located within the gable/removed without approval

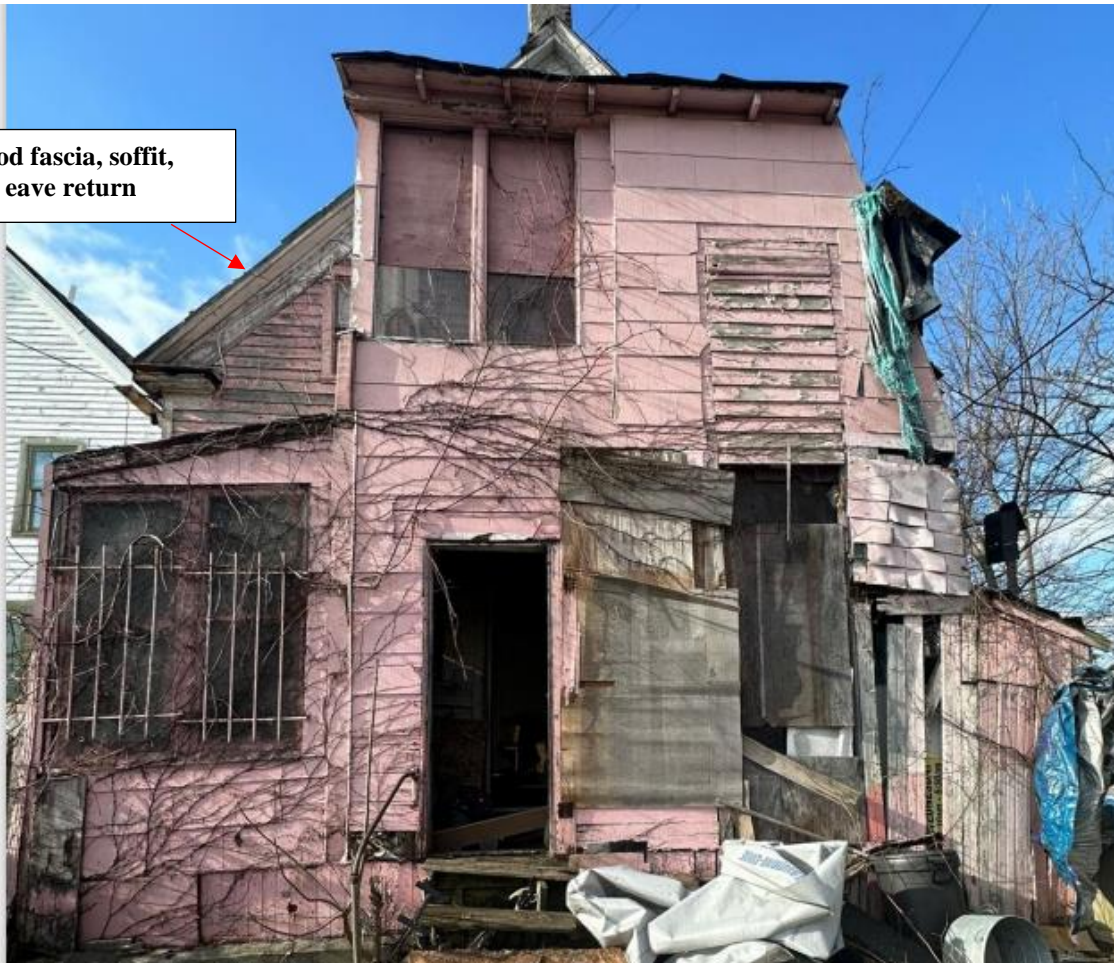
Wood fascia, soffit, and eave return

1480 Shipherd, rear. Showing two-story wing that was removed without HDC approval/location of new addition which was erected without HDC approval. Photo provided by applicant

- The below Sanborn Maps indicate that the rear wing that was removed without approval was built sometime after 1910. A review of photos taken of the rear wing prior to its demolition, at both the interior and interior indicate that it was in poor condition and was not at all compatible with the historic character of the original portion of the house. Staff therefore supports its removal.

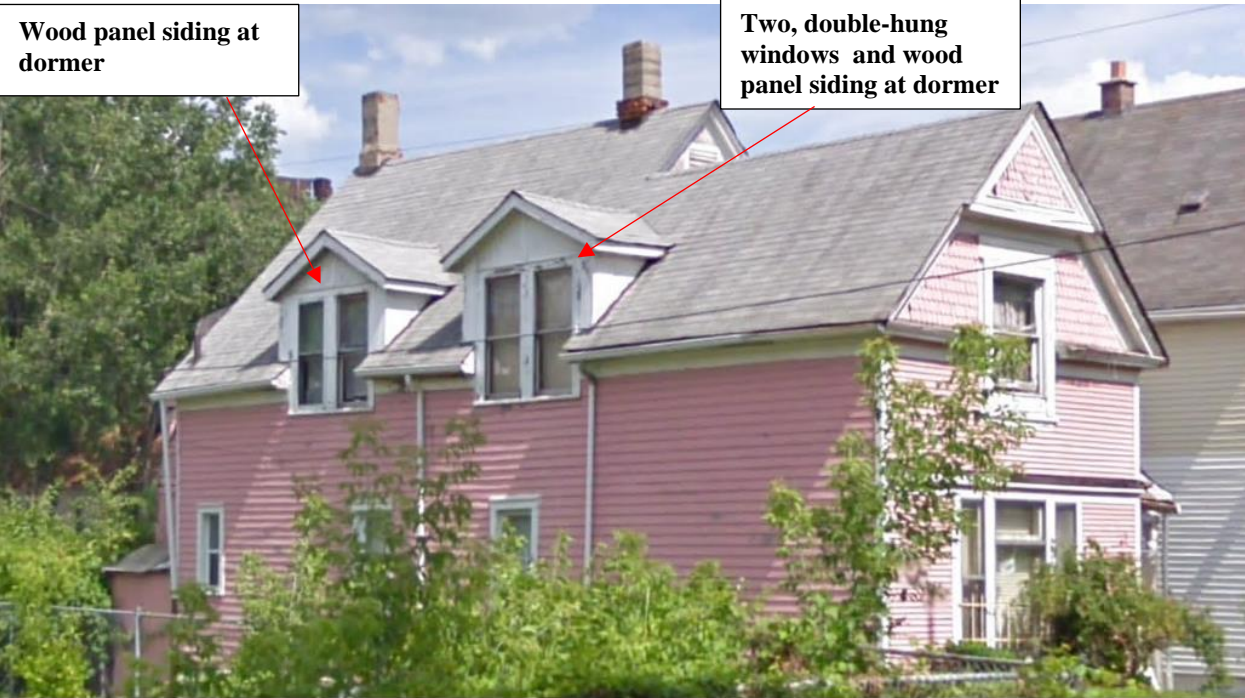
1480 Shipherd, Google Streetview, 2013 showing north side wall

Wood panel siding at dormer

Two, double-hung windows and wood panel siding at dormer

- The application also appears to seek to replace the double-hung windows which were removed from the north elevation with new sliding units.
 - The exposure dimensions of the new lapped wood siding will not match that of the original siding/the siding that was removed without HDC approval.

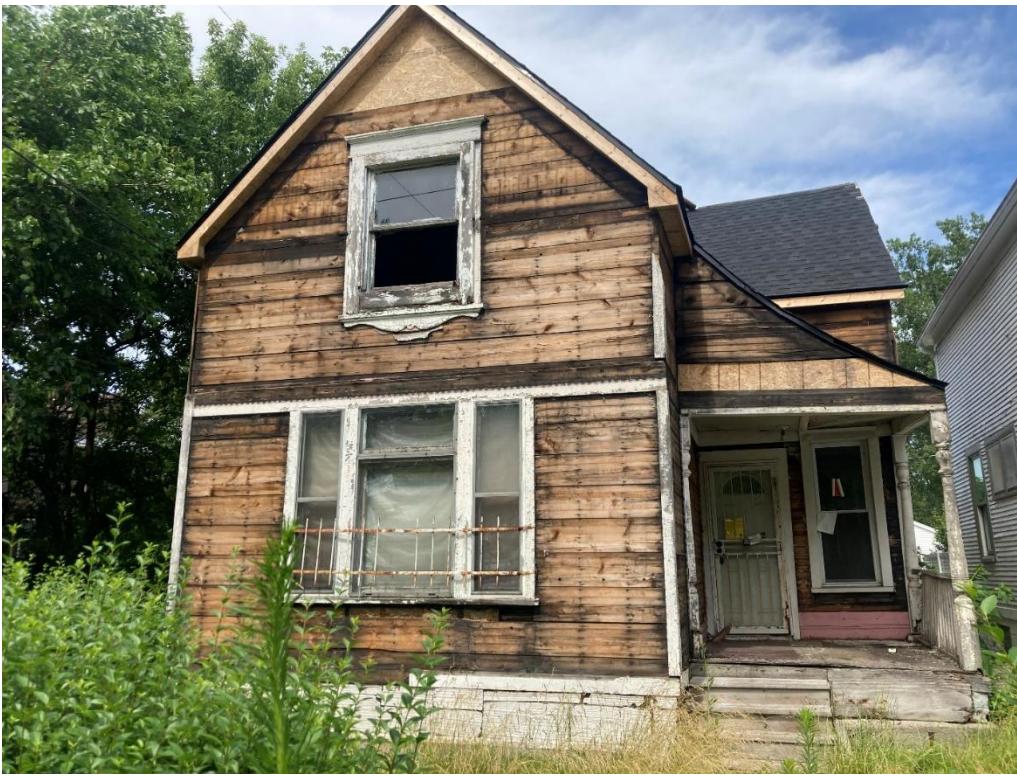
1480 Shipherd, front façade. Current condition. Staff photo taken on 6/25/2024. Note that only small areas of corner board trim, the windows; and porch posts, pilasters, floor, steps, and railing remain at the front façade. All other siding and detailing at the walls and roof have been removed without HDC approval.

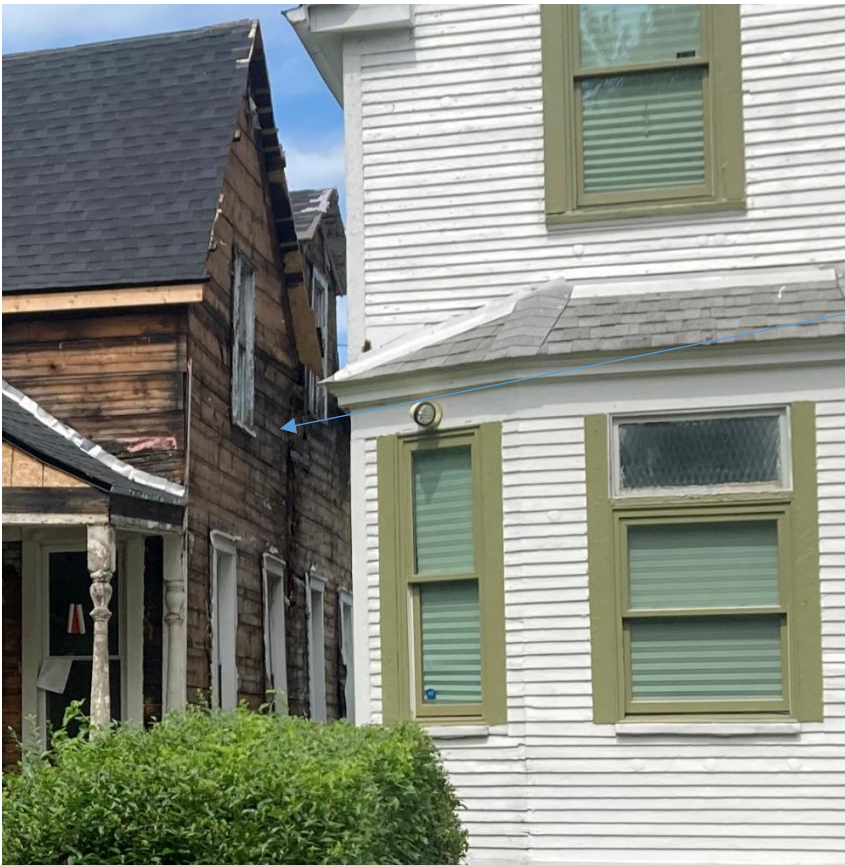
1480 Shipherd, south side wall. Current condition. Staff photo taken on 6/25/2024. Note that only the windows remain. All siding and detailing/trim at the walls and roof have been removed without HDC approval.

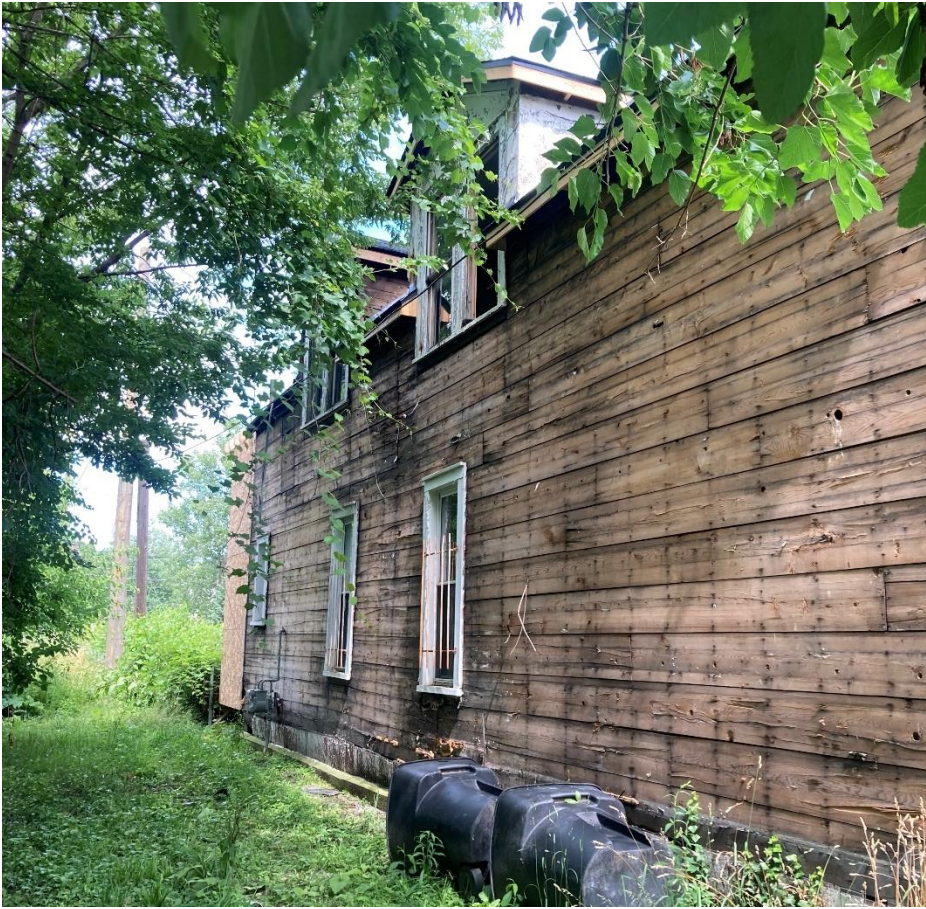
1480 Shipherd, north side. Current condition. Staff photo taken on 6/25/2024. Note that only 5 windows remain. The two windows in the western dormer and all siding and detailing/trim at the walls and roof have been removed without HDC approval

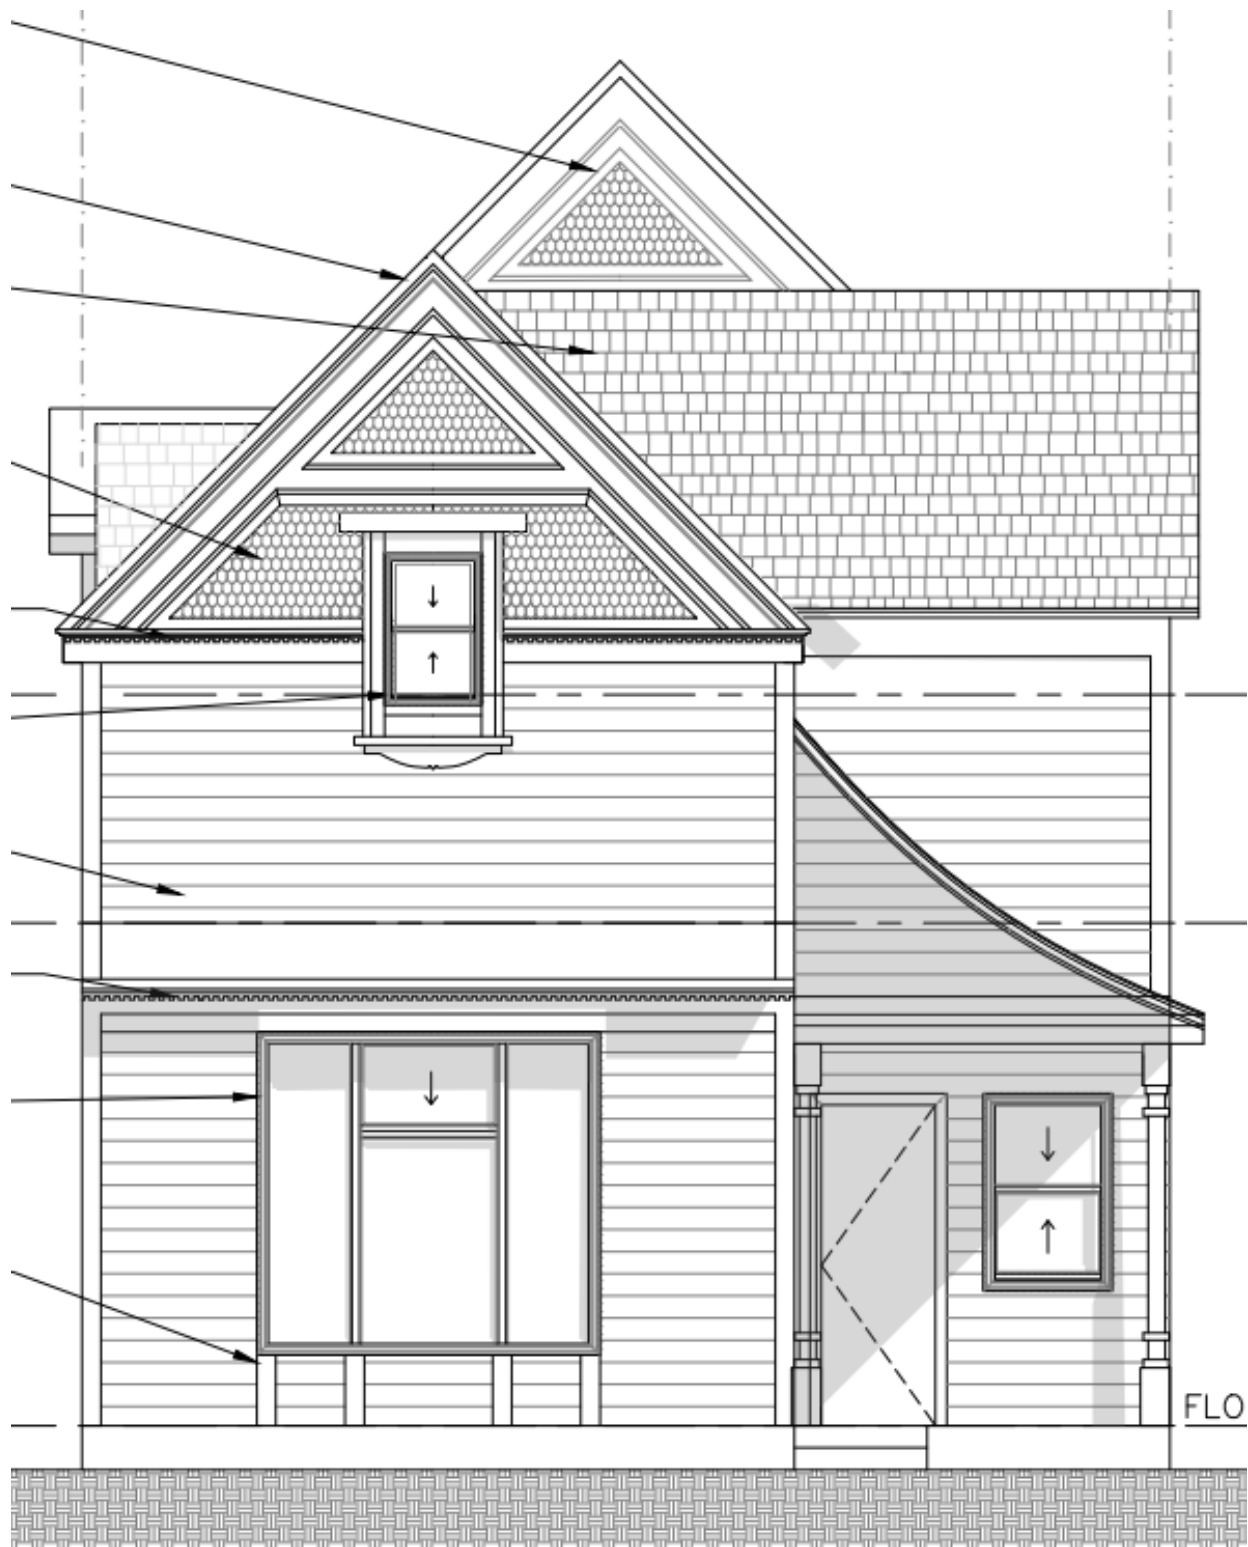
West elevation, proposed condition

- The submitted drawings (see below) indicate the following regarding the historic, character-defining elements that were removed without approval:
 - The applicant is proposing to bring back some of the decorative detailing which was removed without approval at the front façade. However, staff would need to review enlarged drawings depicting dimension and detail to ascertain how closely the new decorative elements with match the old

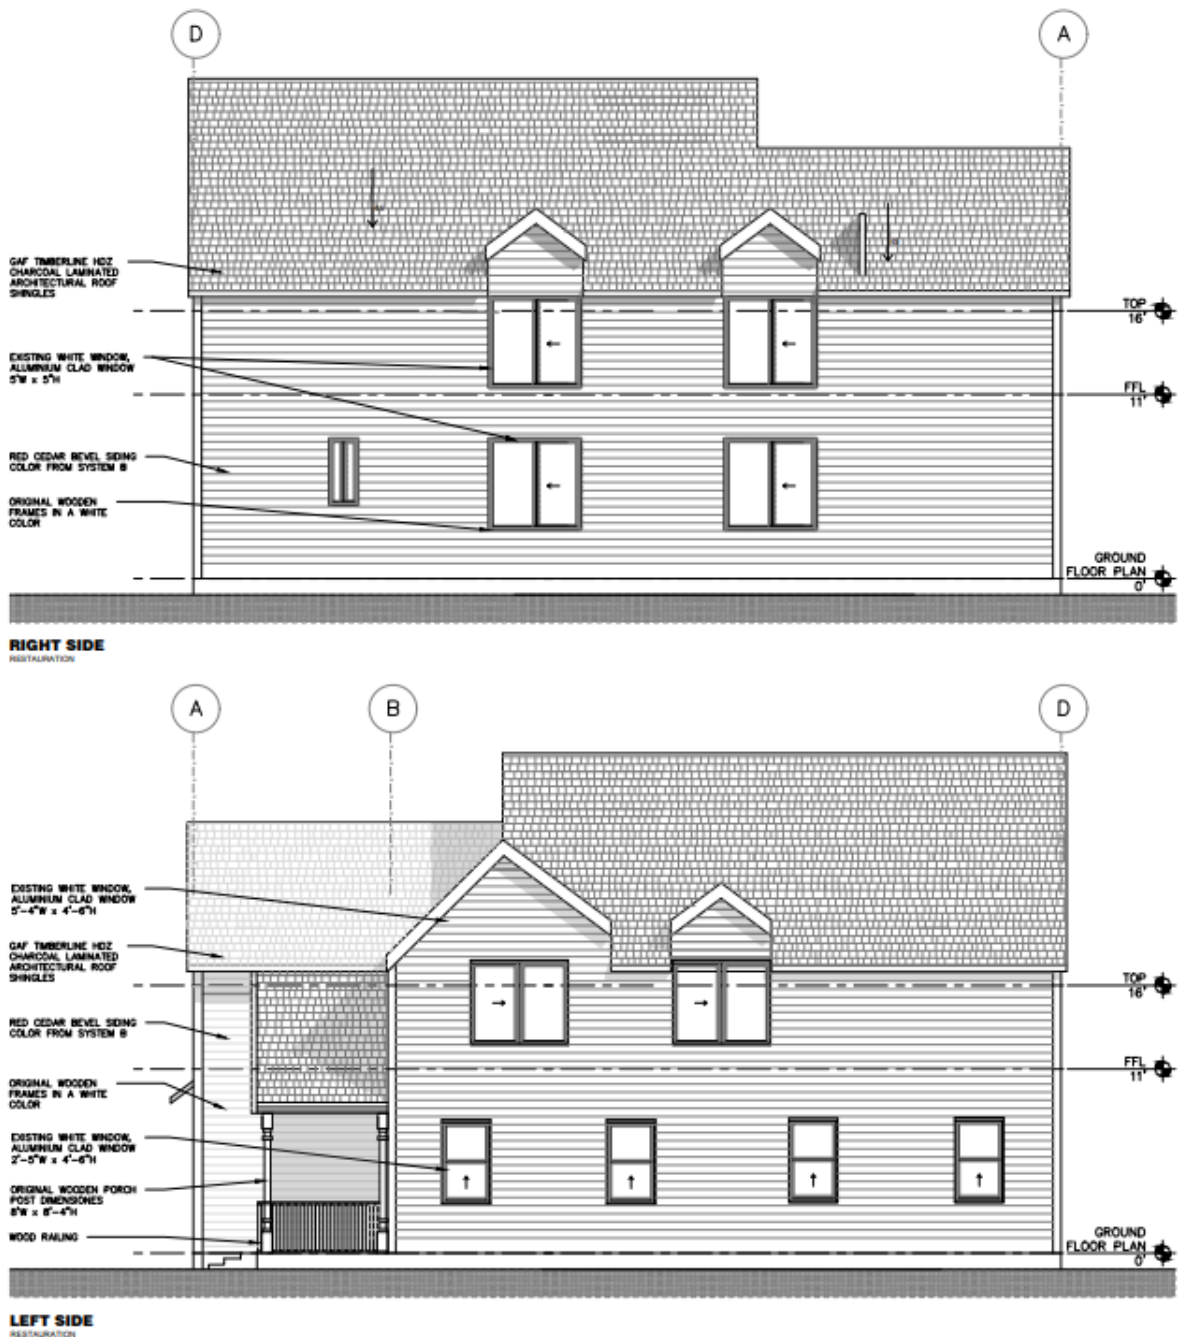
North (top) and south (bottom) elevation, proposed conditions

- The drawings indicate the presence of slider windows at the side walls, however all remaining windows at these locations appear to be 1/1, double hung units. Also, the drawings note that the existing windows will be retained, but staff is unclear if the notes are incorrect and the applicant is instead intending to install sliding units at these locations as depicted in the drawings.

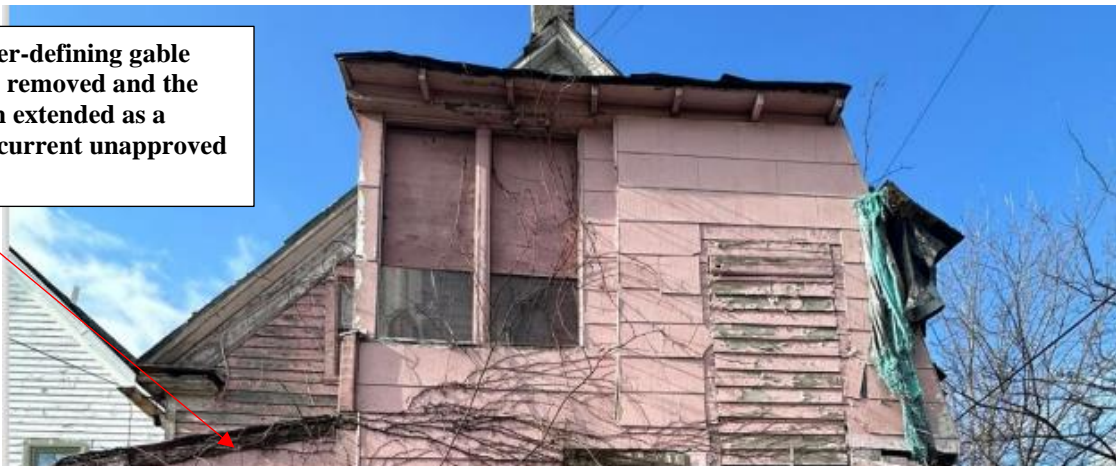
- It is staff’s opinion that the newly erected rear wing does not meet the Standards because it has been directly appended to rear of the building, resulting in the removal of its entire east wall at its distinctive character-defining elements (see below) and the extrusion/extension of the original roofline.

This character-defining gable end has been removed and the roof has been extended as a result of the current unapproved addition

1480 Shipherd, rear wall gable end which was removed as a result of the new rear addition. Photo by applicant

- The newly erected rear wing has been directly appended to the rear of the building, resulting in the removal of the entire east wall and its distinctive character-defining elements and the extrusion/extension of the original roofline.
