STAFF REPORT: JULY 10, 2024, REGULAR MEETING
APPLICATION NUMBER: HDC2024-00331
ADDRESS: 1730 EDISON
HISTORIC DISTRICT: BOSTON-EDISON
APPLICANT/OWNER: ANDRE GILBERT
DATE OF PROVISIONALLY COMPLETE APPLICATION: JUNE 12, 2024
DATE OF STAFF SITE VISIT: JUNE 24, 2024

SCOPE: REPLACE WOOD WINDOWS WITH ALUMINUM-CLAD WOOD WINDOWS

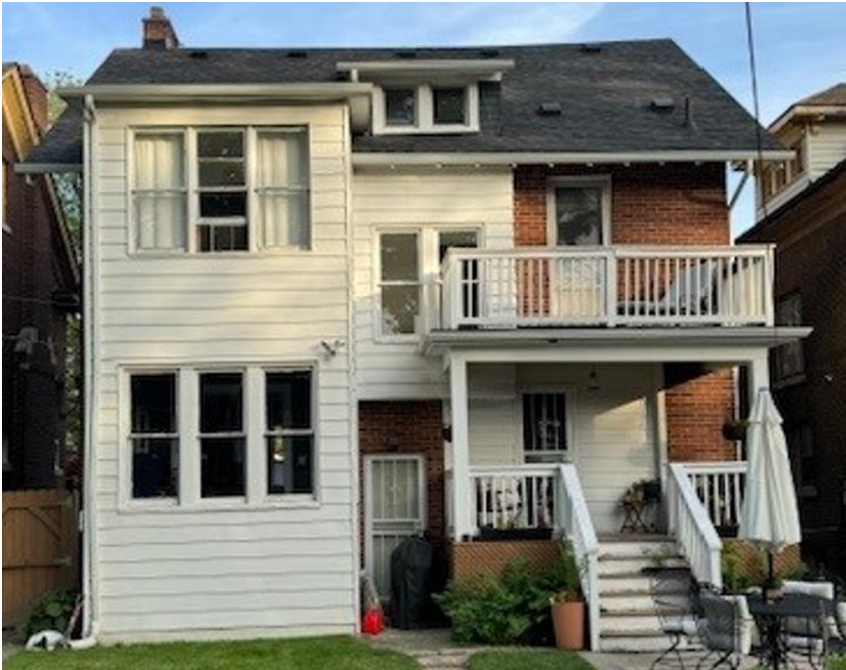
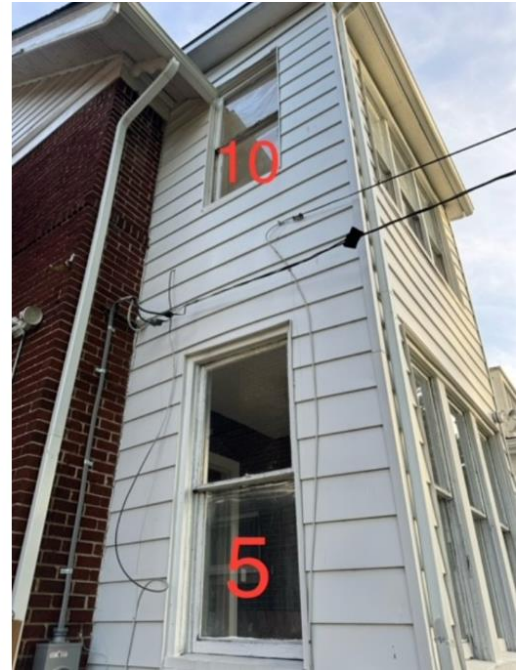
The rear of the subject property. Photos by applicant. Note that the applicant did not provide a photo of the west face of the sun porch.

- The aluminum siding and window cladding on the sun porch are non-historic alterations. There is no record of Historic District Commission approval for this work; however, it is possible that this work was performed prior to the establishment of the Boston-Edison Historic District in 1974.

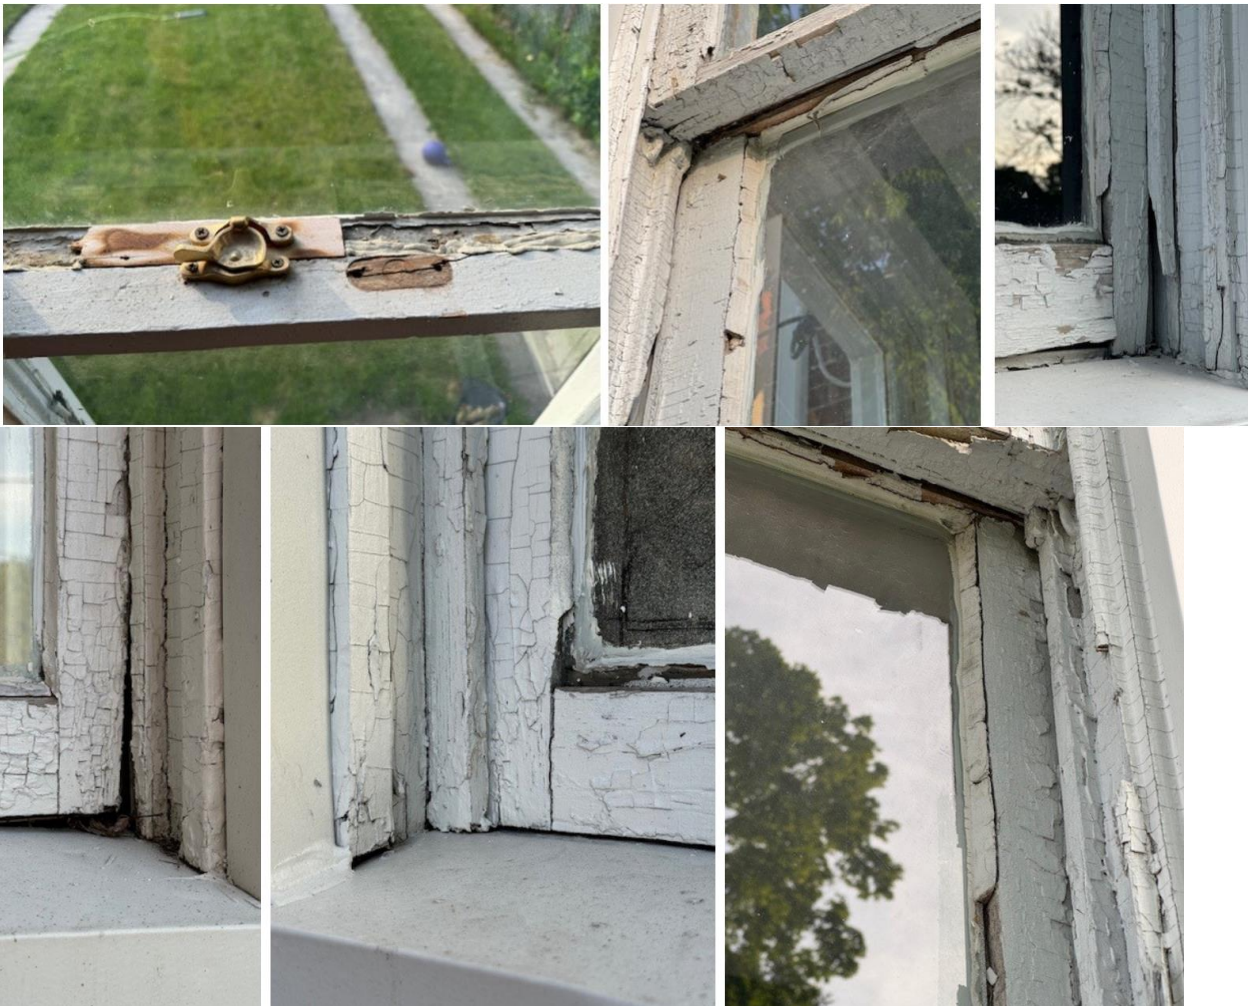
- The applicant has provided detailed interior and exterior photographs along with a written description of each window. For example, five of the windows are described as having areas that are “soft to the touch” and all ten described as “not flush with the sill.”

Selected images showing deterioration. Please see application documents for full, higher-resolution images.

- From the photos provided by the applicant, staff observes that there are several patches and repairs to the windows and that much of the hardware appears to be non-original.

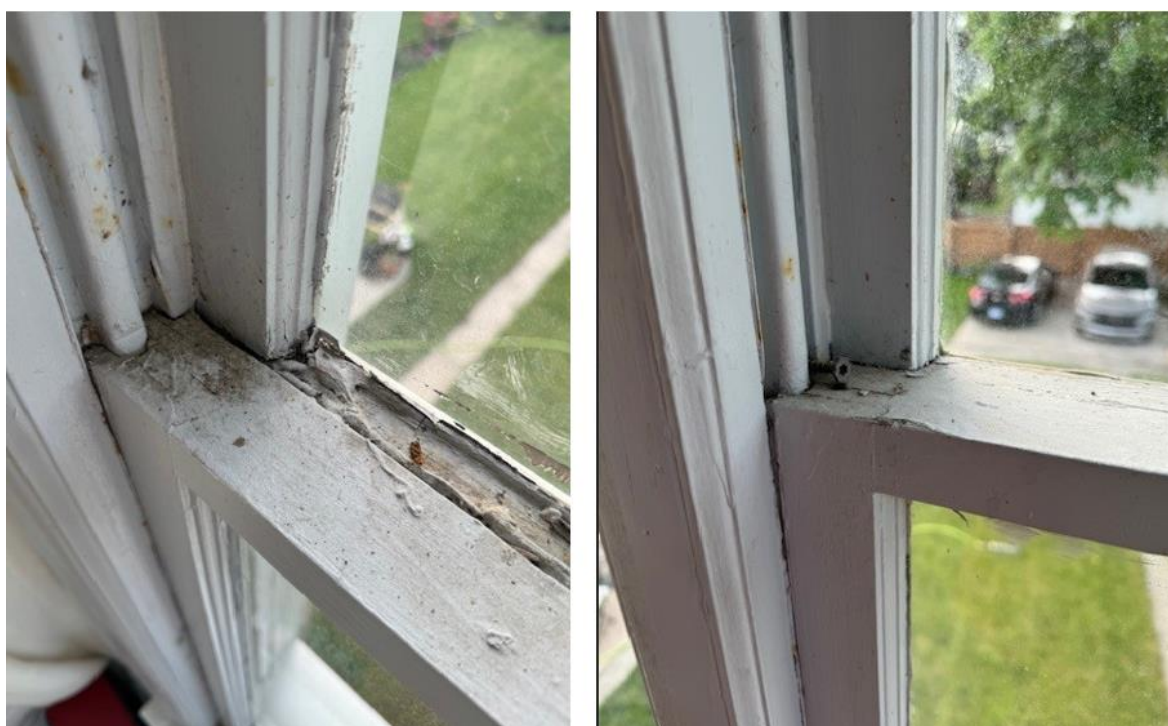
Detail of window 7 (left) and window 9 (right), typical of windows 6 through 10. Photos from applicant.

- Based on photos provided by the applicant, staff concurs that the second-floor windows (numbered 6 through 10 in the application documents) are likely not original or historic, for the same reasons provided by the applicant above. The replacement of non-historic windows is appropriate if the new windows are compatible with the property and the district.

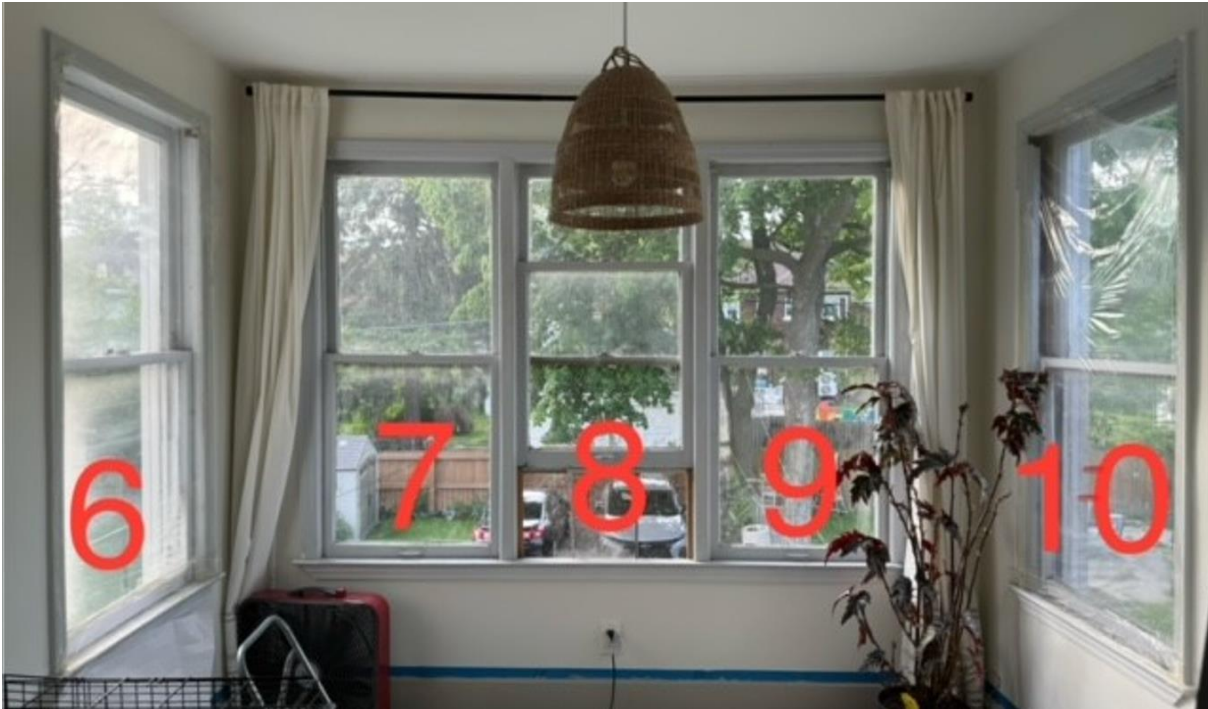
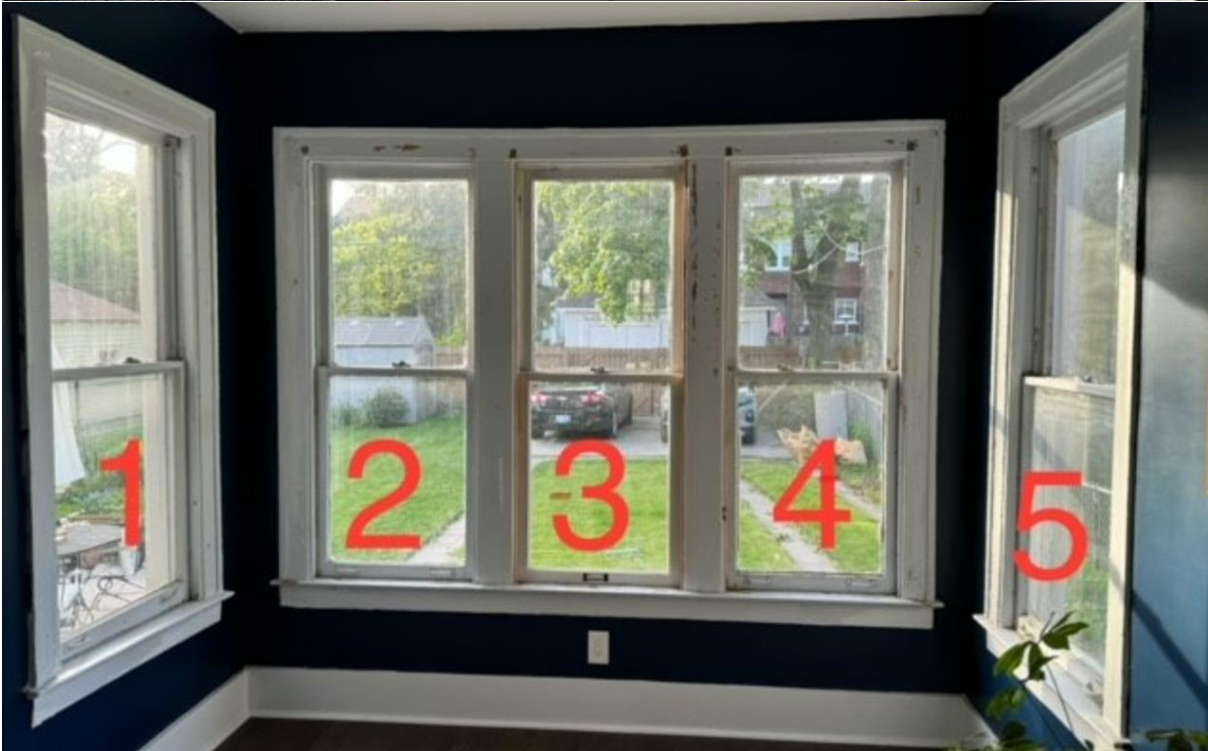
- The first-floor windows (1 through 5) appear to be original or historic, though they have seen extensive repairs. In viewing the photos and written descriptions provided by the applicant, staff observes a noticeable degree of deterioration. Staff suggests that this information, along with the professional opinions noted above, indicates that replacing all ten windows with good matches may be reasonable and appropriate under the Standards.¹ The Secretary of the Interior’s Standards, namely Standard #6, allow character-defining features to be replaced when beyond repair: “Deteriorated historic features

Above: Second-floor windows; below: first-floor windows. Photos from application materials.

- If the windows are to be replaced, the existing aluminum trim should be removed to determine if the outer casing (head, jamb, and sill) and brickmould, if any of the historic windows remains. If so, the Standards would require their preservation or, if beyond repair, their replacement with matching materials. Prefabricated aluminum cladding products are not appropriate (Standard #6).

- Historic window casing and brickmould, if any remains, must be preserved.
