STAFF REPORT: SEPTEMBER 11, 2024 MEETING

APPLICATION NUMBER: HDC2024-00424

ADDRESS: 15302 PIEDMONT

SCOPE: REPLACE WOOD WINDOWS WITH FIBERGLASS WINDOWS

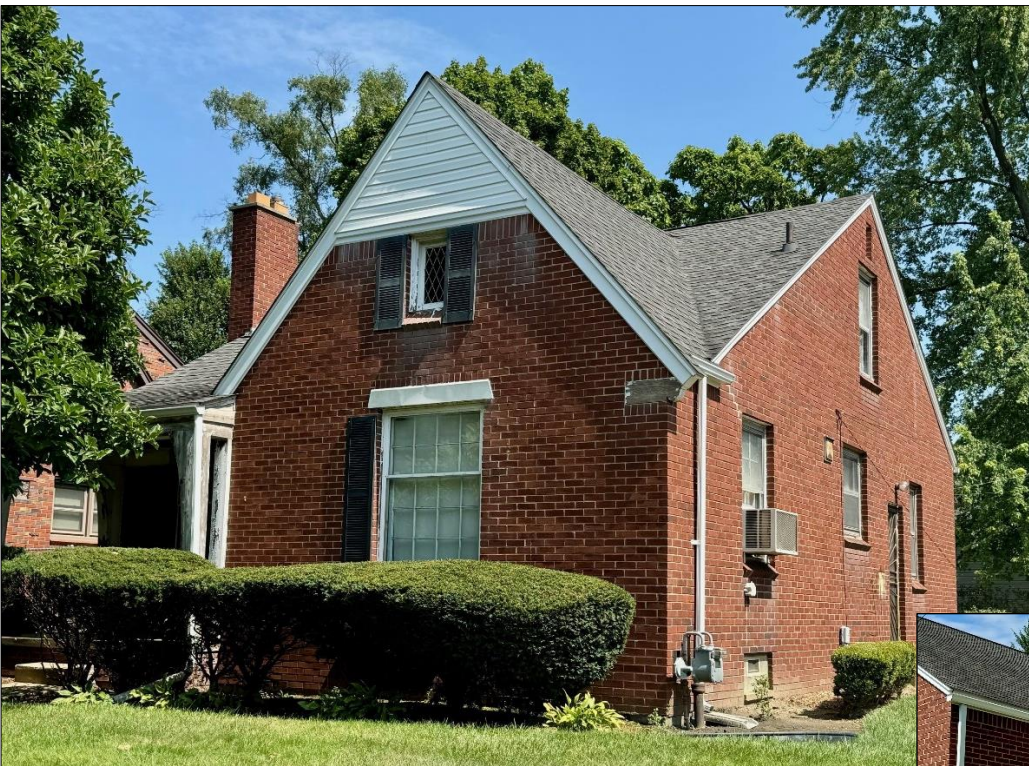
Above: Front and south side walls. A window ac unit is in the lower half of the 6-over-6 double-hung opening. Staff photo, August 27, 2024.

- It is staff's opinion the rowlock sills and wood brickmould present at all of the masonry window openings, as well as the front wall's two cottage-style and leaded glass windows and the 6-over-6 double-hung window on the south wall near the front, are character-defining features of the house.

- The front 8-over-12 cottage windows, diamond paned leaded glass window, and south side 6-over-6 double-hung window are character-defining features and the applicant has not provided information to support the windows are beyond repair. Therefore, a replacement product should not be considered at this time. Additionally, when windows are beyond repair, the Standards require that the new windows must match the old in design, dimension, and operation.

- The front 8-over-12 cottage windows, diamond paned leaded glass window, and south side 6-over-6 double-hung window are character-defining features and the applicant has not provided information to support the windows are beyond repair. Therefore, a replacement product should not be considered at this time.

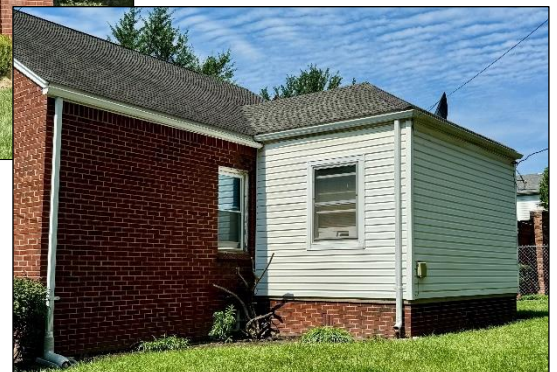
Rear wall and extension, Staff photo, August 27, 2024.

- The house was erected in 1948 and, according to the 1950 Sanborn map, did not include a rear porch or extension. Staff did not find a record of when the rear addition was erected. However, according to an October 2007 Google street view image, it was in place at time of district designation.
