STAFF REPORT: SEPTEMBER 11, 2024, REGULAR MEETING PREPARED BY: T. BOSCARINO
APPLICATION NUMBER: HDC2024-00433
ADDRESS: 1710 VAN DYKE (ALSO KNOWN AS 8005-8025 ST. PAUL)
HISTORIC DISTRICT: WEST VILLAGE
APPLICANT: BRIAN REBAIN, KRAEMER DESIGN GROUP
PROPERTY OWNER: 1710 VAN DYKE LLC
DATE OF PROVISIONALLY COMPLETE APPLICATION: AUGUST 2, 2024
DATE OF STAFF SITE VISIT: AUGUST 24, 2024

SCOPE: ALTER ROOF

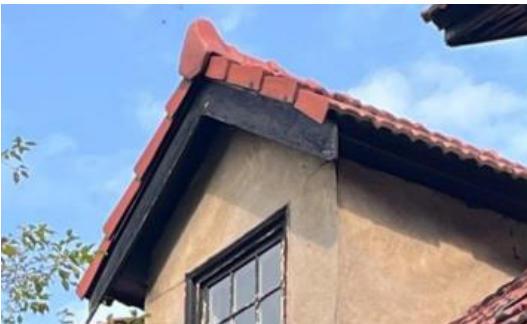
Dormer with distinctive ridge terminal. Photo from application materials.

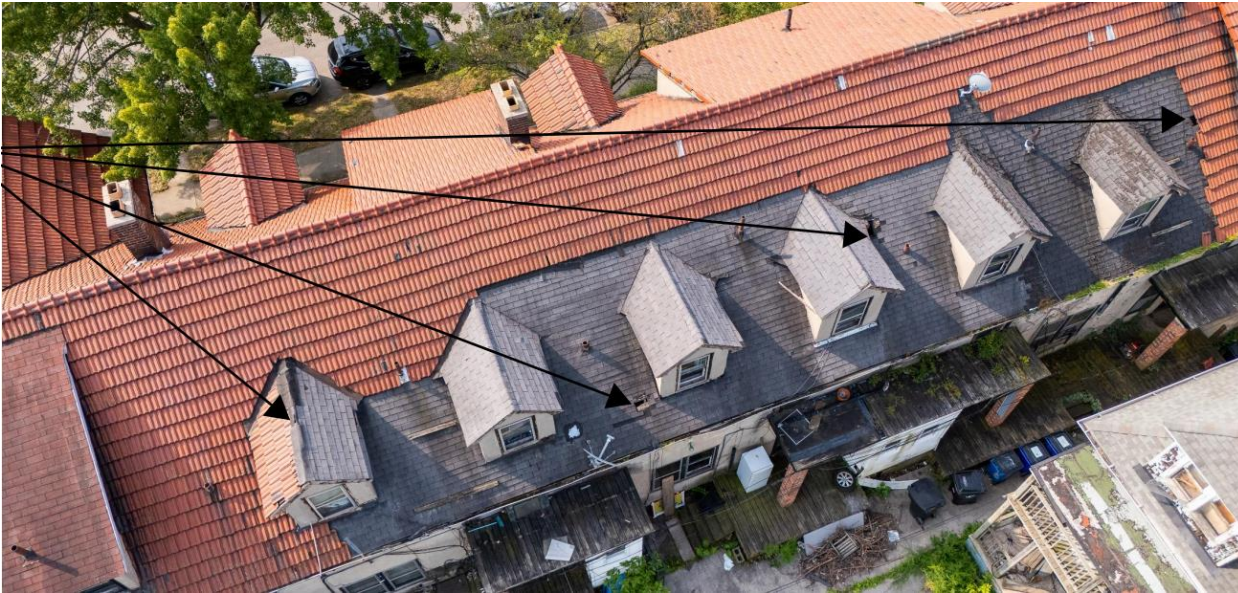
A relatively small section of historic clay tile has previously been replaced with non-matching, asphalt shingles. There is no record of Historic District Commission approval of this work. The area of asphalt shingles, comprising about 15% of the total roof area, is on the rear (north) plane of the roof. It is mostly hidden from view behind the ridge and between two flanking, shed-roof dormers.

Undated photo showing rear (north) asphalt section with arrows highlighting damaged areas. Image from application materials.

- *Undamaged clay tiles will be salvaged and reused to the maximum extent possible, subject to review and approval by staff.*
- *New clay tile will match the historic clay tile as closely as possible, subject to review and approval by staff.*
- *Asphalt shingles will not be used.*

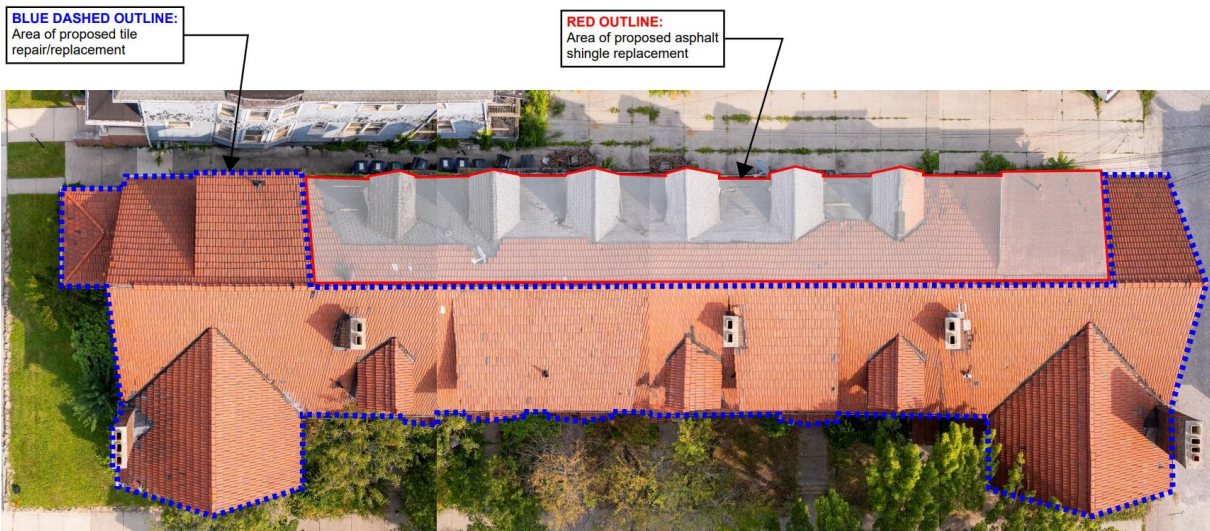
Sketch showing proposed repair and replacement areas. Note that the proposed work would approximately double the extent of the area currently finished with asphalt shingles, from about 15% of the total area to about 30%. Image from application materials.

- Staff does not consider the use of asphalt shingles on this building to be appropriate, due to the following considerations:
 - Standard #6, quoted above, suggests that damaged areas of clay tile should be replaced with matching materials.
 - Asphalt shingles, in general, are not an appropriate intervention for this particular building due to its Mission-influenced style and the highly distinctive nature of the existing tiles.
- The application scope notes that some “specialty tiles” may need to be replaced, but it does not specify a particular product for replacement other than to state that the tiles “will be evaluated for size and shape once removed.”

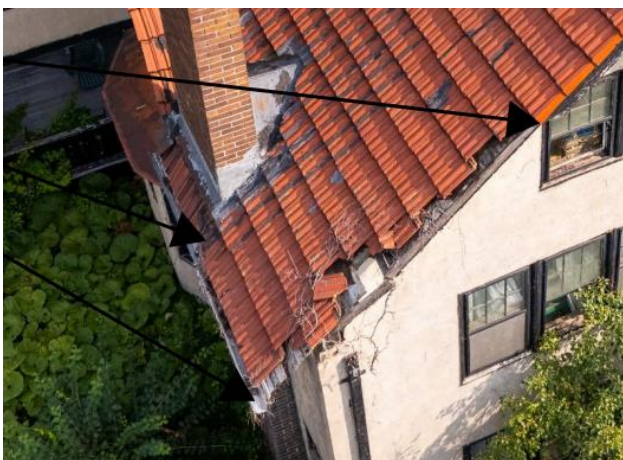
- The application describes and provides photos of “numerous areas of broken or missing tiles, notably at the different edge transitions of the roof, leading to several openings through the roof decking into the attic space below.” Staff stipulates that a comprehensive reroofing effort is thus necessary and appropriate.

Image, from application, showing area of broken and missing tiles.
