STAFF REPORT 10-09-2024 REGULAR MEETING

APPLICATION NUMBER: HDC2024-00523

ADDRESS: 1457 SEMINOLE

SCOPE: REPLACE ASBESTOS-CEMENT SHINGLE ROOFING WITH ASPHALT SHINGLES

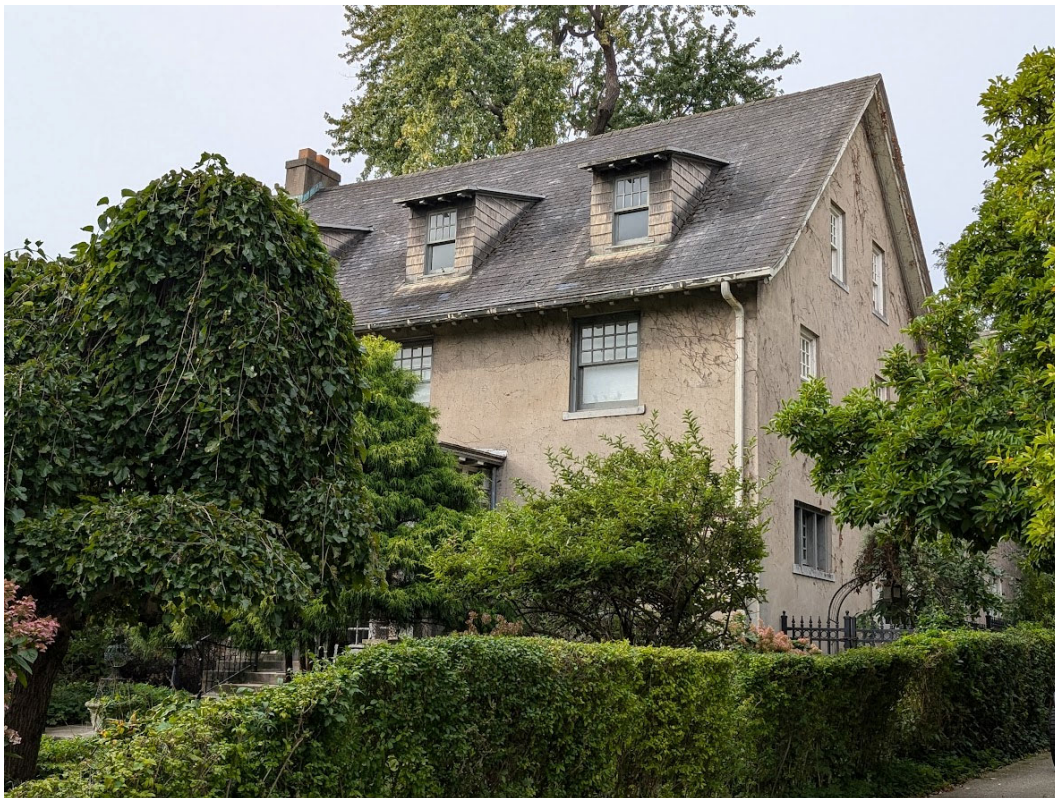
View of 1457 Seminole, looking west from the sidewalk. Staff photo, September 29, 2024.

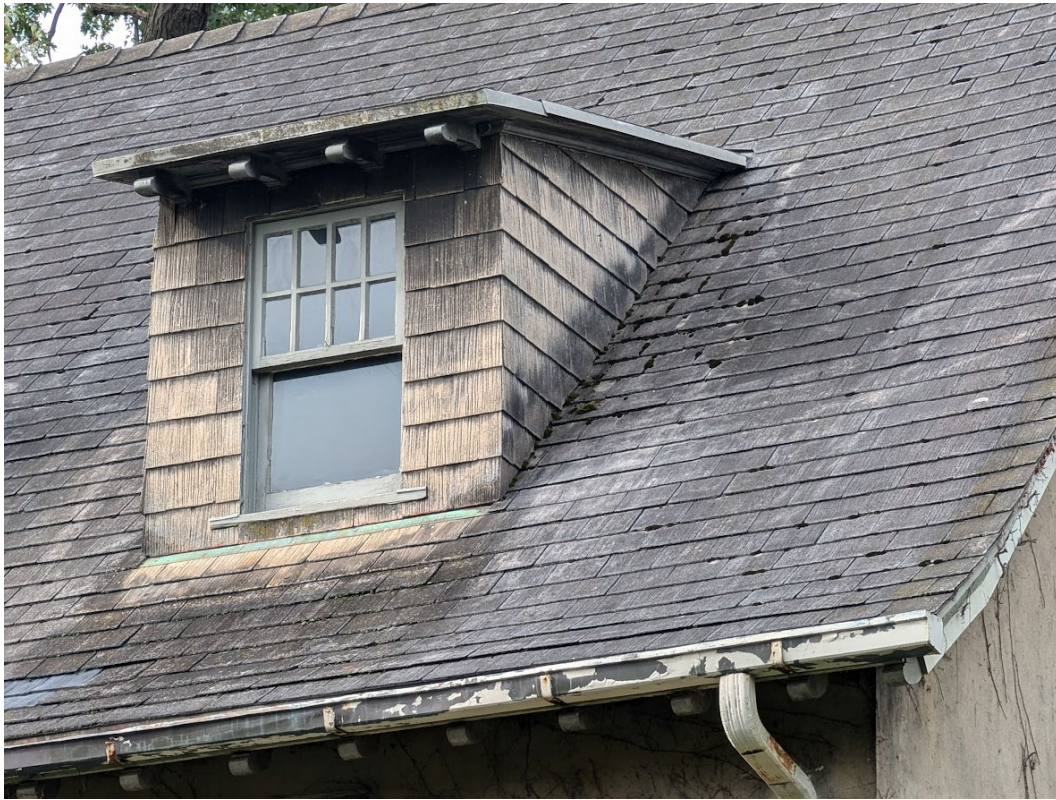
Detail view of roof conditions at northeast dormer. Staff photo, September 29, 2024.

- Staff stipulates that, per the application, the current roofing has “many tears, broken and missing tiles, and mold growth.” The applicant further states, and staff agrees, that “asbestos tiles are impossible to repair, present a safety hazard for workers, and require an abatement company to remove the tiles.” Documentation is included in the application proving that the current shingles contain asbestos. The applicant also includes a letter from their property insurer threatening loss of insurance unless the roof is replaced.

Staff recommends that the proposed work should qualify for a Certificate of Appropriateness, as it meets the Secretary of the Interior’s Standards for Rehabilitation and the Indian Village Historic District’s Elements of Design, with the condition that:

- A design for recladding of the dormer sidewalls be submitted, subject to staff approval.

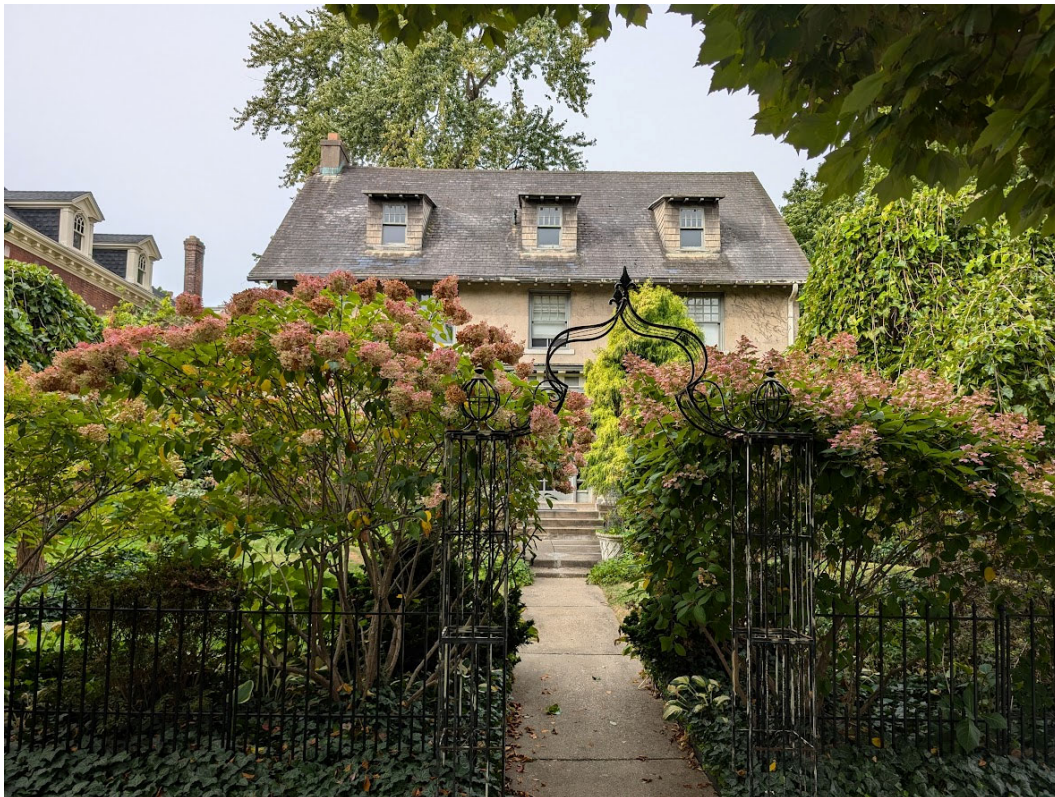
View of 1457 Seminole from the sidewalk through front gate. Staff photo, September 29, 2024.

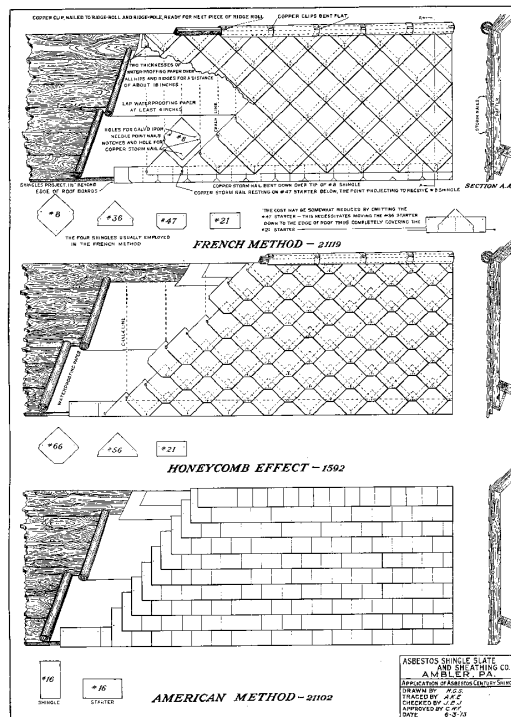
The shingles at 1457 Seminole were laid using the "American Method" (bottom), per this drawing made available by the National Park Service, from 1913. This is an attempt to mimic the rectangular and orderly expression of slate.
