**STAFF REPORT 10-09-2024 REGULAR MEETING**

**APPLICATION NUMBER: HDC2024-00538**

**ADDRESS: 4881 STURTEVANT**

**SCOPE: ALTER PORCH, CONSTRUCT DECK (WORK COMPLETED WITHOUT APPROVAL)**

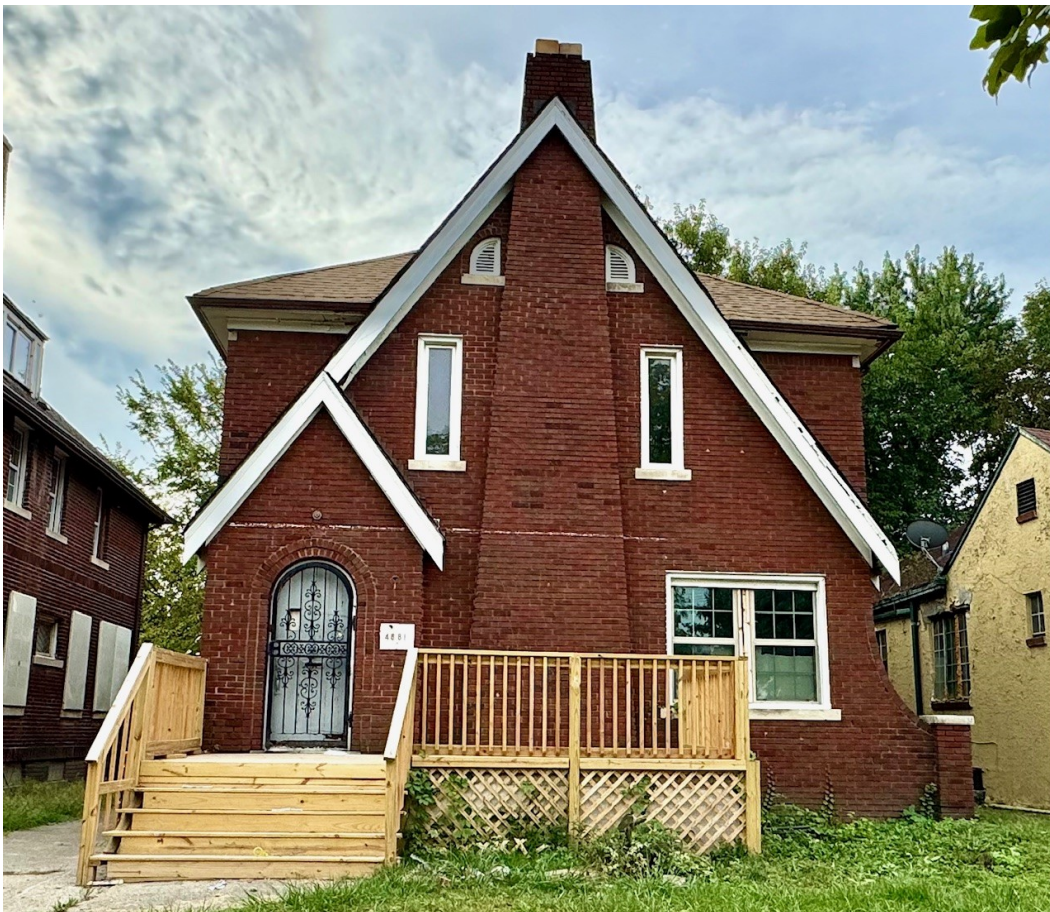
*View of 4881 Sturtevant. Staff photo, September 20, 2024.*

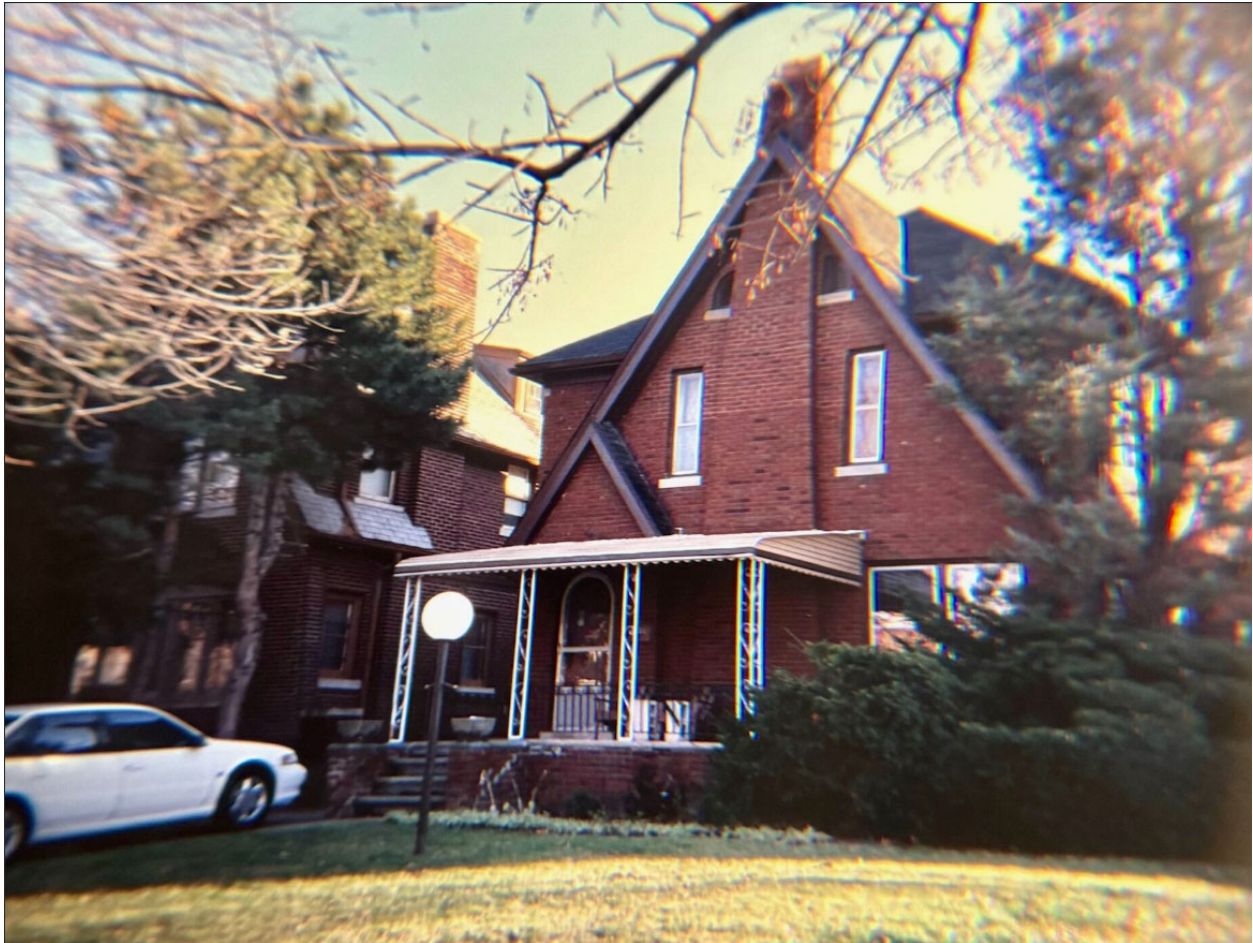
*HDAB designation image of subject property showing condition of brick porch in 1999.*

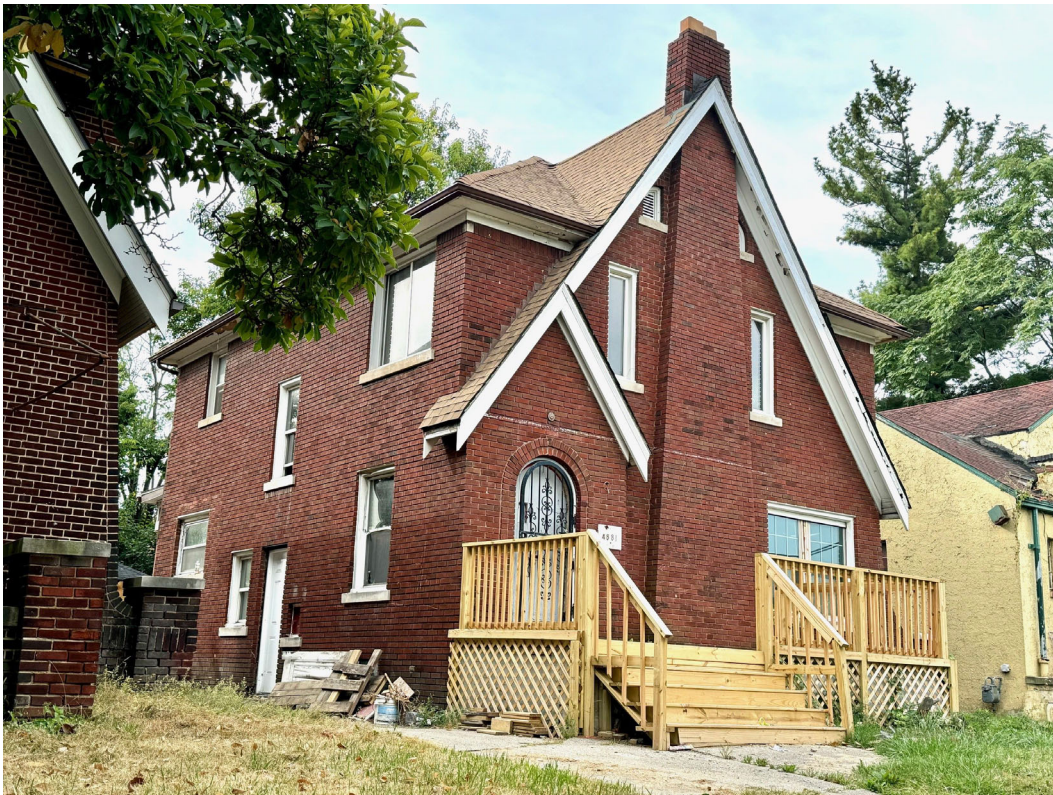
*View of 4881 Sturtevant. Staff photo, September 20, 2024.*

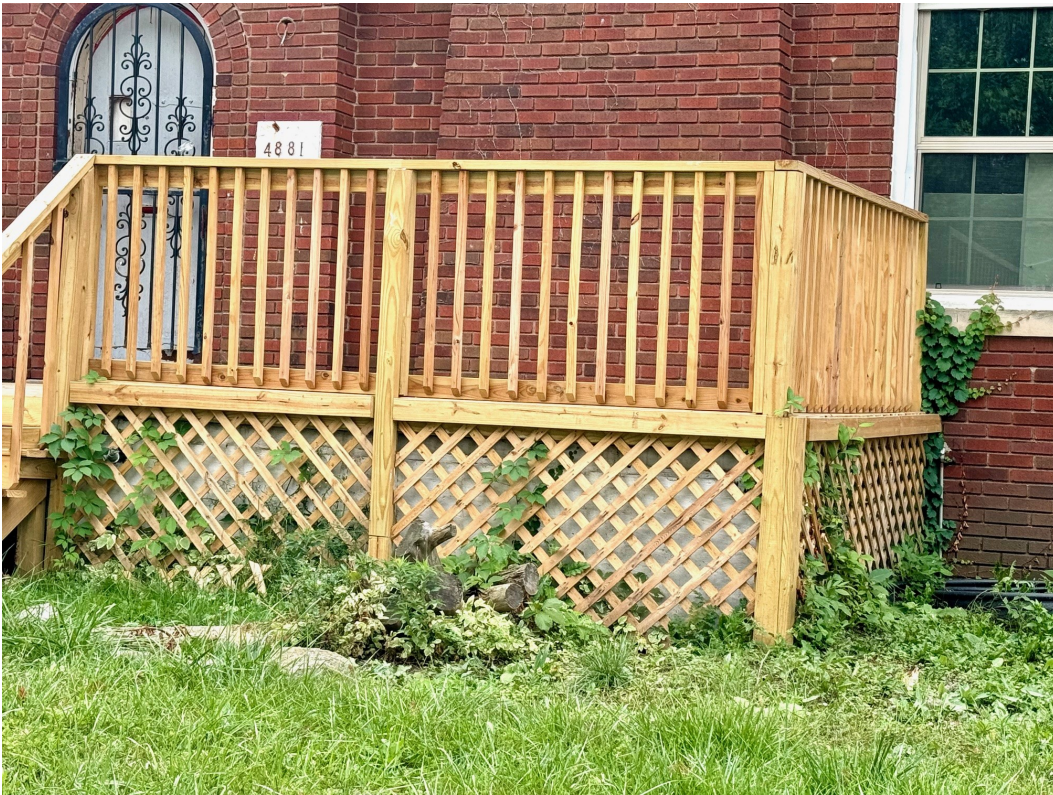
*View of 4881 Sturtevant. It appears that part of the porch still exists below the deck. Staff photo, September 20, 2024.*

- Instead, the applicant has built a deck of standard contemporary design over the porch. Although it is apparent that some original porch material exists below the deck, the extent of the surviving elements is not clear.

- The deck is of a standard recreational/contemporary design built of “off the shelf” parts, perhaps suitable for a backyard, but makes no effort to integrate into the historic design of the house, contrary to historic standards and guidelines. In staff’s opinion, the wood deck should be removed and a brick/concrete porch of compatible design rebuilt.

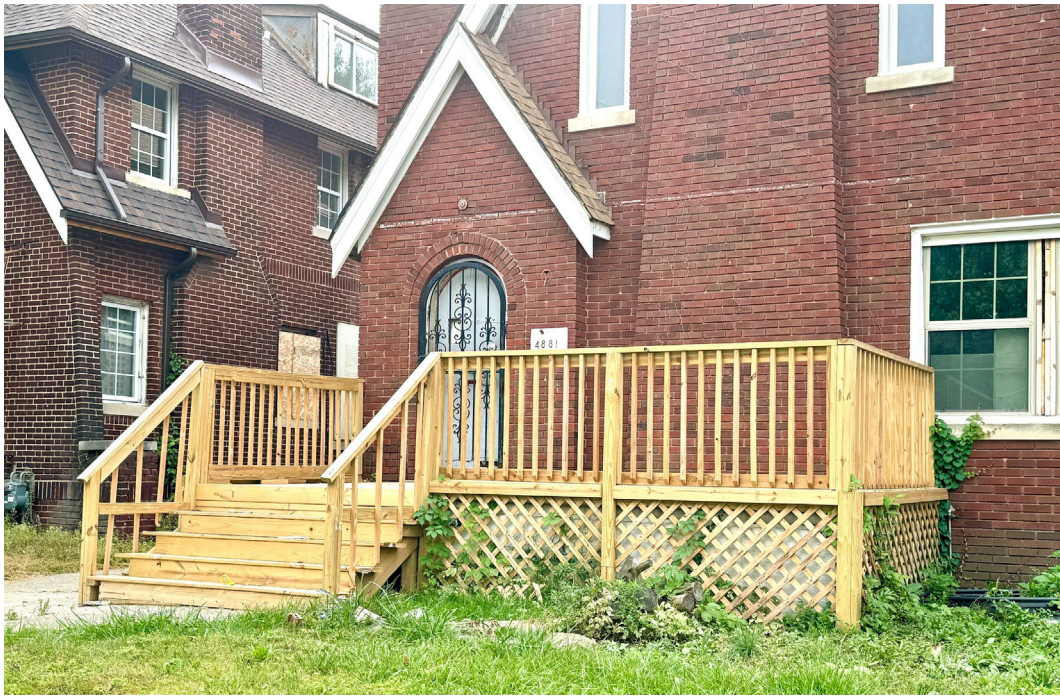
*View of 4881 Sturtevant. Staff photo, September 20, 2024.*

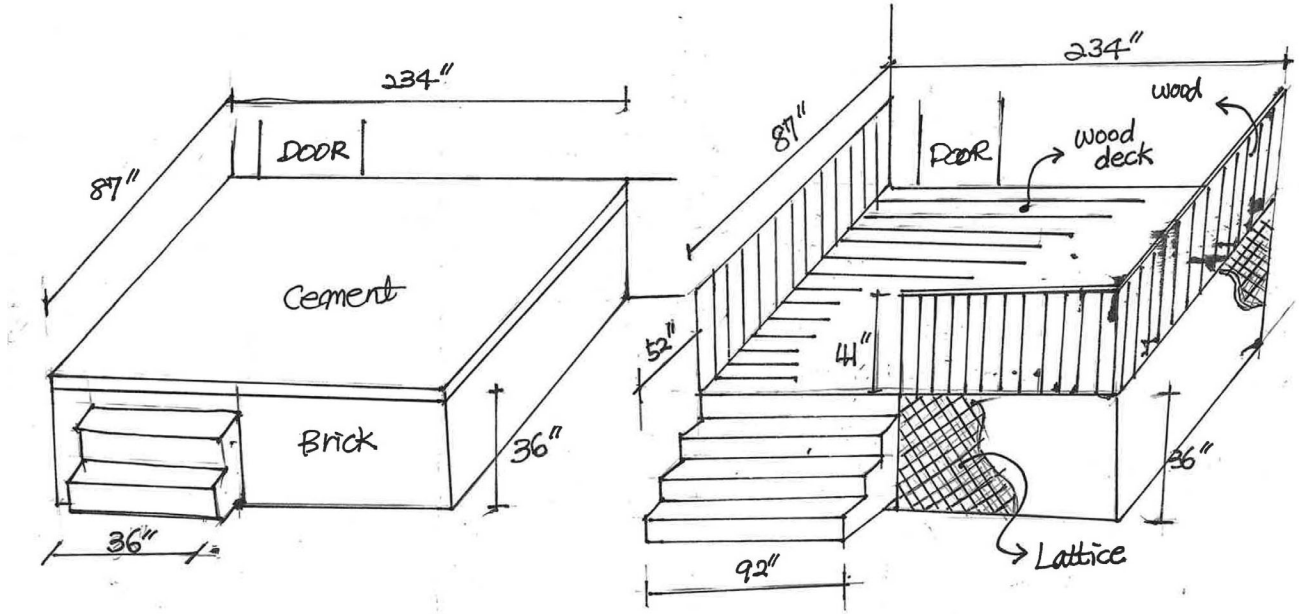
Project Name :  
RES2024-0796

The applicant seeks an after-the-fact approval for work done in violation, specifically the erection of a contemporary/utilitarian deck at the front of the house, occupying the location of the original historic porch, which was at least partially altered/demolished. The applicant has provided the below before/after sketch.

- The original porch, like many similar examples in the district, was a concrete platform supported by brickwork matching the house. A short flight of concrete steps leading up from grade was framed by a pair of modest brick wing walls, also capped by concrete or stone. The applicant's "before" sketch does not show the wing walls, which were present as late as 2020.

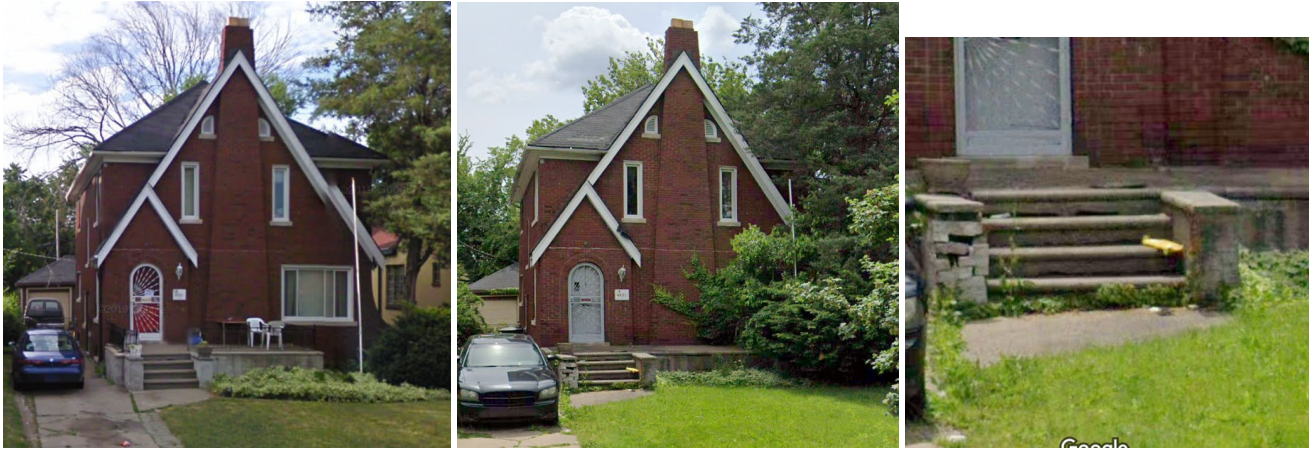
- At some point, likely prior to designation, the original brick porch was parged (coated) with mortar or cement, creating an incompatible and ahistorical monolithic appearance and obscuring the original brick expression. By 2019, the parge-coat was visibly failing, as were the bricks behind it. See images below:

Google Street View images of 4881 Sturtevant. At left, 2009. Center, 2019. At right, zoomed into 2019 image showing brick decay.

- The correct and appropriate treatment for the deteriorating porch, as a distinctive character-defining feature of the house, would be to repair it; or if necessary, rebuild it in matching brick and concrete. Other property owners in the district, including the Detroit Land Bank Authority, have successfully completed such repairs, thus preserving the historic character of the district.
