ADDRESS: 1628 LEVERETTE

APPLICATION NO: HDC2024-00498

HISTORIC DISTRICT: CORKTOWN

SCOPE: REHABILITATE DWELLING

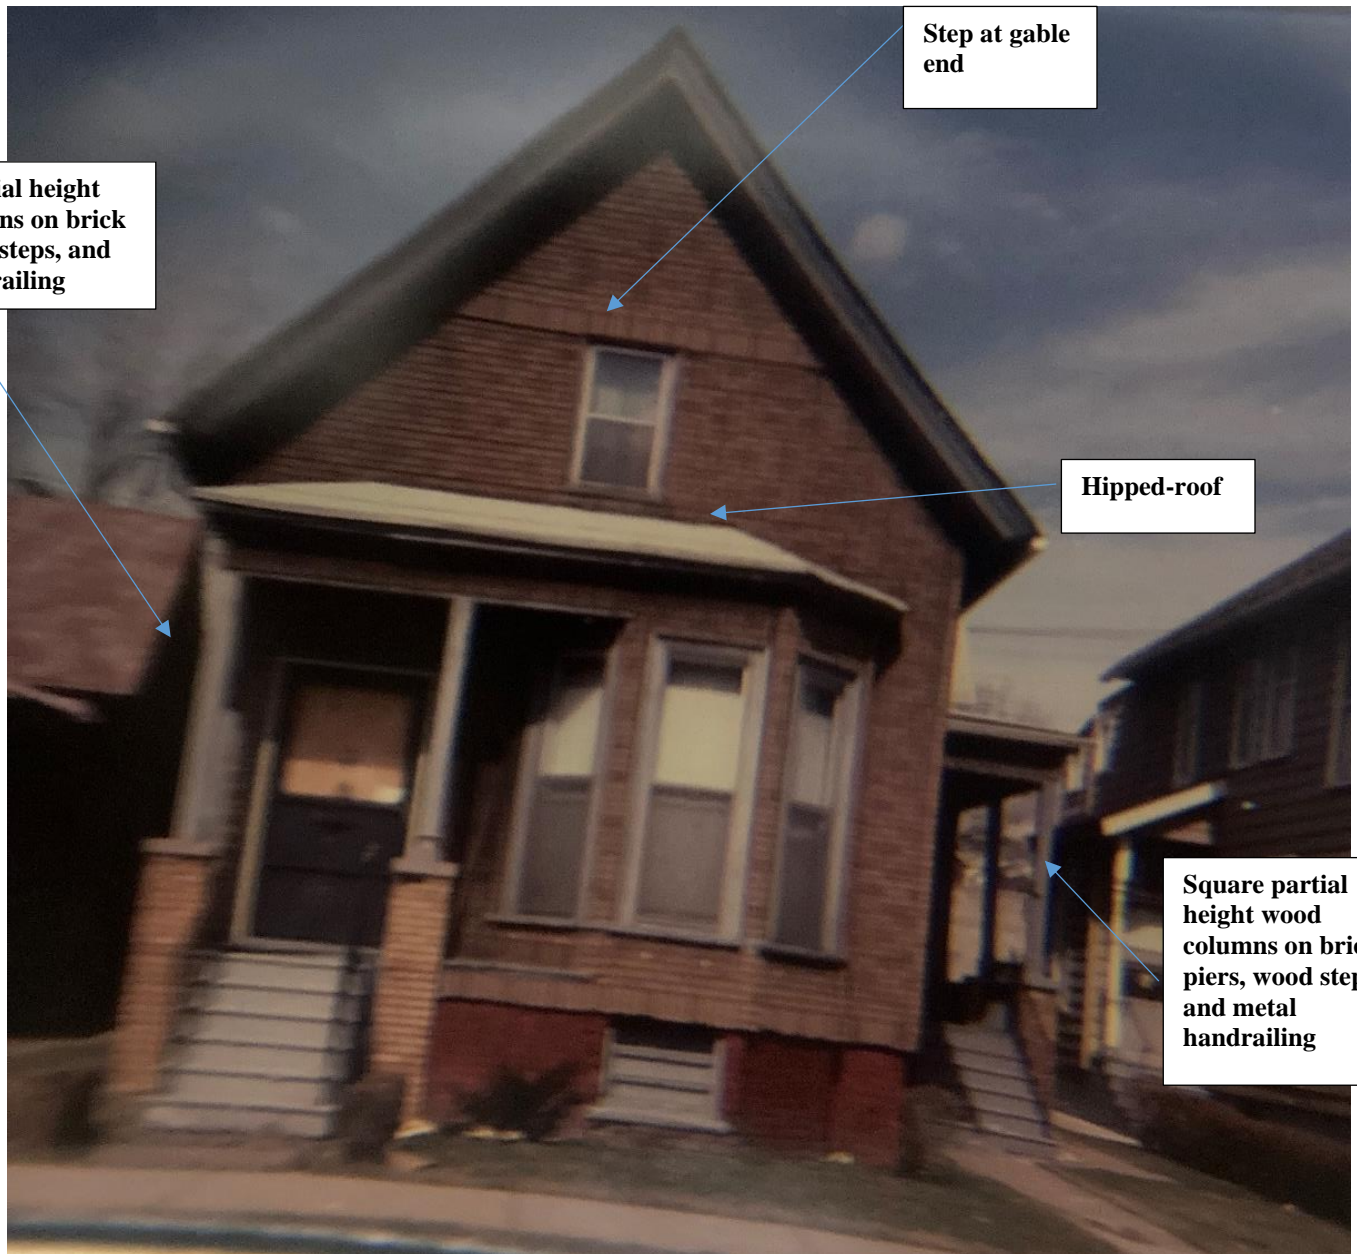
1628 Leverette, photo taken in 1983 by HDAB. Note that any exterior decorative detailing/trim is covered by the siding

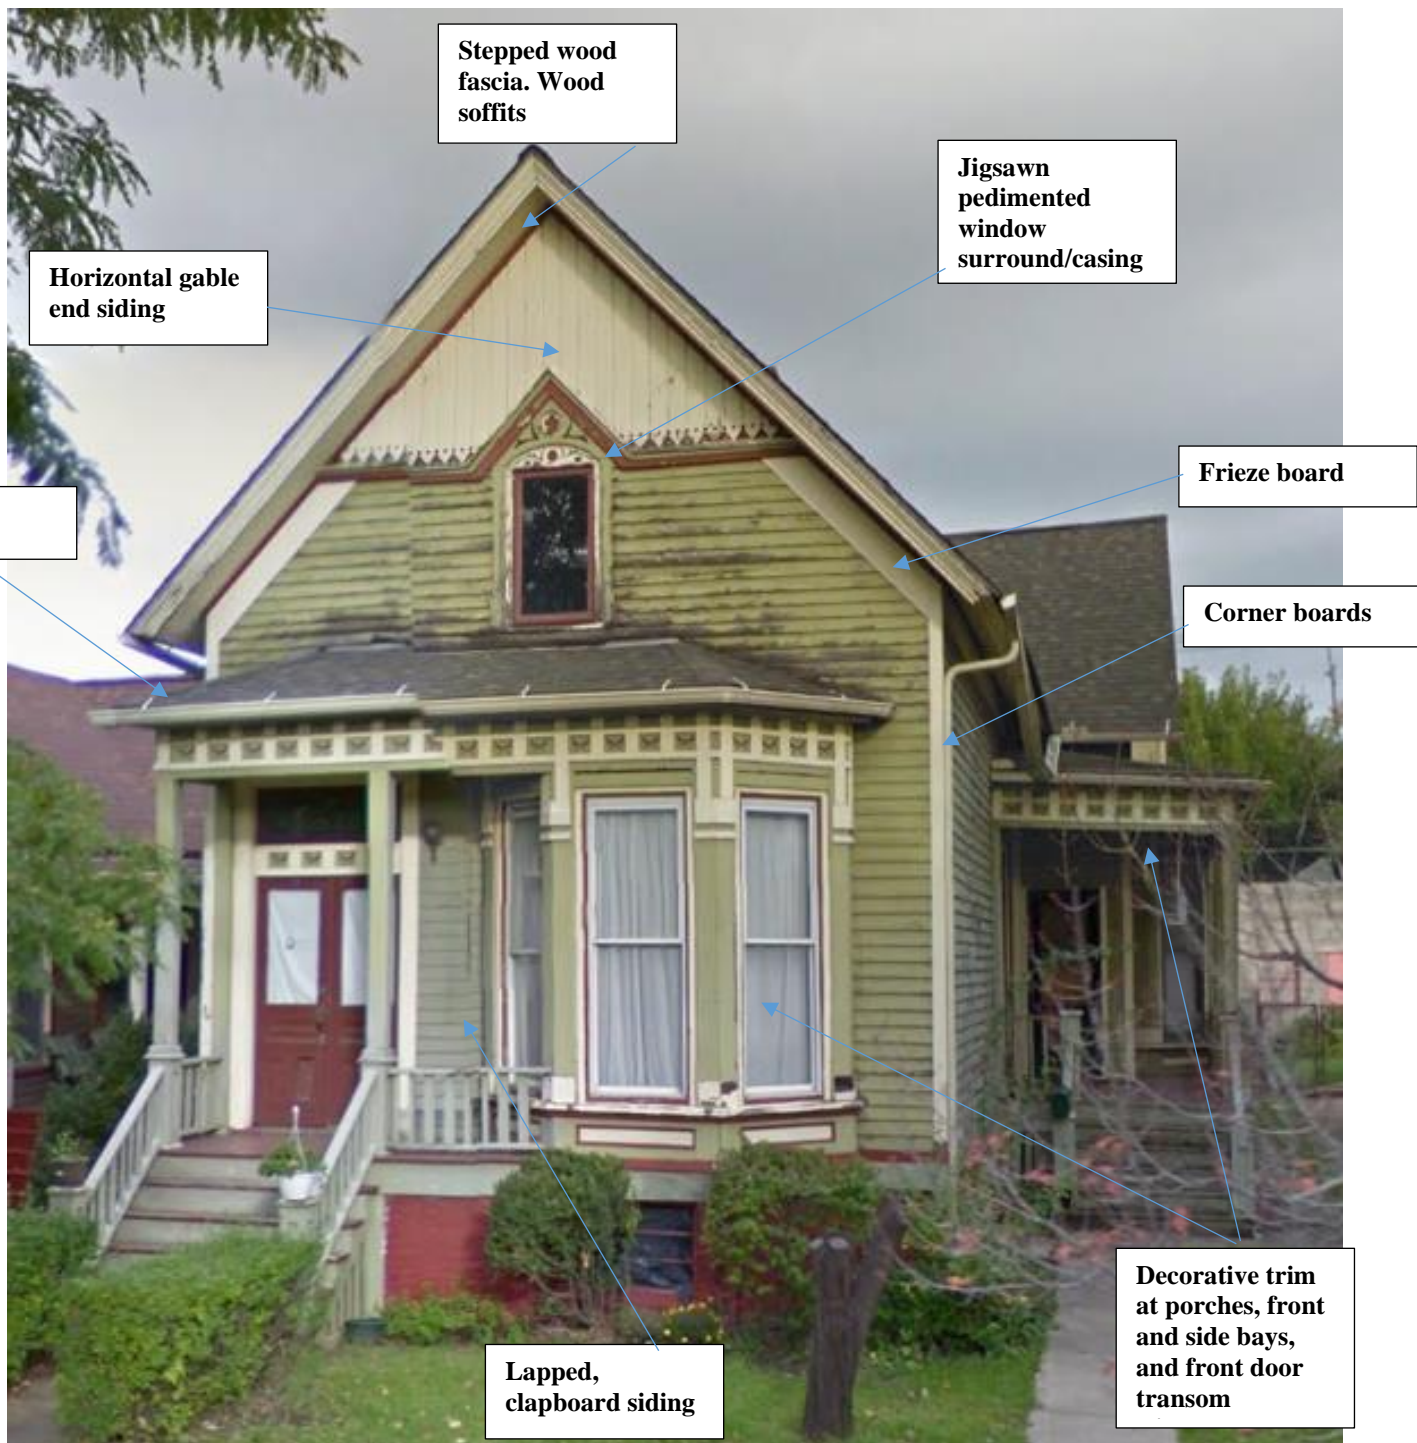
Appearance in 2016, after faux brick asphalt siding was removed. Note exposed decorative detailing at front gable end, above the front door, at the front porch roof and bay window, and at the side porch roof and bay window. Also, the front and side porch posts, piers, decking, and steps which were extant in 1983 have been replaced by this time. Source: Google Streetview

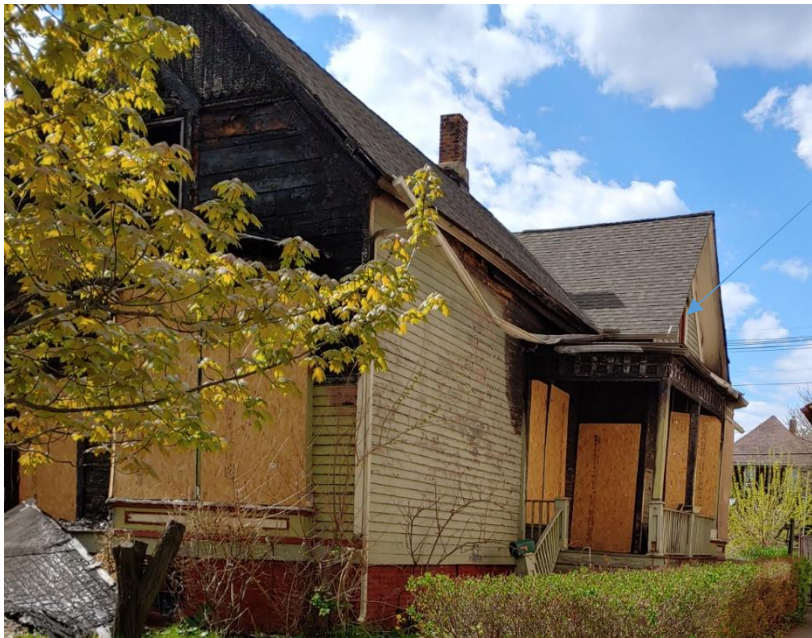
Conditions in 2019. Photo taken by Debra Walker, facing northwest.

It is unclear if 2nd story jigsawn window trim/casing remained at this gable end in this 2019 photo or if it was damaged by the fire. Note that the trim *currently* is missing

Side porch and bay window remain in fire damaged condition. Siding at this wall also remains in damaged condition

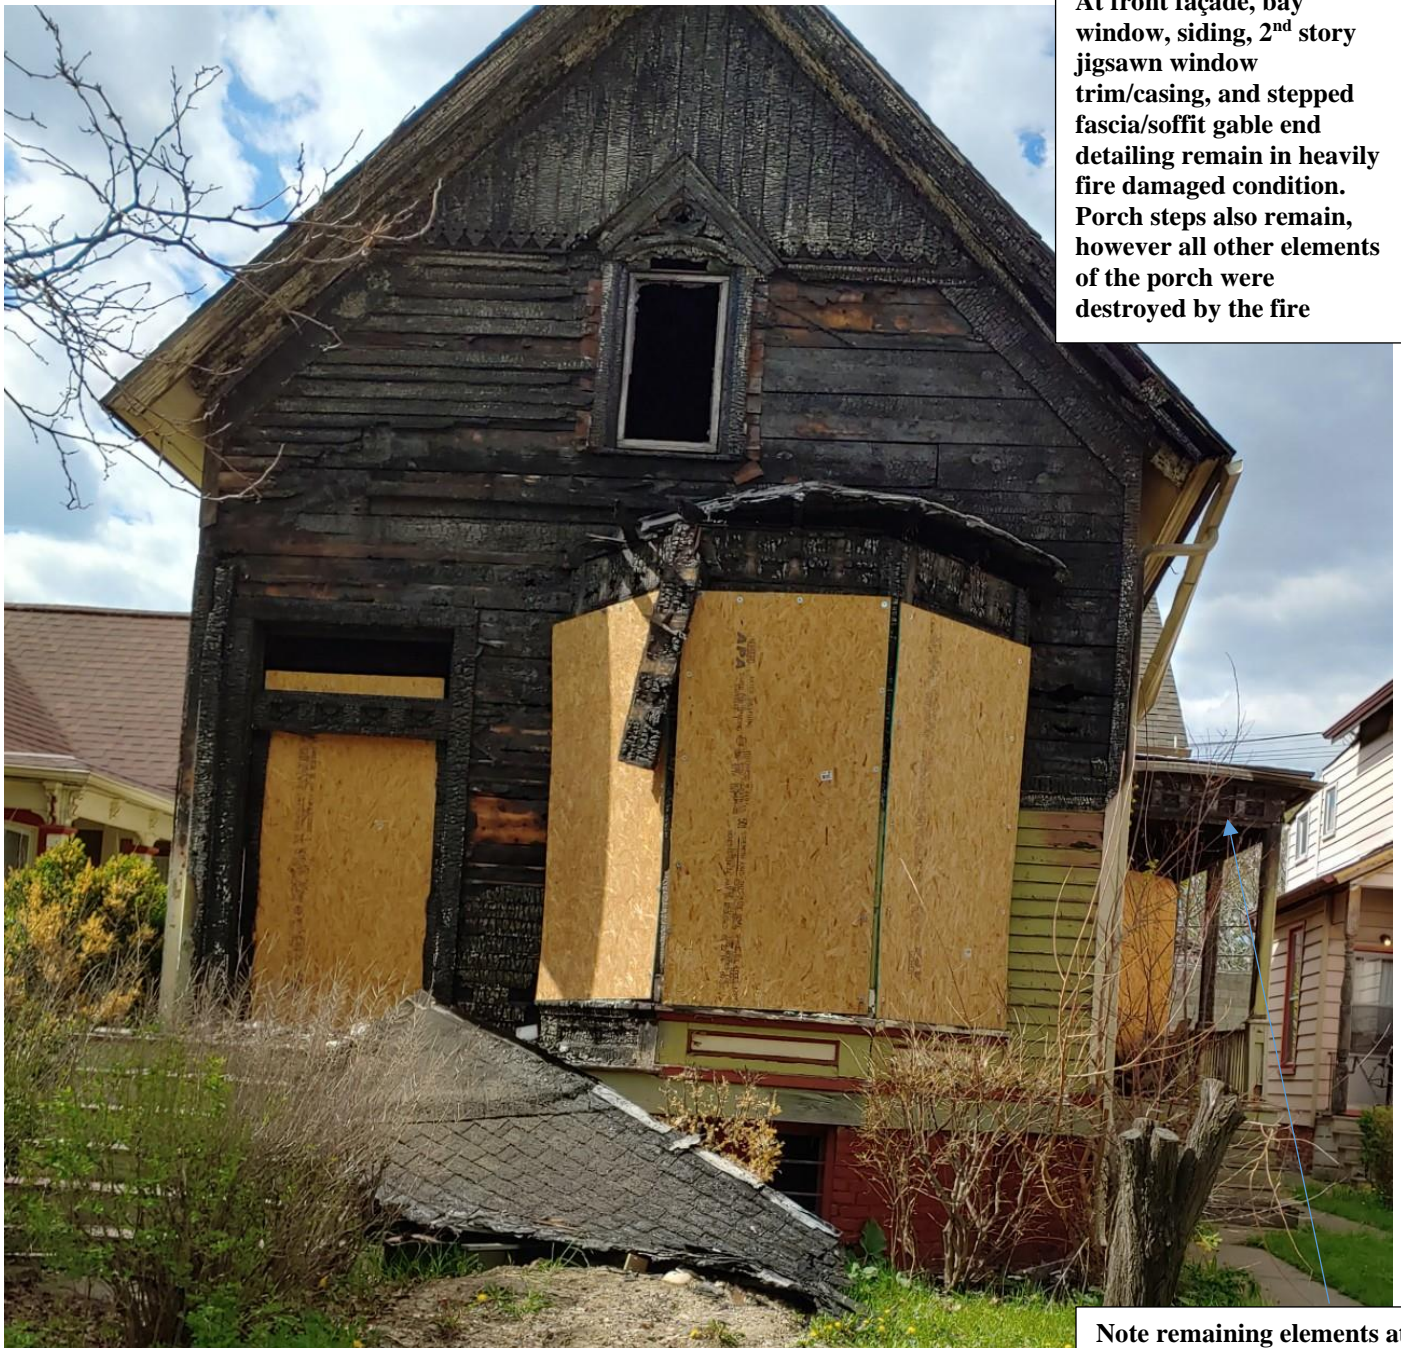
Conditions in 2019. Photo taken by Debra Walker, north.

At front façade, bay window, siding, 2nd story jigsaw window trim/casing, and stepped fascia/soffit gable end detailing remain in heavily fire damaged condition. Porch steps also remain, however all other elements of the porch were destroyed by the fire

Note remaining elements at side porch

2nd story jigsaw window trim/casing remains at this gable end. Note the window at this opening is a non-historic casement unit

At front façade, bay window, siding, and stepped fascia/soffit gable end detailing remain in heavily fire damaged condition. Porch steps also remain, however all other elements of the porch were destroyed by the fire

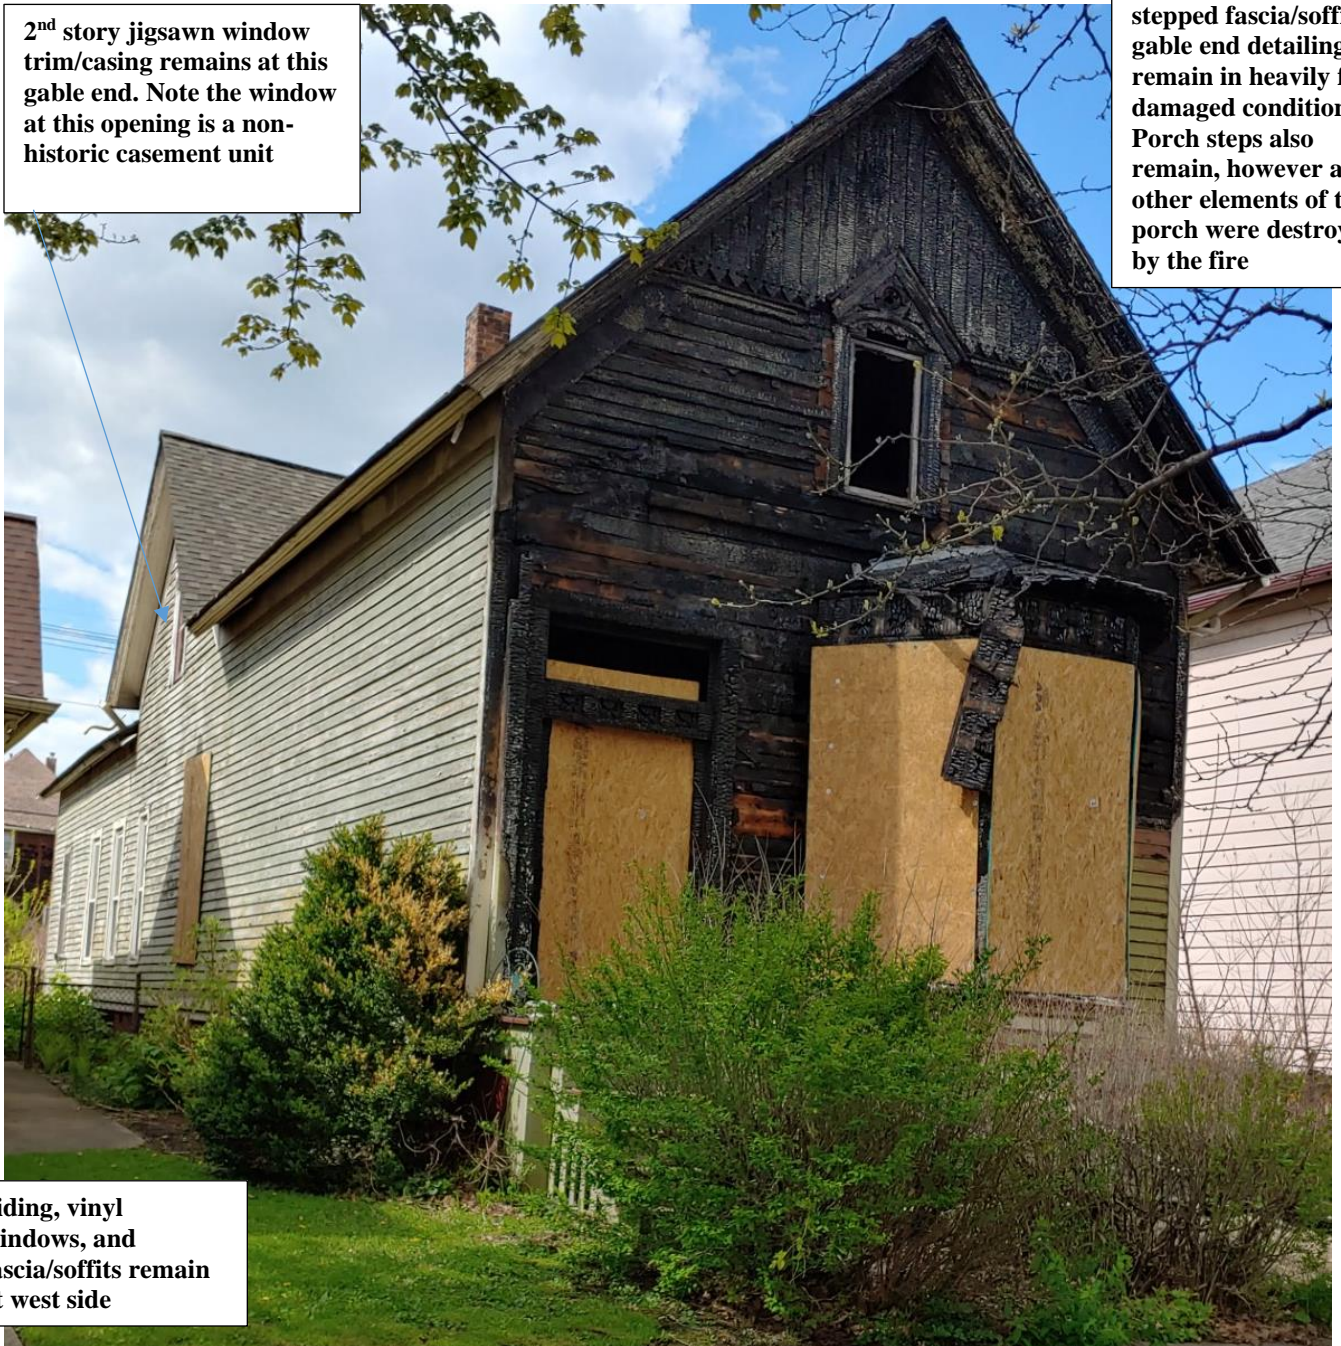
Conditions in 2019. Photo taken by Debra Walker, facing northeast.

Siding, vinyl windows, and fascia/soffits remain at west side

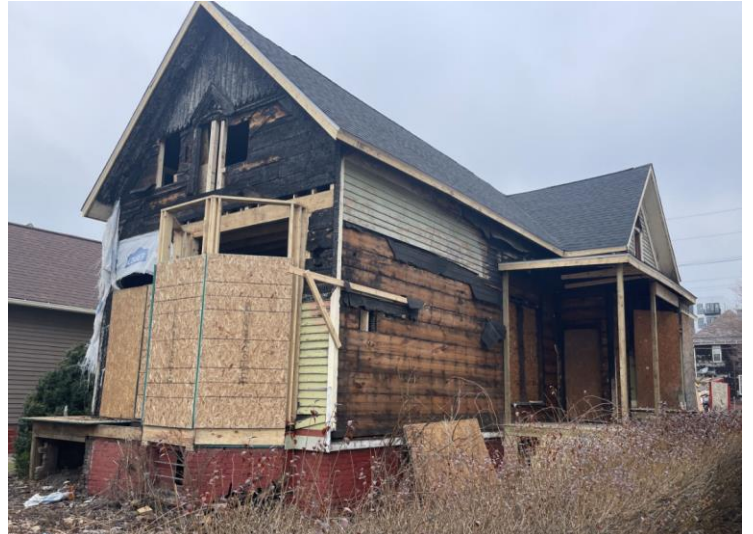
Appearance in 2/2024, after unapproved work. HDC staff

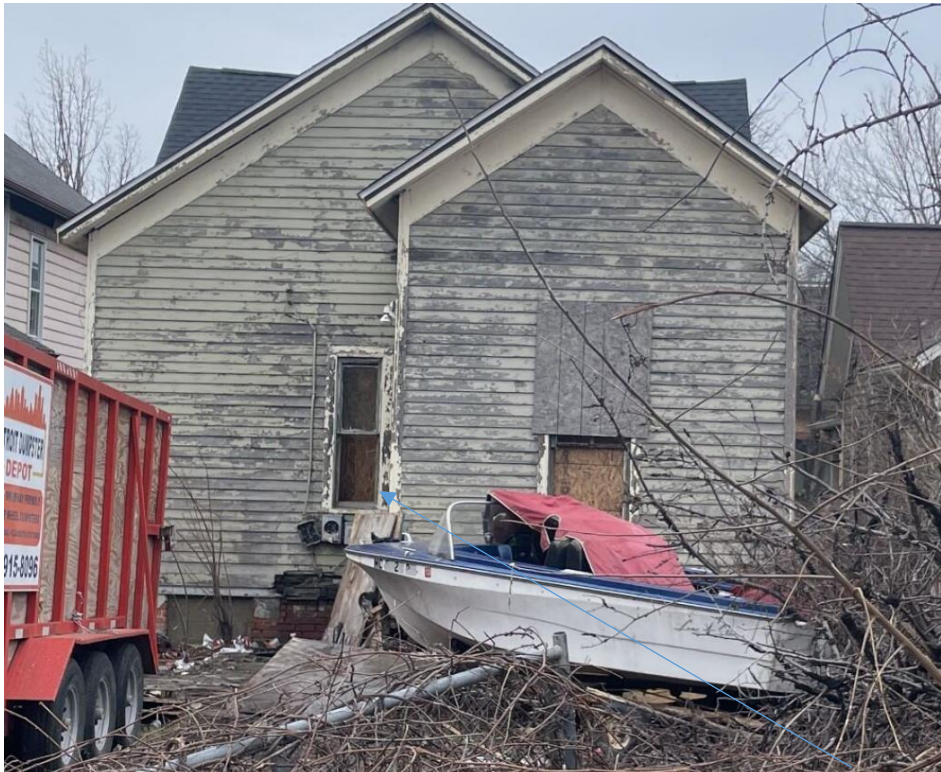
Rear, photo taken by HDC staff in 2/2024. Note that the two wood windows visible in this photo have been removed the openings covered by plywood.

- At the rear, wall elements, roof elements and the historic window casing/trim appeared intact/undamaged by the fire. The two wood sash, 1/1 windows were recently removed without HDC approval as previously mentioned. The applicant had stated that the windows were severely damaged by the fire and therefore merited removal. As review of the 2019, post fire photos do indicate that it is plausible that the two remaining wood windows were heavily by the fire and merited removal.

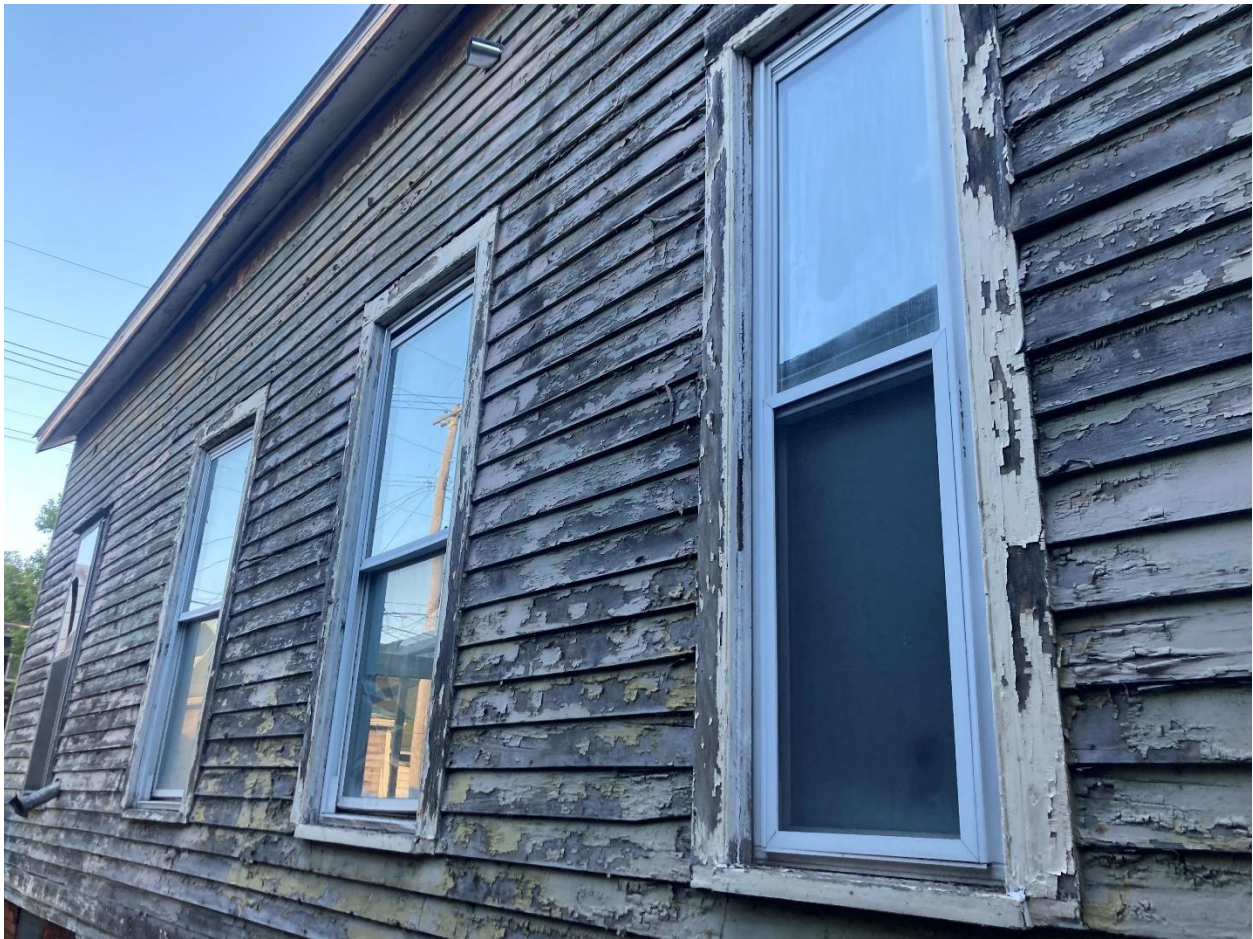
West side wall vinyl windows and remaining casing. Current condition. Photo taken by HDC staff on 9/30/2024

- At the west side, wall elements, roof elements, and historic window trim/casing, to include the historic casing/trim of the decorative jigsawn window at the second story gable end, appear intact/undamaged by the fire. Note that the actual window sash at this wall is vinyl/not of historic age.

- The existing historic-age wood casing and sills shall be retained and repaired in kind where necessary and new aluminum clad wood sash inserts be installed within the existing casing/opening.

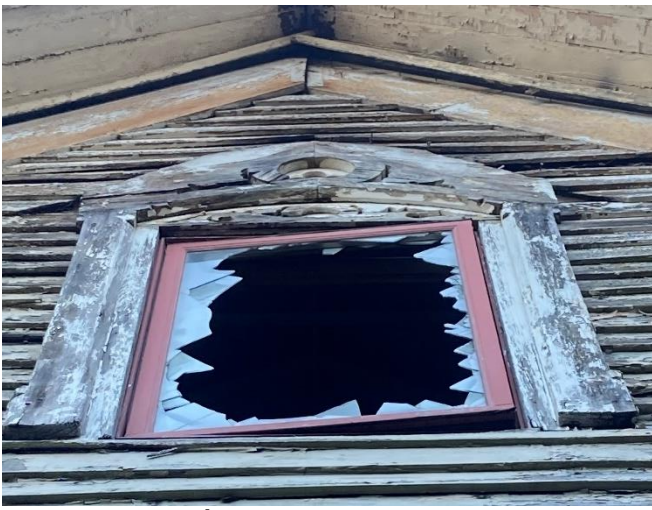
West side wall, 2nd story gable end trim. Showing current conditions. 9/30/2024 by HDC staff. Note that the remaining damaged window is a non-historic vinyl casement

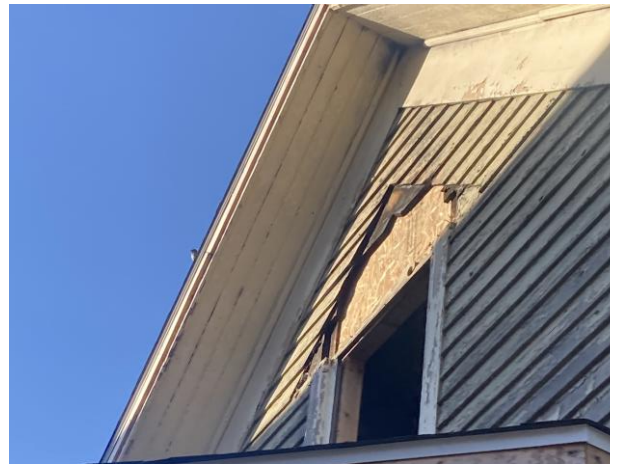
West side wall, 2nd story gable end window. Showing current condition/missing trim. 9/30/2024 HDC staff

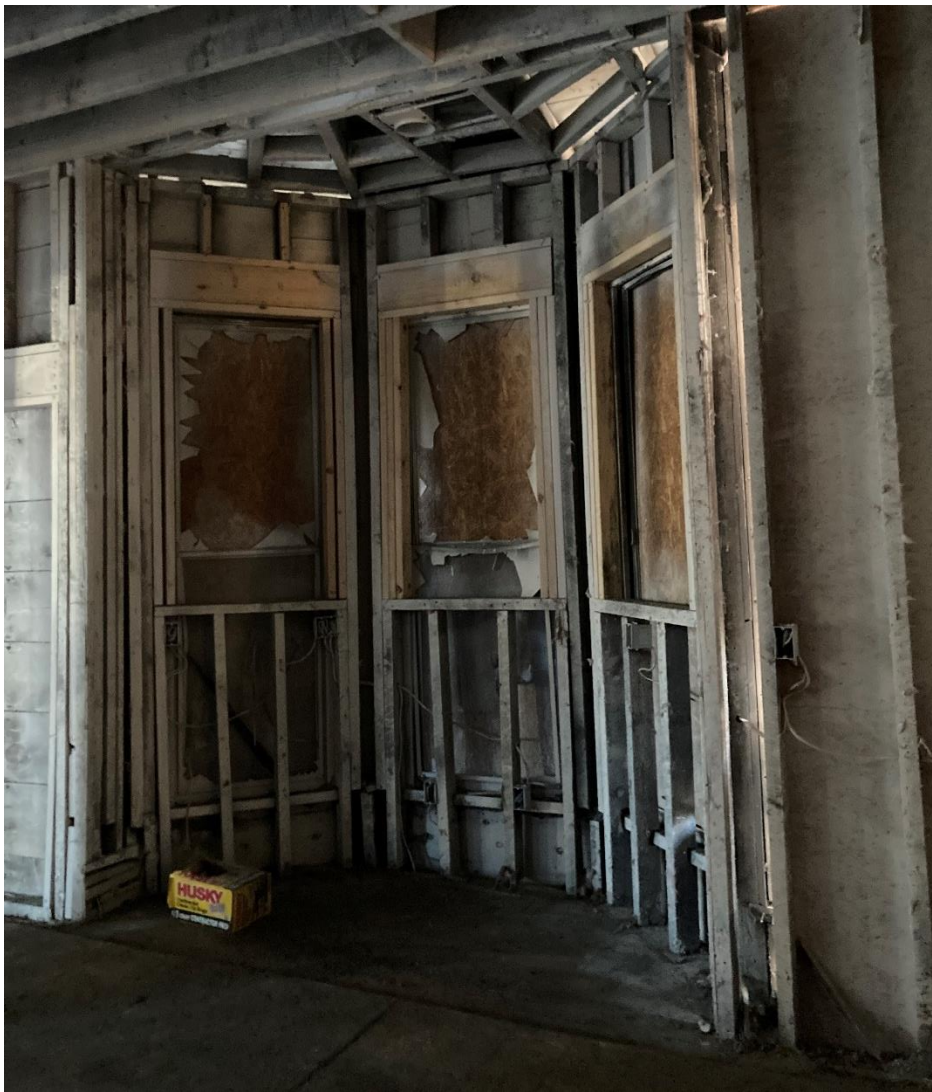
Interior, showing remaining historic east wall bay. Note that remnants from the windows which were damaged by the 2019 fire. Photo by HDC staff on 9/30/2024

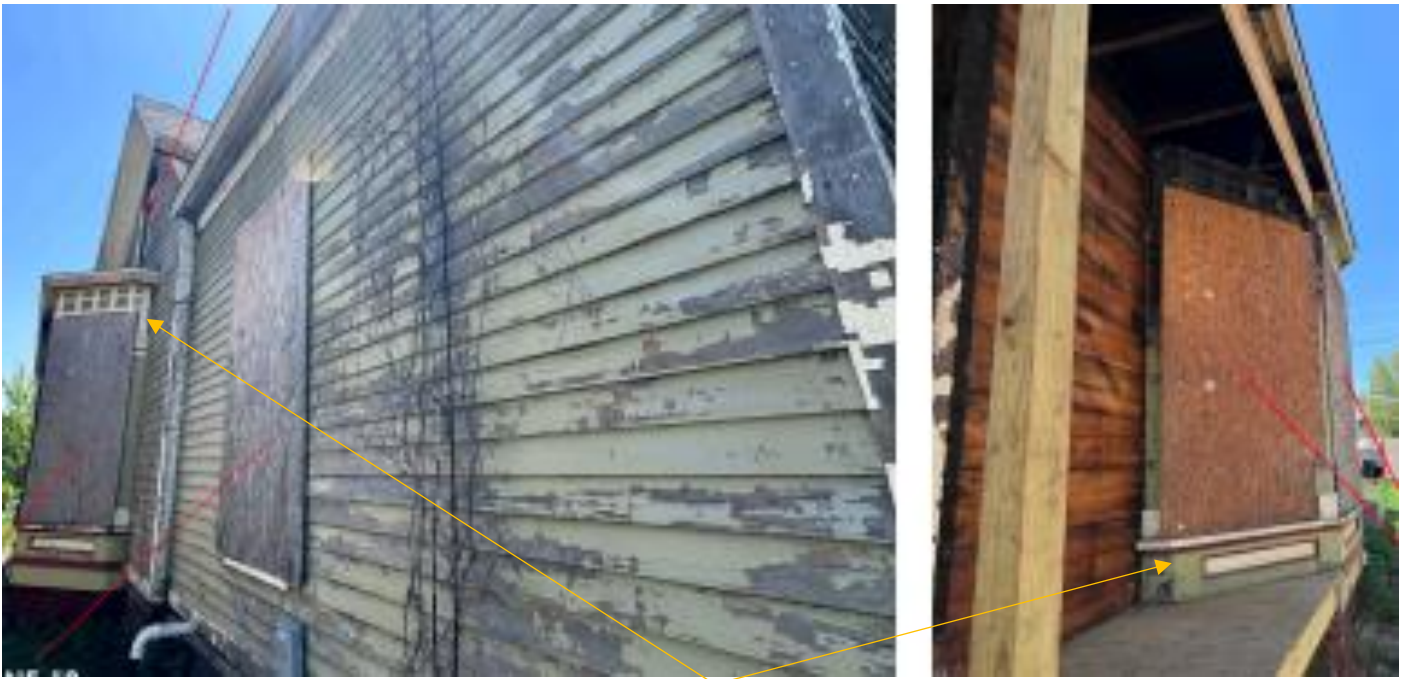
East wall bay, current conditions. Note that the historic wood detailing remains at this location despite the damage caused by the 2019 fire. Photo by applicant

- At the east side wall, the roof fascia/soffits, porch, projecting bay, and siding were damaged by fire. It appears these historic elements could have been retained and repaired in kind where required. The window sash at this was not historic. The historic casing/trim of the decorative jigsawn window at the second story gable end is currently missing and was likely damaged by the fire. It is unclear to staff if the historic window trim/casing at the first story bay is present because the openings are currently covered with plywood board.

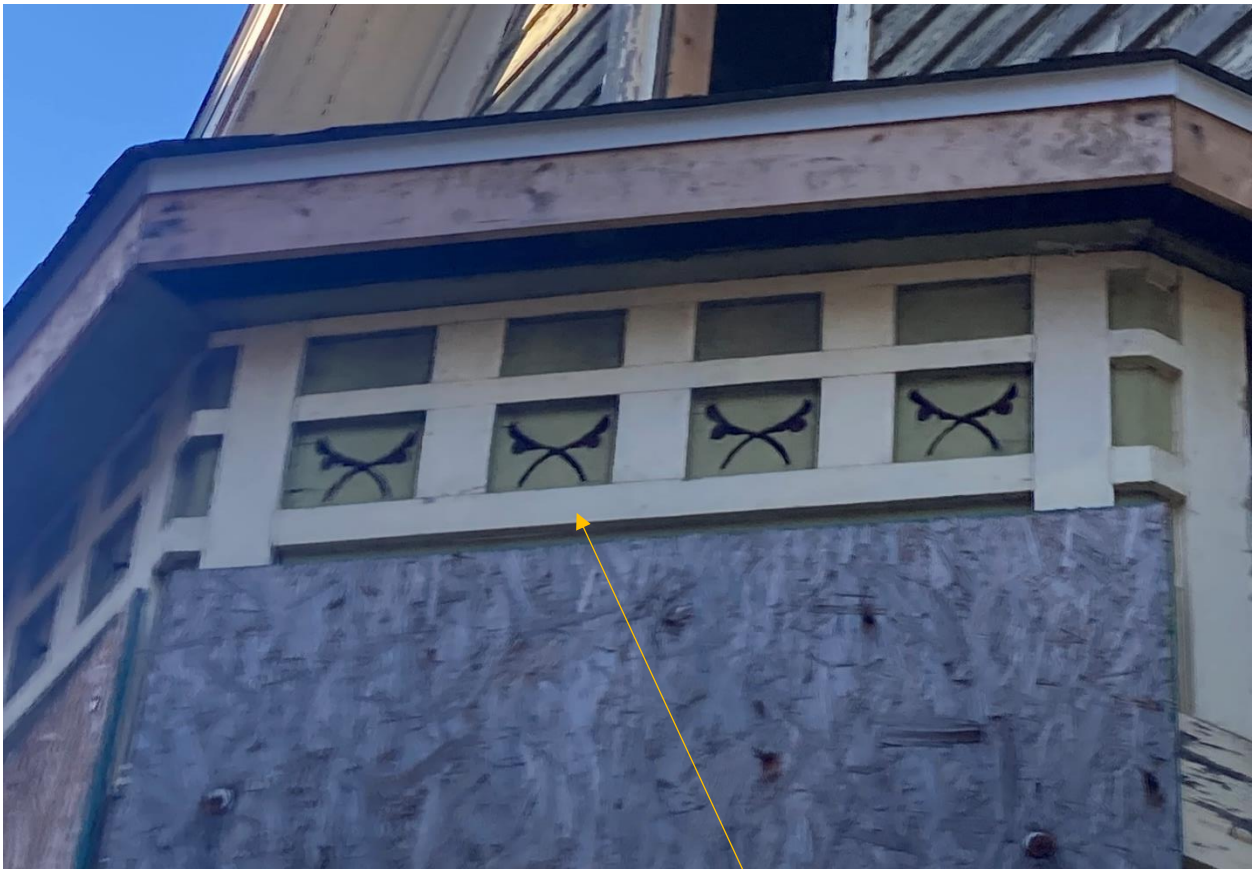
East wall bay, current conditions. Note that the historic wood detailing remains at this location despite the damage caused by the 2019 fire. Photo by HDC staff, 9/30/2024
