STAFF REPORT: OCTOBER 9, 2024, REGULAR MEETING
APPLICATION NUMBER: HDC2024-00569
ADDRESS: 1180 VINEWOOD
HISTORIC DISTRICT: HUBBARD FARMS
APPLICANT: VALERIA LOPEZ
PROPERTY OWNER: VALERIA LOPEZ
DATE OF PROVISIONALLY COMPLETE APPLICATION: SEPTEMBER 19, 2024
DATE OF STAFF SITE VISIT: SEPTEMBER 26, 2024

SCOPE: ALTER DWELLING INCLUDING WINDOW AND DOOR OPENINGS, ROOF, SIDING, AND PORCH (WORK COMPLETED WITHOUT APPROVAL)

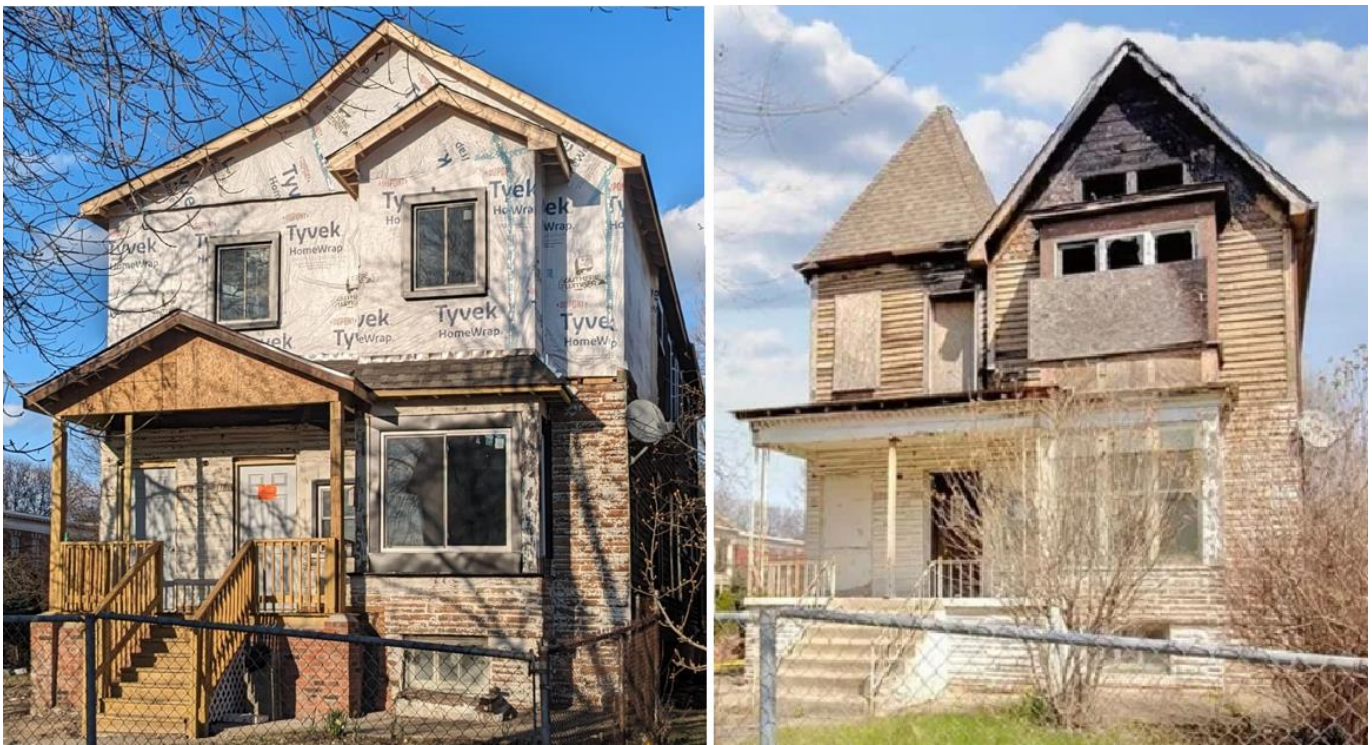
Left: March 2024 photo by staff. Right: Photo from July 2023 listing on realtor.com.

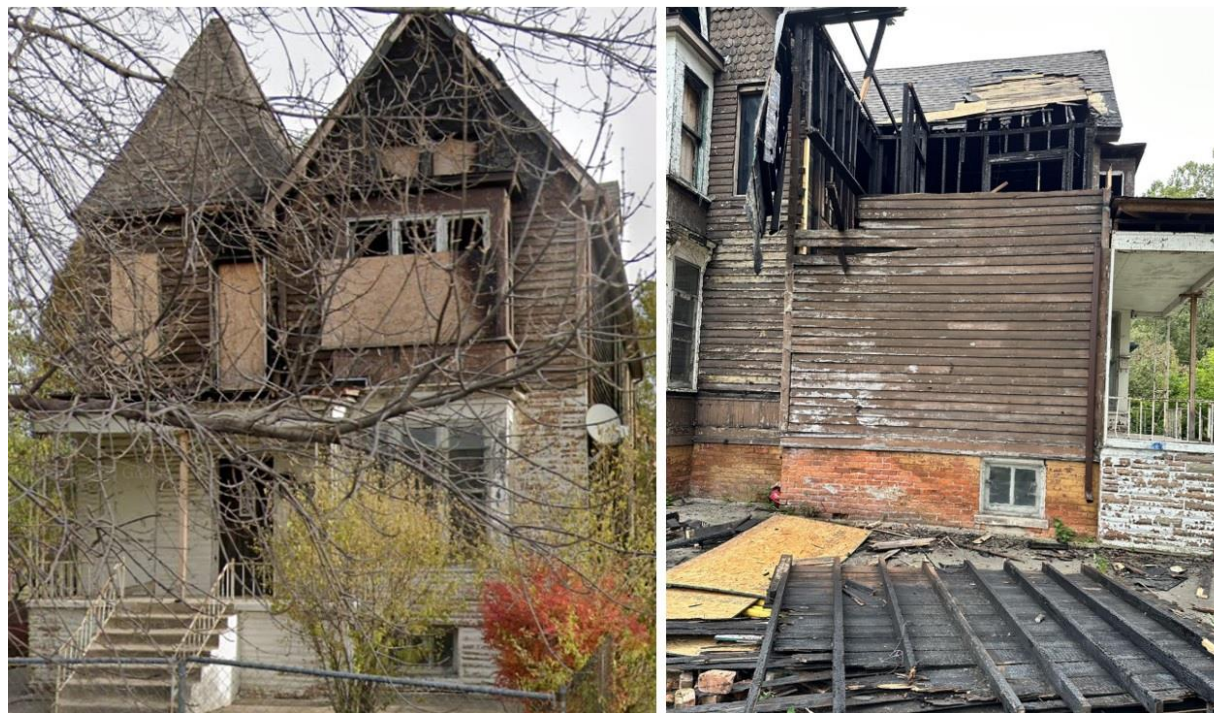
Left: November 2020 photo from Google Street View. Right: Image from 2023 application documents, view from the north. Note that the pyramidal roof tower is missing; red arrow is added by staff to indicate former tower location.

At some time between May 2019 and November 2020¹ a fire damaged the second story and attic half-story. The fire caused damage to the interior framing of the building, as seen in a photo provided by the applicant, and also caused damage visible on the building exterior.

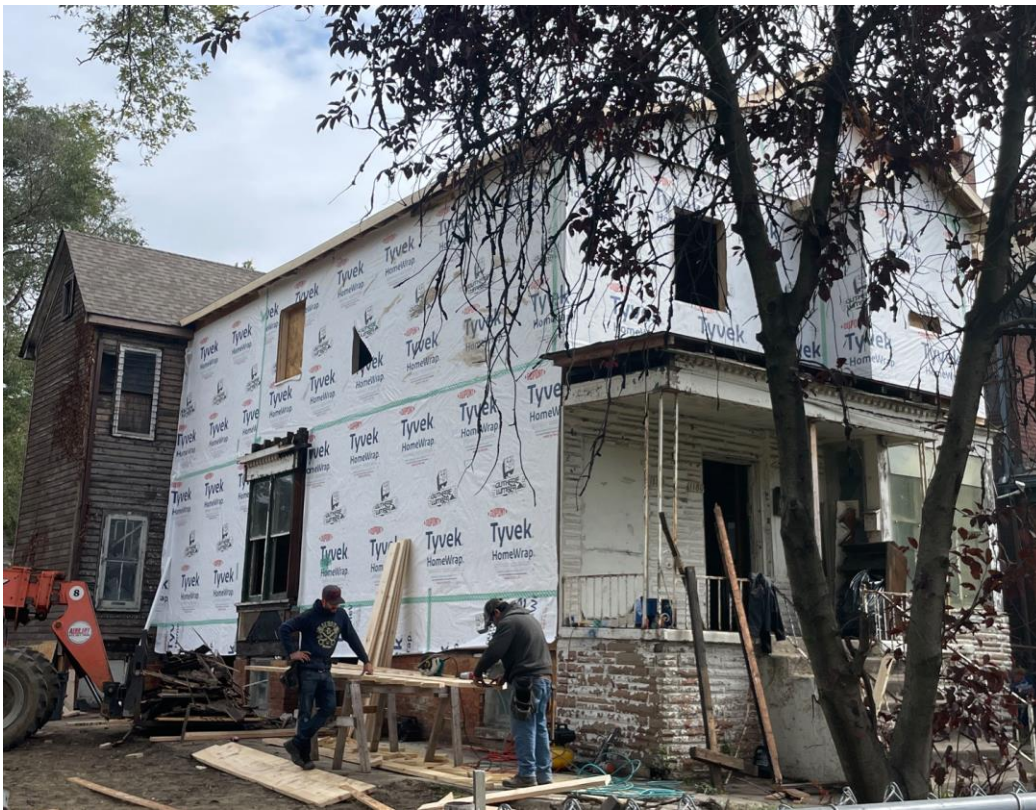
In 2023, staff observed extensive work completed at the property without Historic District Commission approval. Perhaps most noticeably, the attic half-story had been shortened, eliminating its pyramidal tower, front-facing gable, north-facing cross gable, and south-facing dormer. The fenestration pattern had been altered, with many window openings reduced in size or eliminated altogether. The footprint of the north wall was expanded slightly, eliminating a recessed central section and creating a solid plane. The north-facing box-bay window had been reduced from two stories to one, and the front-facing box-bay window had been altered by either removing or covering over a Classical entablature with dentils and adding a gable to the top of its second story. Expanses of building paper suggest that much of the historic siding had been removed as well. A few historic, wood, one-over-one or two-over-two windows remained on the building, along with Classical trim on the historic porch and what remained of the north-facing box bay window.

October 11, 2023, photo by staff.

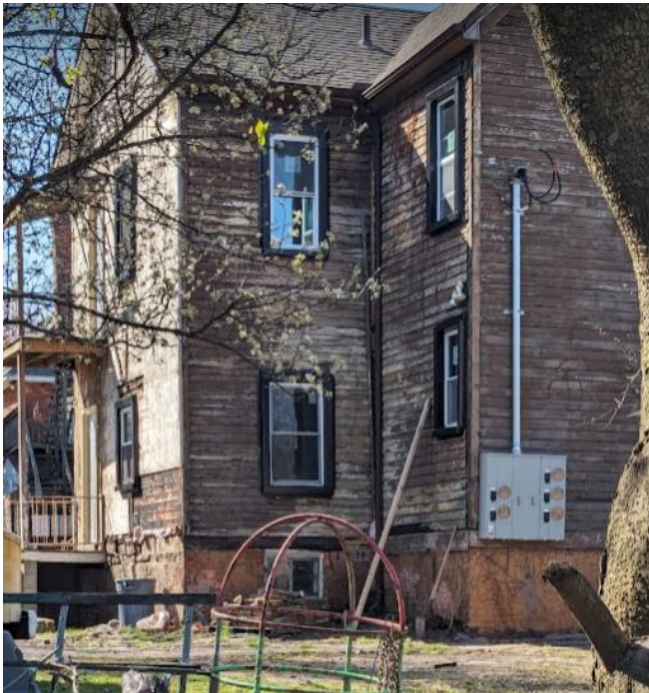
After the Stop Work order, staff observed additional work on the house: New electrical service connections were added to the exterior, north elevation. This work was visible on April 5, 2024, but not present on March 28, 2024.

April 2024 staff photo; new electrical service connections visible at bottom right.

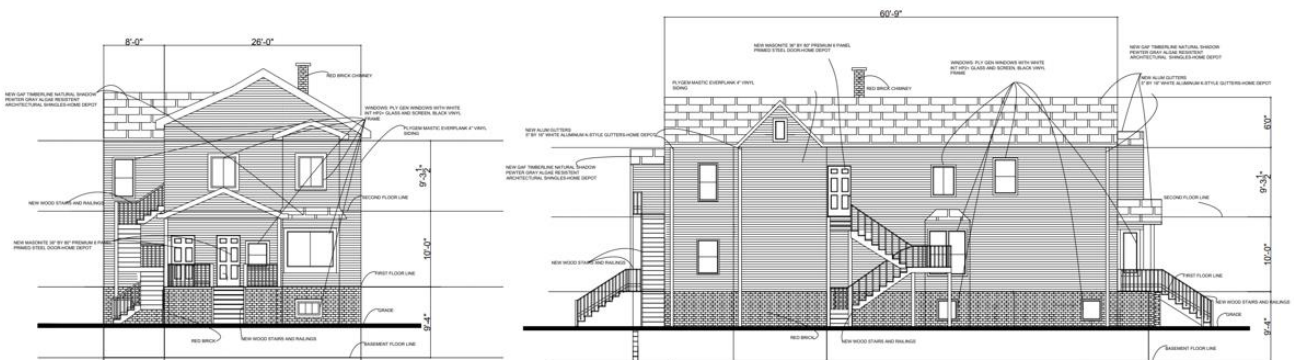
West (left) and north (right) elevations of work from March 23, 2024, application, largely completed without approval. This application received a Denial.

At its April 10, 2024, meeting, the Commission issued a Denial for the proposed (largely already completed) work, citing the following reasons:

- The proposed work removes distinctive and character-defining features from the building (such features must be preserved; if beyond repair, they may be replaced with matching new features). These features include the front porch, decorative trim on bay windows, wood siding, and wood scalloped shingles.

- The proposed work alters historic features and spaces by fundamentally changing the form of the building. Inappropriate spatial alterations include reducing the height of the building, converting the historic roof form with tower, front gable, side gable, and side dormer to a gable roof, increasing the footprint of the building on the north wall, adding a gable top to the west-facing bay window, converting the north-facing bay window from two stories to one, and altering the fenestration pattern.
- The proposed work adds an incompatible new front porch to the building.
- The proposed work adds historically inappropriate vinyl materials to the building

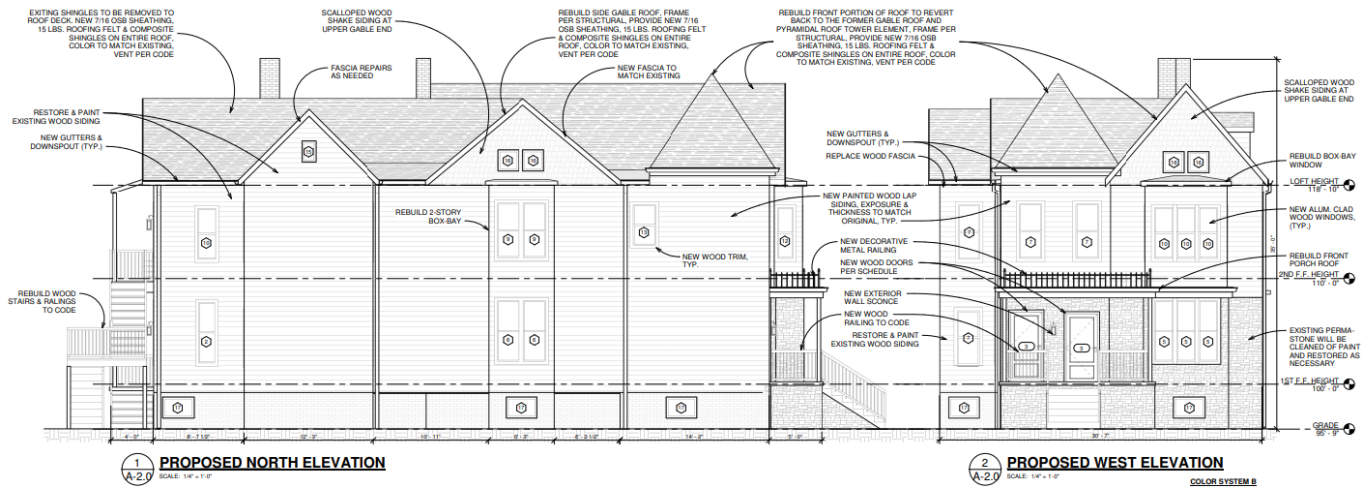
Proposed front (west) and side (north) elevations. Drawings from application materials.

- The proposed work creates large expanses of blank wall that are incompatible with the building and the district, contrary to Standard #9.
- The proposed elevation drawings show the three box-bay windows on the second floor, west (front) elevation to be reduced in height from the historic condition.

- Additional window openings shall be added to the north elevation, subject to staff approval.
- The three windows on the second floor, west (front) elevation, box-bay shall be increased in height to match the historic condition, subject to staff approval.
- The selection of scalloped shingles shall be subject to staff approval.

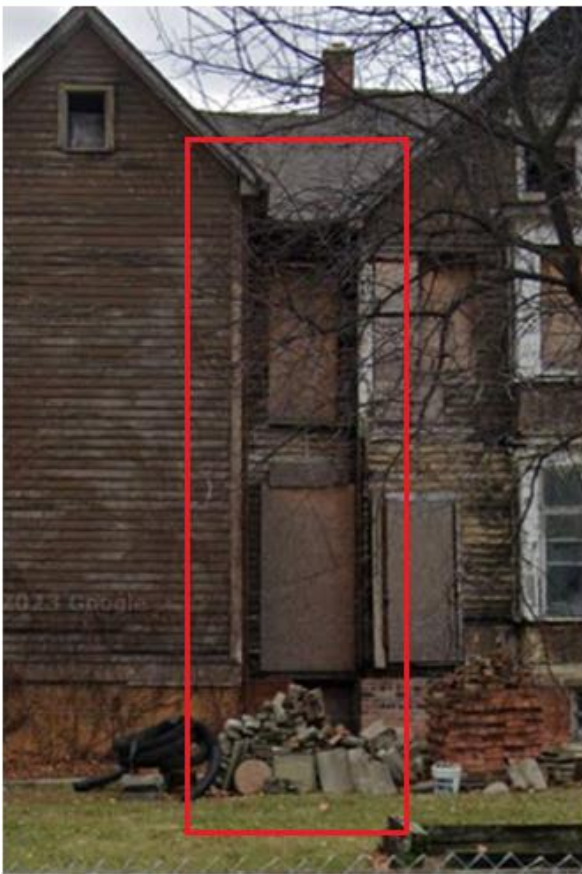
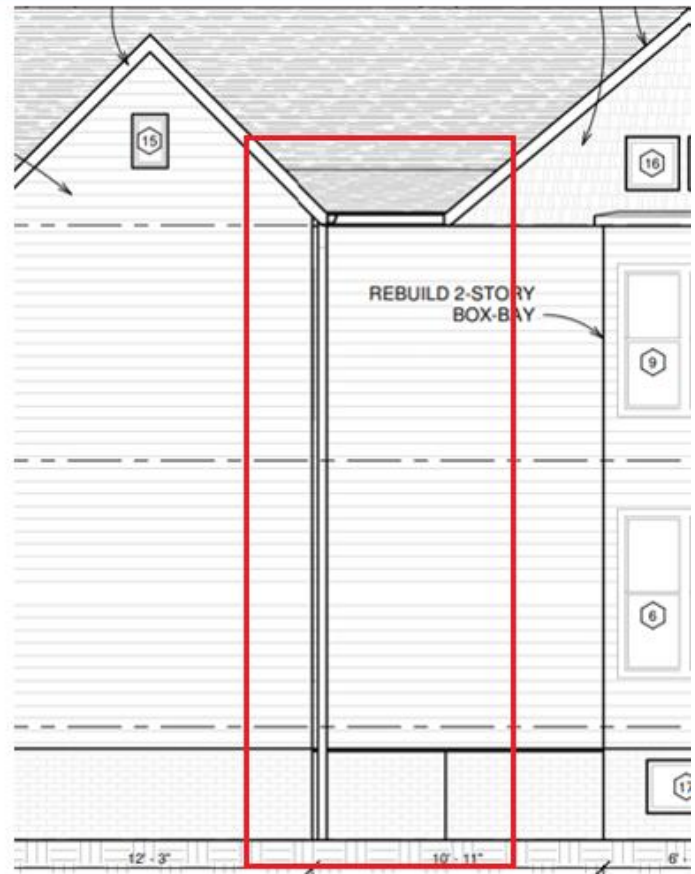
- The prior, unapproved work changed the overall footprint of the building by the elimination of a recessed, central portion of the north wall.
- The proposed work does not restore this feature to the pre-violation condition, and would therefore allow an unapproved “alteration to features and spaces that characterize the property,” per Standard #2, to persist. The application narrative states:

Recessed area between gabled bays on side (west) of building, indicated by red boxes added by staff. Left: historic condition (Google Maps 2023); Right: proposed work (from application drawings, cropped by staff).

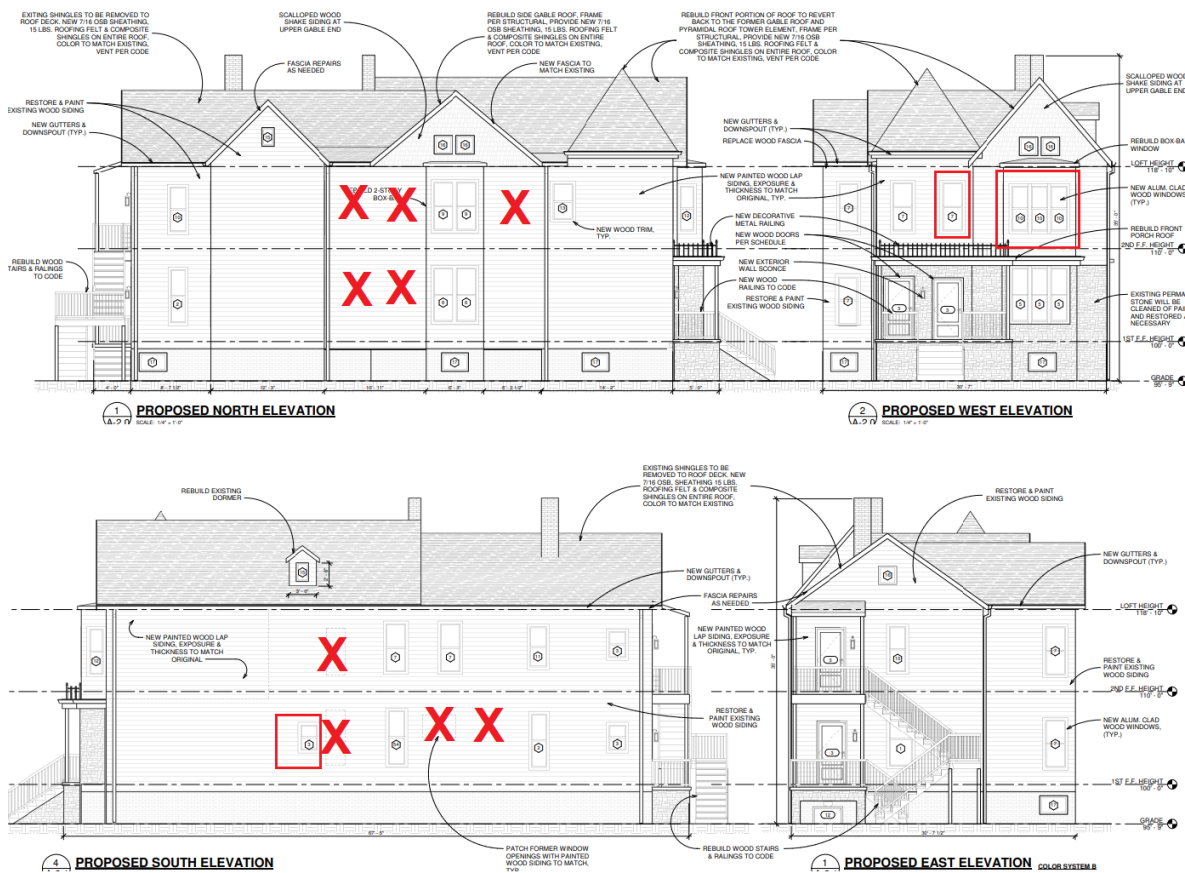
- Another component of the unapproved work greatly reconfigured window openings by reducing some openings in size or eliminating some openings altogether. Again, this was contrary to Standard #2, which requires that “the alteration of features and spaces that characterize a property shall be avoided.”
- The proposed work returns many, but not all, of the window openings to their pre-violation condition.
- The application narrative argues the following:

Elevation drawings from application, marked in red by staff. X represents prior window openings proposed for elimination. Boxes indicate prior window openings proposed to be resized.

- However, staff also believes that the overall reduction in the number of window openings creates expanses of blank wall that are not compatible with the character of the building or the district, contrary to Standard #9: “exterior alterations ... shall be compatible with the massing, size, scale, and architectural features to protect the historic integrity of the property and its environment” (again, see “Issues,” below).
