**STAFF REPORT: OCTOBER 9, 2024, REGULAR MEETING**

**APPLICATION NUMBER: HDC2024-00522**

**ADDRESS: 19566 CANTERBURY**

**SCOPE: REPLACE STEEL WINDOWS WITH COMPOSITE WINDOWS**

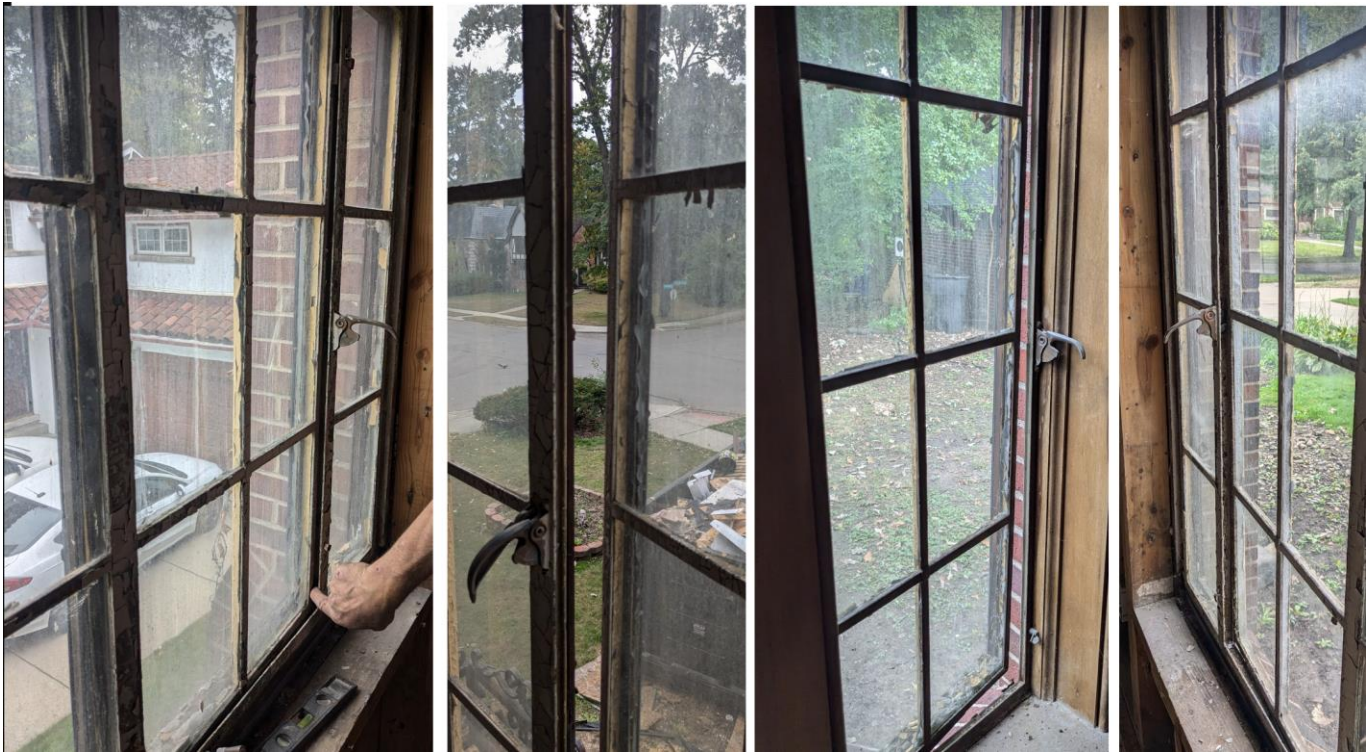
- Staff was invited to view the windows in person. As is common with steel windows, they consist of an outer row of fixed panes, with operable casement panels set within. Staff observed that the outer panes generally appeared to be in need of sanding, painting, and reglazing. These conditions are not beyond repair. However, staff also observed that the inner casements were visibly warped or racked to the extent that they are misaligned and do not close, often leaving a gap of about an inch or more at the top or bottom. This condition was clearly visible on about half of the windows on the property.

October 2024 staff photos showing warped casements.

- Preservation Briefs 13: The Repair and Thermal Upgrading of Historic Steel Windows* describes a repair process for bent casements:

“Bent or bowed metal sections may be the result of damage to the window through an impact or corrosive expansion. If the distortion is not too great, it is possible to realign the metal sections without removing the window to a metal fabricator’s shop. The glazing is generally removed and pressure is applied to the bent or bowed section. In the case of a muntin, a protective 2 x 4 wooden bracing can be placed behind the bent portion and a wire cable with a winch can apply progressively more pressure over several days until the section is realigned. The 2 x 4 bracing is necessary to distribute the pressure evenly over the damaged section. Sometimes a section, such as

the bottom of the frame, will bow out as a result of pressure exerted by corrosion and it is often necessary to cut the metal section to relieve this pressure prior to pressing the section back into shape and making a welded repair.”

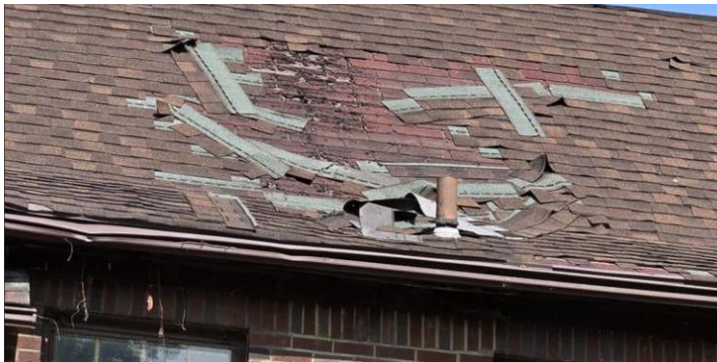
- Preservation Briefs 13: The Repair and Thermal Upgrading of Historic Steel Windows*, notes “since moisture is the primary cause of corrosion in steel windows, it is essential that excess moisture be eliminated and that the building be made as weathertight as possible before any other work is undertaken.” Extensive roof damage, formerly visible, has recently been repaired.

Area of prior roof deterioration. Image from August 22, 2024, application documents for roof repairs.
