STAFF REPORT: 11/13/2024 MEETING

ADDRESS: 1624 EDISON

APPLICATION NO: HDC2024-00434

SCOPE: REHABILITATE DWELLING AND GARAGE

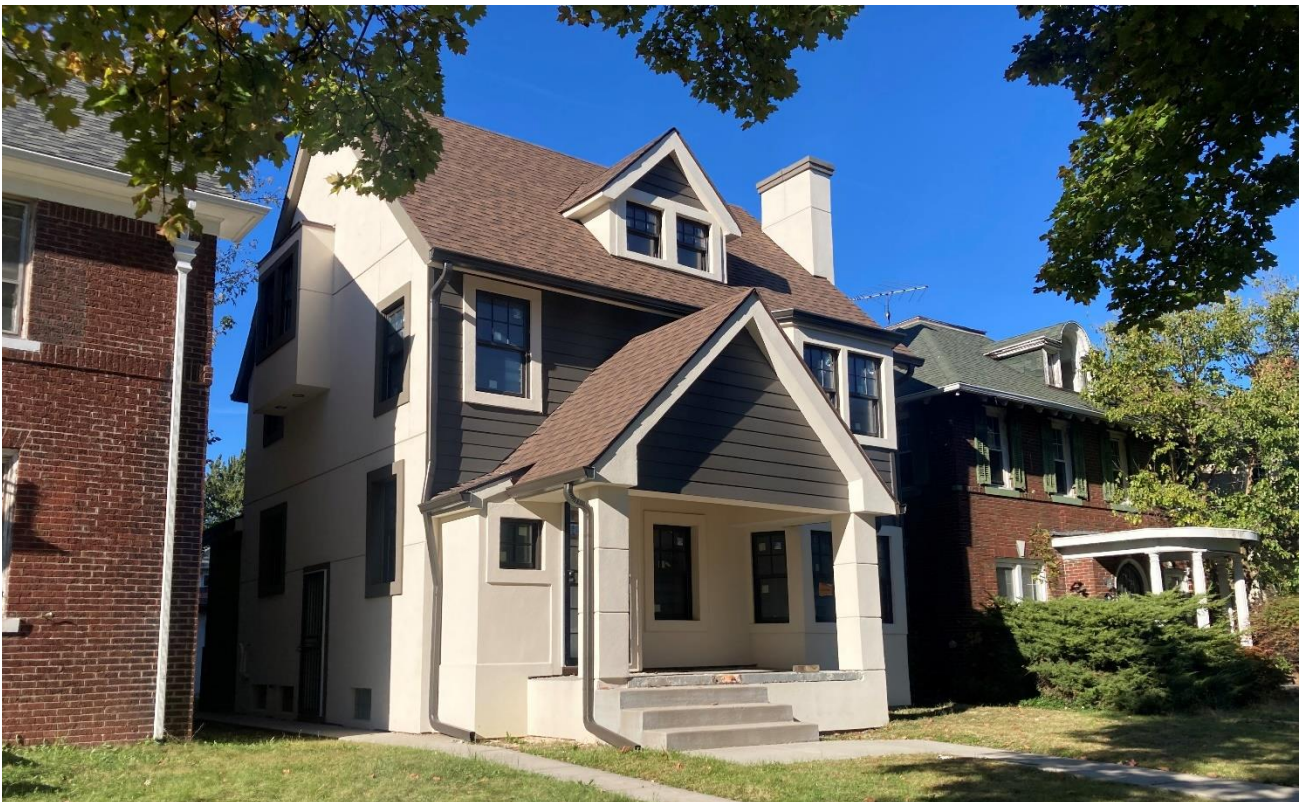
Current condition. Staff photo taken 10/16/2024

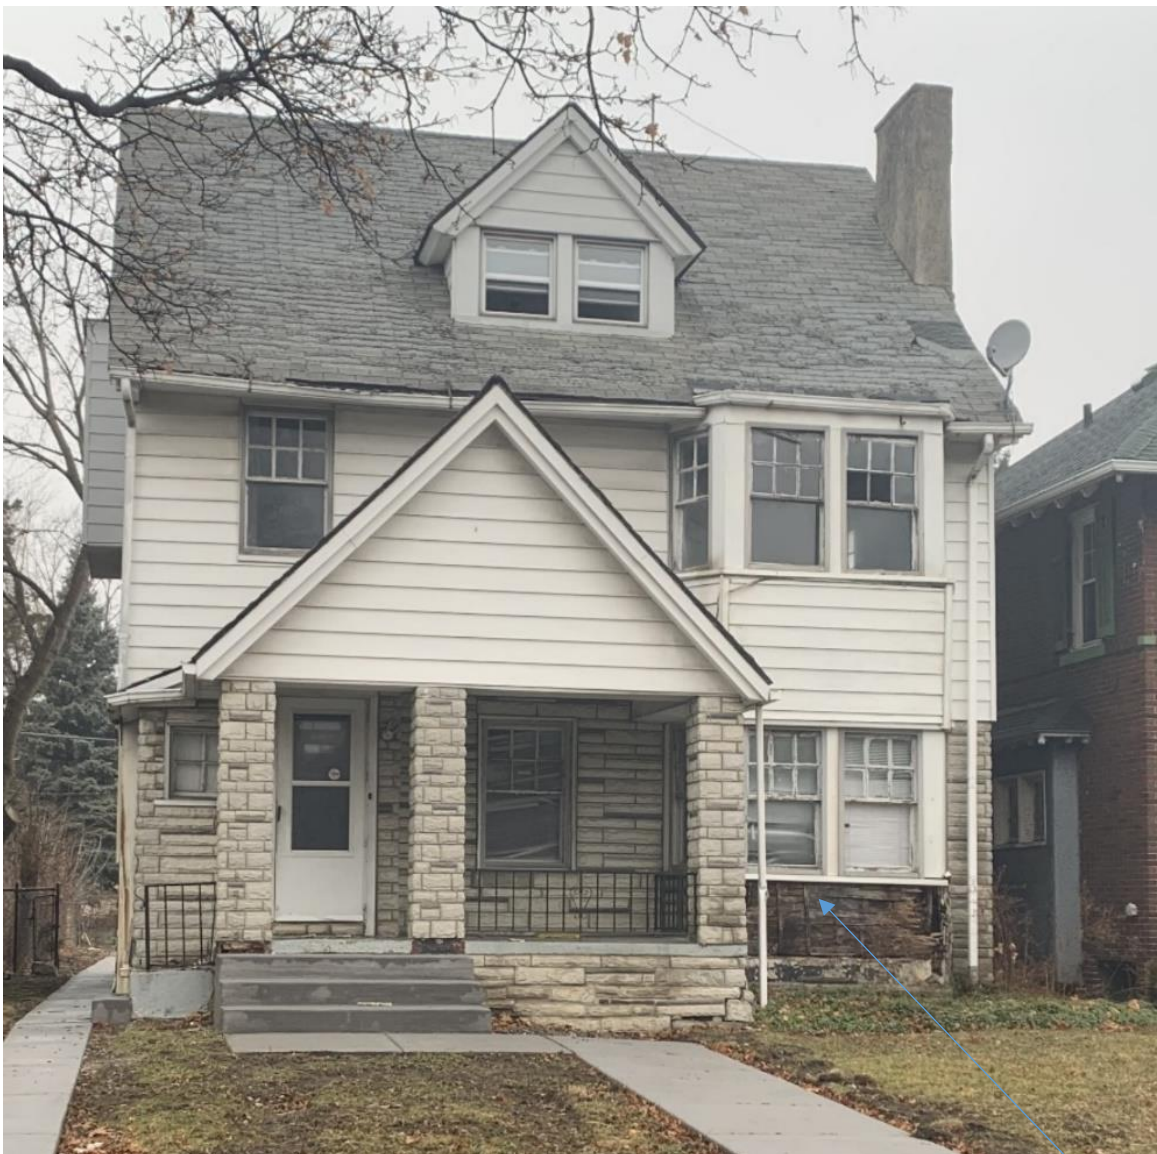
Front façade, 2020 photo taken by previous applicant. Note area where Permastone has fallen off

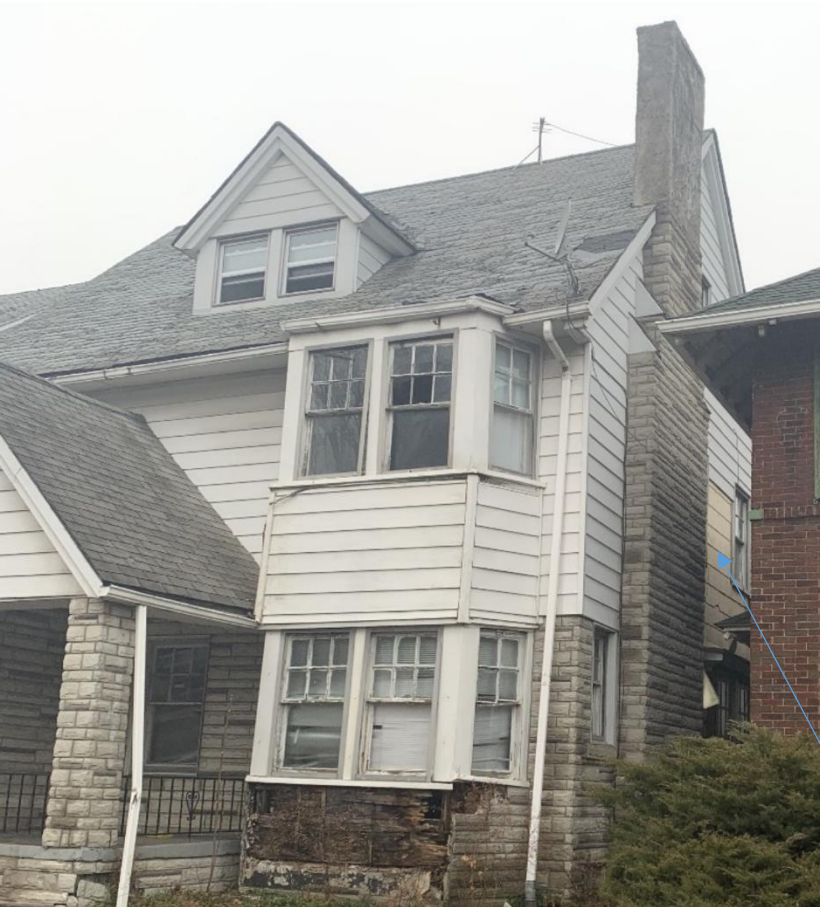
Photo taken in 2020 by previous applicant. Note area where aluminum siding has fallen off, revealing synthetic shingle siding underneath.

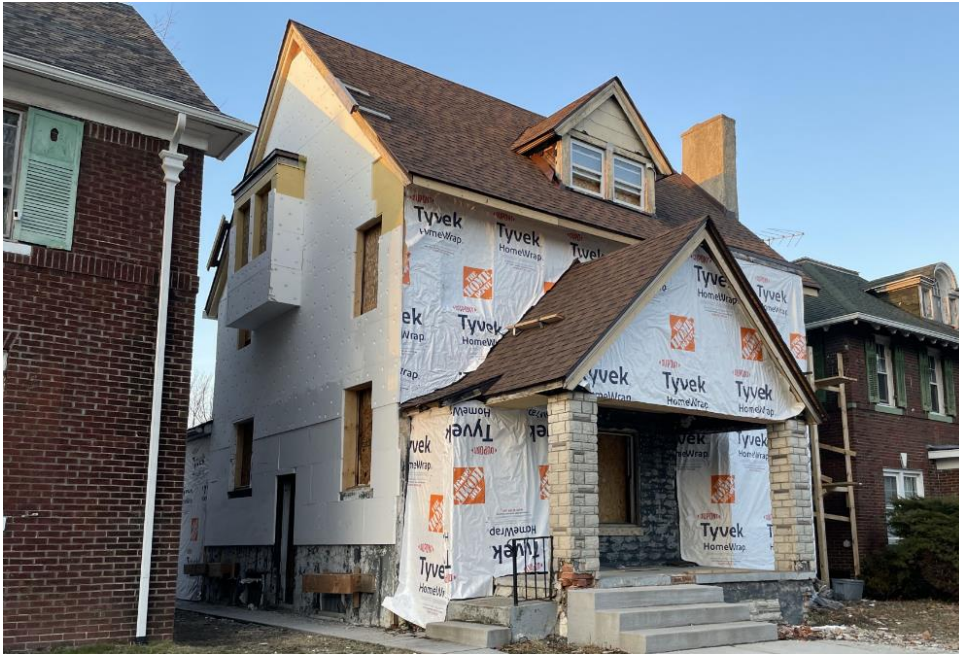
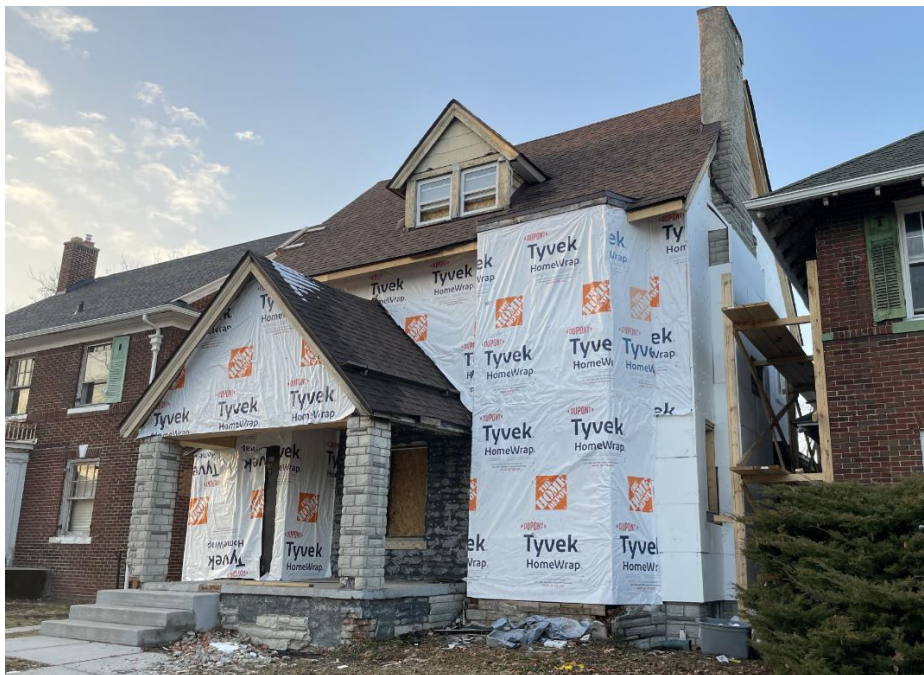
- In January 2023, HDC staff was alerted that the following work had been undertaken without HDC approval:
 - All windows removed
 - All exterior cladding removed
 - Side wall, second story bay rebuilt
 - Original fascia and soffit at main roof and porch roof replaced
 - New driveway added

Conditions on 1/24/2023. Photo by HDC staff
