**STAFF REPORT: NOVEMBER 13, 2024 MEETING**

**APPLICATION NUMBER: HDC2024-00630**

**ADDRESS: 2310 EDISON**

**SCOPE: REPLACE WINDOWS (WORK COMPLETED WITHOUT APPROVAL)**

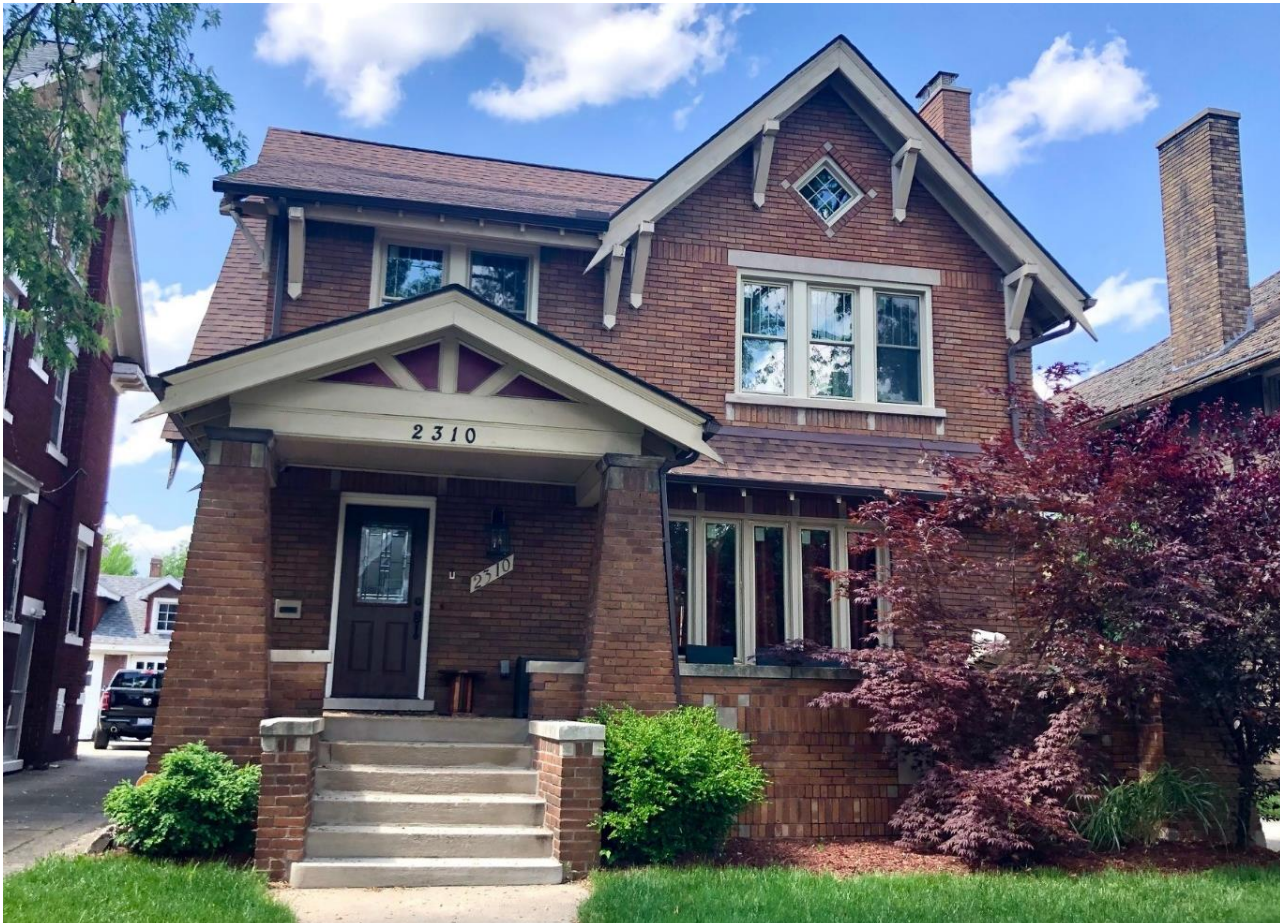
*Façade, east-facing wall. Staff photo, May 22, 2024.*

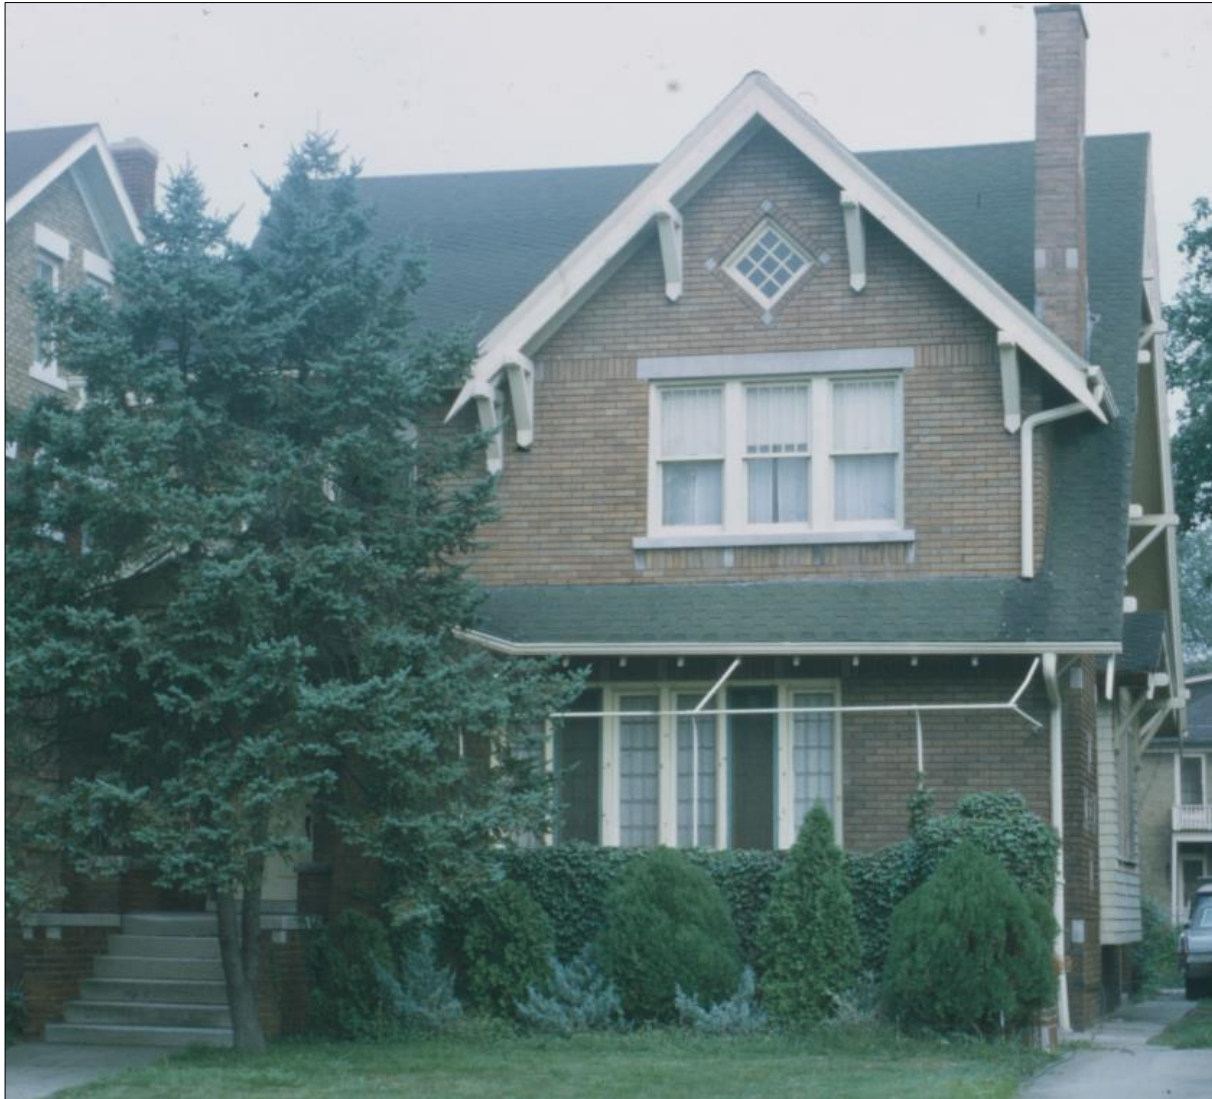
*1974 designation photo, HDAB.*

- The leaded glass windows on the façade at the first floor (visible in the above designation photo) were replaced without Commission approval between 2011 and 2013, based on Google street view images. The remaining windows on the house were replaced in April 2024.

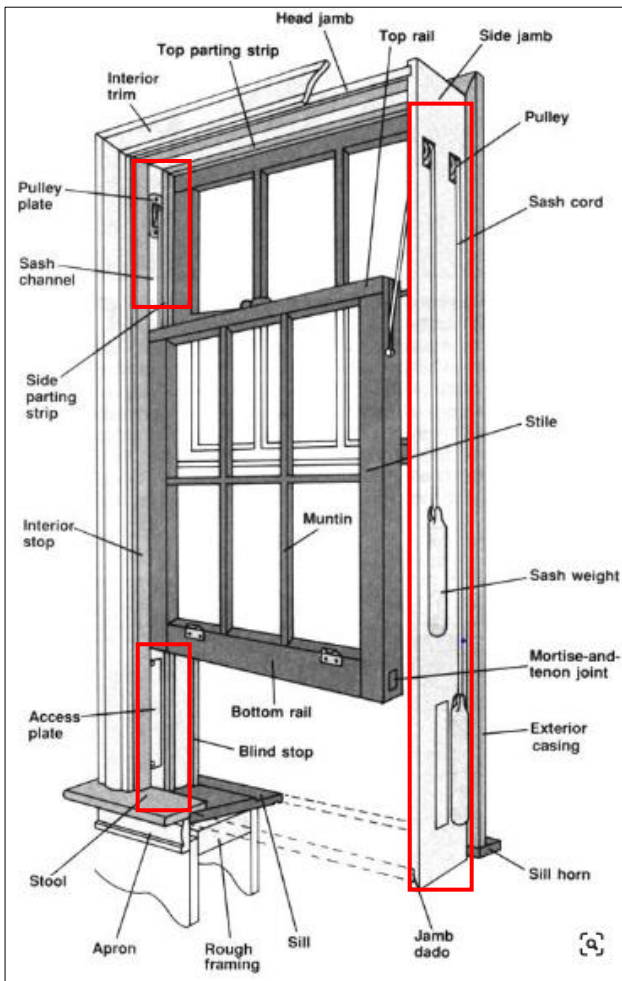
*Left: All the interior components (boxed in red) that held and operated the window sash were removed and discarded. The window replacement contractor then sprayed foam in the open spaces left behind.*

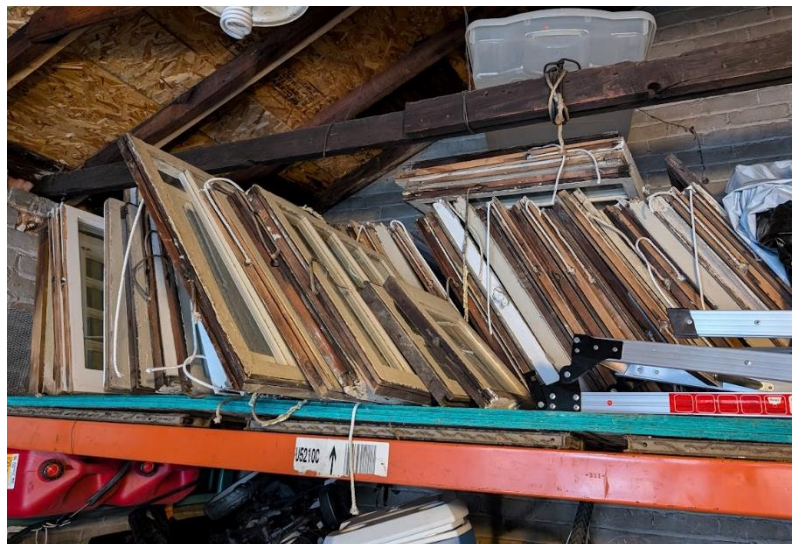
*Above: The wood window sash remain at the property and are being stored on a shelf in the owner's garage. Staff photo, November 4, 2024.*

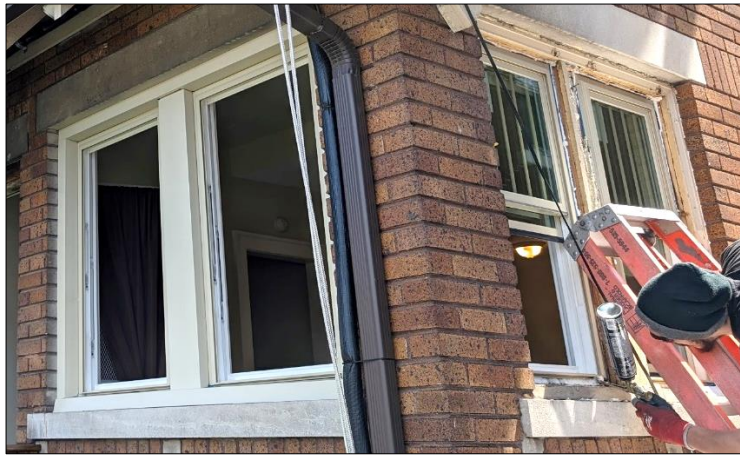
*HDC staff photos of in-progress replacement window installation, April 2024. These windows are at the rear northwest corner of the house.*

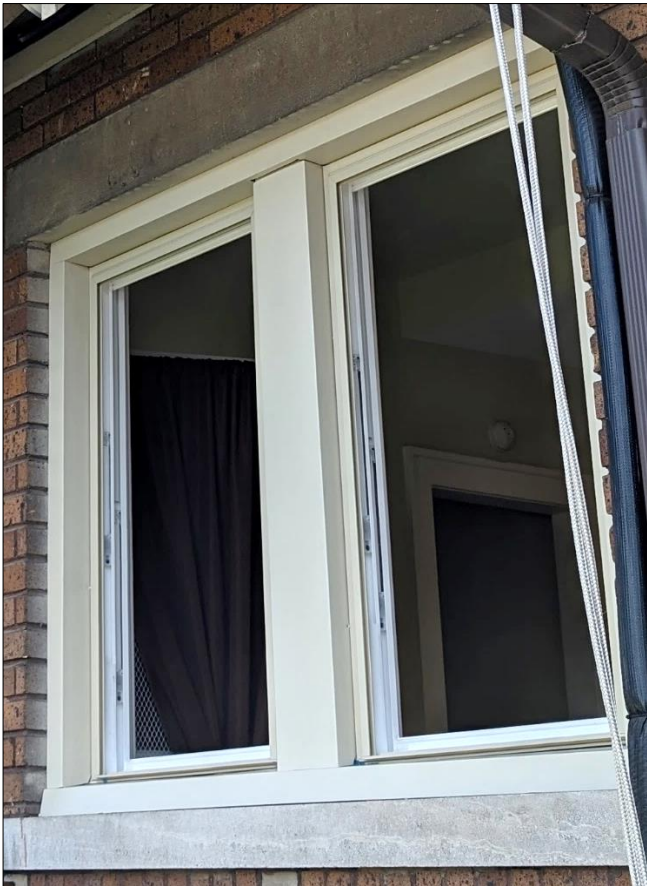
*This photo shows two openings that have the vinyl frames in place, but not the sash. The wood brickmould, central mullion and sill has been covered with aluminum coilstock.*

- All aluminum coil stock will be removed and the existing wood mullions and brickmould will be retained and repaired as needed. If any parts are missing, new components will be fabricated that match existing material, dimensions and profiles.

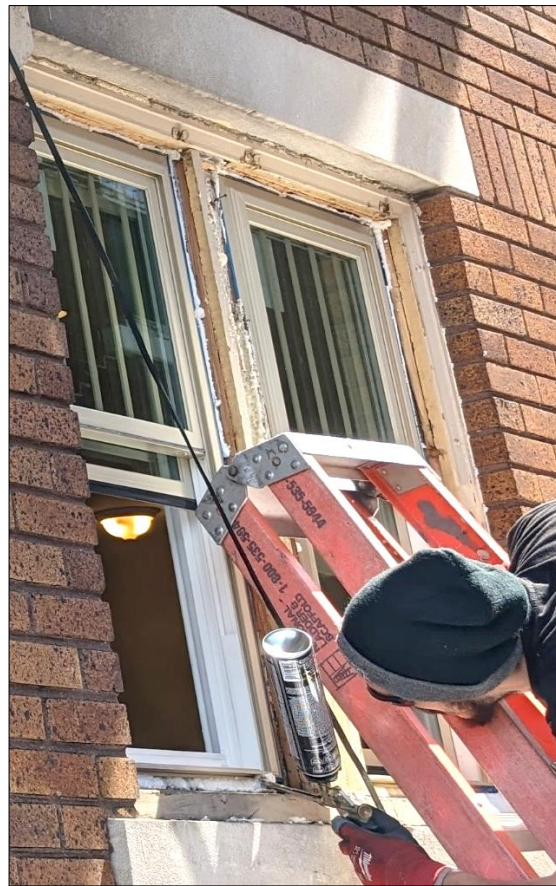
*This photo shows the vinyl frames and sash in place, and foam is being added in open areas prior to the wood brickmould, central mullion and sill being covered with aluminum coilstock.*

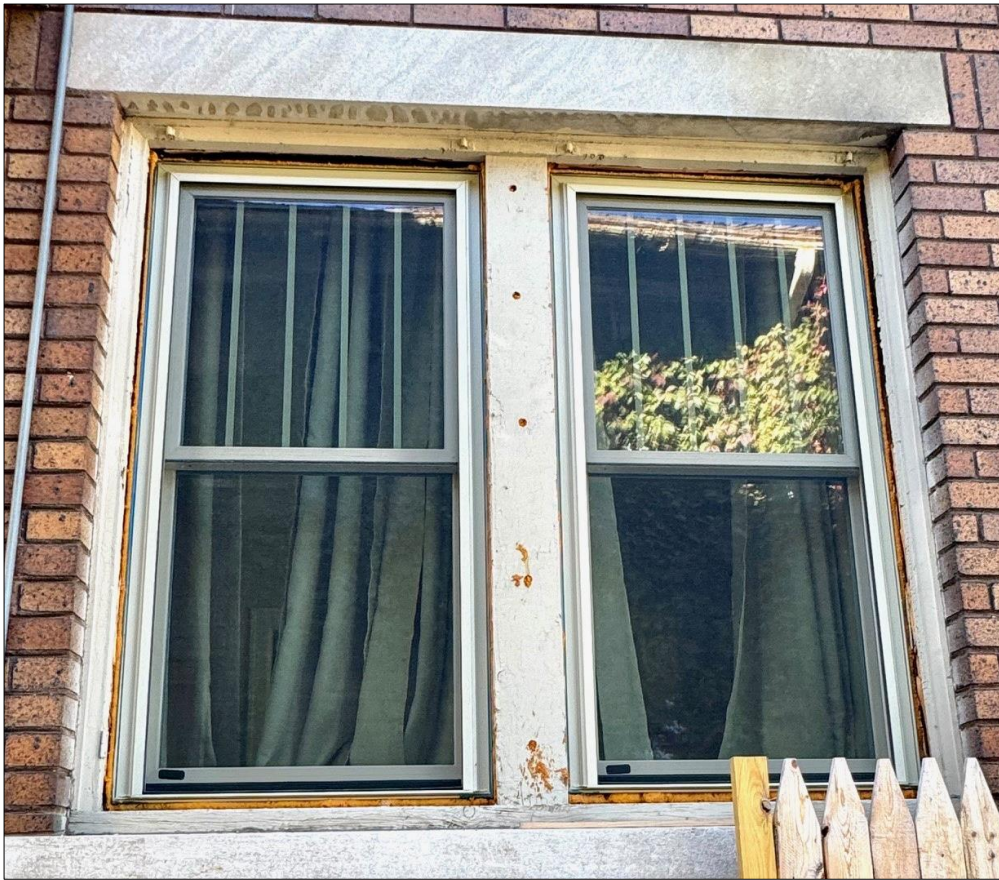
*This two-unit window opening is located on the east wall at the rear of the house. The replacement windows are in place and the spray foam applied, but the wood brickmould, central mullion and sill remain exposed.*

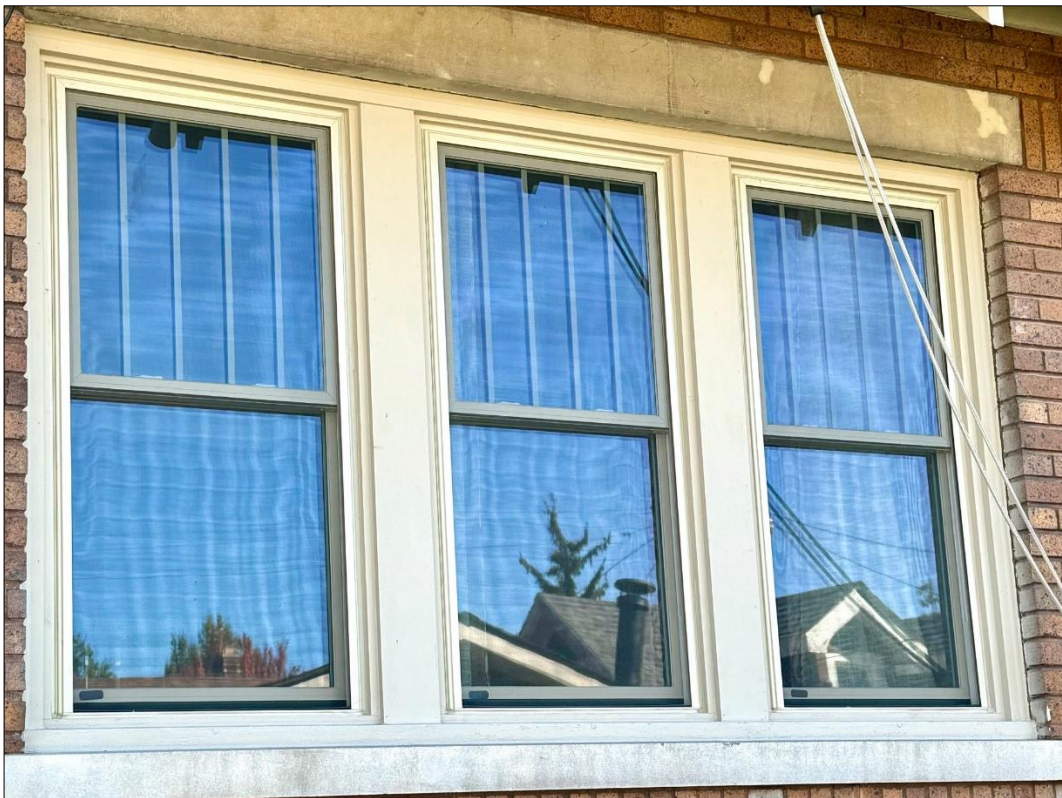
*This three-unit opening is located on the rear wall. The window replacement for this opening has been completed. Staff photos, October 9, 2024.*

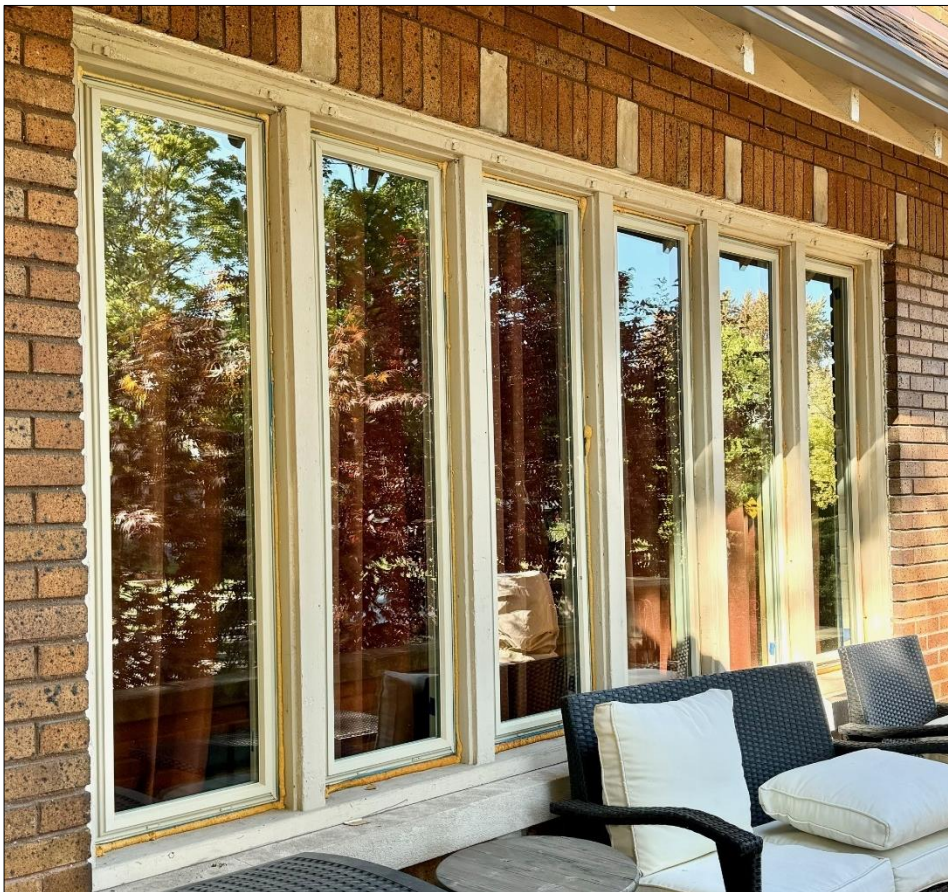
*Façade window opening, first floor. These vinyl units replaced non-original, non-approved windows that were installed in 2013 and replaced the original leaded glass casement units. Staff photo, October 9, 2024.*

- If the Commission considers not requiring leaded glass windows to be fabricated for the front elevation openings, it is staff's opinion that undivided glass windows that fit within the six individual openings would be the most compatible solution as any pattern using a simulated divided light "grille" would create a strong visual pattern that was not present with the leaded comes. Also, should the Commission consider a replacement window proposal for the remainder of the windows on the house, it is staff's opinion that either exterior primed wood or aluminum-clad wood windows that match the dimension, operation, pattern and profile of the historic windows could be a compatible solution.
