STAFF REPORT: DECEMBER 11, 2024 MEETING

APPLICATION NUMBER: HDC2024-00674

ADDRESS: 1783 IROQUOIS

SCOPE: REPLACE WOOD WINDOWS, REPAINT EXTERIOR

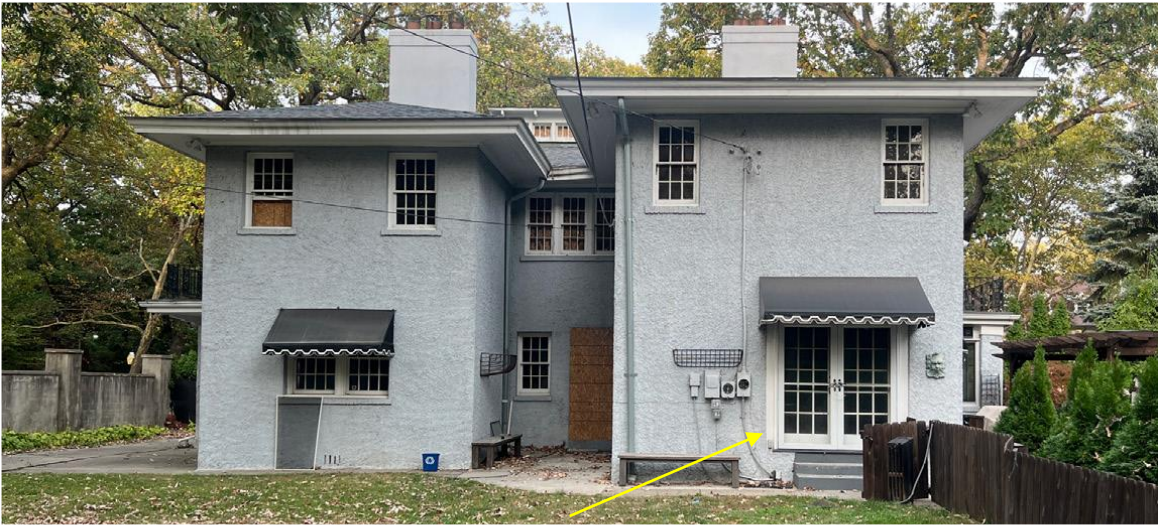
Rear wall of the house. Applicant photo. The French door is proposed for replacement.

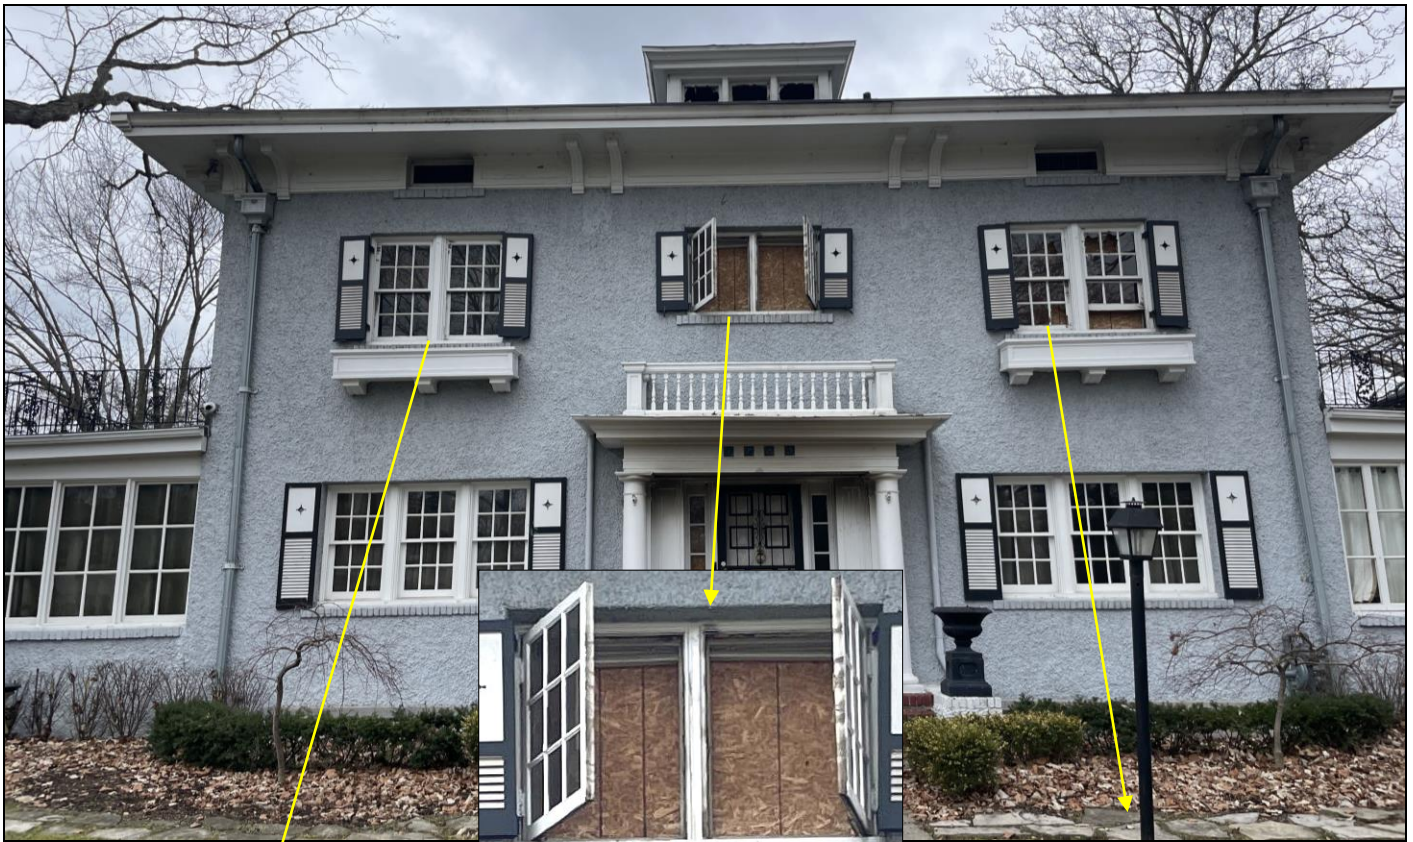
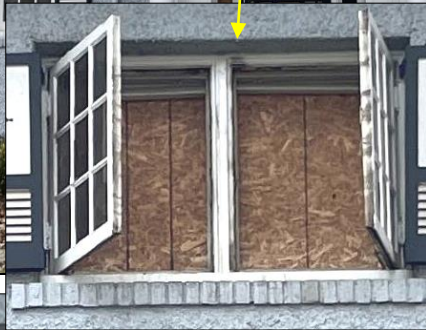
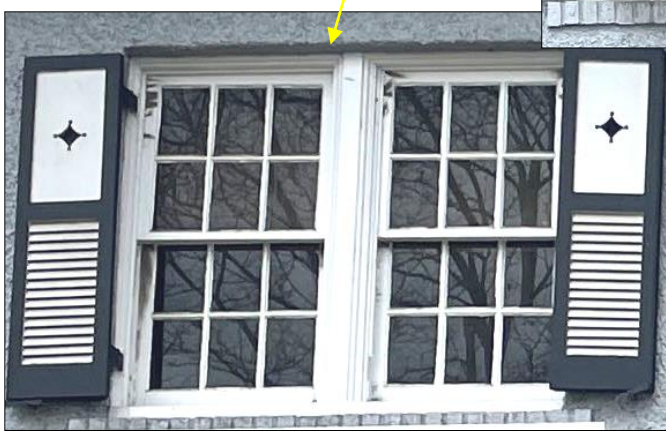
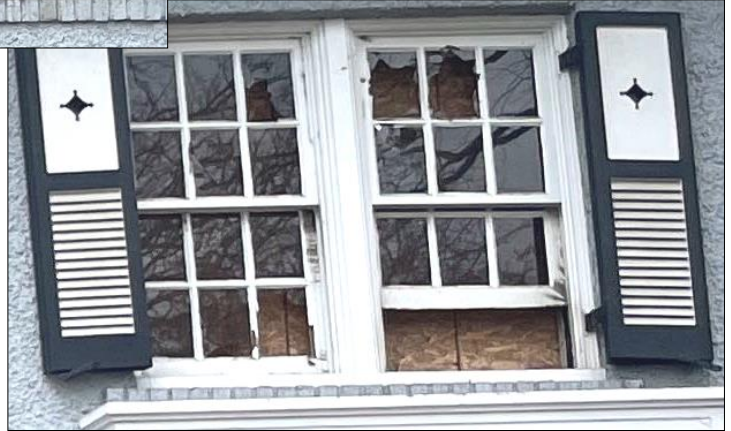
HDC staff photos taken on February 13, 2024 shortly after the fire. These photos show smoke on all the window frames, as well as several glass panels broken at the second story.

- According to staff’s research on immediate and lasting effects of fire damage, it is possible for fire to stress glass in way that, although intact, it has become extremely fragile and may break by a tap or a push. Intact wood frames might also have damaged seals and/or weakened integrity, and smoke can linger in the wood frames and cavities where operational components, such as the sash cords, are housed.

- Based on the technical and economic feasibility standard due to the level of confirmed and probable deterioration due to fire, staff believes the existing windows are deteriorated beyond repair. It is also staff's opinion the selected replacement windows may be an accurate replication of the historic wood windows and window trim.

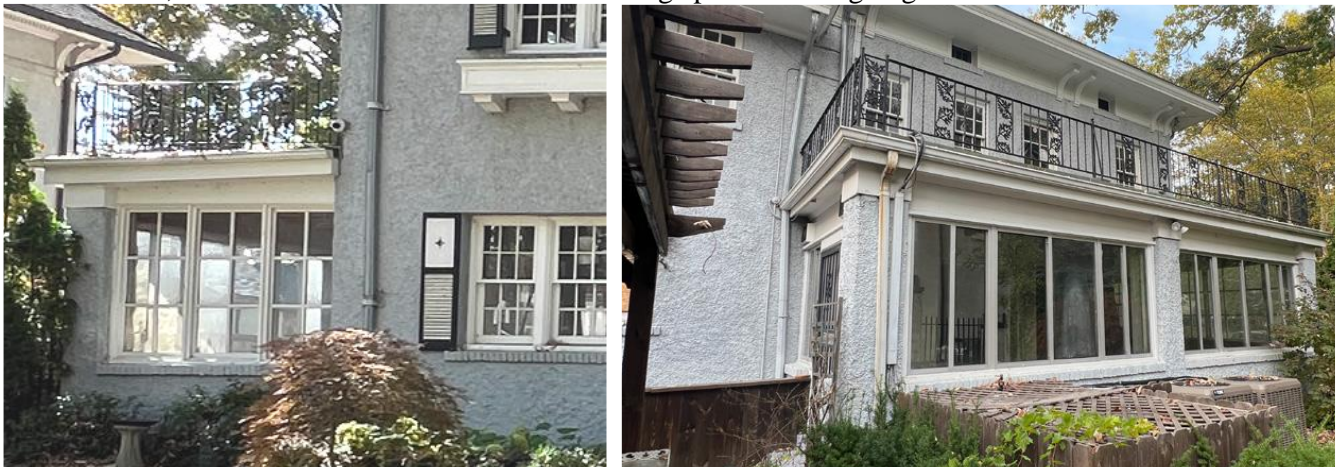
Windows to be retained on the three walls of the south wing. Applicant photos.

- The applicant also proposes to repair the remaining wood windows that were not strongly affected by the fire, which are the windows on the side wings/porches and garage.

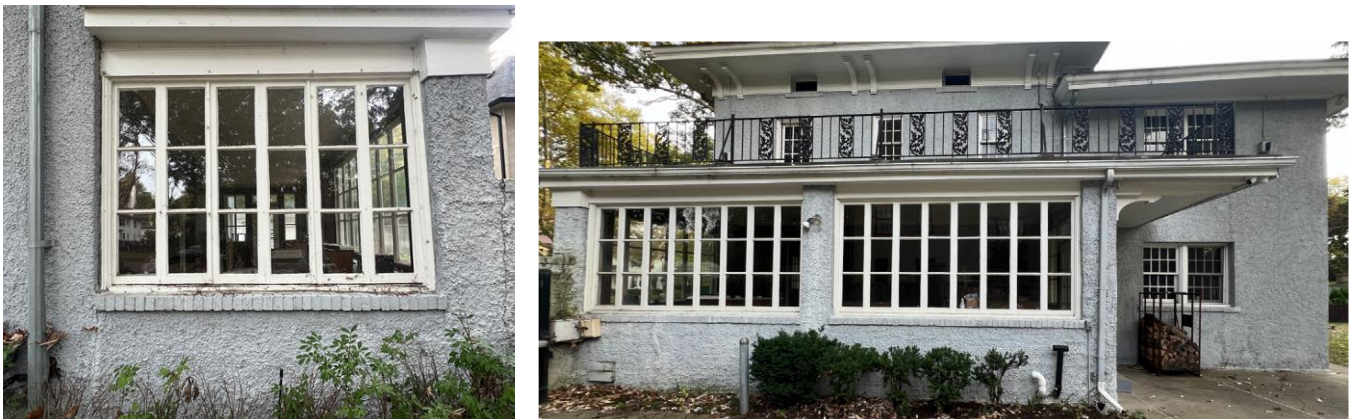
Windows to be retained on the northern wing. Applicant photos.

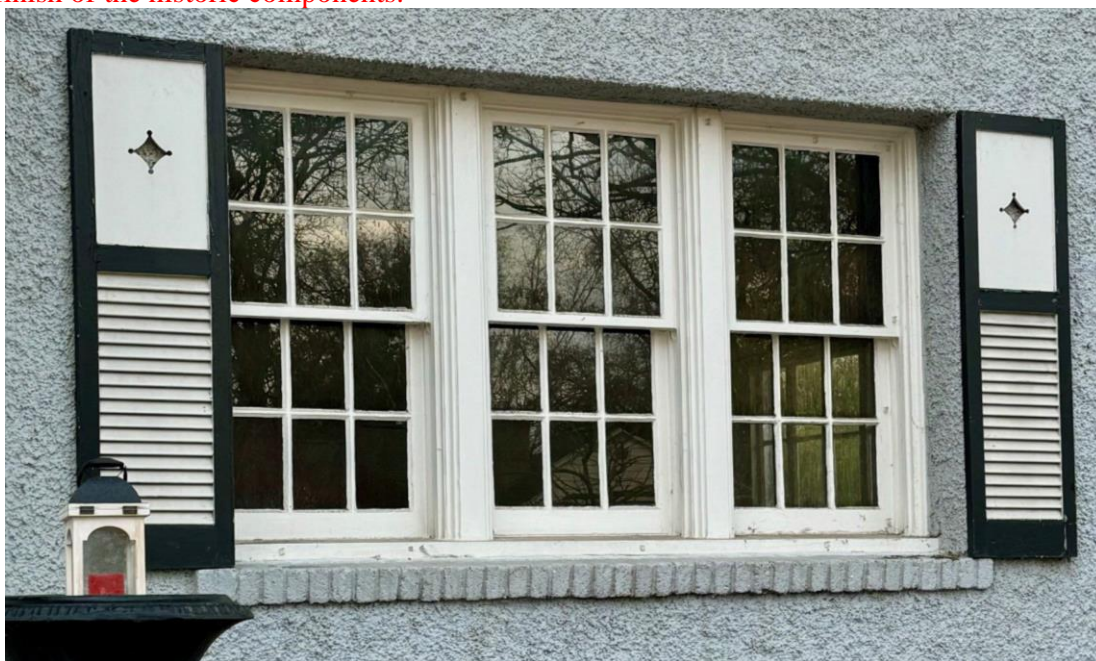
Staff photo, November 26, 2024.

The window openings are distinctive character-defining features, and the trim/brickmould, mullions and subsills are the most forward-facing and visible components of the window openings. Staff wasn't provided with a section or dimensioned photograph of the existing features, so it isn't clear if the proposed aluminum designs can match the existing in profiles due to extruding and/or structural limitations of aluminum coil stock. Therefore, it is staff's opinion that these exterior-facing elements must be fabricated from wood and painted so that the window openings retain the dimensions, pattern/profile and surface finish of the historic components.

- Additional information is needed related to the existing windows and trim and proposed replacement products and shall be submitted to staff for review before final approval can be granted.
 - Exterior photo of each wall with window openings numbered to match submitted window order.
 - Dimensions of existing window sash – bottom rail, meeting rail, top rail, stile, and muntin.
 - Dimensioned window sections of selected replacement window for comparison to historic windows.
 - Close-up photo and dimensions of existing brickmould, mullions and subsills for comparison to proposed replacement components. These components will be fabricated from wood and painted to match the new window frames.
