STAFF REPORT: DECEMBER 11, 2024 MEETING

APPLICATION NUMBER: HDC2024-00570

ADDRESS: 751 CHICAGO BOULEVARD

SCOPE: REPLACE FRONT DOOR AND TRANSOM

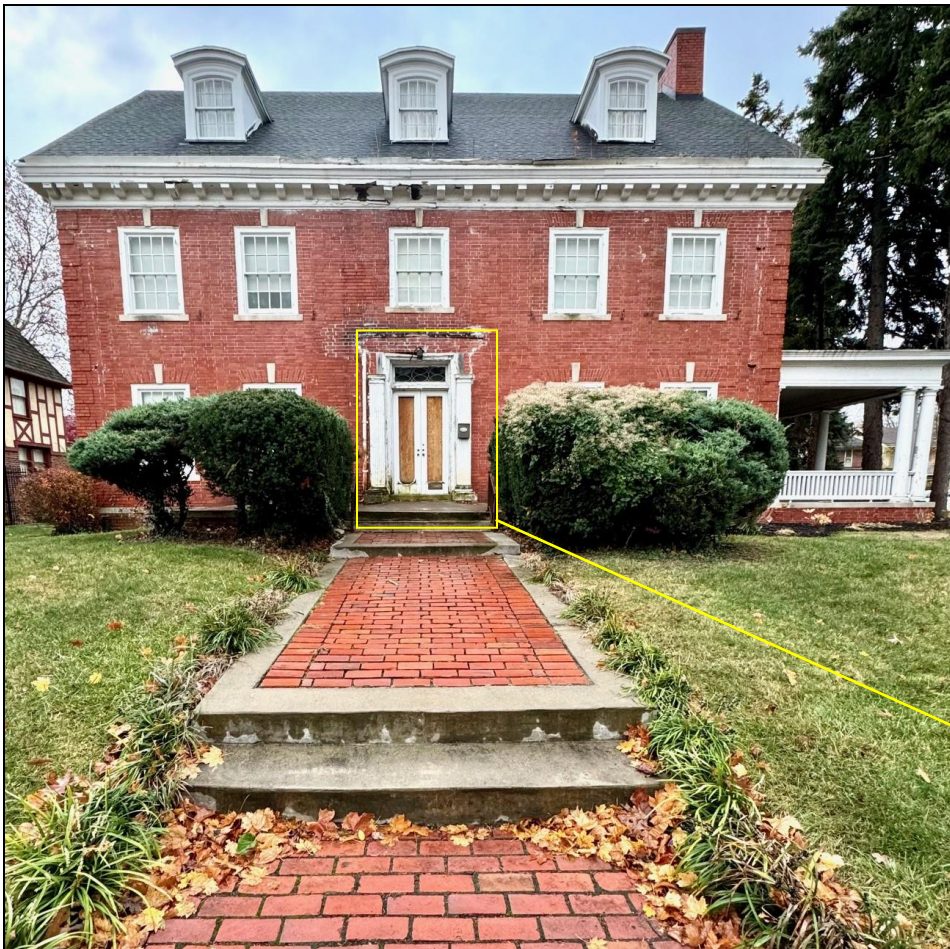
Façade facing Chicago Boulevard.

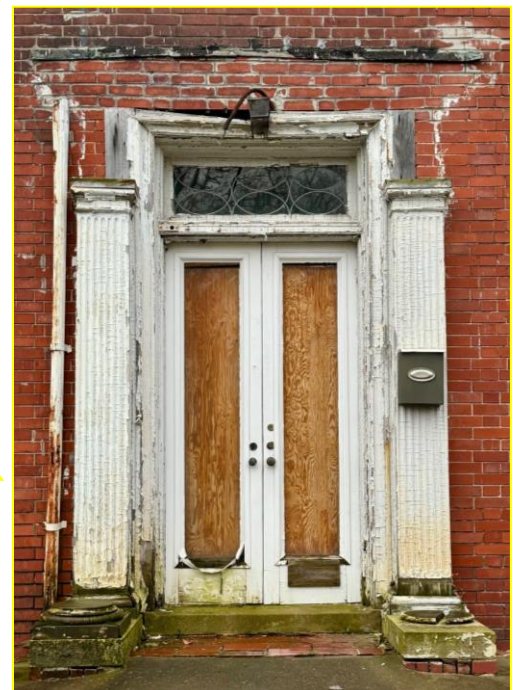
A brick walkway bisects the front lawn and features multiple steps at varying points that lead to a wide concrete landing. Fluted pilasters flank the French door and leaded glass transom. Missing from the façade is the projecting entry surround. The entablature is evidenced by ghost lines on the masonry wall and extending stone bases hold remnants of round wood columns.

Close view of remaining front entry details.

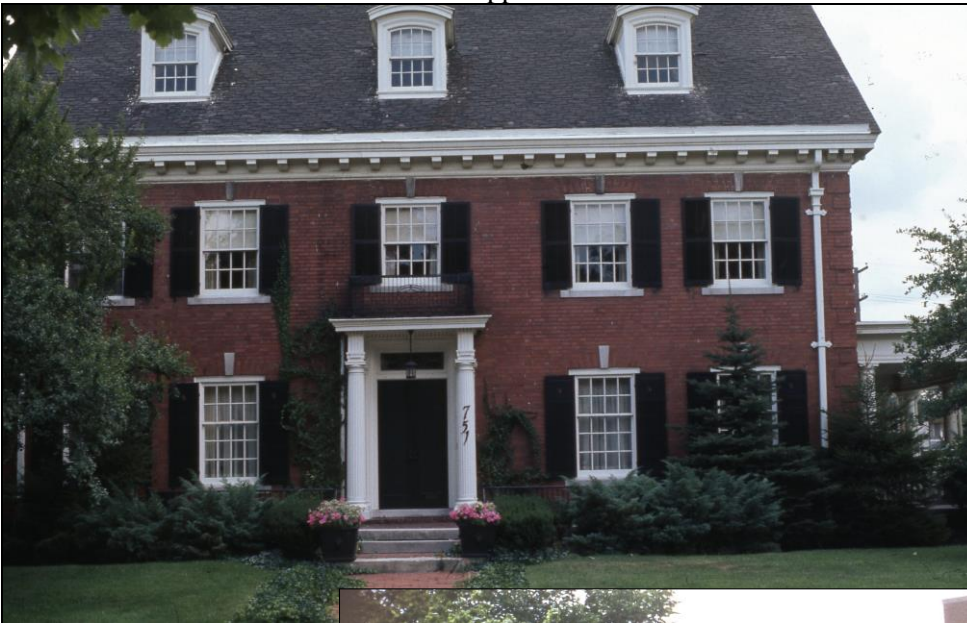
- The 1974 designation photos show architectural components that are now missing, including the entry portico with iron railing at second floor, window shutters, and downspout collector boxes. According to staff's research, these components were removed without Historic District Commission approval and are violations that must be addressed in a future application.

Designation photos, 1974, HDAB.

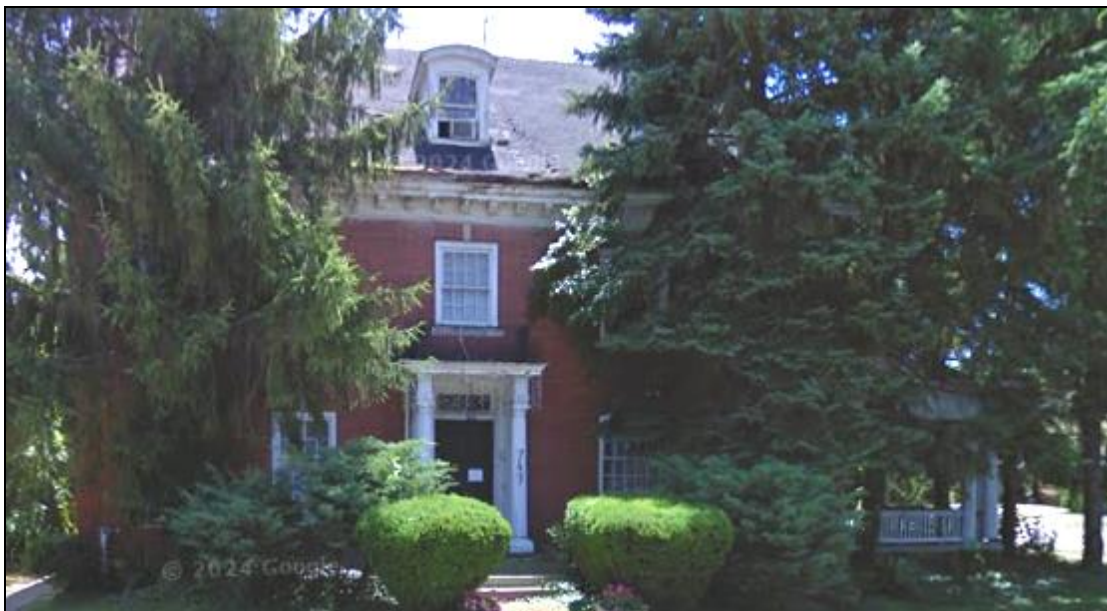
This 2009 Google street view image shows the evergreen trees dwarfing the house. Their proximity to the house coupled with deferred maintenance, exacerbated deterioration to some portions of the façade's eaves, soffits and brackets.

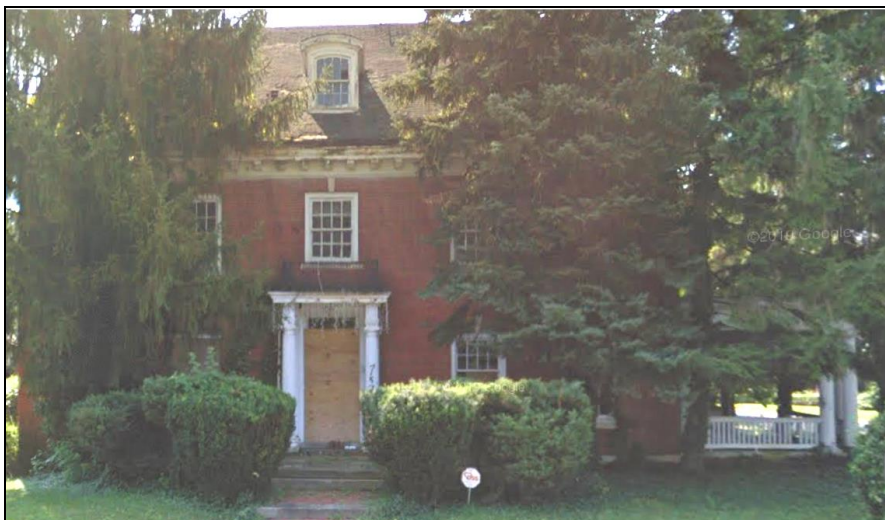
The last documentation of the intact portico is this 2013 Google street view.

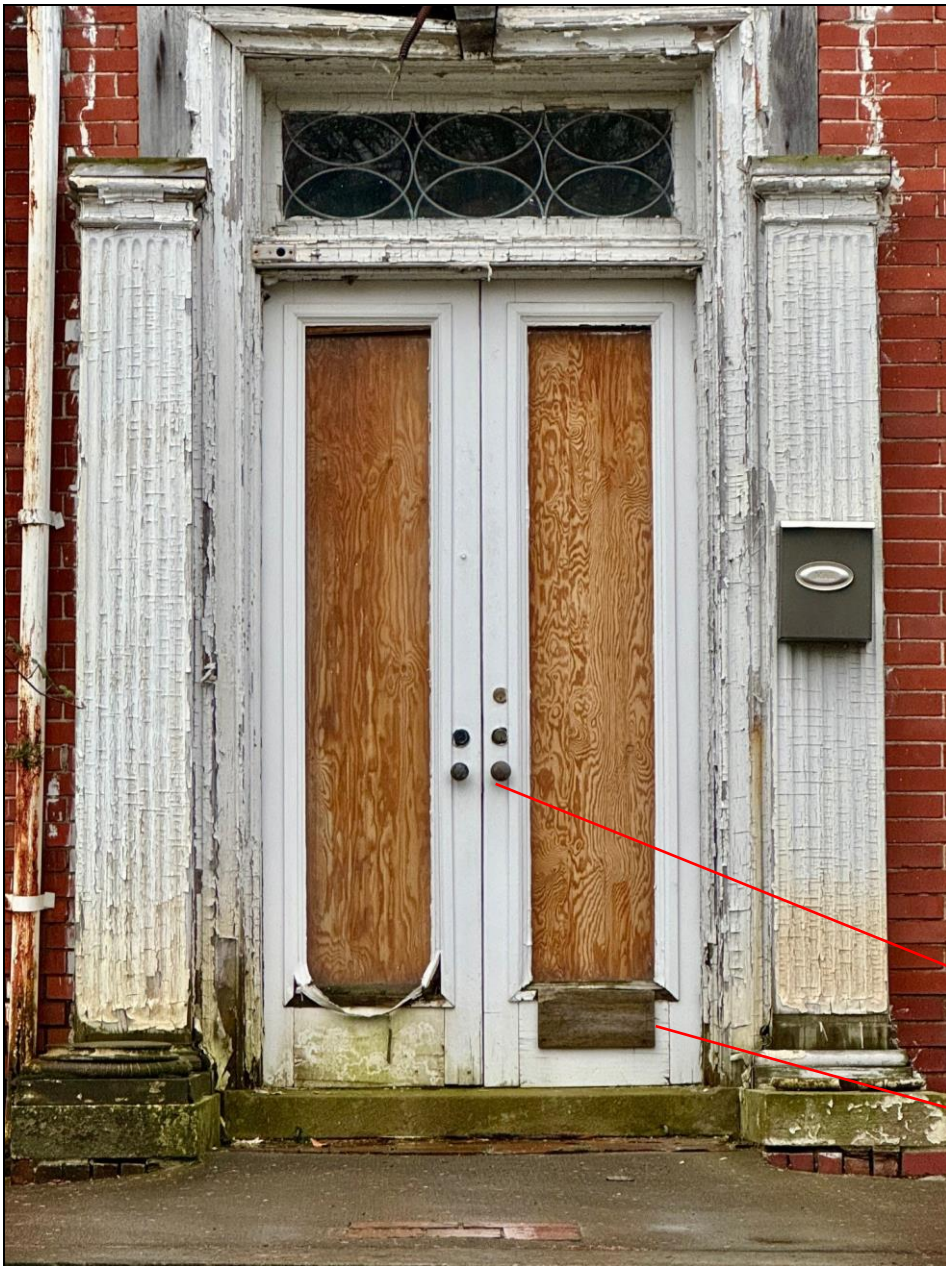
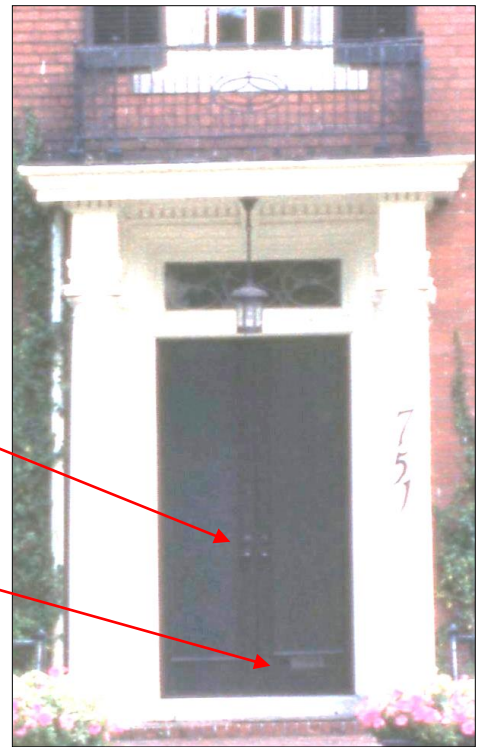
Staff lightened up the 1974 designation photo to gain definition to the entrance doors. The door handles and locks are visible, as is the mail slot at the bottom of the right-side door. It is staff's opinion wood panels covered, or had replaced, some type of glass inserts.

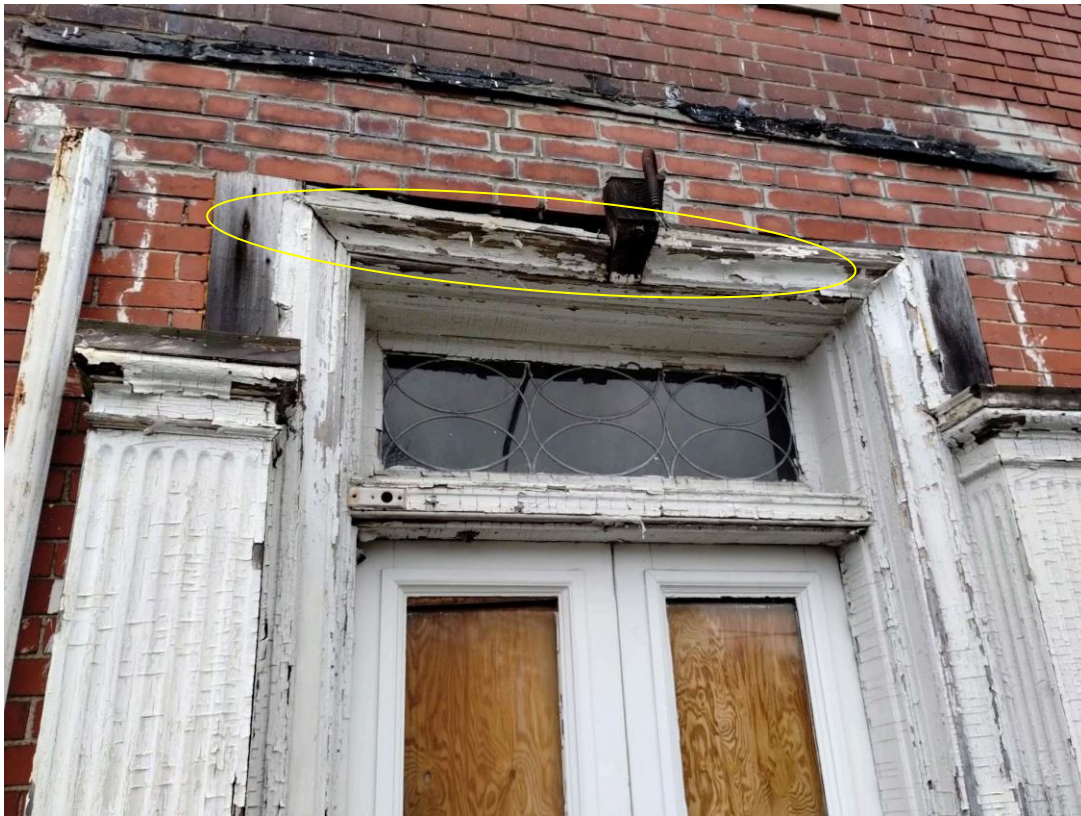
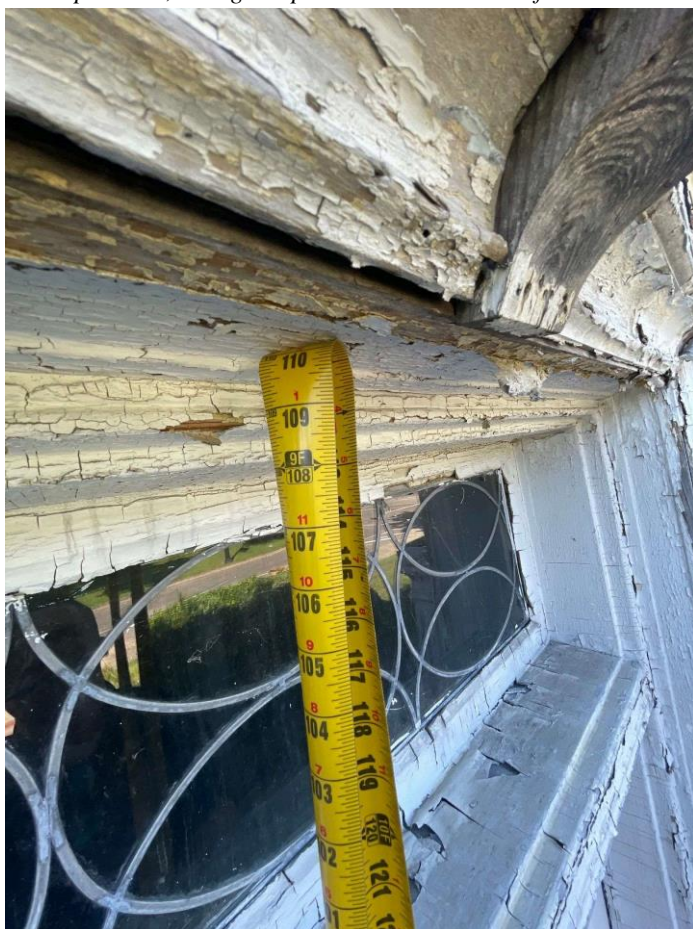
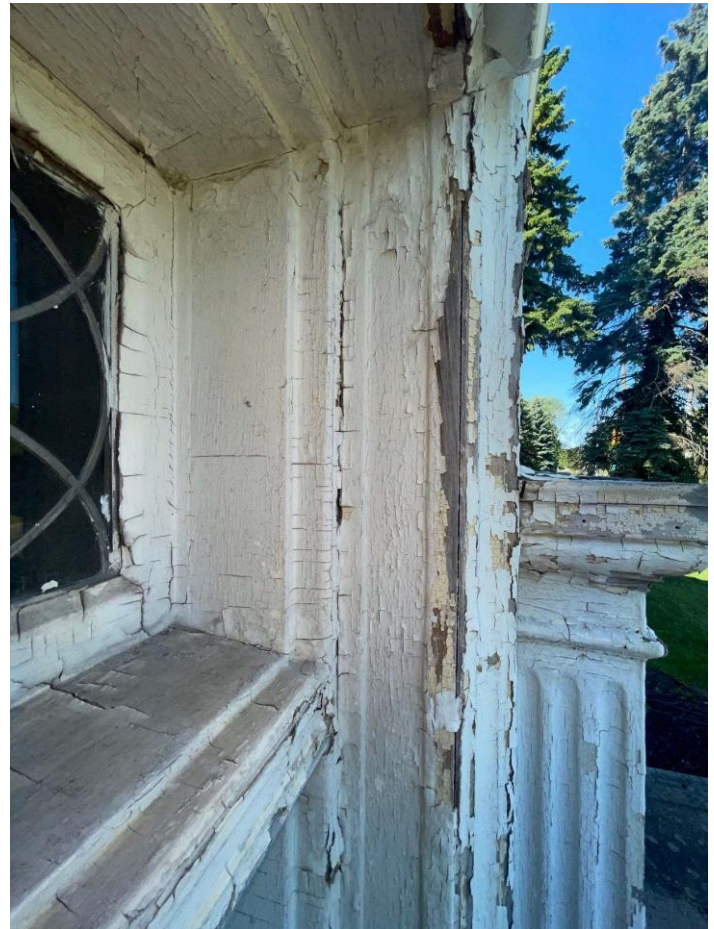
- It is staff's opinion that the existing French doors and transom are historic-age and are distinctive character-defining features within the larger highly detailed entry portico.
- The applicant is not aware if the owner obtained a repair estimate for the doors and window. Staff made multiple requests to the applicant that they submit details on why it is stated that the current door is beyond repair.

Applicant photographs. The entire entry surround requires repair and repainting, and that missing elements be fabricated and installed. For this application's scope of work, the transom window (glass and lead cames) and French doors are intact and repairable; new glass panels can be ordered for the doors.

- The French doors and leaded glass transom are character-defining features, and the applicant has not provided information to support that they are beyond repair. Therefore, replacement products should not be considered at this time. Additionally, when windows and doors are beyond repair, the Standards require that the new components must match the old in design, dimension, and operation.

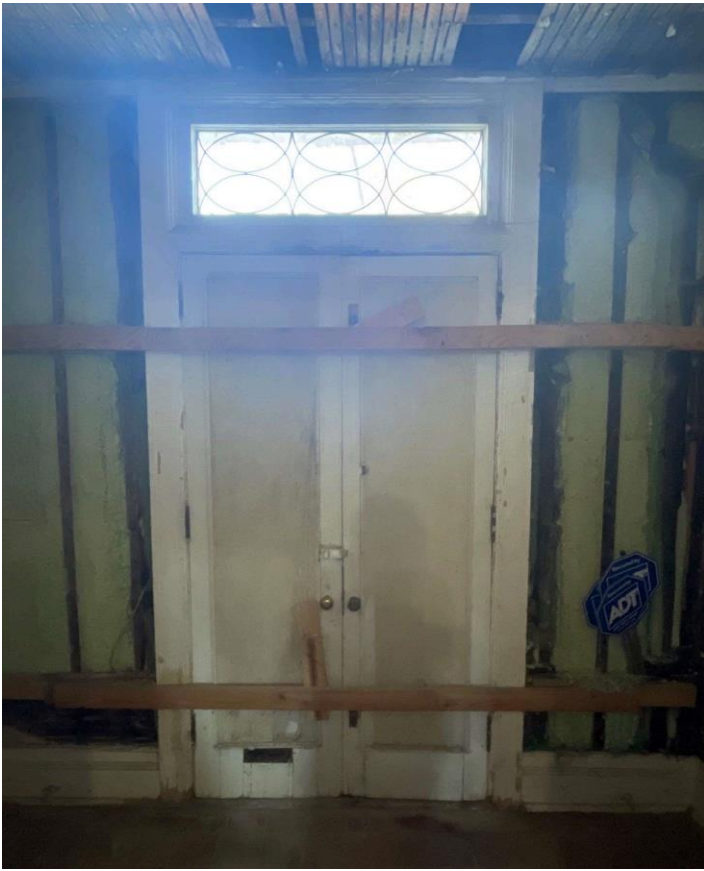
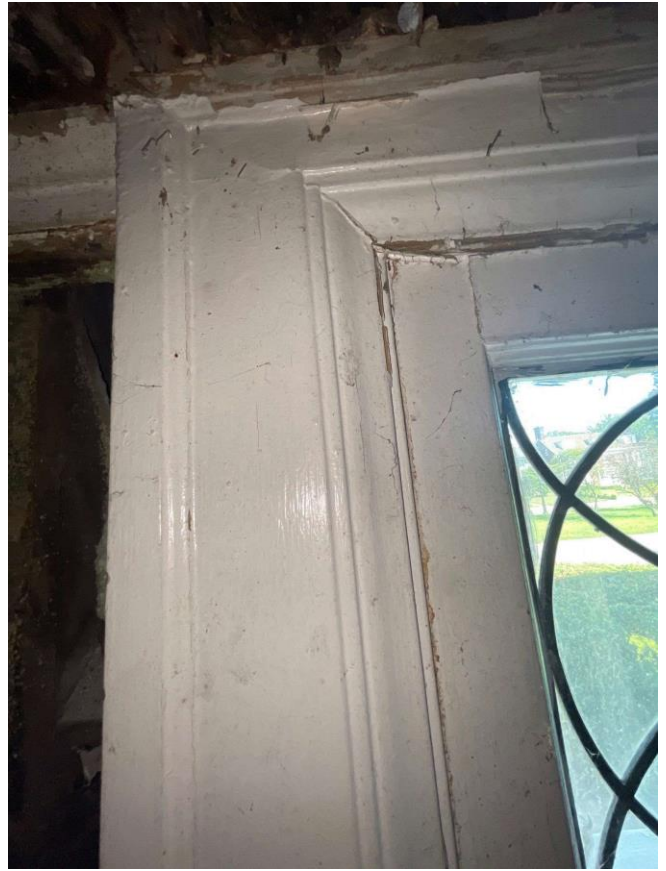
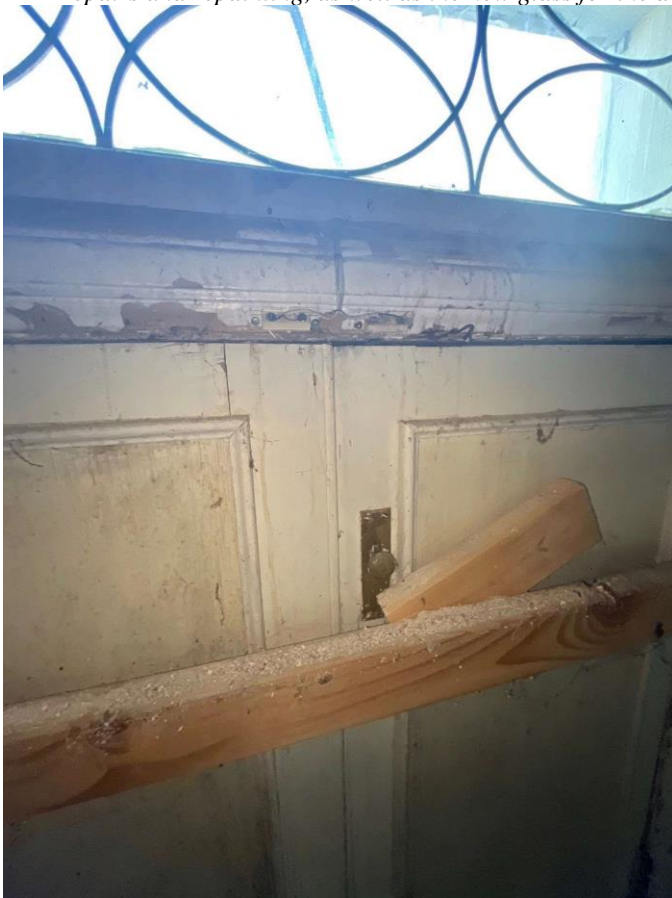
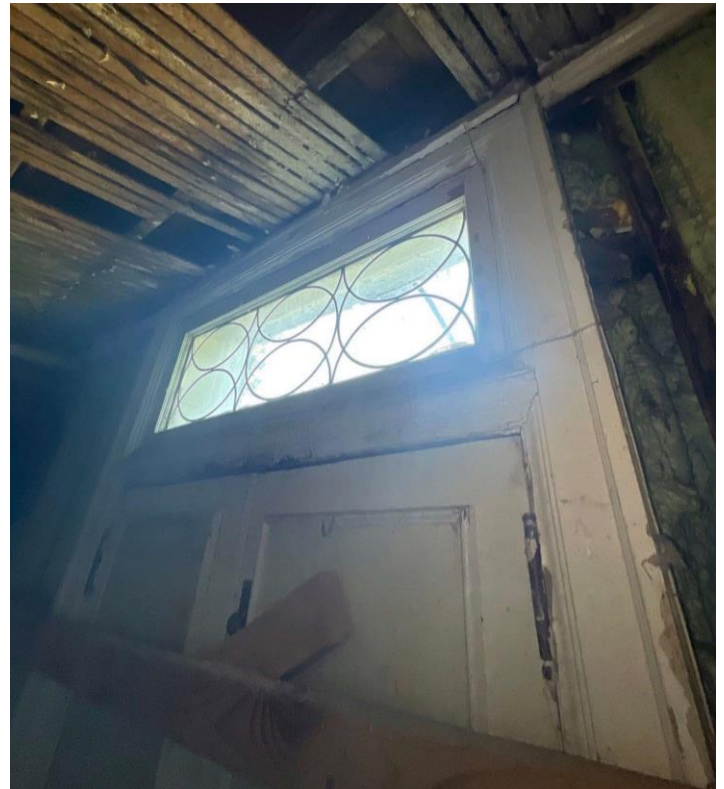
Applicant photographs. The interior framing understandably exhibits less weathering than the exterior, and only requires spot repairs and repainting, as well as the new glass for the doors.
