ADDRESS: 4071 LESLIE**APPLICATION NO: HDC2025-00014****HISTORIC DISTRICT: RUSSELL WOODS-SULLIVAN****APPLICANT/CONTRACTOR: ALEXANDER BELILOVESKY/ALEXANDRIA
MANAGEMENT****OWNER: DARIN BARNES****DATE OF STAFF SITE VISIT: 2/25/2025****DATE OF PROVISIONALLY COMPLETE APPLICATION: 02/18/2025****SCOPE: REPLACE STEEL CASEMENT WINDOWS****EXISTING CONDITIONS**

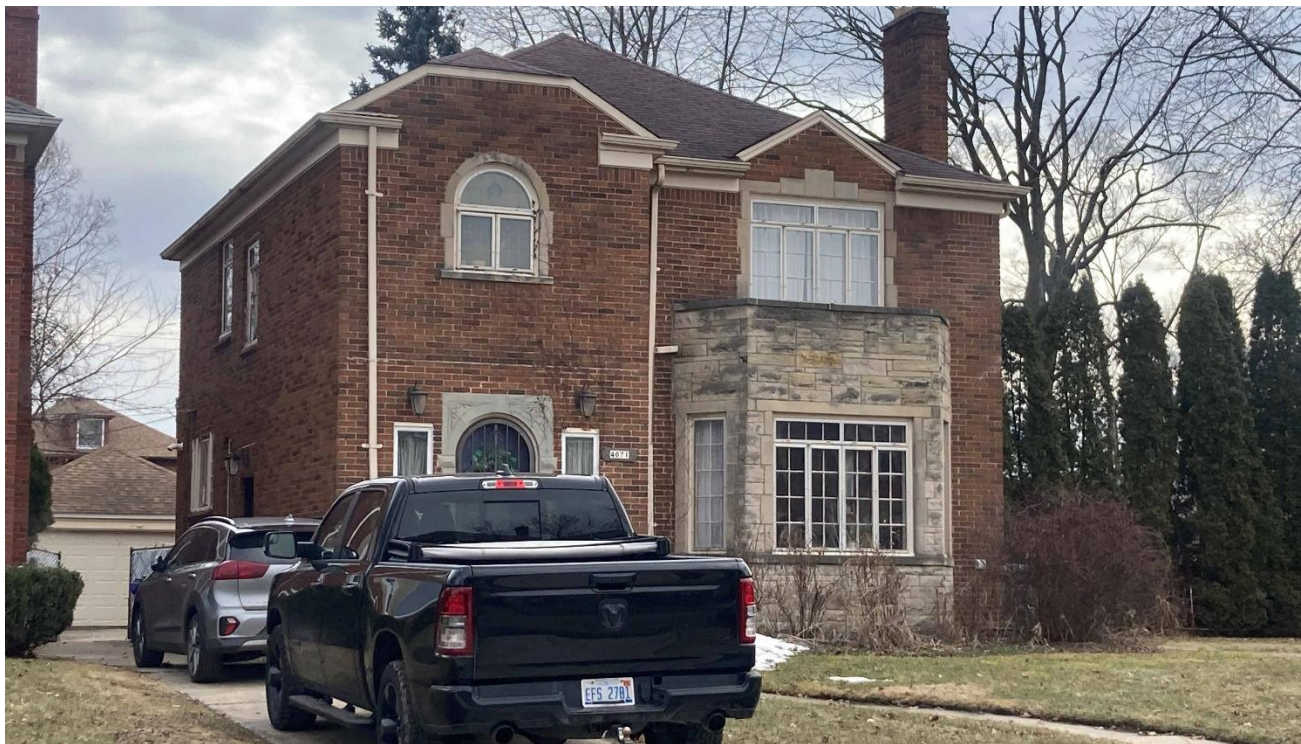
4071 Leslie, current conditions. Photo by staff 2/25/2025

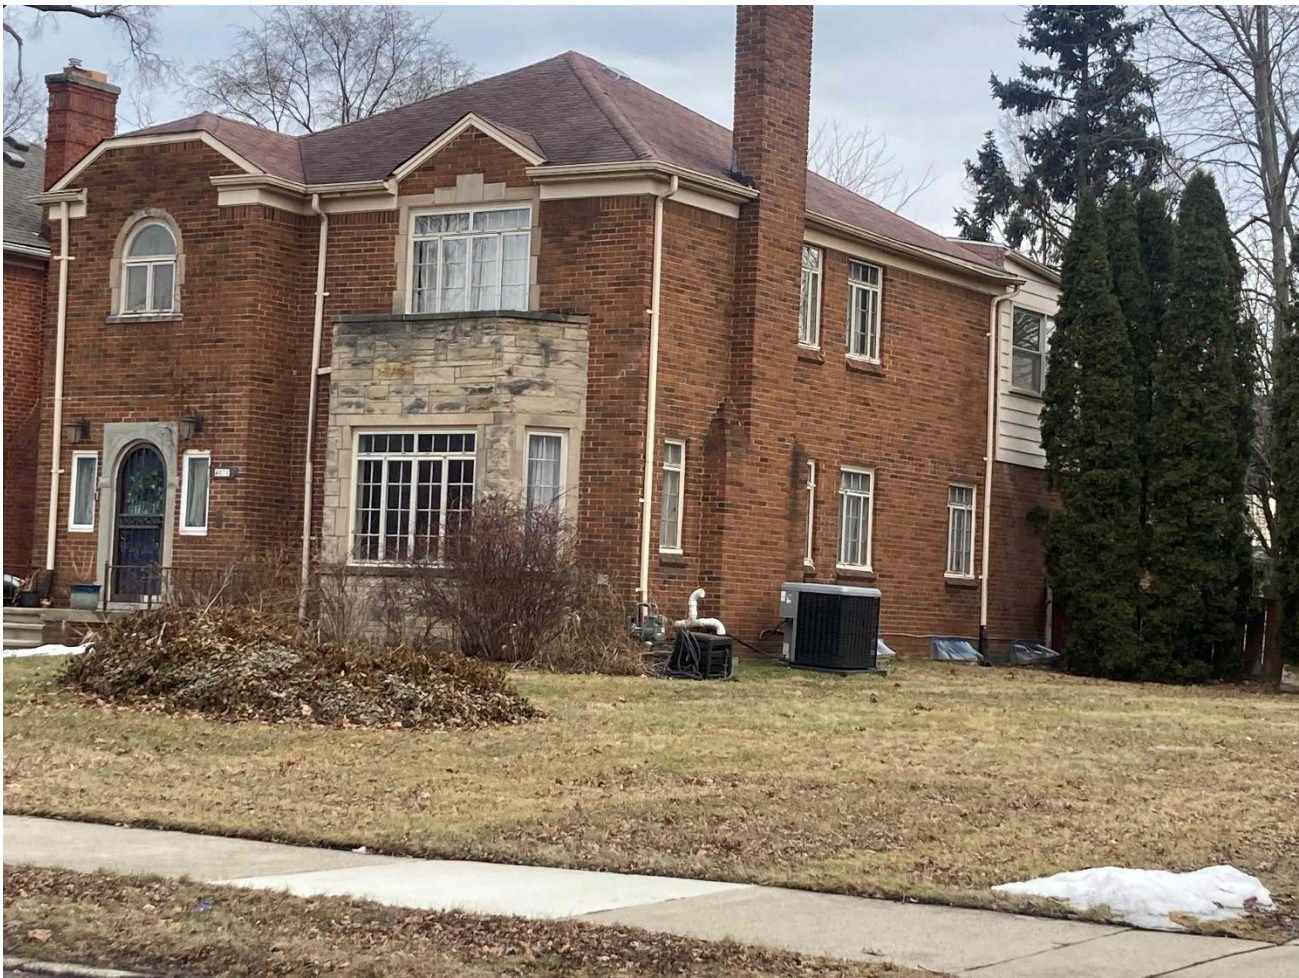
4071 Leslie, current conditions. Photo by staff 2/25/2025

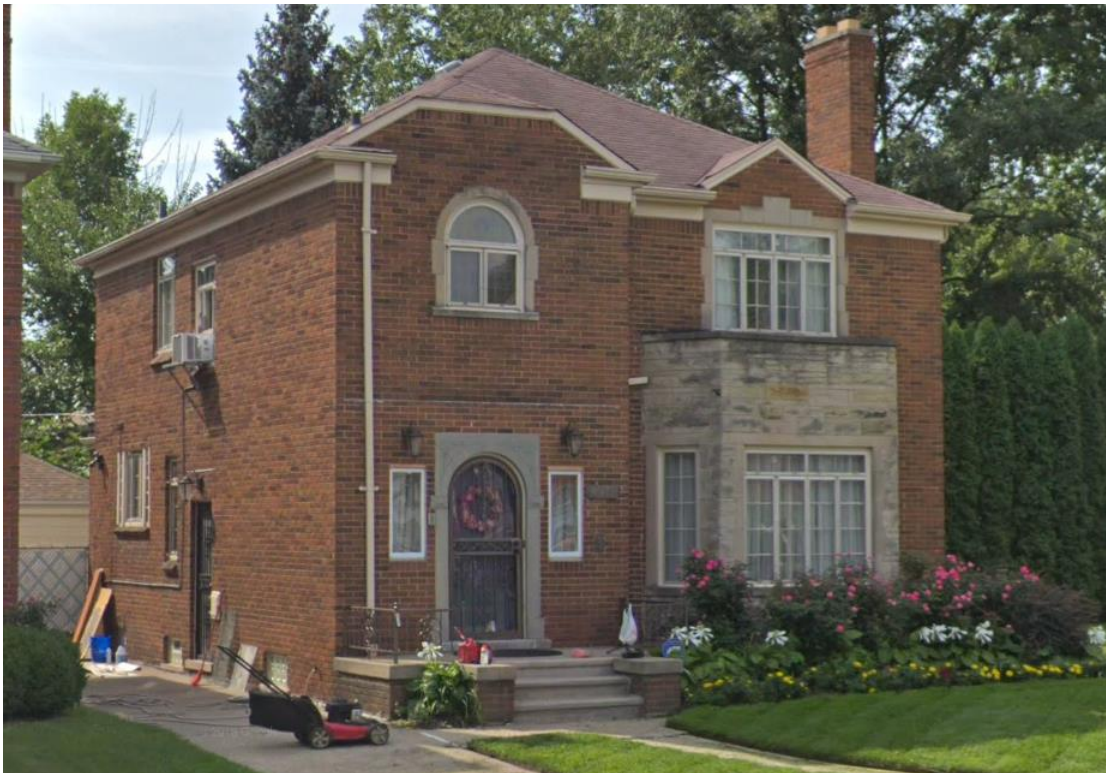
Google Streetview image from 2018. Note that the glass block windows that flanked the front door at the time of designation have now been replaced with fixed vinyl units. Also, the 1967 awnings have been removed and the foundation planting which were present at the time of designation are no longer present

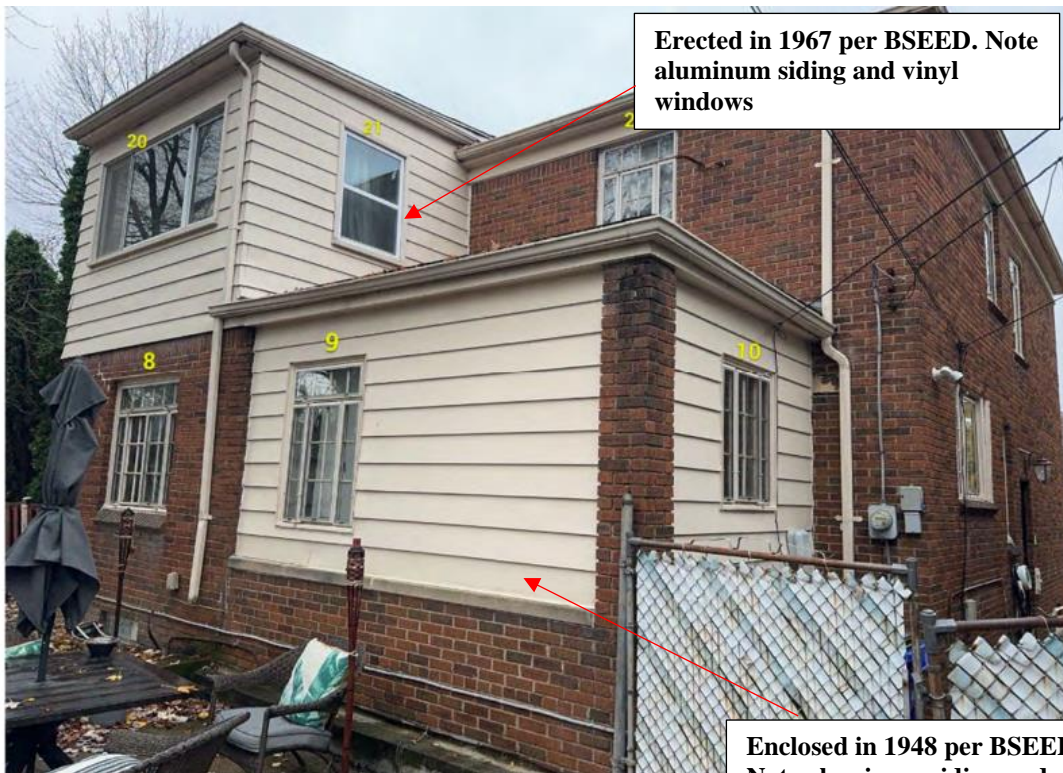
- The building has two rear enclosed porches (see the below photo). As noted above, the lower/first story porch was enclosed in 1948, during the district's period of significance. Building department records indicate that the rear second story sunporch was built in 1967. Both porches are currently clad with aluminum siding. The application proposes to replace this siding with cement fiber siding. Staff notes the following with respect to this scope item:

- The first-story rear porch was enclosed during the district's period of significance and remains as a character-defining feature of the house. As the current aluminum siding was installed ca. 1980, it is not clear to staff if historic siding remains underneath. Note that the first-story rear porch enclosure displays steel casement windows which hint that it is possible that historic siding remains beneath the current aluminum siding. Therefore, staff recommends that enough of the current aluminum siding be removed to determine if historic age, character-defining siding remains underneath. If historic siding does remain underneath the aluminum siding at the rear first story enclosed porch, it should be retained and repaired. If historic siding remains beneath the aluminum siding, but is deteriorated beyond repair, it should be replicated per the Standards. If no historic siding remains beneath the existing aluminum siding, then new siding which is compatible with the building's historic character should be installed. In this case, it is staff's opinion that wood siding (either lapped horizontal or shake) would be the most appropriate cladding if no historic siding remains underneath the current aluminum siding. Wood siding is readily available and, per the above-referenced Elements of Design, is commonly found in combination with brick siding within the district. Fiber cement is not recommended for this application because it is not as thick as traditional wood siding and therefore cannot provide the same deep shadow line that wood offers. The Standards prioritize replacement in-kind for character-defining features, when reasonable.

- As the second story porch was erected in 1967, after the district's period of significance, any siding that remains beneath the current aluminum siding would not be considered to be character defining/historically significant. Therefore, it can be removed and replaced as long as the new siding is compatible with the building's historic character. Again, wood siding (either lapped horizontal or shake) would be the most appropriate cladding for this location as it is readily available and, per the above-referenced Elements of Design, is commonly found in combination with brick siding within the district.

Rear, current conditions. Photo provided by applicant

- The current aluminum siding at the rear first-story enclosed porch shall be removed to an extent necessary to determine if historic age, character-defining siding remains underneath. Photos of

the conditions underneath the aluminum siding shall be submitted to HDC for review prior to any additional work at the rear porches. If historic siding does remain underneath the aluminum siding at the rear first story enclosed porch, it shall be retained and repaired. If historic siding remains beneath the aluminum siding at the first story enclosed porch, but is deteriorated beyond repair, it shall be replicated. If no historic siding remains beneath the existing aluminum siding, then new wood siding (either lapped horizontal or shake) shall be installed at the first story, enclosed porch.

- Cement fiber siding shall not be installed at the second story rear enclosed porch. Rather, wood siding (either lapped horizontal or shake) shall be installed, subject to HDC staff review and approval.

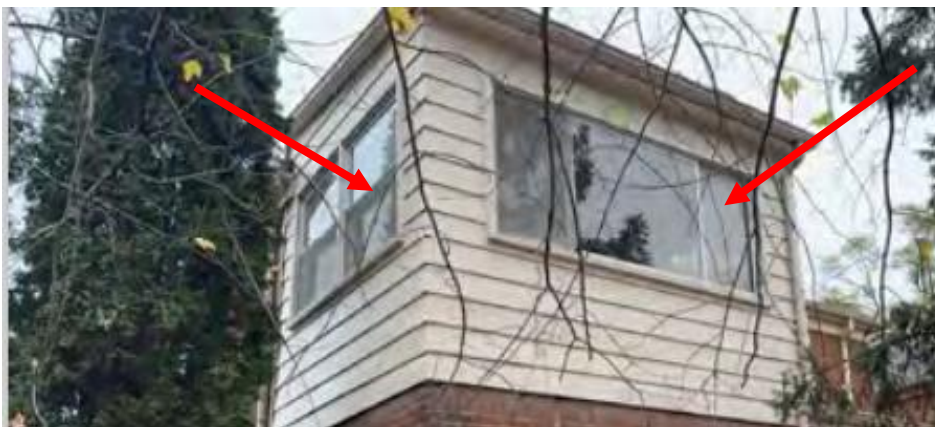
Rear second story porch, erected in 1967. Vinyl windows proposed for replacement with aluminum-clad wood units, indicated by arrows. Photo by applicant

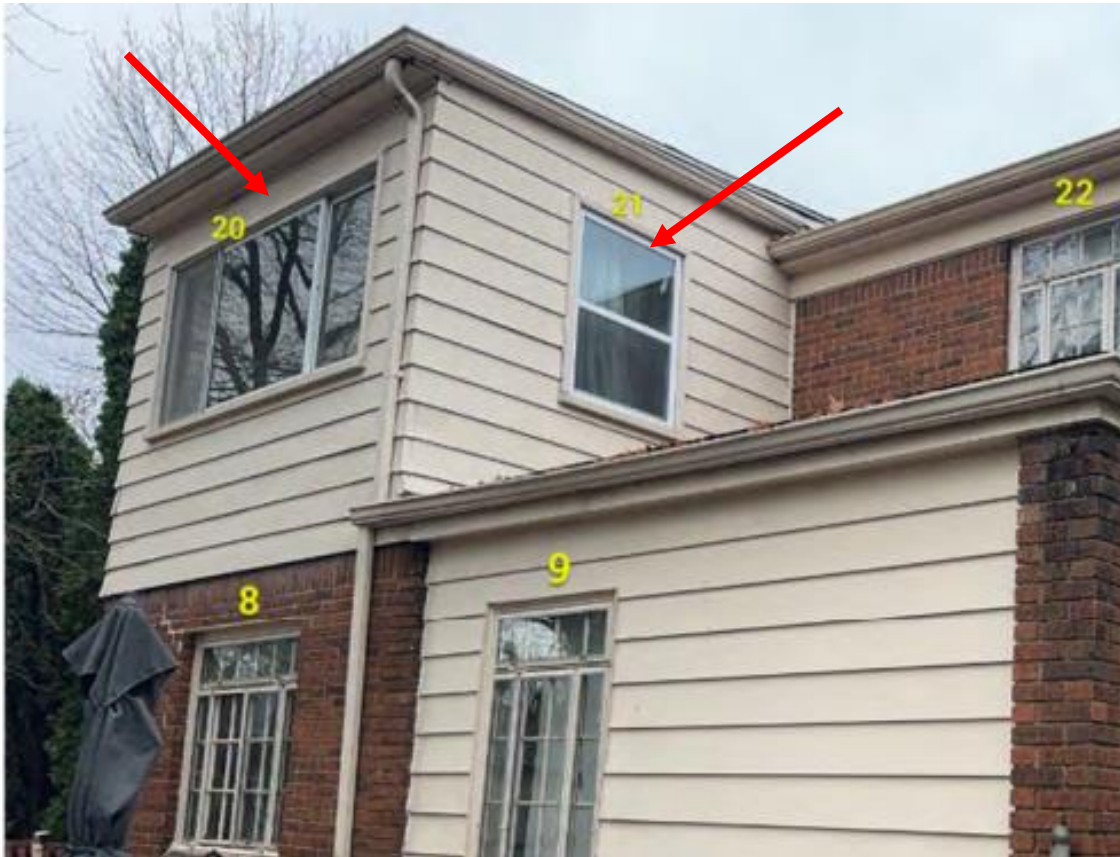
Rear second story porch, erected in 1967. Vinyl windows proposed for replacement with aluminum-clad wood units, indicated by arrows. Photo by applicant

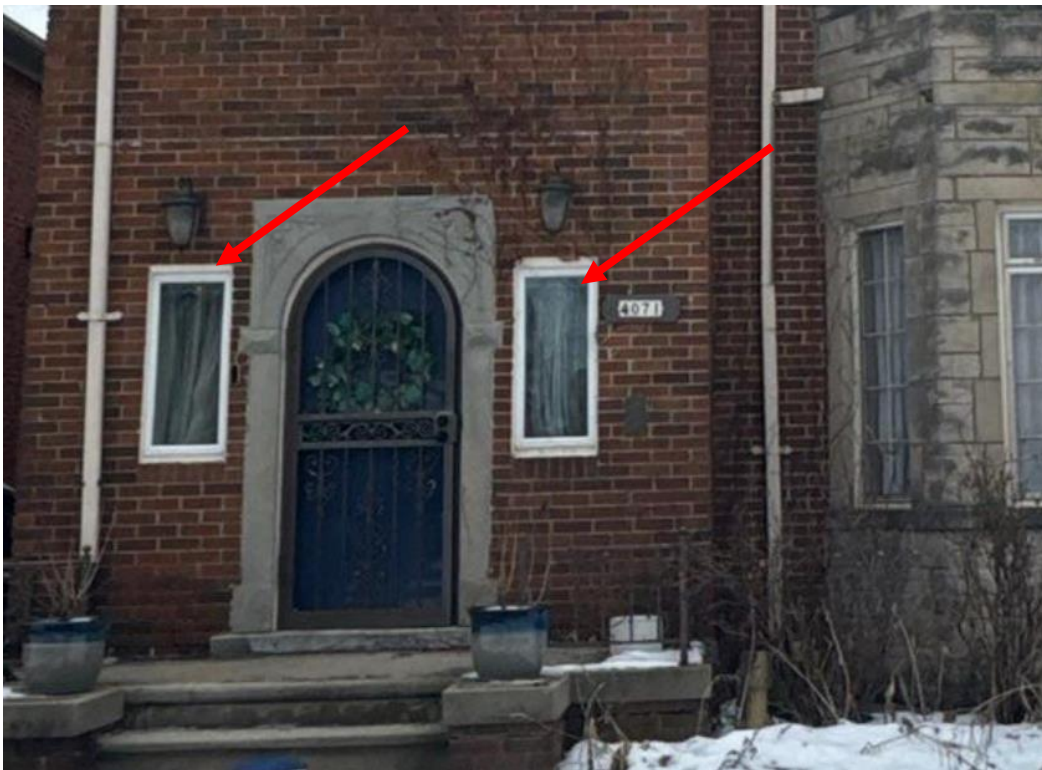
Front façade vinyl windows added ca. 2013. Proposed for replacement with aluminum-clad wood units, indicated by arrows. Photo by applicant

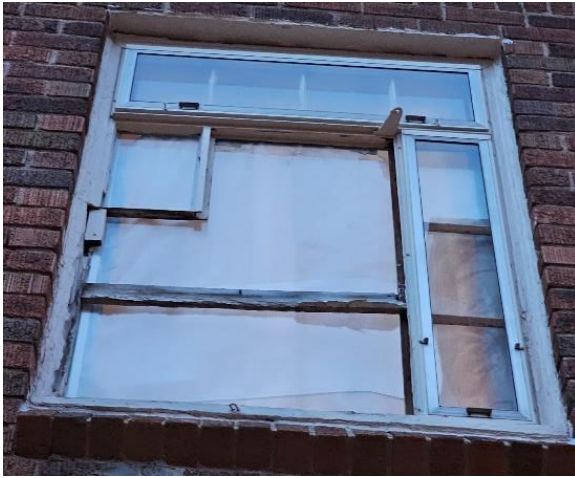
- Please note that the Commission approved the replacement of these six windows in 2023. As the existing non-historic windows are not distinctive character-defining features, the one (1) steel window at the east side wall, second story, has been heavily altered/compromised beyond repair to an extent that it has lost its historic integrity, and the new windows which will replace these six (6) units will have an operation and lite configuration that is compatible with the existing steel casement units, staff supports their replacement per the current proposal. See the below photos of the non-historic vinyl units and single heavily altered steel window at the east side wall, second story which are proposed for replacement with new aluminum-clad wood units

Window at the side/east façade, second story. This window has been compromised to the extent that it no longer retains its historic integrity and thus can be replaced with a new compatible window, in staff opinion. All remaining steel windows appear to be in repairable condition. Photo by staff, 2023
