Job Name: Fowler Building

Job Location: Detroit, MI

Historic Window Site Review:

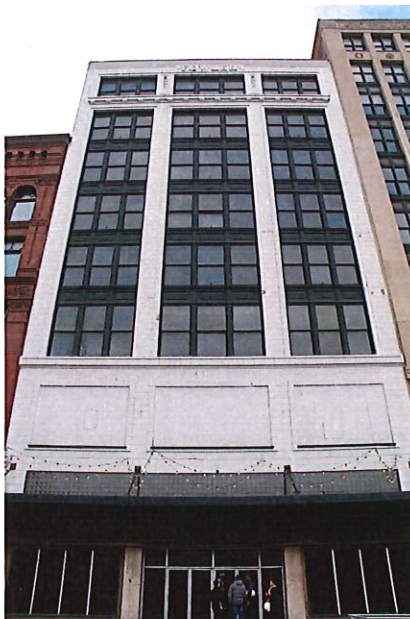
The windows are in very poor condition including sashes, parting bead, and interior sash trim. The master frames and sills are in good condition. We observed all the exterior components including the sill, blind stop, mullions, and all exterior millwork

Fowler Building
Front Façade
Wood Double Hung Windows

Recommendation: BlackBerry recommends the scope of work should replace the double hung sashes with new historic replica sashes that are aluminum clad on the exterior and wood on the interior. In our investigation we have found a manufacturer that has such a product used on a recent landmark project. Because of the sash size and profiles this type of product is not typically available. Also because of the small number of openings custom extrusions would be cost prohibitive typically. If the leaving of the exterior cladding on the exterior casework including sills, blind stops, mullions, and spandrel panels is acceptable to NPS this suggested approach would be ideal. New sashes can set in place and fixed with the replacement of parting bead and interior sash stop. The new sashes would include insulated glass with low-e/argon. Pricing would include interior and exterior finish. Windows will require lead paint and ACM abatement.

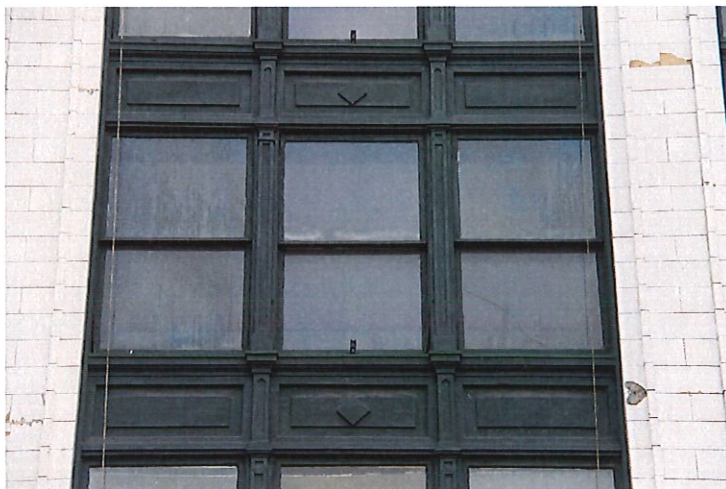
was covered with custom formed break metal (type of metal to be determined). This was carefully executed and appears in very good condition especially in sealing out water penetration. Before a final analysis can be concluded this façade needs to be inspected on the exterior using a lift or swing stage. **The years of disrepair, and exposure to the elements has taken its toll on the sash components. Most all the double hung sashes have failed joinery at the meeting rails or bottom rails. Not maintaining the exterior glazing compound has allowed water to get into the sash rails and stiles causing warping, joinery failure, and decay. We estimate that over 65% have failed joinery that is not repairable.** All sashes need to be fully replaced with a replicated product. We would suspect that all the exterior perimeter caulking will need to be abated for containing asbestos which is common with a building of this age.

Front Façade
Wood Windows and
Cover Casework

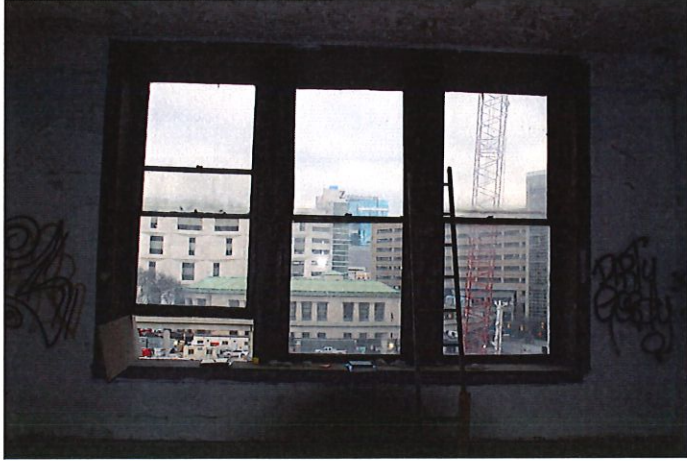
Typical Interior
Wood Double Hung

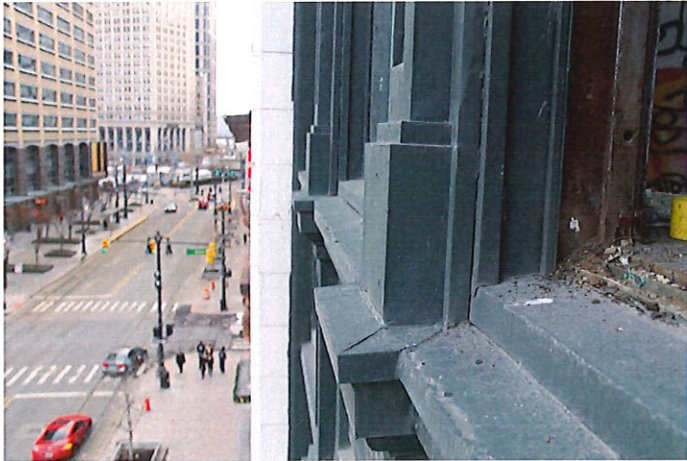
Exterior View of Metal Clad
Casework and Master Frame

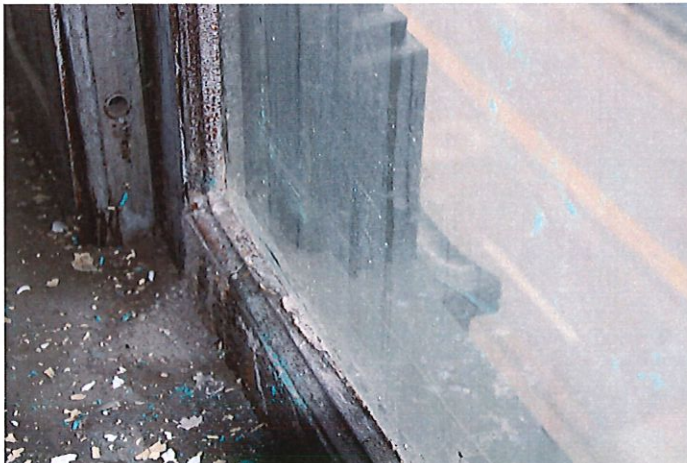
Stool/Sash Detail
Wood Double Hung

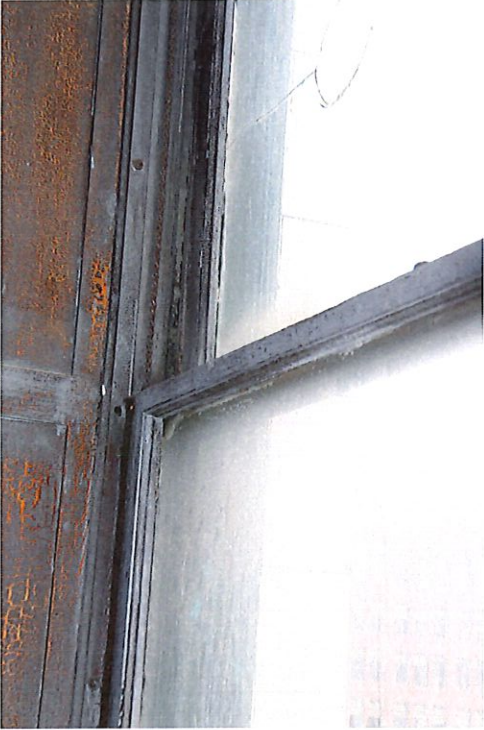
Interior Jamb Detail
Wood Double Hung

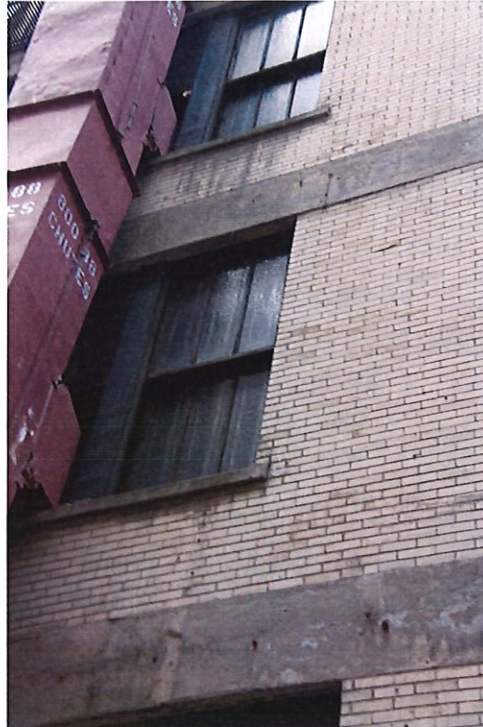
These windows are located on the West Elevation, rear façade on the alley side of the building. The windows are in poor condition with heavy corrosion and rust on all exterior components. Because of water penetration there is joinery failure at the bottom sash rail and meeting and meeting rail. These windows are notoriously difficult to restore since there is no way to arrest the corrosion in the tubular profiles. Even when the exterior surfaces are in good condition the joinery will show rust deposits soon after full restoration. Glazing compound is failed and likely contains asbestos as well as all the perimeter exterior caulking. The sash and frame components mimic wood window in the era. The bottom rail is 4", the typical side rail is 1 3/4" and top rail is 1 3/4"; meeting rail is 1 3/4". The parting bead is 1/2" x 1/2" and sash stop is 1/2" x 1 3/4". Note all window components are galvanized steel. All sashes are 2" thick and have 1/4" clear plate glass. Muntins are 1 1/2", and mullions are approximately 9" but must be checked from the exterior since the window are inoperable. The interior case work is in various states of condition, some is missing, some is damaged, and some is in good shape.

Exterior of Steel
Double Hung

Recommendation: BlackBerry would recommend the full replacement of the cold rolled steel windows with an historic replica thermally broken aluminum single hung window. The entire existing metal frames and sash would be removed and replaced. The following budget price does not include the metal door and transoms. We would need direction as to the design, hardware, and code compliance issues. Windows will require lead paint and ACM abatement.

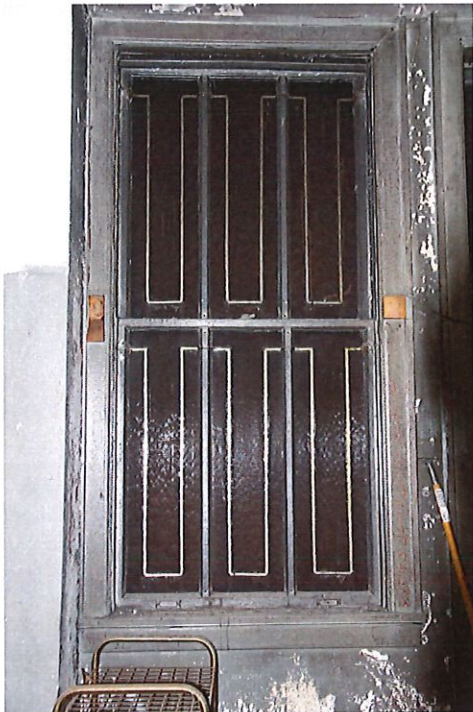
Interior of Steel
Double Hung

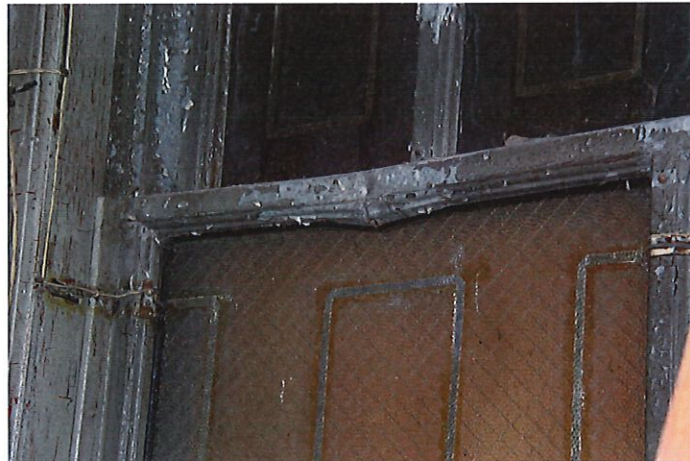
Meeting Rail of Steel
Double Hung
