6/9/2020

Job Name: Fowler Building
Job Location: Detroit, MI

Historic Window Site Review: Addendum 6.9.20

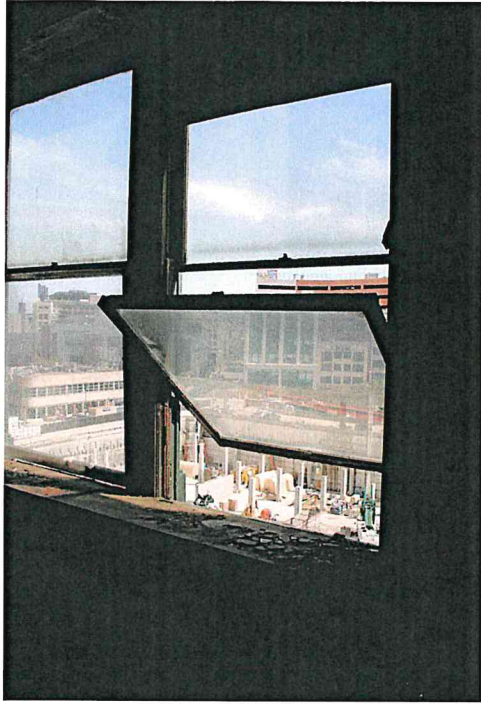
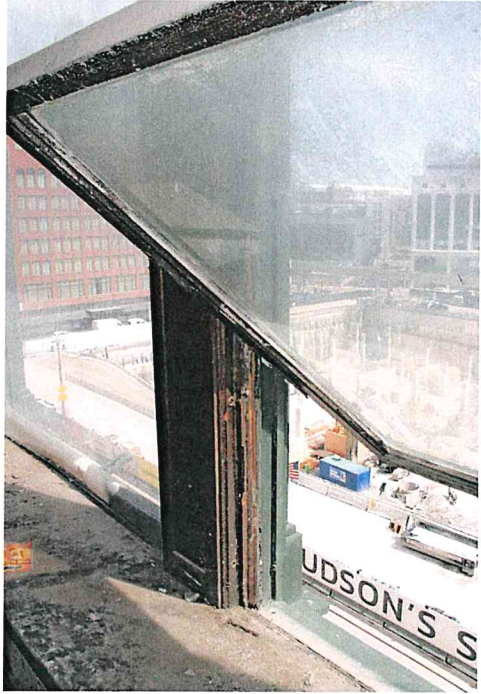
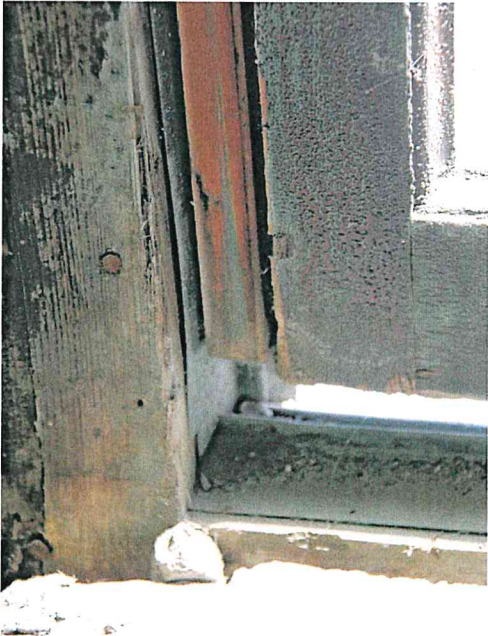
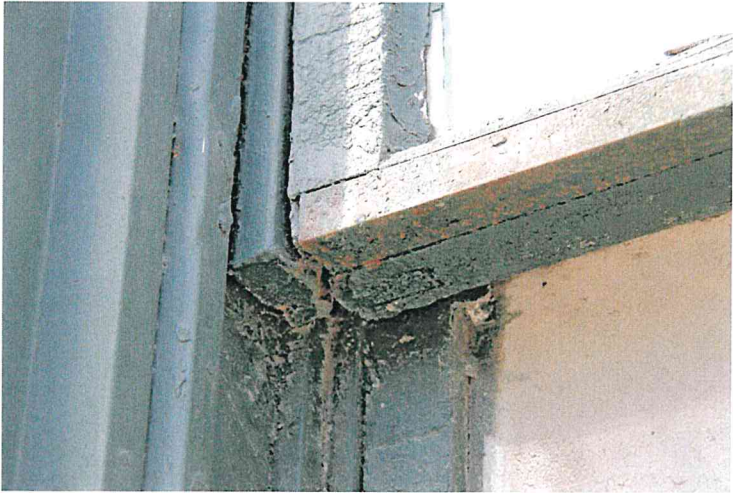
- All wood window sashes are using "Williams Pivot Hardware", this hardware was popular in the 1920's thru 1930's in high rise buildings in major urban areas. The assembly and hardware allowed both the upper and lower sash to

rotate on a horizontal axis to be washed from the interior. All jambs have a split side stile that allows a portion of the sash to separate from main body of the sash, staying in place in the jamb pocket. See Figures 1- 4. From inspection the majority of the upper and lower sashes do not have functioning pivot hardware and the portion of the jambs that stay stationary are broken, split, and not functioning. All these would have to be replaced and no tooling is available nor replacement hardware since the product has not been manufactured since after WWII. The condition really eliminates any option for any sash restoration. Replacement sashes can be manufactured without this feature as proposed and fixed in place to provide a restoration/replication scenario.

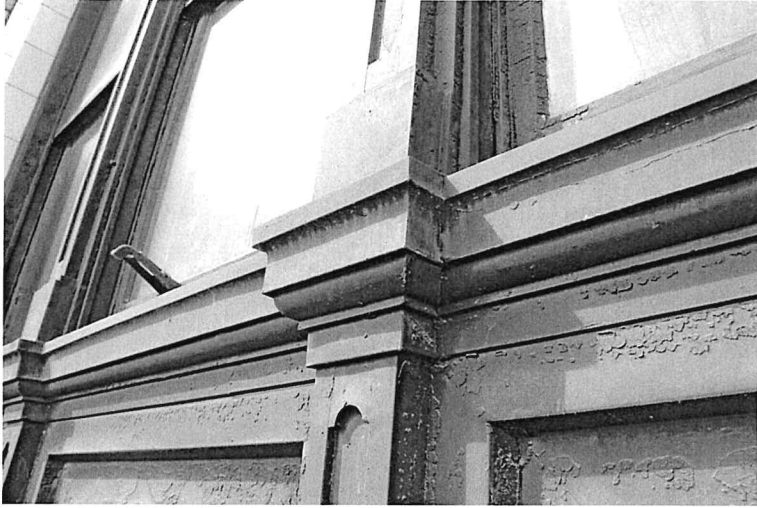
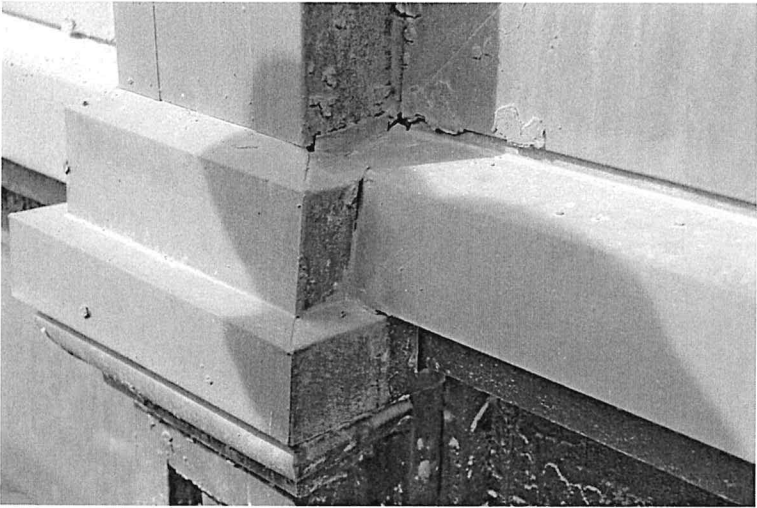
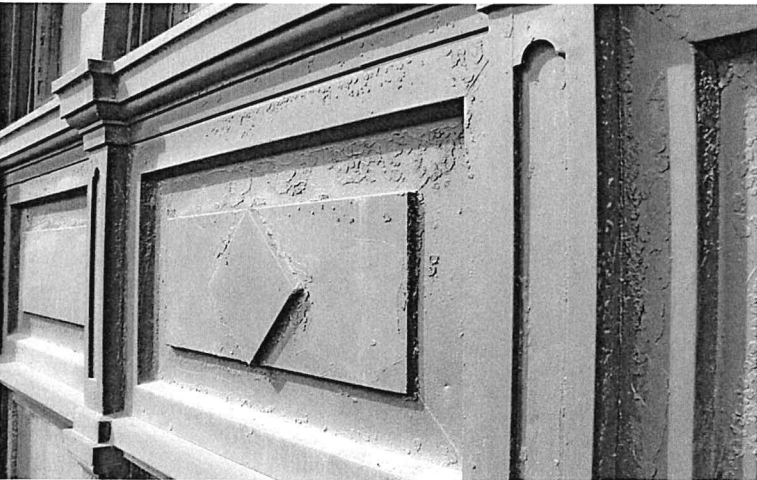
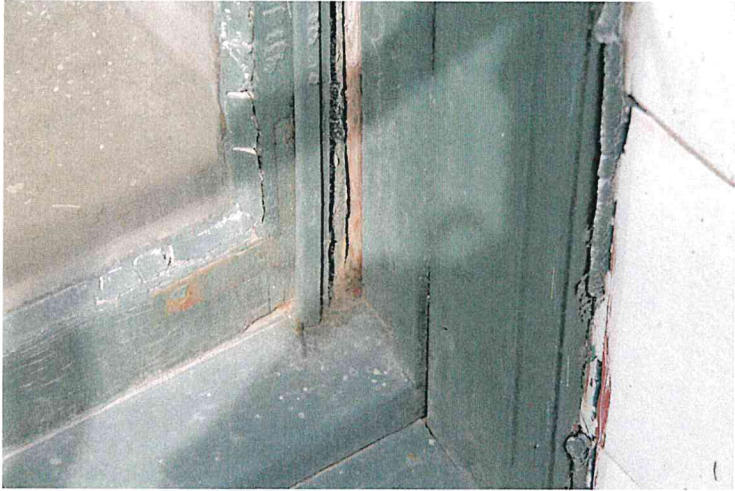
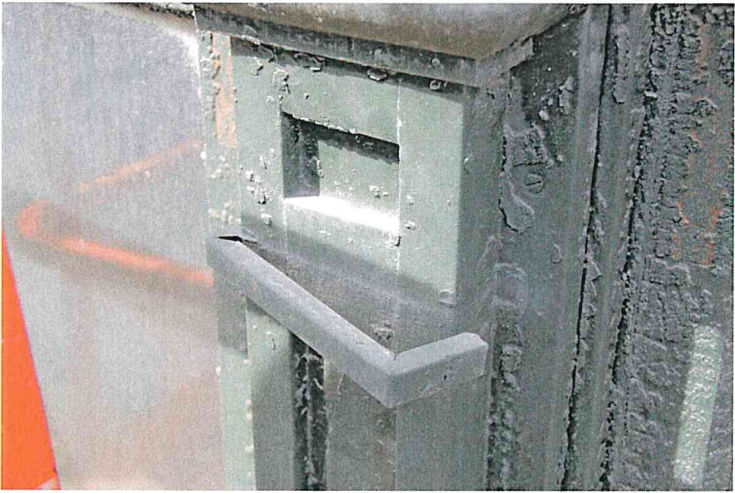
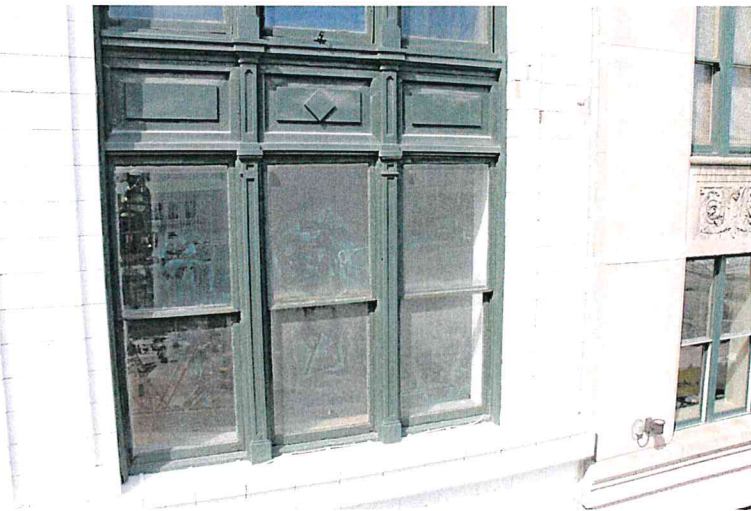
- All sashes are wood, but a unique element to the window design we have documented, is that all other exterior components were originally clad with copper break metal. This includes sills, all exterior ornamental spandrel panels, mullions, blind stops, and parting beads. The material no longer has a patina finish but has been painted green multiple times over the years. Most of the material is in good condition and tightly fit; however, there is some repair work needed to replace some parts in various locations including parting bead, sills, trim components. This will need to be done by a metal façade contractor in coordination with the window work. See Figures 5-10.

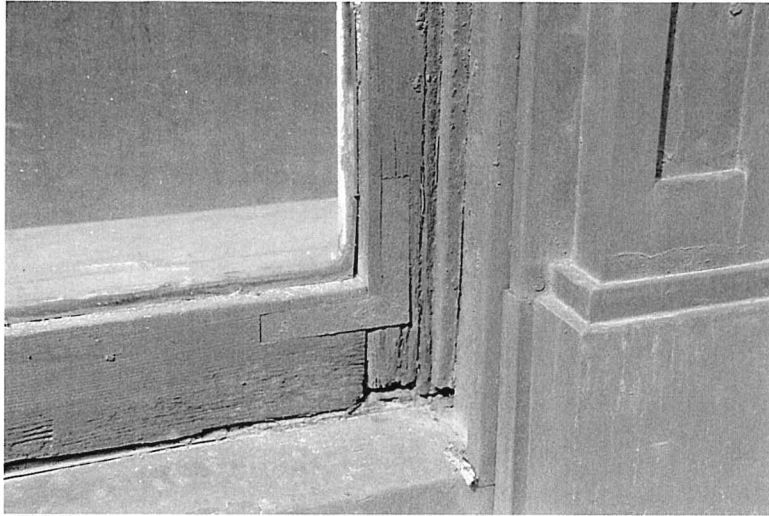
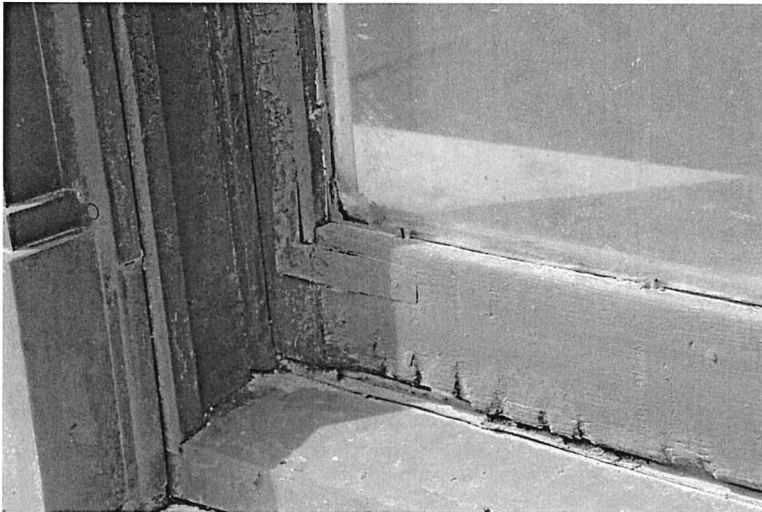
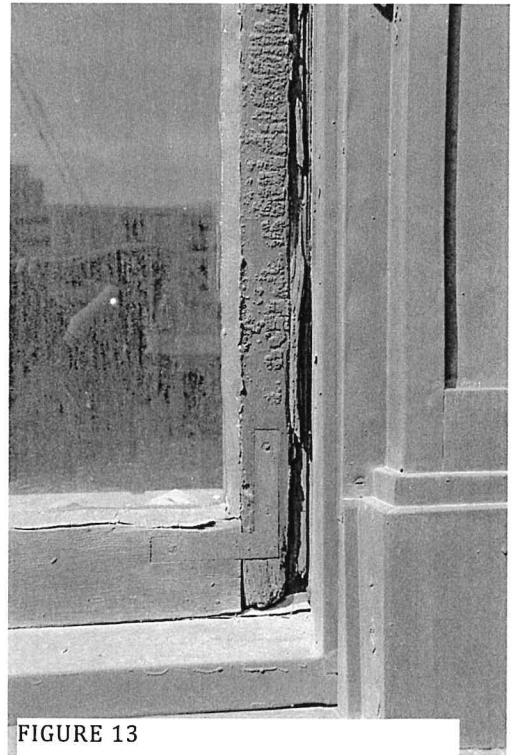
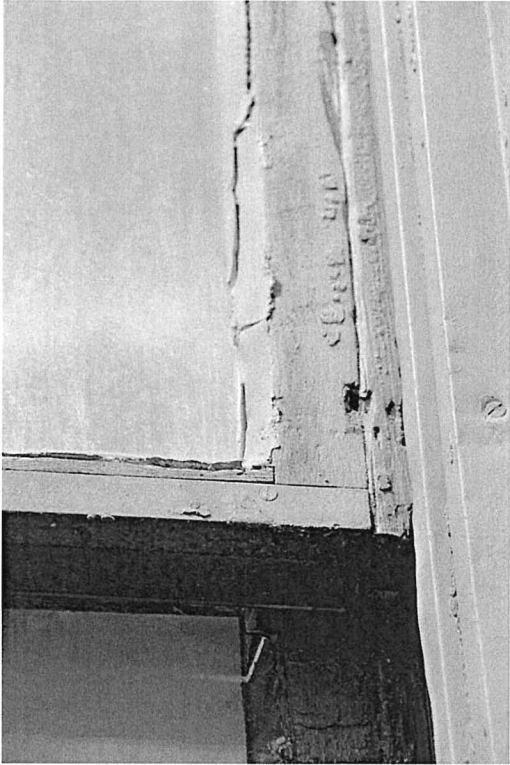
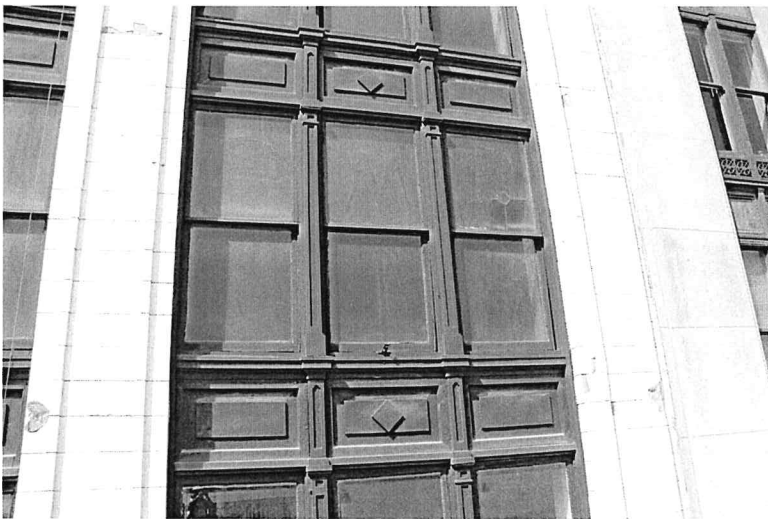
- We have documented the sash condition on the exterior side, see Figures 11-15.

Most of the sashes have a combination of joinery breakdown, bowed rails or stiles, and cracked or broken sash stiles or rails.

- In conclusion, there is no question from my review of these windows that the sashes need to be replaced; especially know we can use the existing master frames and only replace the sash with replica exterior clad material to match the rest of the exterior metal cladding.

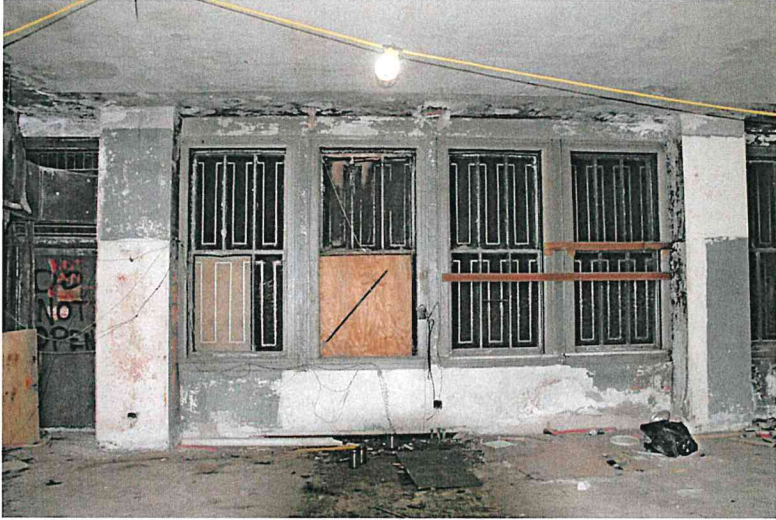
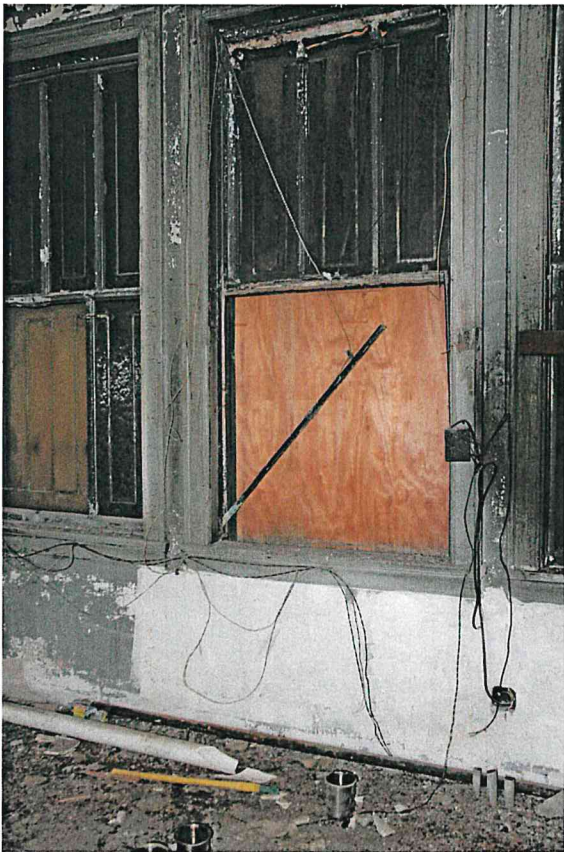
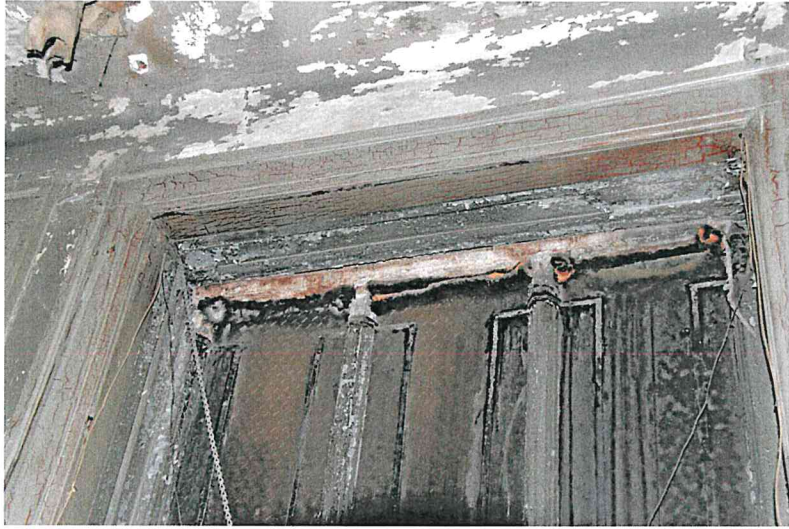
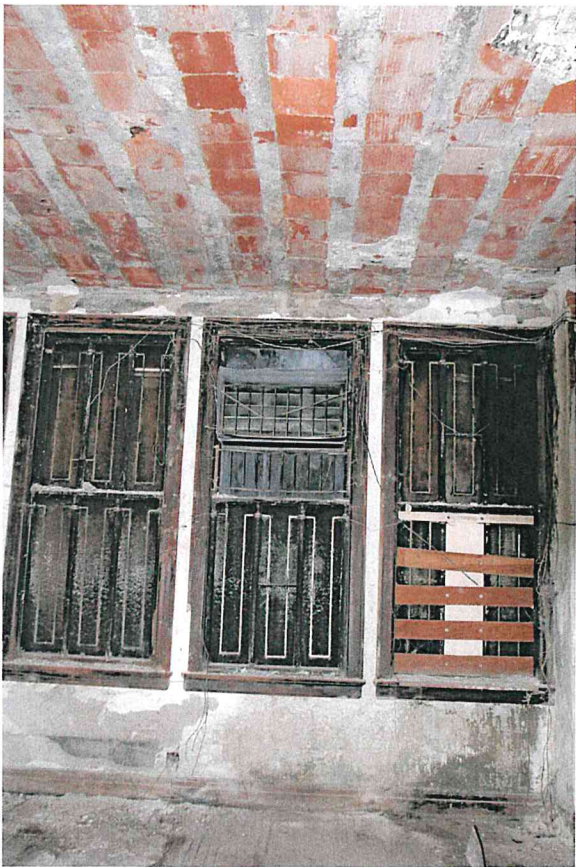
- One of the greatest concerns is the fact that we counted 13 sashes are missing from the site. This being the case there are no sources available to provide replica cold rolled steel sashes. This is not a product that is available, as is the

case for replica wood window components from a variety of millworks. This fact alone deters the ability to restore the alley side steel window. See Figures 16-19.

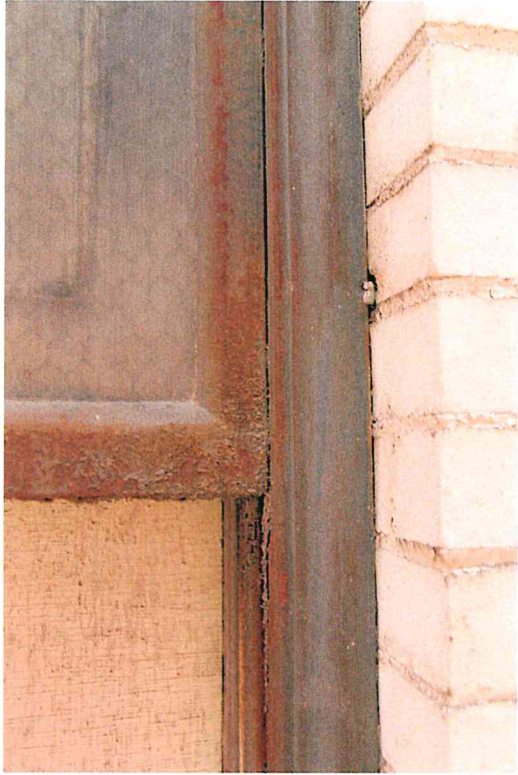
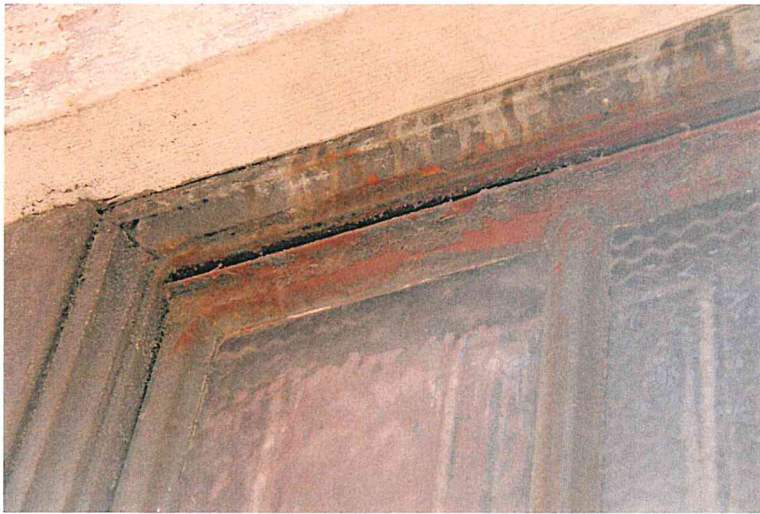
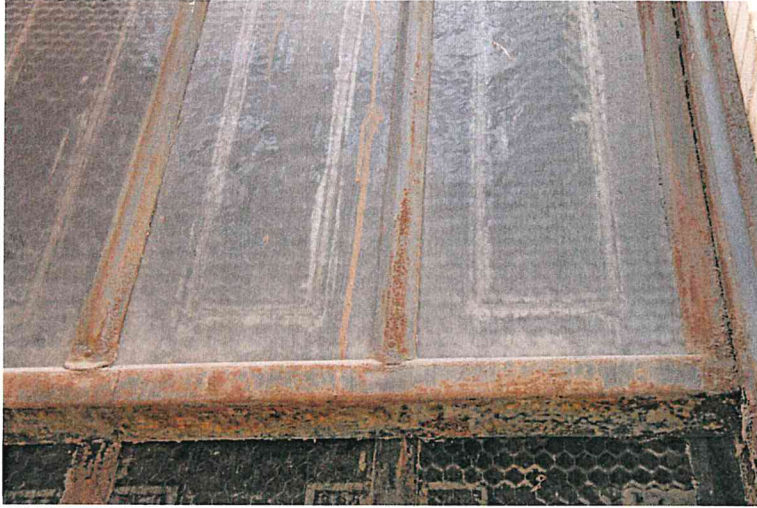
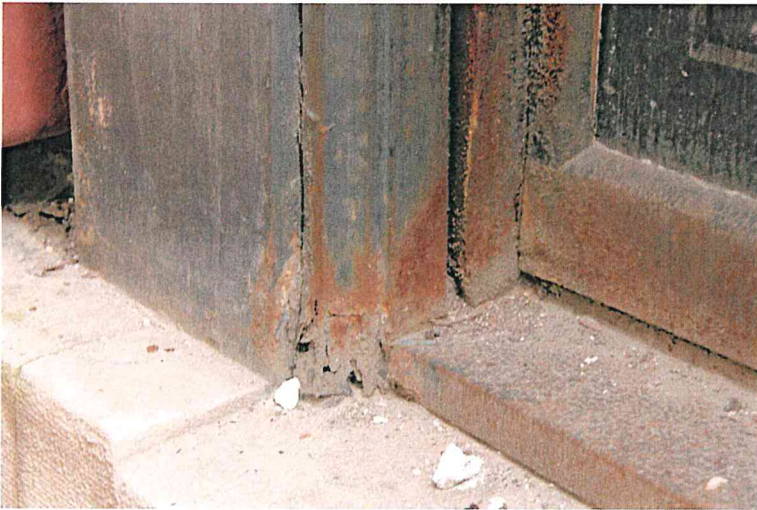
- These windows appear to not have been maintained for decades without any exterior painting or caulking. Sashes are rusted shut with no signs of galvanized material remaining. Many of the sill and frame corner joinery location are failed or failing with metal twisted or material is missing by corrosion. See Figures 20-23.
- It is difficult to provide photos because the majority of the openings are covered by heavy metal bars or metal fire escape sections. Likewise, the alley is only about 12' wide so getting photos showing the entire rear façade was not possible, even with a lift. Without reservation these windows need to be removed and replicated with a thermally broken aluminum historic replication. See Figures 24-25.
