Confidential Inspection Report

221 E. Boston
Detroit MI 48202

May 24, 2019

Prepared for: Evan Faye

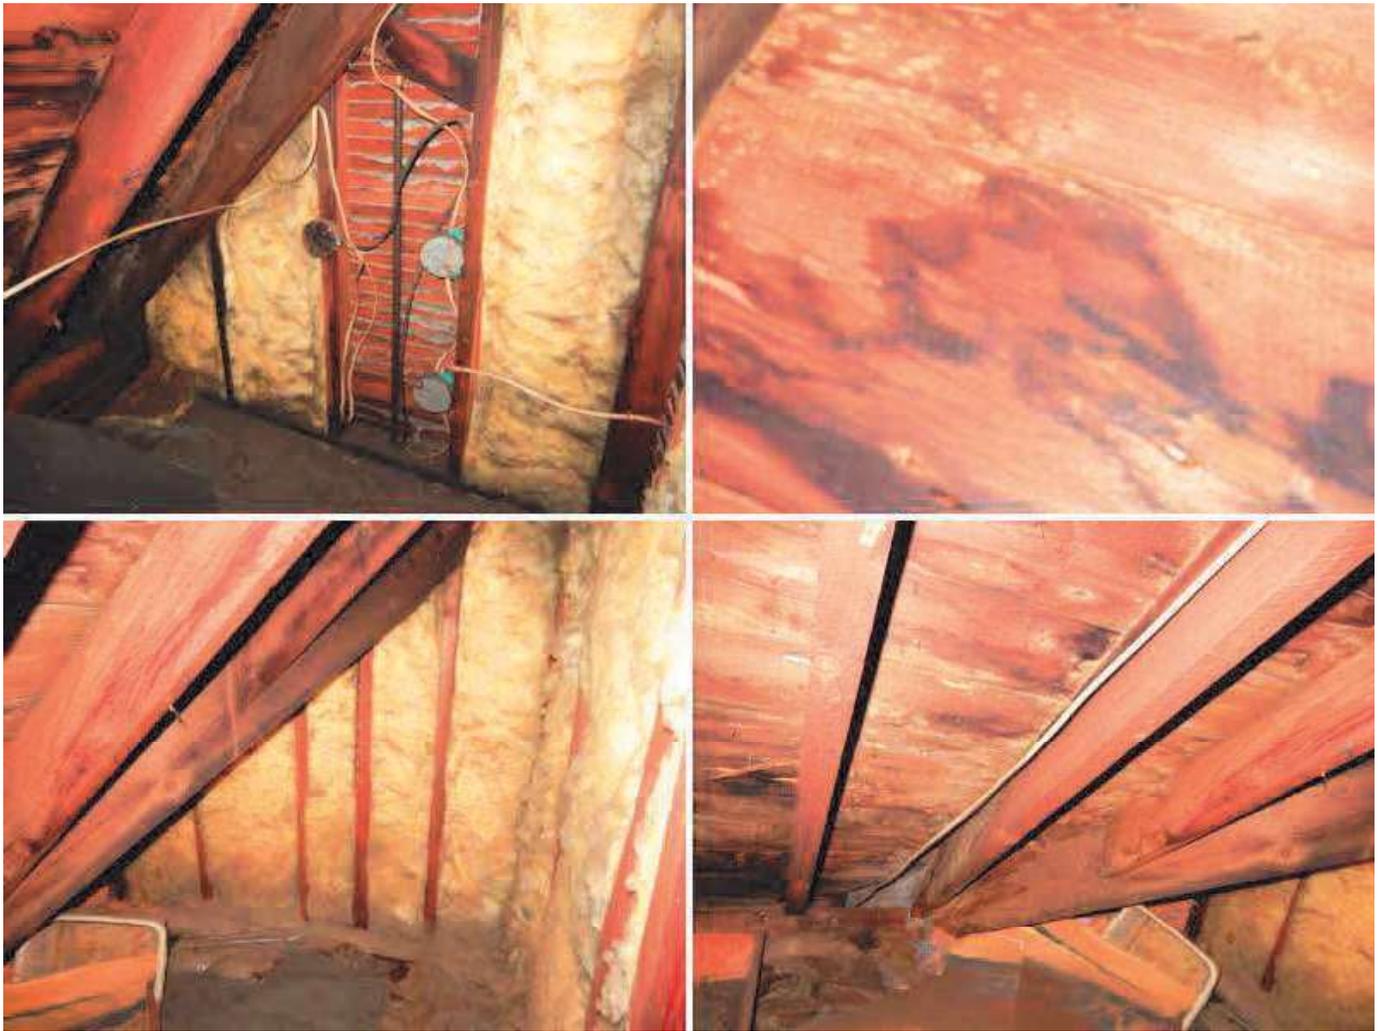
Inspectors no longer walk in attics so as to not disturb or compromise insulation. Viewing was limited, Some unwanted openings are present at fascia or VTR. These locations should be monitored for insect and moisture infiltration. Major staining is noted in some areas. Signs of past/present leakage, No Soffit vents are present on this house. Consider installing them.

Thermal envelop is inadequately sealed or protected due to the improper configuration of the insulation in the "attic" space. Seek the services of a weatherization specialist for further review and corrections as needed. This attic is under ventilated by modern standards. This condition can shorten the life of the roof. Additional attic ventilation is recommended. Call for consultation.

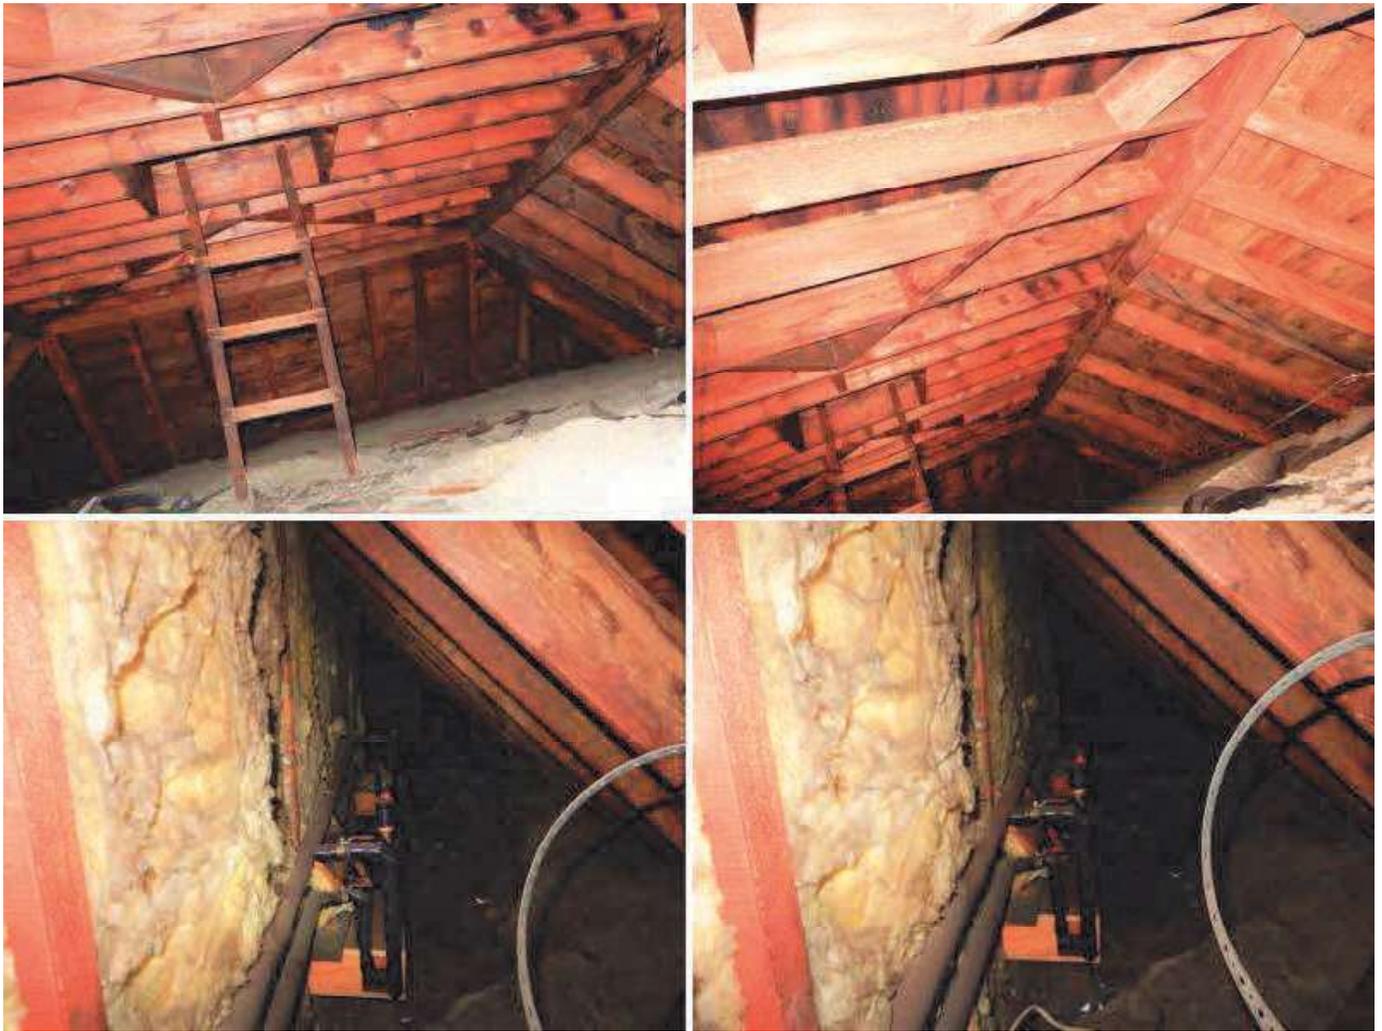
Fiberglass batts and Cellulose- Blown, Insulation here is poorly or incorrectly installed. Seek the services of a skilled weatherization specialists. If recessed lighting has been installed (the following applies to all ceiling lights to some extent). The cans are not sealed or baffled, and the wiring is unsafe. These lights - and even conventional ceiling lights - can allow unwanted moisture into the attic, and create conditions that promote mold. Further review is recommended.

A Weatherization expert should be consulted. Some insulation is installed unevenly, or has been disturbed, thus reducing the R-value. Recommend additional insulation in the attic area especially the floor. Wiring in this area may be unsafe and in need of correction.

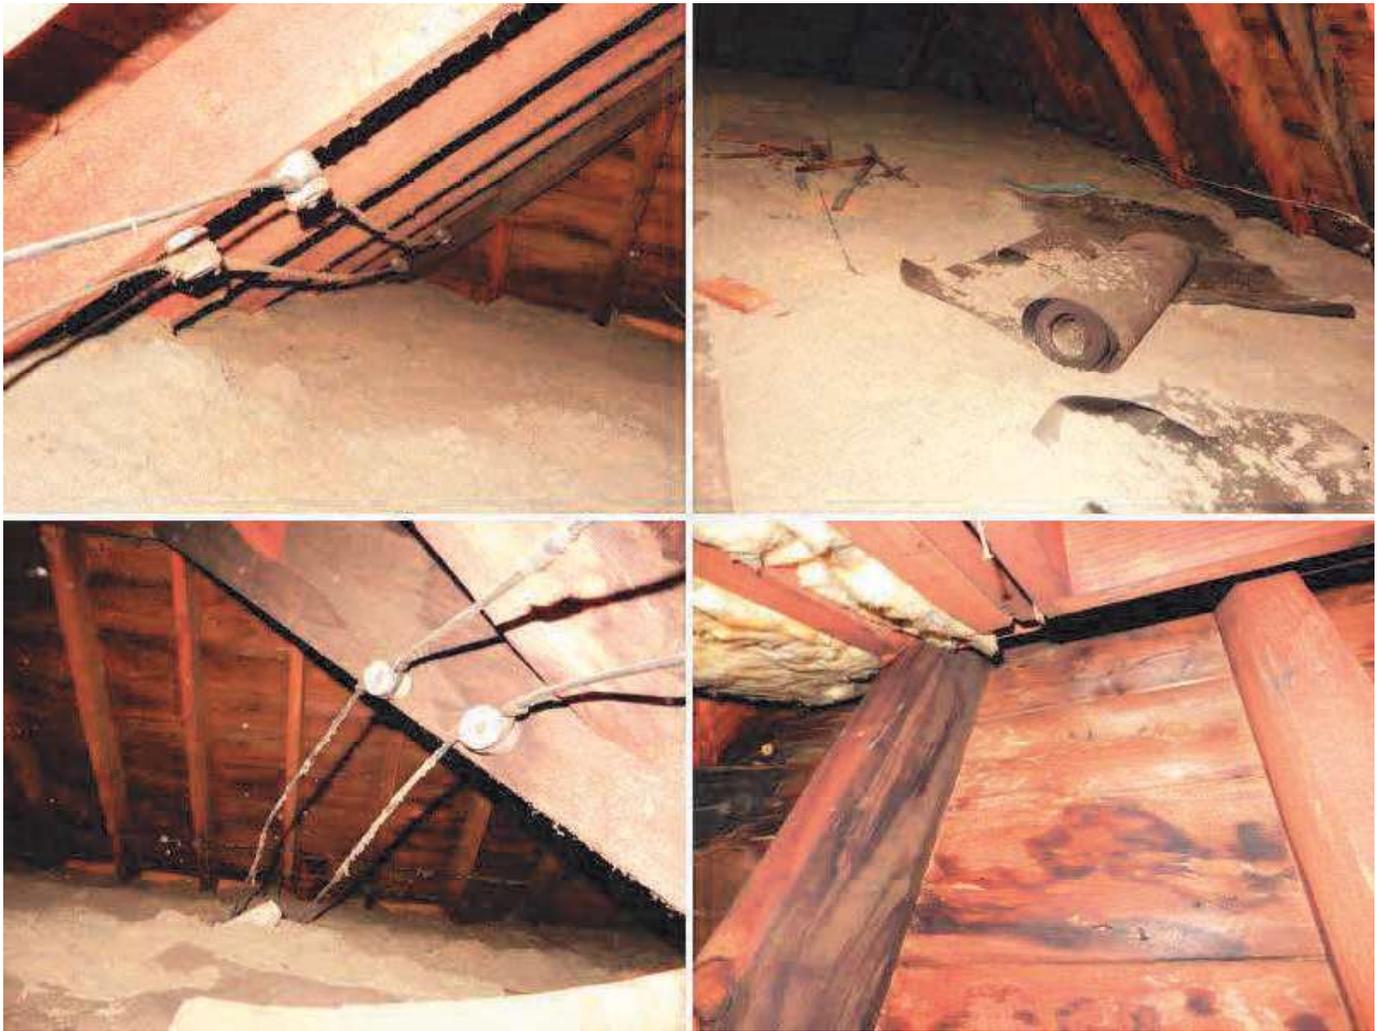
5-6 inches is recommended for side/knee walls with kraft paper facing the "winter-warm" wall. R-60, or 24" of approved insulation material is recommended to achieve desired modern efficiencies. Call for consultation. A Weatherization specialist should be consulted for further review and modern recommended updates. Insulation has been disturbed and good coverage is no longer present. Existing R-Values are impossible to determine.

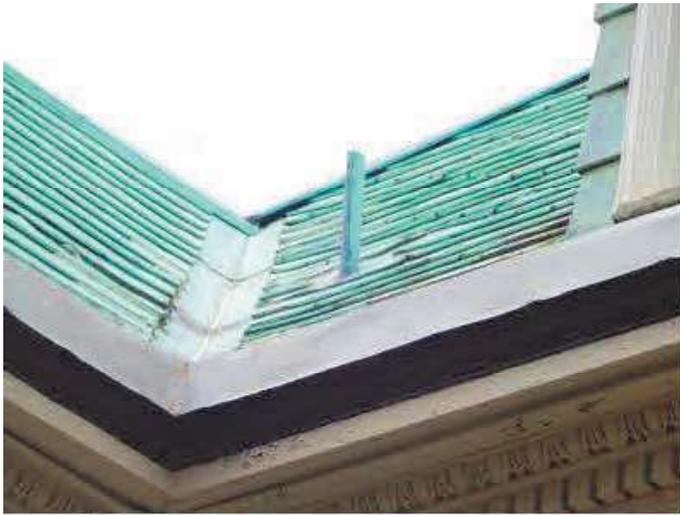
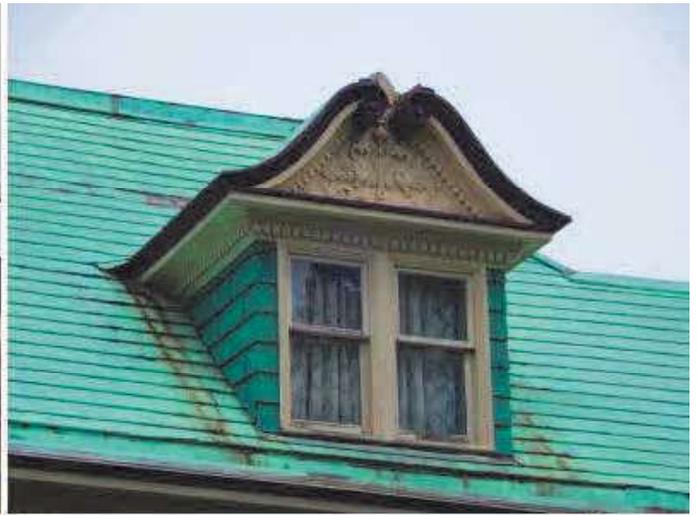
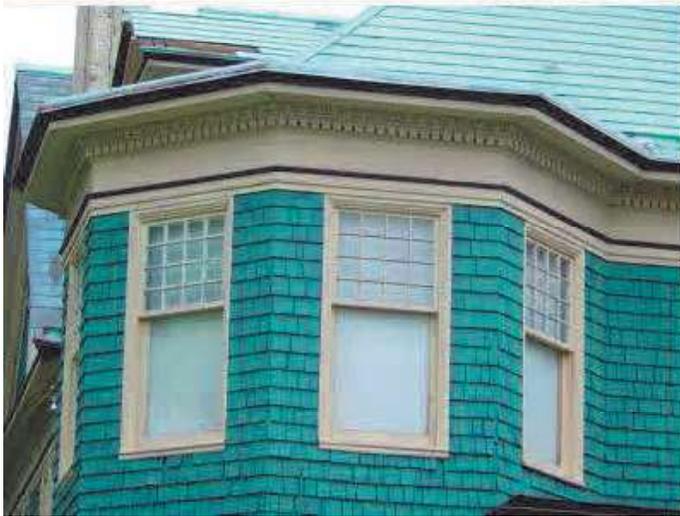
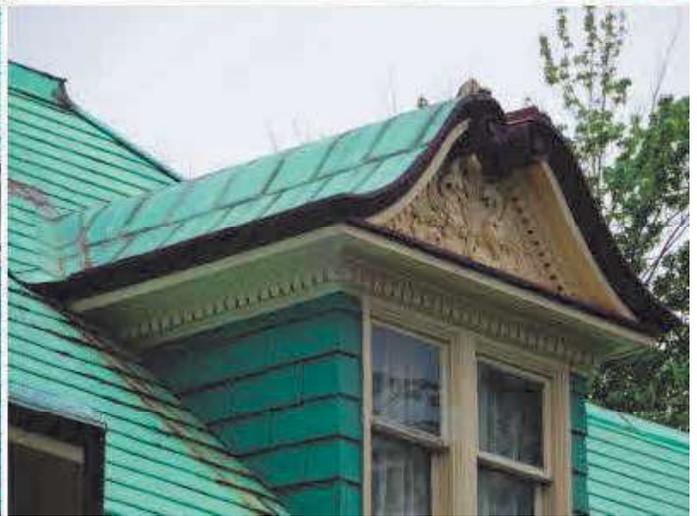
From the ground with a telescoping camera. and viewed from attic where damage can often be readily seen.

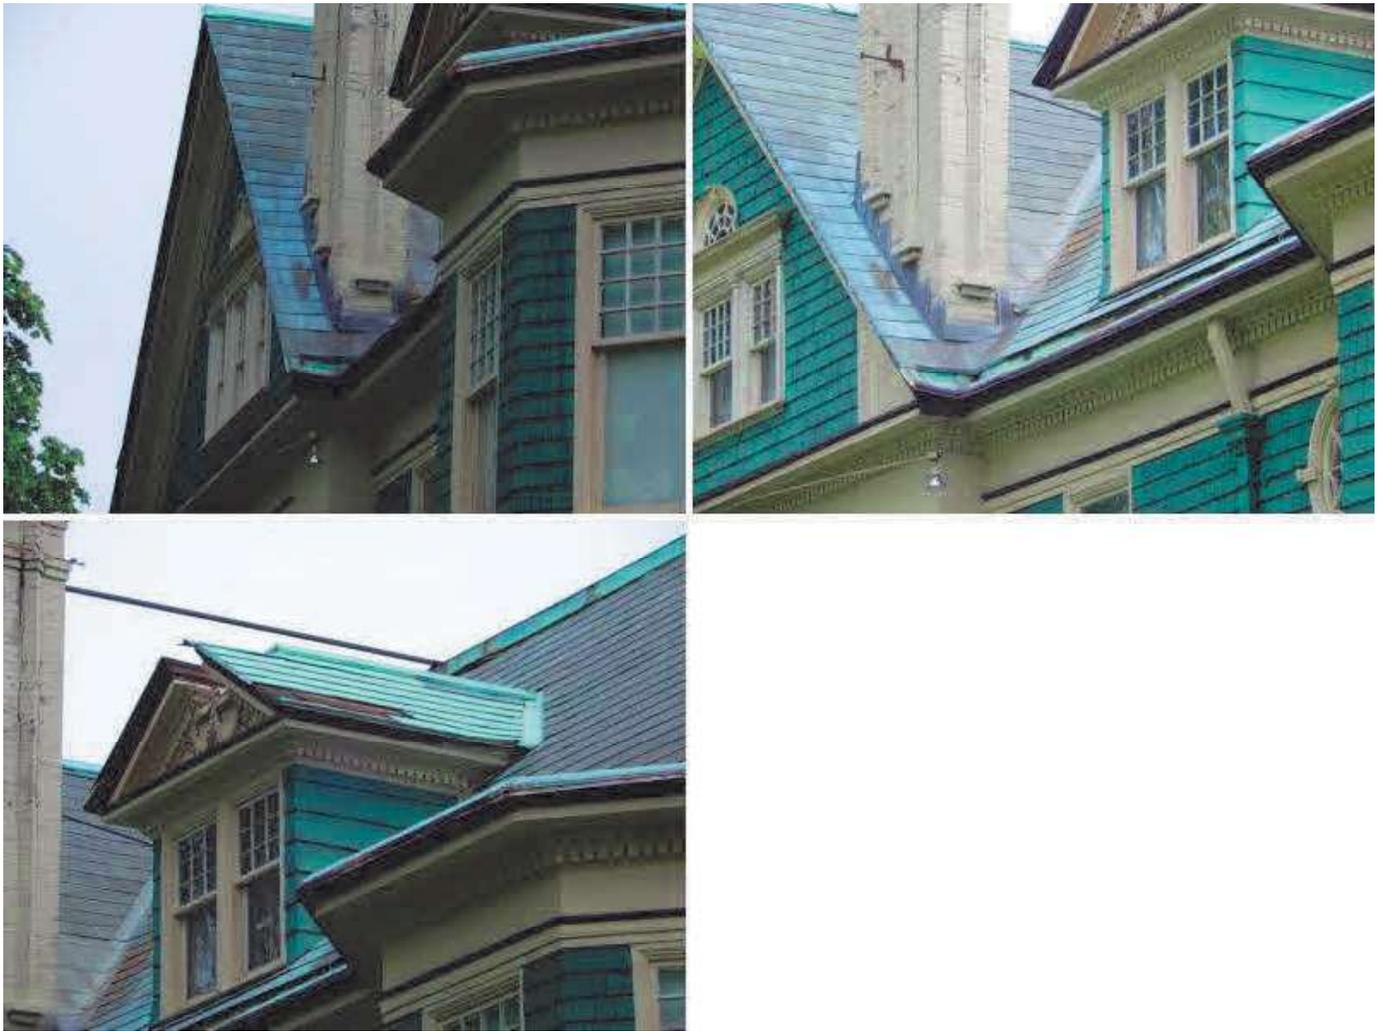
Damage/Deterioration/Defects noted, Roof appears to be leaking in isolated areas, particularly transition areas. Immediate repair is needed here. A licensed roofing contractor should be consulted.

Roof appears to be at/near the end of its useful life, Ice-damming is possible under the existing configuration. See attic, This roof must be replaced immediately. It is currently open to the elements. You should hire licensed professionals for this work. Anticipate the need to replace the roof covering in the not too distant future.

Metal, Damage is noted-or possible at: Dormers and transitions, Stacks or plumbing vent pipes are improperly or poorly installed. at the valley, Transitions from one surface to another (roof - to -wall), Active leakage is noted-in isolated areas.

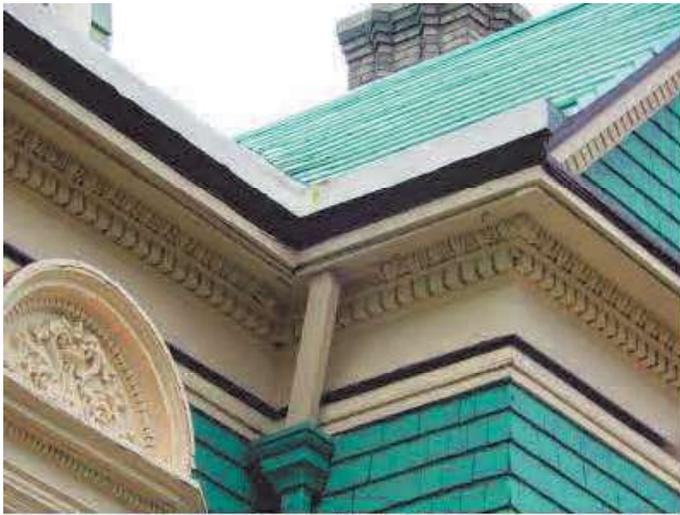
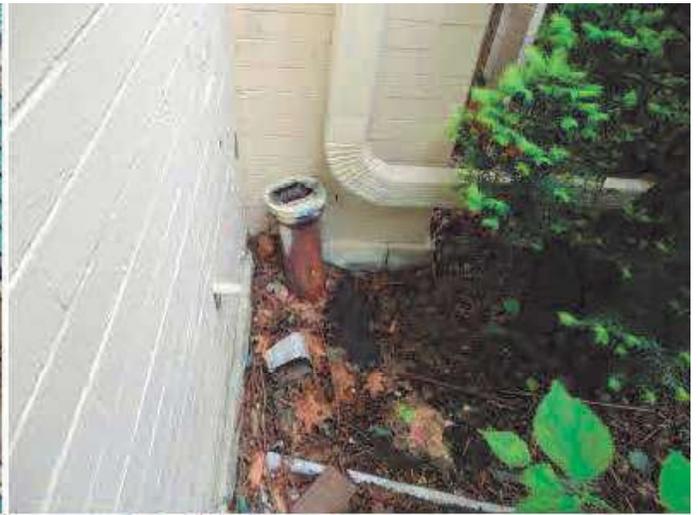
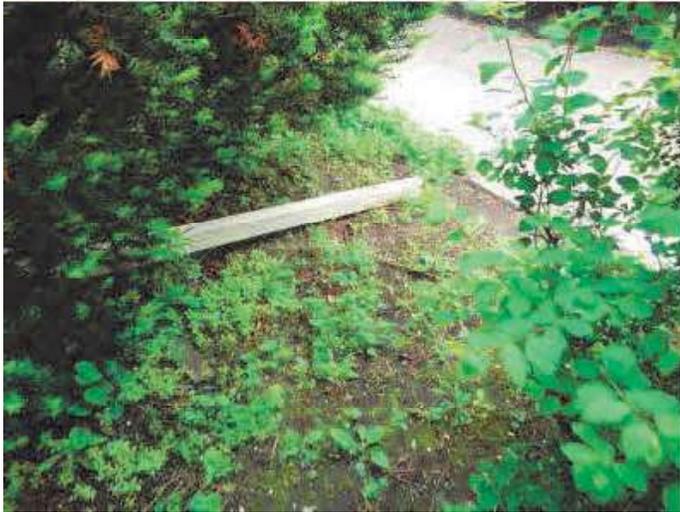
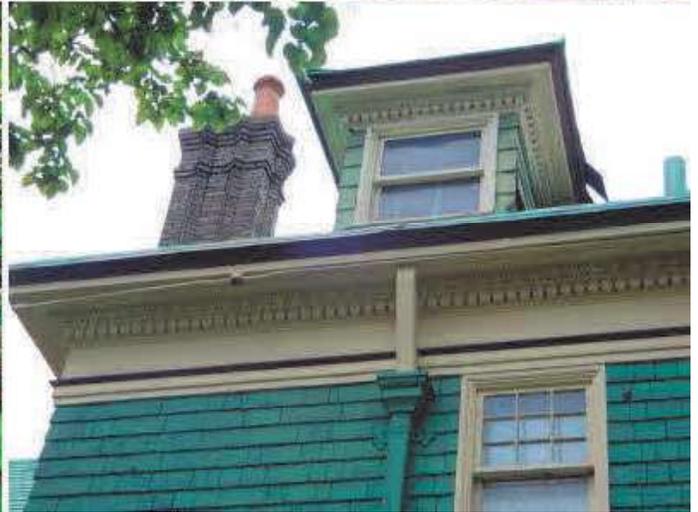
Full system. (Gutters are almost always improperly installed. Be sure to regularly monitor for proper flow). A very complicated system is present here. Consider pitty-pat (a gravel base with landscape fabric that slopes sharply away from the house), this technique does not work at every house, so call for discussion. General improvement is needed here. Consider hiring a licensed contractor to make the necessary corrections. System is built-in to the roof line. This is a historical technique and requires specialists to make proper repairs.

There are many options for improvement rain water flow and distribution. Consider and research "Rain-Bird" Pop-ups as an alternative drainage option. Downspout placement can be challenging. However there are many market place options to choose from. This matter should be researched. Corrugated extenders are not recommended as they can accumulate debris and cause water back ups. A tune-up is suggested: clean, re-pitch, etc, Damage/Defects viewed are common to most gutter installations.

This is very common: Gutters are sloped improperly (no or too little pitch) or "bellies" are present and can/will hold water- and pull gutters away from the fascia. Poor slope can be too much or too little pitch. Correction is needed here. Repair is needed.
