1225/1227 Hubbard Street

Porch Portfolio

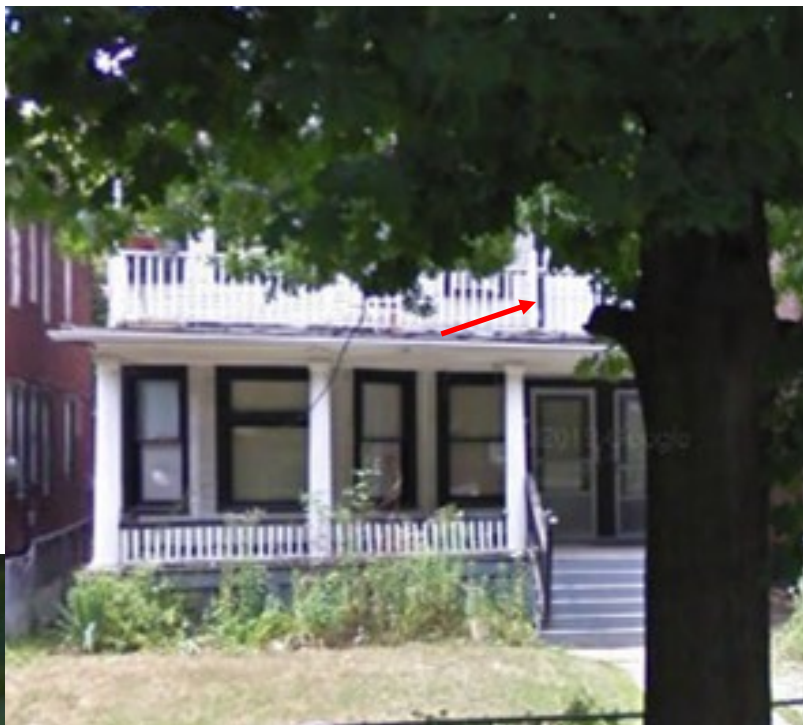
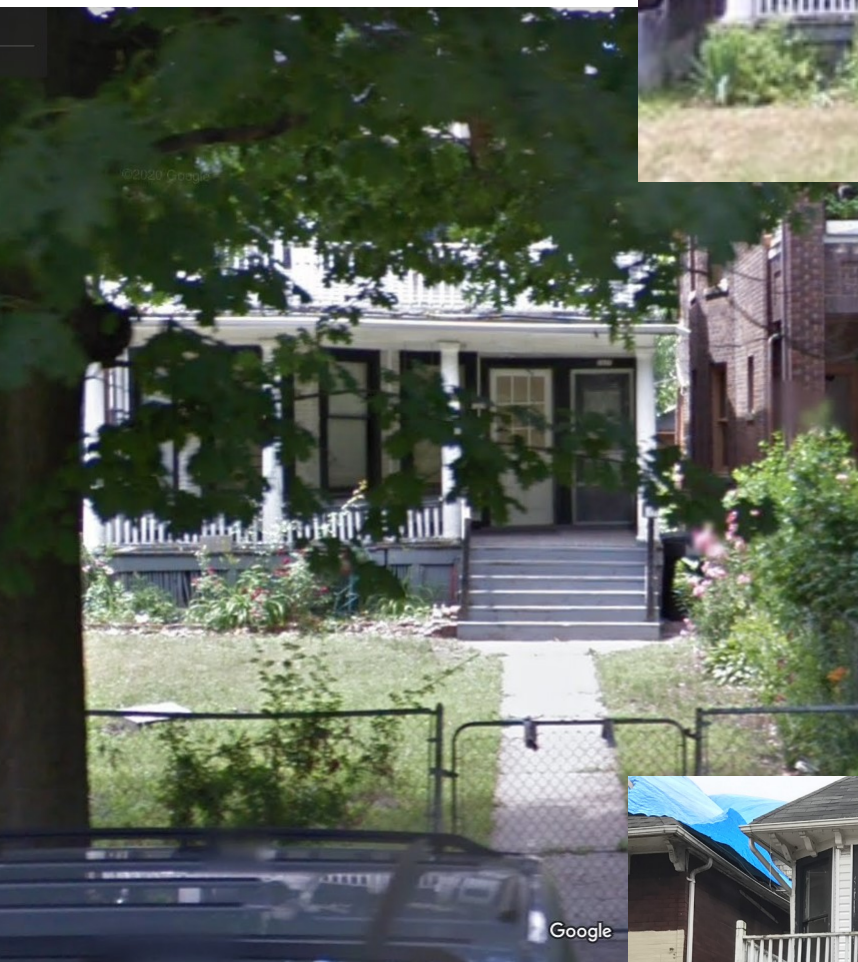
2007, Right. Sourced from Google Maps.

Visible 2nd story deck and railings, probable door frame, typical of all two-family flats in the area (red arrow). Resolution is insufficient to evaluate woodwork condition, though some damage to fascia may be visible.

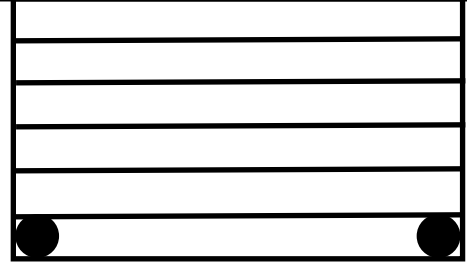
Footprint. Original and current, unchanged footprint of the porch. There are four 6" support posts at approximately 8' intervals. The lower deck floor is 40" above grade. An 8' stairway has 6 steps, with 12" treads and 6.75" closed risers.

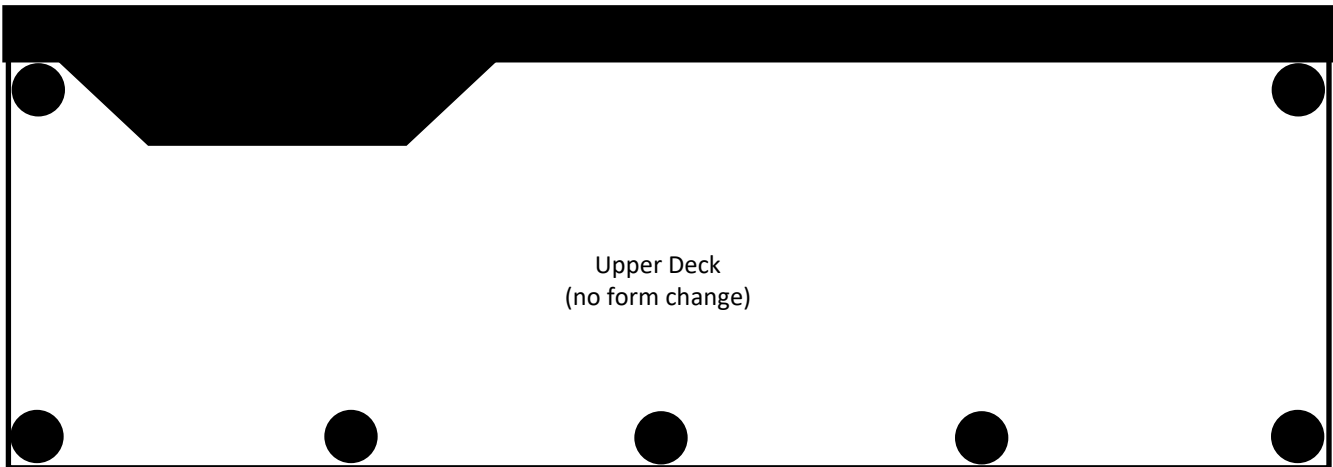
The upper deck retains five posts on the front, with four 6' railing sections.

The footprint and profile are congruent with all original woodwork. The current railing height and baluster spacing conform with building codes for safety.
