RE: 7949 Lafayette Residential Duplex Renovations, Historic District Commission Submission

Description of Existing Window Conditions

Window Assessment

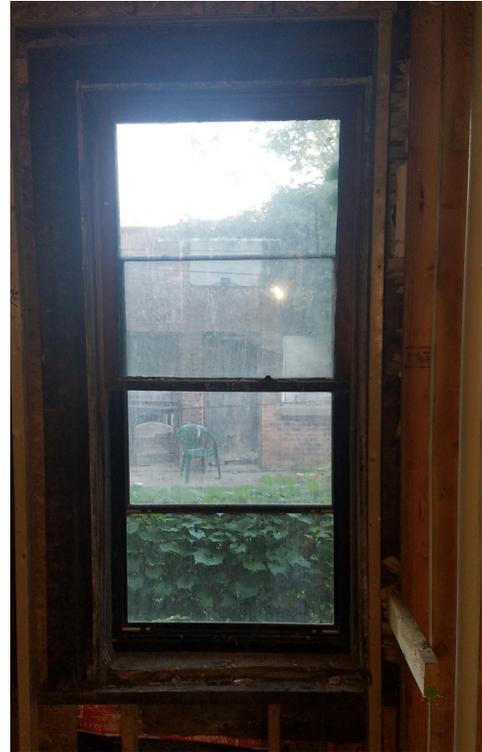
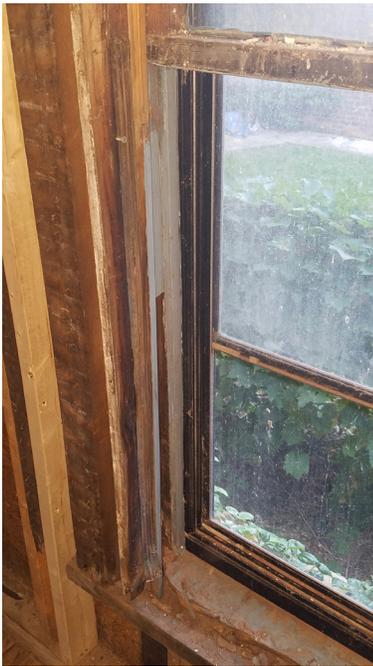
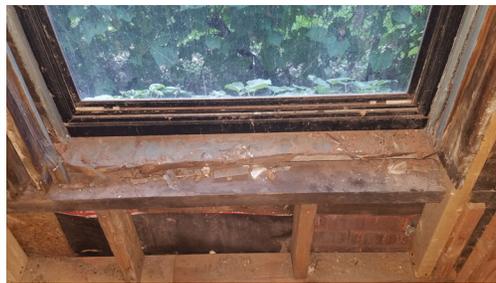
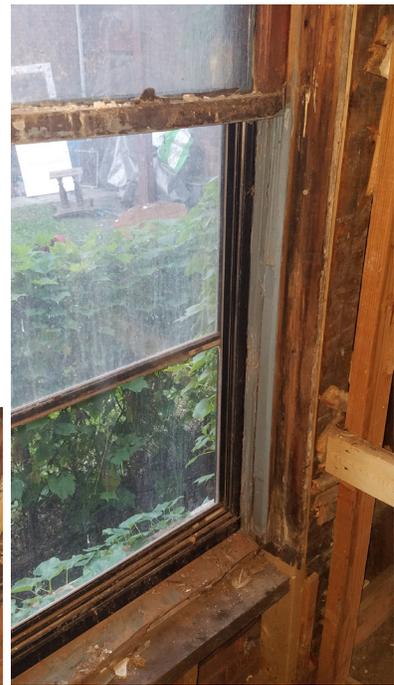
E1-01 (East Unit, North Elevation)

- Missing lower sash
- Deteriorated/rotted sill
- Broken/split left jamb framing
- Missing rope/counterweights

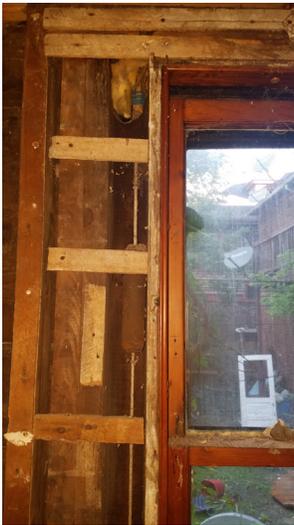
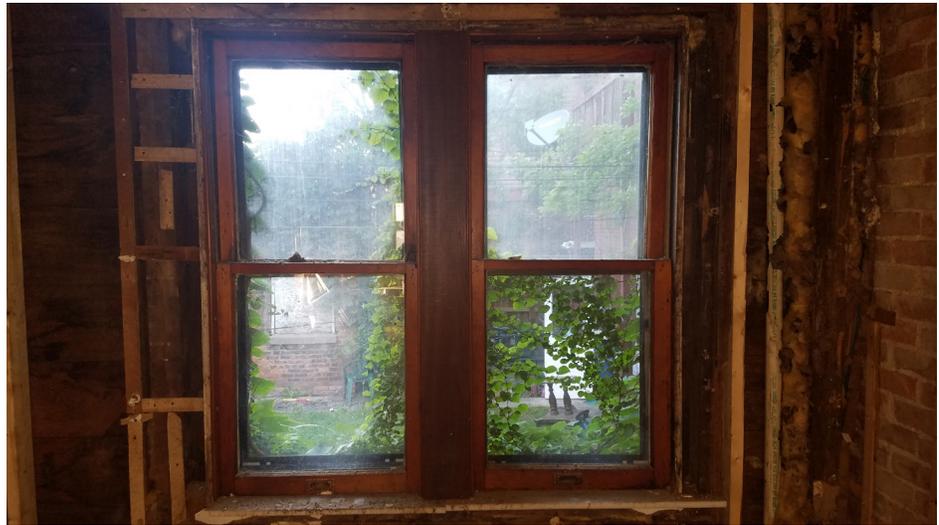
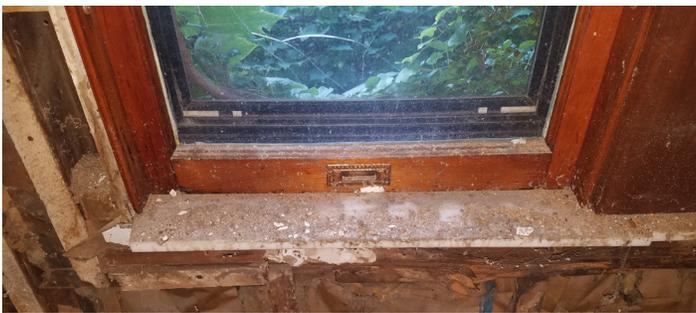
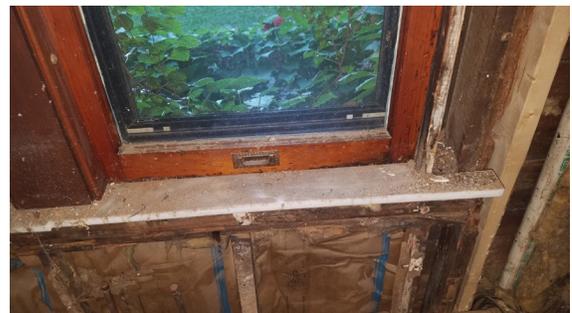
E1-02.03 (East Unit, North Elevation)

- Rotted/split left-top jamb framing
- Center mullion will be retained and repaired as required. Proposal is to replace each double hung unit individually.

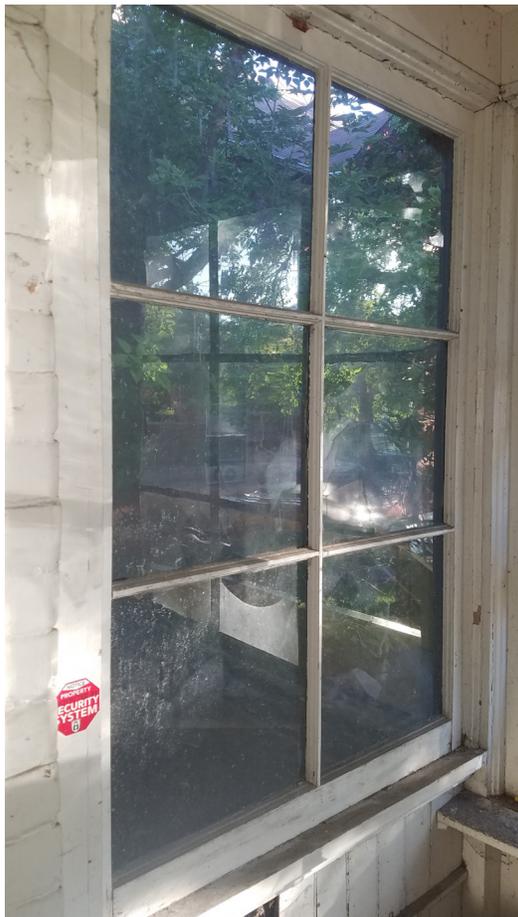
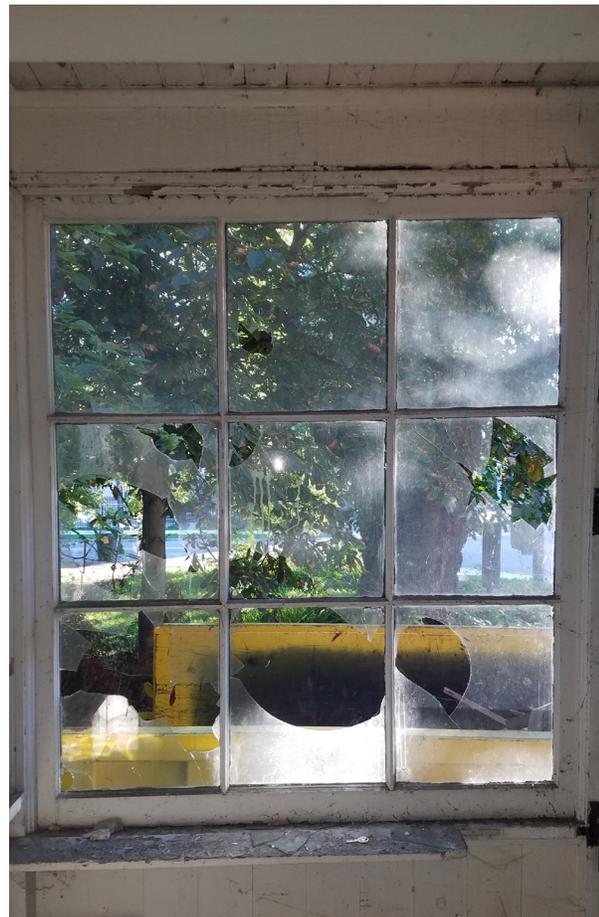
E1-04, 05 (East Unit, East Elevation, in entry vestibule)

- Broken glazing
- Single pane glazing, no insulation value

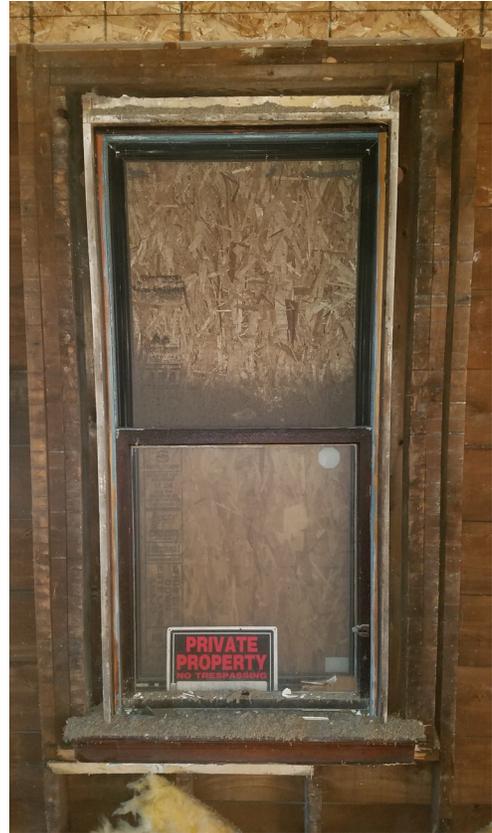
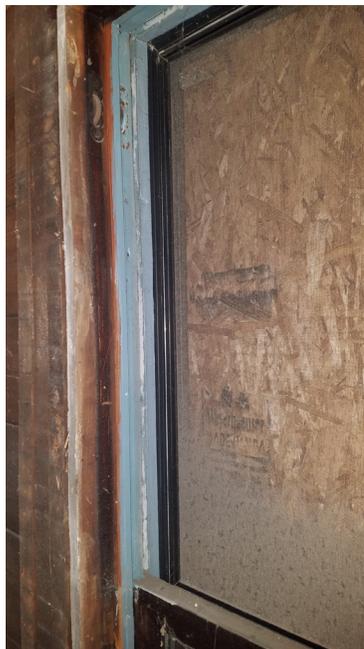
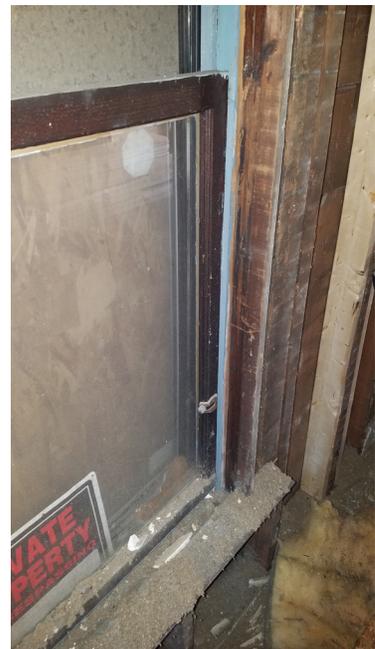
E1-06 (East Unit, East Elevation)

- Missing lower sash
- Missing rope/counterweights

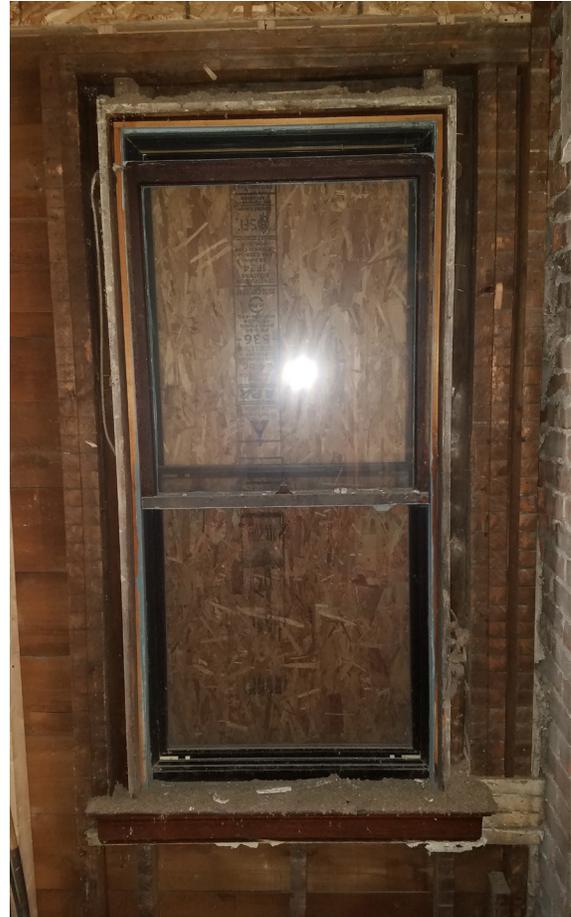
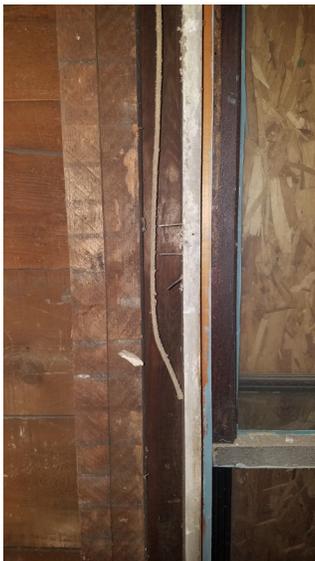
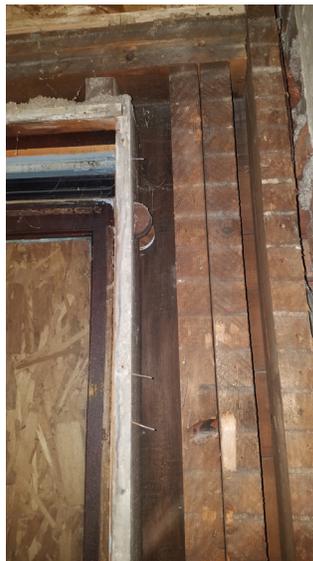
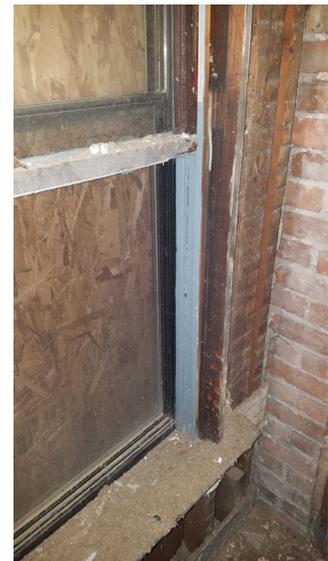
E1-07 (East Unit, East Elevation)

- Missing lower sash
- Missing counterweights

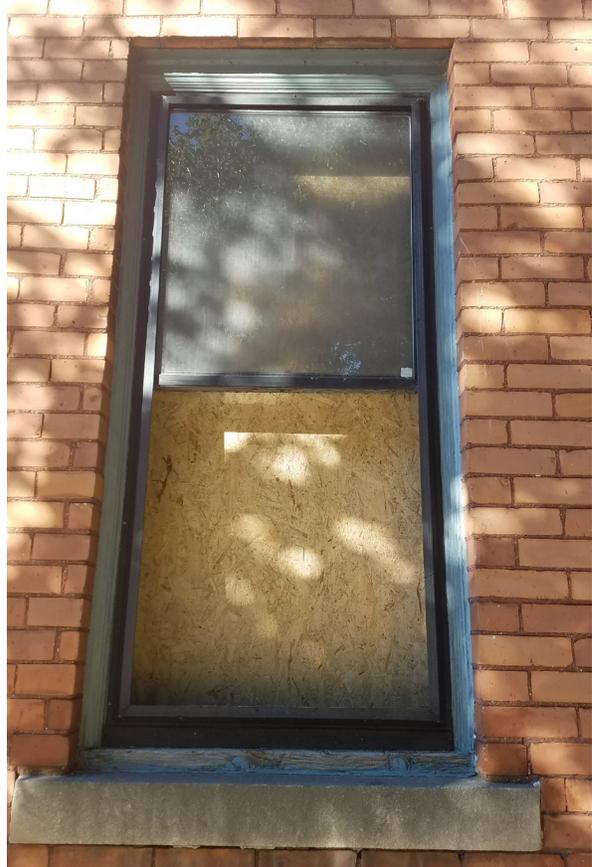
E1-08 (East Unit, East Elevation)

- Entire Window Missing (only half of storm window in place).

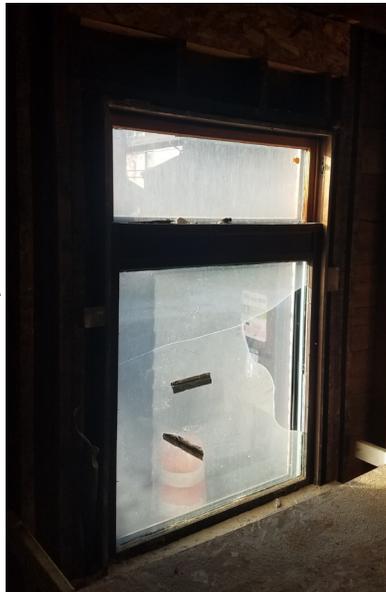
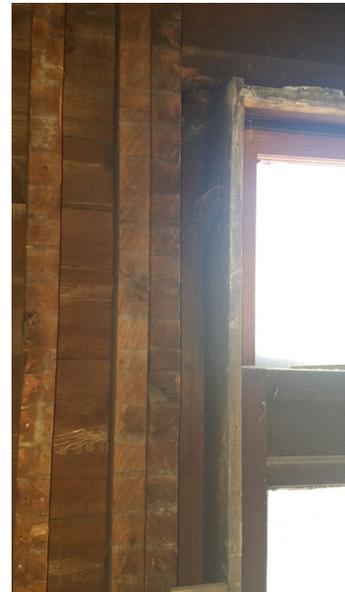
E1-09 (East Unit, South Elevation)

- Broken Glazing
- Rot at upper left corner of casement
- Horizontal mullion will be retained and repaired as required. Proposal is to replace each window unit (transom above, double hung below) individually.

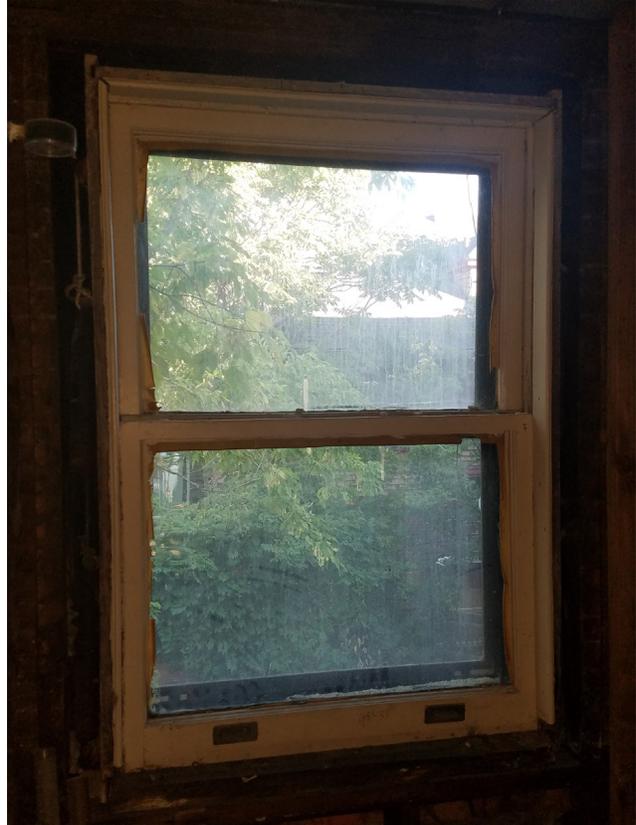
E2-01 (East Unit, North Elevation)

- Missing rope and counterweight (right side)
- Rot/gouges at joints of lower sash

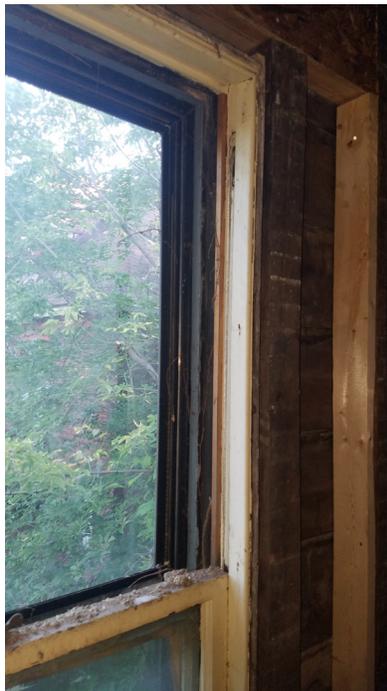
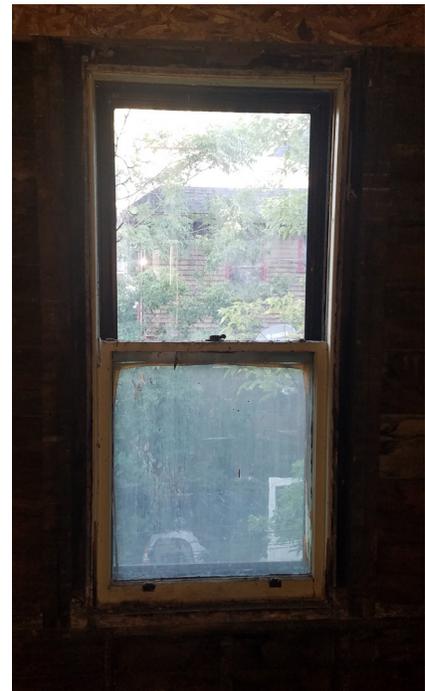
E2-02 (East Unit, North Elevation)

- Missing upper sash
- Rot observed on frame

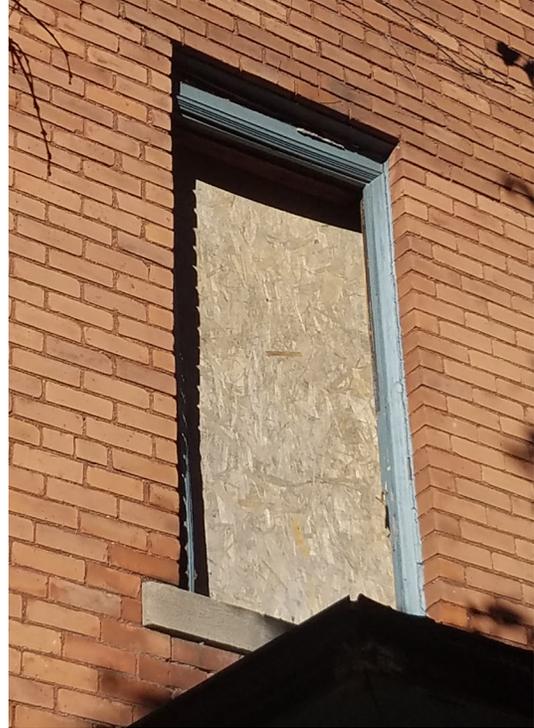
E2-03 (East Unit, East Elevation)

- Missing entire window

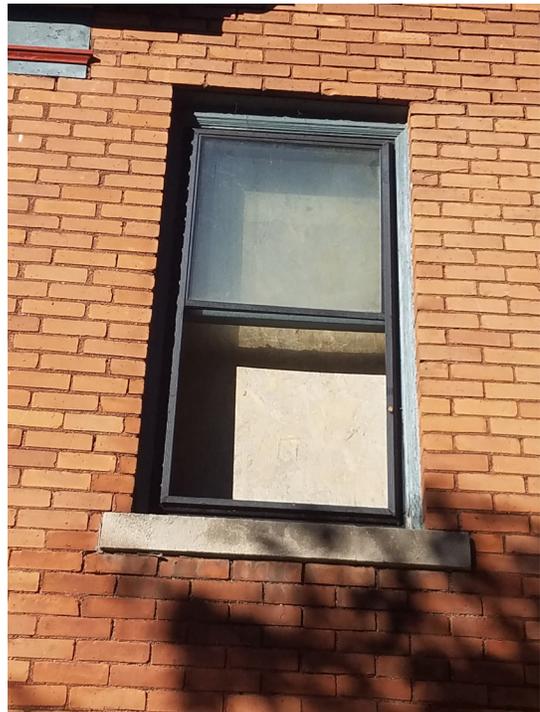
E2-04 (East Unit, East Elevation)

- Missing lower sash

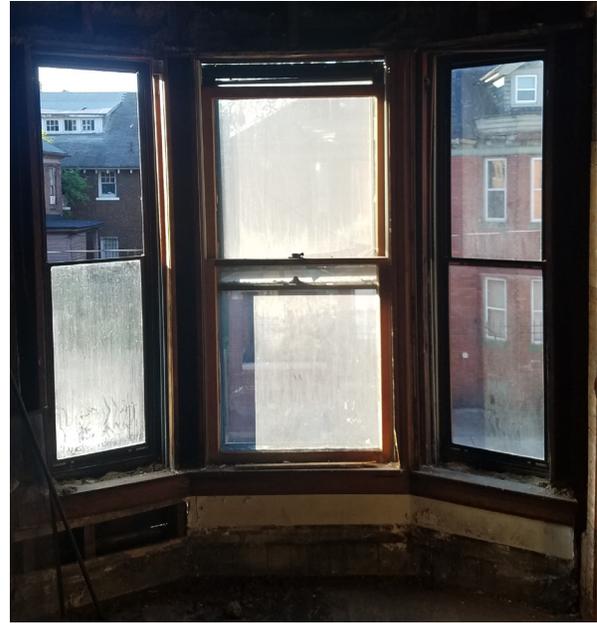
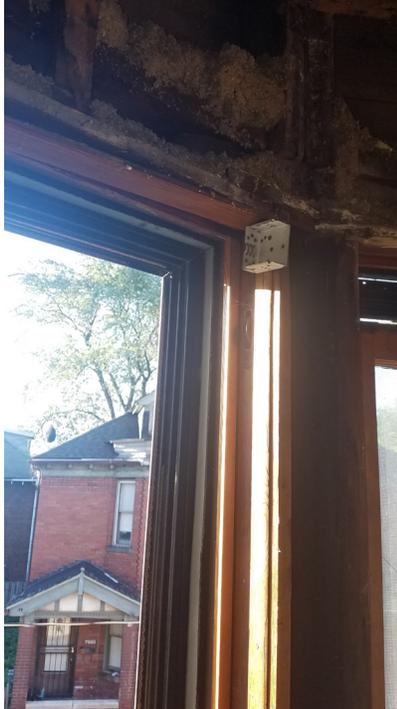
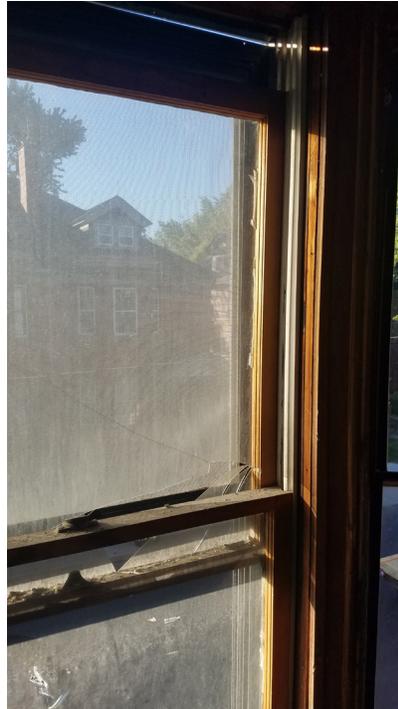
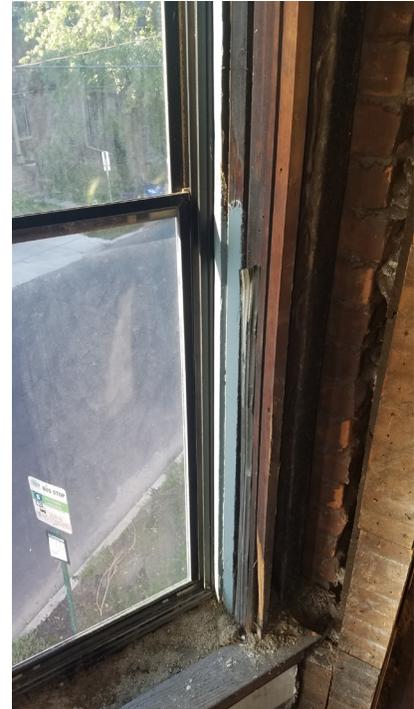
E2-05, 06, 07 (East Unit, South Elevation)

- Missing entire windows (left and right)
- Broken Glazing (center window)
- Split/damaged wood (right jamb)
- Missing ropes and counterweights

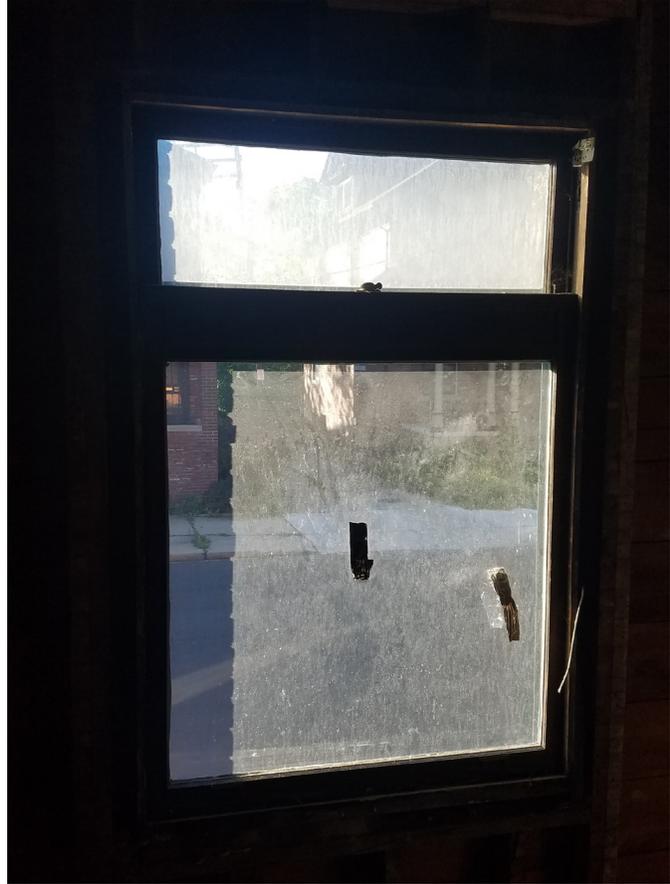
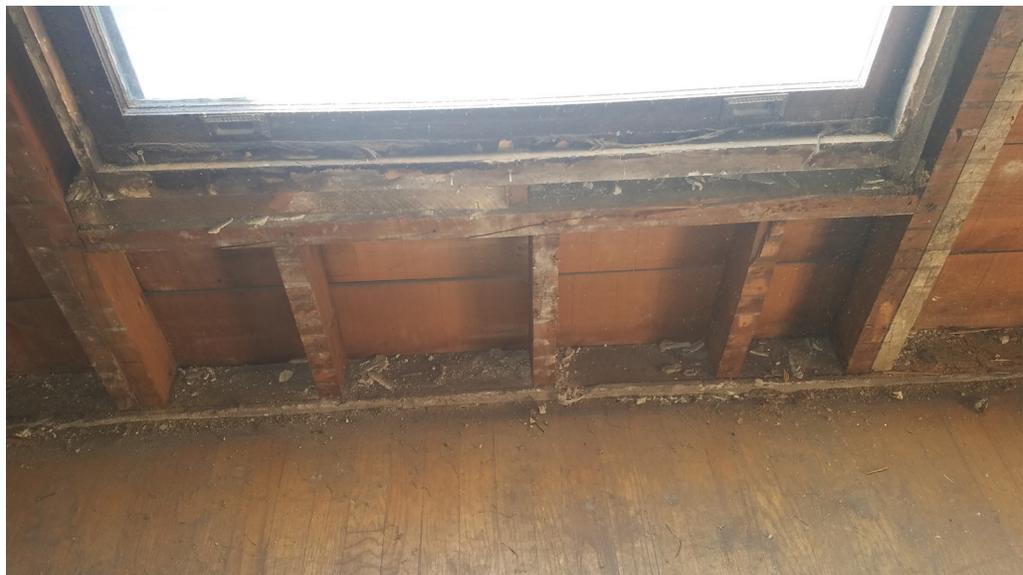
W1-01 (West Unit, South Elevation)

- Rot/damage at sill
- Horizontal mullion will be retained and repaired as required. Proposal is to replace each window unit (transom above, double hung below) individually.

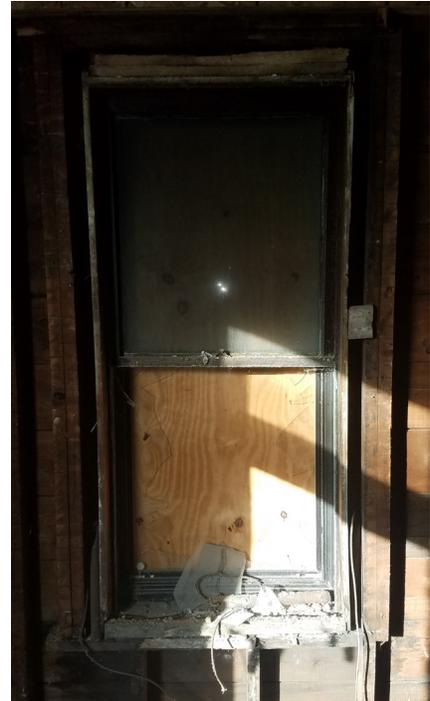
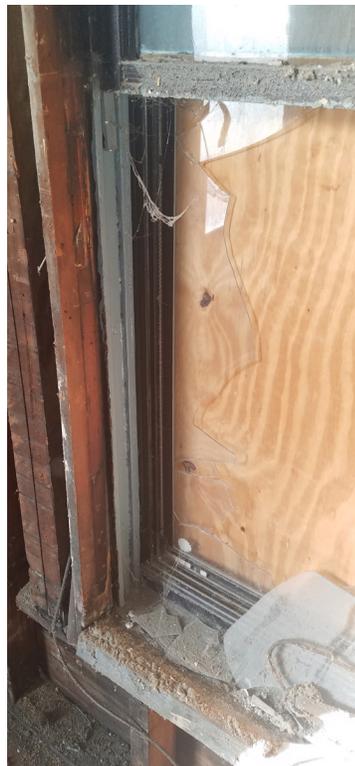
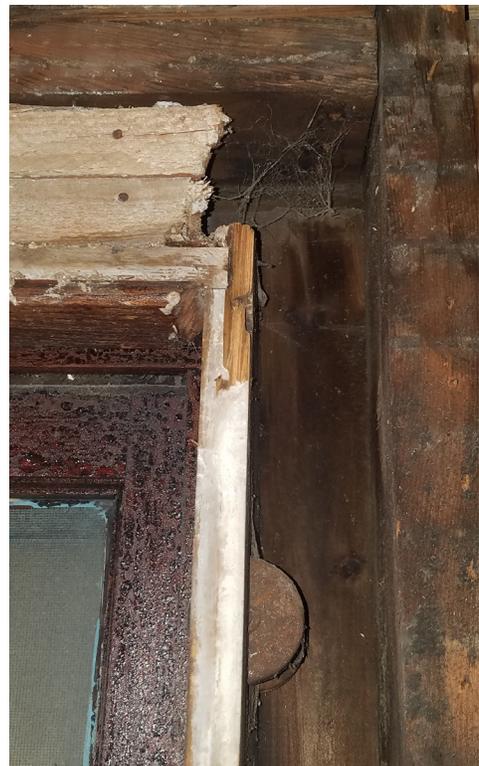
W1-02 (West Unit, West Elevation)

- Missing lower sash
- Rot/damage at frame

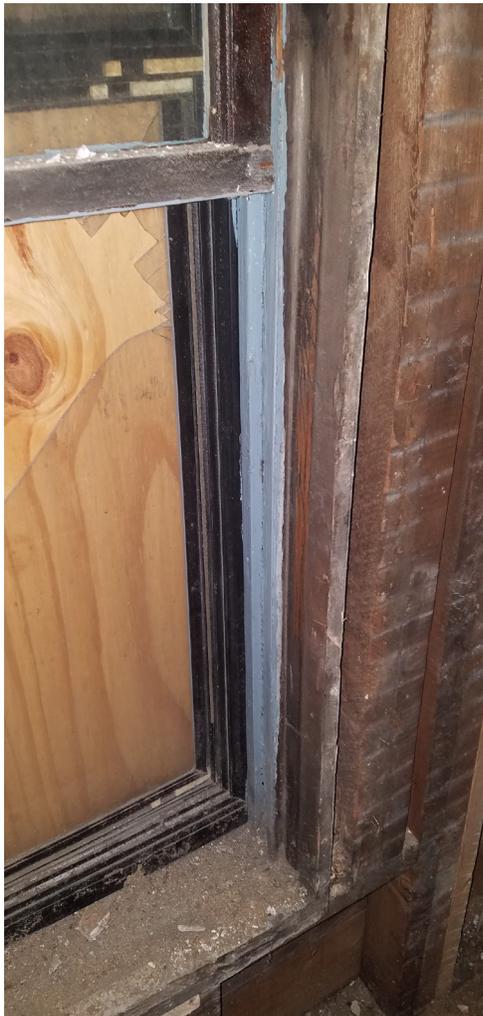
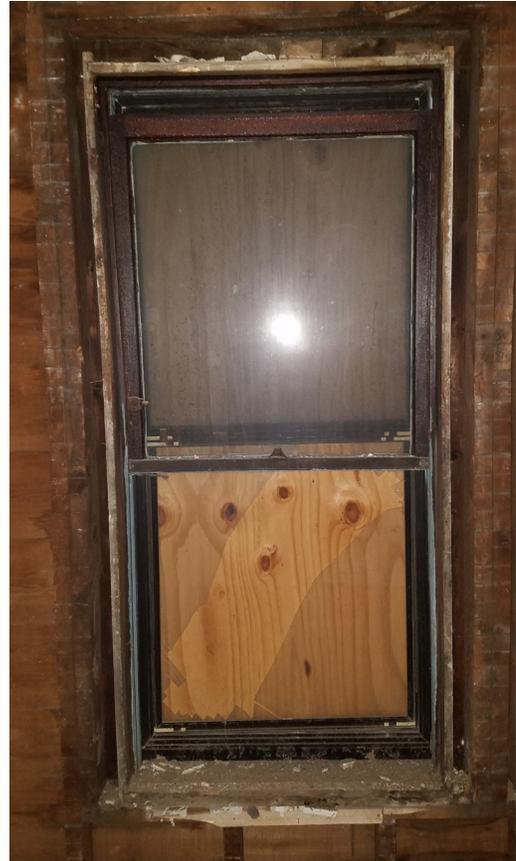
W1-03 (West Unit, West Elevation)

- Missing lower sash
- Missing ropes/counterweights
- Broken glazing in storm window

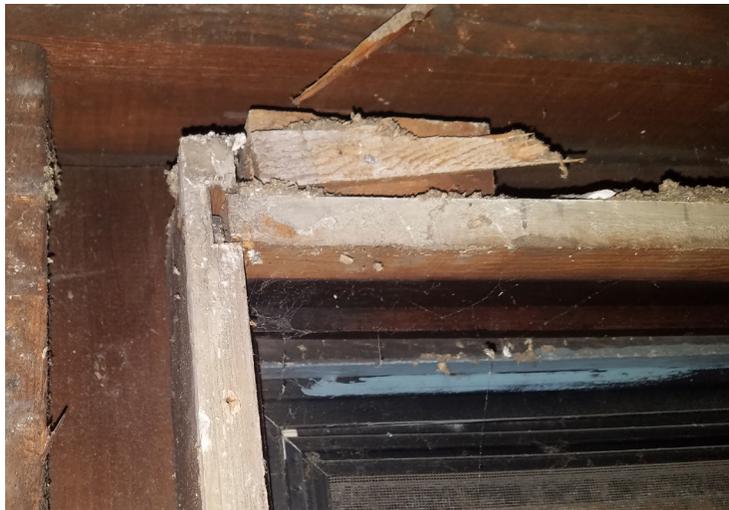
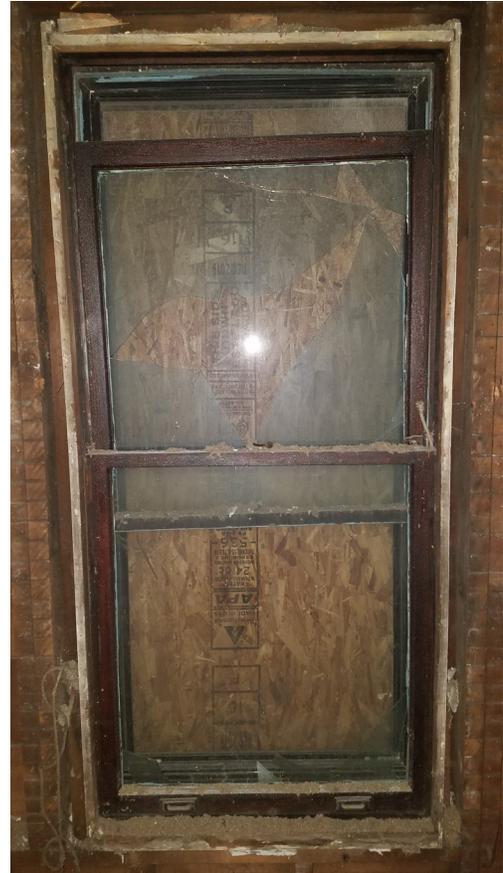
W1-04 (West Unit, West Elevation)

- Broken glazing (upper and lower sash)
- Damaged frame
- Missing rope/counterweights

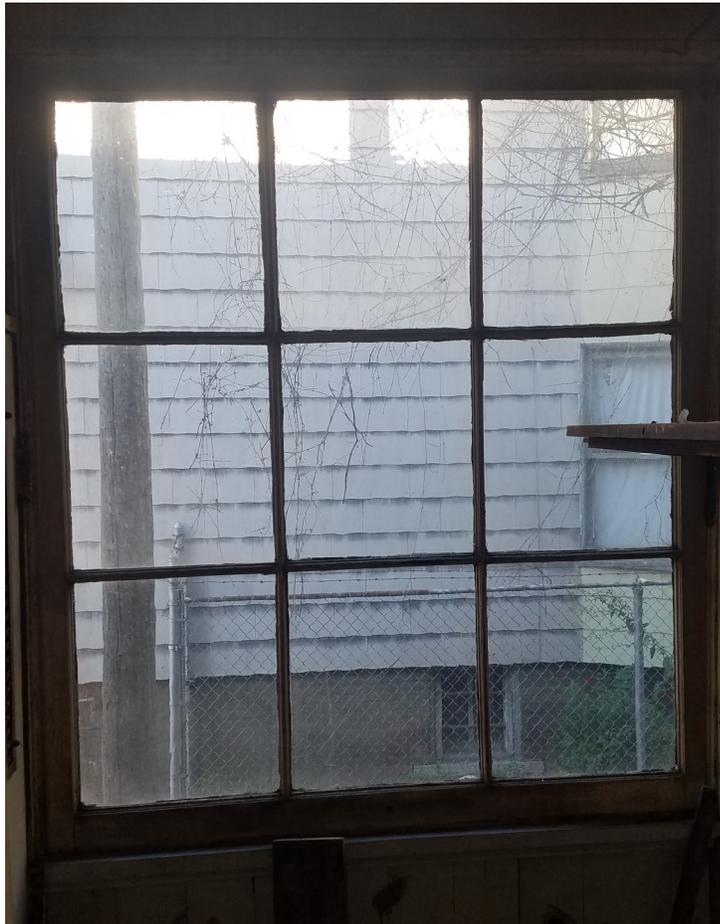
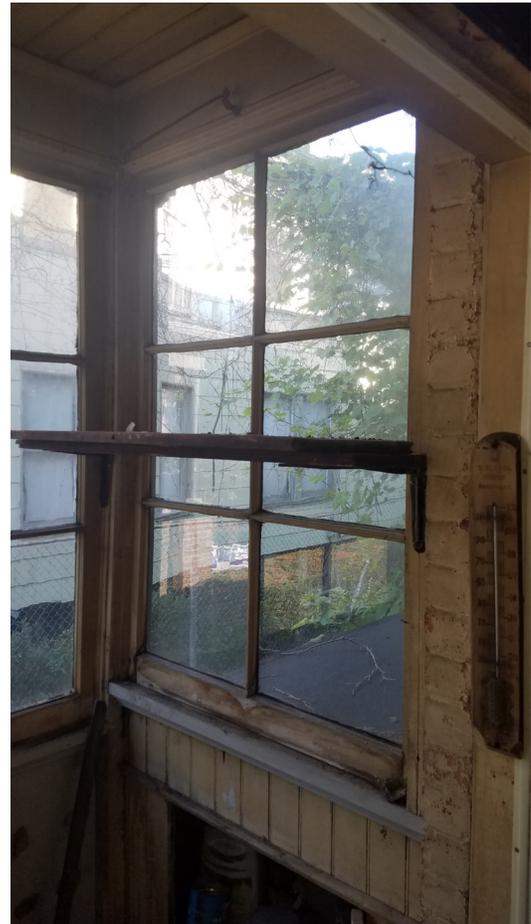
W1-05, 06 (West Unit, West Elevation)

- Single pane glazing, no insulation value

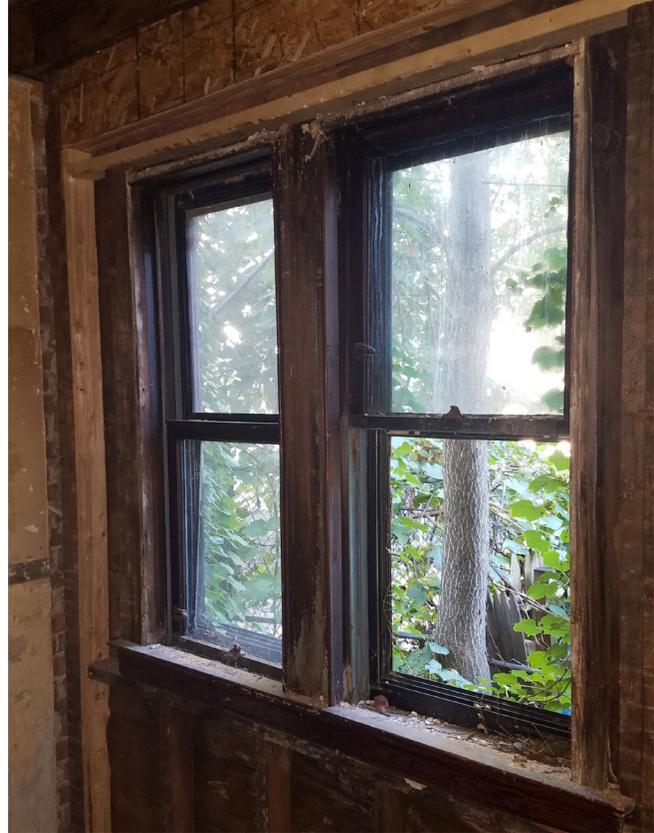
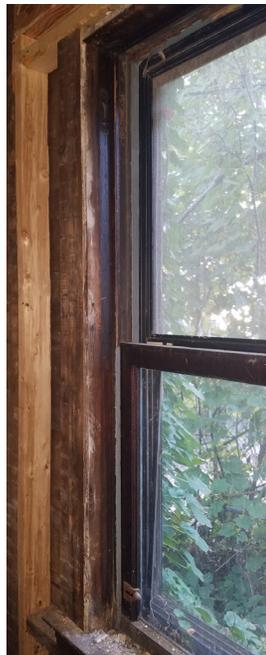
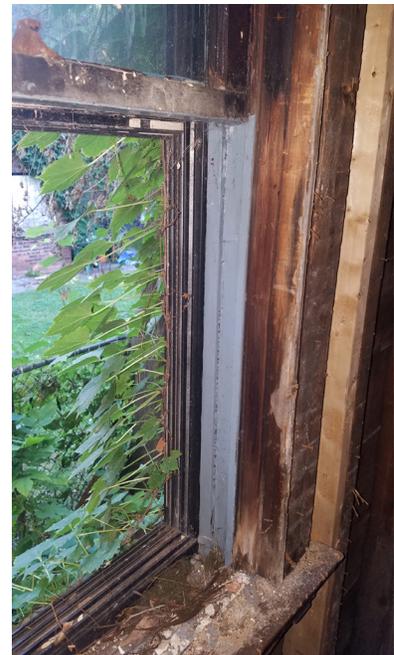
W1-07, 08 (West Unit, North Elevation)

- Missing lower sash (left and right windows)
- Missing glazing (right storm window)
- Rot at sill, head framing
- Center mullion will be retained and repaired as required. Proposal is to replace each double hung unit individually.

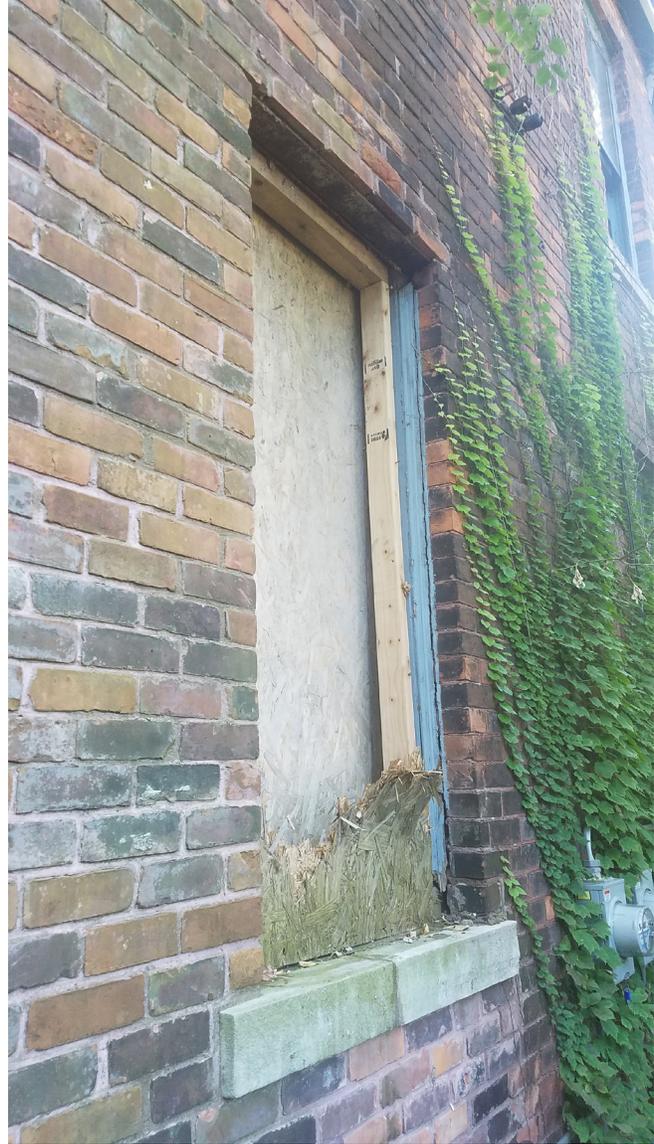
W1-09 (West Unit, North Elevation)

- Missing entire window unit
- Existing sill height will be raised to match adjacent windows, W1-07,08.
- Existing stone sill will be salvaged and reinstalled at new height.
- remaining opening will be infilled with brick to match existing.

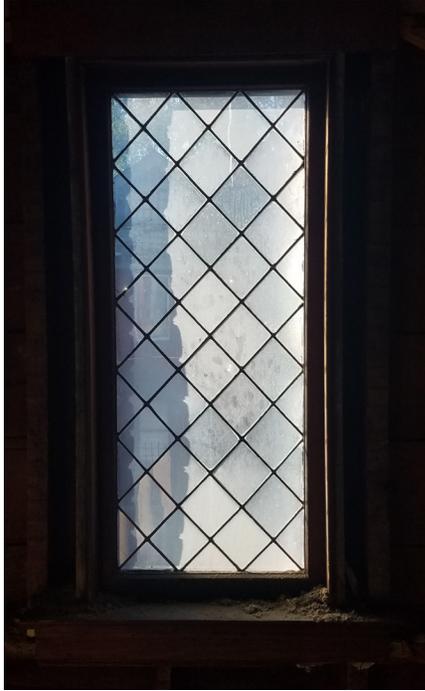
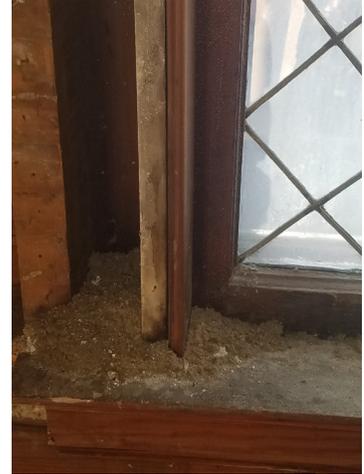
W2-01 (West Unit, South Elevation)

- Leaded single plane glazing with diamond pattern (fixed window)
- These windows will be retained and repaired as required.

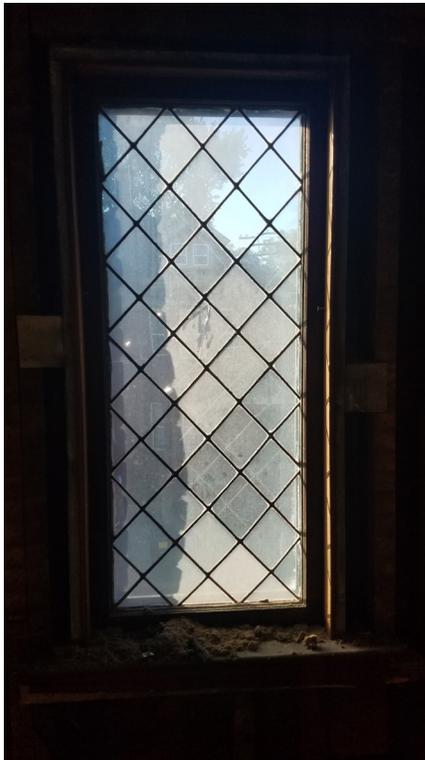
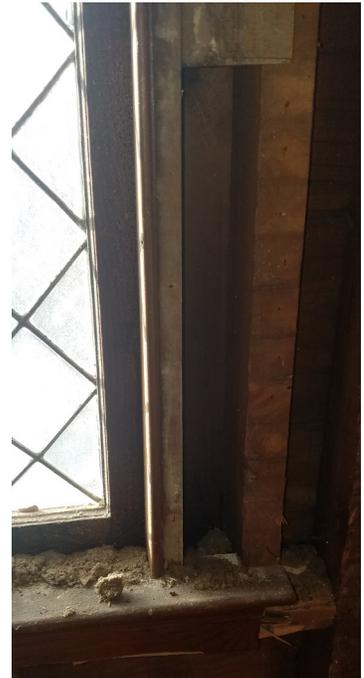
W2-02 (South Unit, South Elevation)

- Leaded single plane glazing with diamond pattern (fixed window)
- These windows will be retained and repaired as required.

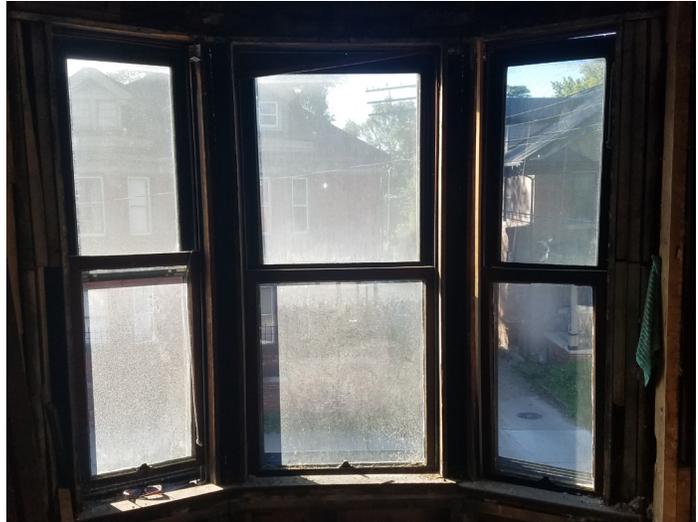
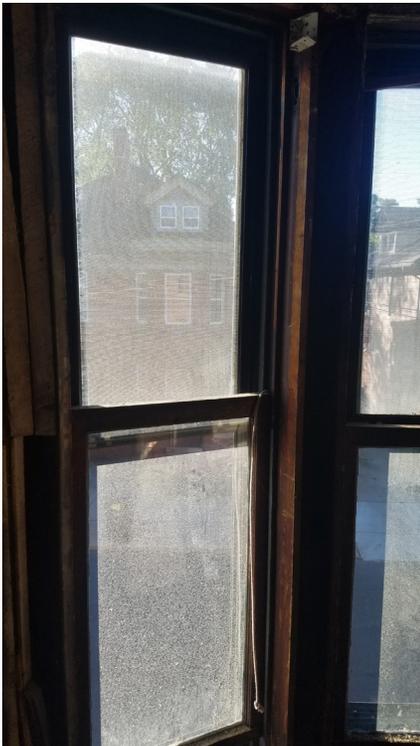
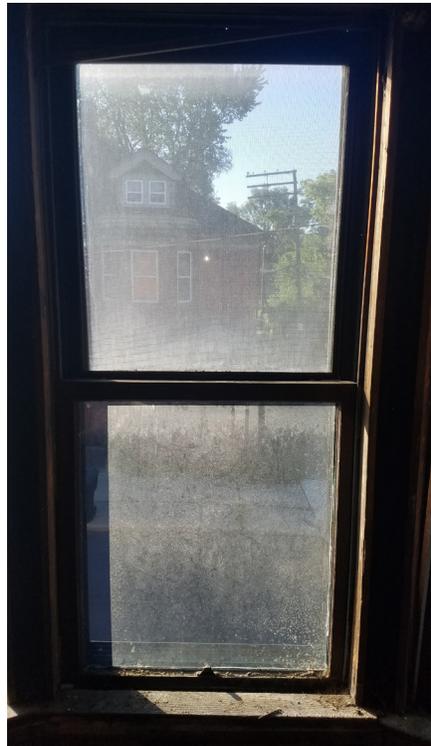
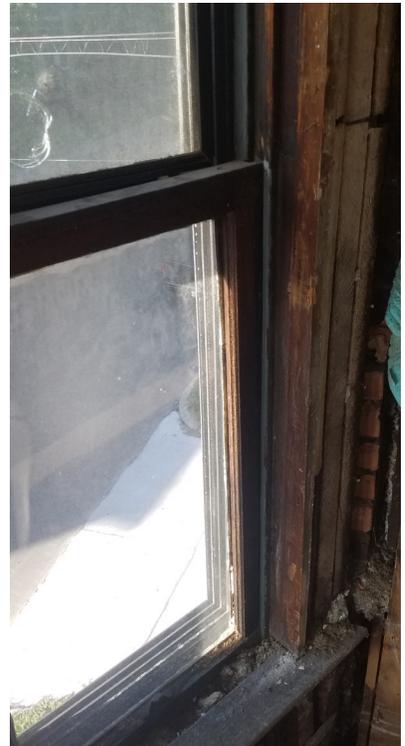
W2-03, 04, 05 (West Unit, South Elevation)

- Missing lower sash (all windows)
- Storm window is pulling away from rotted frame (right side)
- Missing counterweights

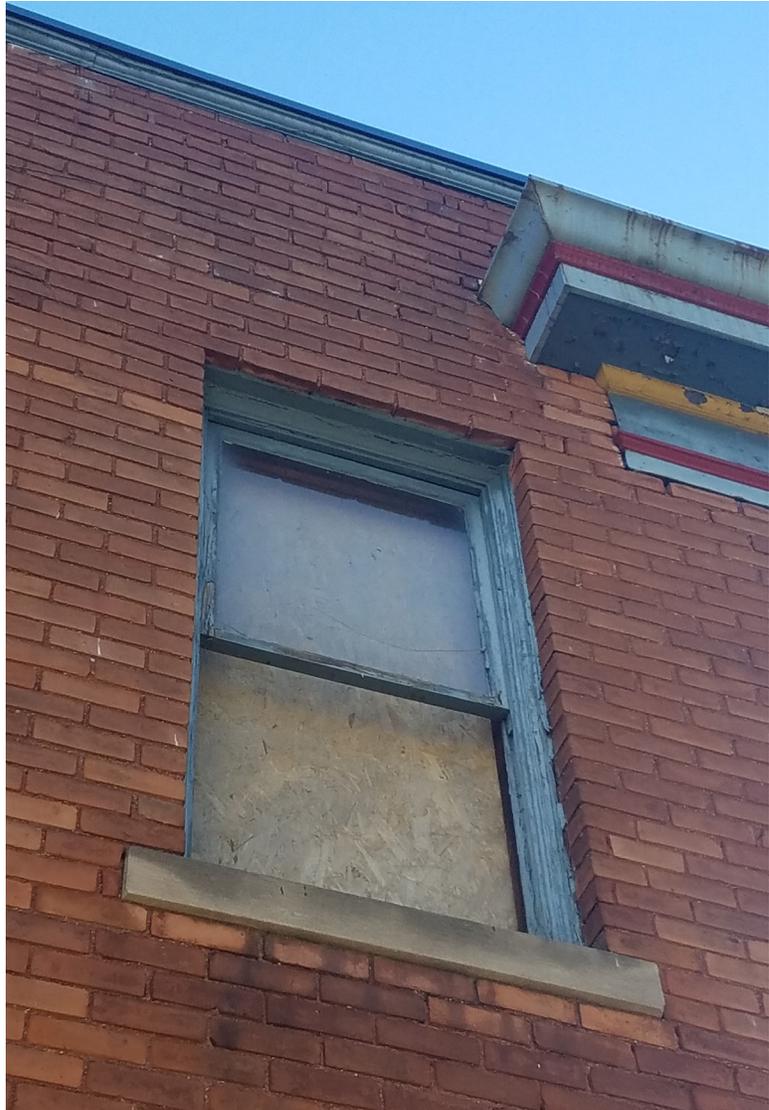
W2-06 (West Unit, West Elevation)

- Missing lower sash

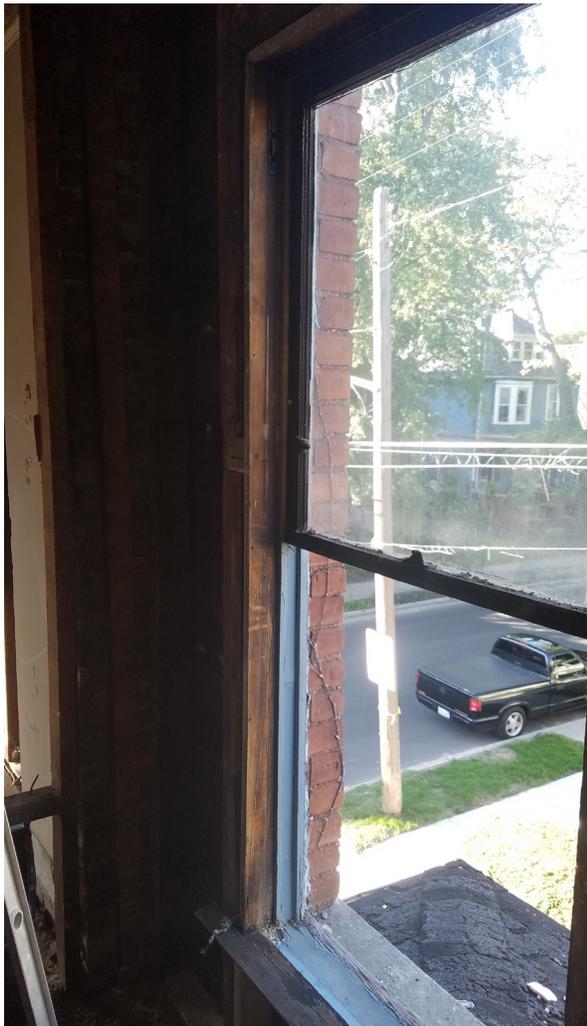
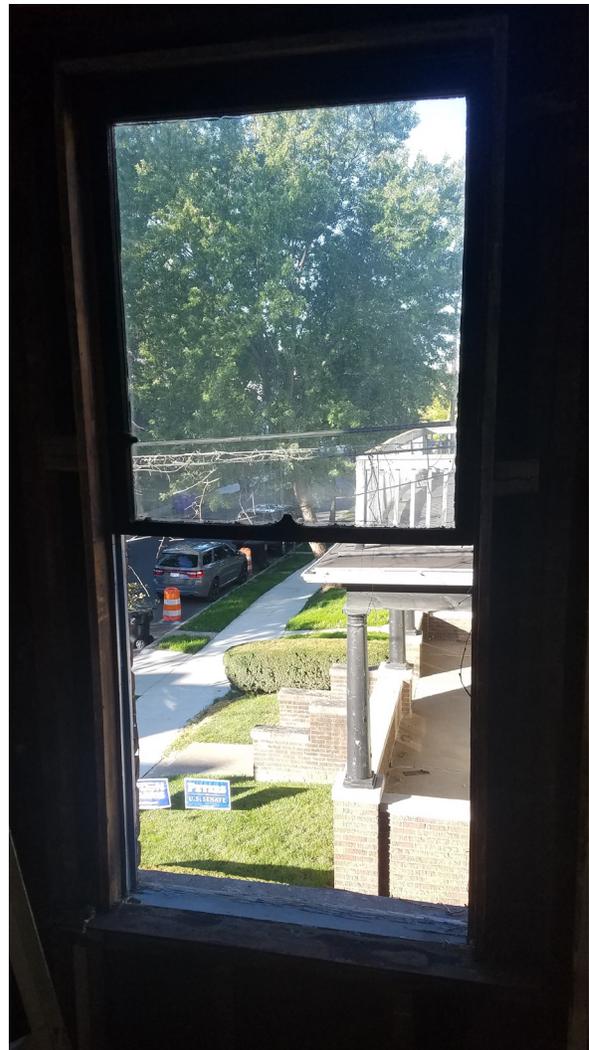
W2-07 (West Unit, West Elevation)

- Missing entire window
- Missing lower sash of storm window

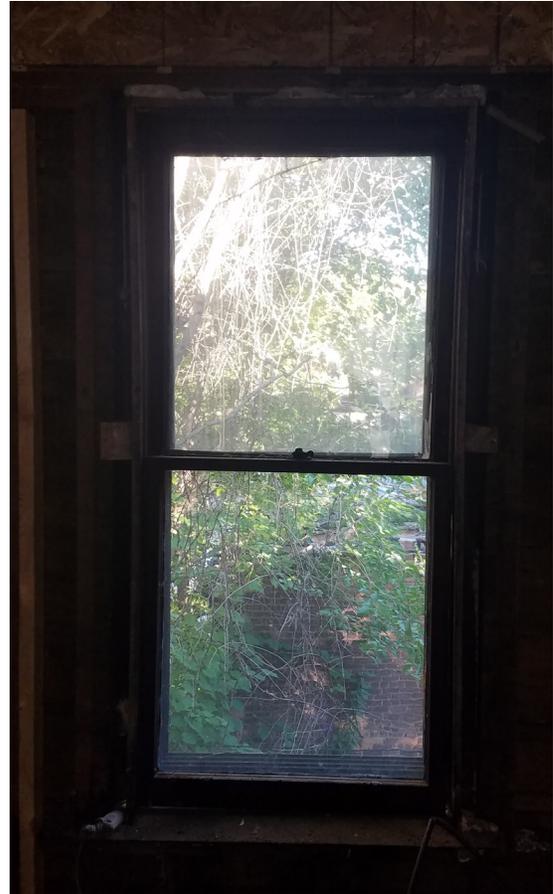
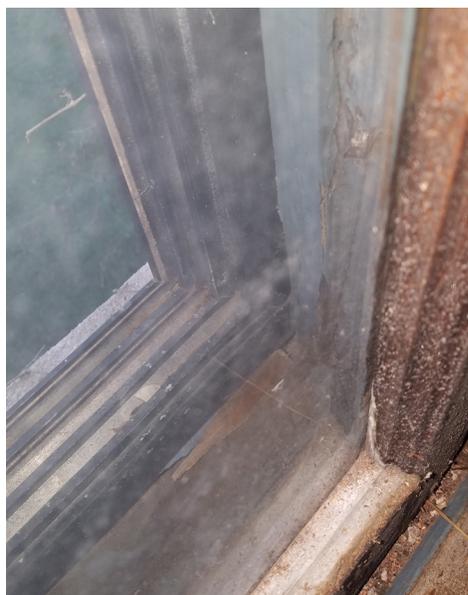
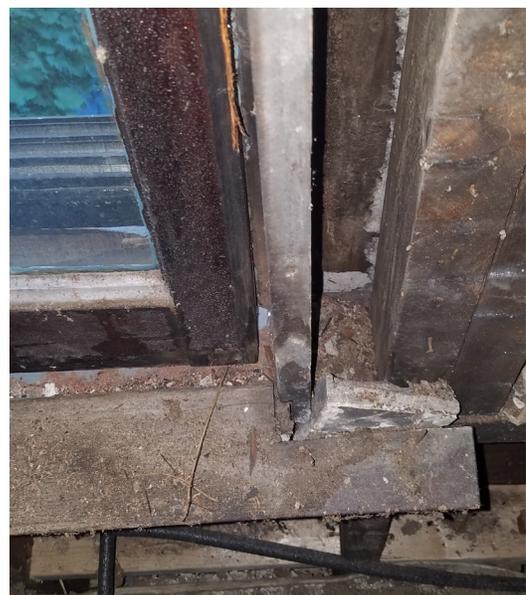
W2-08 (West Unit, North Elevation)

- Missing upper sash
- Damage at sill
