RE: 7949 Lafayette Residential Duplex Renovations, Historic District Commission Submission

Description of Existing Window Conditions

Window Assessment

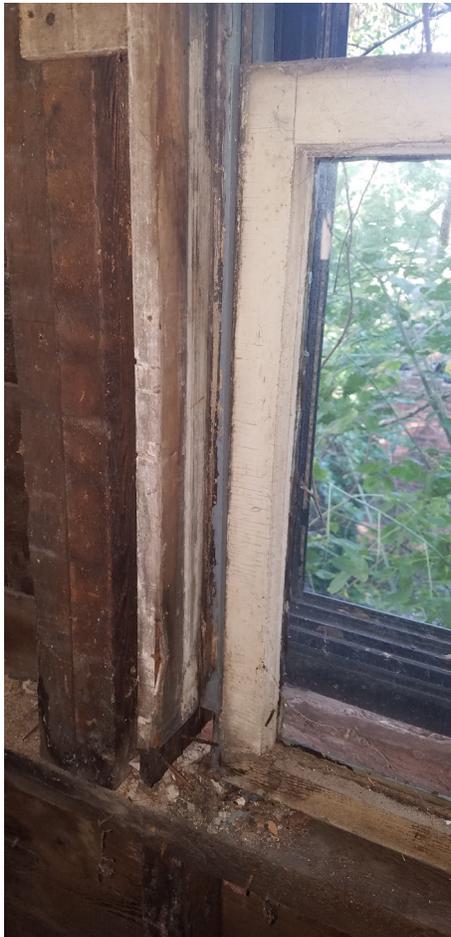
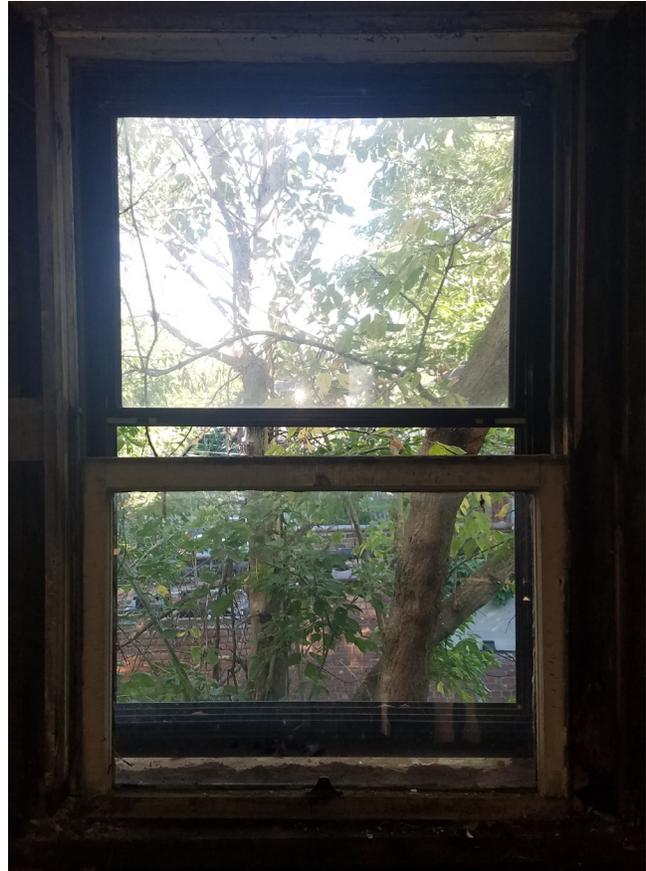
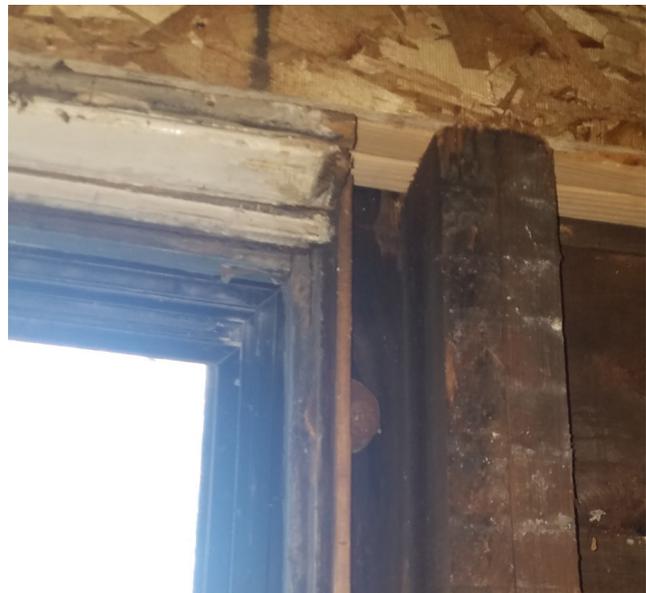
W2-09 (West Unit, North Elevation)

- Missing lower sash
- Missing lower sash of storm window
- Rot observed at bottom of upper sill
- Missing right jamb frame
-
