RE: 2221 Wabash – Structural Condition Evaluation

Project No. 19-1005

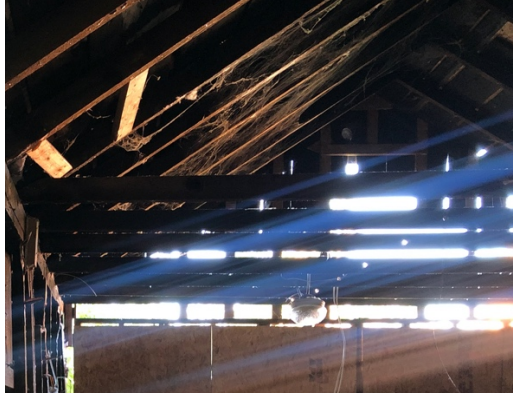
- a. Many roof framing members are showing signs of water exposure, efflorescence, and rot
- b. Roof framing members (2x4's at 24" O.C.) are structurally deficient for current code required wind and snow loads – refer to Photograph P1
- c. Roof framing is missing critical stability elements such as ties and hold downs
- d. Roof at rear of cottage has collapsed and is no longer attached to the main area framing

P1: Roof Framing Members

Roof is framed of 2x4's with no ties at the ridge preventing separation for wind uplift forces. Roof framing members are significantly undersized and the roof configuration is unstable

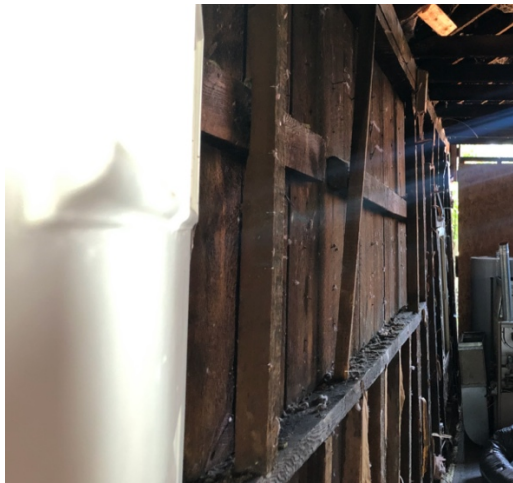
Photograph P2

P2: Bearing Wall Leaning

Exterior walls are leaning significantly as a result of structurally deficient lateral force resisting and roof framing systems.

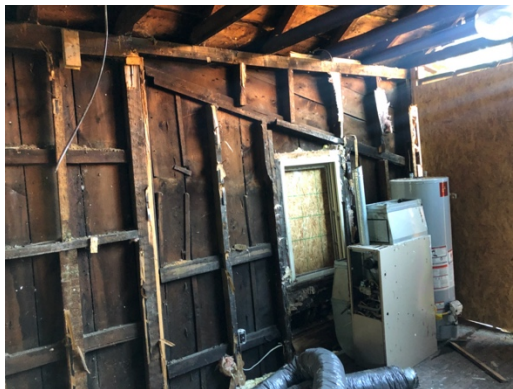
Photograph P3

P3: Representative Lateral System

The existing lateral force resisting system consists of members which do not form a complete load path and are otherwise not suitable to serve their intended purpose both in terms of strength and performance.

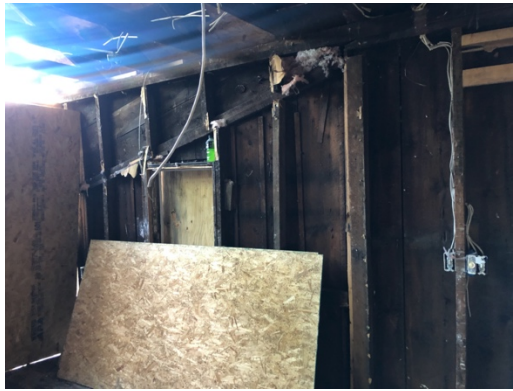
Photograph P4

P4: Representative Lateral System

Alternate condition to P3 – refer to P3 commentary

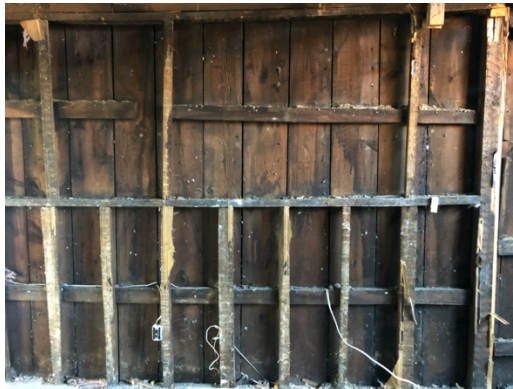
Photograph P5

P5: Wall Framing Conditions

Wall studs are in many cases portions of a rough sawn 2x4. Most wall studs are also discontinuous near the middle third of their span. Stud spacing are also irregular throughout the cottage with studs spaced at 64-inches on center in the most extreme circumstances

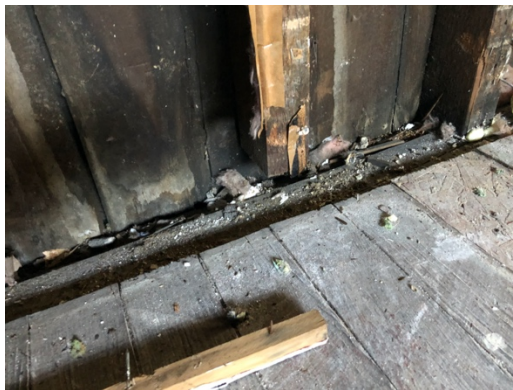
- a. Walls are leaning both in plane and out of plane significantly – refer to Photograph P2
- b. No suitable lateral force resisting system exists – refer to Photographs P3 and P4
- c. Wall studs are significantly smaller than nominal 2x4 dimensions as a result of the manufacture process - some studs appear to have been split from logs as opposed to rough sawn
 - i. Wall studs are structurally deficient for current code required wind and snow loads – refer to Photograph P5
- d. Wall stud spacings range from 16" O.C. to 64" O.C. – refer to Photograph P5
- e. Many wall studs are not continuous from the sill plate to the top plate forming an internal hinge which compromises the stability of the walls for out of plane wind forces – refer to Photograph P6

P6: Wall Framing Conditions

Many wall studs are not connected at the sill plates. They appear to be hanging from a combination of the wall top plate and the slat sheathing.

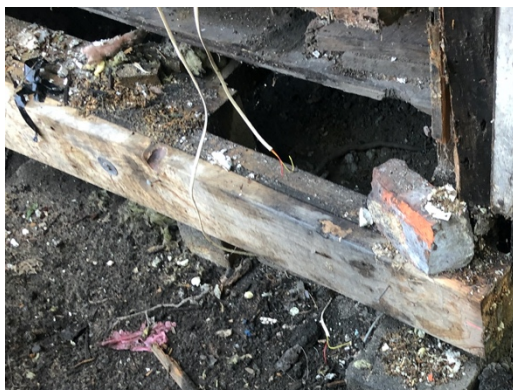
- a. Floor structure deflects noticeably under the weight of a person - approx. 1.5" as measured at entrance threshold under walking loads
- b. Floor framing members have experienced heavy rot likely a result of water exposure – refer to Photograph P7
- c. Floor framing members have experienced significant section loss likely a result of insect infestation – refer to Photograph P7
- d. Floor structure has a considerable slope - approx. 1V:8H

P7: Floor Structure Deterioration

Framing has been exposed to moisture and the environment. Rot and insect infestation were observed and appear to occur through the structural framing of the first floor.

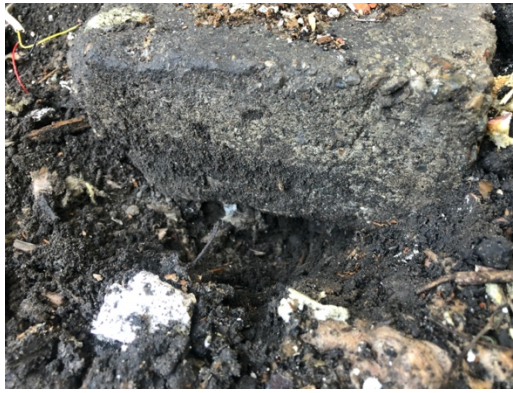
Photograph P8

P8: Foundation Above Frost Depth

The foundation system does not extend to frost depth and consists of approximately 4-inch thick concrete blocks laid close to grade elevation (foundations are approximately 4-8-inches below exposed grade at the cottage). The unreinforced strength of the concrete block is insufficient to safely carry current code required loads and is otherwise structurally deficient.

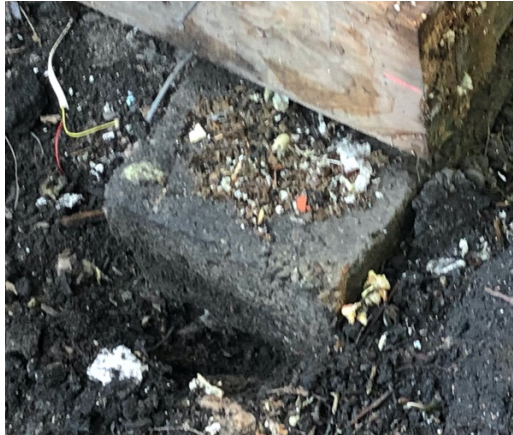
Photograph P9

P9: Foundation Above Frost Depth

Alternate perspective photograph of foundation identified in P8 - refer to P8 for commentary.
