J&M

WOOD PORCH at 687 ALEXANDRINE

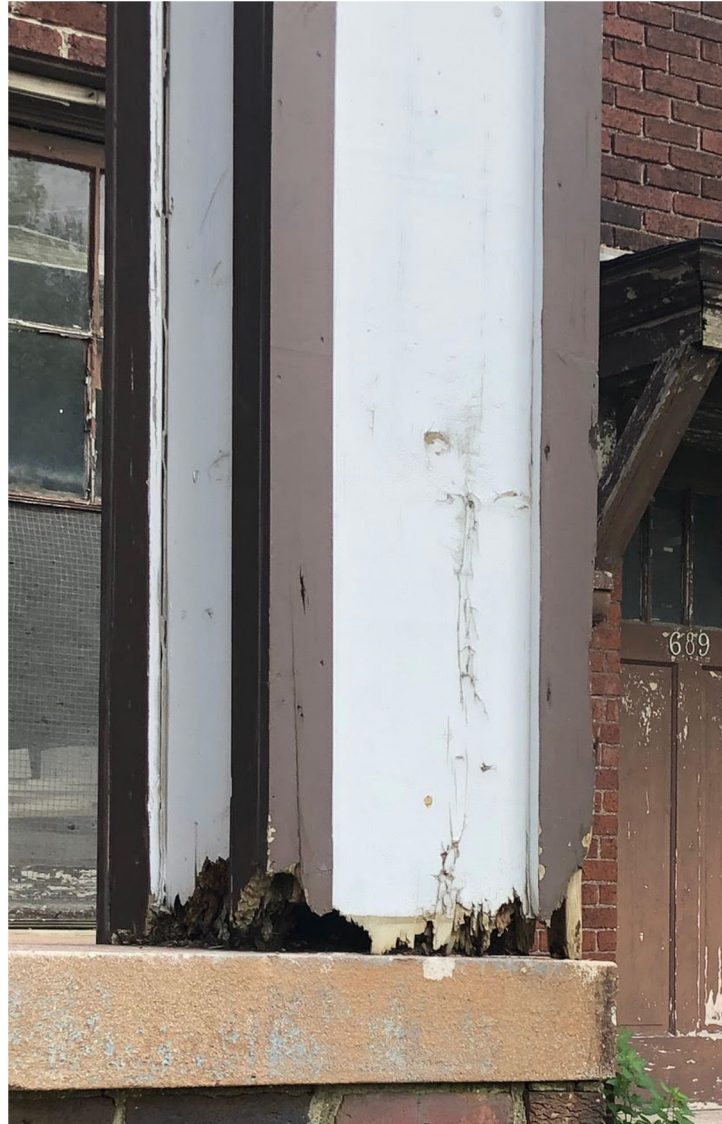
PORCH COLUMNS

- Columns have severe rot and decay
- Trim boards are missing

It is our opinion that the wood on the porch has severe rot and is in disarray. The upper porch is dangerous and should not be used. The wood on the porch needs to be disassembled while supporting the roof. The porch to be rebuilt using new wood and support columns. Trim board to be installed to match existing and painted to reduce the chance of rot.

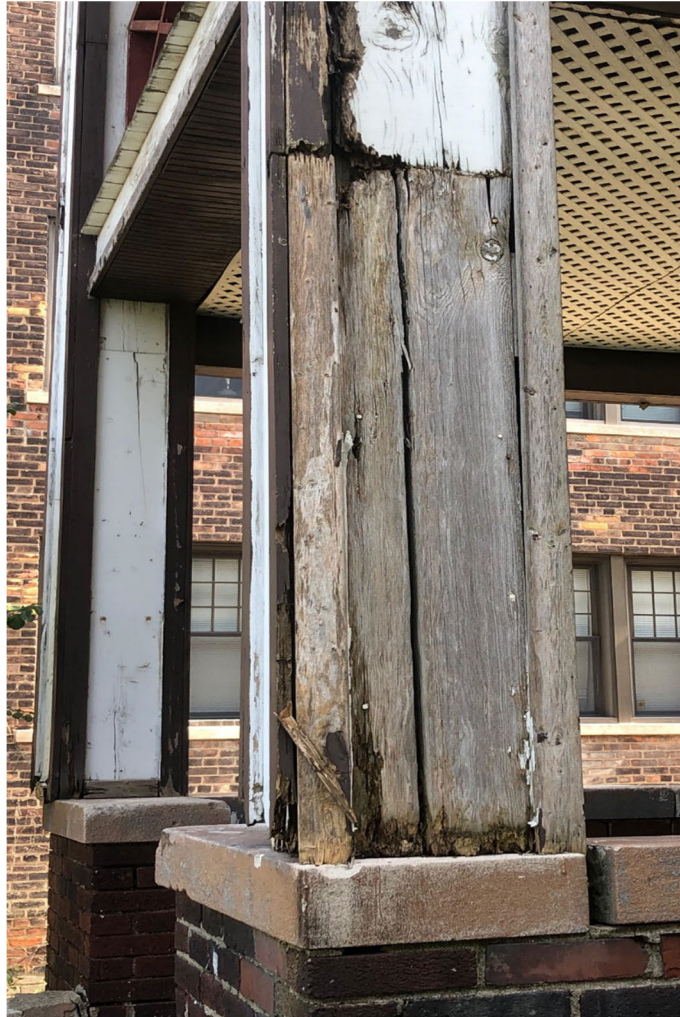
- Boards have been replaced
- Columns have severe rot and decay
- Support for the upper porch is in risk

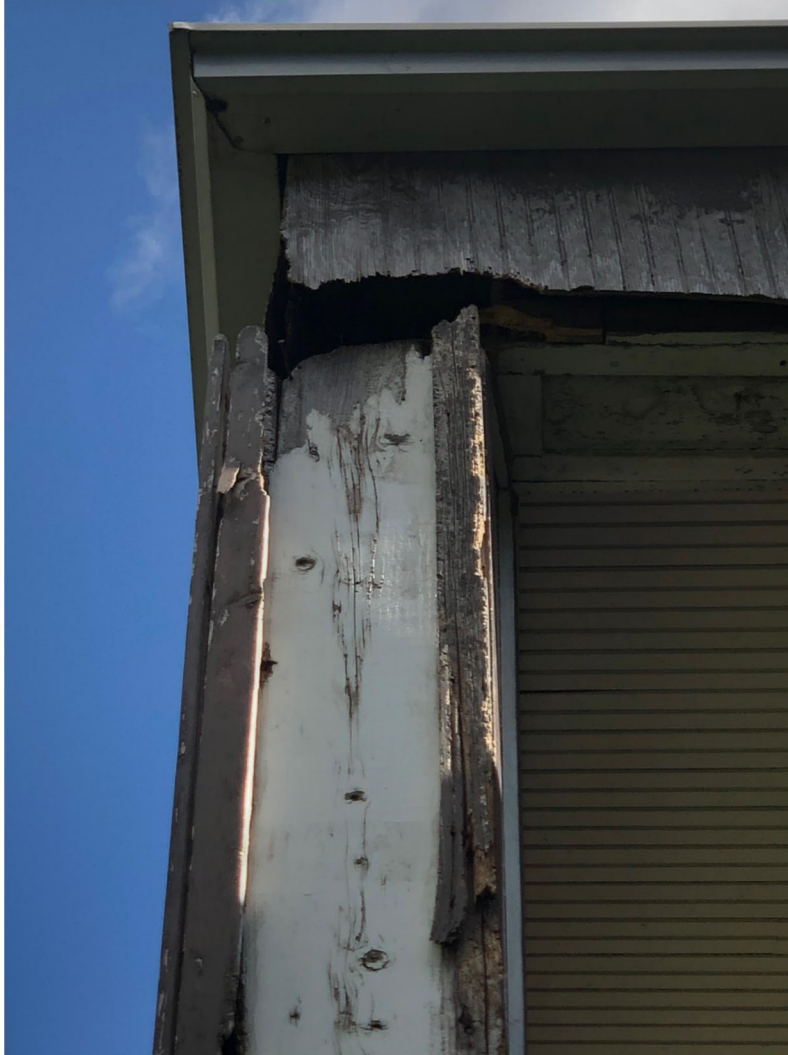
- Boards have been replaced
- Trim boards are missing
- Columns have severe rot and decay could collapse causing the upper porch to collapse.
- Facia boards have rotted away

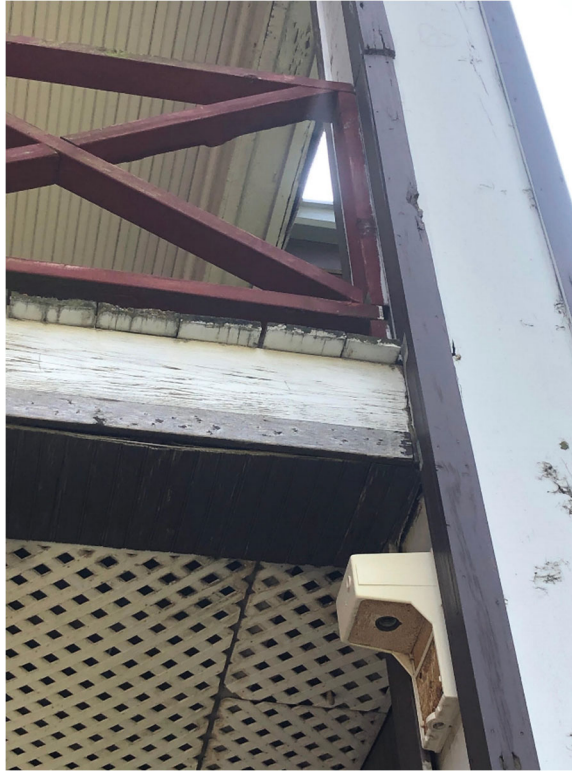
UPPER PORCH

- Upper porch has some rot in the supports
- The flooring has a lot of rot (would not recommend anyone venture onto the porch)
- The ceiling of the lower deck has been replaced with viny lattice.

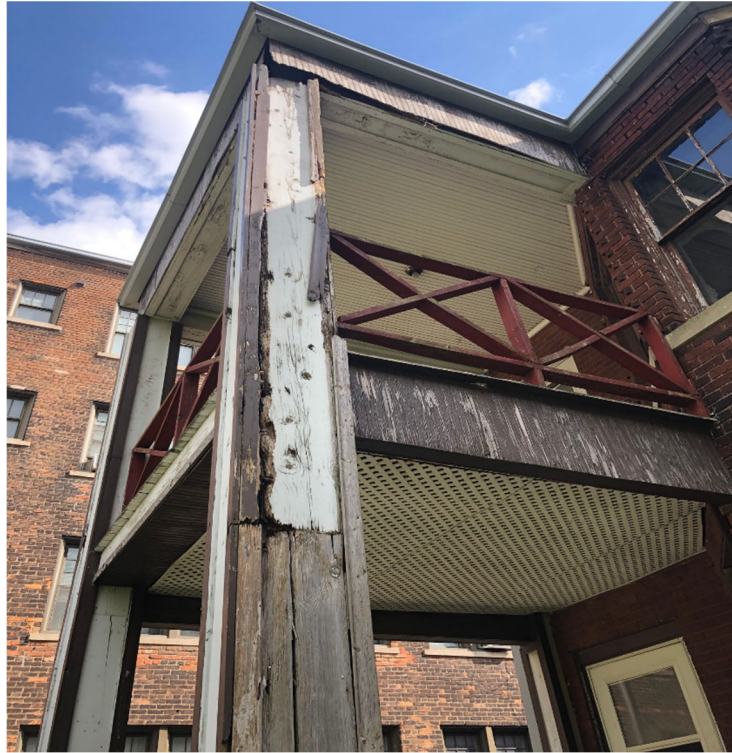
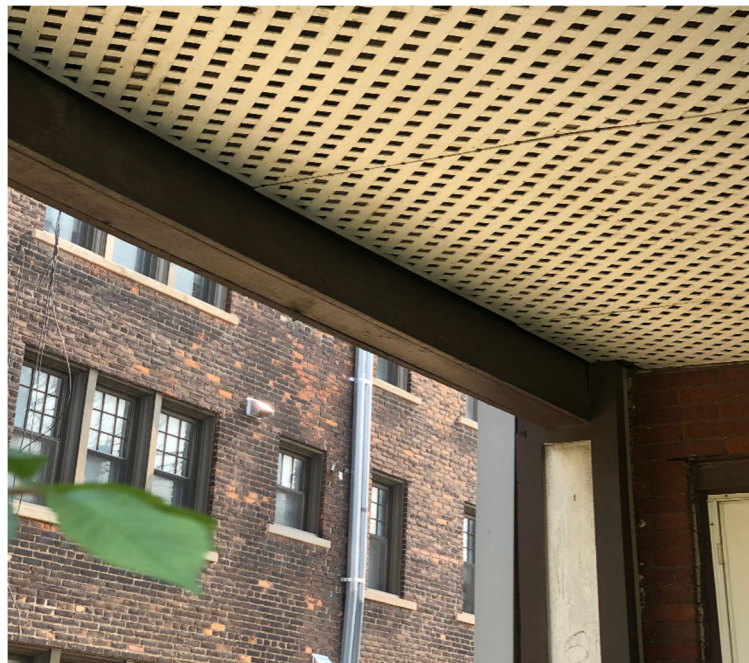
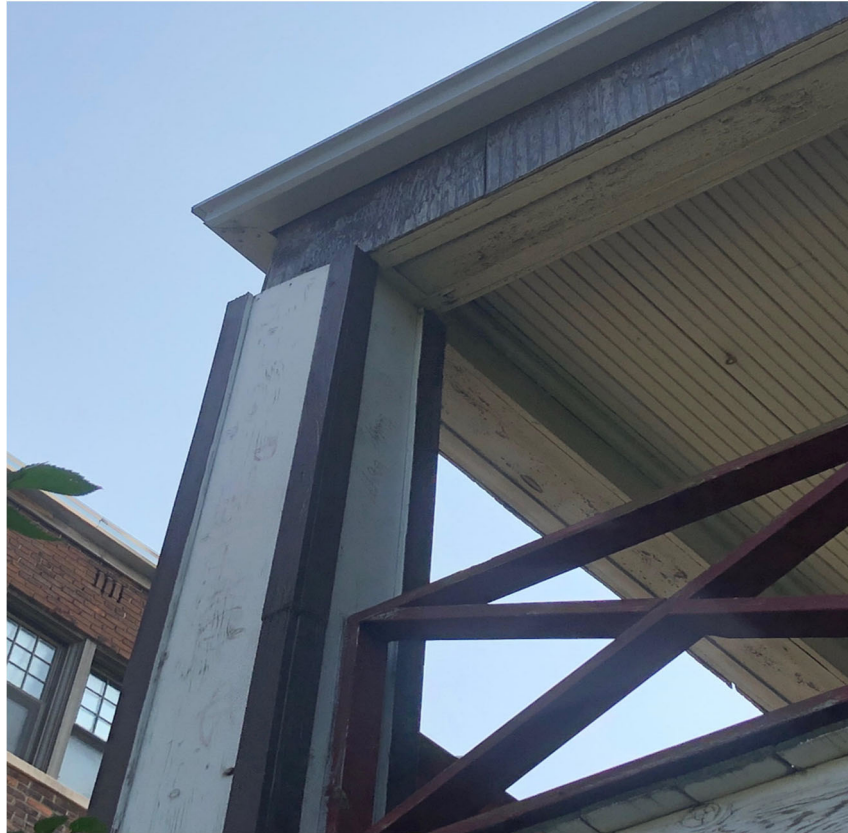
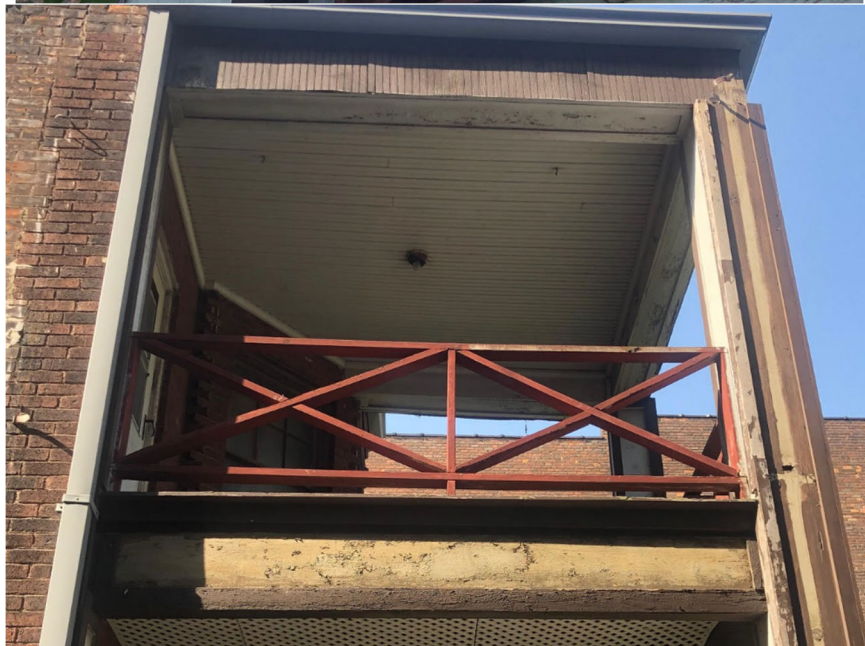
- Column has shifted from support on the upper roof.
- Railing has rot.
- Railing does not meet code.
