687 Alexandrine Porch's Report

STEP and STEP WALLS

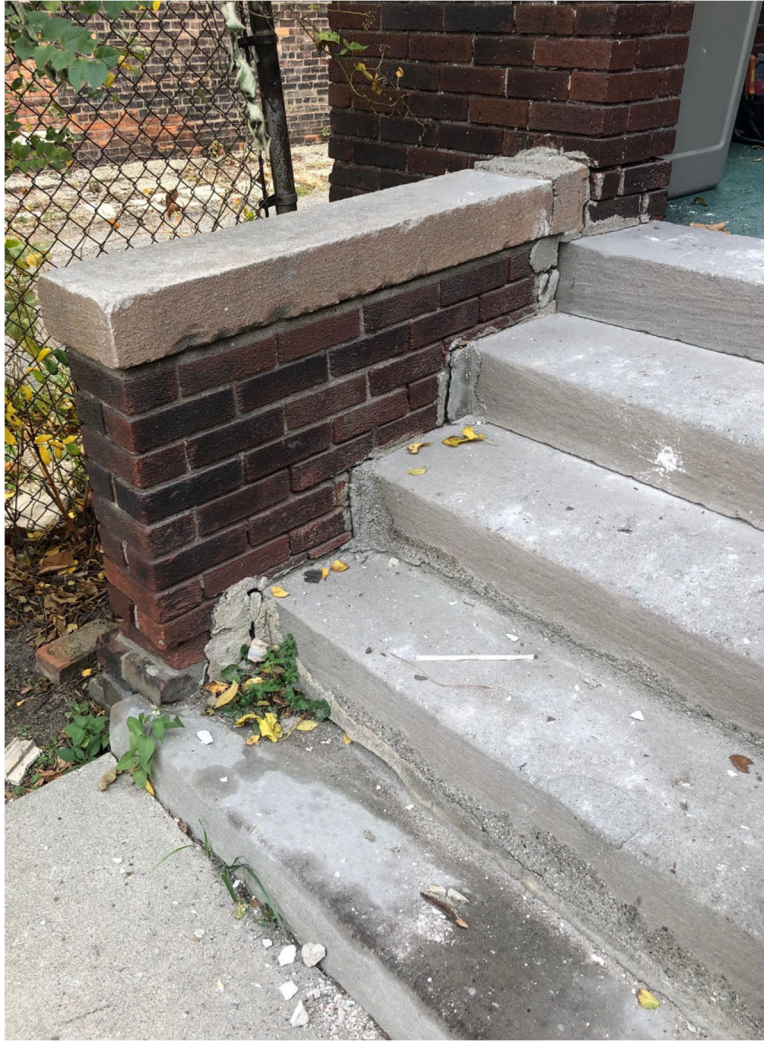
- Steps have pulled away from the porch and was improperly filled
- Wall has pulled away from the porch and was improperly filled
- Steps are not to code or ADA compliance.
- There are gaps between the steps and have been filled

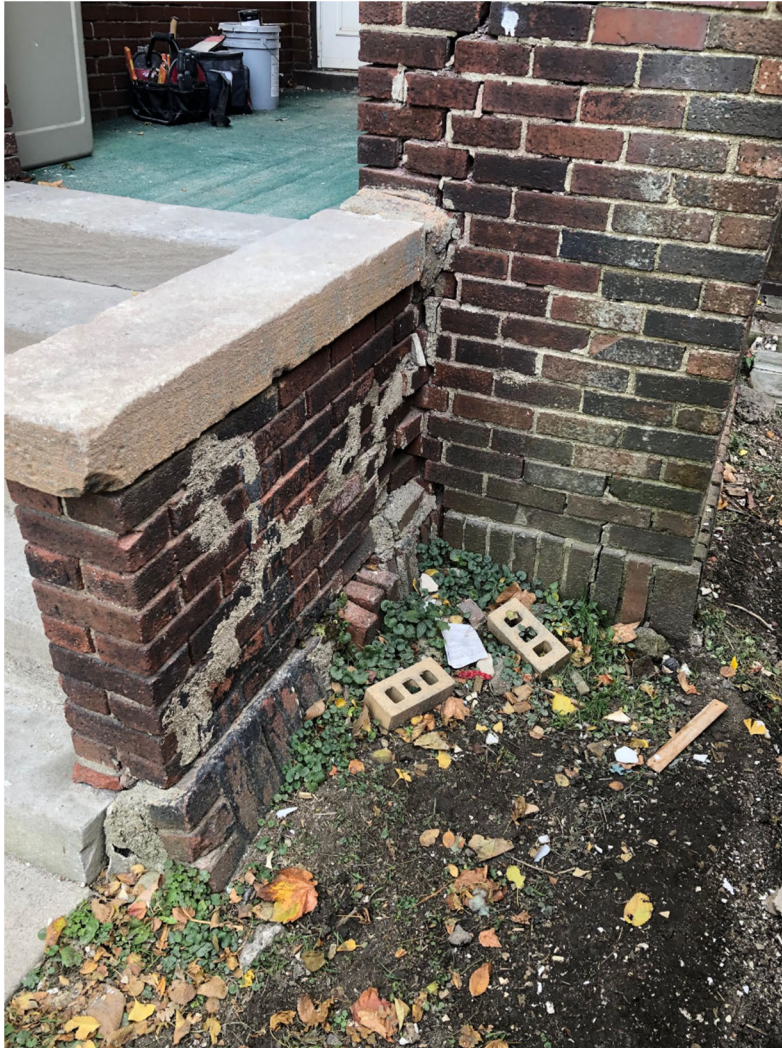
- Wall is 2 layers of brick
- Wall has pulled away from the porch and was improperly filled
- Wall is falling apart. Will need to be torn down and rebuilt to make right.
- The gaps in the brick have been improperly filled and look bad.
- Bricks are loose and falling out

It is our opinion that the porches are in server disarray. The porches are dangerous and needs to be disassembled, and the brick be cleaned of old mortar, the limestone steps, and caps to be removed and cleaned. The porch to have a concrete footing and the porch to be rebuilt using the existing brick and limestone steps and caps.

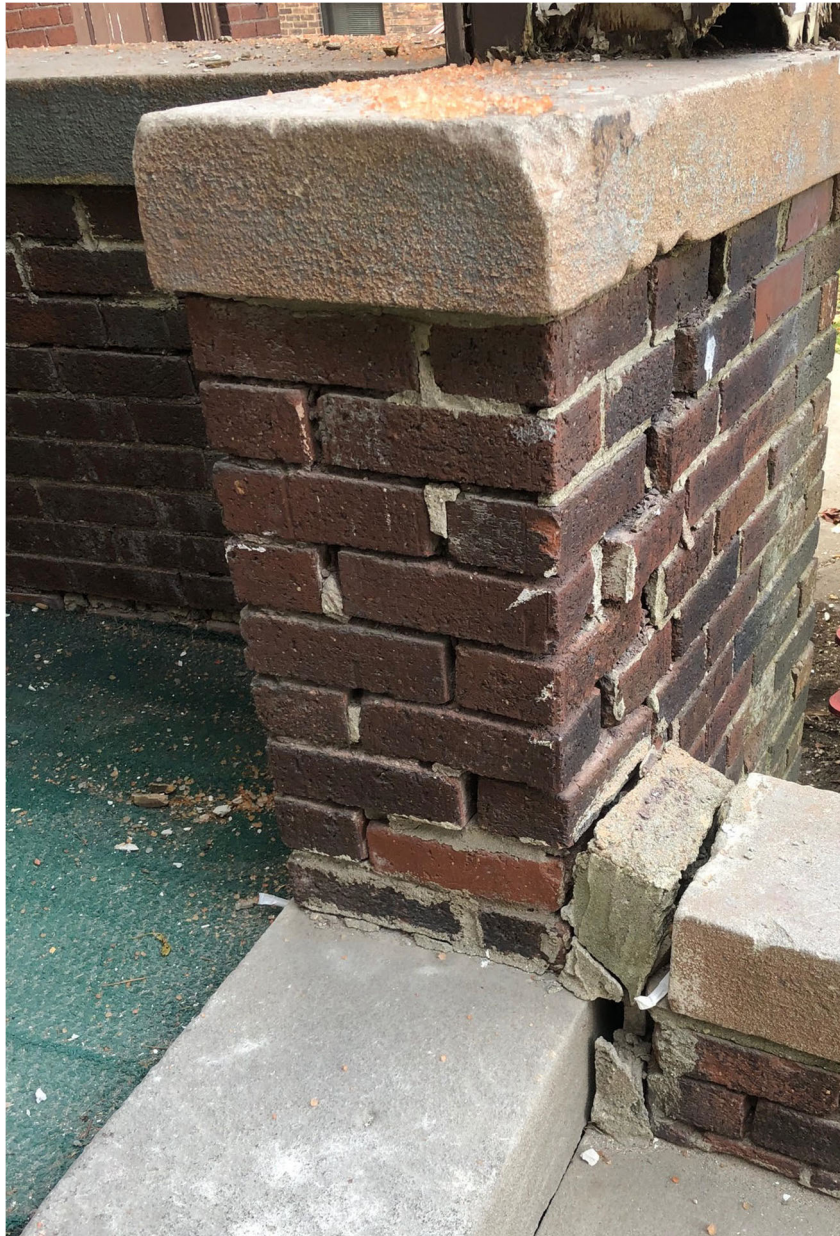
- Wall is 4 layers of bricks
- The gaps in the brick have been improperly filled and look bad.
- Bricks are loose and falling out
- Wall is falling apart. Will need to be torn down and rebuilt to make right.
- Some bricks have been replaced with non-matching bricks.

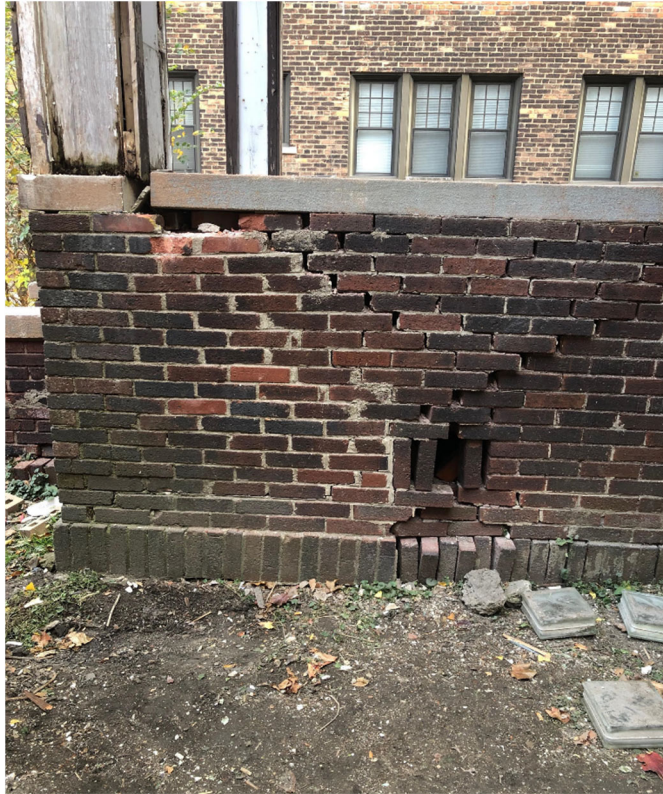
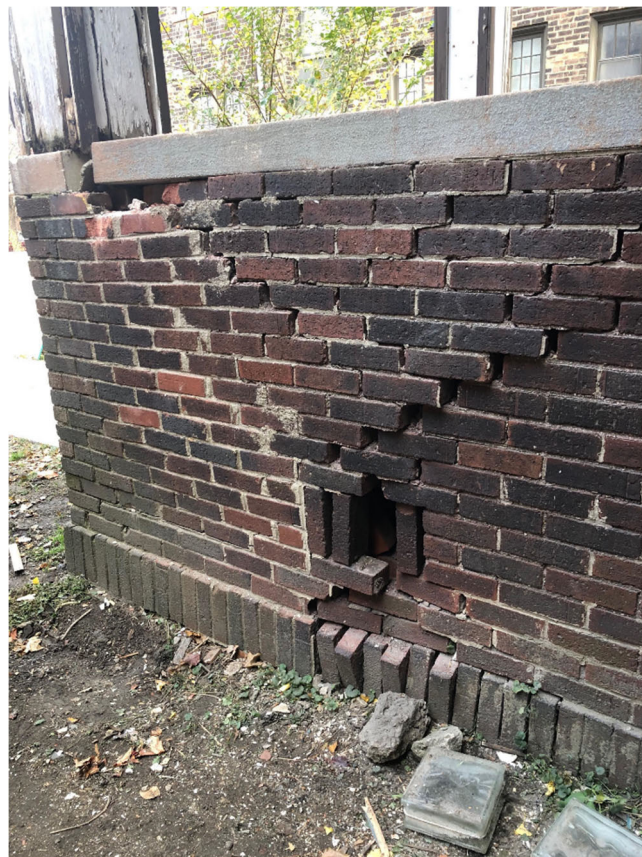
- Wall is 4 layers of bricks
- There are severe cracks in the porch wall
- The gaps in the brick have been improperly filled and look bad.
- Bricks are loose and falling out
- Wall is falling apart and is unsafe. Will need to be torn down and rebuilt to be corrected.
- Some bricks have been replaced with non-matching bricks.
- Wall supports the upper porch and is leaning out and could collapse causing the upper porch to collapse also.

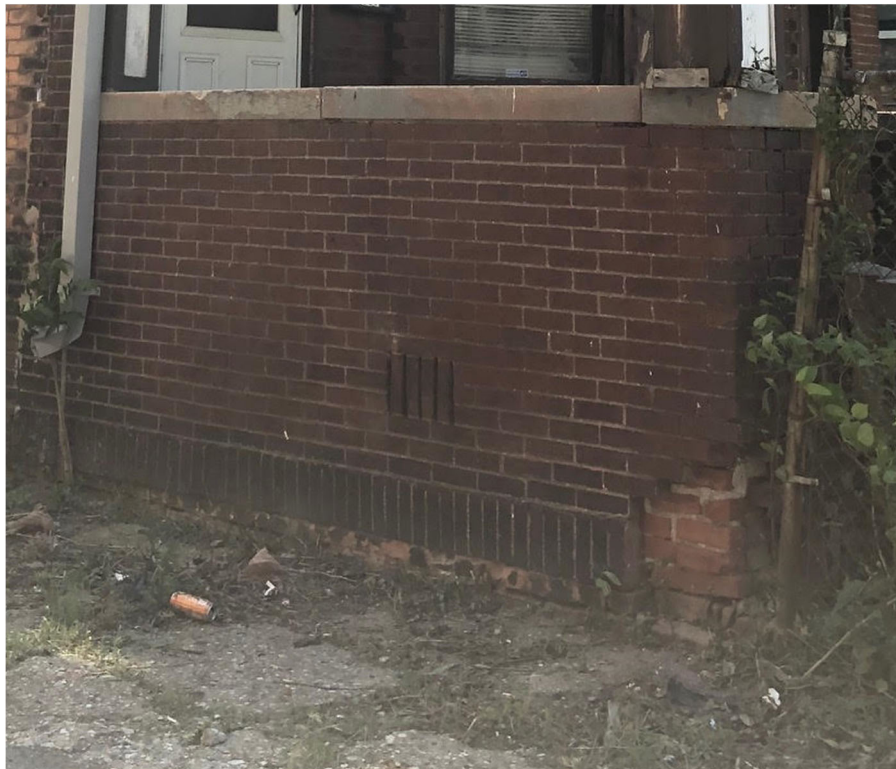
- Bricks on corner are missing.
- The rest of the porch walls is in good condition. Bricks need to be cleaned.

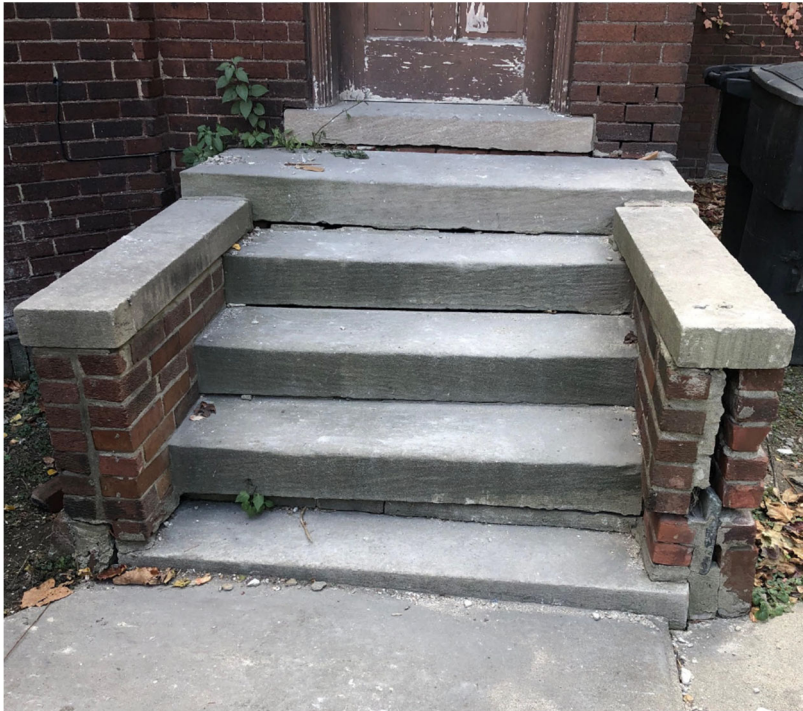
- Steps have pulled away from the porch and was improperly filled
- Step Wall has pulled away from itself and was improperly filled
- Steps are not to code or ADA compliance.
- There are gaps between the steps and have been filled

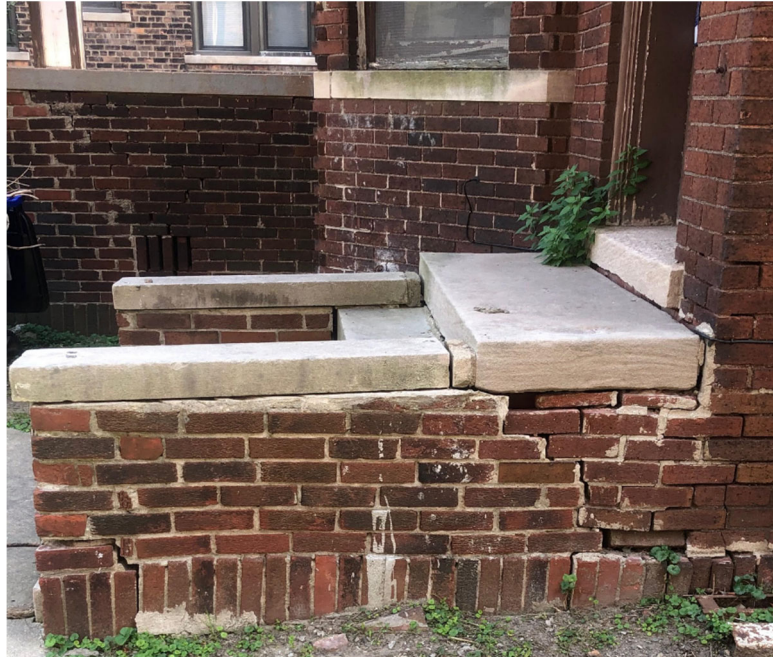
- The gaps in the brick have been improperly filled and look bad.
- Bricks are loose and falling out
- There are severe cracks in the porch wall
- Wall is falling apart and is unsafe. Will need to be torn down and rebuilt to be corrected.
- Some bricks have been replaced with non-matching bricks
