687, 689, 691 **W. ALEXANDRINE** WINDOW REPORT

THE CITY OF DETROIT HISTORIC **DISTRICT COMMISSION HEARING**

DECEMBER 9, 2020

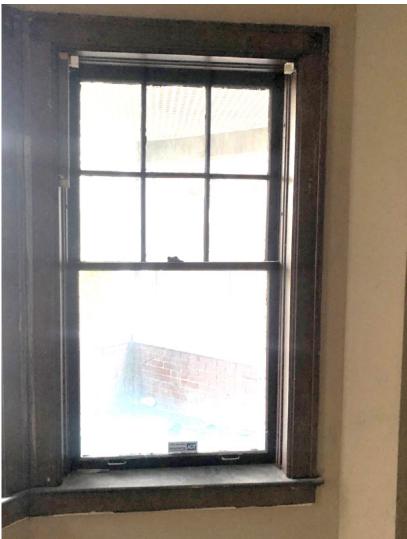
- Window is sealed shout
- Exterior windowsill has some rot
- One of the lead weights is missing
- Window is cocked in opening
- Window will not lock
- Window needs to be re-putted
- Weather stripping missing

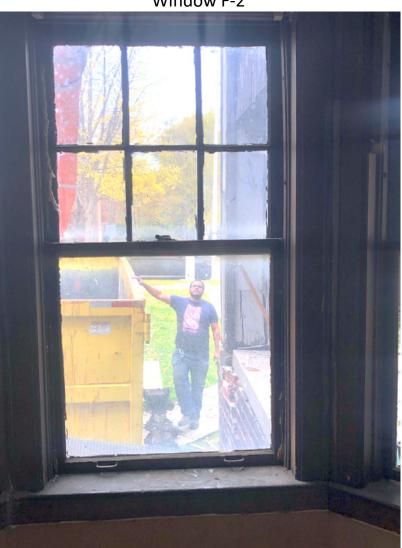
Window F-2

- Window opens but the lead counterweights are missing
- Interior sill is rotten
- One stop is missing, and the other stop is missing all but one of the screws
- Window needs to be re-putted
- Weather stripping missing
- Jamb on right side has rot

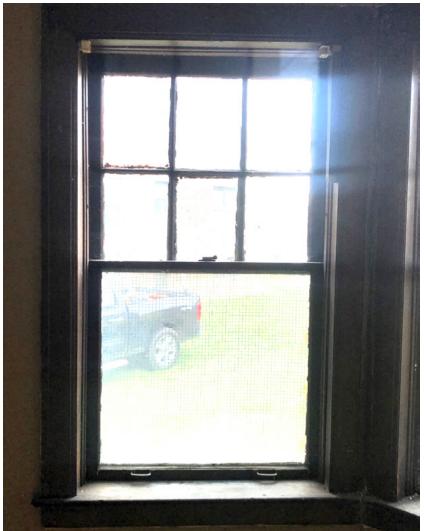
Window F-3

- Window is sealed shout
- Exterior windowsill and jamb have some rot
- Glass is broken in bottom sash
- Both lead weights are missing
- Bottom sash has rot right side
- Trim at bottom of window has rot
- Weather stripping missing
- Window needs to be re-putted

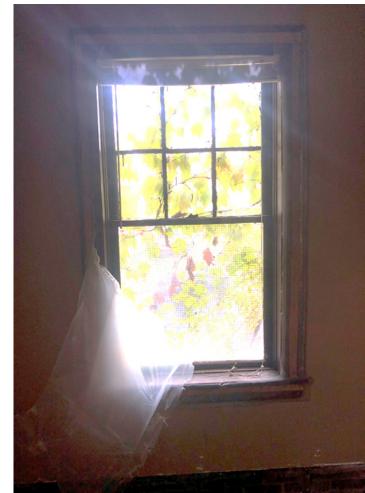
Window F-4

- Window will not open
- Missing Handles
- Both of the lead weights are missing
- Upper Sash has extensive rot on bottom
- Window interior sill had some replacement
- Exterior brickmold extensive rot on bottom
- Exterior sill has extensive rot
- Weather stripping missing
- Window needs to be re-putted
- Window will not lock

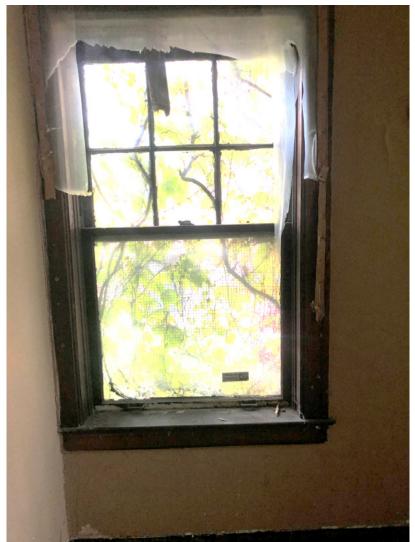
Window F-5

- Upper sash has fallen and will not move. Old newspaper has been stuffed in gap
- Window needs to be re-putted
- Both lead weights are missing
- Interior sill is rotten
- Bottom sash has extensive rot
- Stops have rot
- Exterior left brickmold has extensive rot
- Exterior sill has extensive rot

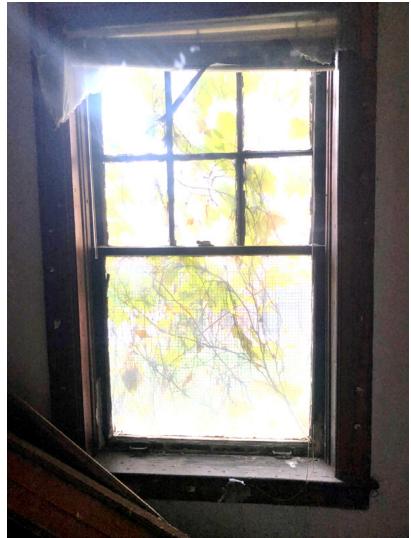
Window F-6

- Window will not open
- Bottom sash has extensive rot
- Window needs to be re-putted
- Both lead weights are missing
- Interior sill is rotten and broken
- Exterior sill has extensive rot, and the sash is pushed out
- Stops are missing
- Weather stripping missing

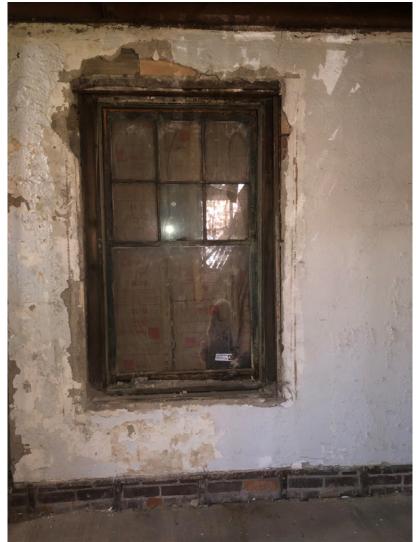
Window F-7

- Internal sill is missing
- Window was boarded up on the outside and sealers was use around the sashes
- Stops are broken on both sides
- Sever rot on what is left of the jambs
- Stops are missing
- Upper Sash glass is broken
- Lead weights are missing
- Trim is missing

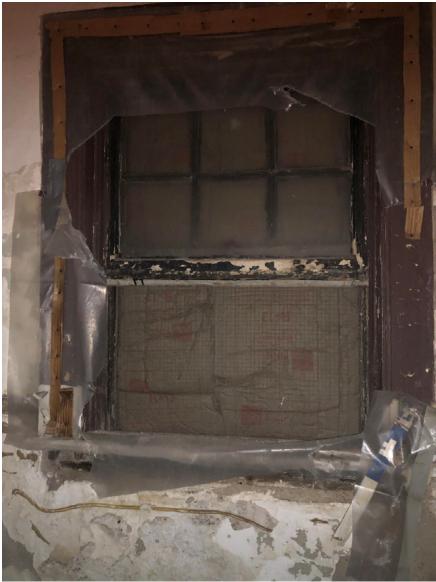
Window F-8

- Internal sill is missing
- Window was boarded up on the outside
- Bottom sash missing
- Stops are broken on both sides
- Sever rot on jambs

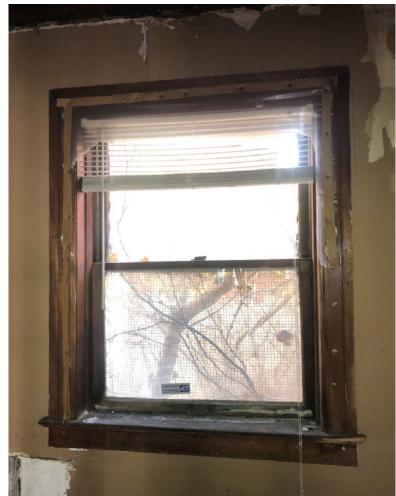
Window F-9

- Both sashes' have severe rot
- Missing both handles
- Window needs to be re-putted
- Both lead weights are missing
- Window will not open
- Weather stripping missing
- Jamb on right side has water damage
- Brick molding on both sides have severe rot
- Exterior sill has extensive rot
- Stops have been replaced and do not match

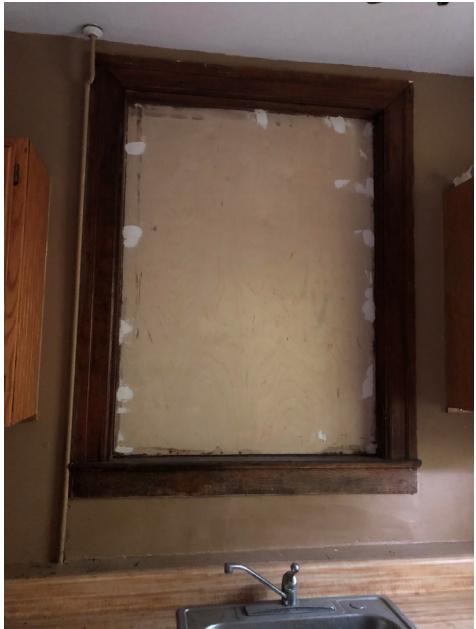
Window F-10

• Sashes' and stope have been removed and the window is boarded up inside and on the outside.

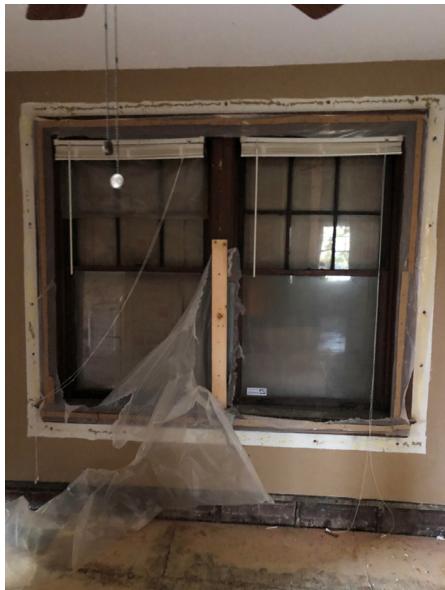
Windows F-11 & 12

- The window is boarded up on the outside.
- Exterior sill has extensive rot
- Both sashes' have severe rot
- Windows need to be re-putted
- Weather stripping missing
- Lead weights are missing in both windows

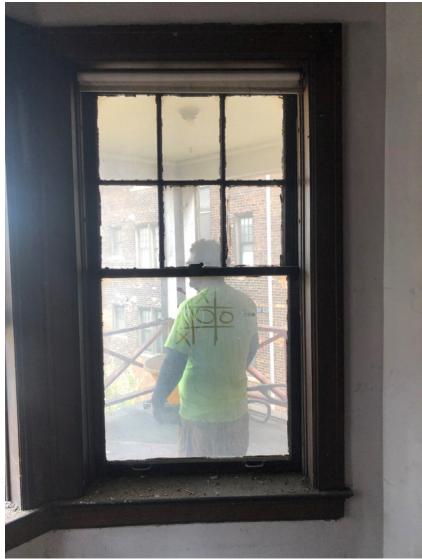
Window S-1

- Window will open
- Exterior sill has rot
- Sashes will not line up or lock
- Weather stripping missing
- Interior sill is rotten
- Window needs to be re-putted
- Lead weights are in place, but cords need replacing

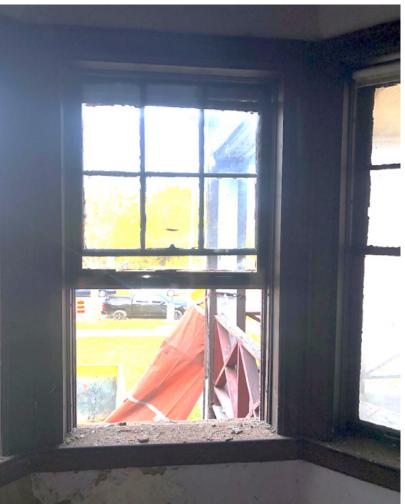
Window S-2

- Window will open
- Lead weights are in place, but cords need replacing
- Bottom sash has some rot
- Stopes are missing screws
- Sashes will not line up or lock
- Weather stripping missing
- Window needs to be re-putted
- Interior sill is rotten and loose
- Brick molding on right side have some rot

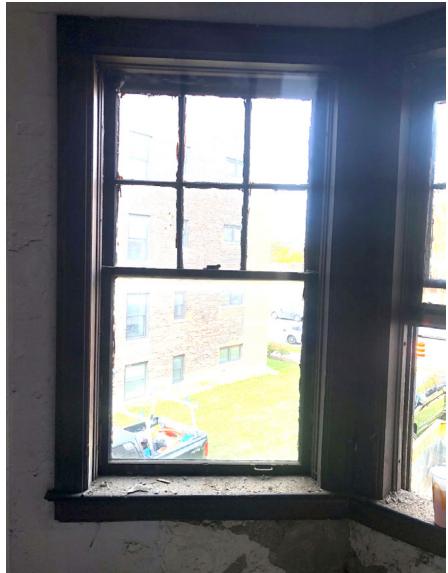
Window S-3

- Right lead weight is missing
- Exterior Sill is broken
- Brick molding on left side has severe rot
- Window will only open halfway
- Missing one handle
- Weather stripping missing
- Bottom sash has rot at bottom

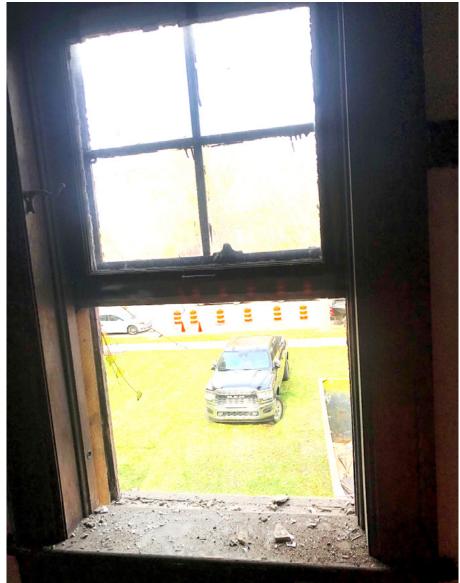
Window S-4

- Window will open
- Lead weights are missing in both sides
- Exterior sill is broken and has rot
- Interior Jamb has water damage
- Window needs to be re-putted
- Weather stripping missing

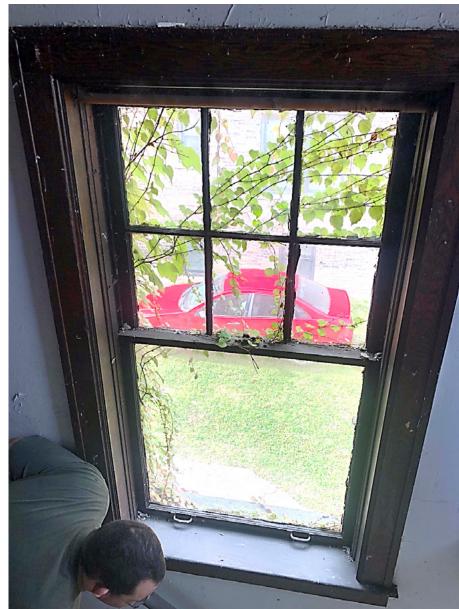
Window S-5

- Missing both weights
- Exterior sill has extensive rot
- Window will not open
- Weather stripping missing
- Window needs to be re-putted

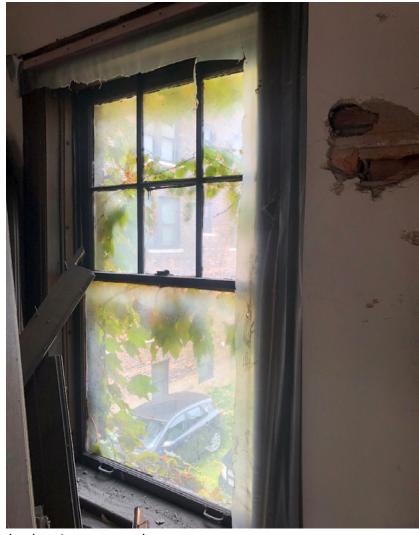
- Glass is broken in upper sash
- Window will not open
- Missing both weights
- Exterior sill has extensive rot
- Window needs to be re-putted
- Missing screws in stops
- Weather stripping missing
- Top sash has rot on right side
- Vines are growing thru window

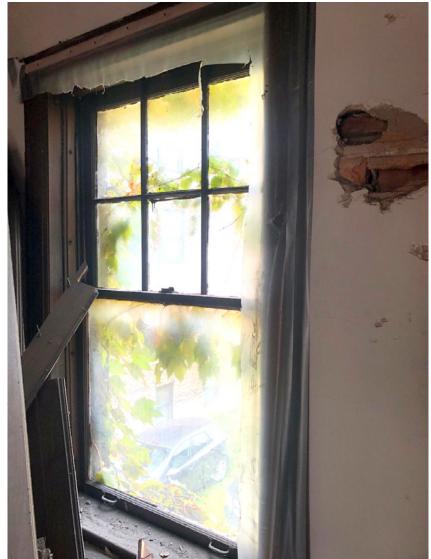
Window S-7

- Window will not open
- Missing one lead weight
- Vines are growing thru window
- Bottom sash is rotten
- Interior sill has damage
- Weather stripping missing
- Window needs to be re-putted

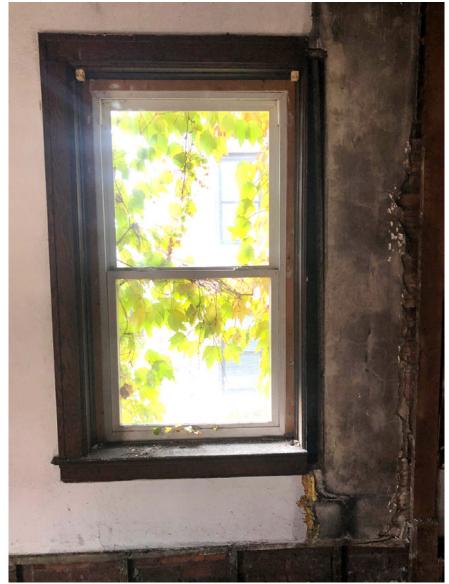
Window S-8

- Window has been replaced with a vinyl replacement that does not fit in opening
- Wood was used to infill the gapes
- Stops are missing
- Sashes are missing
- Lead weights are missing
- Exterior sill is rotten

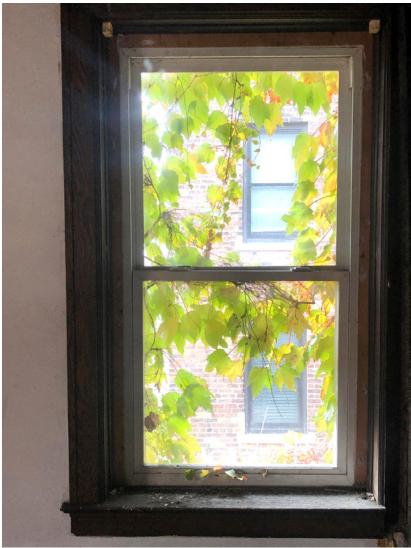
Window S-9

- Windows has been replaced with a vinyl replacement that does not fit in opening
- Wood was used to infill the gapes
- Stops are missing
- Sashes are missing
- Lead weights are missing
- Exterior sill is rotten
- One window is missing trim on right side

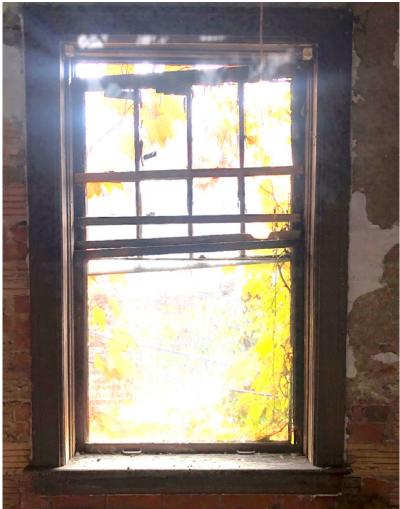
Window S-10

- Upper and lower sashes have massive rot
- Both sashes are falling apart
- Missing glass in upper sash
- Interior sill has massive rot
- Exterior sill has massive rot
- Weather stripping missing
- Stops & Jambs have massive rot and are falling apart
- Trim around window has water damage
- Lead weights are in place, but cords need replacing
- This window is beyond repair and needs to be replaced

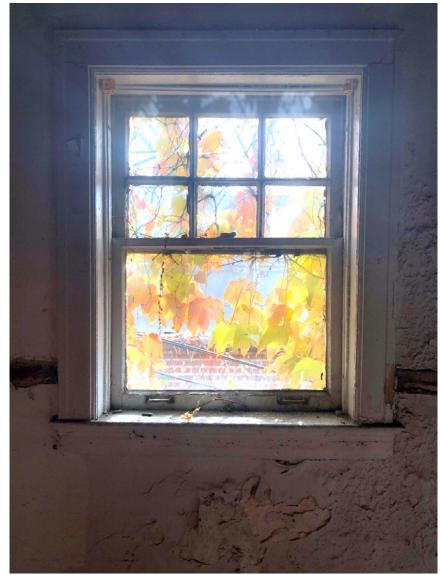
Window S-11

- Window will not open
- Lead weights are in place, but cords need replacing
- Exterior sill has massive rot
- Interior sill is rotten and loose
- Weather stripping missing
- Window needs to be re-putted
- Bottom sash has extensive rot

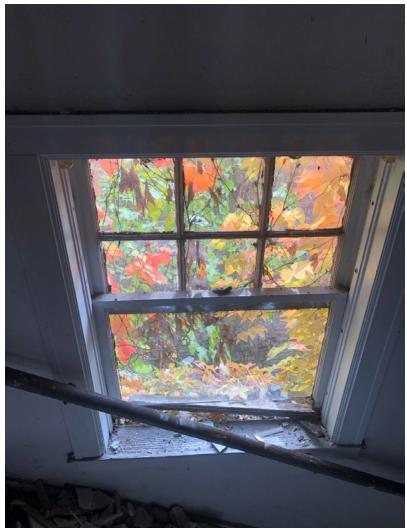
Window S-12

- Window will not open
- Window is three over one
- Bottom sash has extensive rot and is broken
- Glass in upper sash is broken on right side
- Interior sill has massive rot
- Weather stripping missing
- Window needs to be re-putted
- Exterior sill has massive rot
- Lead weights are missing

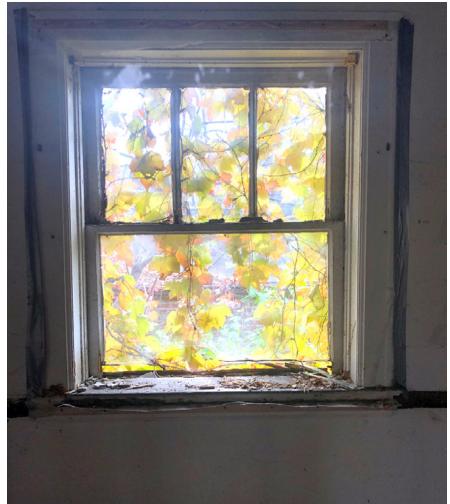
Window S-13

- Window will not open
- Window is three over one
- Bottom sash has extensive rot
- Glass in upper sash is broken on left side
- Interior sill has massive rot
- Exterior sill has massive rot
- Window needs to be re-putted
- Lead weights are missing
- Weather stripping missing
- Brick molding has extensive rot

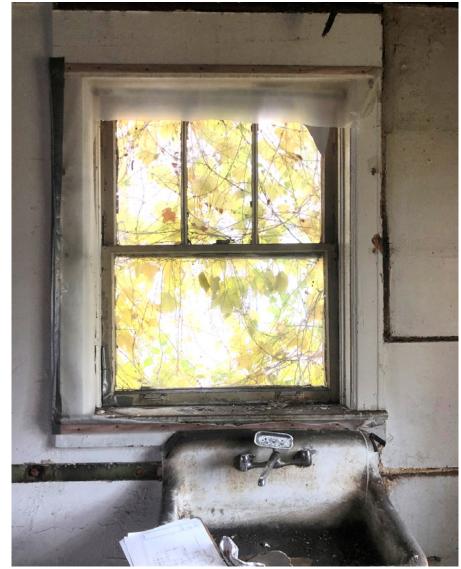
Window S-14

- Window will not open
- Both Lead weights are missing
- Bottom sash has extensive rot
- Window needs to be re-putted
- Lower sash glass is falling out
- Weather stripping missing
- Interior sill has massive rot

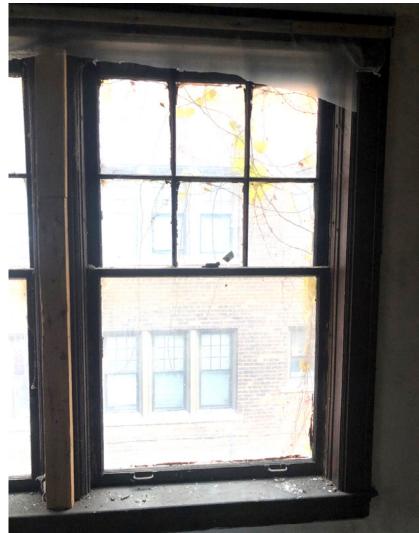
Window S-15

- Window will not open
- Lead weights are in place, but cords need replacing
- Bottom sash has extensive rot
- Weather stripping missing
- Window is boarded up on the outside
- Window will not lock
- Brick molding has extensive rot
- Glass in upper sash is broken
- Upper sash has extensive rot

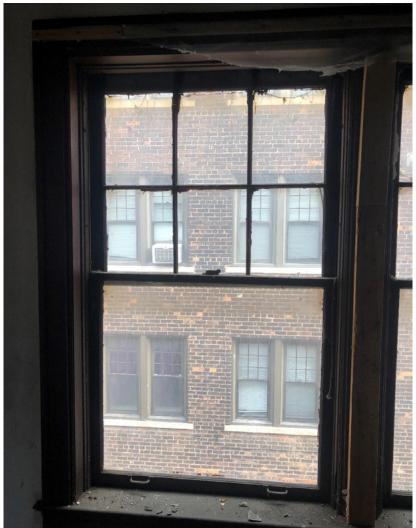
Window S-16

- Window will not open
- Lead weights are in place, but cords need replacing
- Bottom sash has extensive rot
- Weather stripping missing
- Window is boarded up on the outside
- Window will not lock
- Brick molding has extensive rot
- Trim below window has water damage
- Window will not lock
