447 Henry- Steel Factory sash behind CMU infill- examine after CMU removed.

427 Henry- Window #1, some minor deterioration

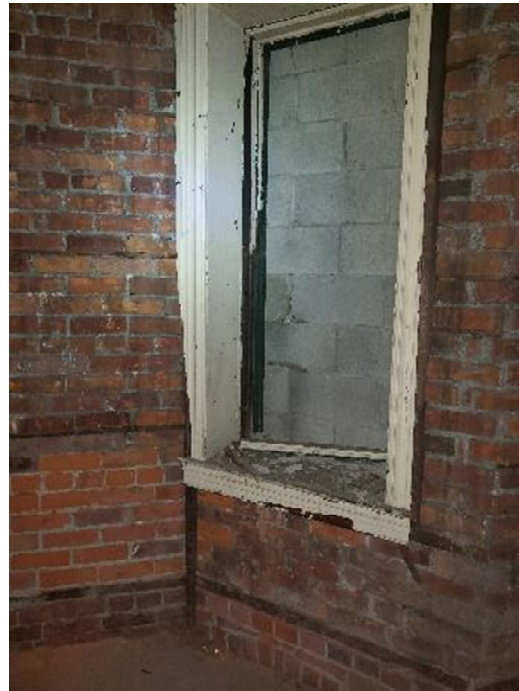
Wind #3- mostly missing

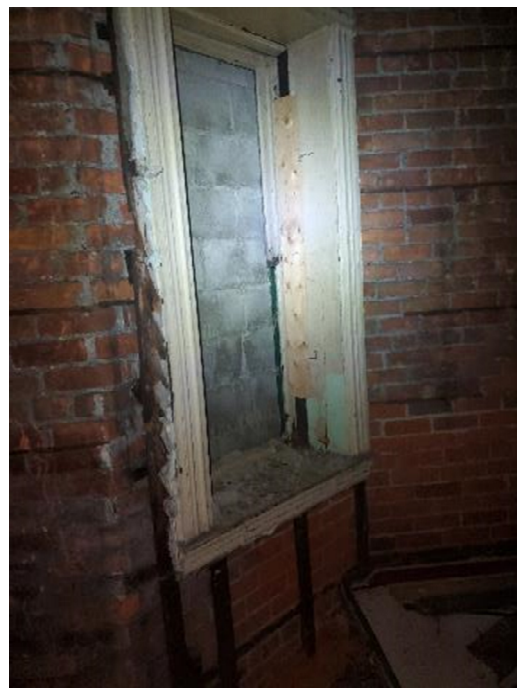
Wind #5- mostly missing

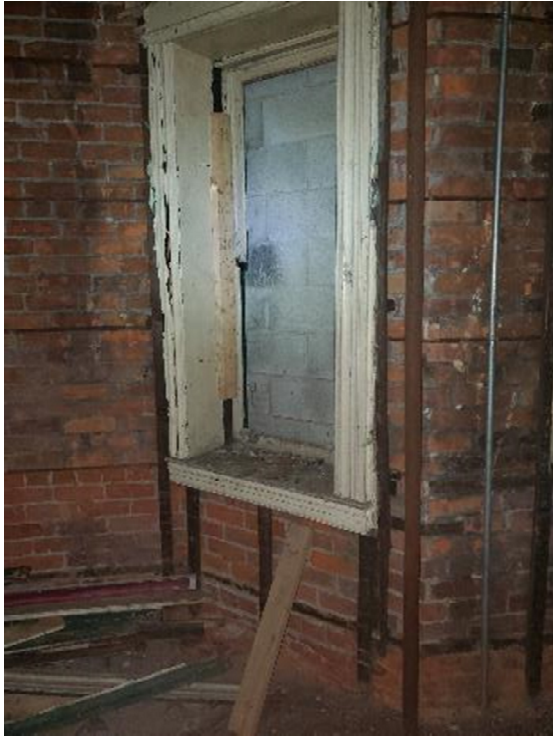
Wind #6- mostly missing

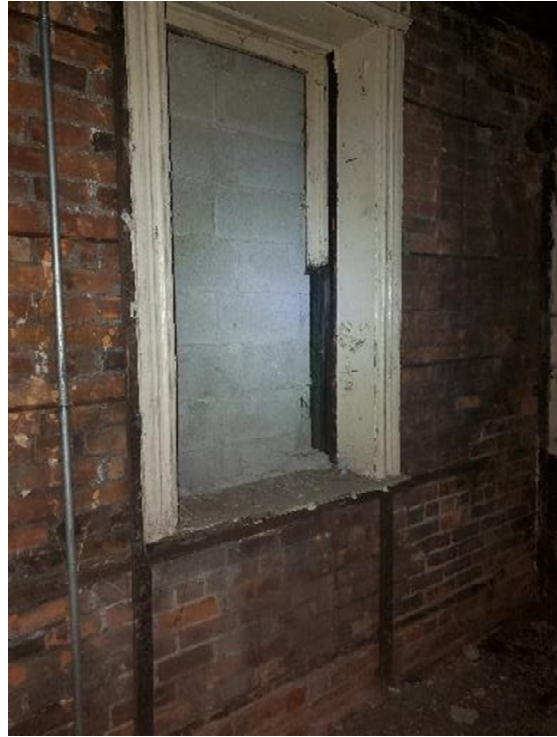
Wind #7- mostly missing

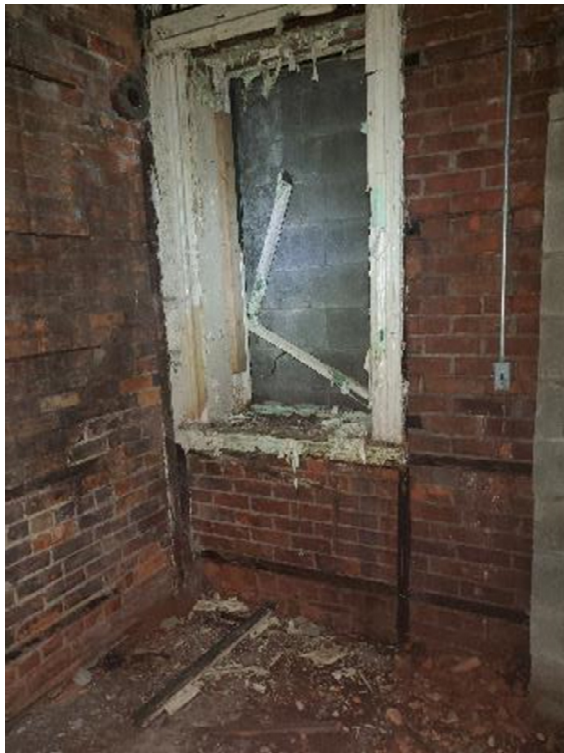
Wind #8- badly damaged

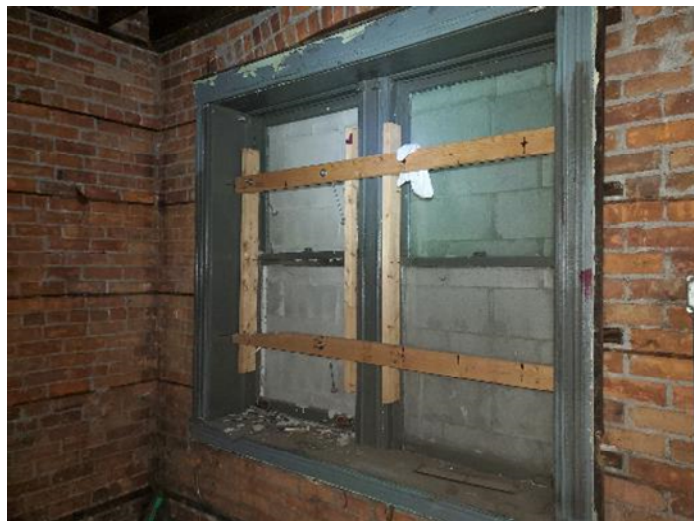
Wind #13- partially covered

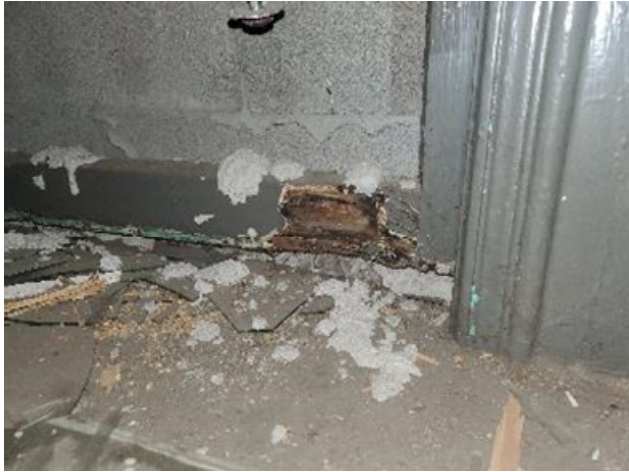
Wind #13a- deterioration detail

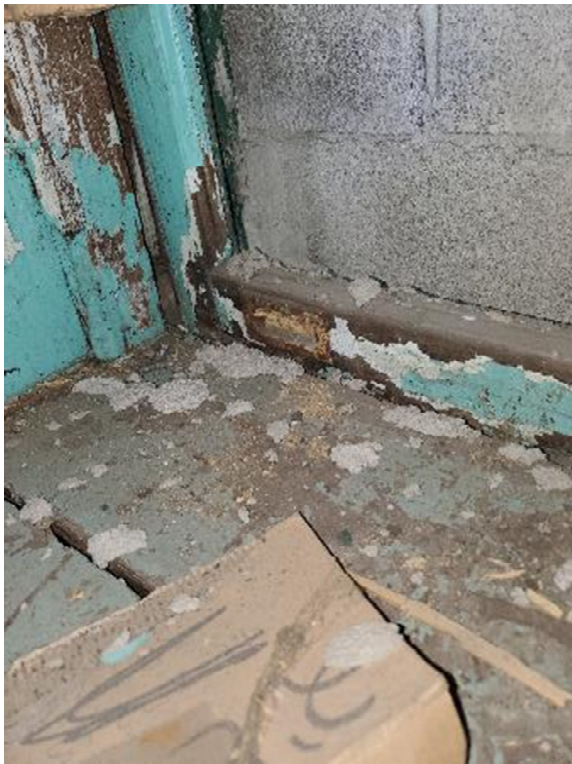
Wind #14a- damage detail

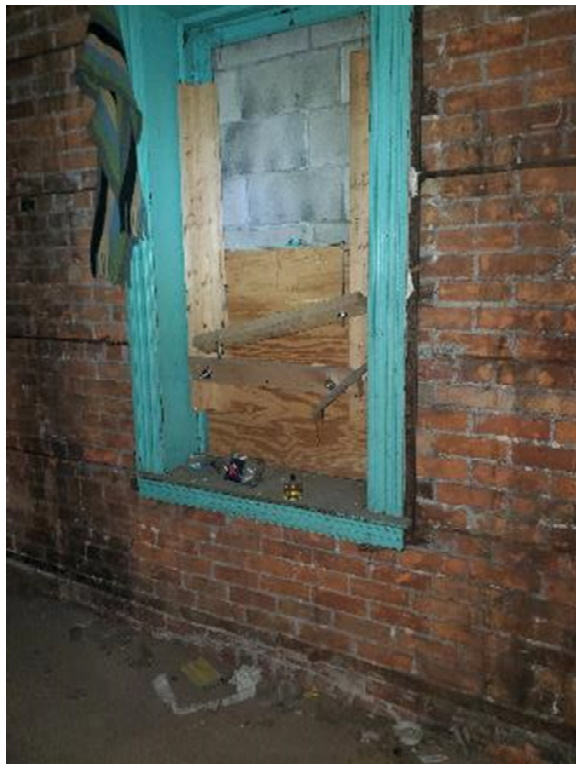
Wind #15- partially covered

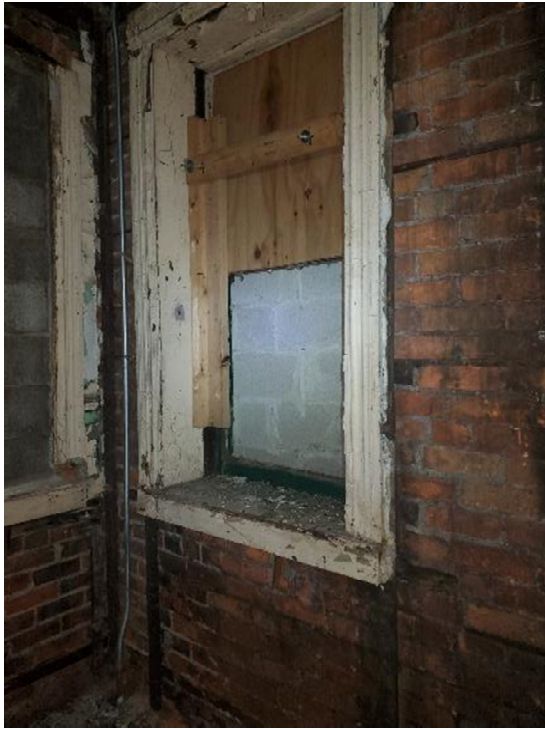
Wind #16- partially covered

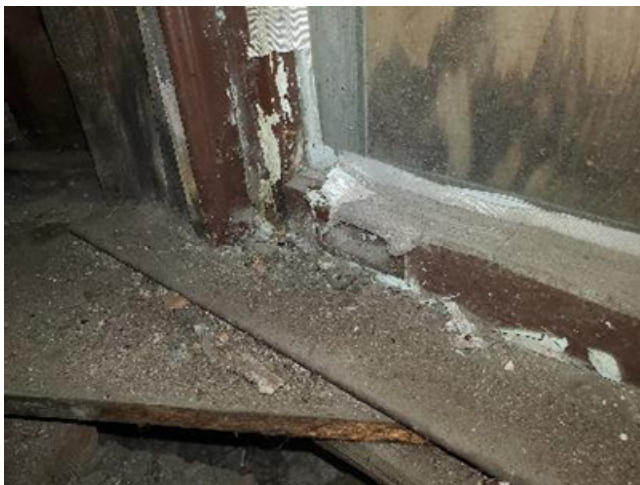
Wind #17a- some sill rail damage

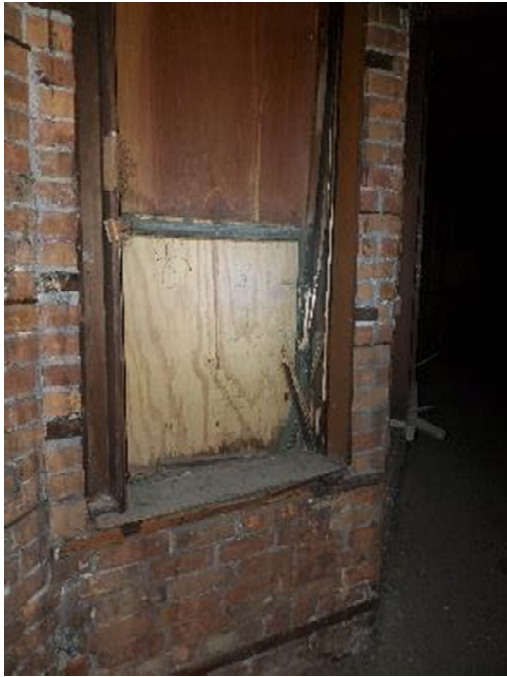
Wind #18- jamb stile damage

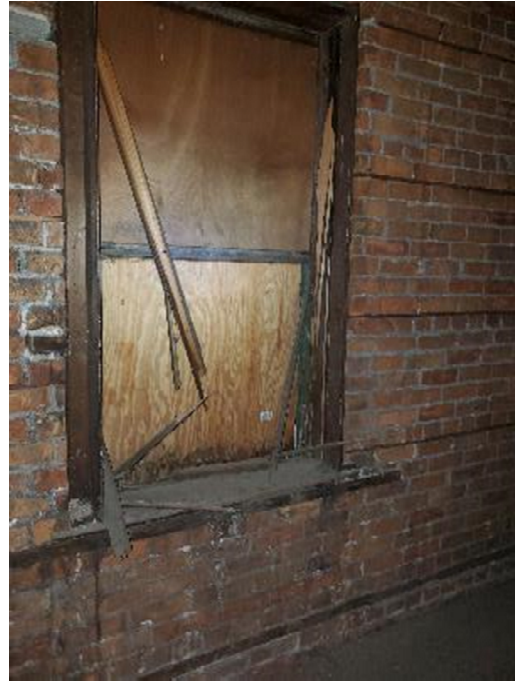
Wind #19- disassembling

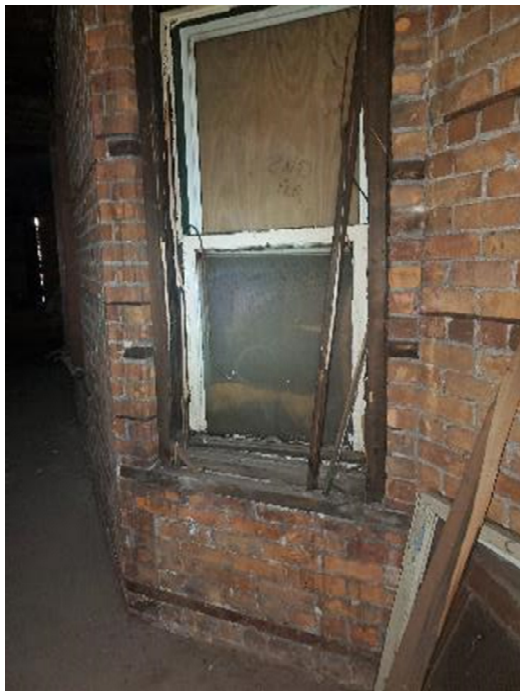
Wind #20- disassembling

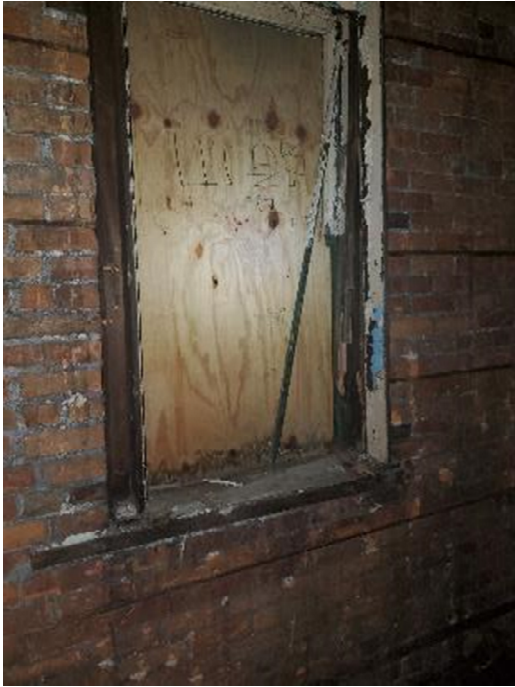
Wind #22- mostly missing

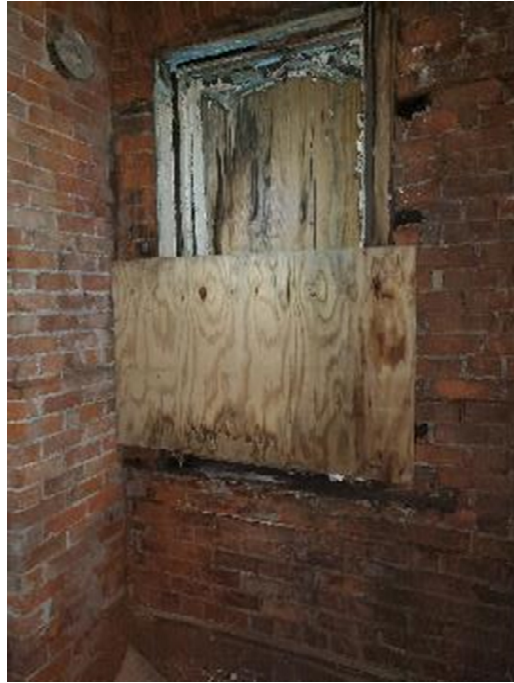
Wind #23- partially covered

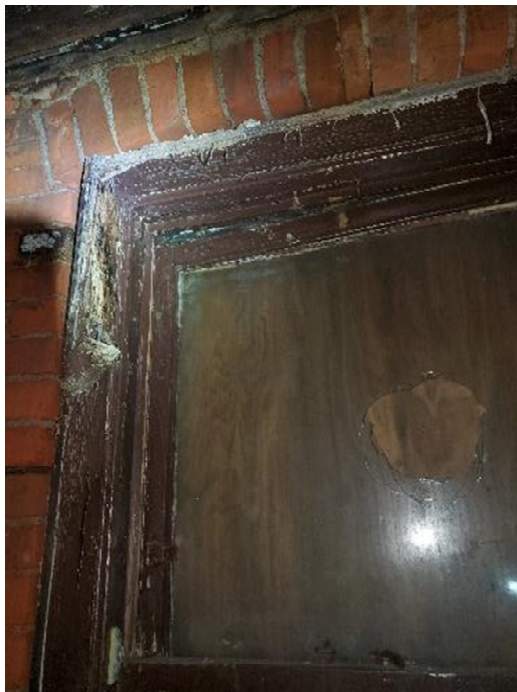
Wind #25a- upper sash saggi

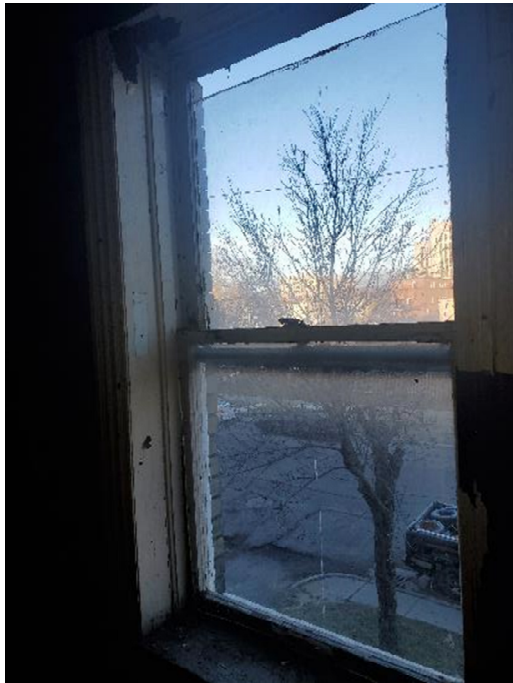
Wind #27- upper sash disassembling

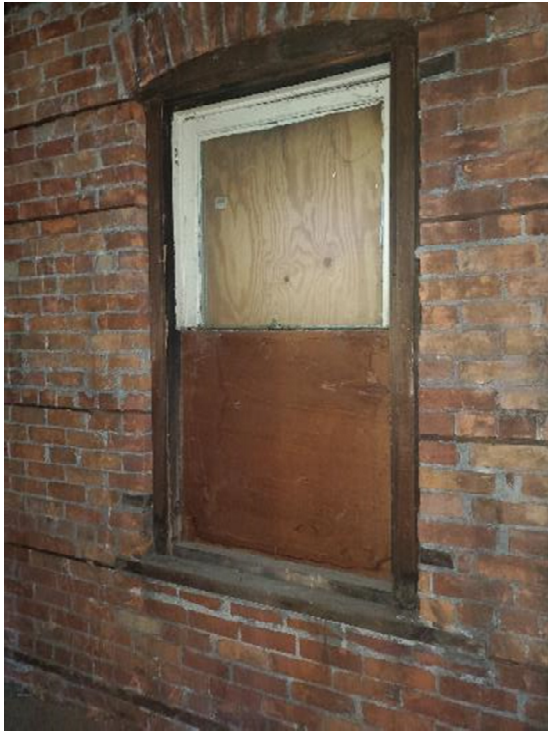
Wind #29- partially covered

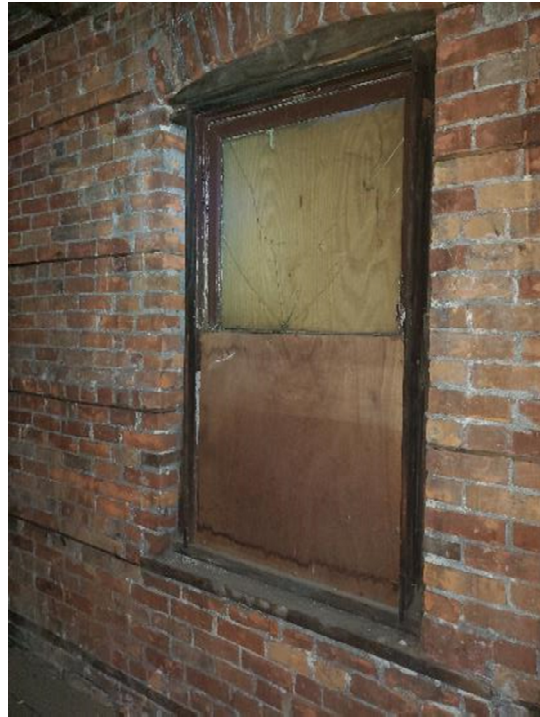
Wind #30- partially covered

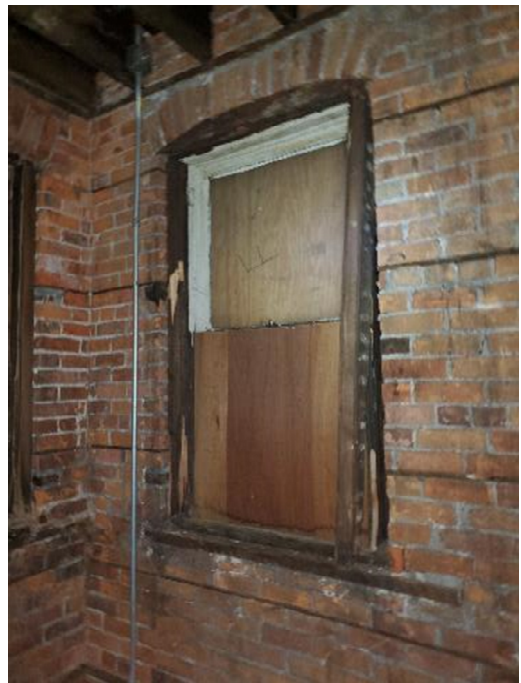
Wind #32- partially covered

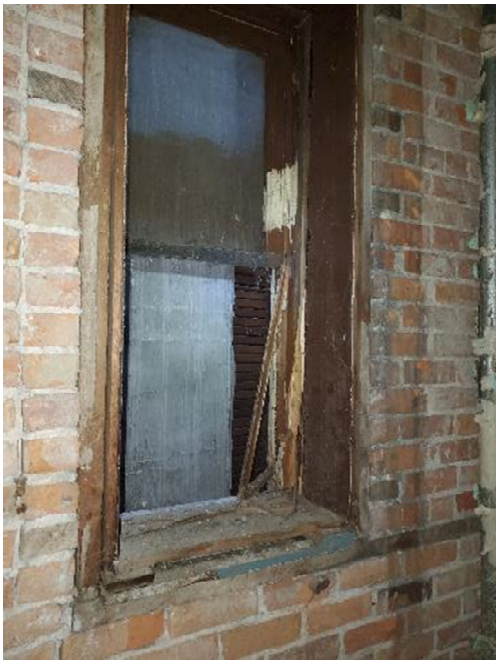
Wind #35- partially missing

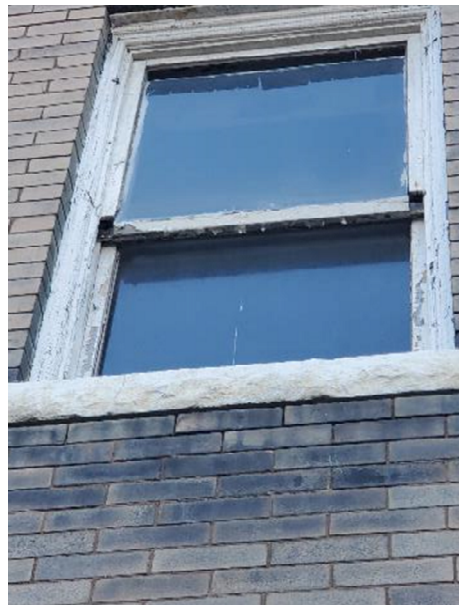
Wind #27- exterior showing upper sash detach
