January 22, 2021

RE: 3700 Trumbull Powerhouse: Structural Condition Evaluation of East Elevation and
Masonry Wing Walls

Project No. 21-1004
The Towns at Scripps Park

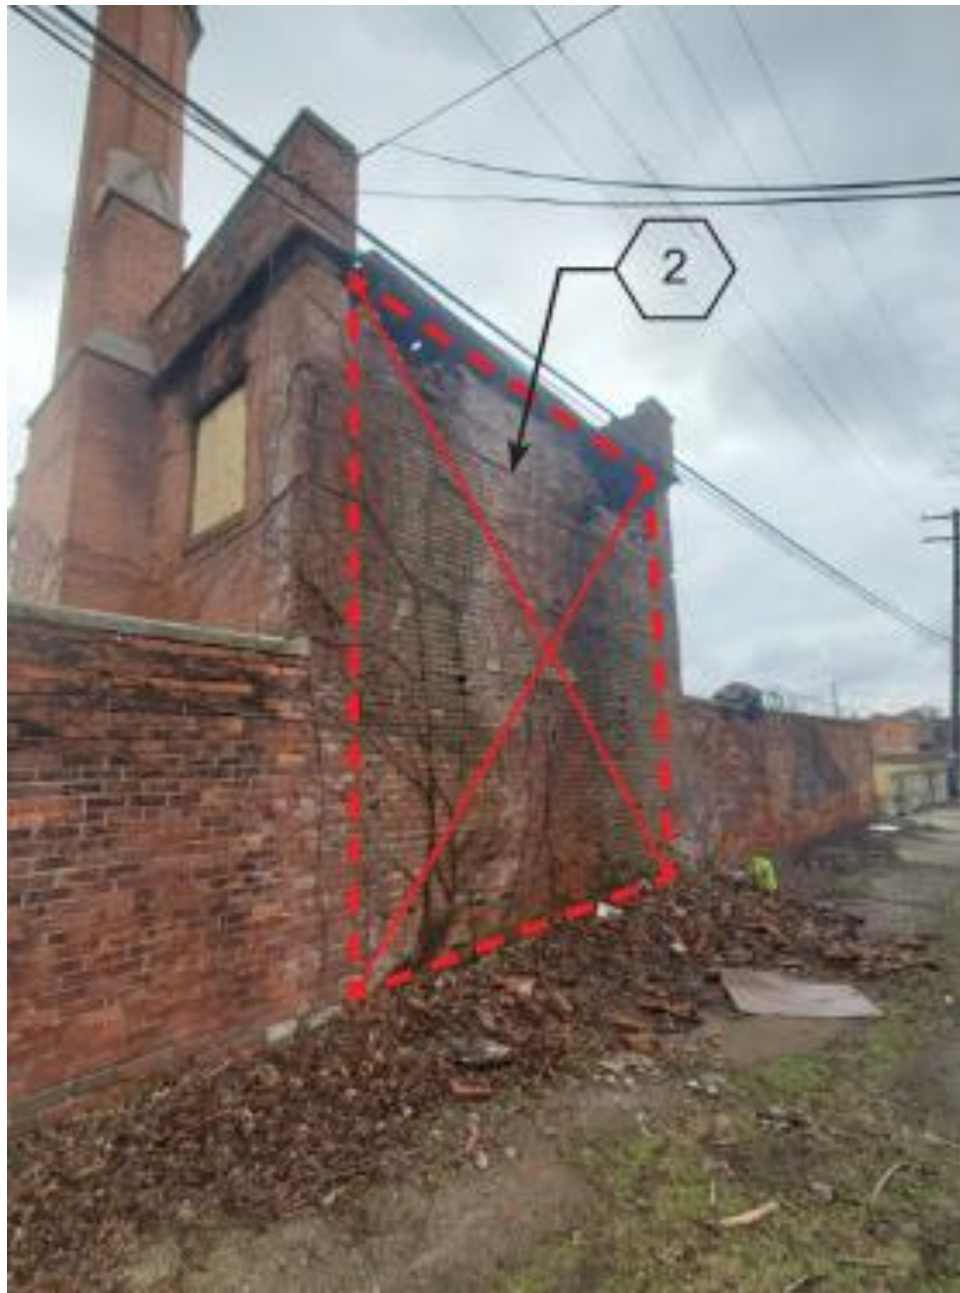
Photograph 1: East Elevation Masonry Wall

The east elevation masonry wall is shown in Photograph 1. The wall is constructed of brick masonry units set in hydraulic sand-lime mortar. Both the masonry units and the mortar joints are in an advanced state of deterioration. A significant number of masonry units have begun to spall and the mortar joints have softened such that a masonry rubble pile has formed at the base of the wall. Further, the wall has been exposed to a fire at the second level, and numerous unabated freeze thaw cycles as a result of water penetrating the damaged building envelope. Aside from those sources of deterioration, calcification and efflorescence was observed covering more than 50% of the surface area of the east elevation, indicating that the masonry material itself has reached its serviceable life and will no longer meet the durability requirements specified in ACI 318.

Accordingly, it is our recommendation that the east elevation masonry wall be removed and replaced, and the east masonry wing walls be demolished.

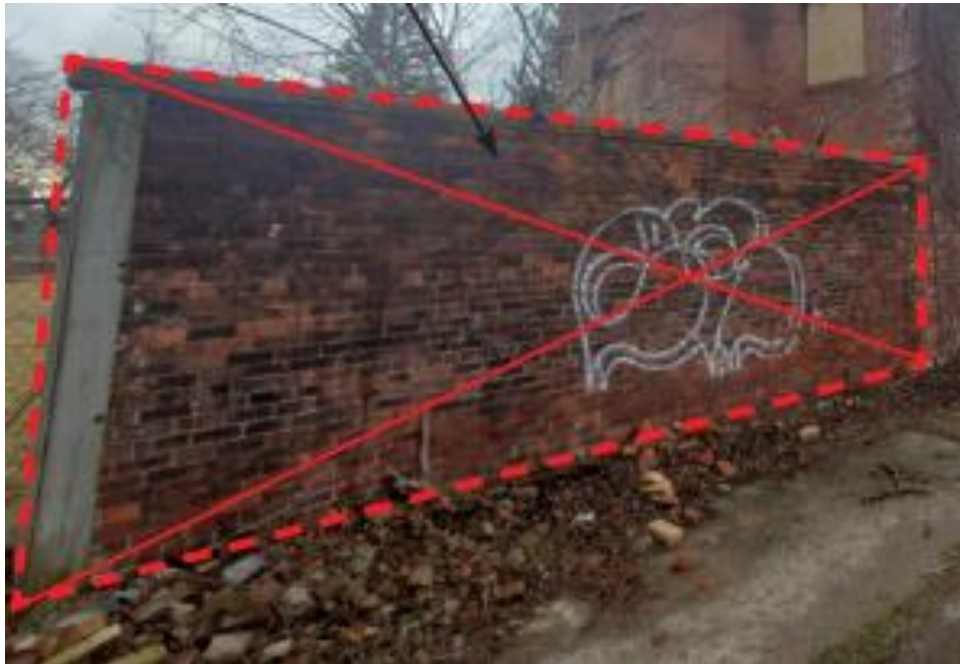
Photograph 2: East Masonry Wing Wall – South

The east masonry wing walls are shown in Photograph 2 and Photograph 3. The walls are constructed of brick masonry units set in hydraulic sand-lime mortar and are approximately 11ft tall by 12in thick. The masonry units and mortar joints are experiencing similar spall, softening, calcification, and efflorescence as the east elevation masonry wall identified in Photograph 1. The level of deterioration is not as advanced as the east elevation masonry wall, however, it has progressed to the point where the masonry materials will no longer meet the durability requirements specified in ACI 318.

elements be evaluated for the current code required minimum design loads associated with the risk category related to the new use. The resulting wind speed of 115mph applied to the approximately 11ft tall freestanding masonry wall structure results in the existing east masonry wing walls to be overstressed and in an otherwise unsafe condition structurally.
