WINDOW SURVEY

The 2nd story windows were surveyed by a visual survey from the interior using a camera. The survey focused on the existing conditions of the wood frames, operability of the window sashes and condition of the glass. The purpose was to determine if the condition of the windows and frames was suitable to be restored or if new window units were required.

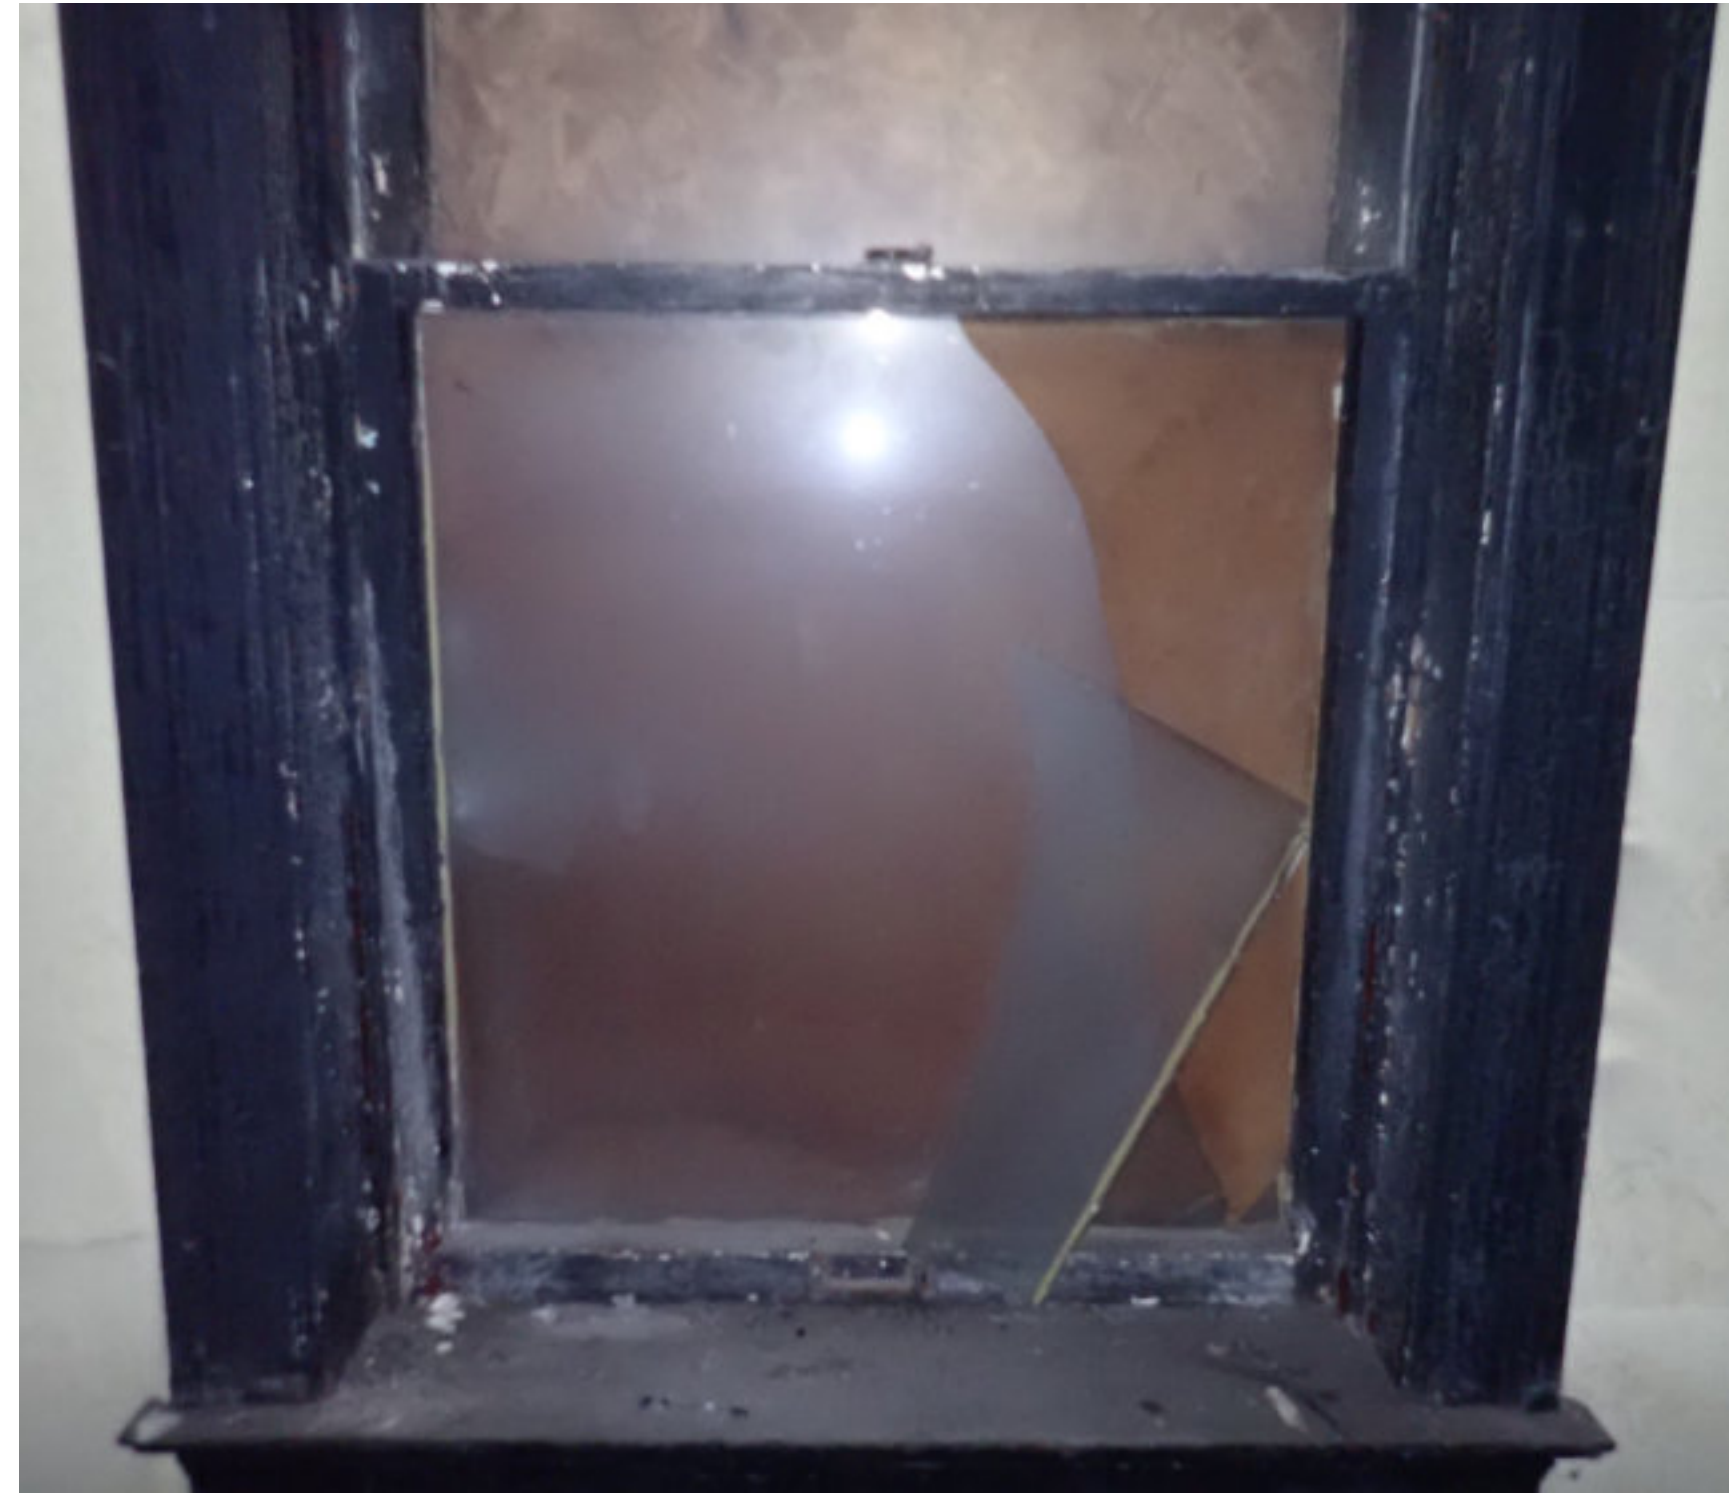
UNIT 201: BROKEN GLASS IN WINDOW FRAME

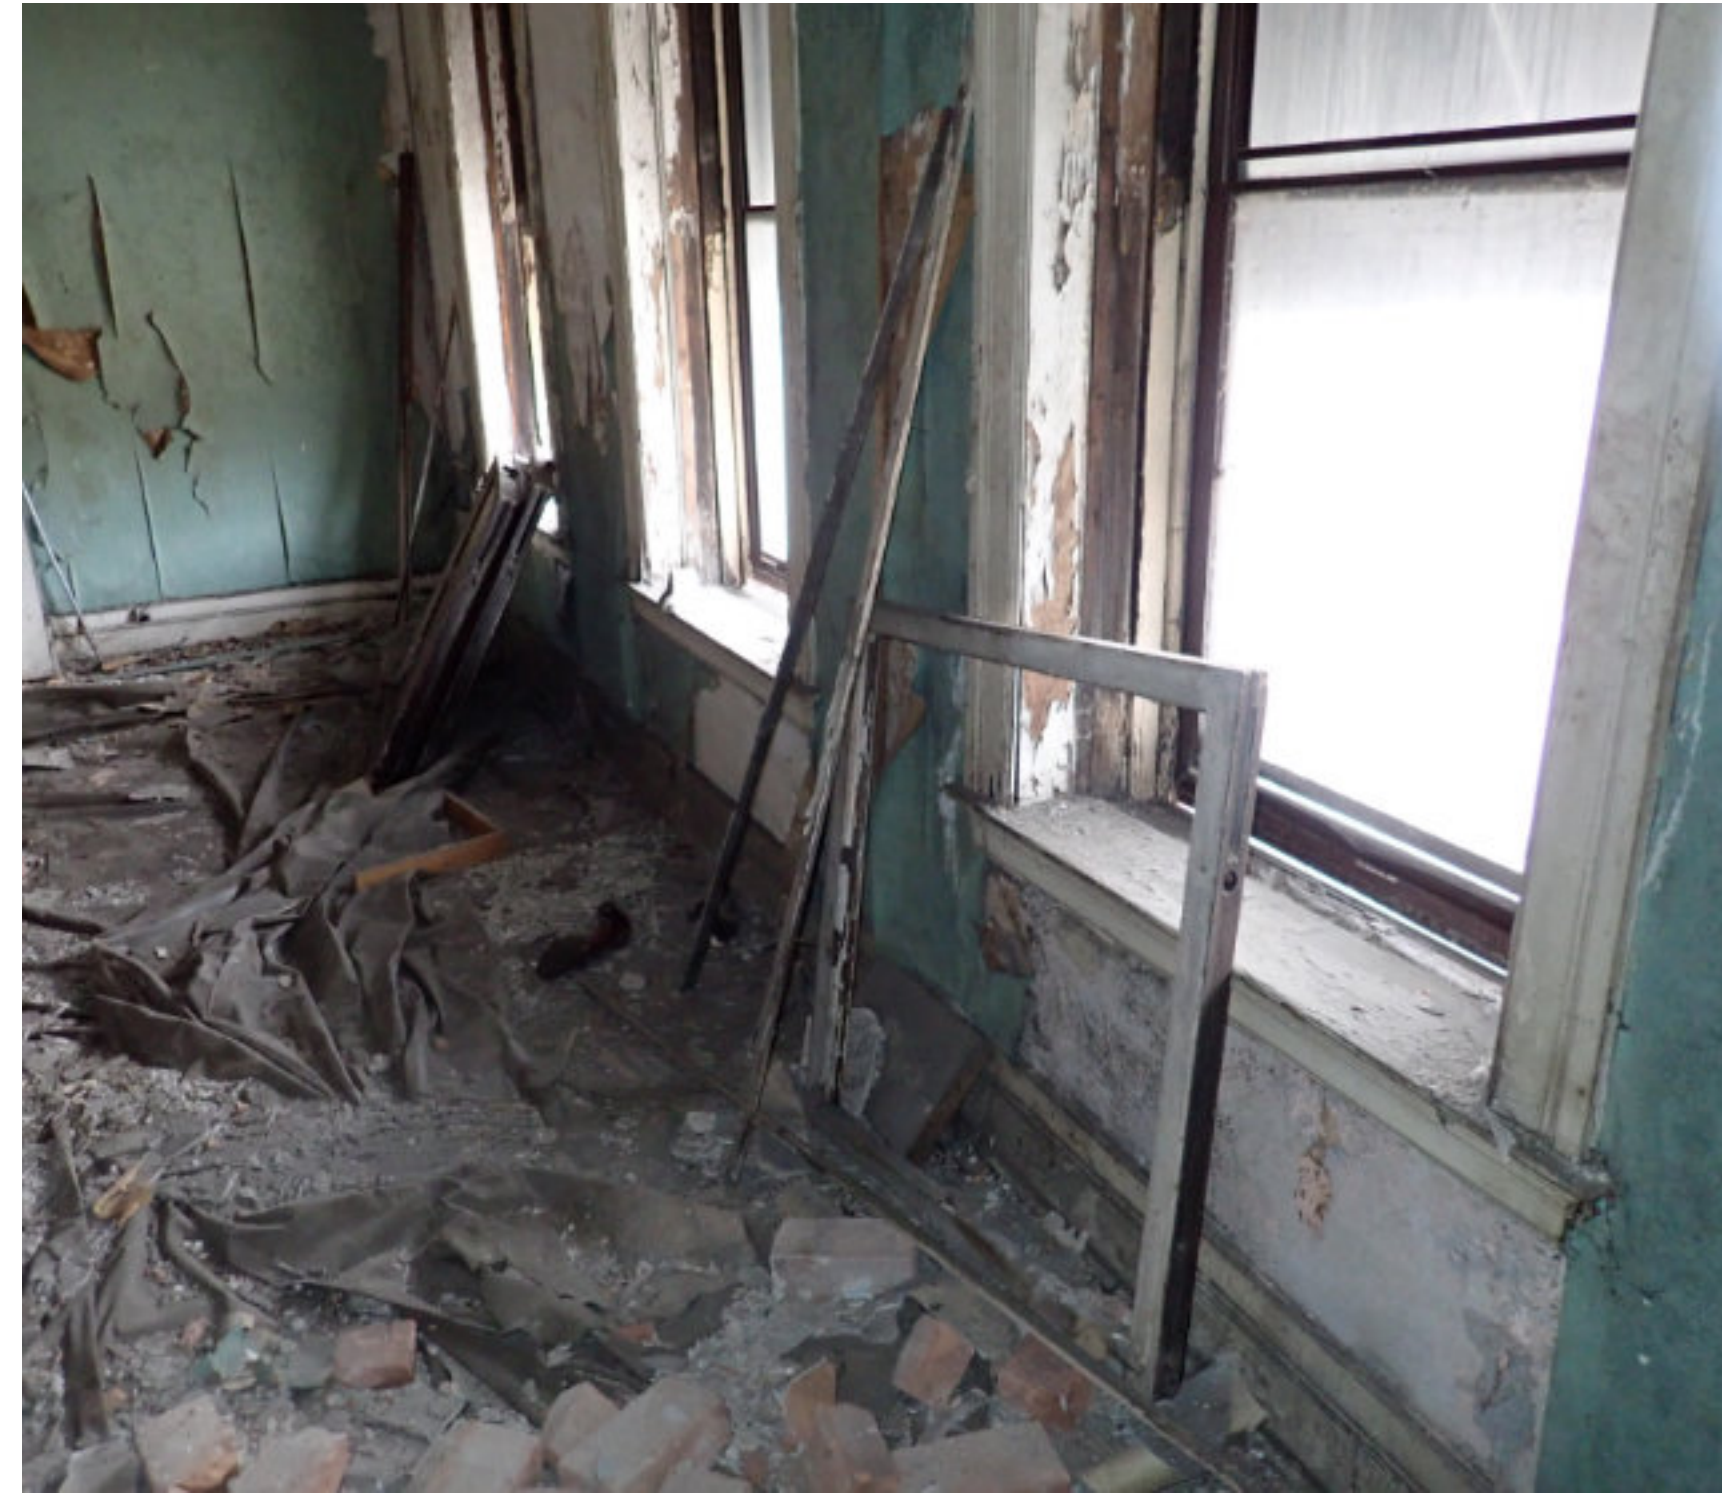
UNIT 203: REMOVED FRAMES AND STOPS

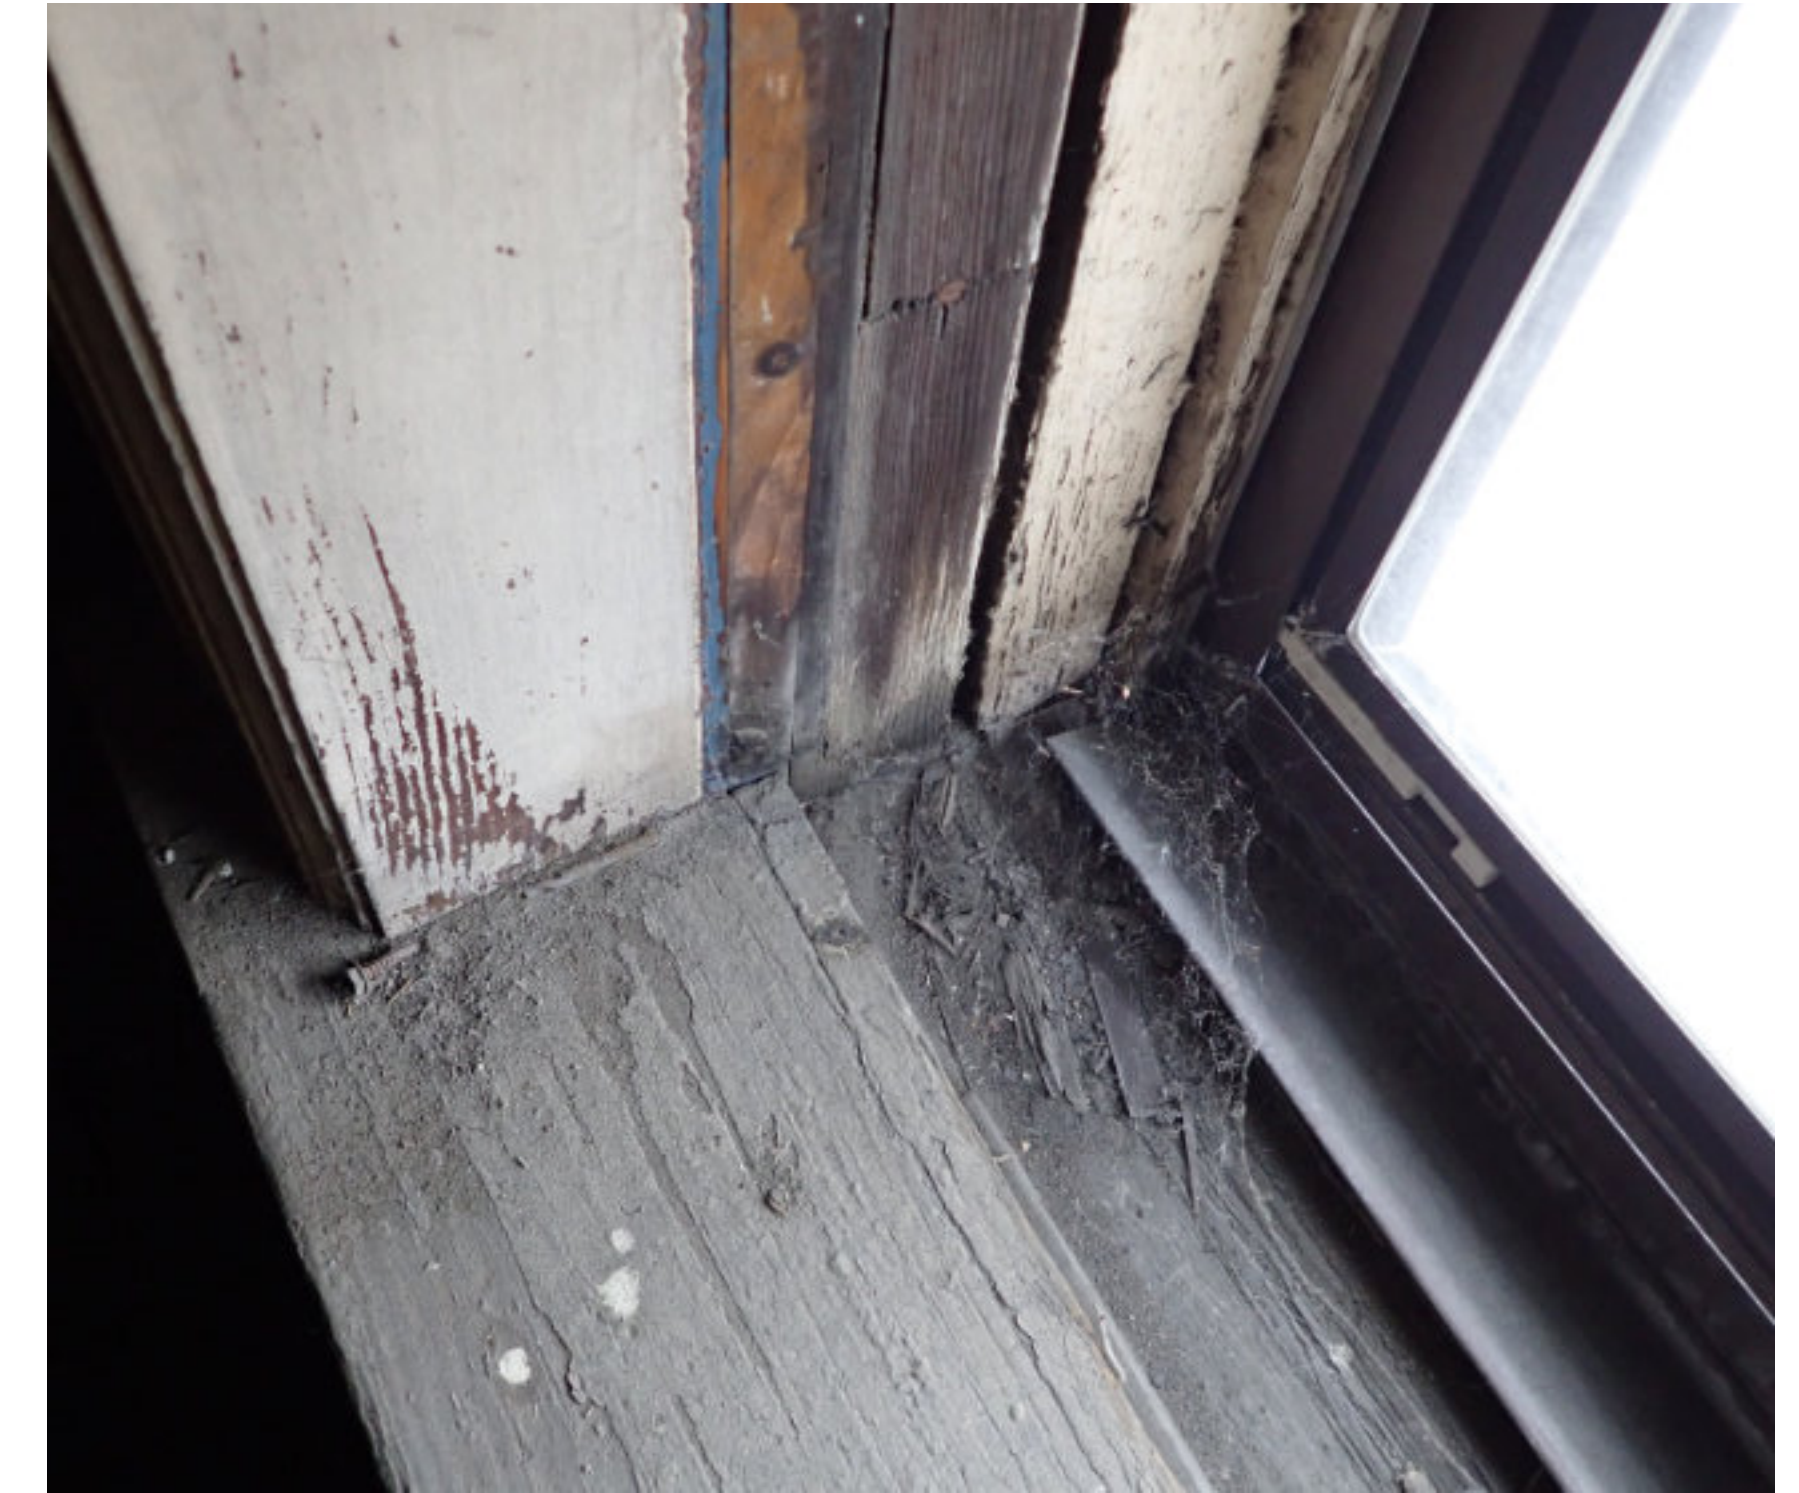
UNIT 204: DETERIORATED STOOP AND CASING

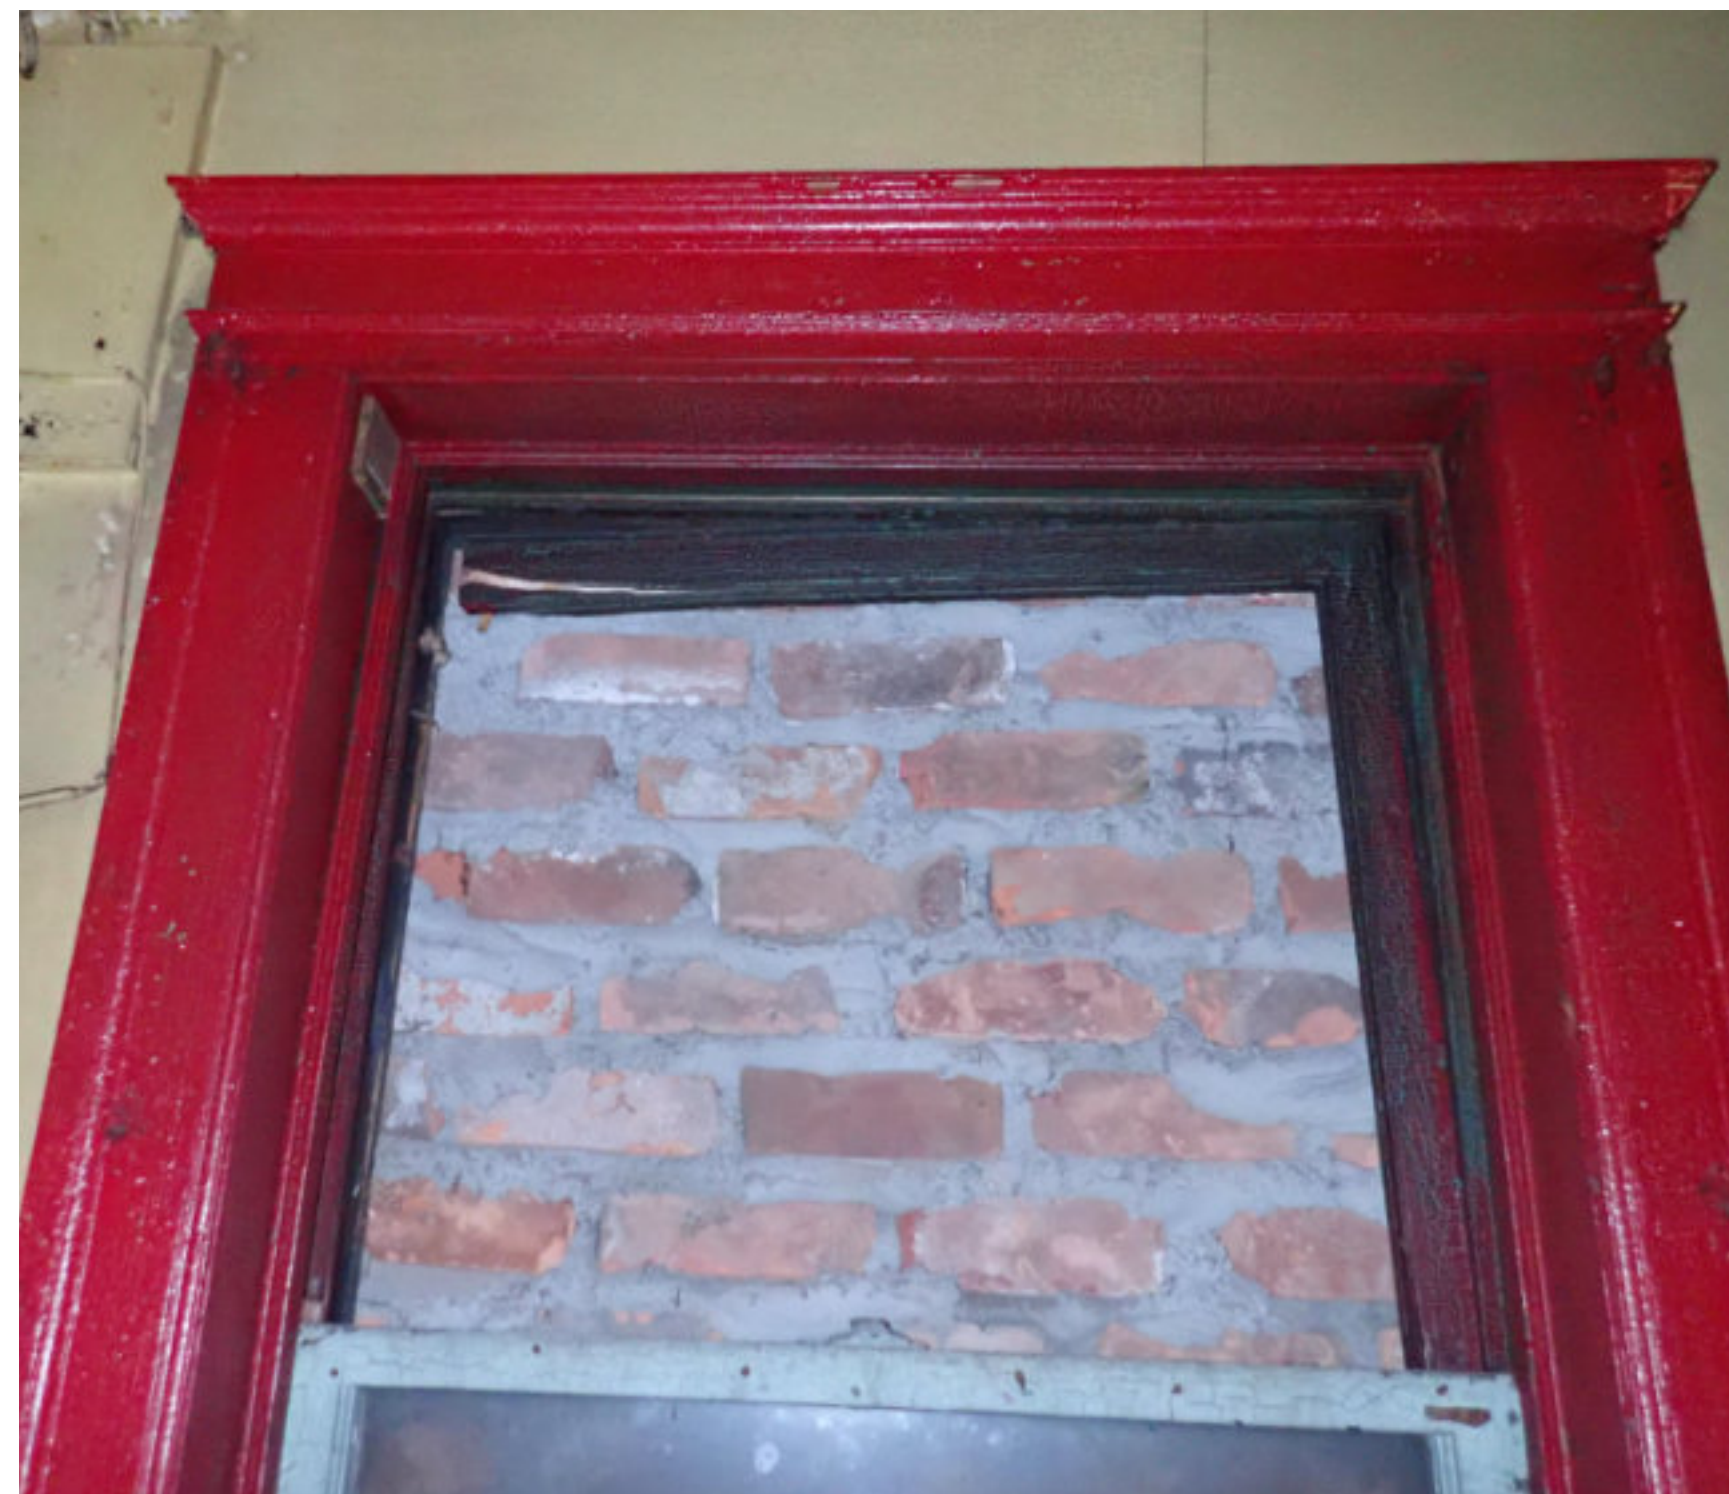
UNIT 202: BROKEN TOP RAIL

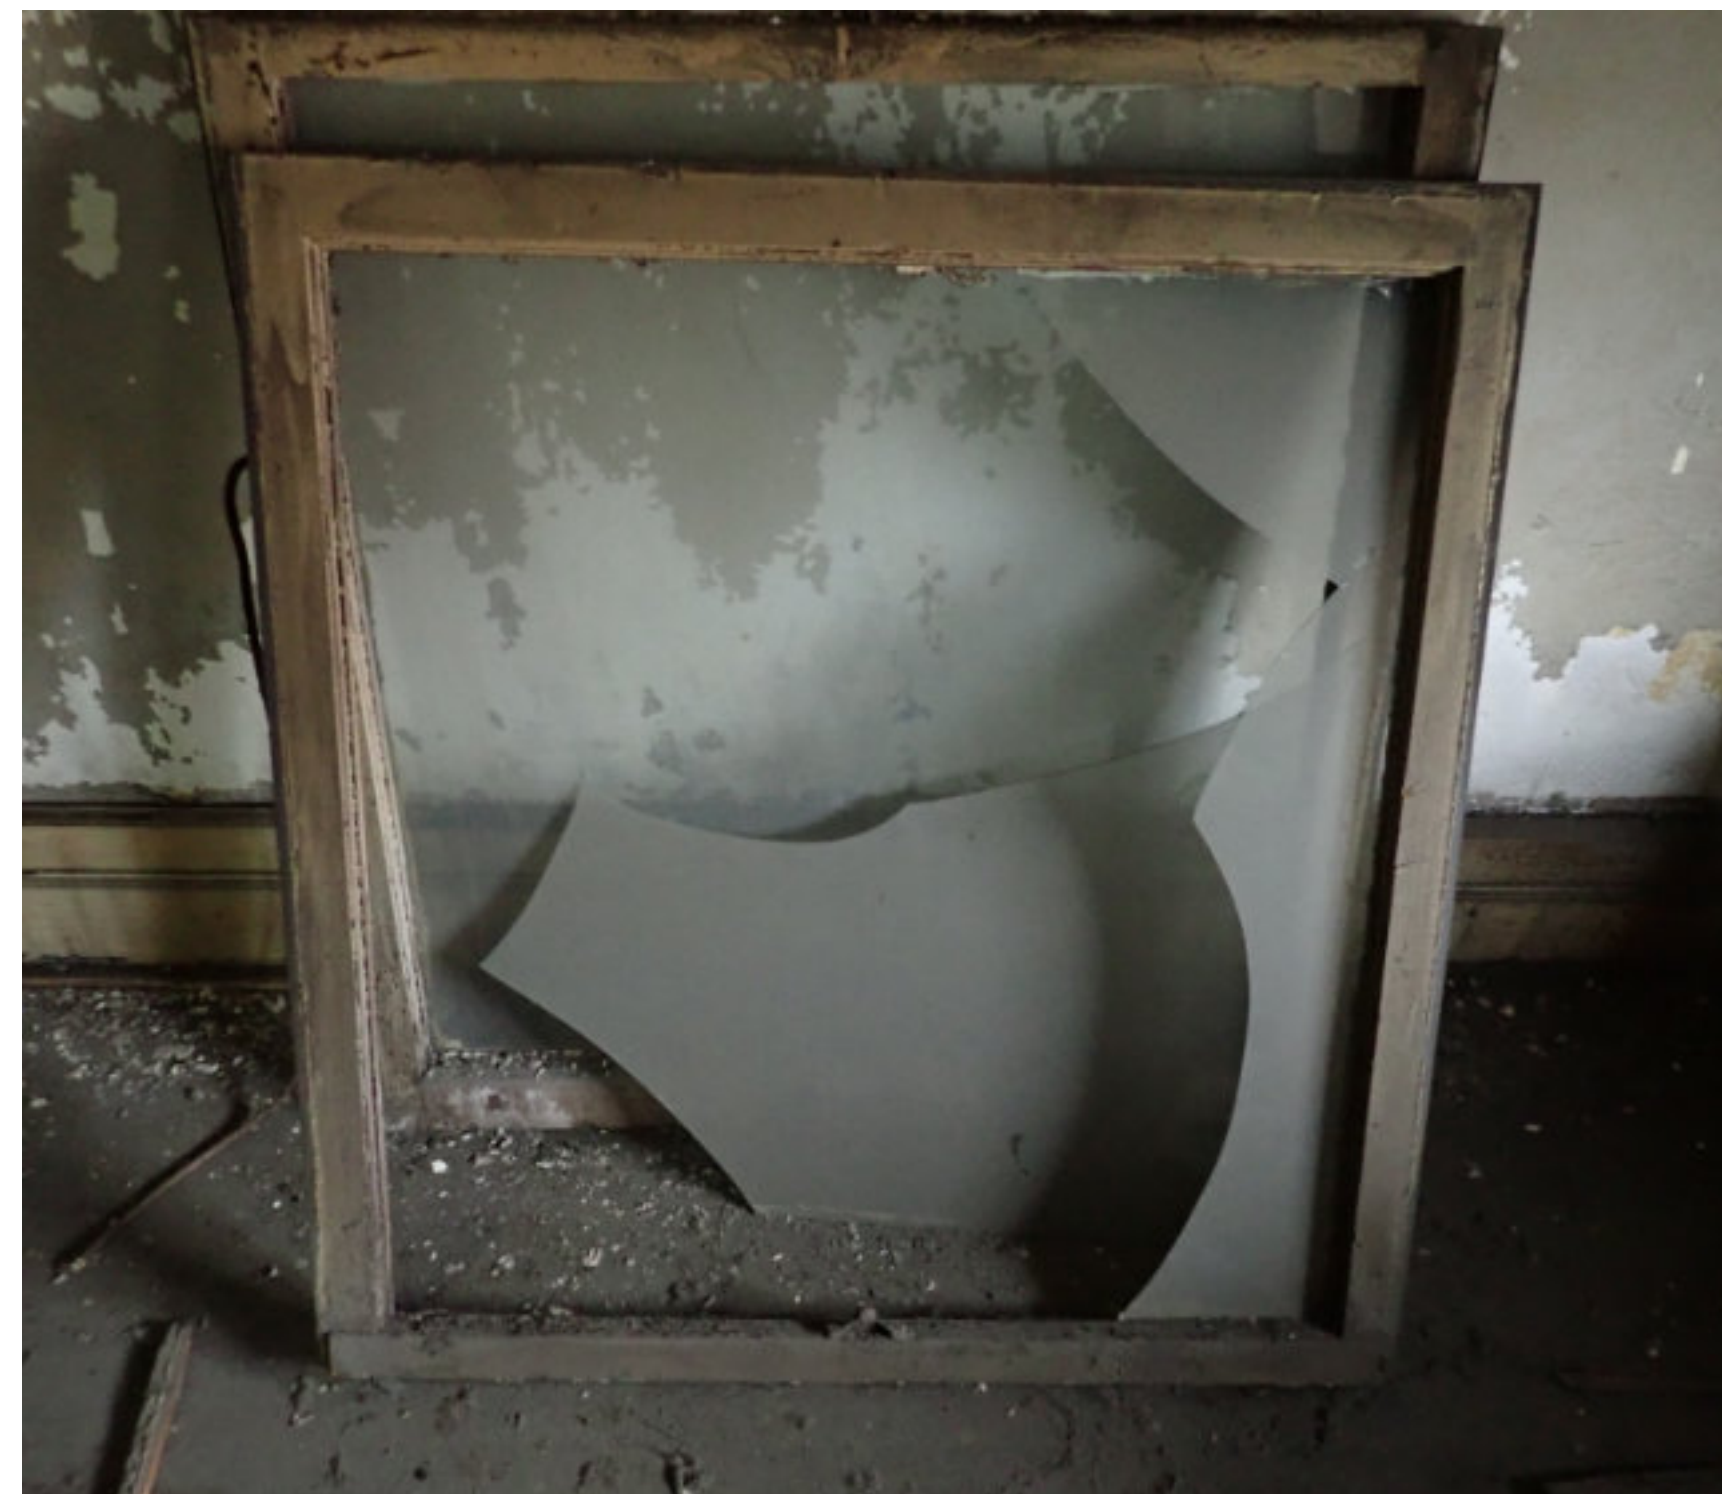
UNIT 204: REMOVED FRAMES WITH BROKEN GLASS

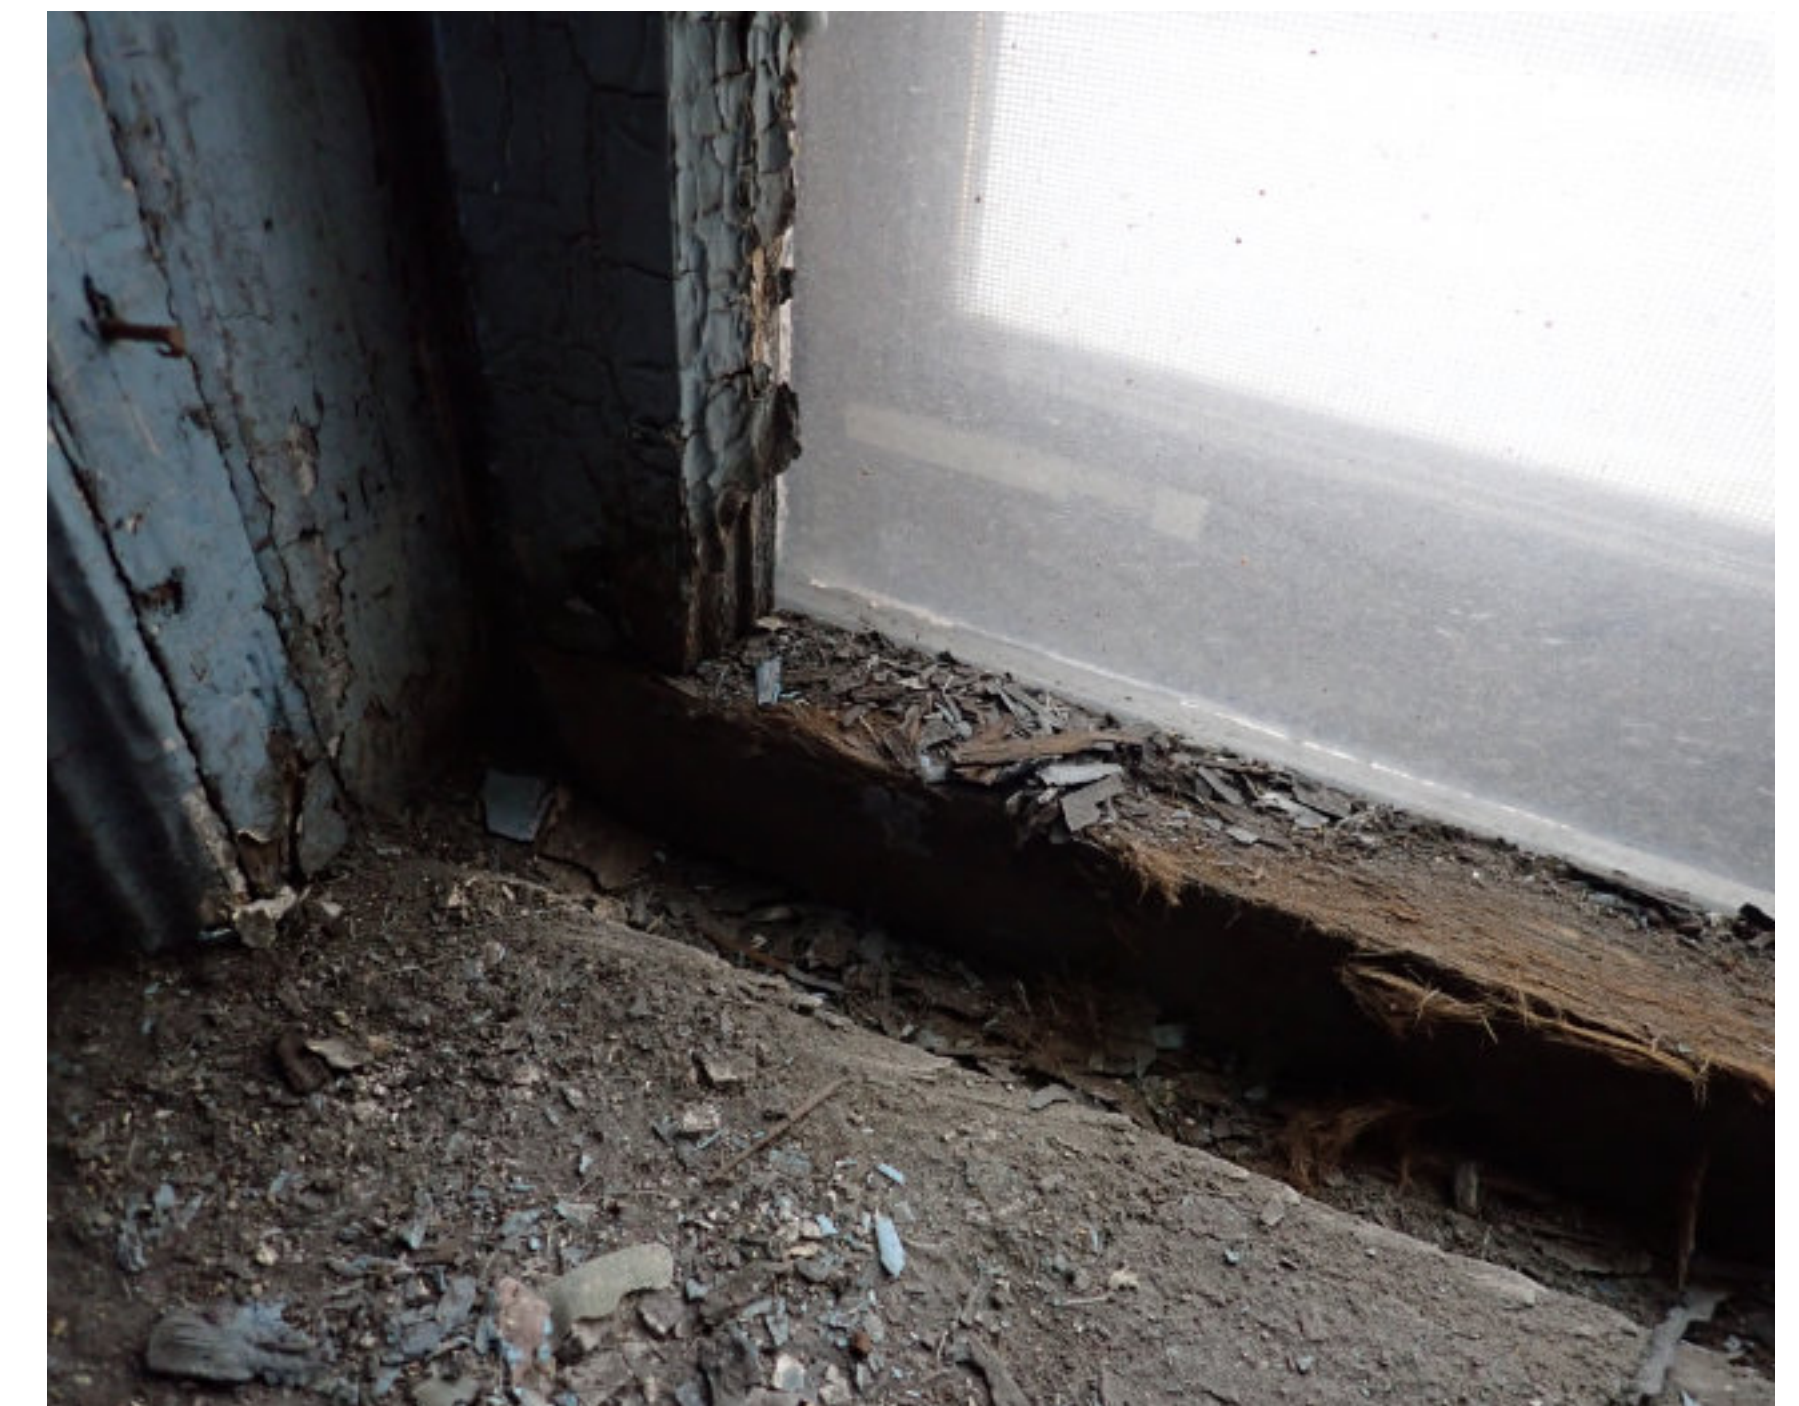
UNIT 204: DETERIORATED LOWER RAIL

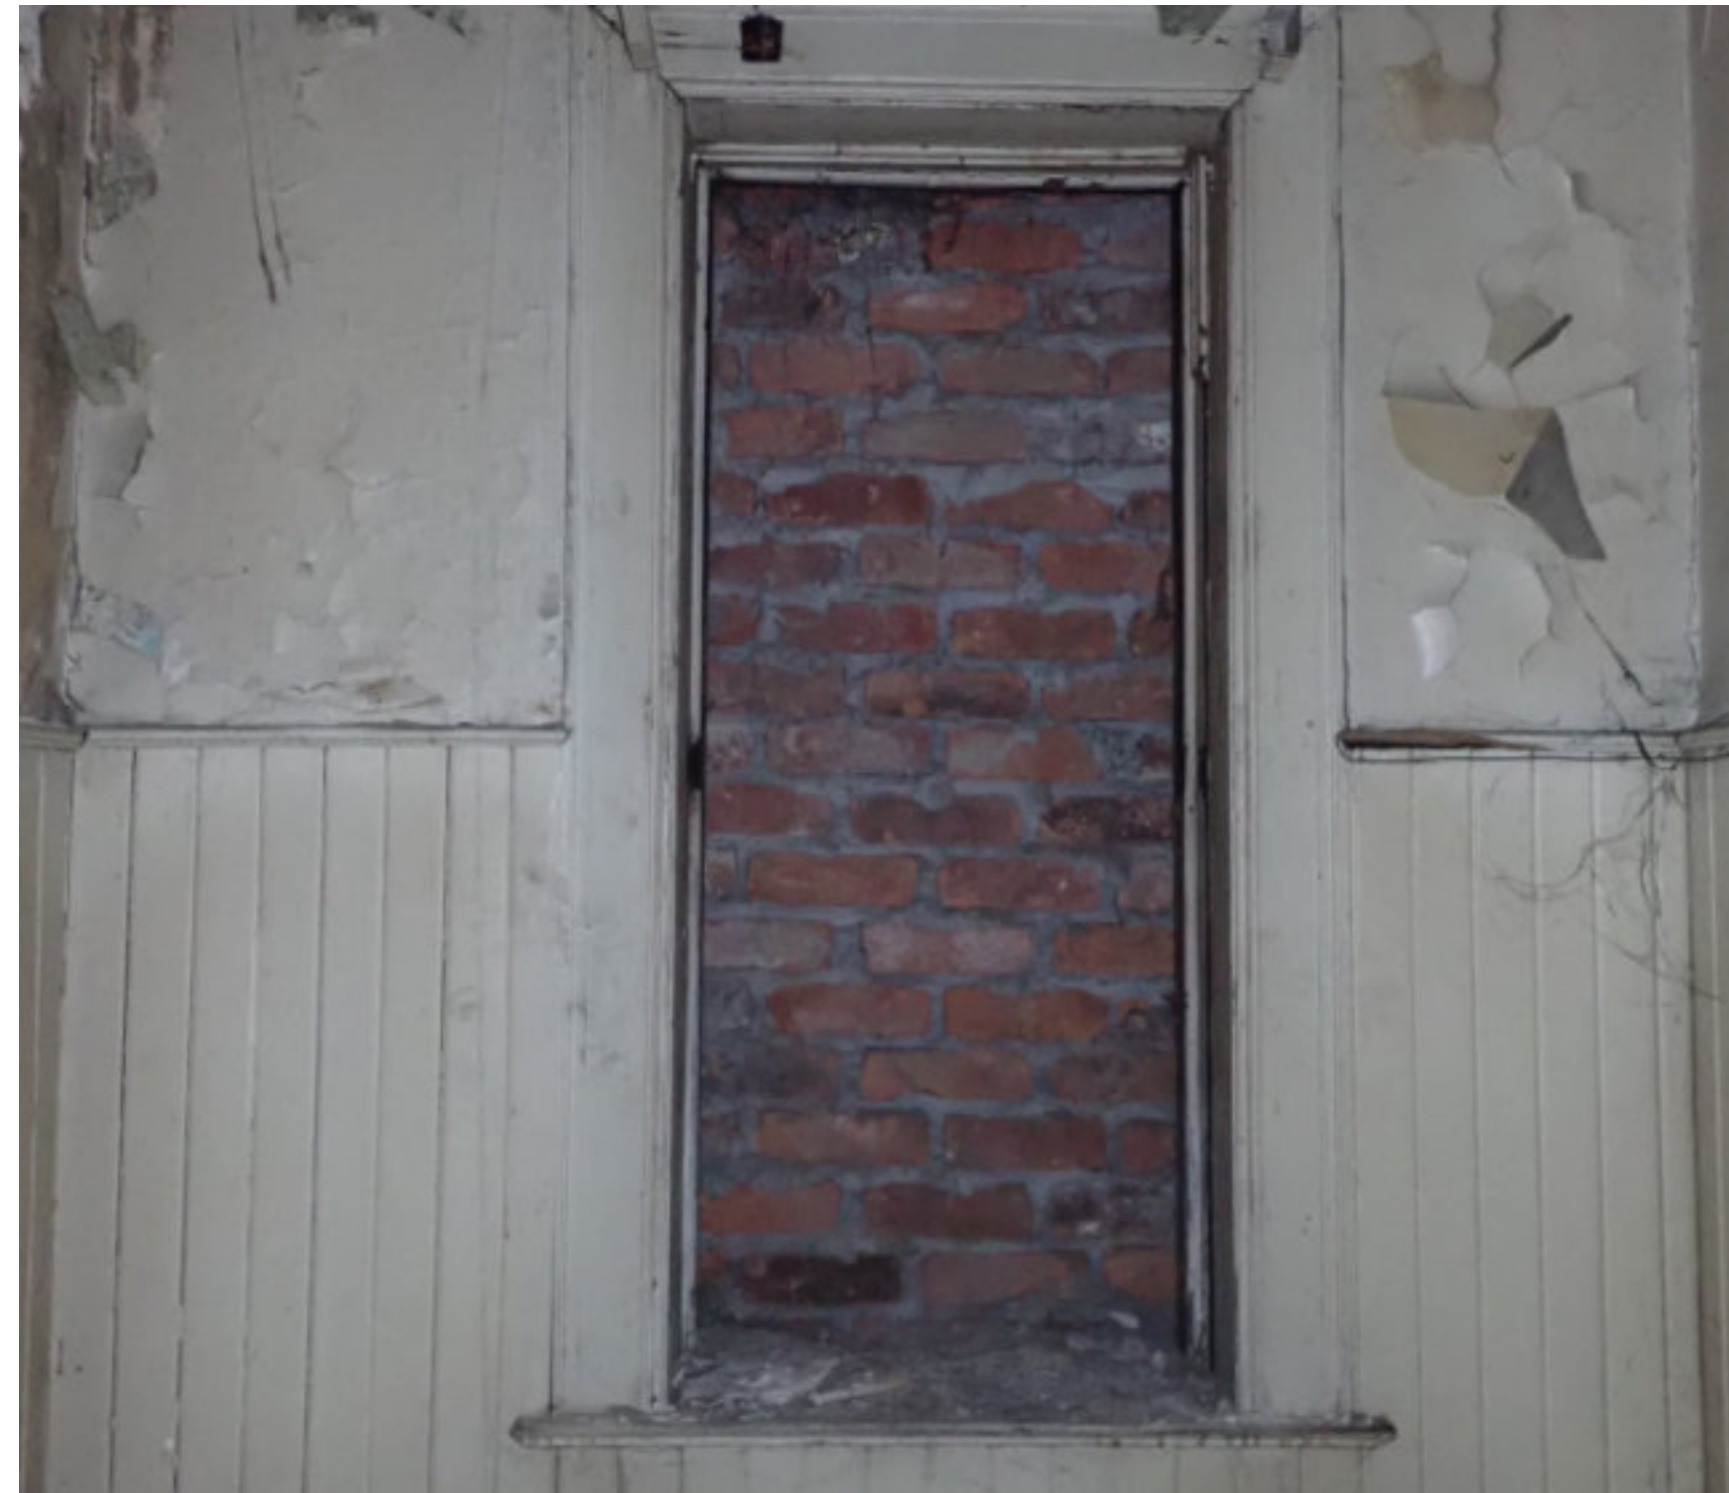
UNIT 206: MISSING WINDOW WITH BRICK INFILL

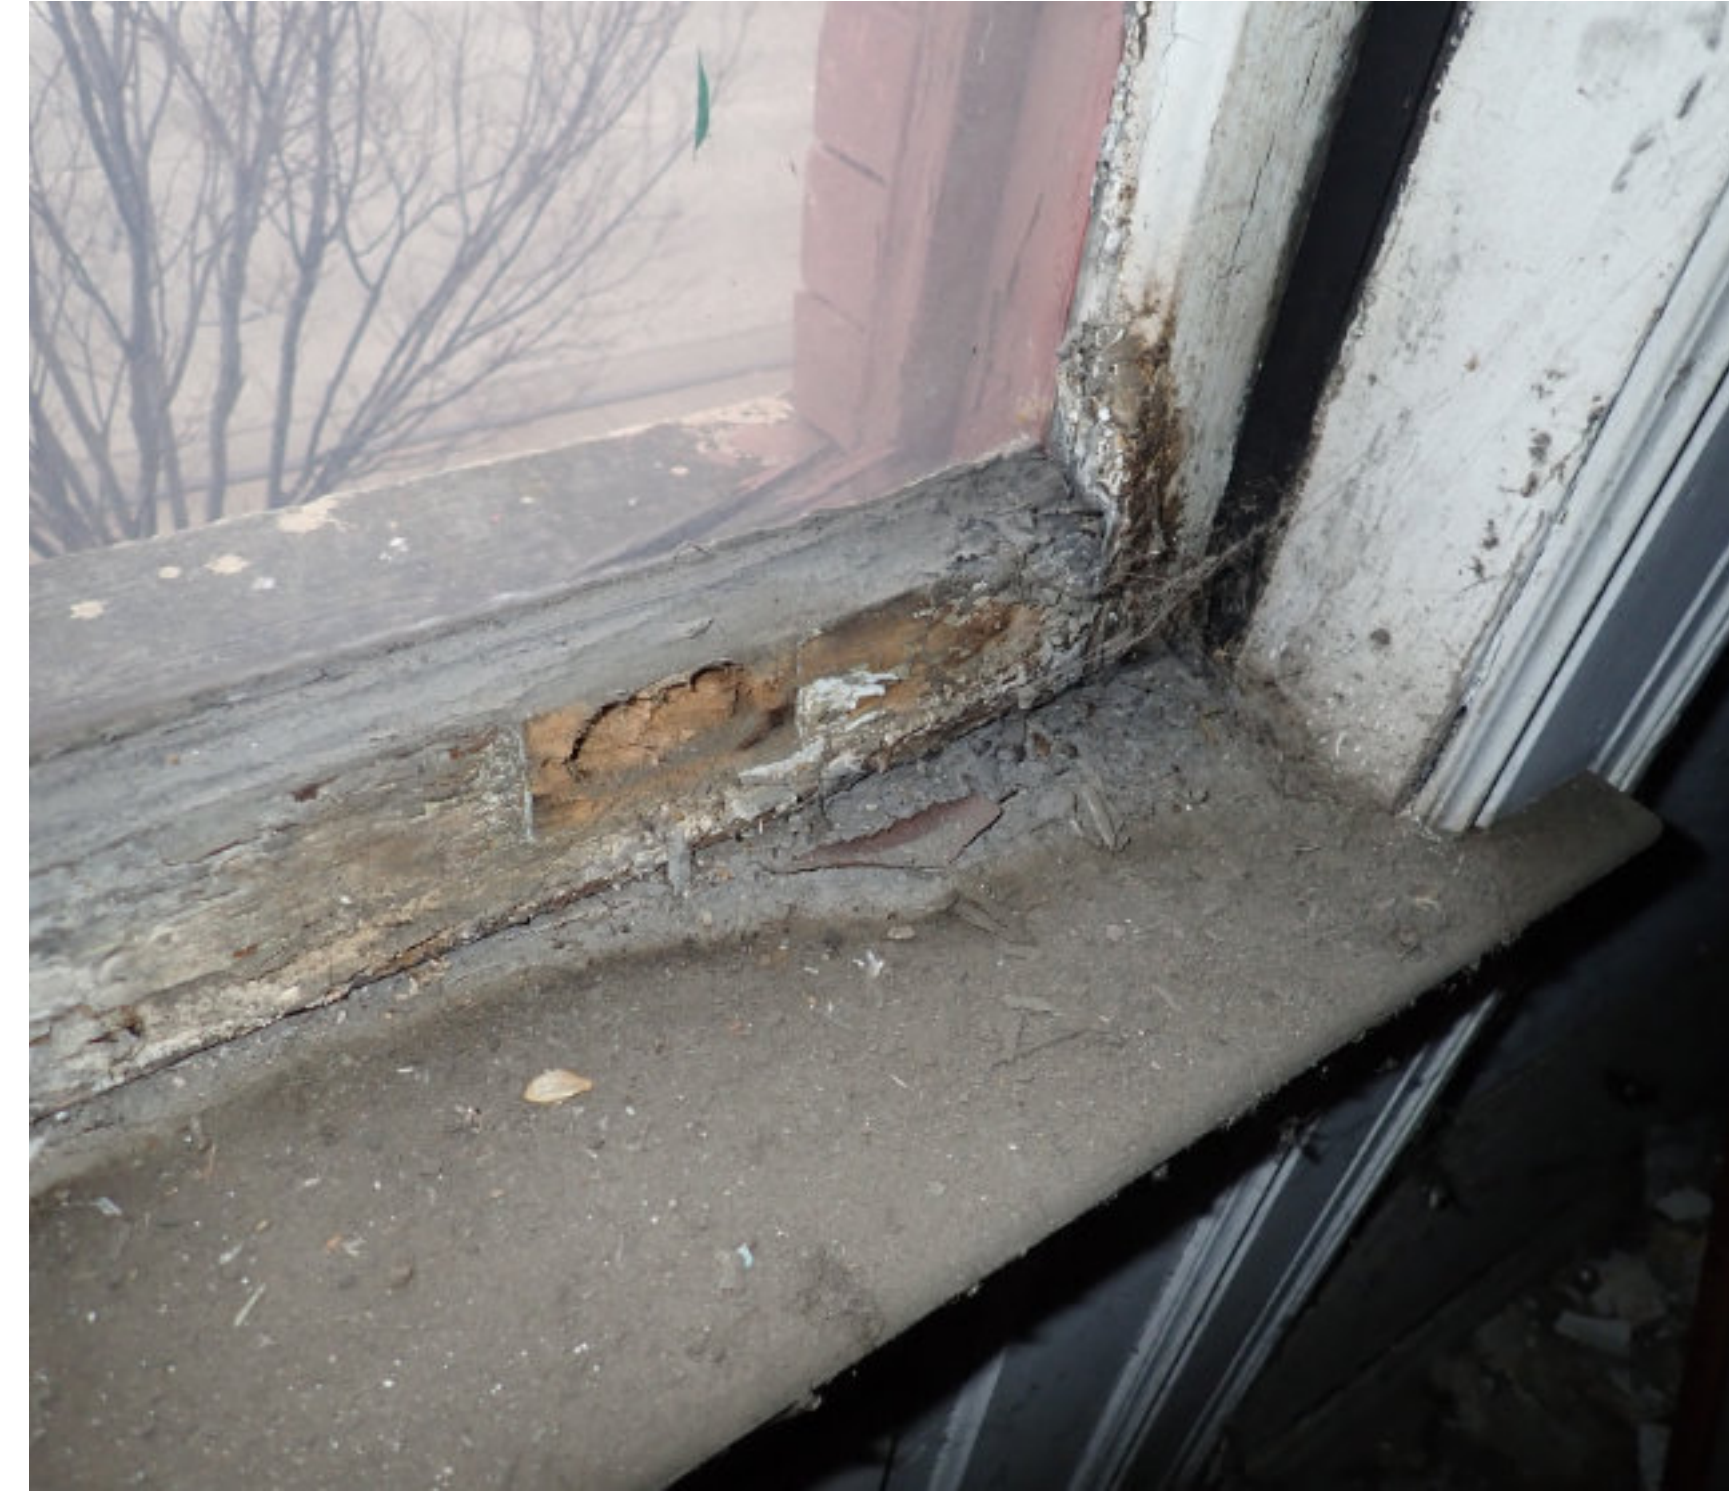
UNIT 206: DETERIORATED LOWER RAIL
