WINDOW SURVEY

The 2nd story windows were surveyed by a visual survey from the interior using a camera. The survey focused on the existing conditions of the wood frames, operability of the window sashes and condition of the glass. The purpose was to determine if the condition of the windows and frames was suitable to be restored or if new window units were required.

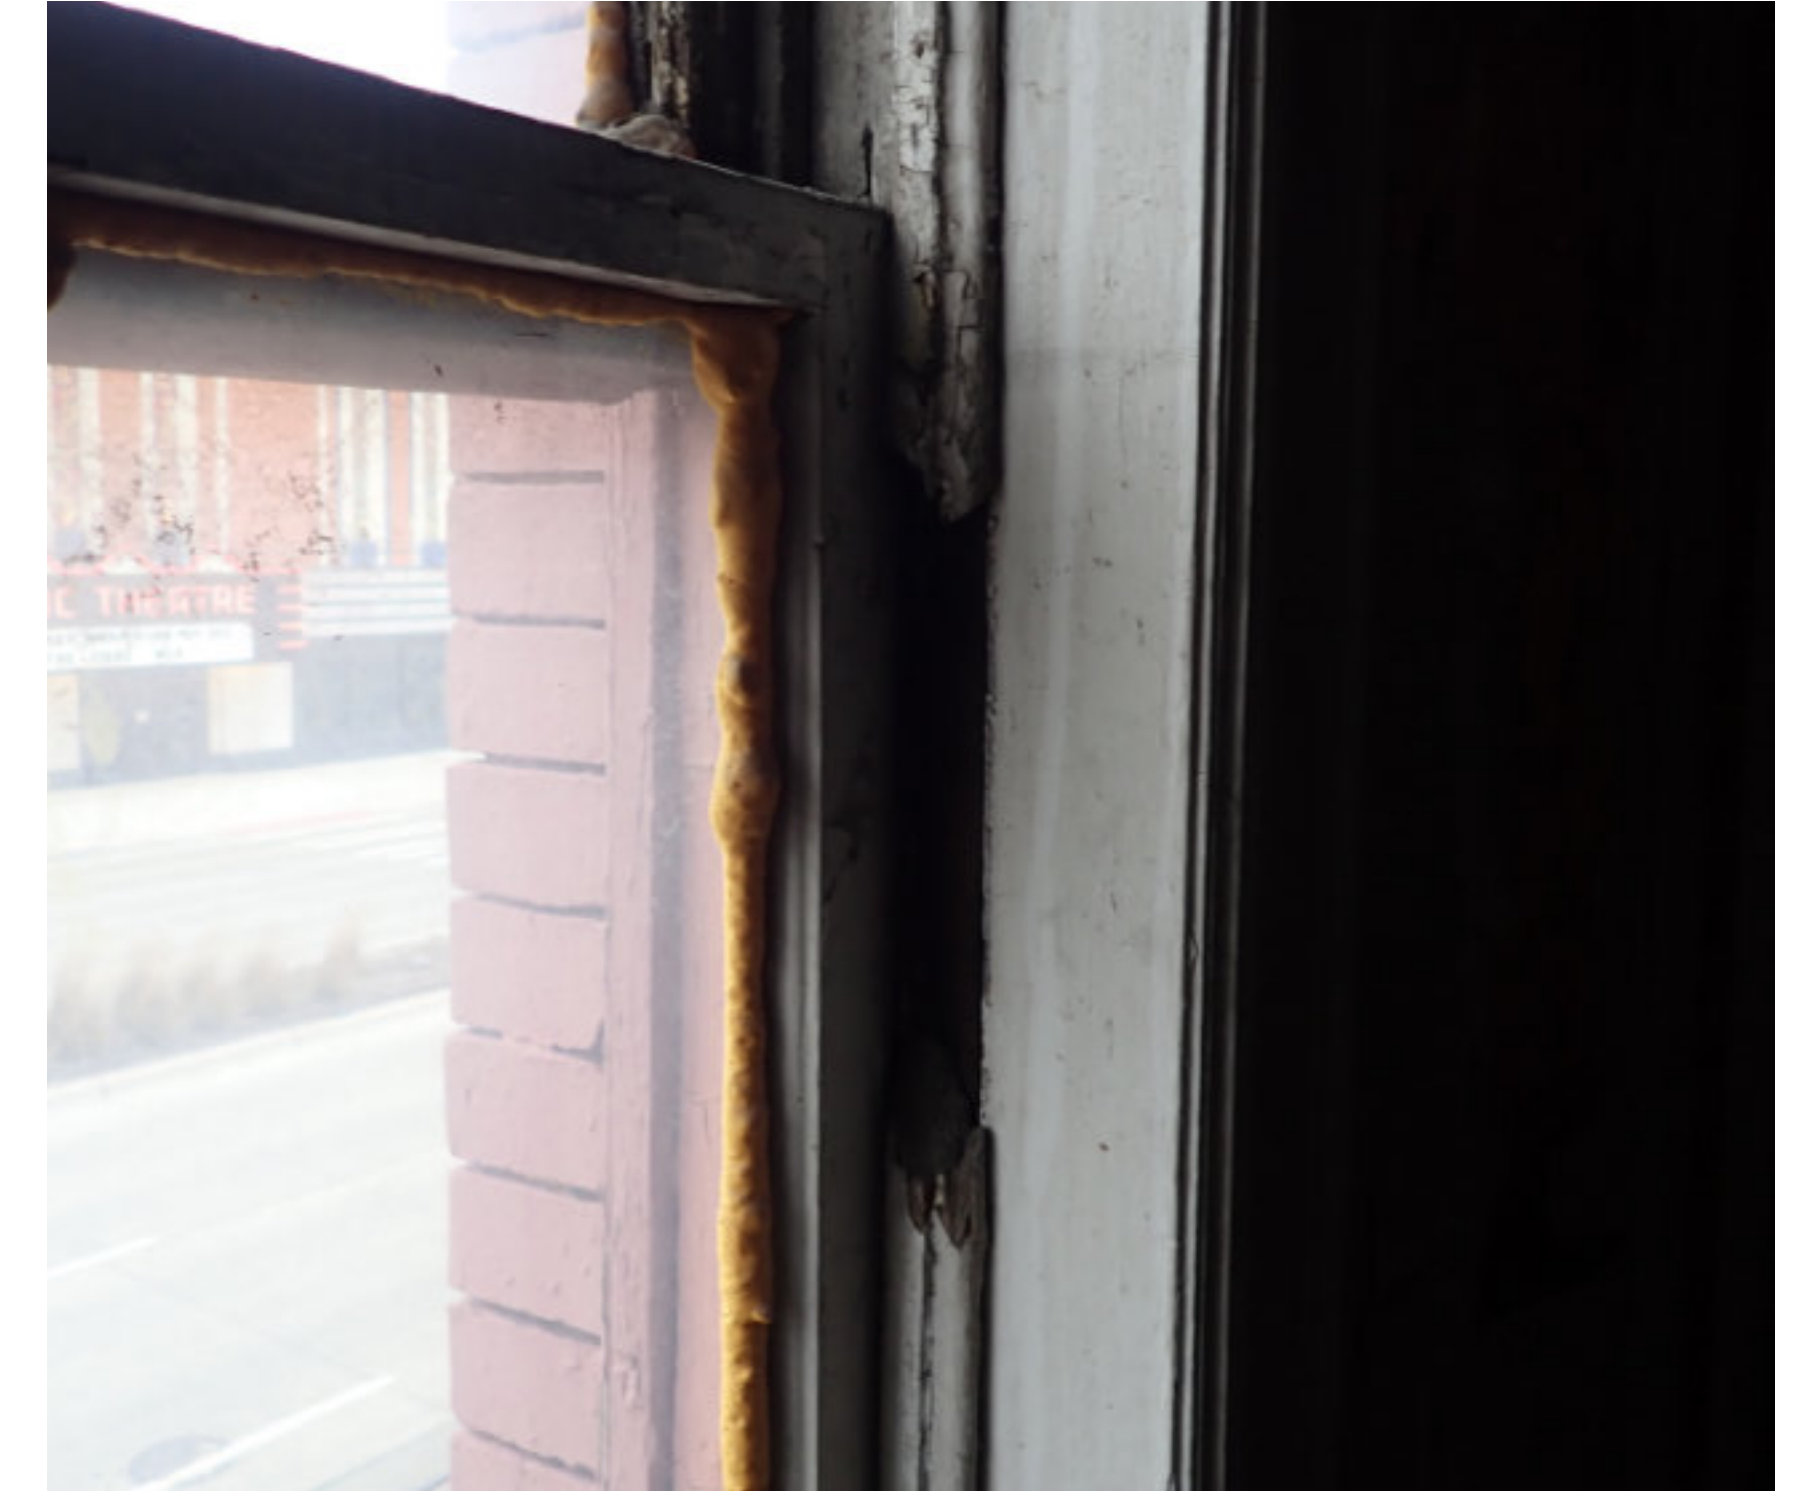
UNIT 207: BROKEN AND MISSING STOP

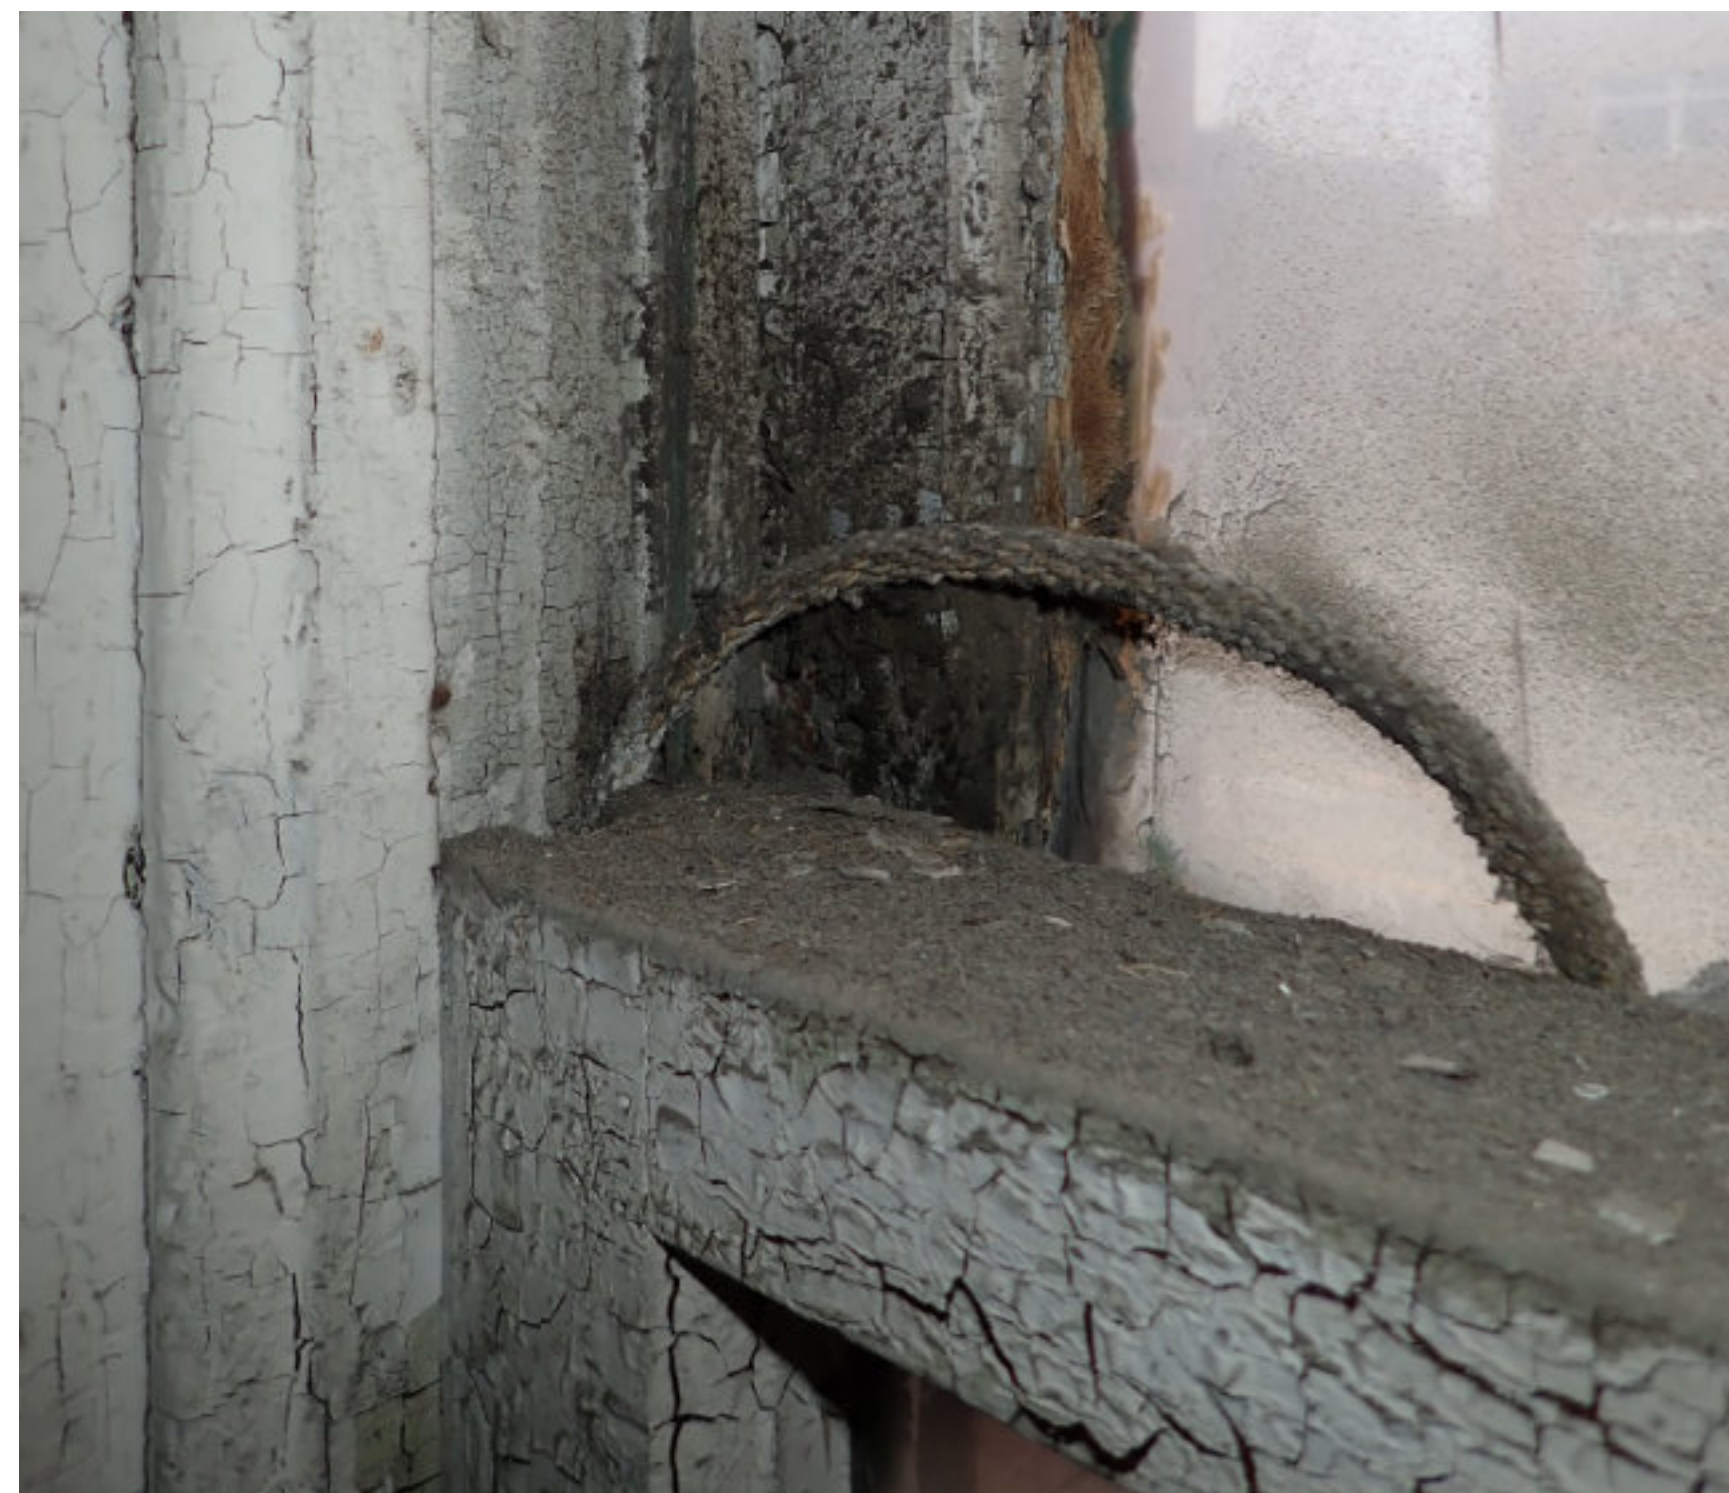
UNIT 206: BROKEN ROPES AND ANCHORS

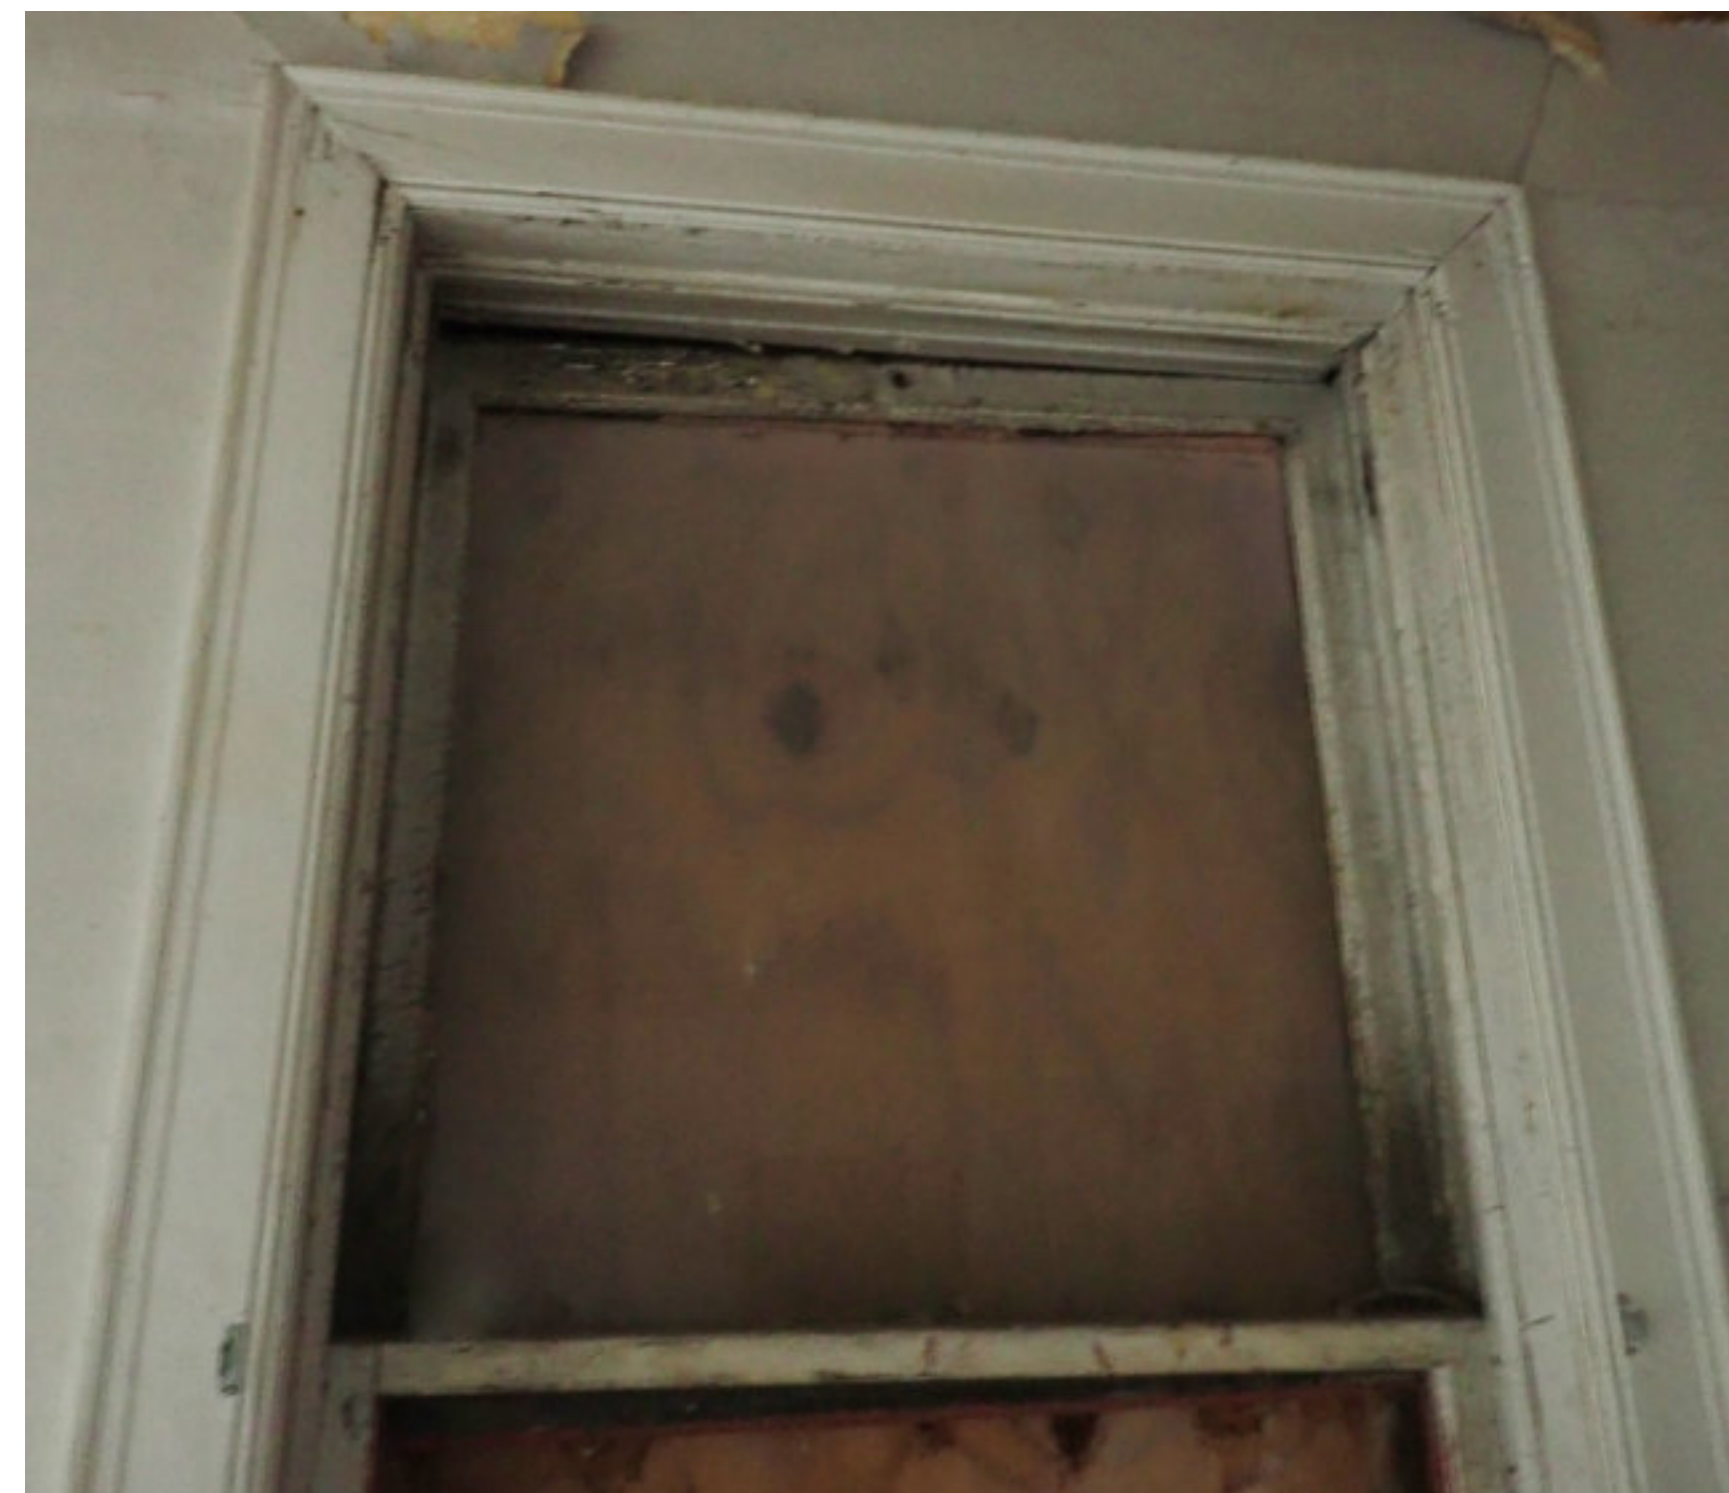
UNIT 206: BROKEN AND OUT OF ALIGNMENT RAILS

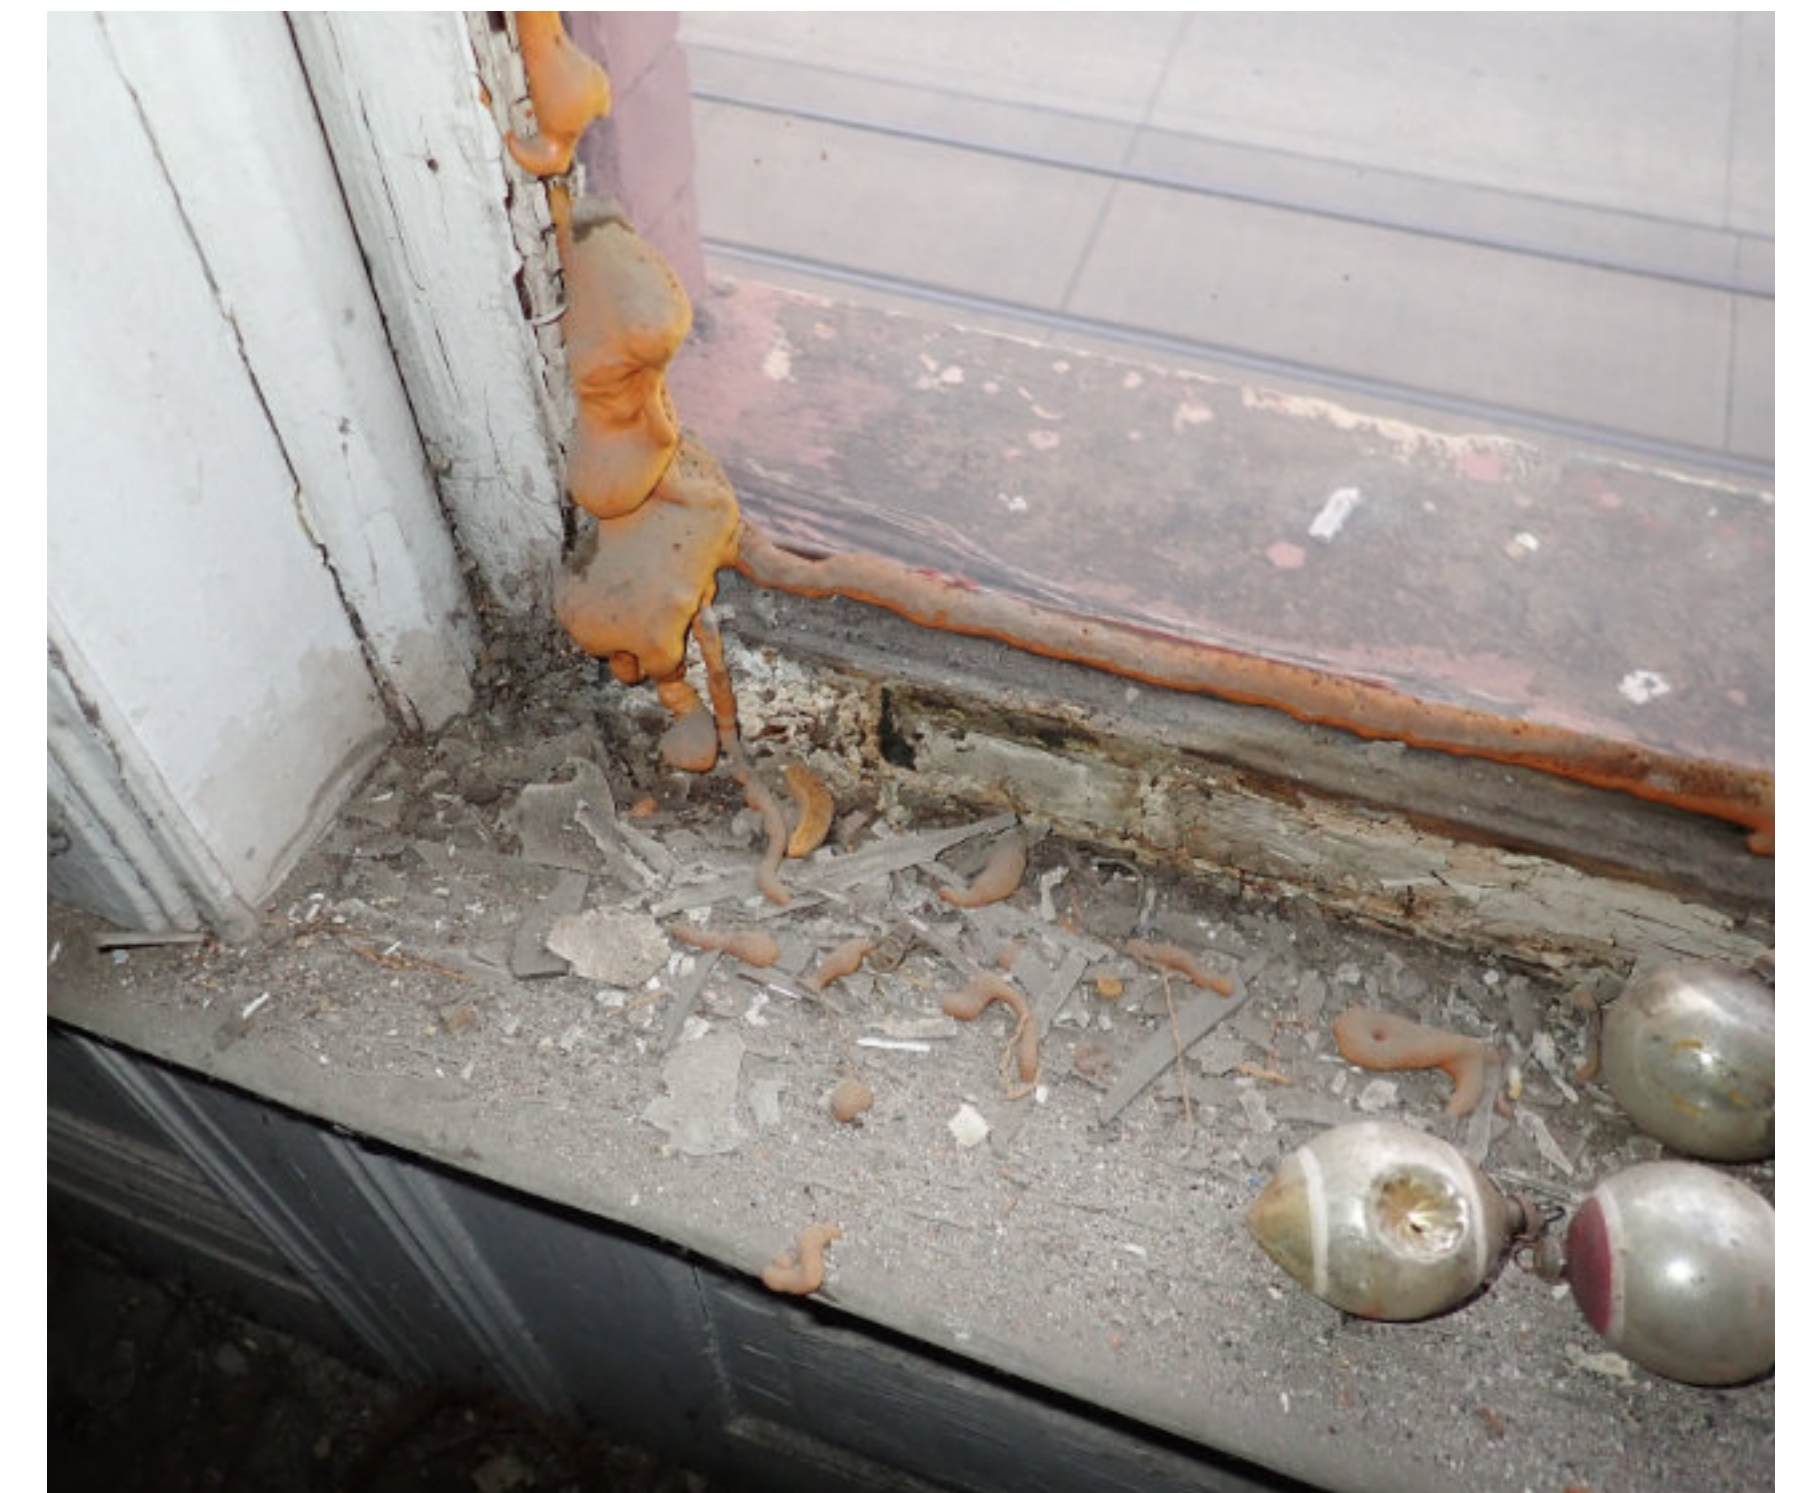
UNIT 207: INAPPROPRIATE MATERIAL

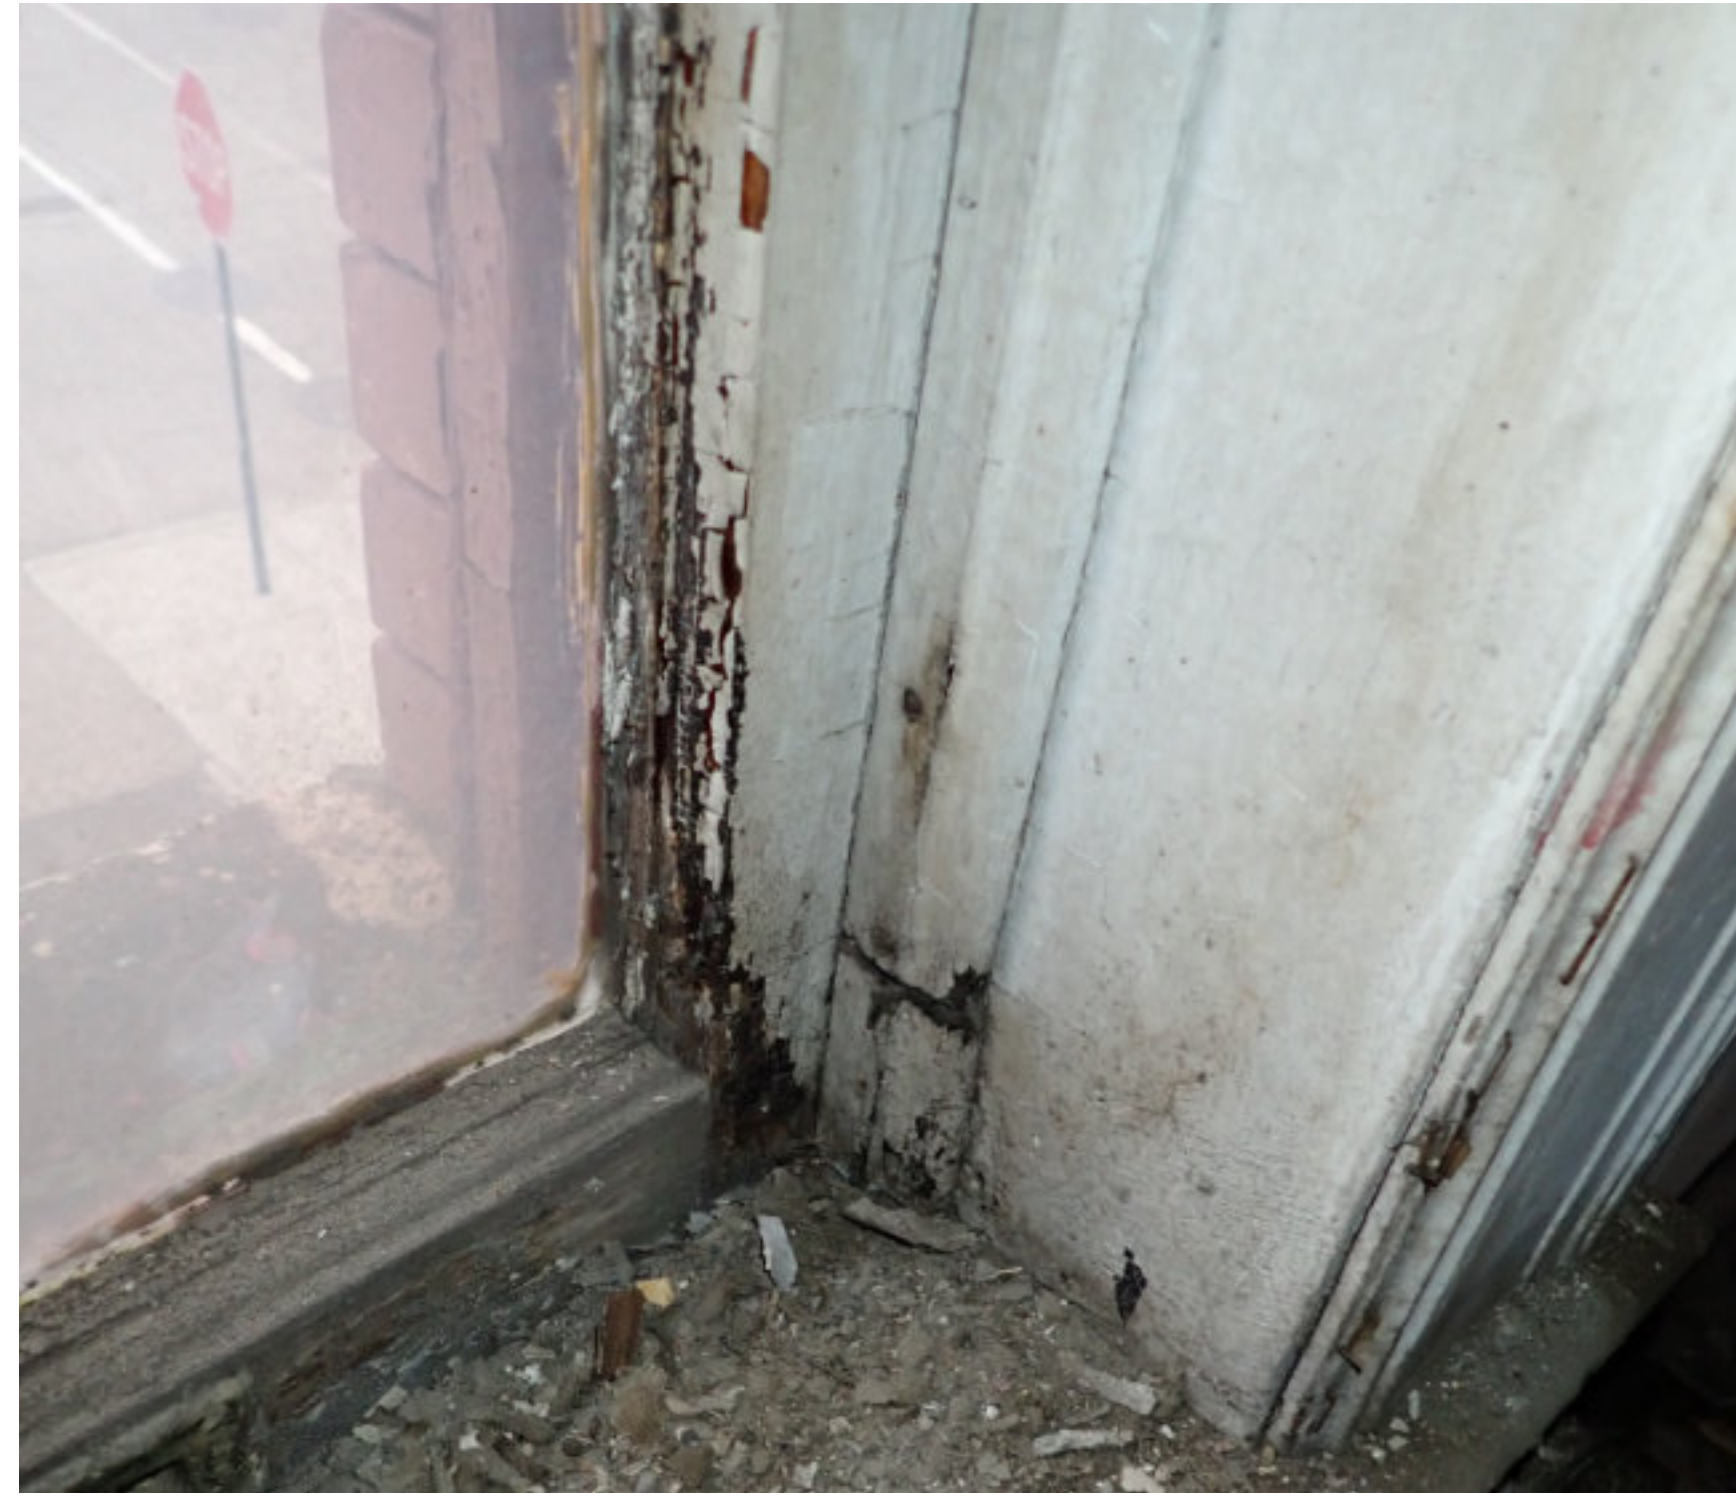
UNIT 208: DETERIORATED STILE

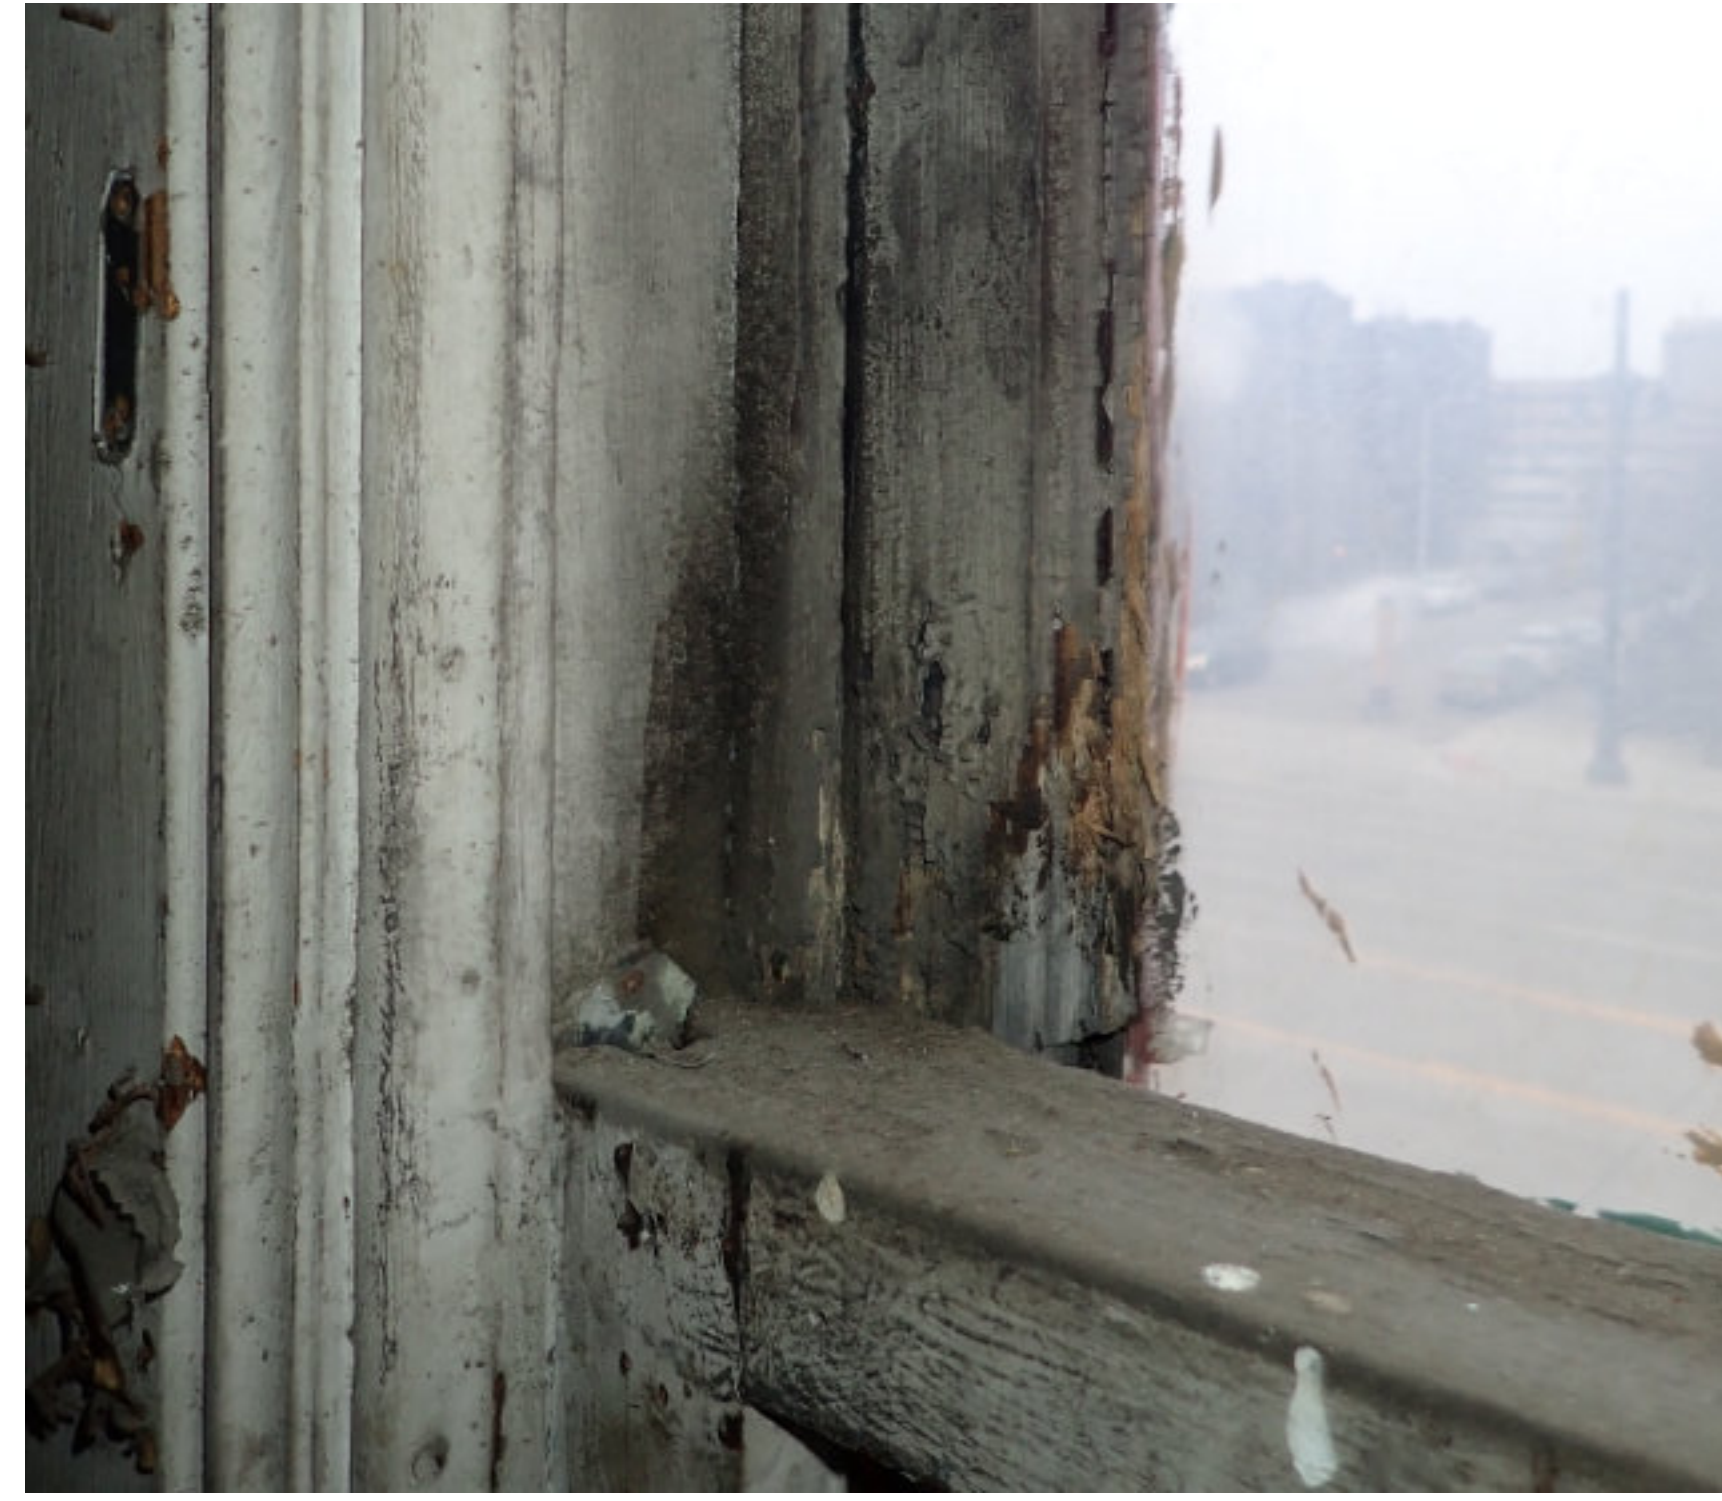
UNIT 208: DETERIORATED STILE

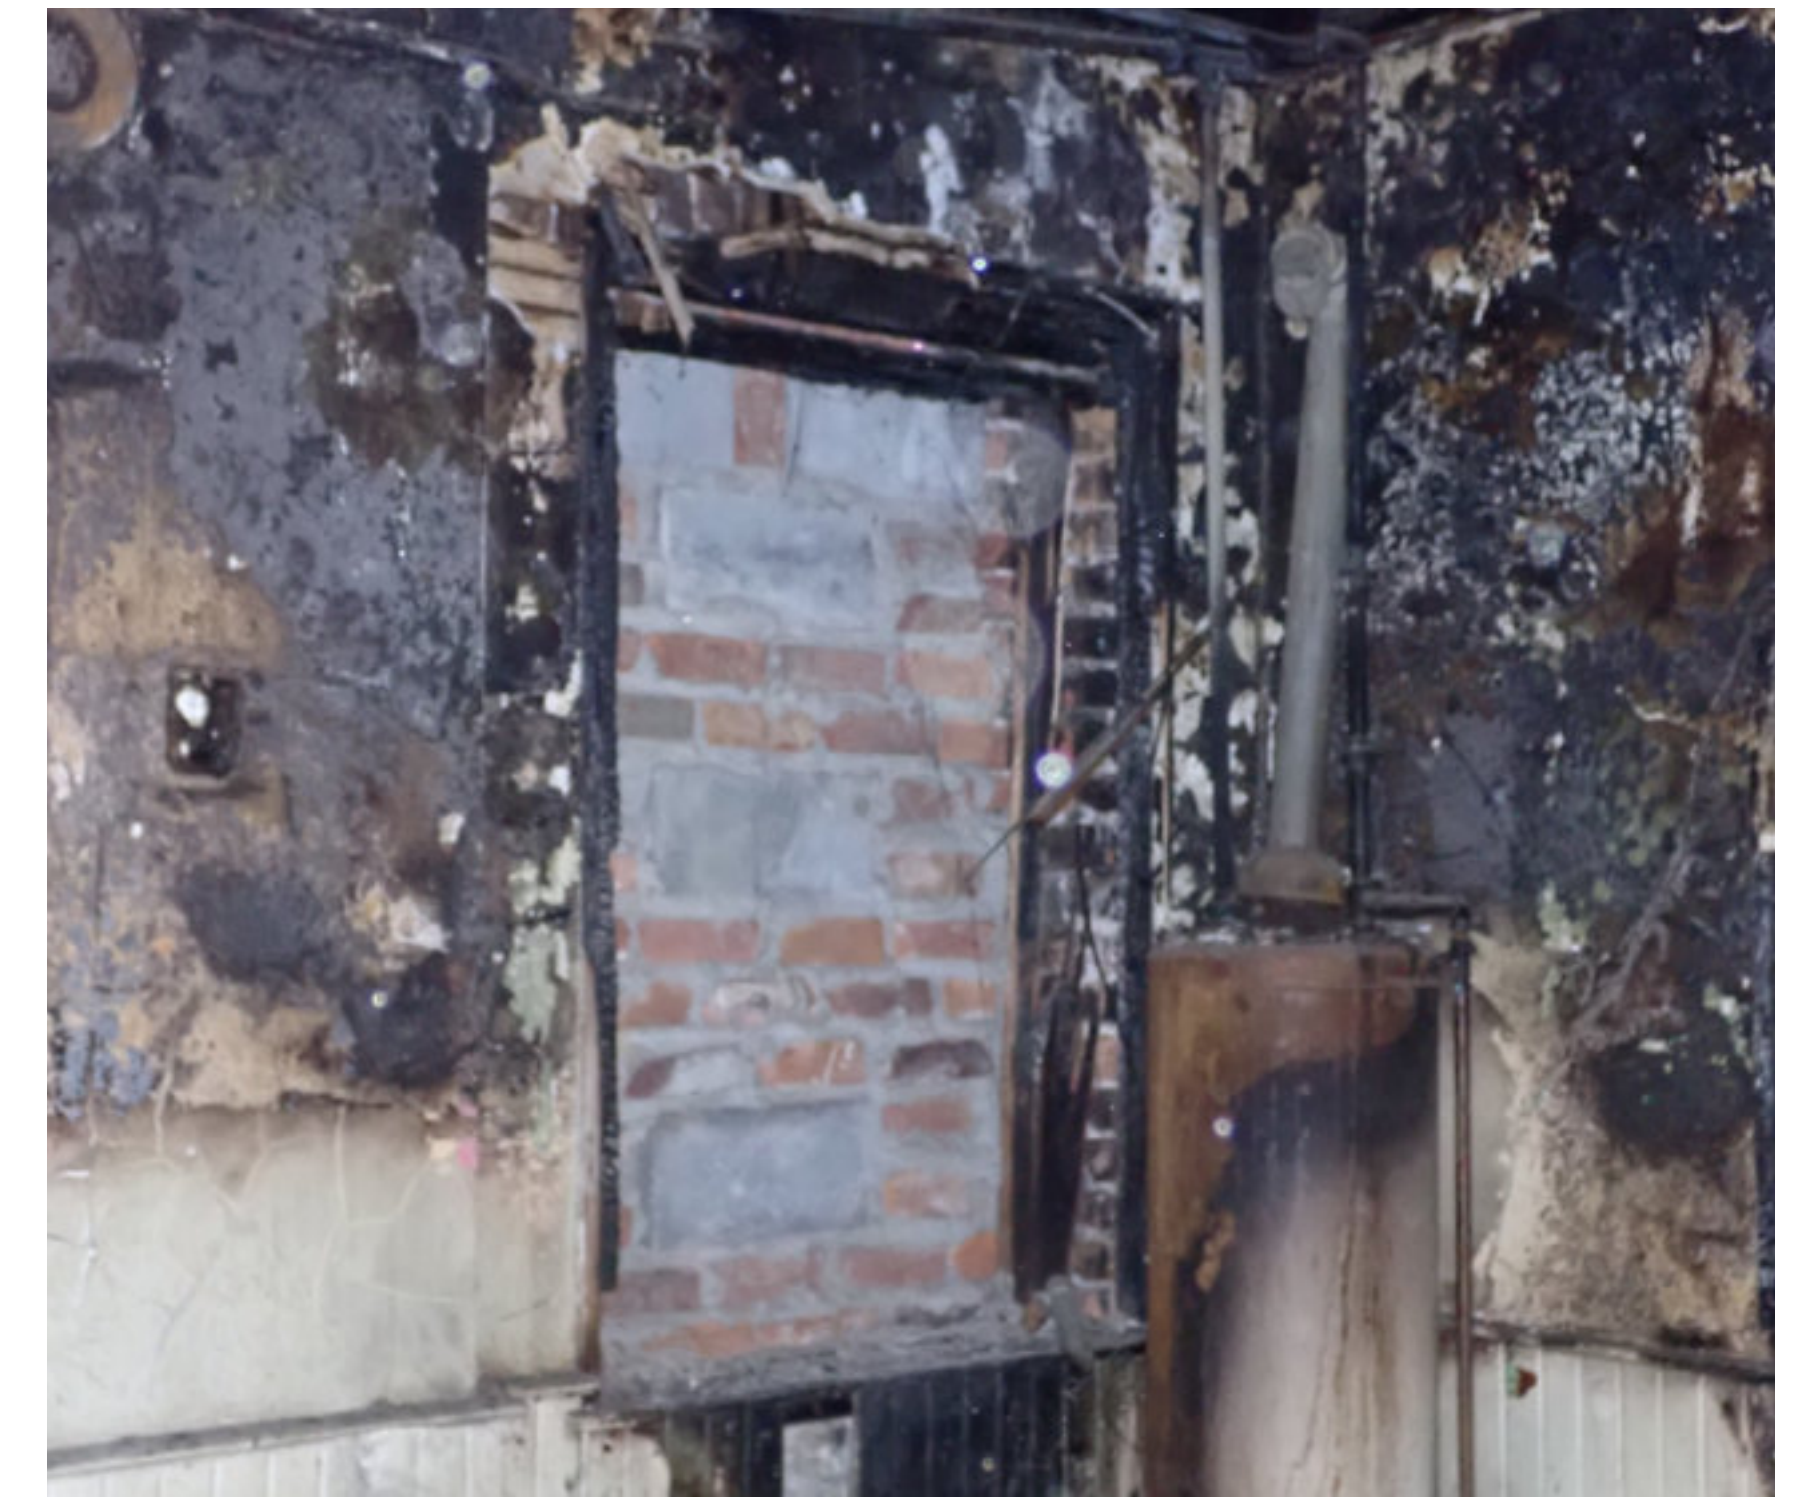
UNIT 208: FIRE DAMAGE
