HDC Application for work @ 14935 Westwood – Detroit, MI 48223

Lead Abatement Project for State of Michigan Lead Program

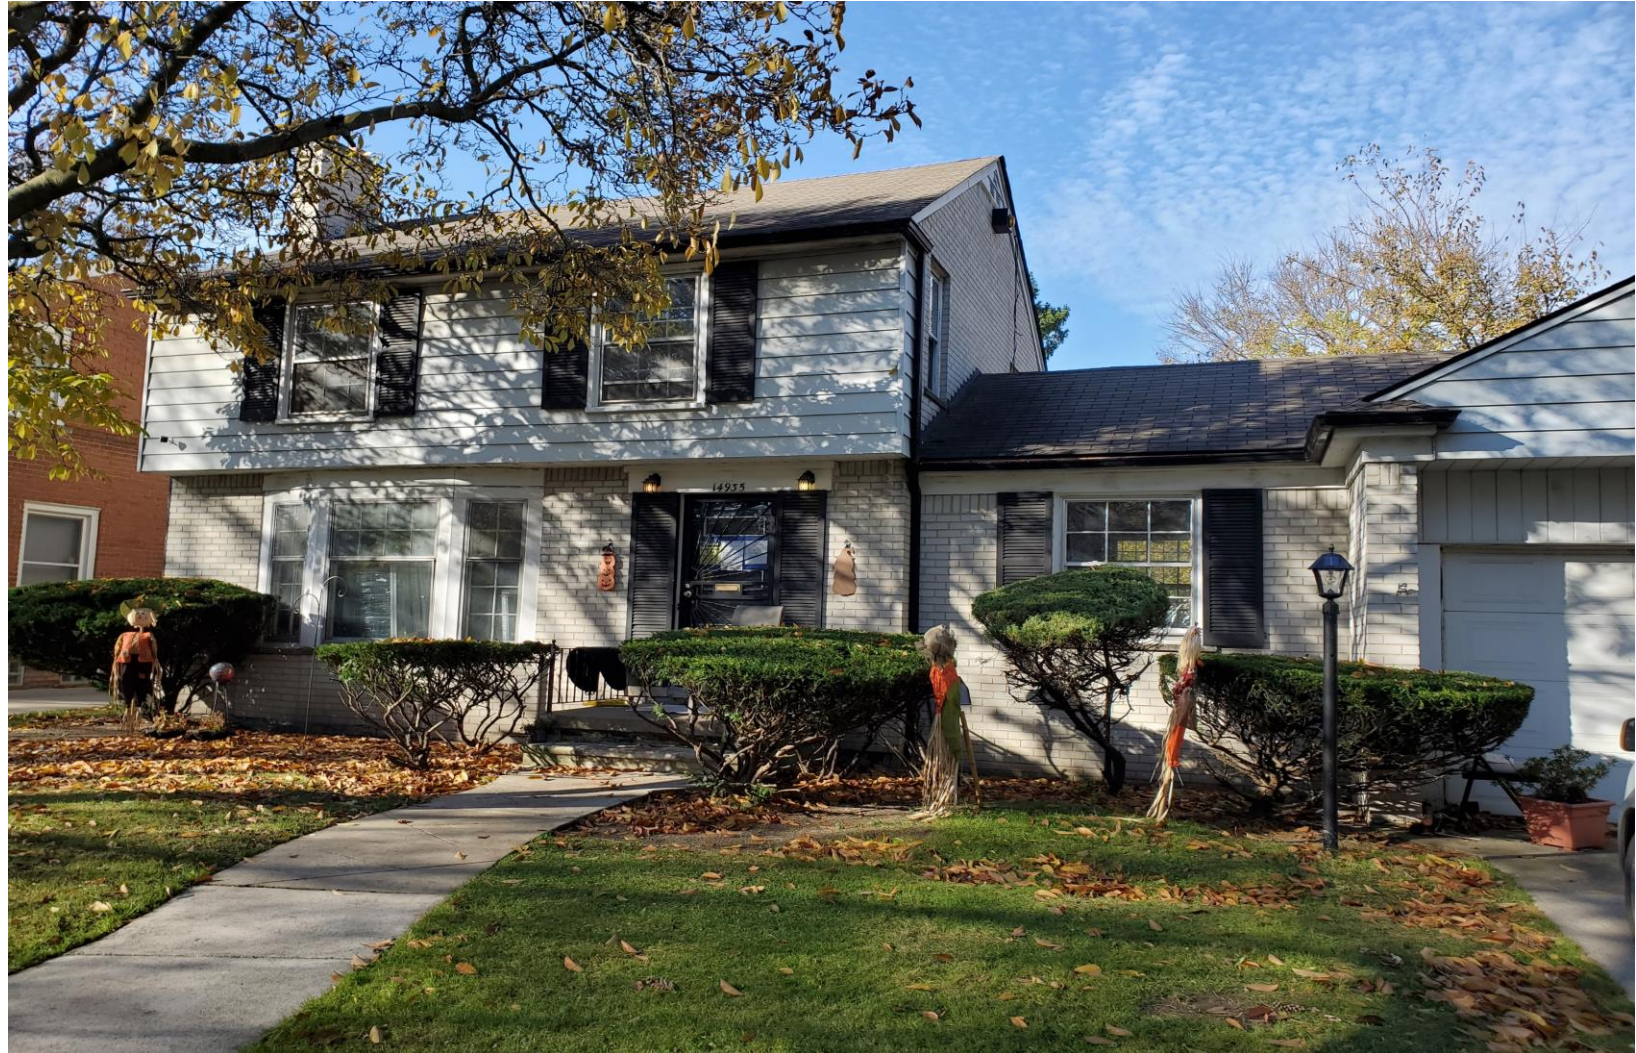
Front Livingroom

Exterior view of front side A

Livingroom windows

Current units are 40% upper & 60% lower
Double Hung type windows

Old Aluminum storm windows are present but
in poor and non-working condition

All windows are trimmed with aluminum coil
trim, white in color

Muntin bars on flankers & only upper on center

Front of home has aluminum soffit and siding
on front & partial sides. All soffit and fascia and
rake boards are already trimmed with aluminum
trim. They were subsequently painted with
lead-based paint on top of the aluminum trim
some time in the past history of paint work

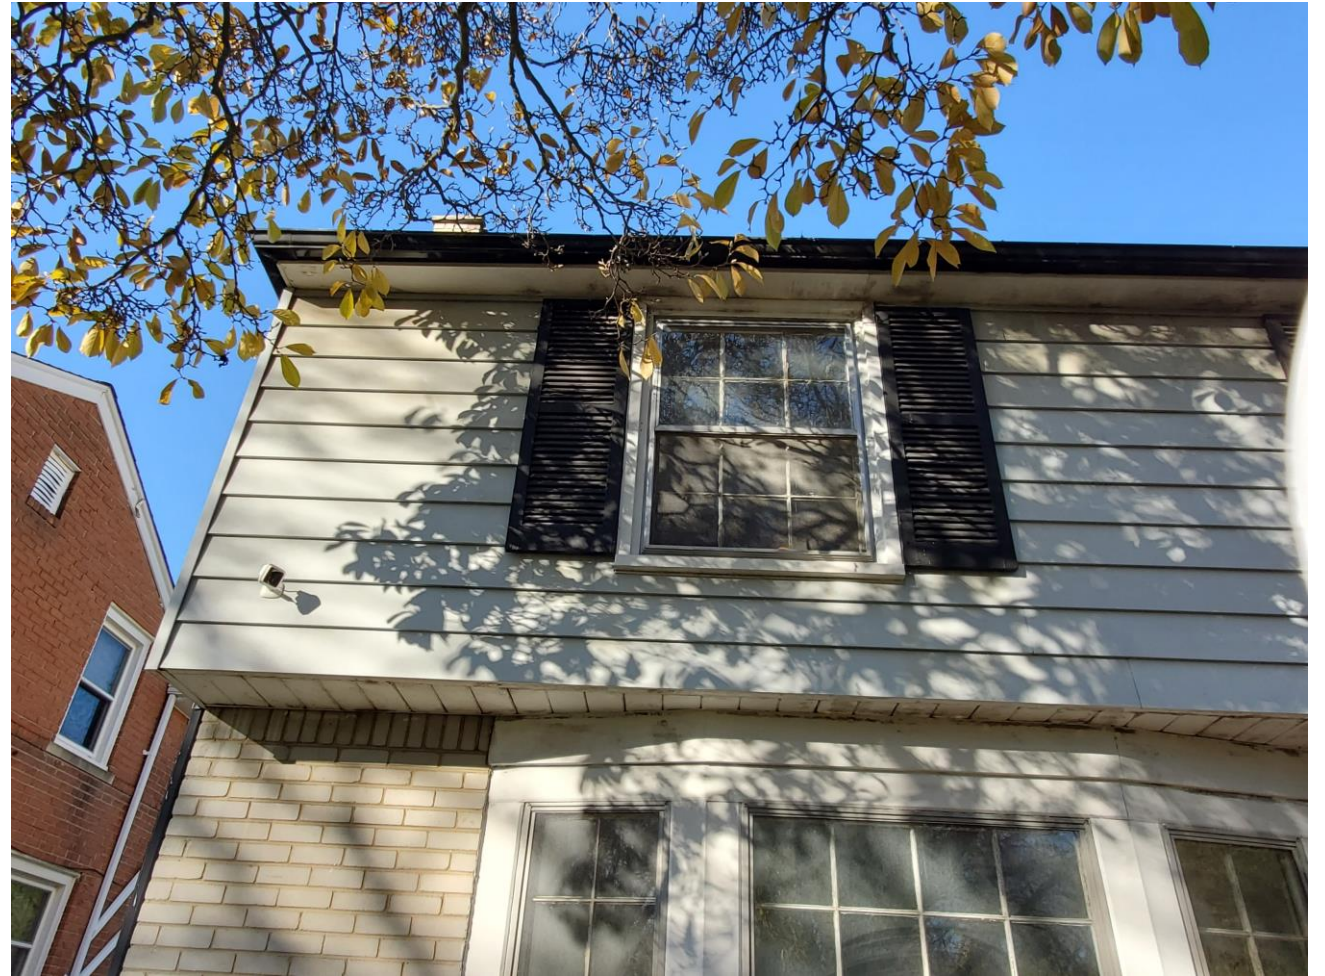
Front Upper Bedroom

Front upper bedroom side A on the home,
but on right side

Current window unit is a 50/50 Double Hung

Muntins are standard colonial pattern

Old Aluminum storm windows are present
but in poor and non-working condition

All windows are trimmed with aluminum coil
trim, white in color

Existing soffit & fascia and gutters are all
aluminum, but were painted over

Shutters are to remain

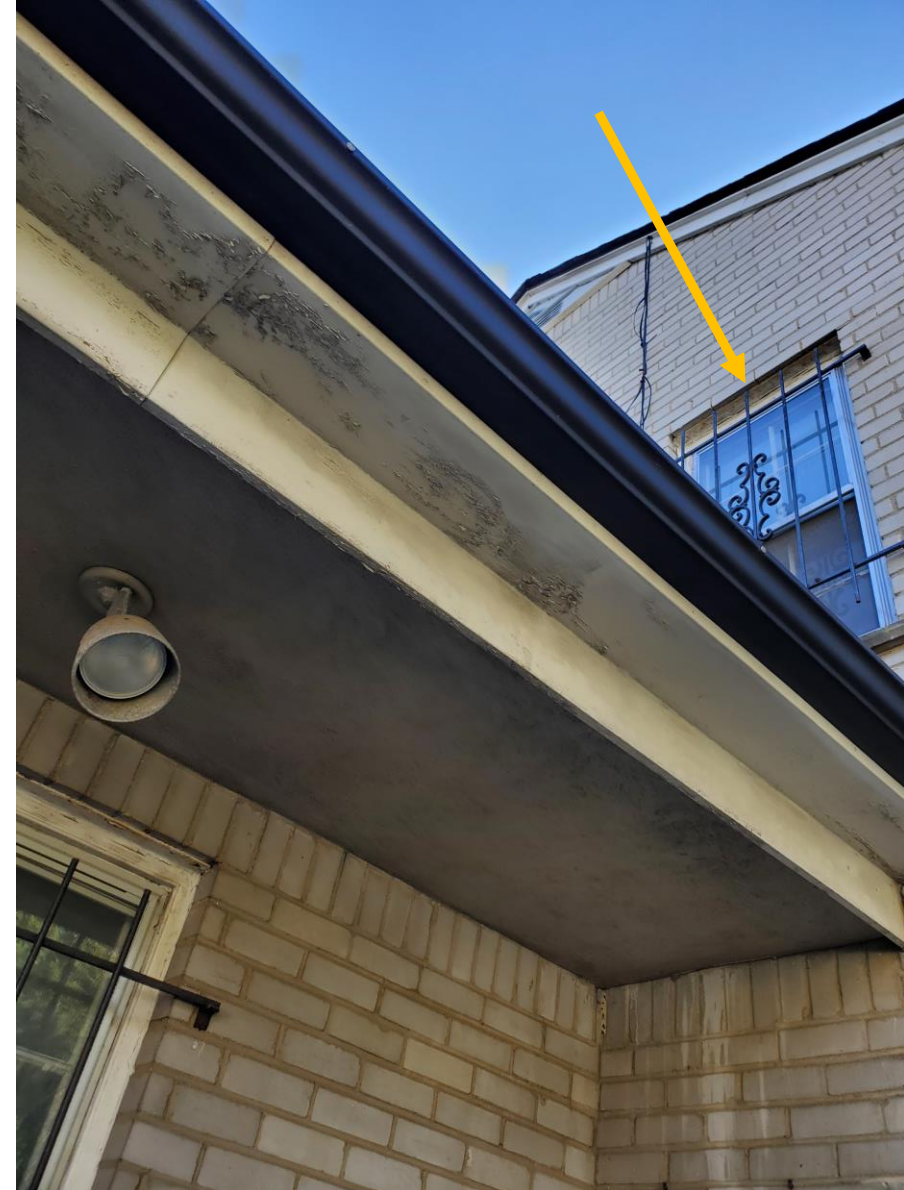
Side D Upper Bedroom

Side D (right side) upper front bedroom window side D on the home, but on right side

Current window unit is a 50/50 Double Hung

Muntins are standard colonial pattern

Old Aluminum storm windows are present but in poor and non-working condition. Only frame is existing

All windows are trimmed with aluminum coil trim, white in color

Existing rake edge and gable vent are all aluminum, but were painted over

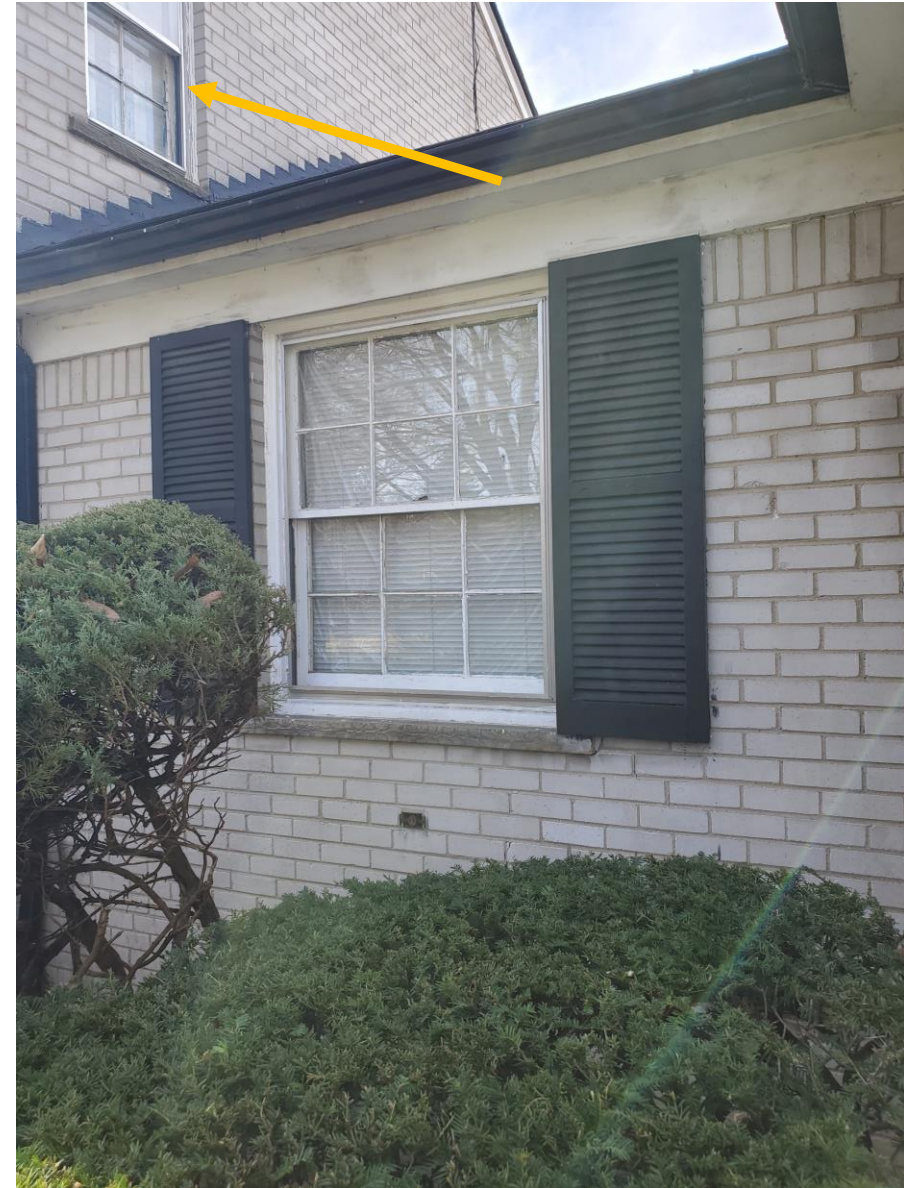
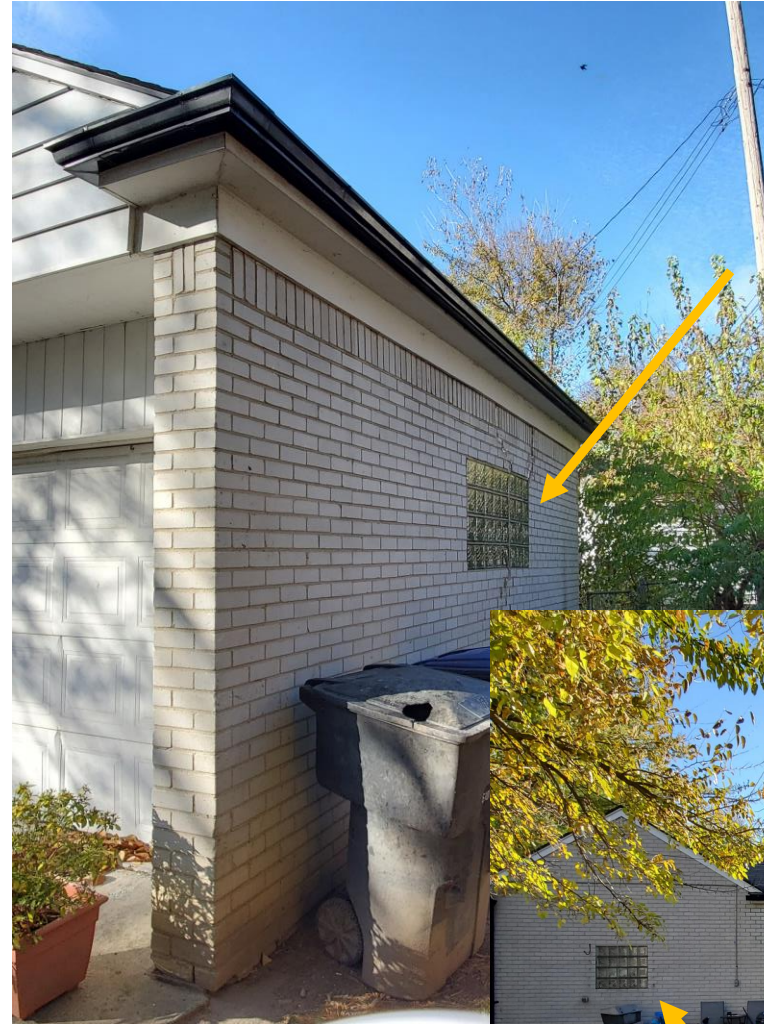
Garage Windows on Side D & C

Both windows are currently and have been for many years a Glass Block type window

These units are not lead painted and will not be addressed as part of the Lead Abatement Project as SOW by the State.

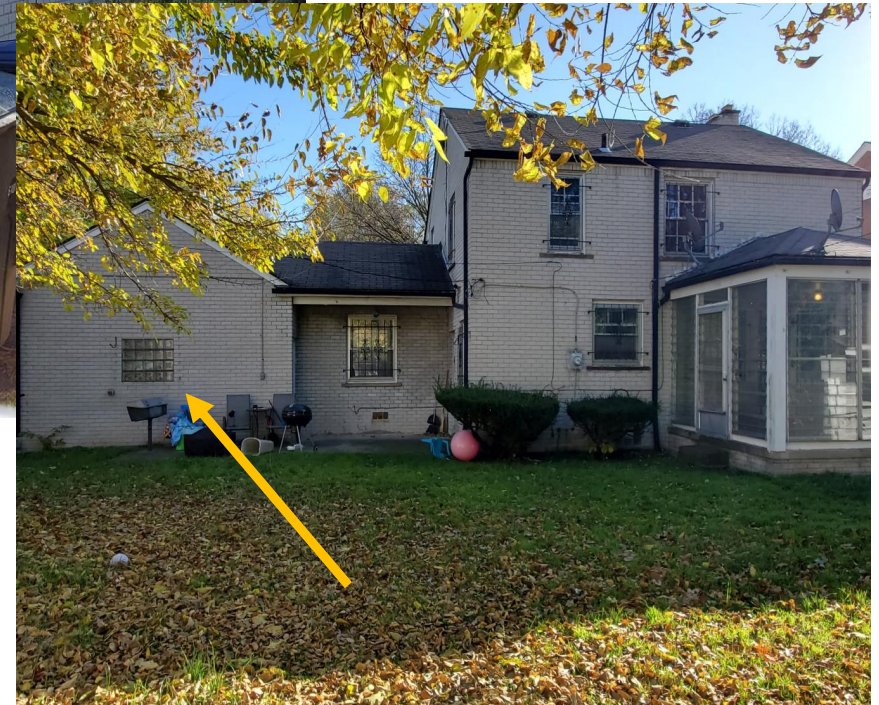
Kitchen Window

Exterior view of Rear side C

Kitchen window

Current units are 40% upper & 60% lower
Double Hung type windows

Muntin bars only on upper section

Old Aluminum storm windows are present
but in poor and non-working condition

All windows are trimmed with aluminum coil
trim, white in color

Paint is flaking off areas where trim is missing

Window bars will be removed

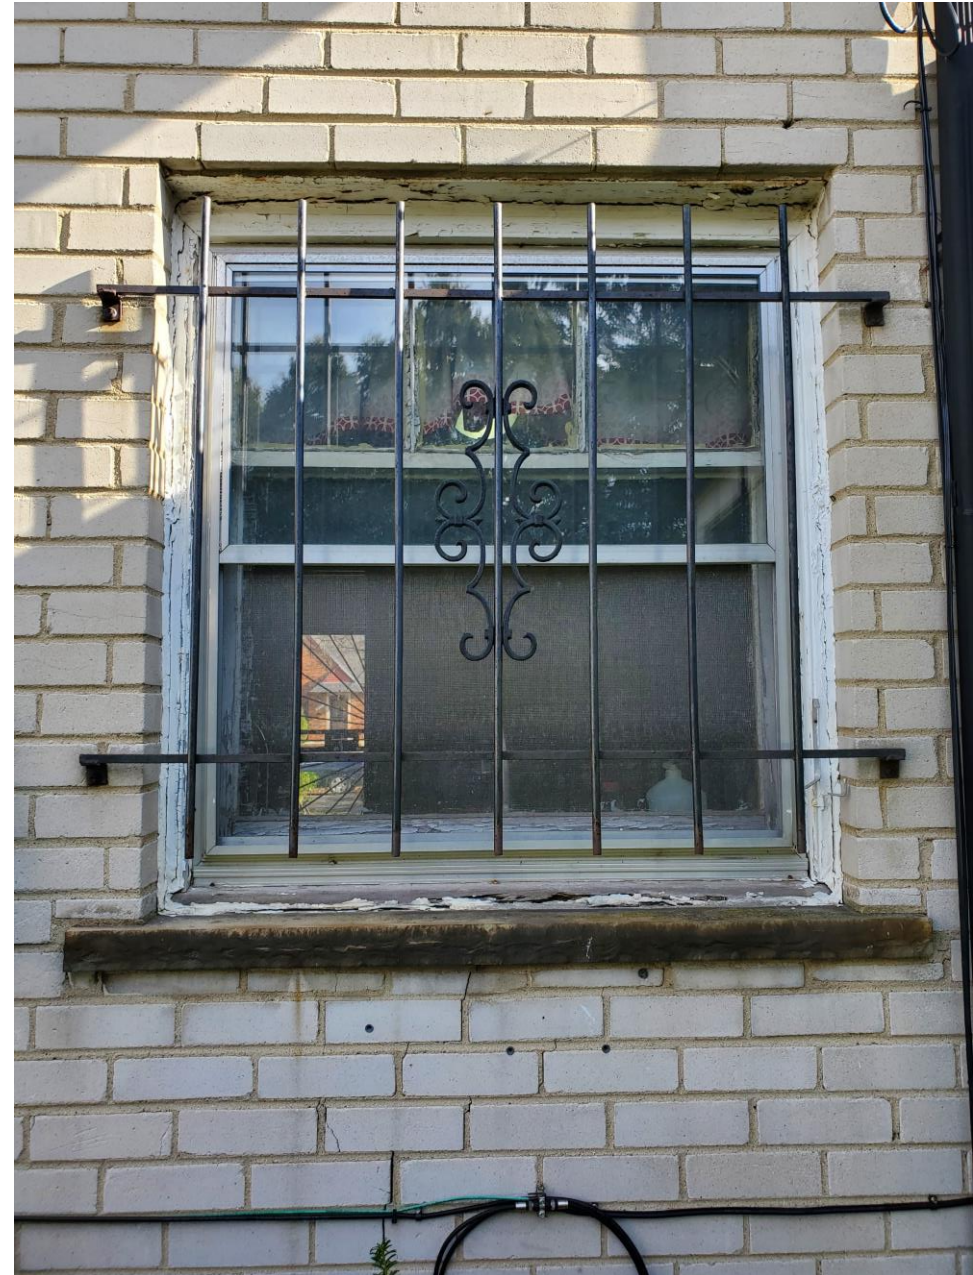
1st Floor ½ Bathroom

Side D (right side) Lower bathroom window
side D on the home, but on right side

Current window unit is a 50/50 Double Hung

Muntins are standard colonial pattern,
missing as glass was changed. Lower glass is
obscure

Old Aluminum storm windows are present
but in poor and non-working condition

All windows are trimmed with aluminum coil
trim, white in color

Paint is flaking off areas where trim is missing

Window bars will be removed

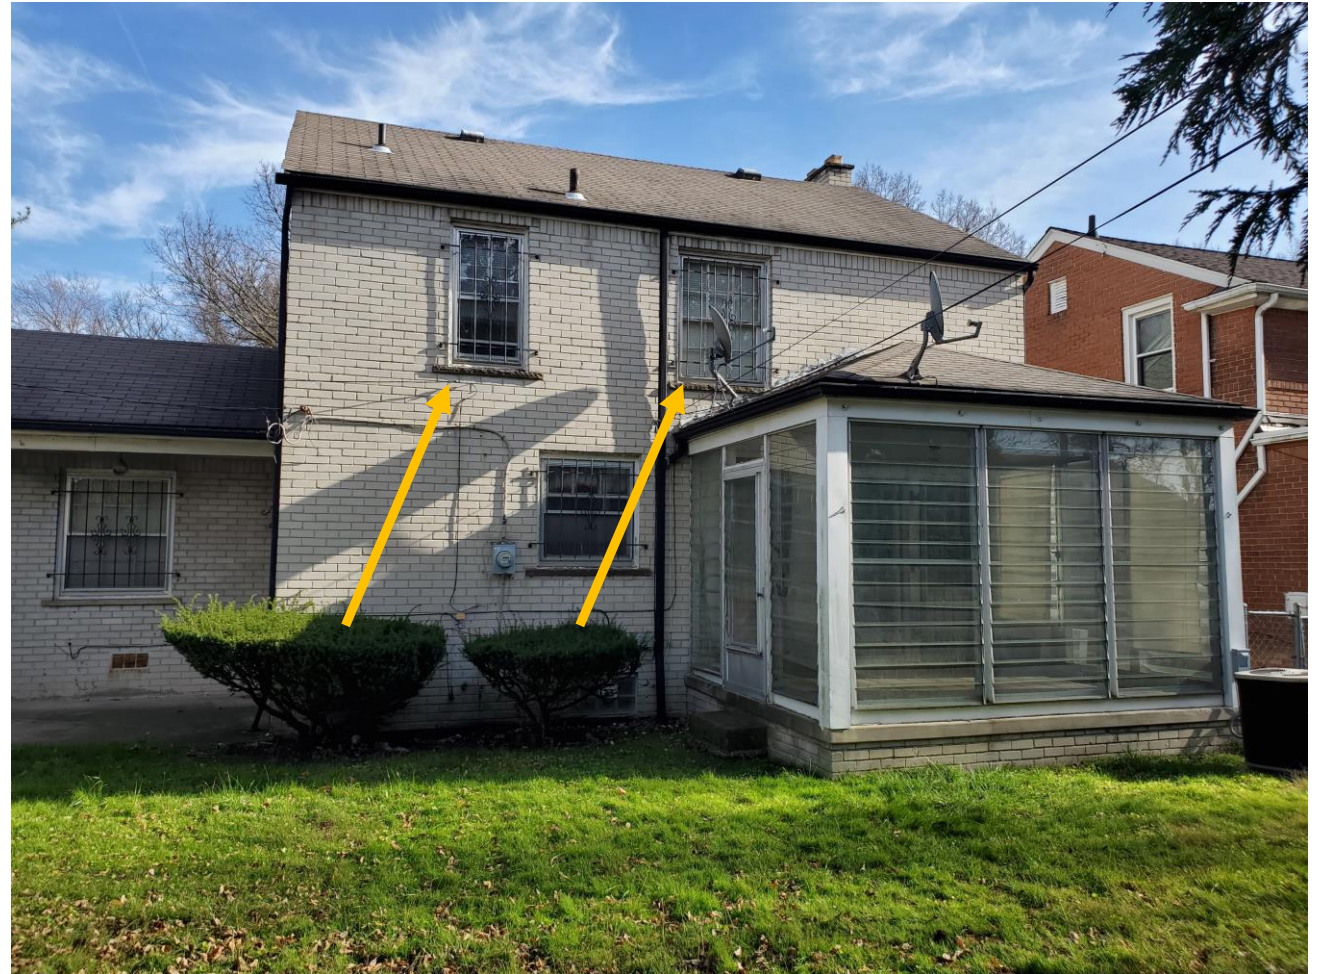
Rear Livingroom 2 / Family room area

Rear lower livingroom / familyroom side C on the home, but on rear side

Current window unit is a 50/50 Double Hung

Muntins are standard colonial pattern

Old Aluminum storm windows are not present only frame. Frame in poor and non-working condition

All windows are trimmed with aluminum coil trim, white in color

Existing soffit & fascia and gutters are all aluminum, but were painted over

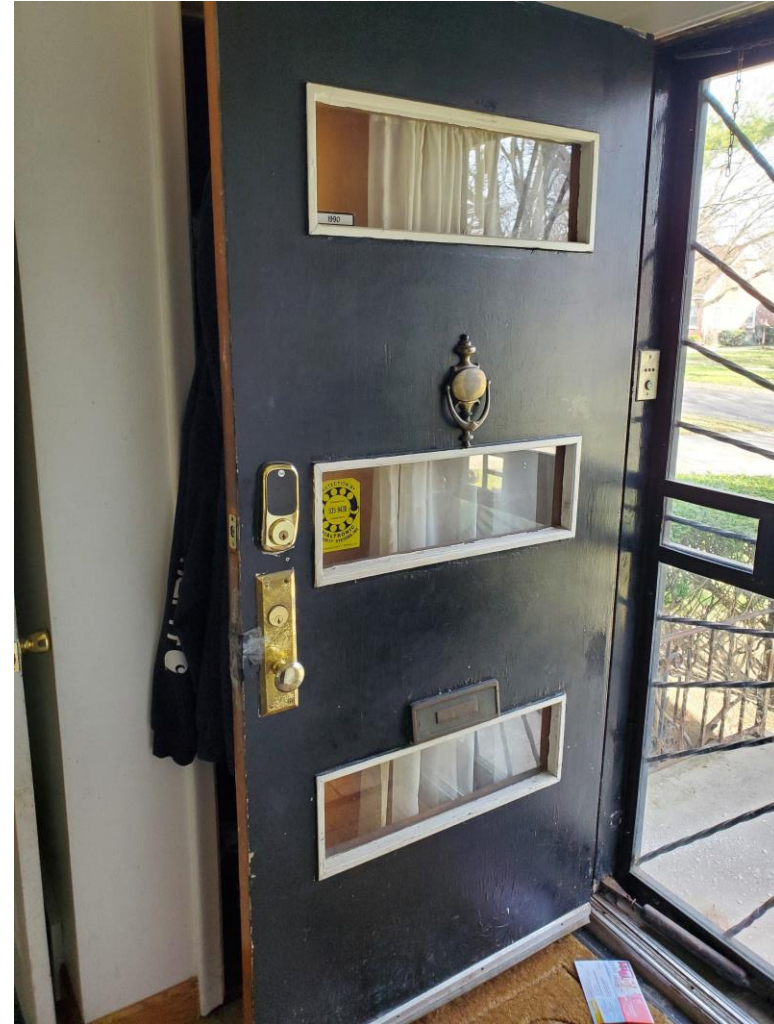
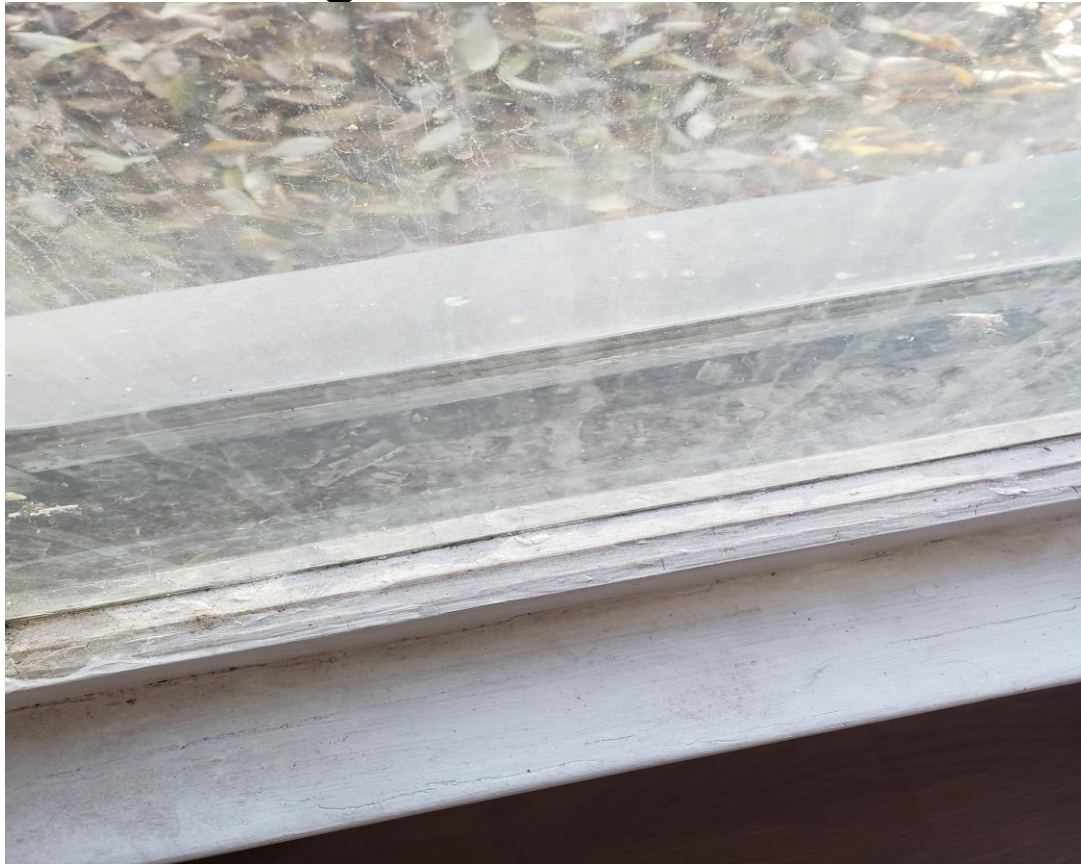
- Livingroom Windows

Paint Chips &
Lead Dust.

High Levels of
Lead Dust
were found
and is
considered
Hazardous

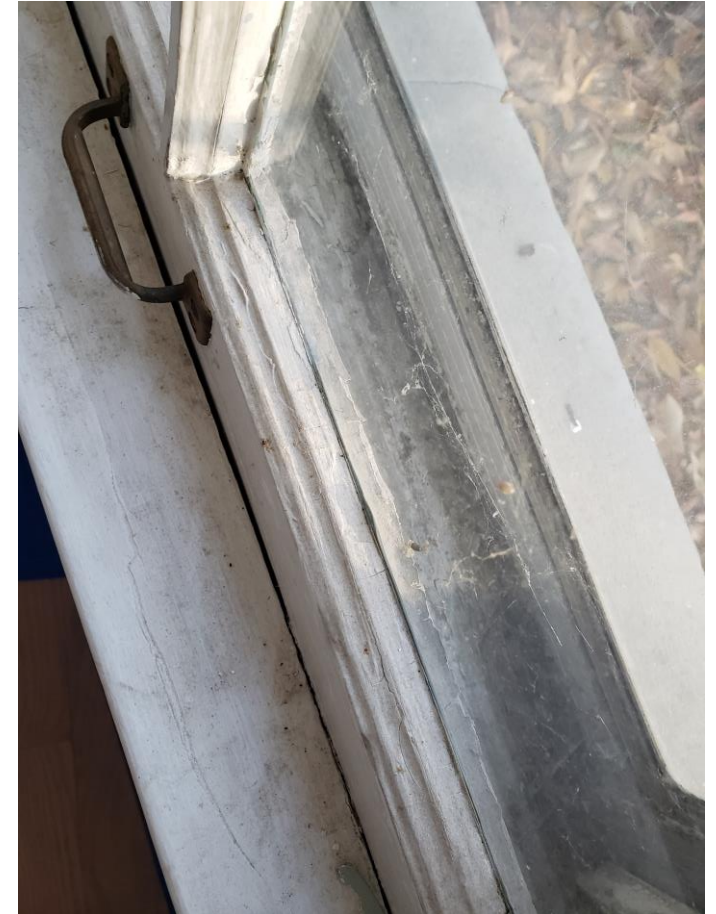
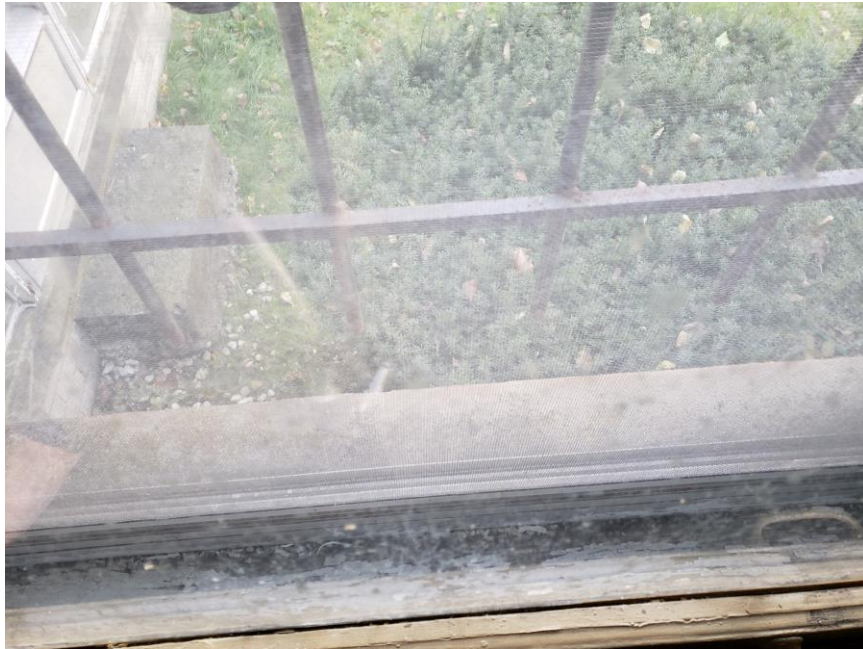
- Old Wood Windows

Paint Chips &
Lead Dust.

High Levels of
Lead Dust
were found
and is
considered
Hazardous

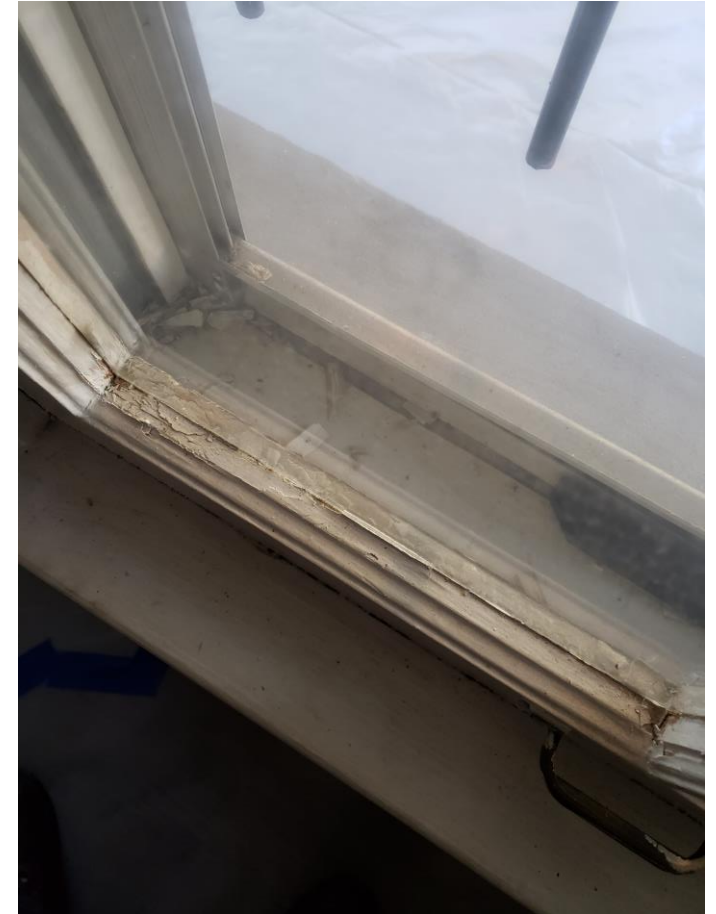
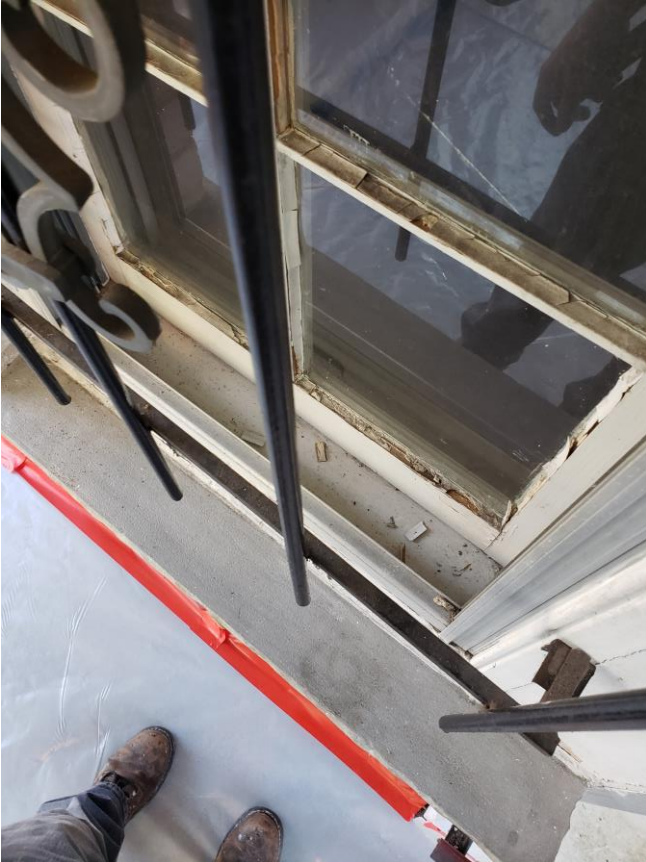
- Old Wood Windows

Paint Chips & Lead Dust.

High Levels of Lead Dust were found and is considered Hazardous

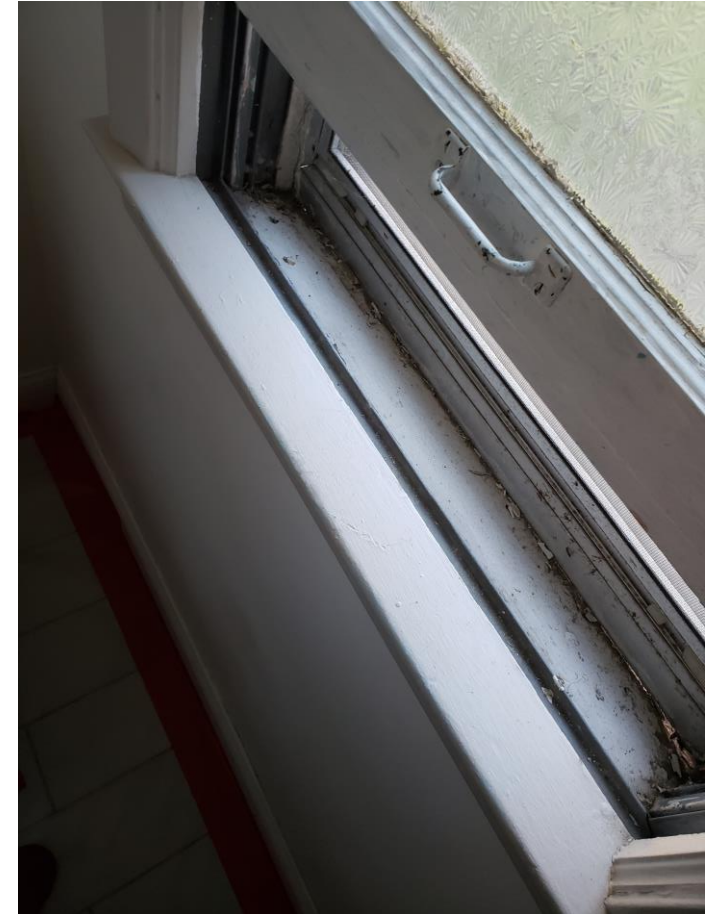
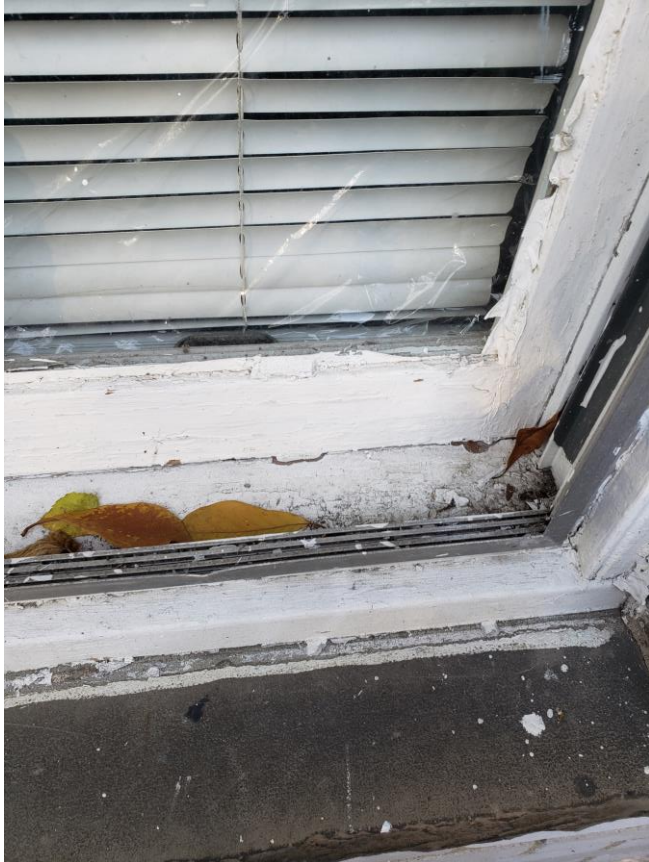
- Old Wood Windows

Paint Chips & Lead
Dust.

High Levels of Lead
Dust were found and
is considered
Hazardous

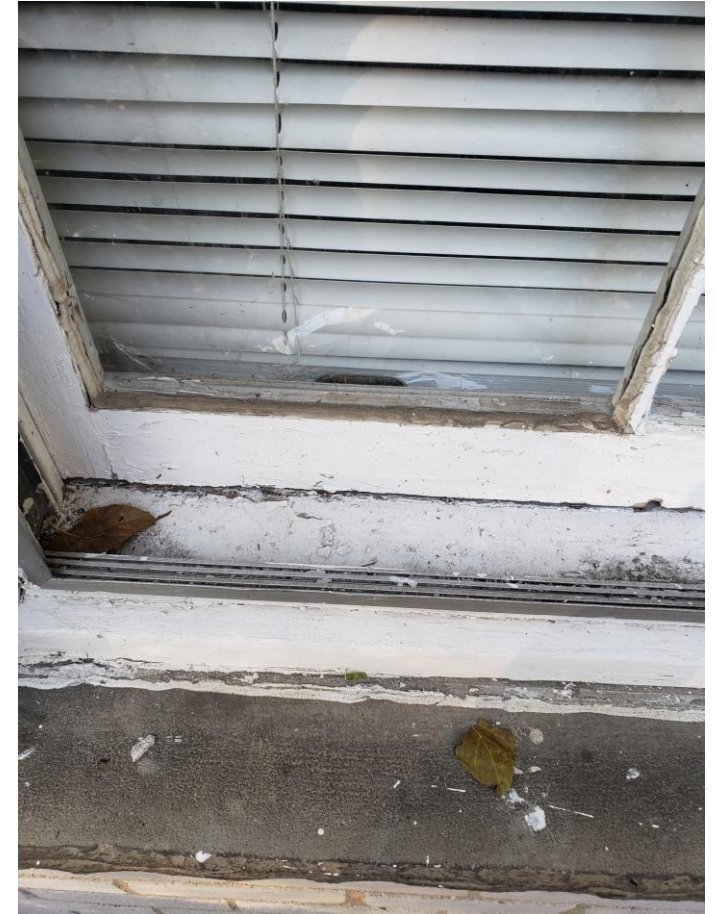
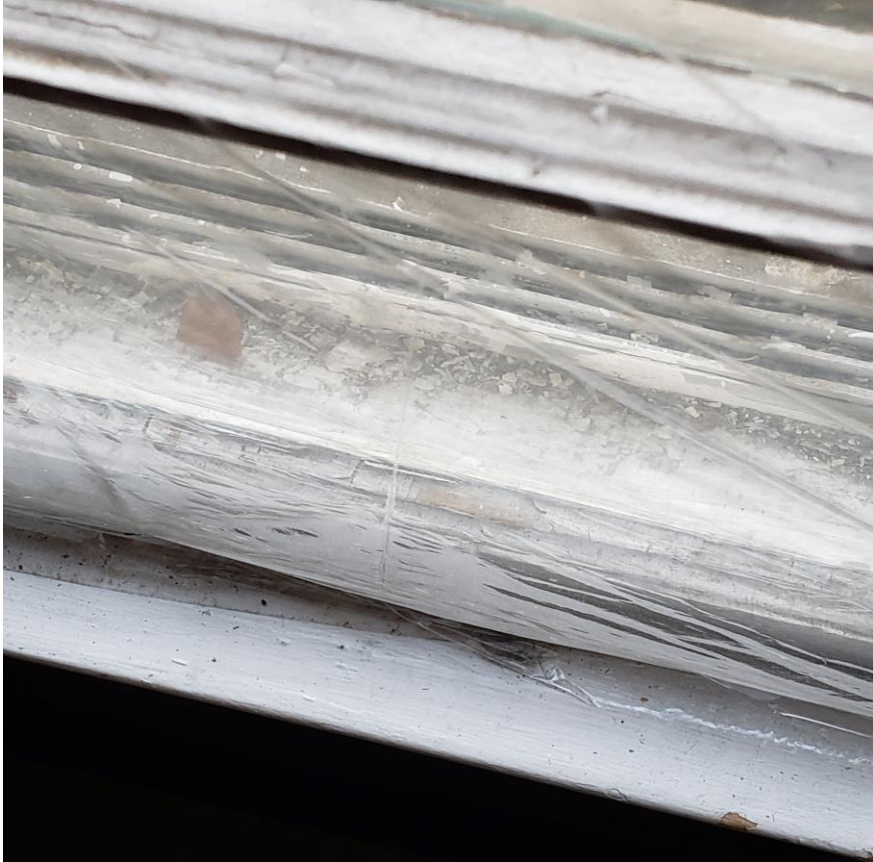
- Old Wood Windows

Paint Chips &
Lead Dust.

High Levels of
Lead Dust
were found
and is
considered
Hazardous

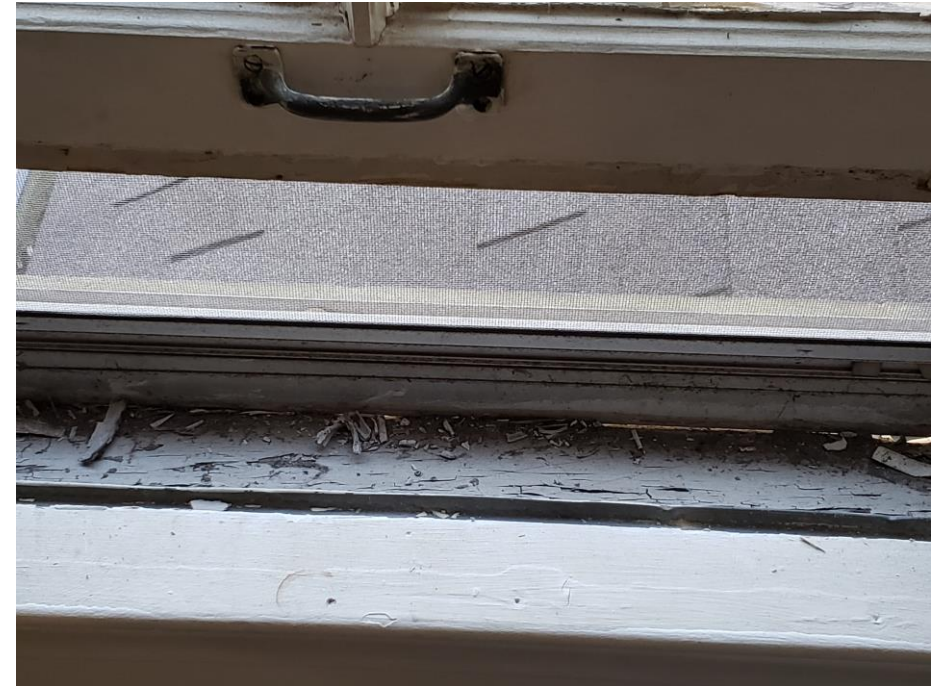
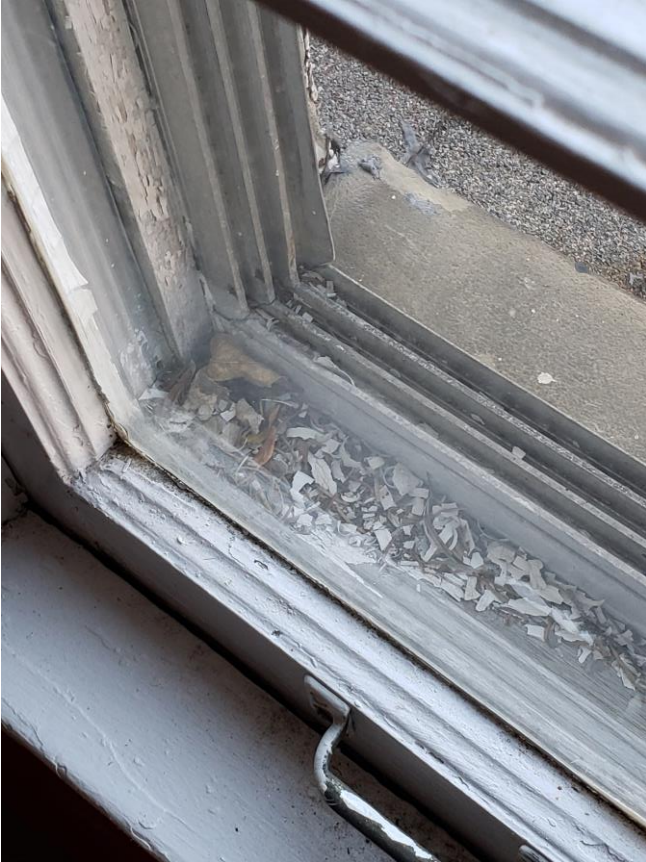
- Old Wood Windows

Paint Chips &
Lead Dust.

High Levels of
Lead Dust were
found and is
considered
Hazardous

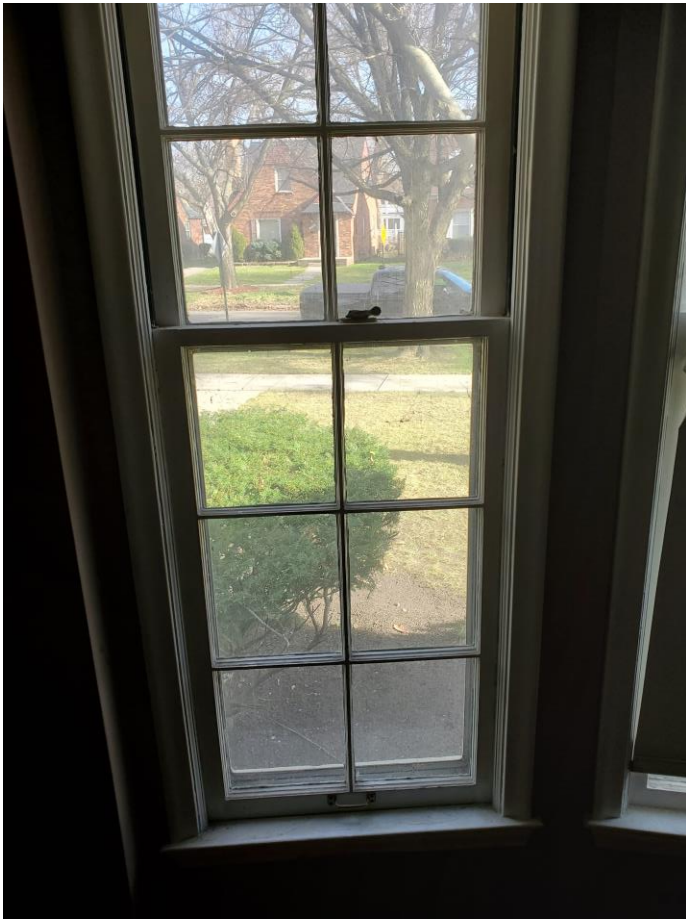
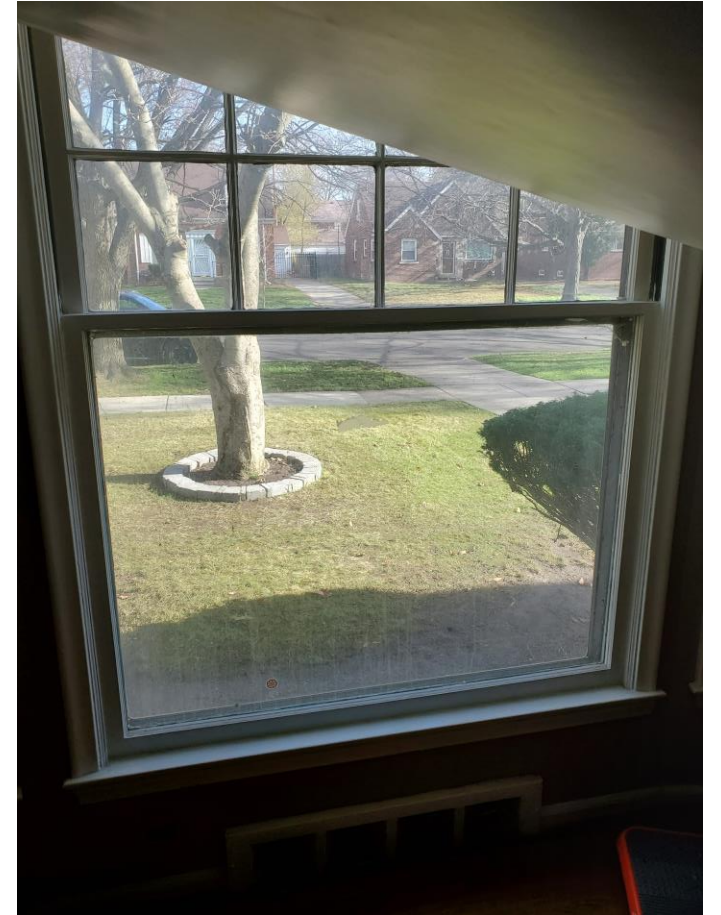
Front Livingroom windows

Center Double Hung unit
painted shut

Locks on other flanker
units do not work

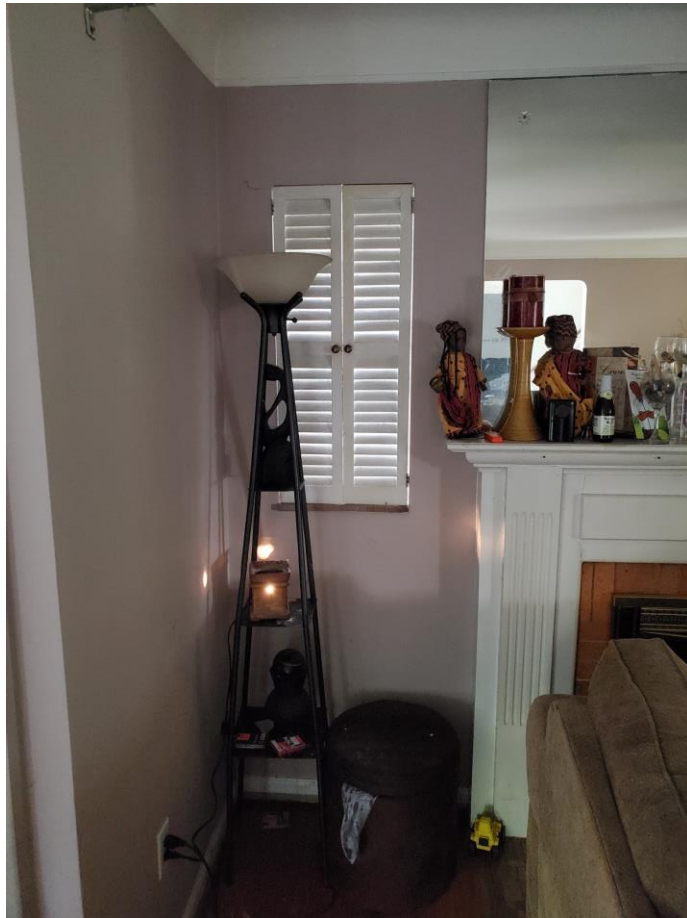
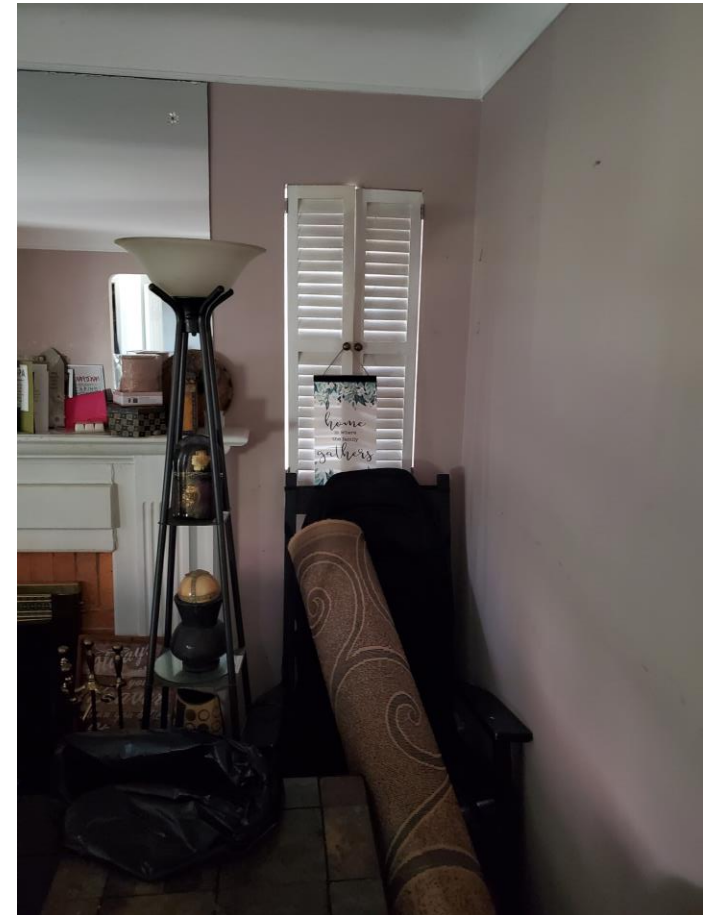
Side B Livingroom
windows – Left side

Glass Block windows

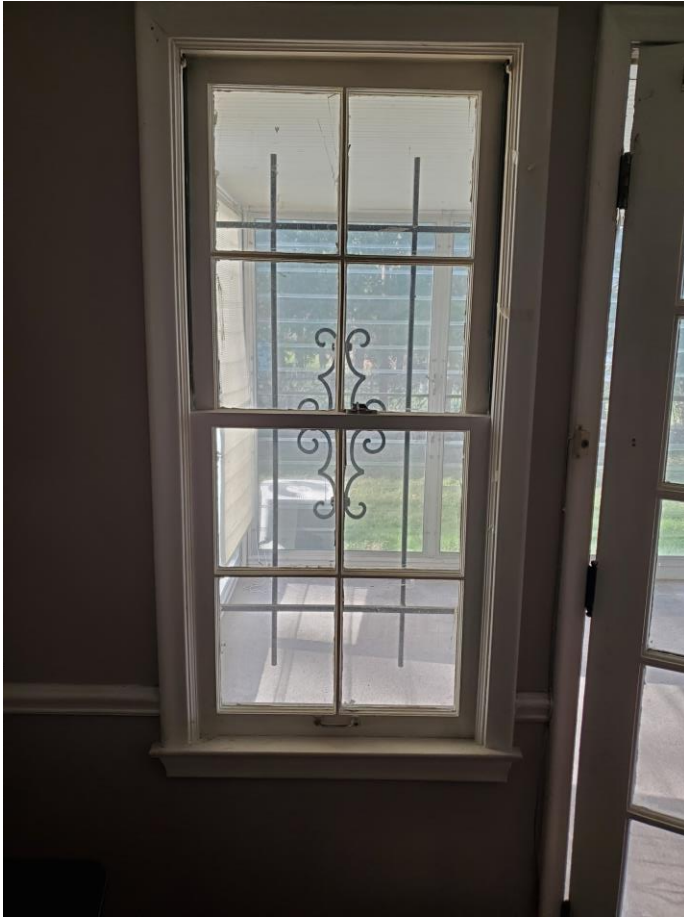
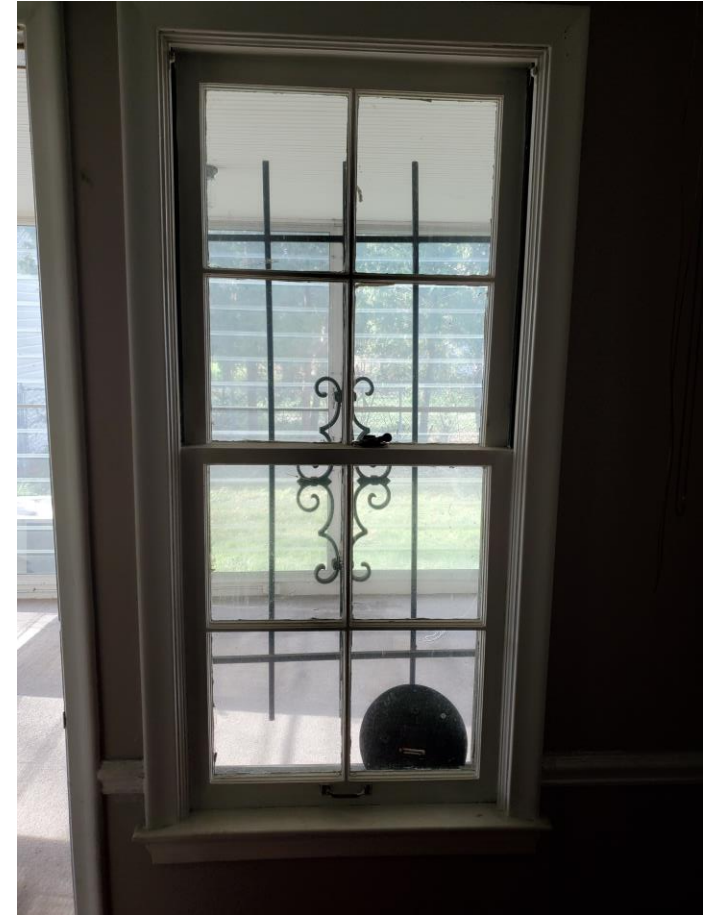
Dining room windows

painted shut

Locks on both units do not work

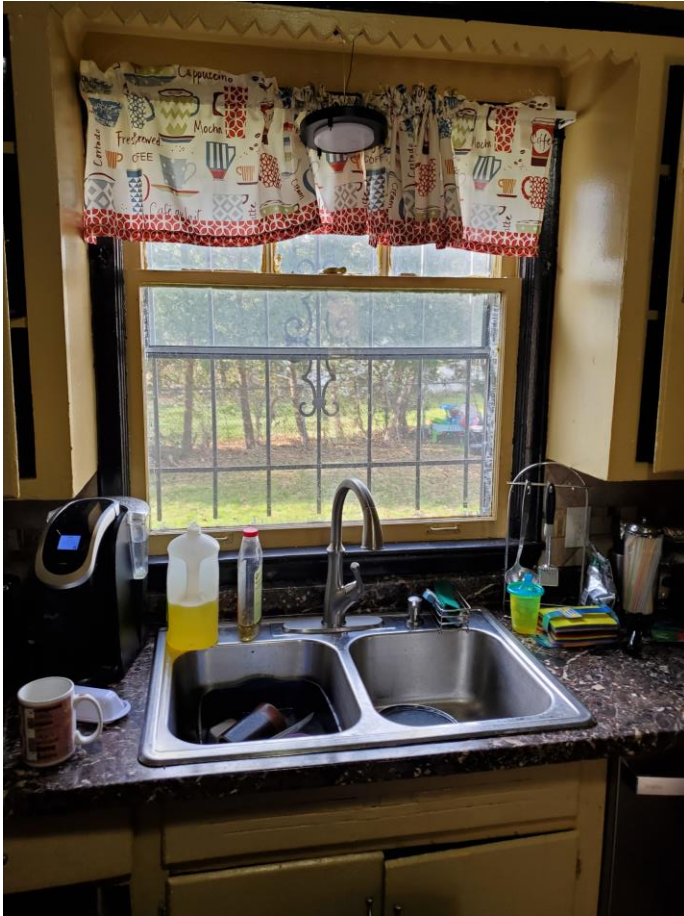
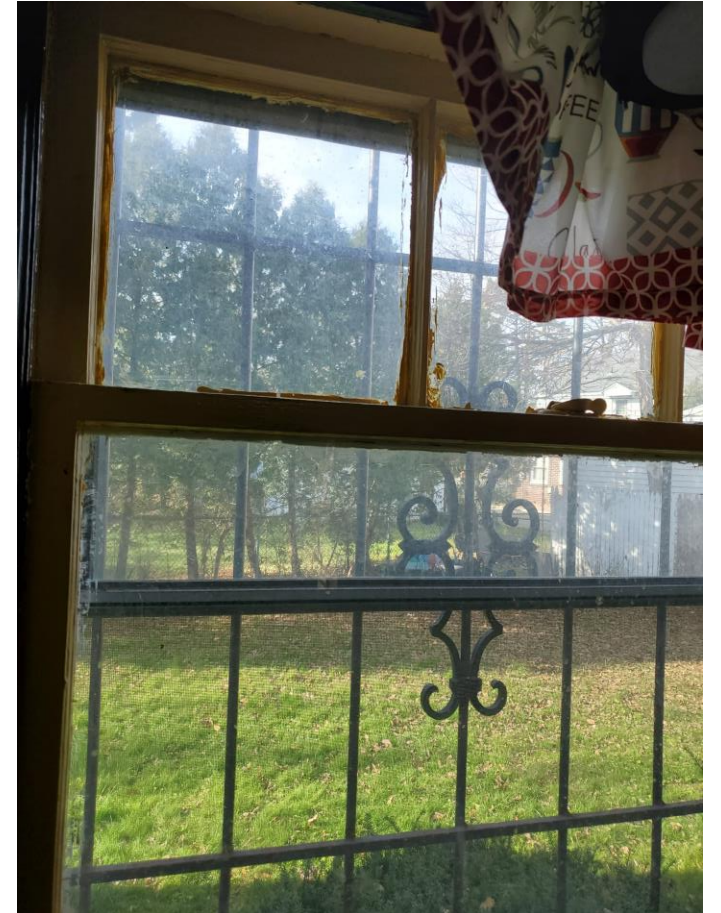
Rear Side C Kitchen window

Center Double Hung unit
painted shut

Locks on units do not work

Storm is missing pieces and
does not work
