HDC Application for work @ 14935 Westwood – Detroit, MI 48223

Lead Abatement Project for State of Michigan Lead Program

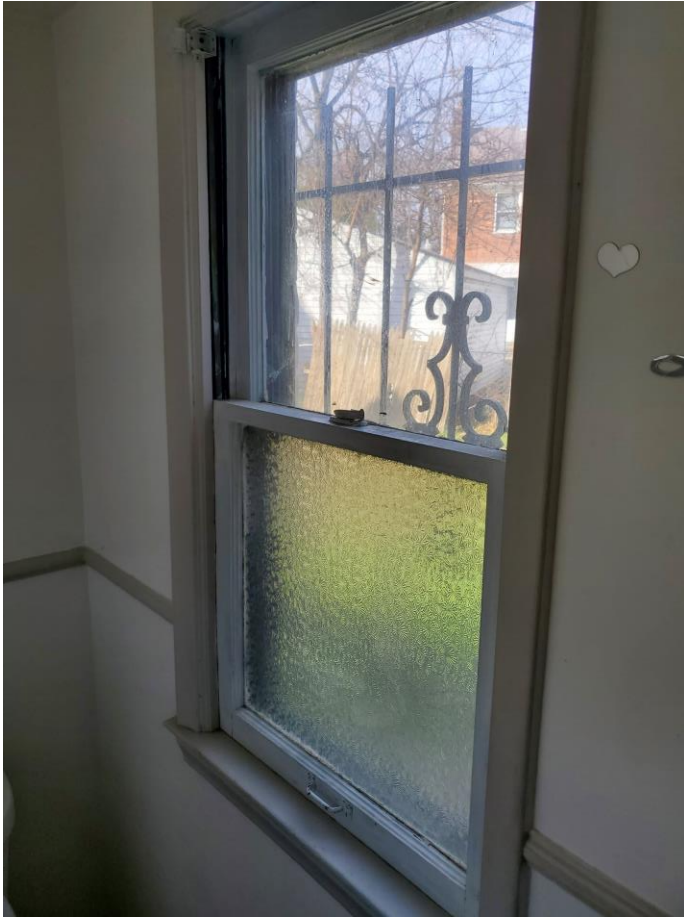
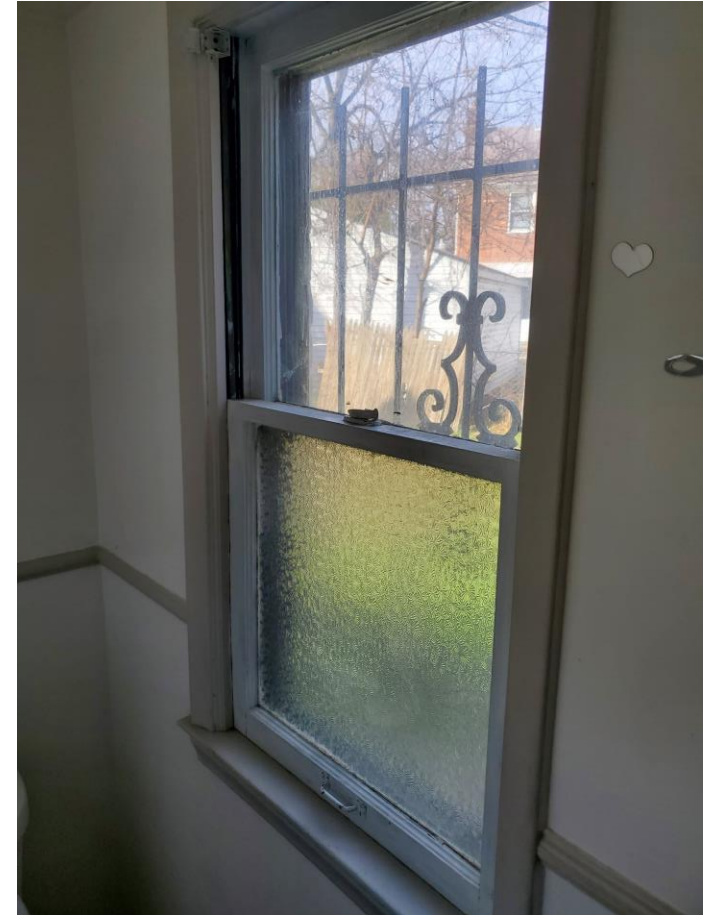
Side D ½ Bath window

Unit does not operate well

Locks on unit do not work

Glass panes have been
changed and muntin bars
removed

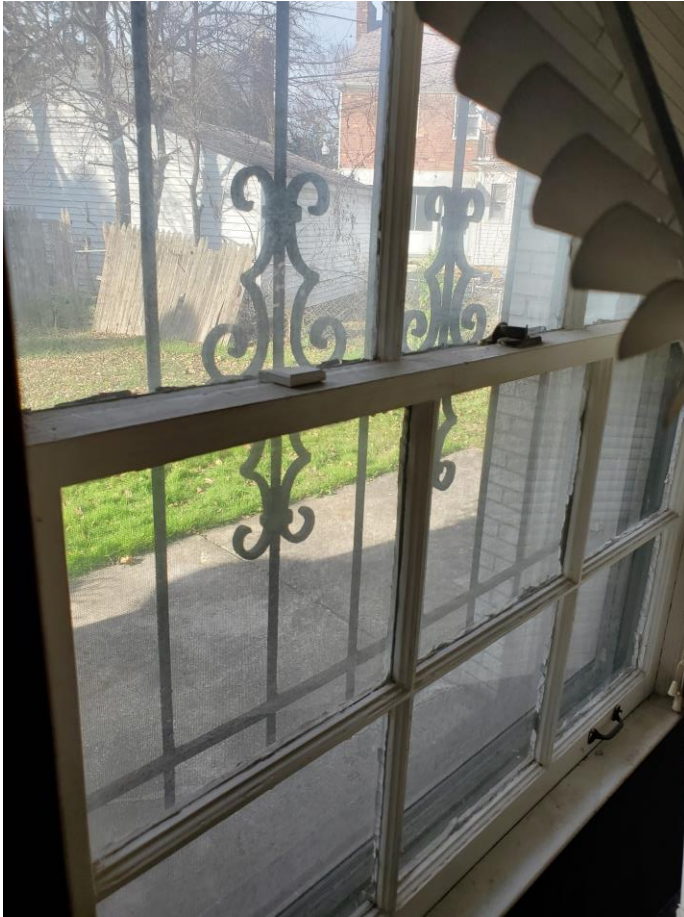
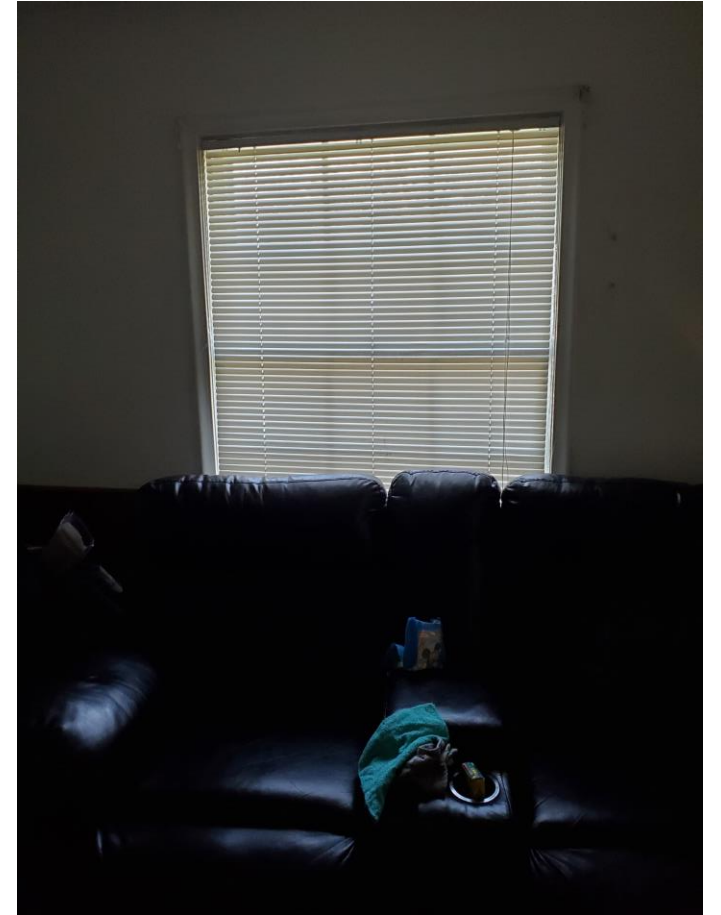
Living room 2 / Family
room windows – 2 Units

Units does not operate well

Locks on unit do not work

Storm windows are missing
panes and frame only

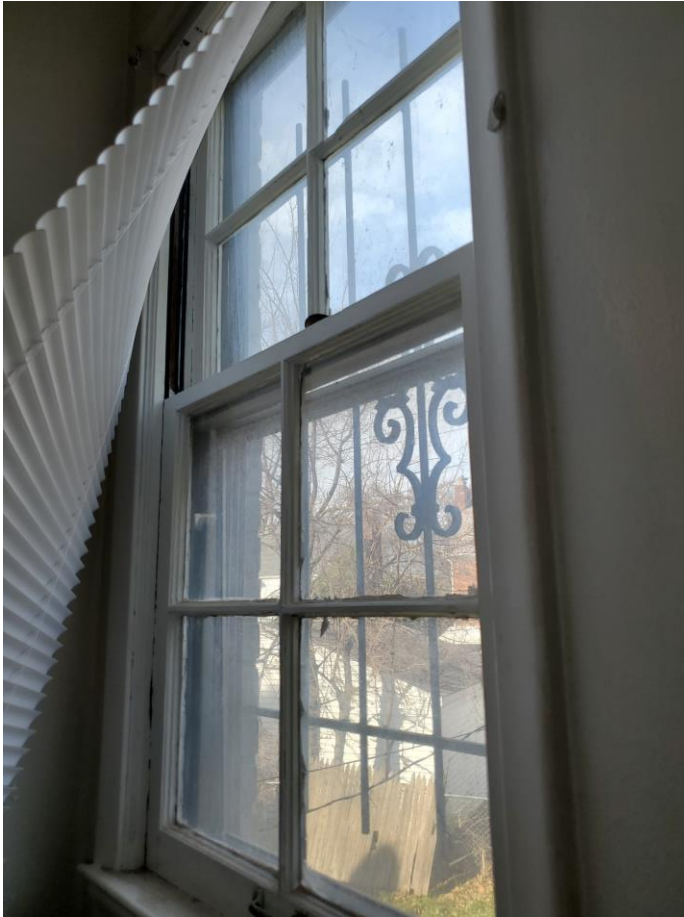
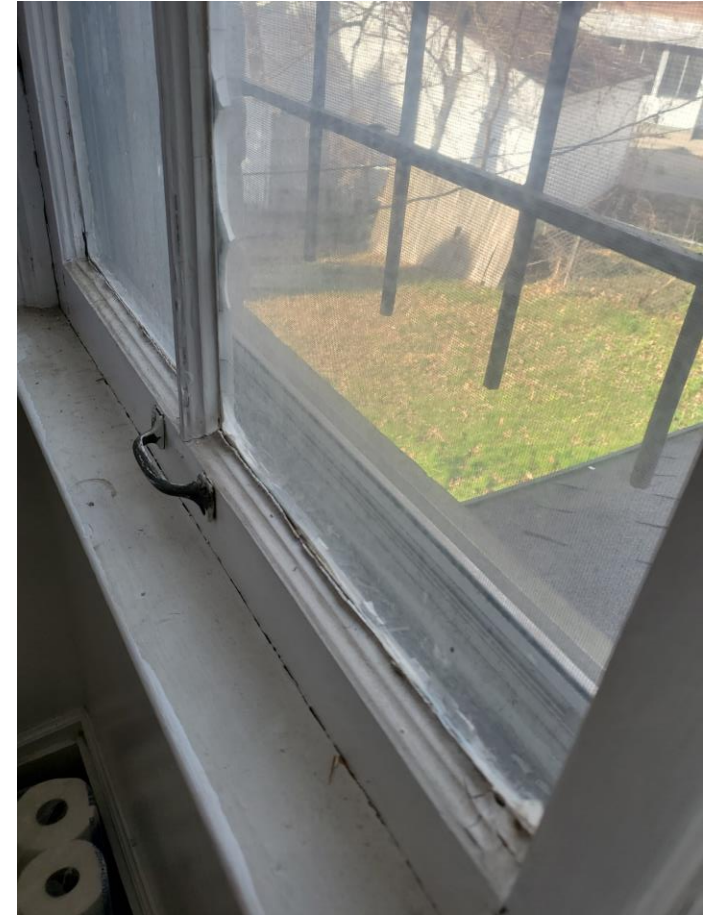
Side D Stairwell window

Unit does not operate well

Locks on unit do not work

Glass panes loose and
glazing bad

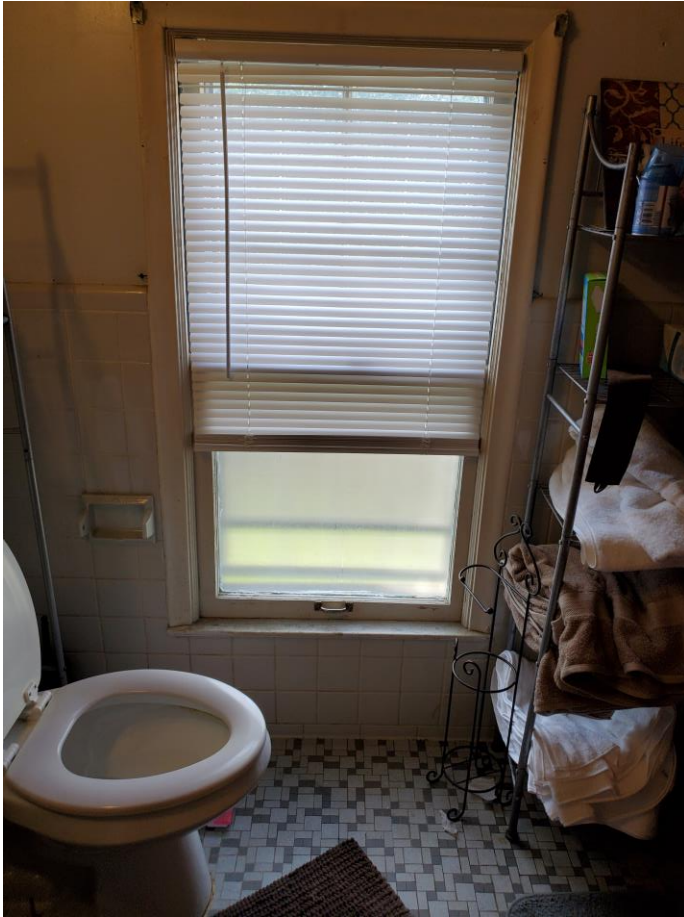
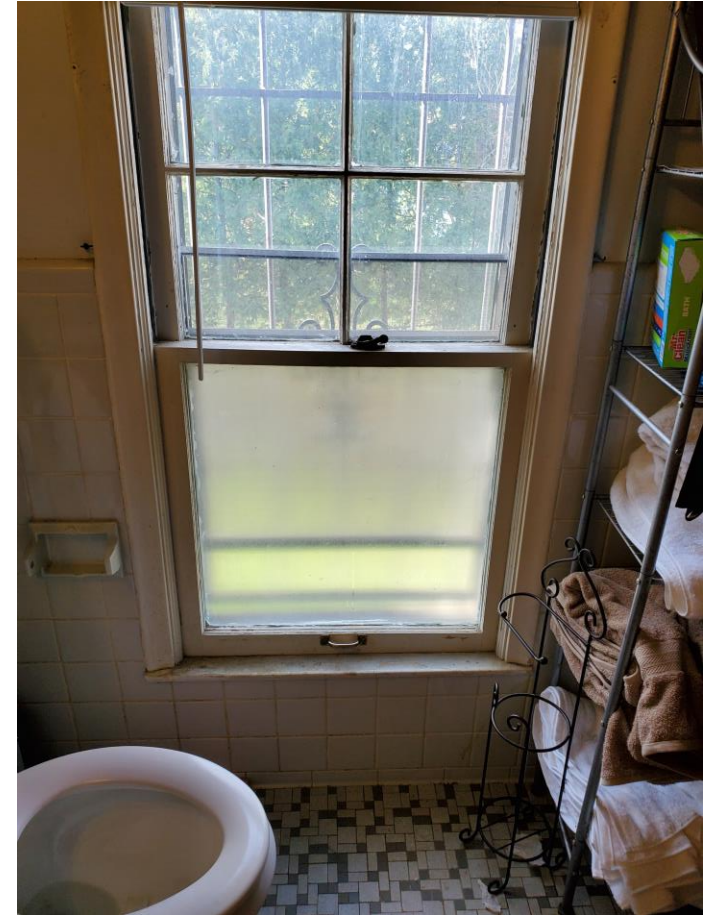
Side C Full Bath window

Unit does not operate well

Locks on unit do not work

Glass panes have been
changed and muntin bars
removed on lower unit

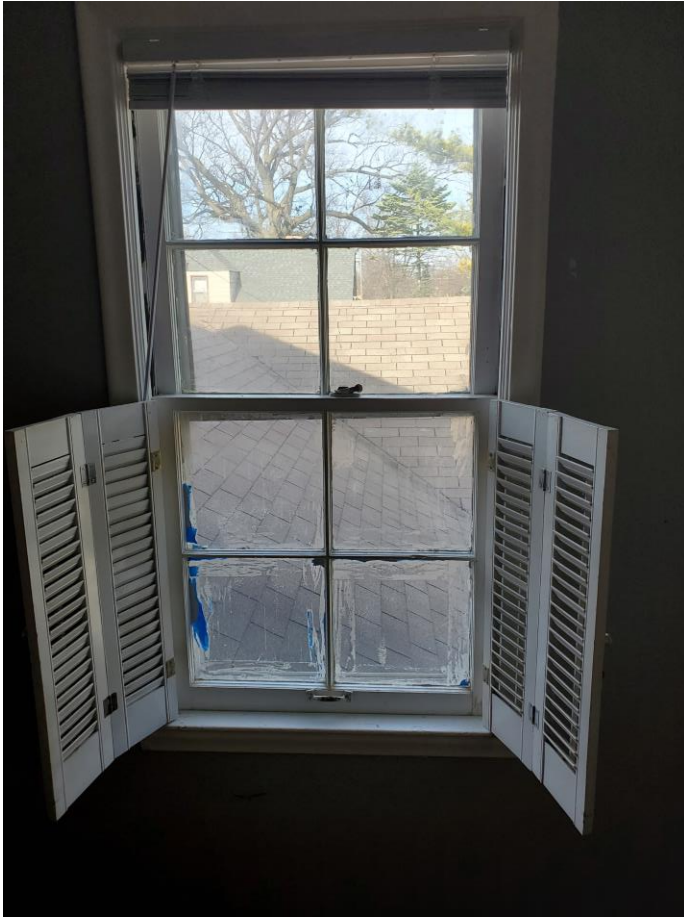
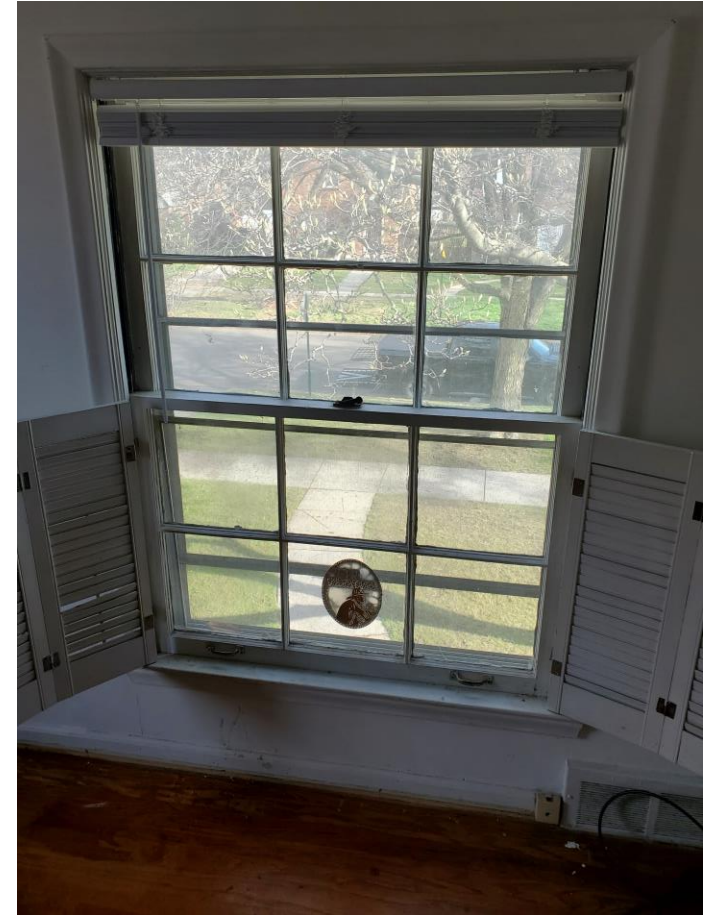
Side A & D Upper Bedroom
Window

Unit does not operate well

Locks on unit do not work

Glass are un poor condition

Storm windows are broken

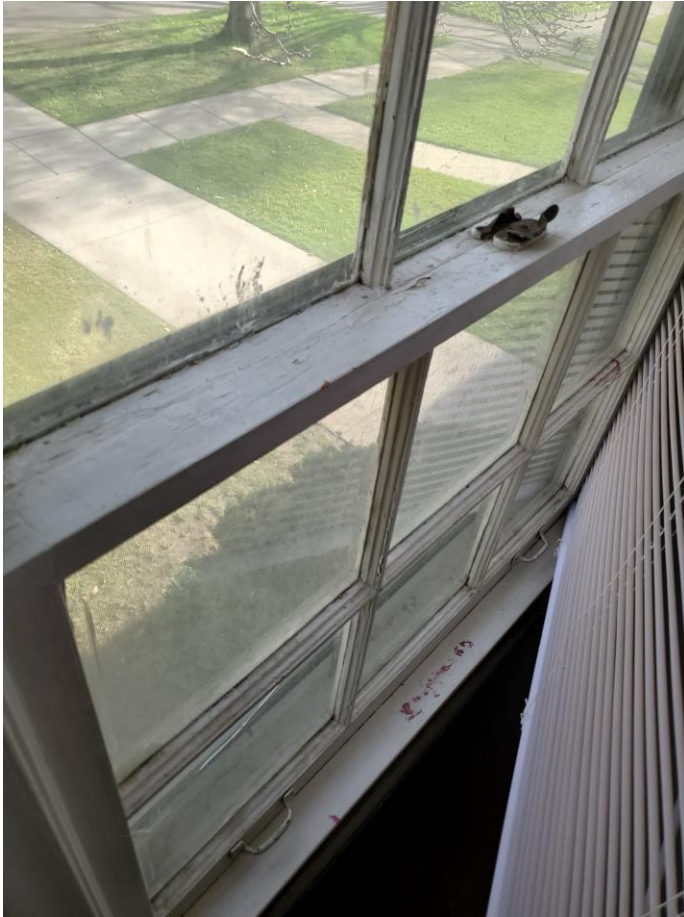
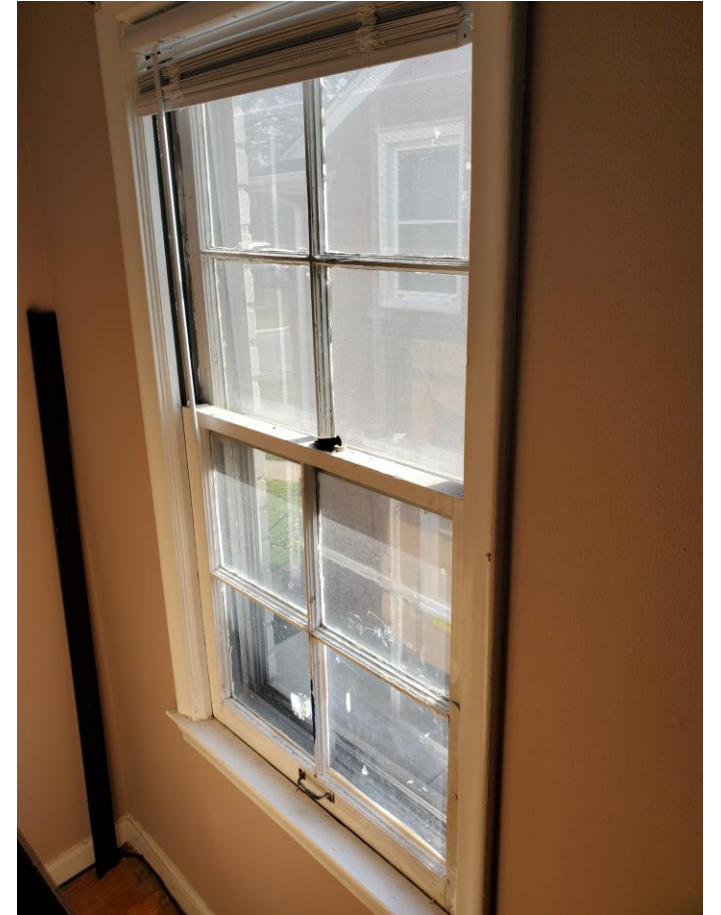
Side A & B Upper Bedroom windows

Unit does not operate well

Locks on unit do not work

Glass panes and glazing in poor condition
