Lead Inspection & Risk Assessment Report

15327 Warwick
Detroit, MI 48223
1925

Date of Inspection: 02/18/2020

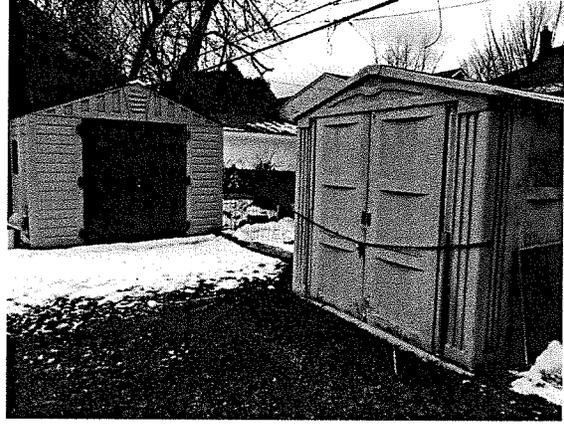
Shed Not Painted
