James Haskins
19365 Warrington Dr
Detroit MI 48221
Sherwood Forest District

Renewal by Andersen 37720 Amrhein Livonia, MI 48150

- Homeowner wants to replace all the windows around house except for one stained glass window unit
- Windows are original steel
- Renewal by Andersen windows are Fibrex (wood composite) material
- Total of 24 windows to be replaced
- Windows exterior color will be black if approved
- Most windows matching style except for bay windows – flankers changed to operable and middle window changed to fixed.
- Windows will match existing mutton bar “pattern”
- Homeowner unable to get quotes for repair

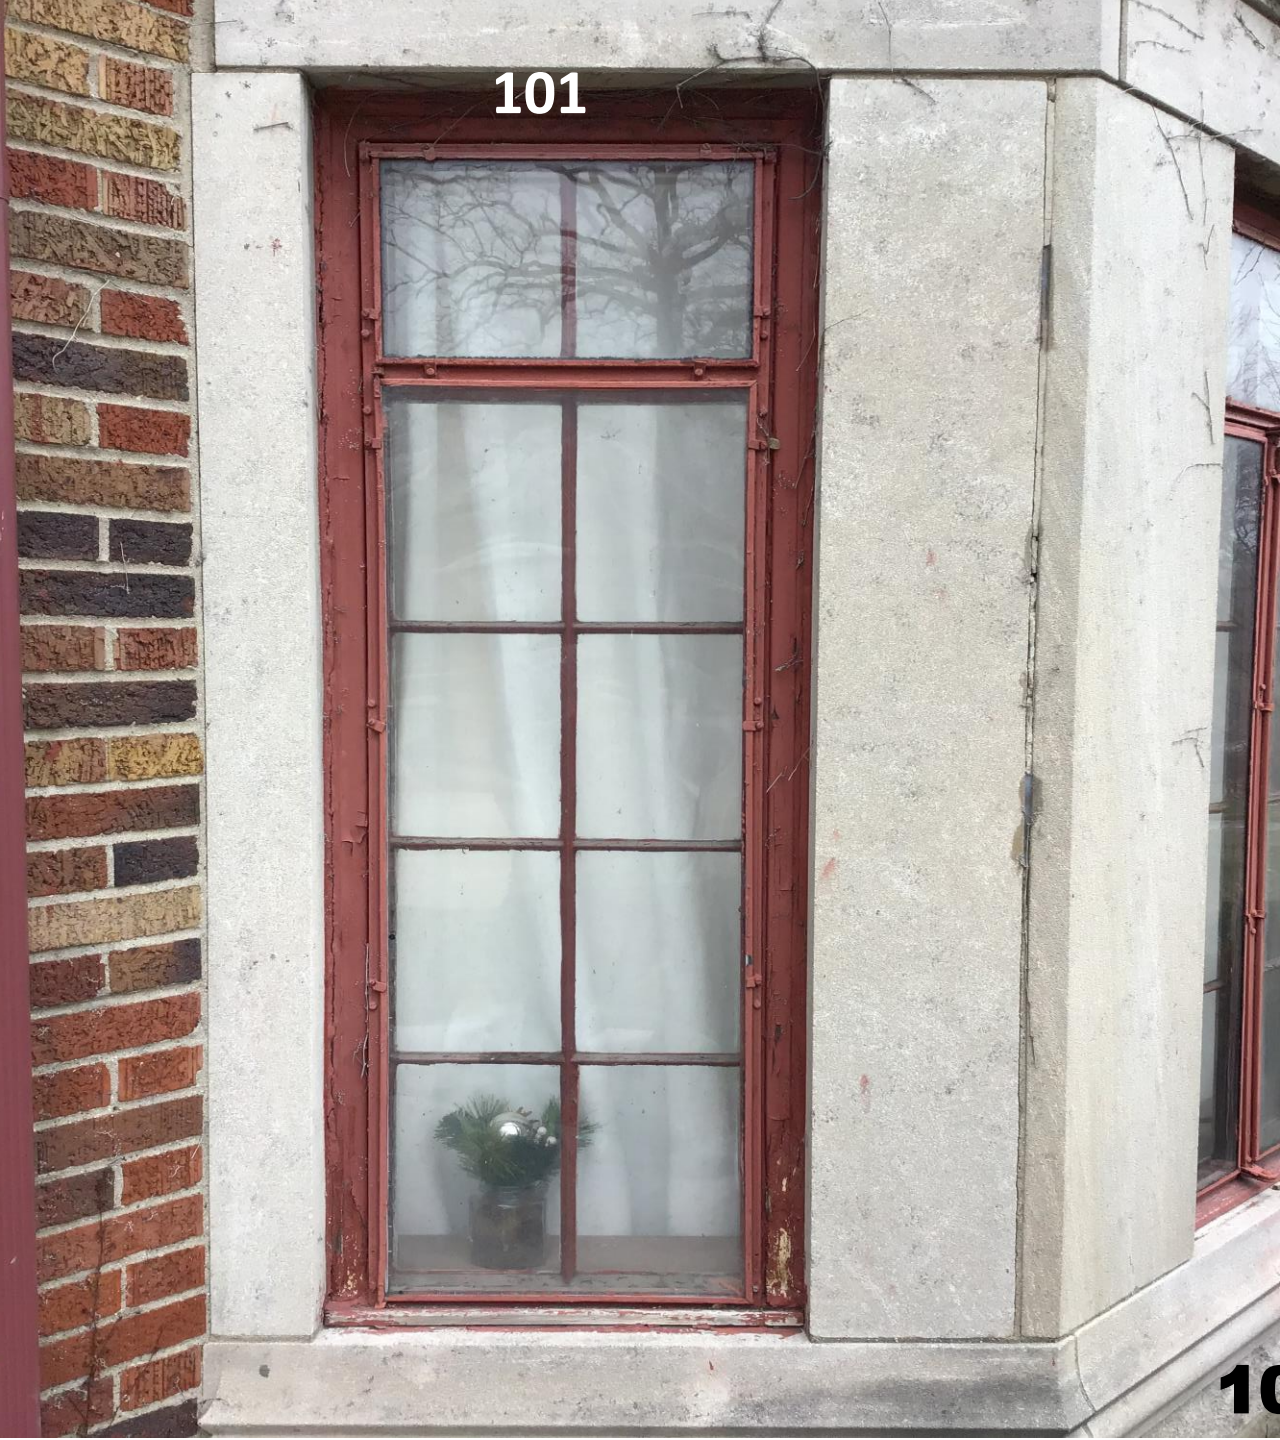
WINDOW OPENING 101 Living Room - Front of House

- Fixed window – Steel casement
- Window is in Living room
- Window is hard to close if opened
- Exterior of window showing signs of rotting around frame

Window: Casement, Single, Left, Base Frame, 2" Brickmould / Traditional, Exterior Black, Interior Black, **Glass:** All Sash: High Performance SmartSun Glass, No Pattern, Tempered Glass, **Hardware:** Black, **Screen:** Fiberglass, Full Screen, **Grille Style:** Grilles Between Glass (GBG), **Grille Pattern:** All Sash: Colonial 2w x 5h, **Misc:** None

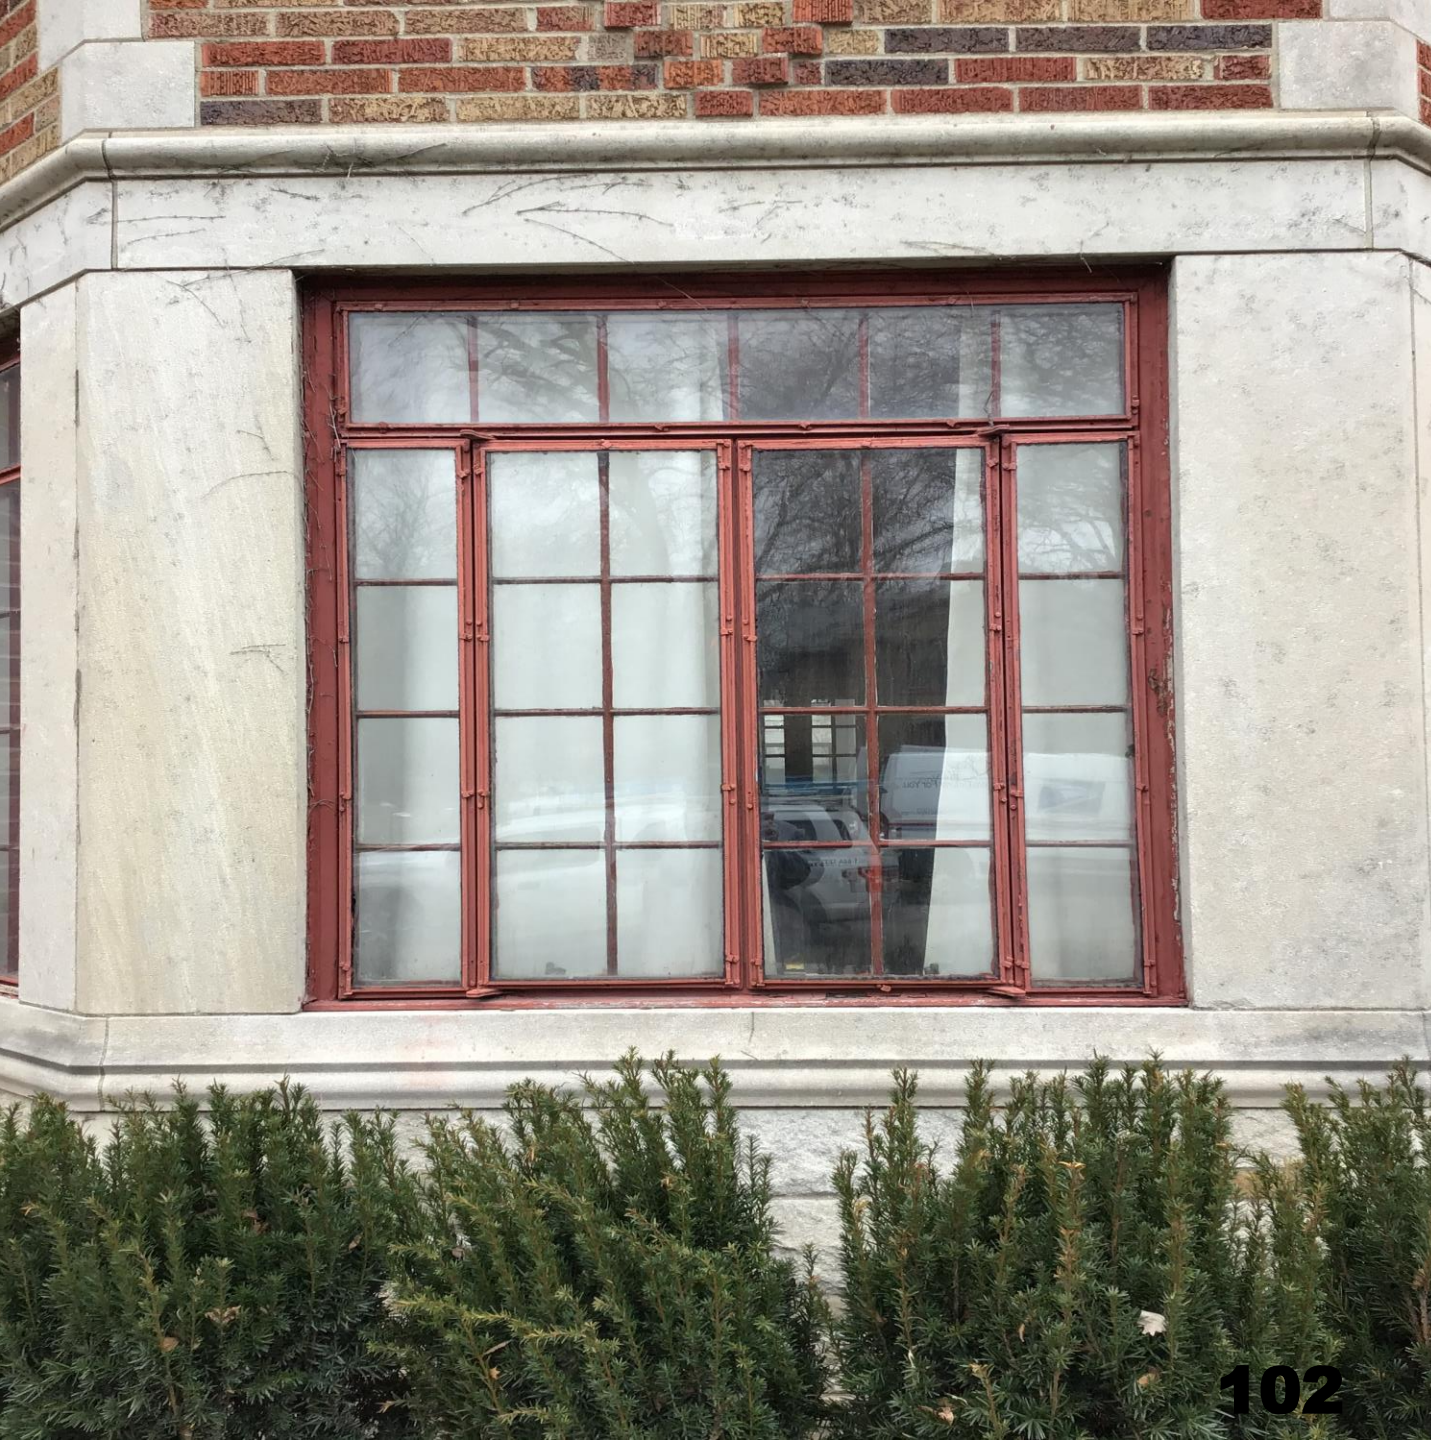
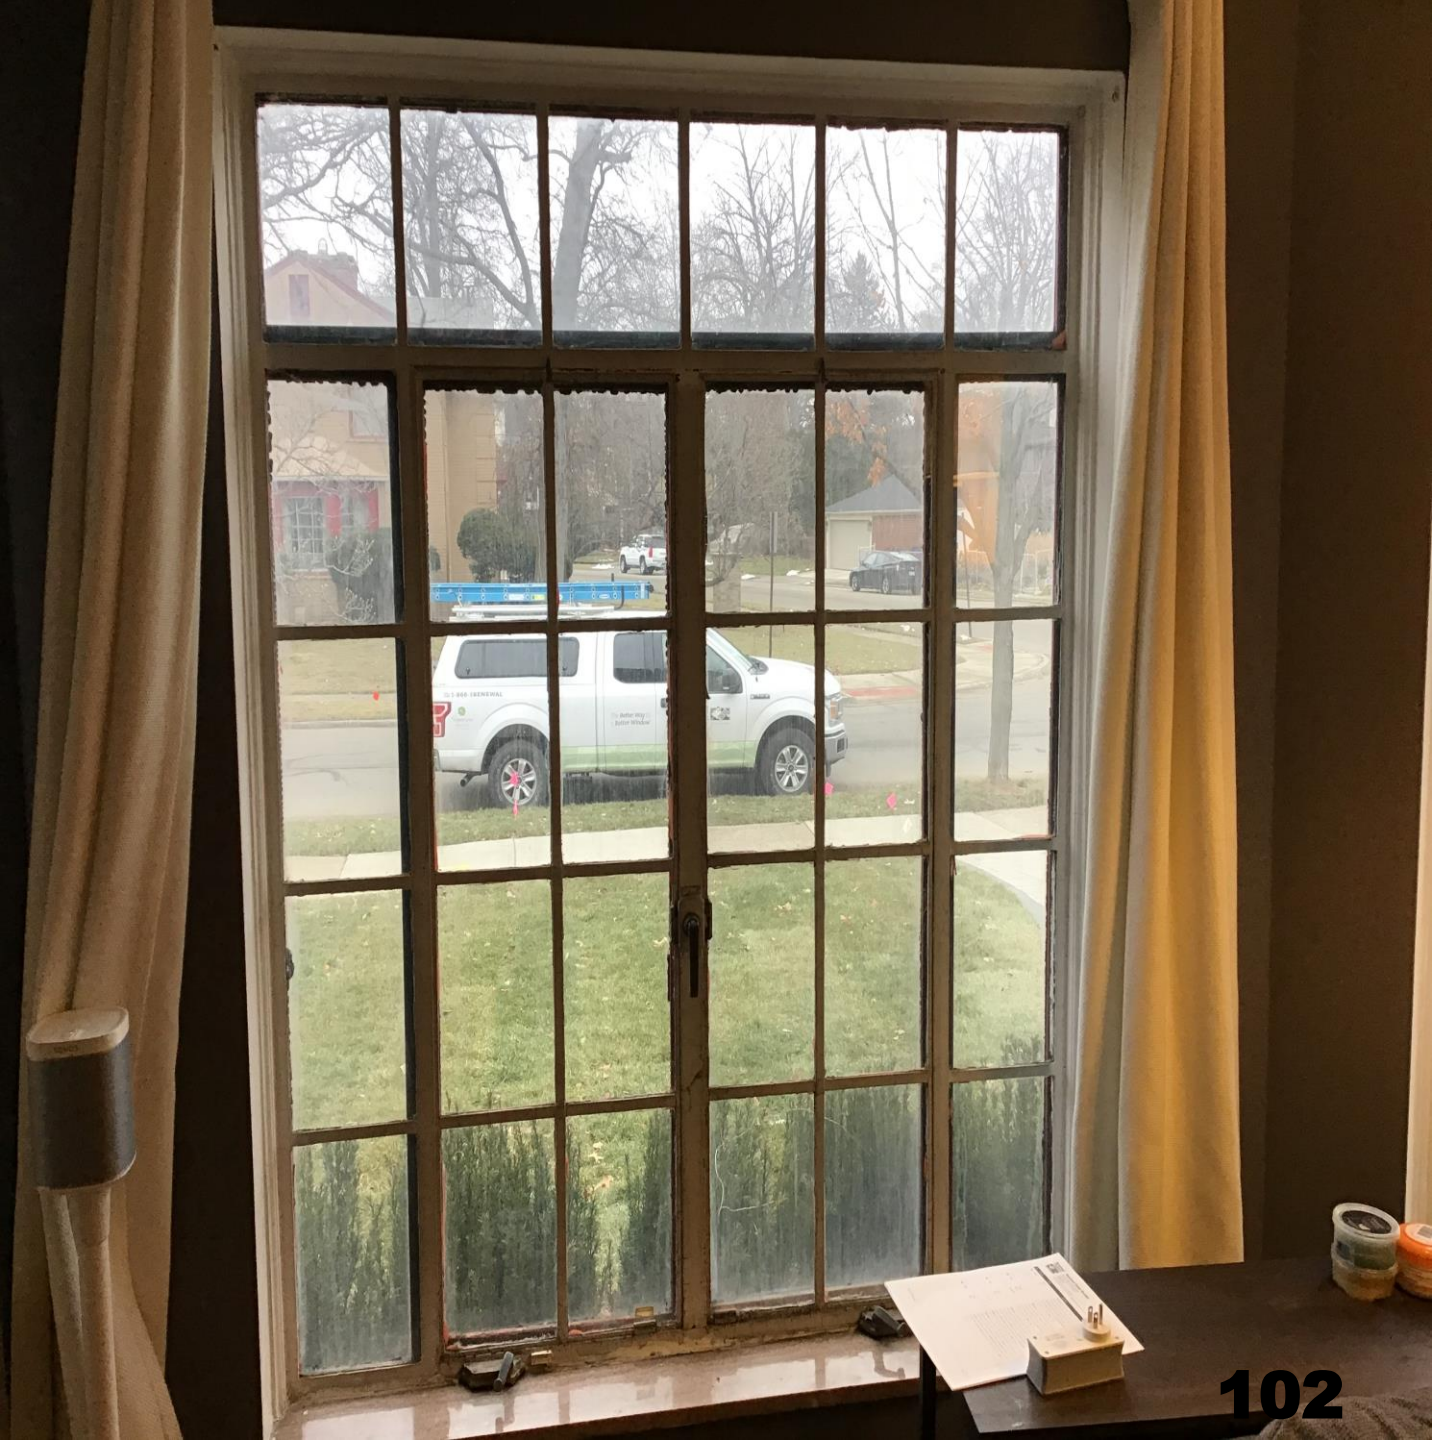
WINDOW OPENING 102 Living Room - Front of House

- Double casement
- Window is in Living room
- Window is hard to close if opened
- Exterior of window showing signs of rotting around frame
- Missing screen

Window: Casement, Fixed Window, Base Frame, Exterior Black, Interior Black, **Glass:** All Sash: High Performance SmartSun Glass, No Pattern, Tempered Glass, **Grille Style:** Grilles Between Glass (GBG), **Grille Pattern:** All Sash: Colonial 6w x 5h, **Misc:** None

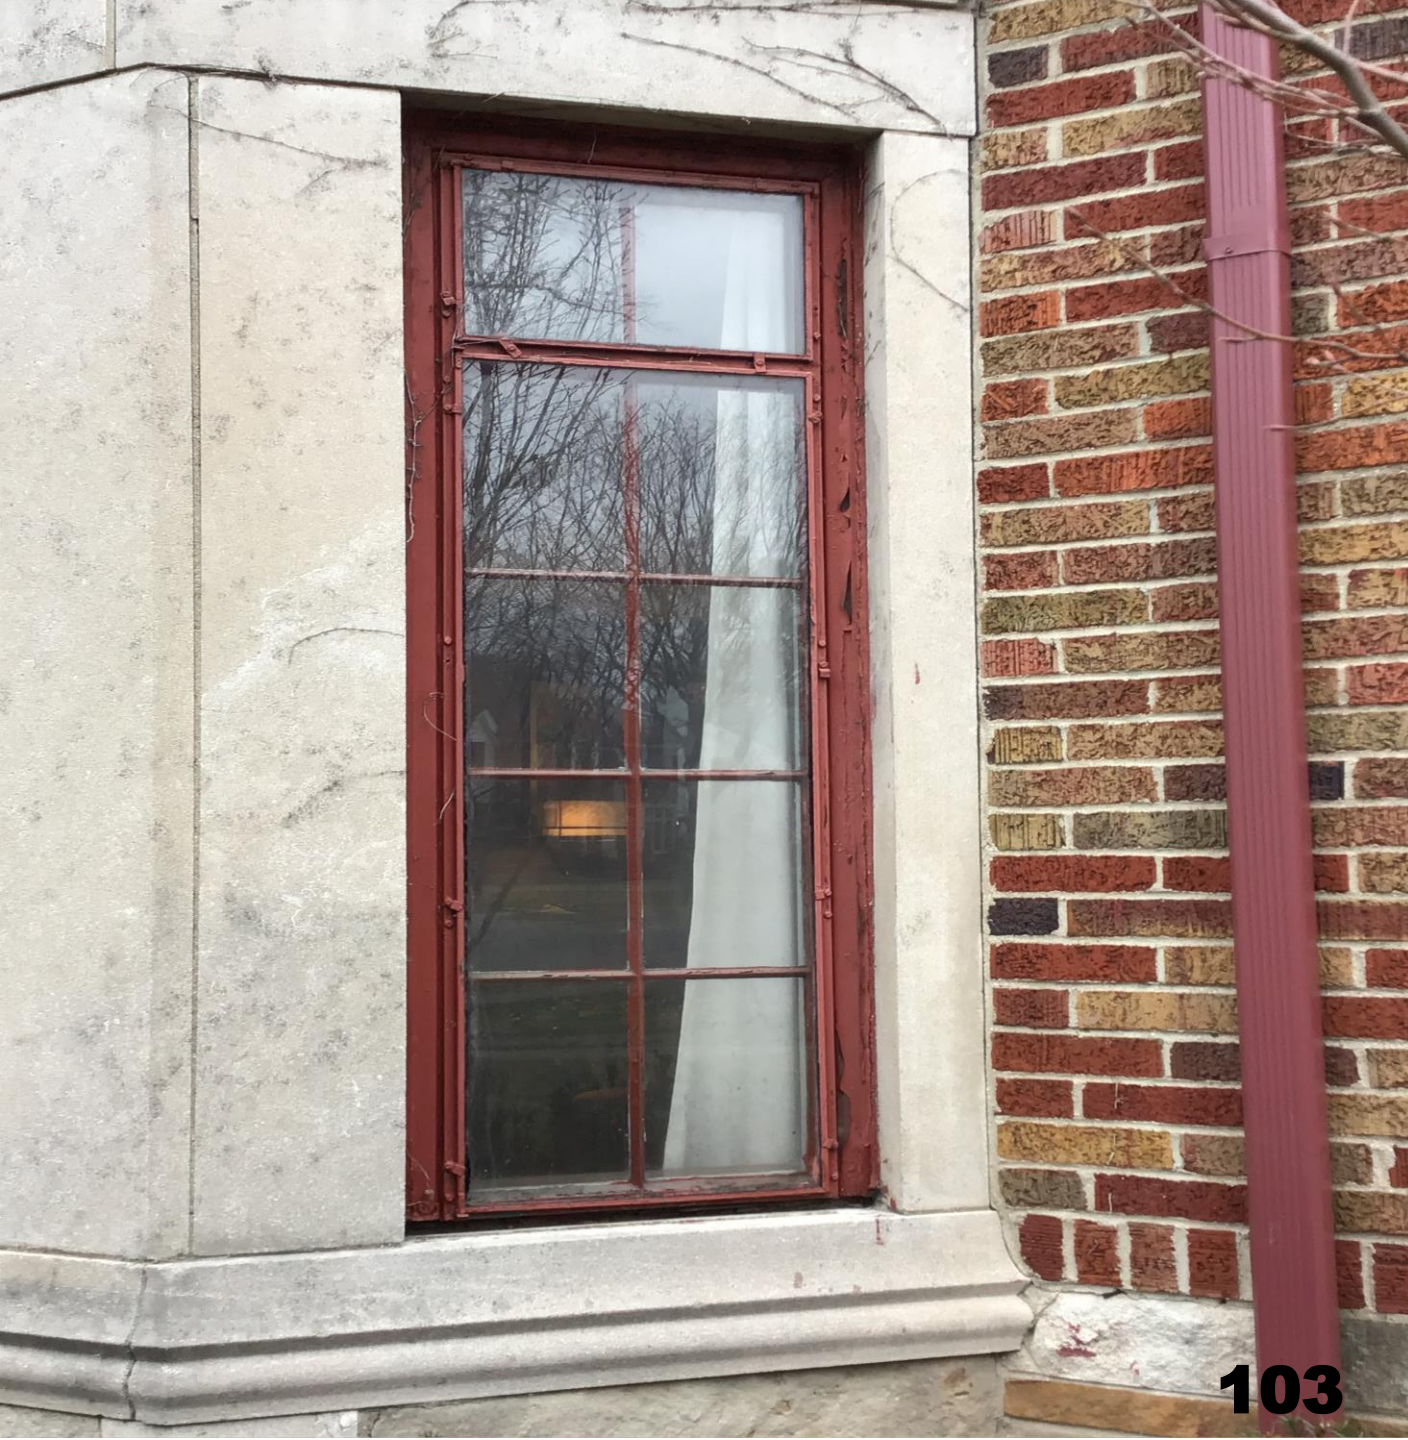
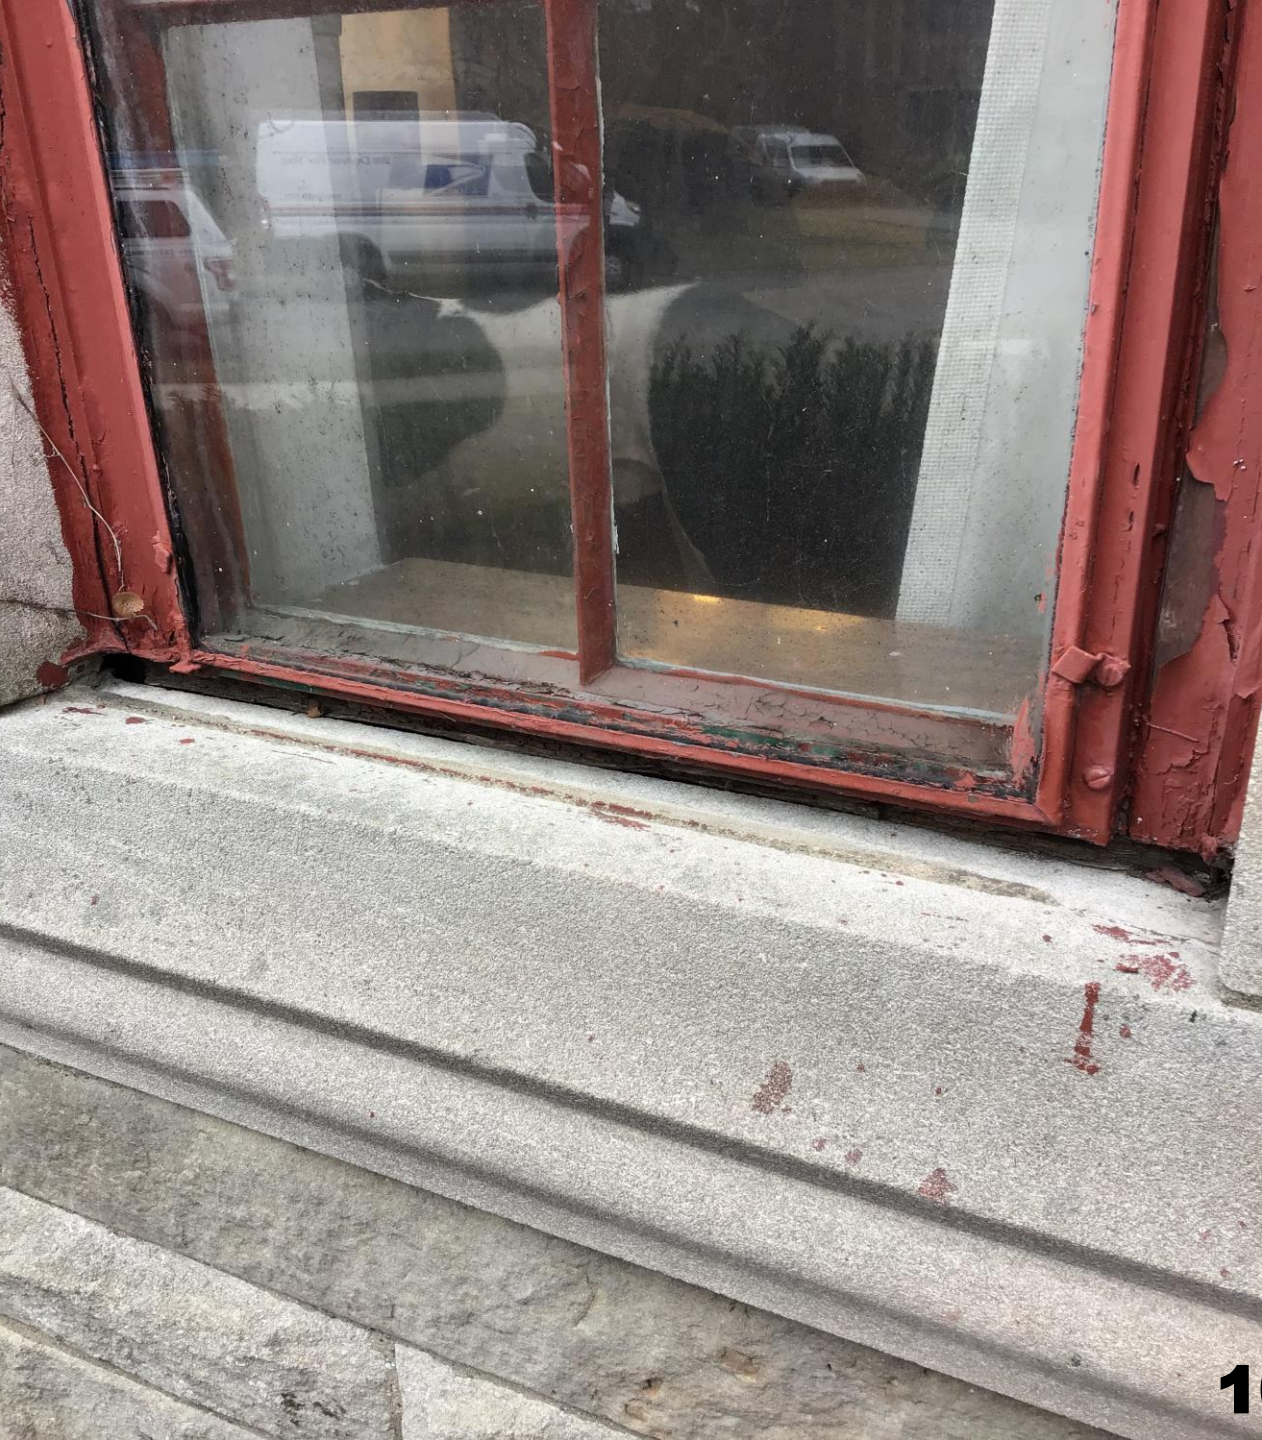
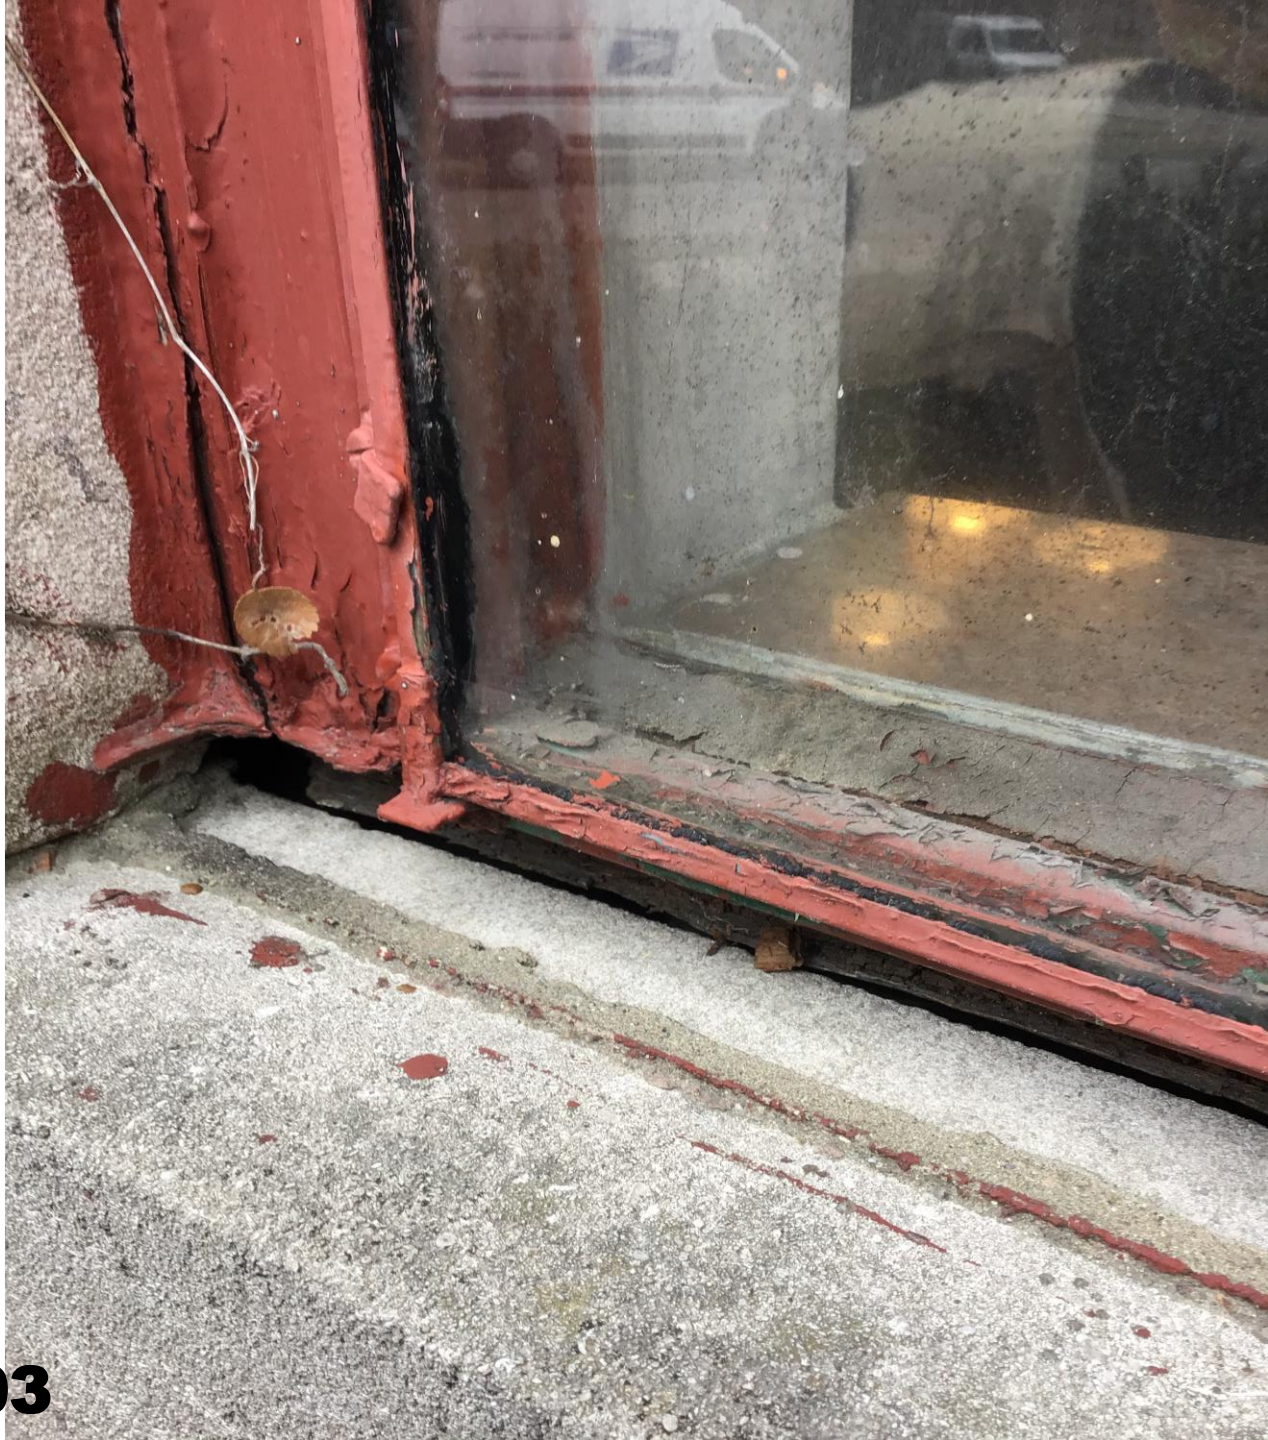
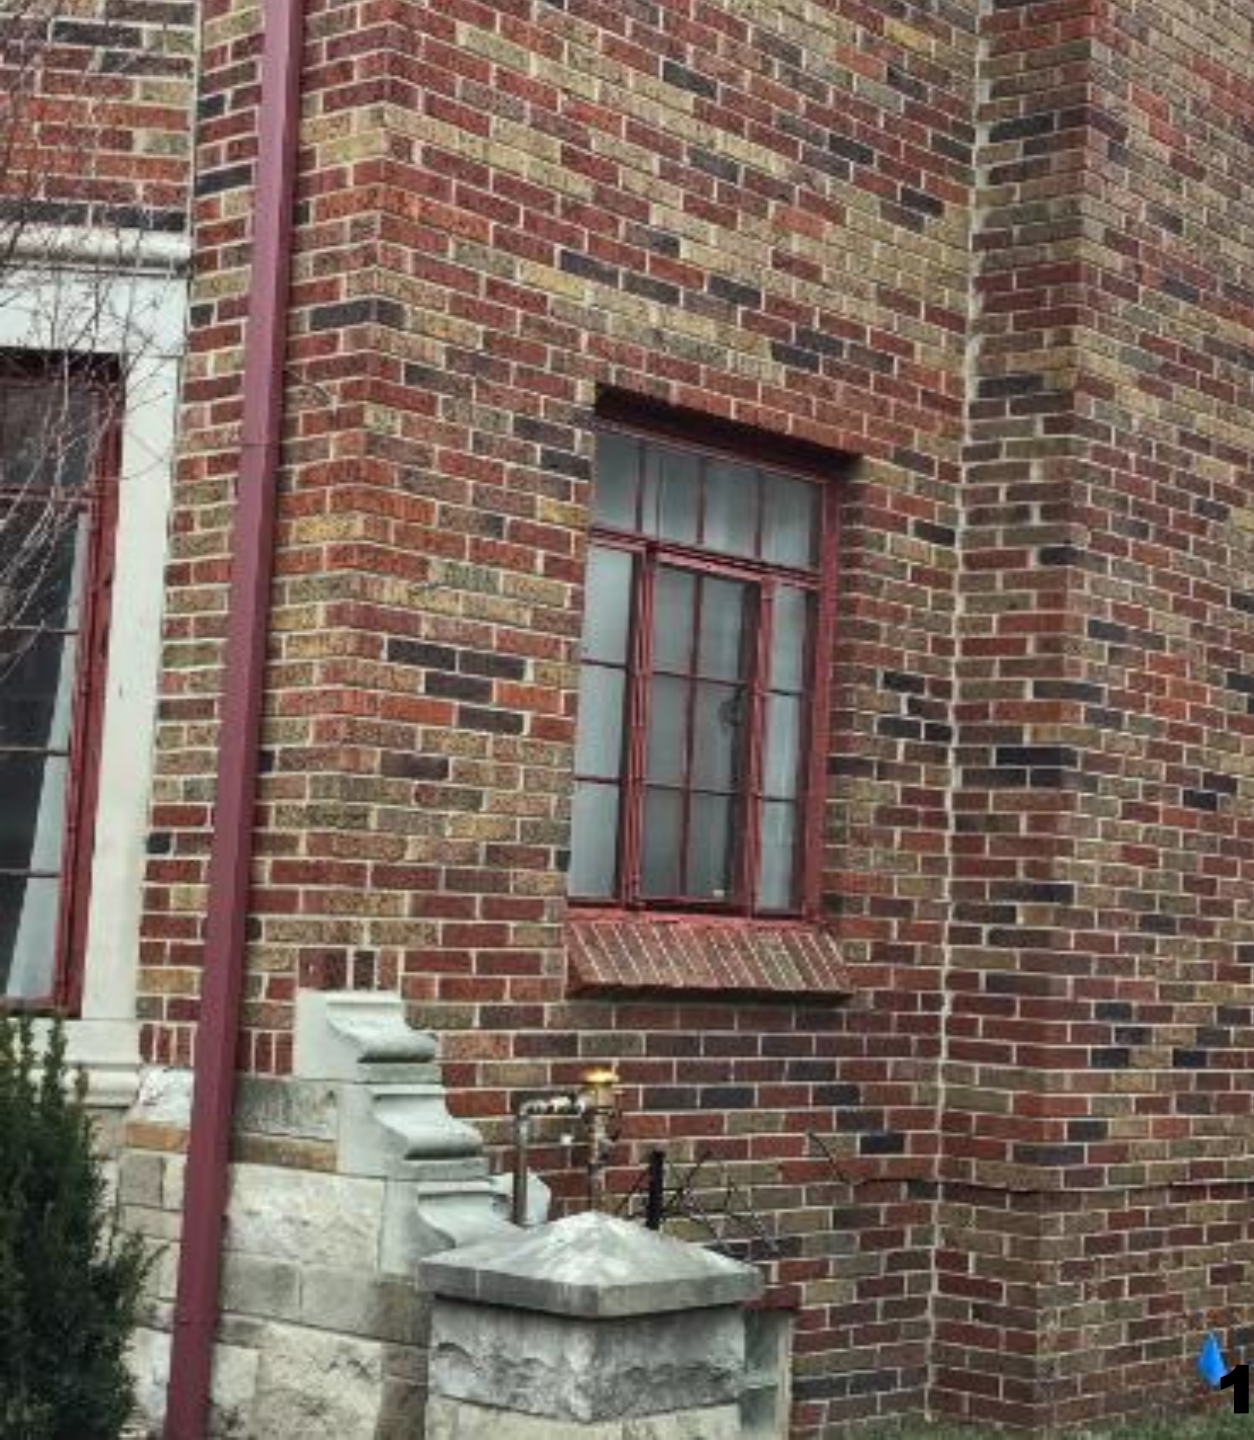
WINDOW OPENING 103

- Fixed window – Steel casement
- Window is in Living room
- Window is hard to close if opened
- Exterior of window showing signs of rotting around frame – bottom exterior sill missing

Window: Casement, Single, Right, Base Frame, 2"

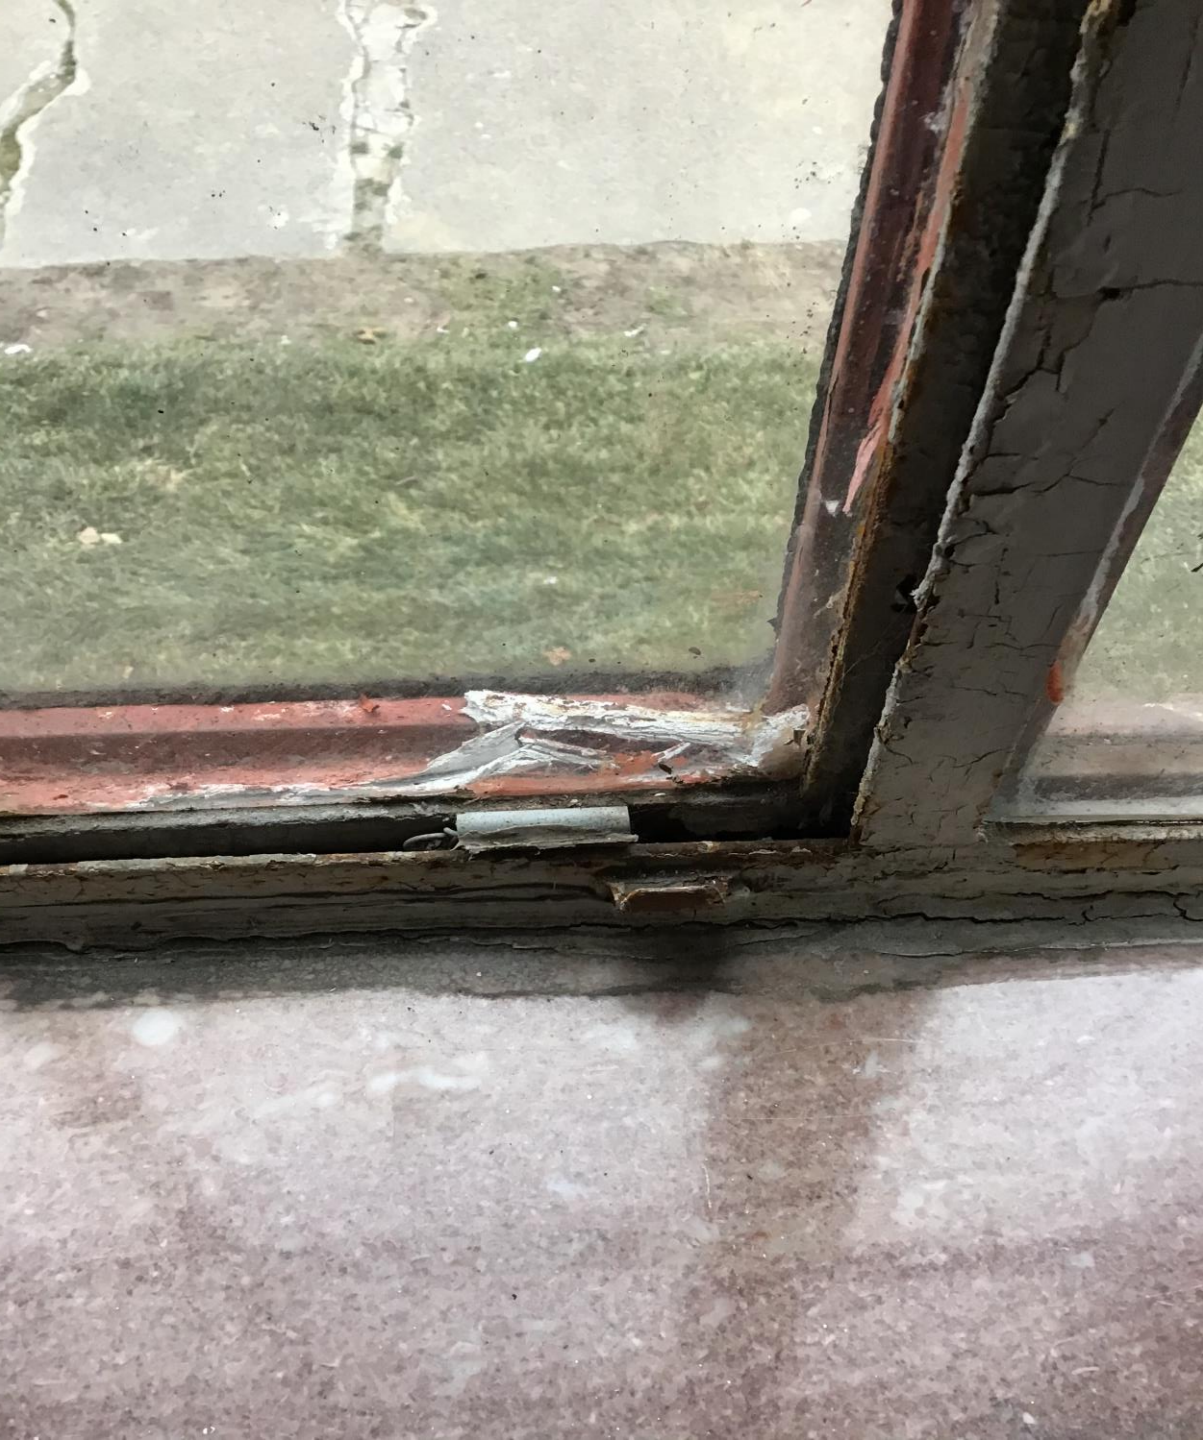
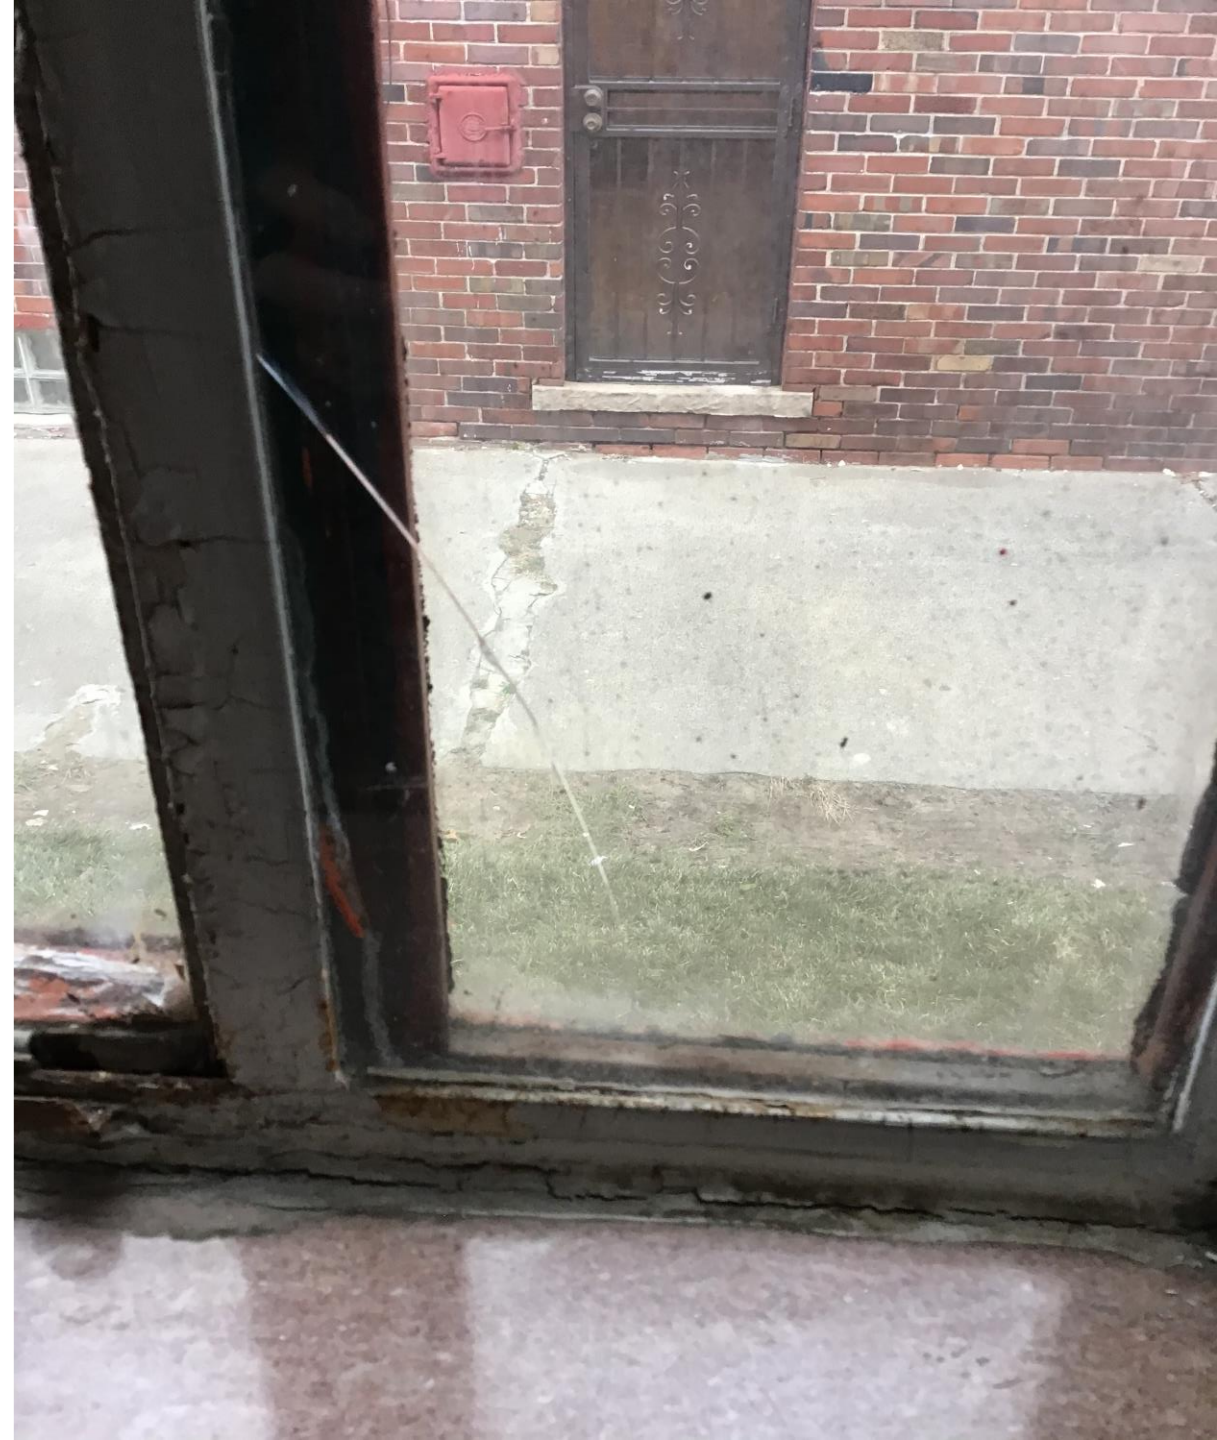
WINDOW OPENING 105

- Single Casement window
- Window is in Living room
- Window doesn't open
- Windowpane cracked
- Missing screen

Window: Casement, Single, Left Base Frame, 2" Brickmould / Traditional, Exterior Black, Interior Black, **Glass:** All Sash: High Performance SmartSun Glass, No Pattern, **Hardware:** Black, **Screen:** Fiberglass, Full Screen, **Grille Style:** Grilles Between Glass (GBG), **Grille Pattern:** All Sash: Colonial 4w x 4h, **Misc:** None
