James Haskins
19365 Warrington Dr
Detroit MI 48221
Sherwood Forest District

Renewal by Andersen 37720 Amrhein Livonia, MI 48150

- Homeowner wants to replace all the windows around house except for one stained glass window unit
- Windows are original steel
- Renewal by Andersen windows are Fibrex (wood composite) material
- Total of 24 windows to be replaced
- Windows exterior color will be black if approved
- Most windows matching style except for bay windows – flankers changed to operable and middle window changed to fixed.
- Windows will match existing mutton bar “pattern”
- Homeowner unable to get quotes for repair

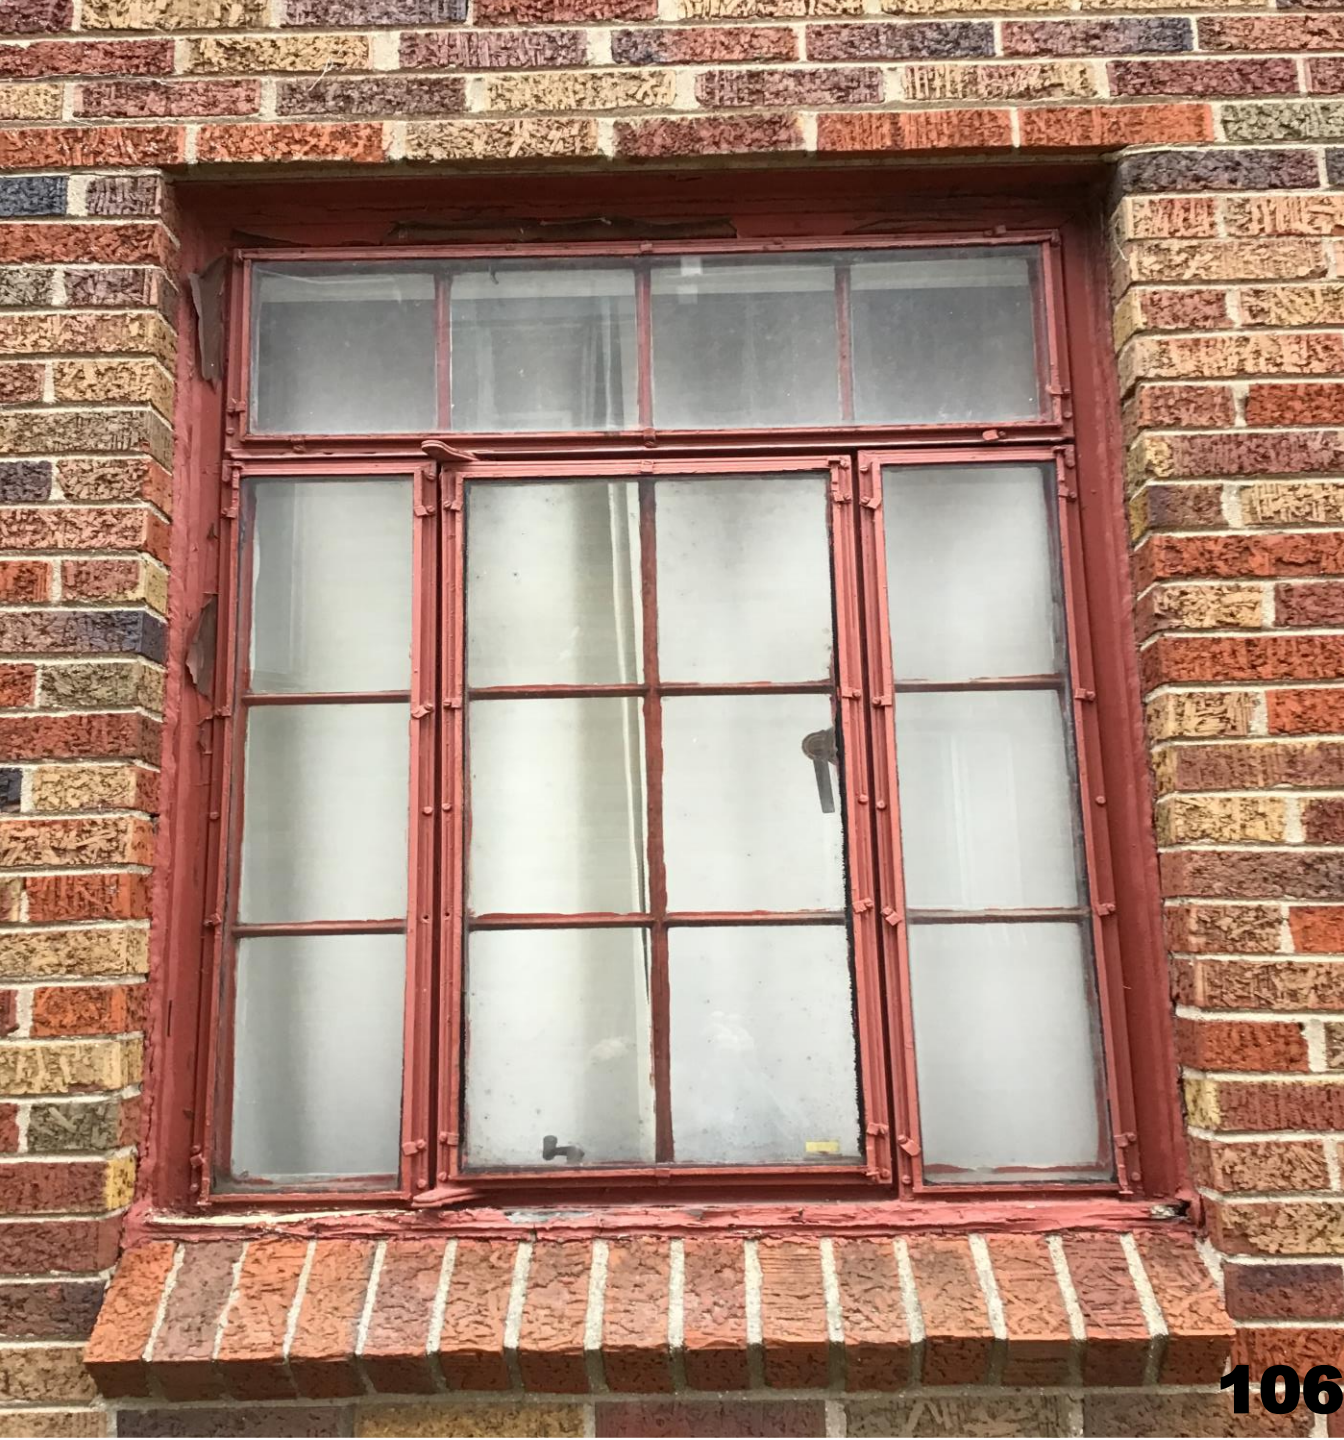
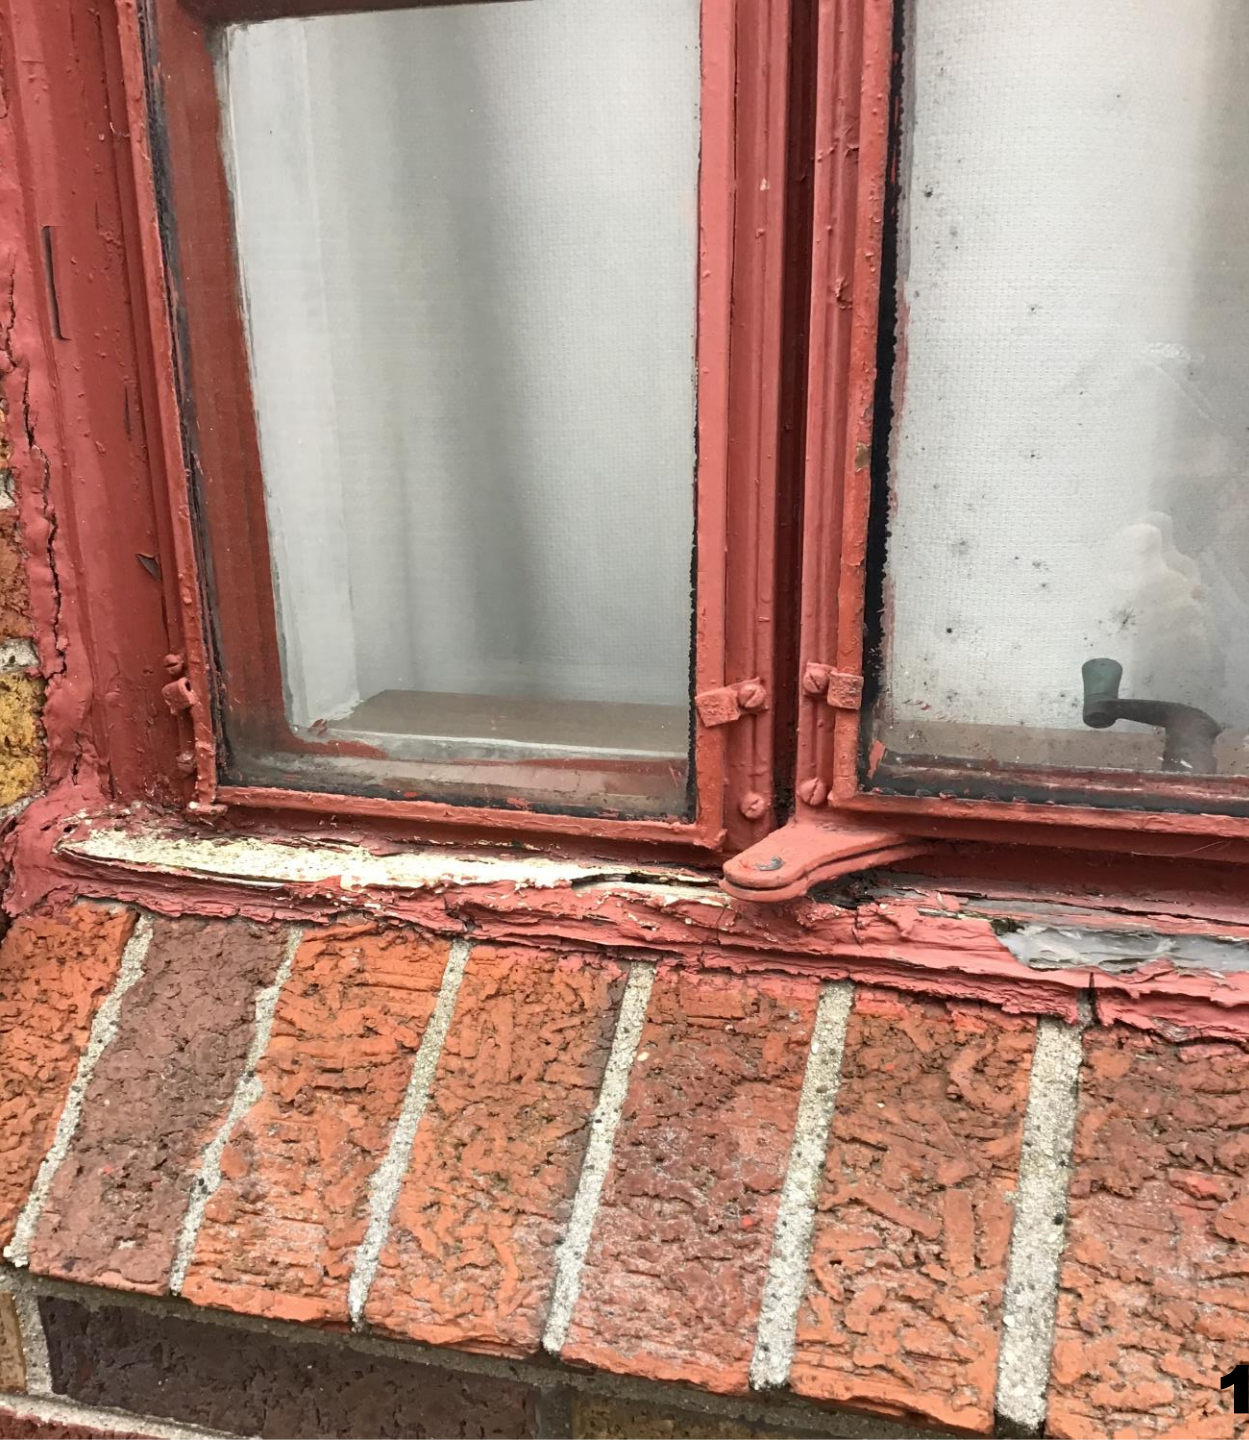
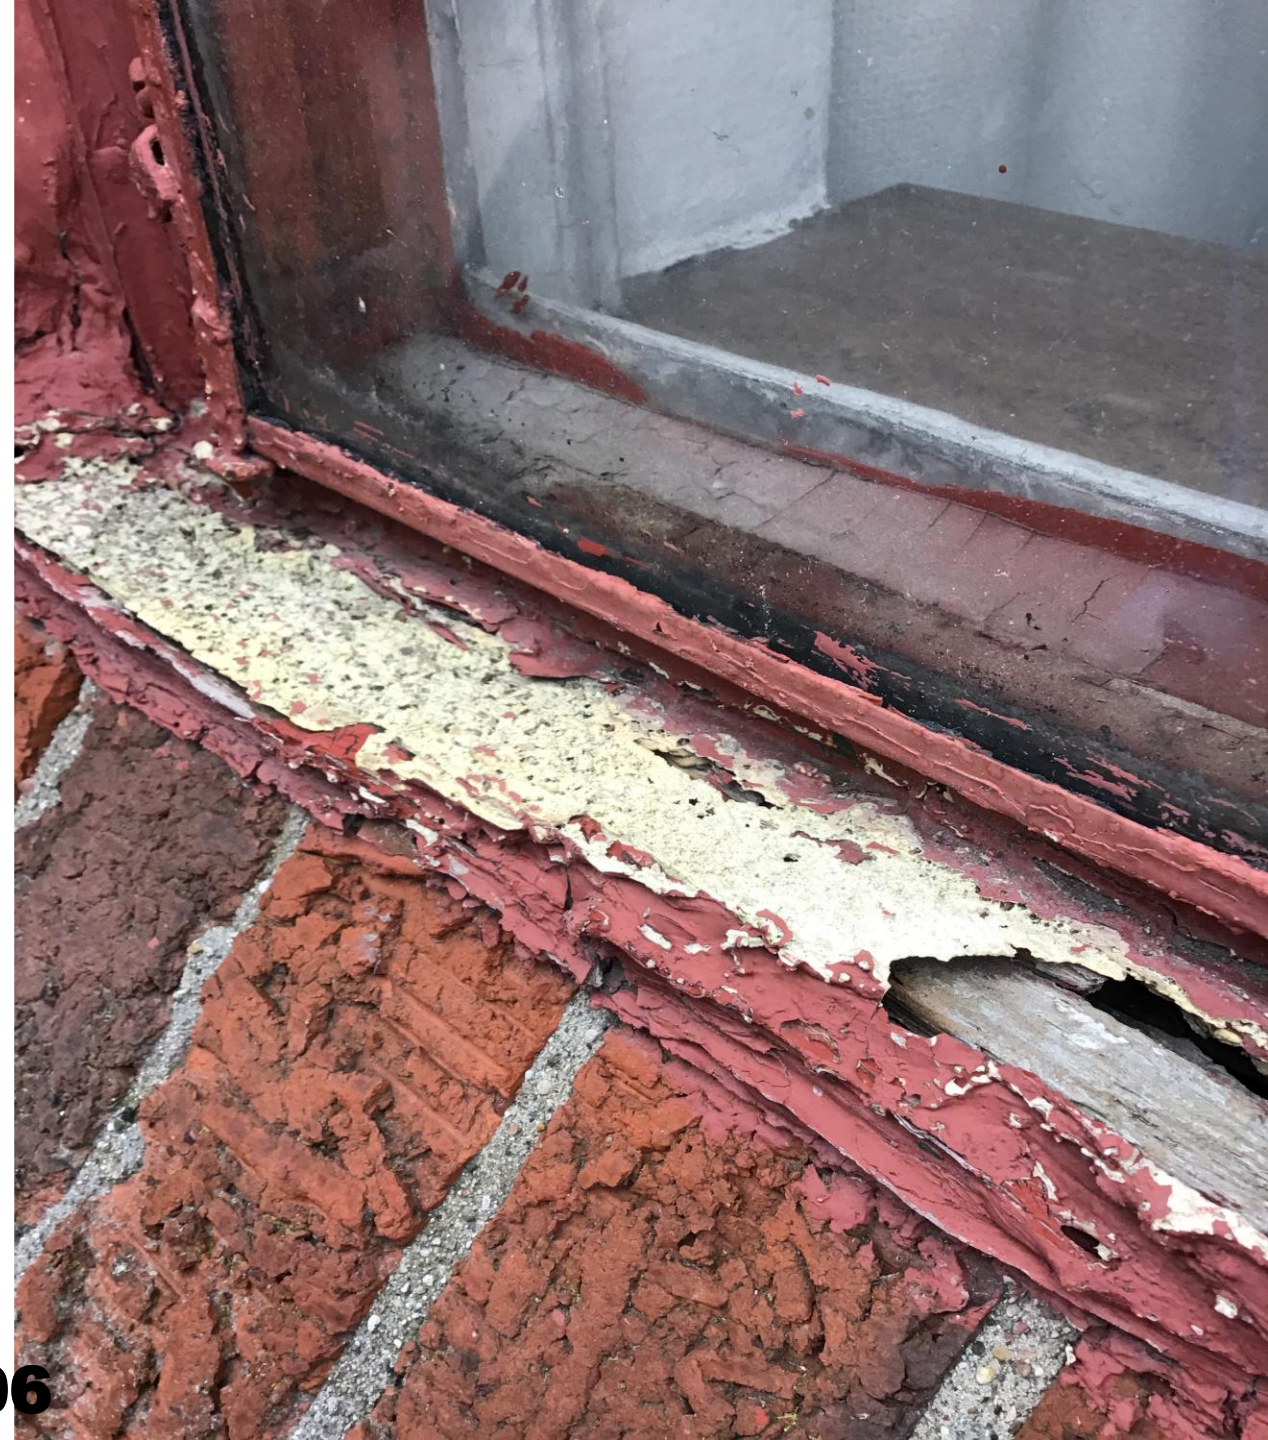
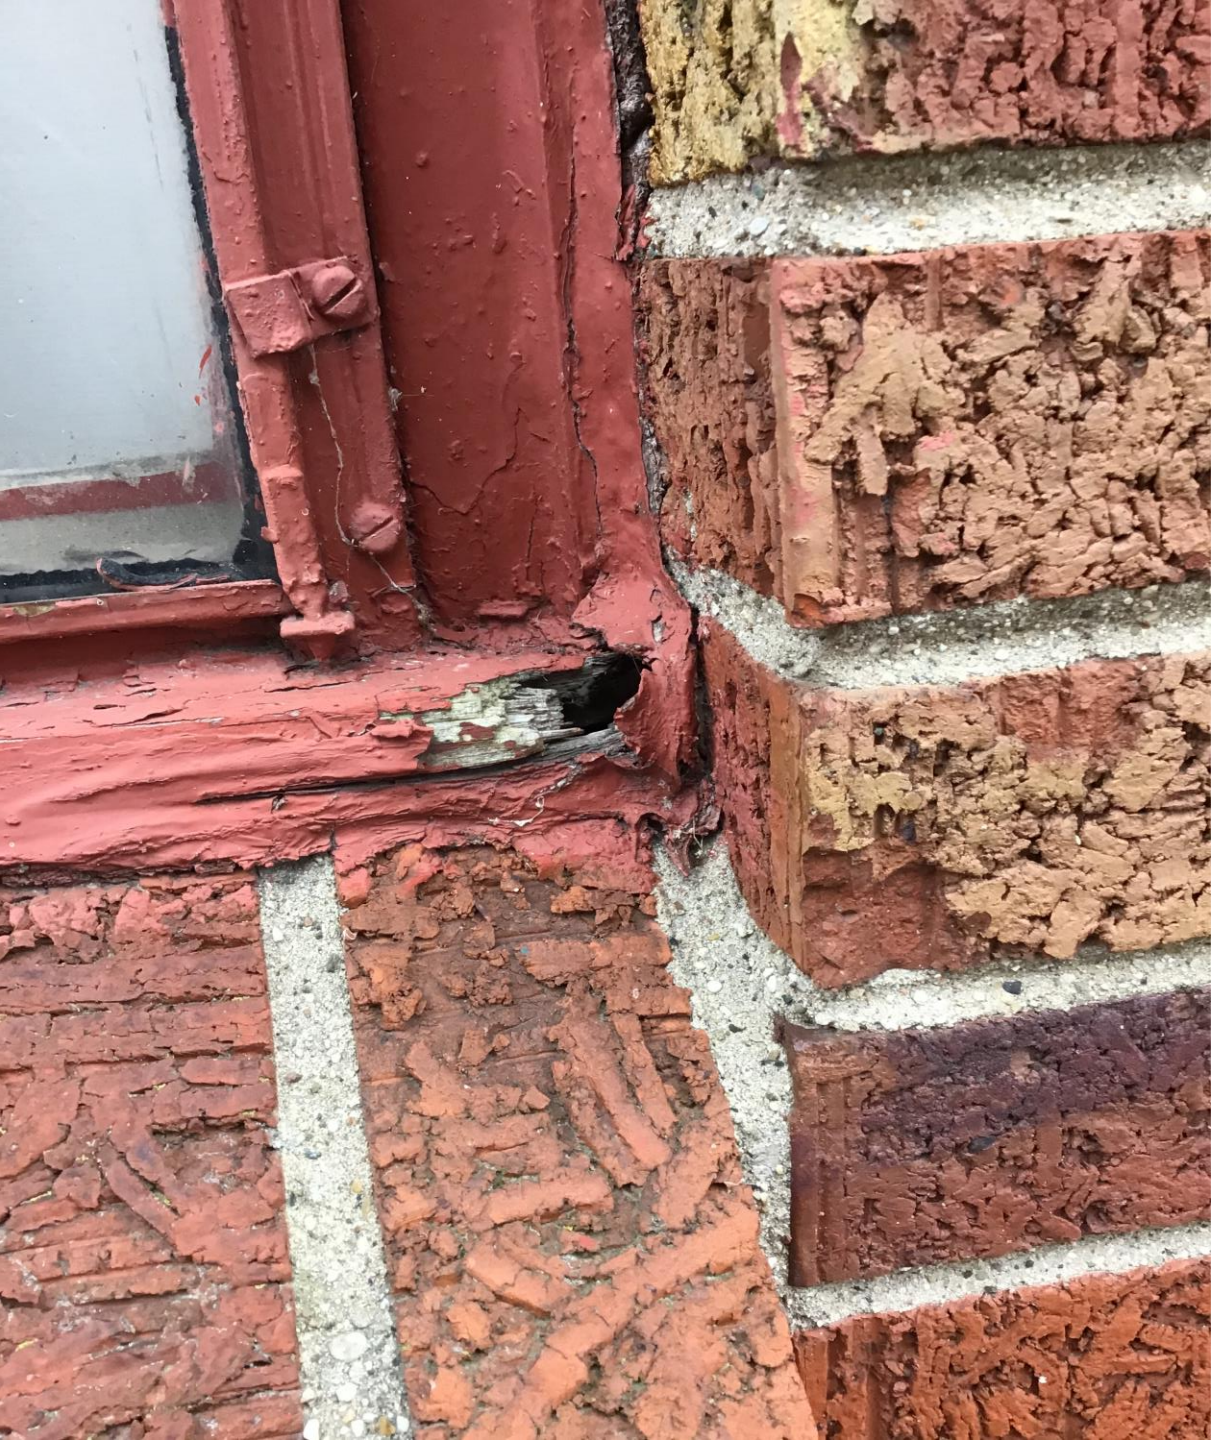
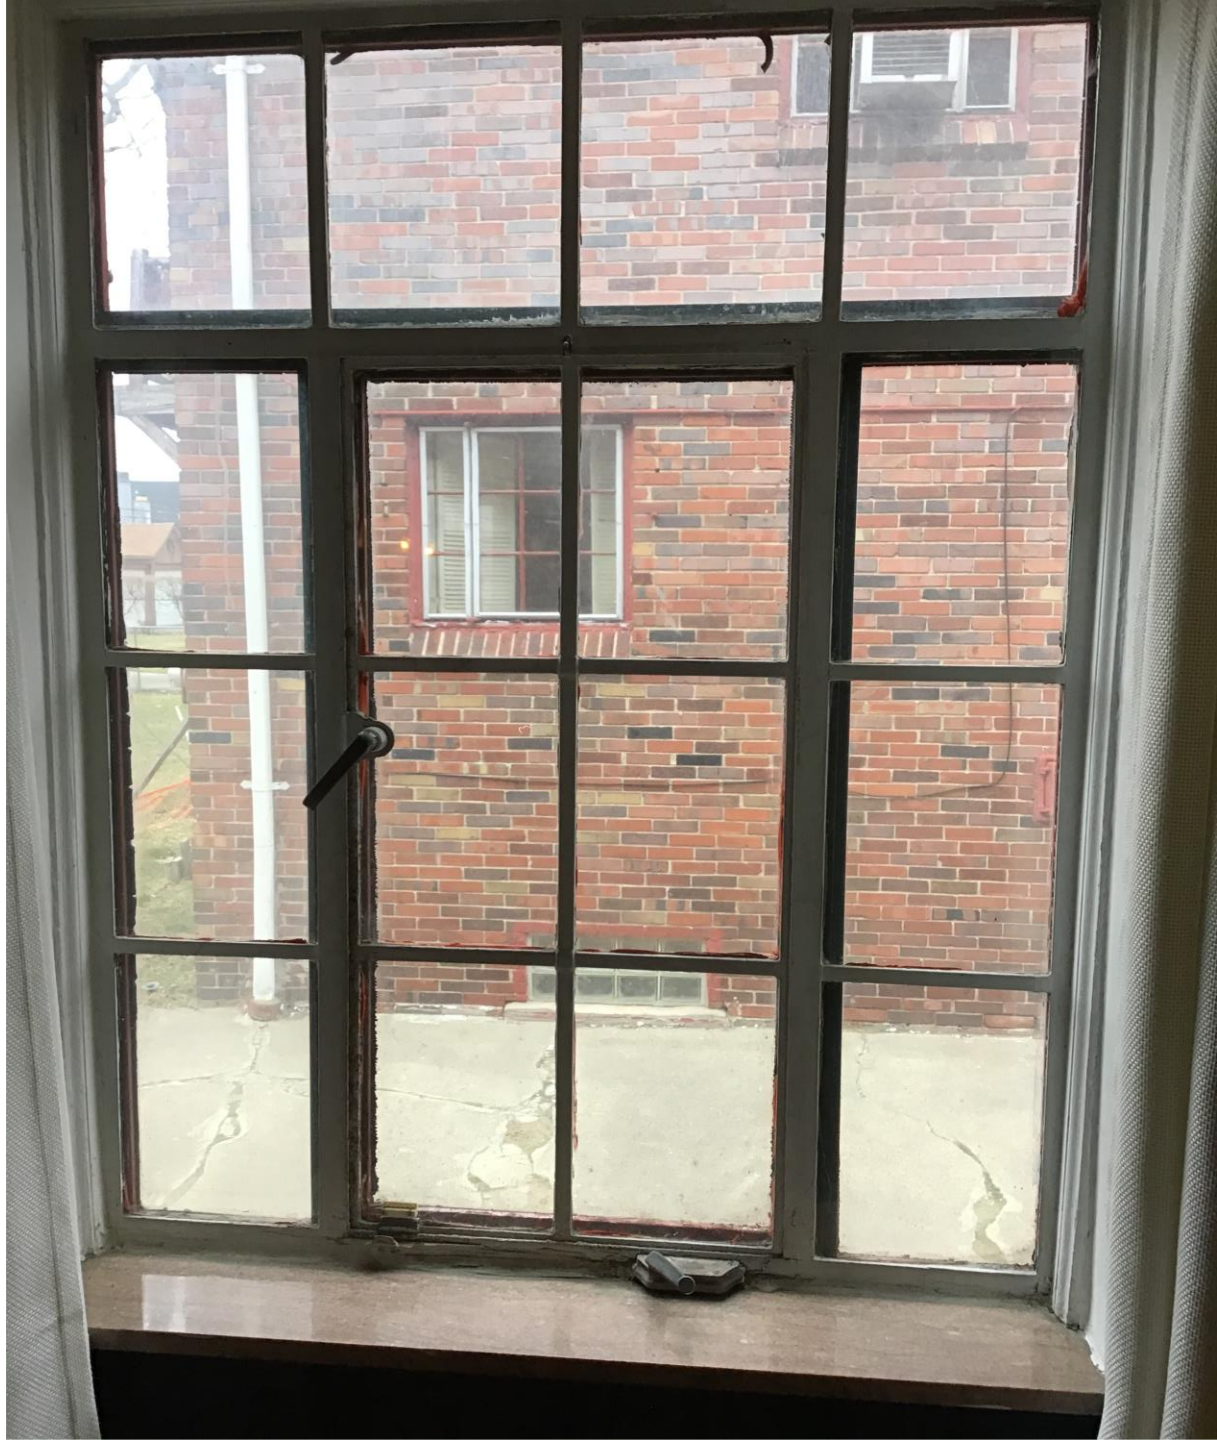
WINDOW OPENING 106

- Single Casement Window
- Window is in Dining room
- Window is hard to close if opened
- Exterior of window is rotting
- Screen missing

Window: Casement, Single, Left, Base Frame, 2" Brickmould / Traditional, Exterior Black, Interior Black, **Glass:** All Sash: High Performance SmartSun Glass, No Pattern, **Hardware:** Black, **Screen:** Fiberglass, Full Screen, **Grille Style:** Grilles Between Glass (GBG), **Grille Pattern:** All Sash: Colonial 4w x 4h, **Misc:** None

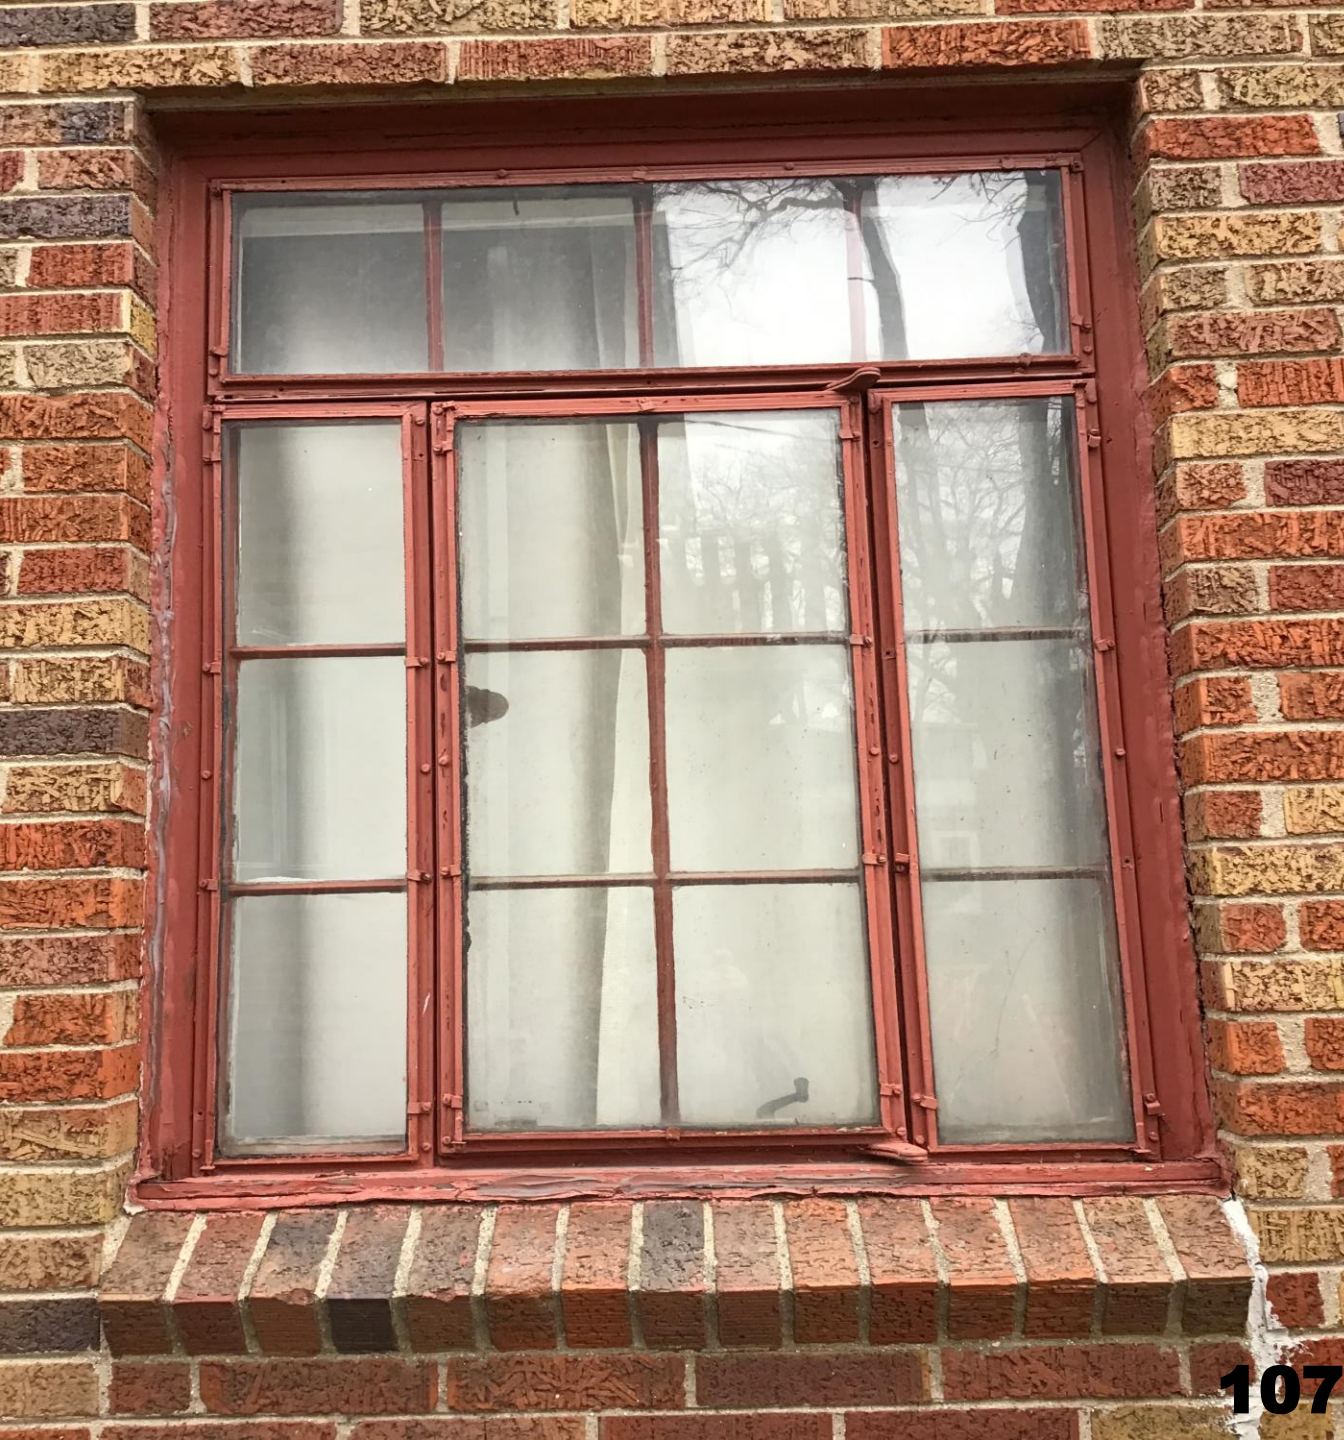
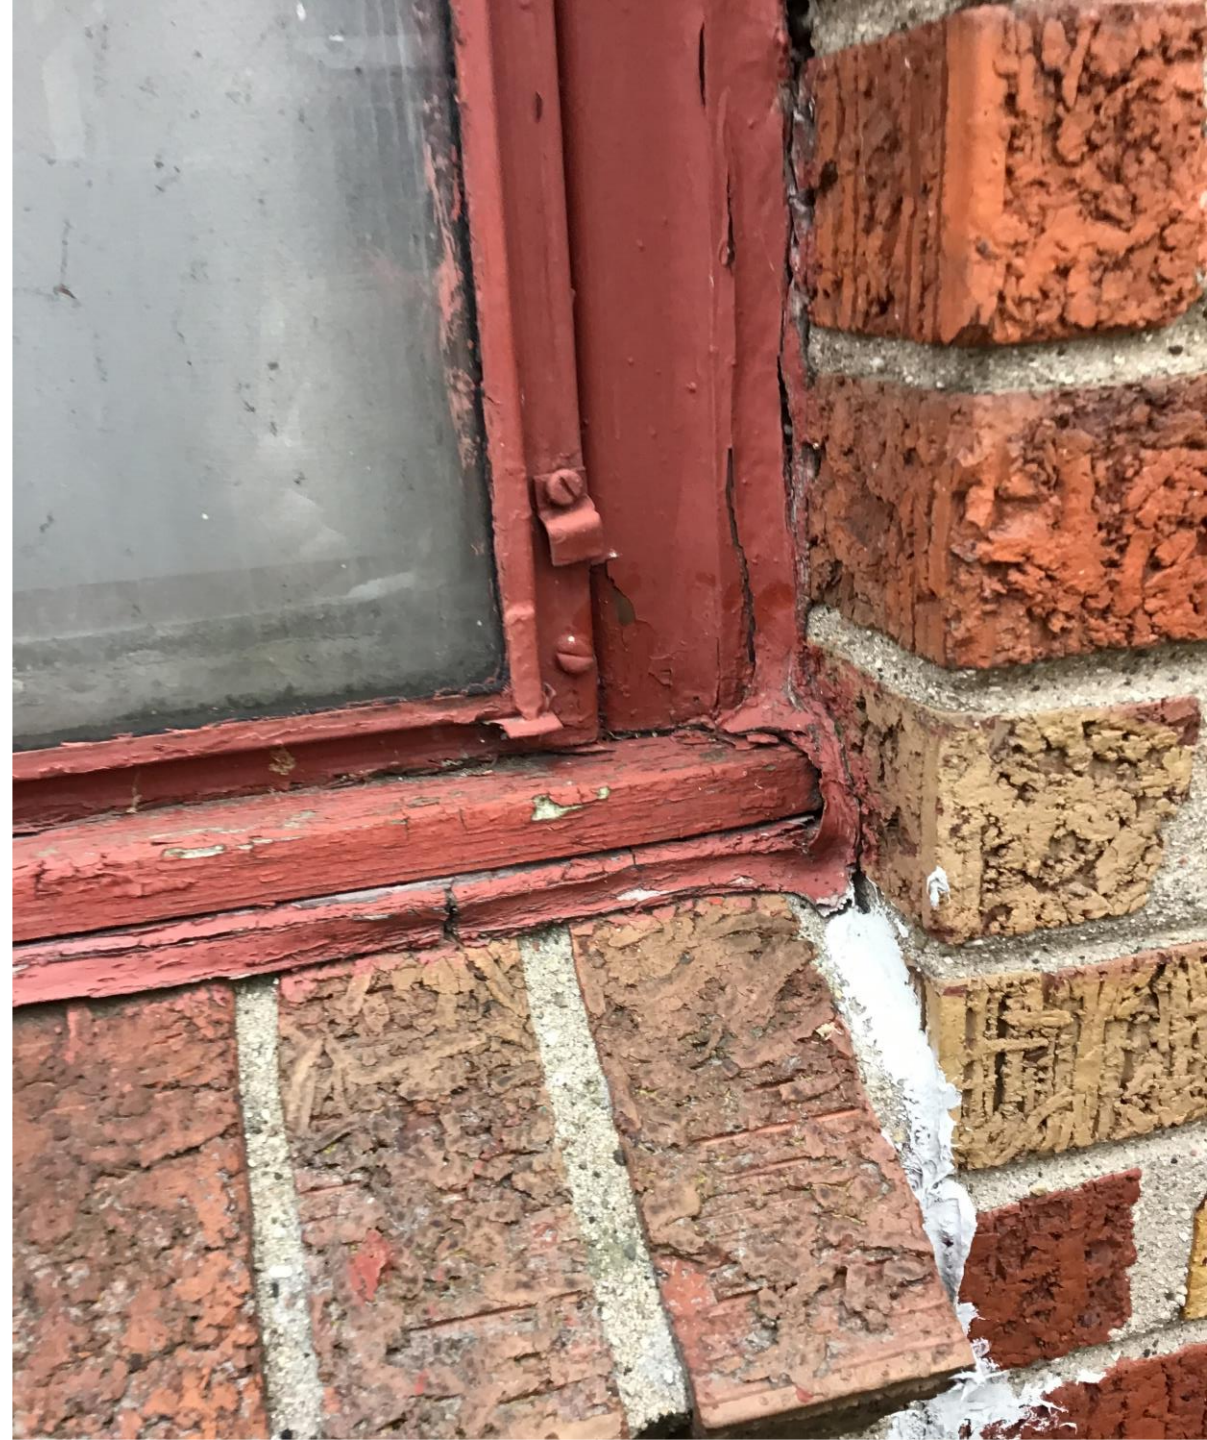
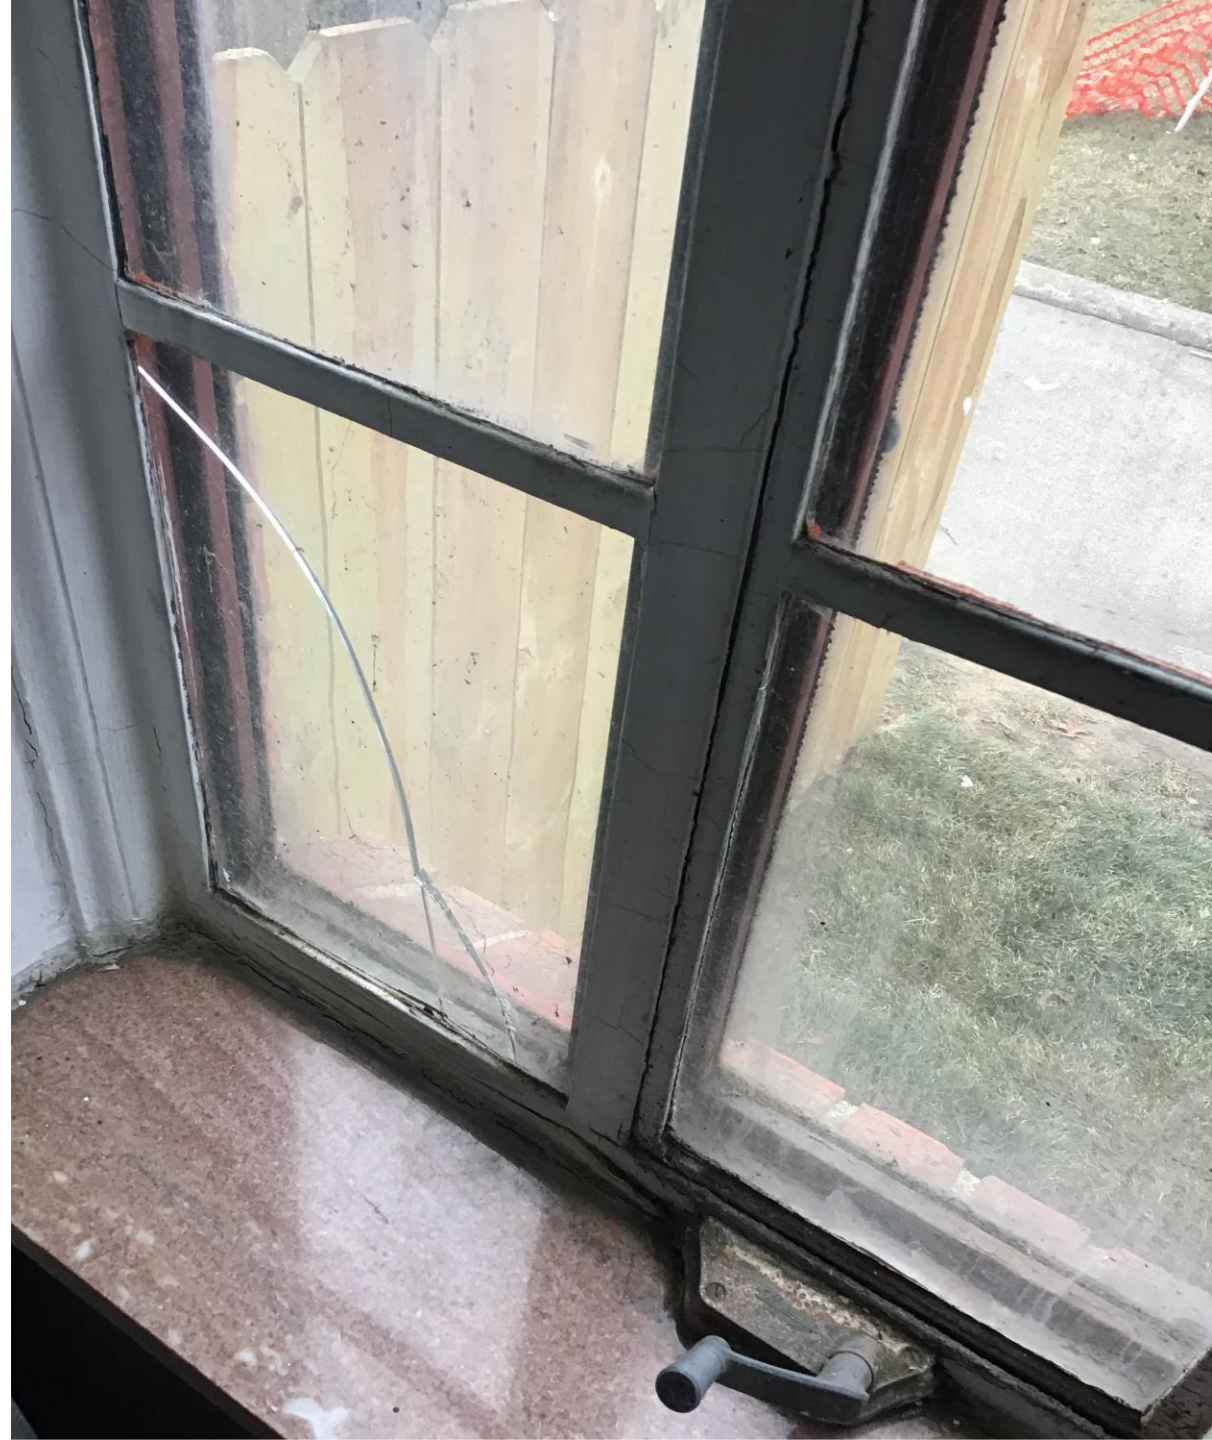
WINDOW OPENING 107

- Single Casement Window
- Window is in Dining room
- Window is hard to close if opened
- Windowpane cracked
- Screen missing

Window: Casement, Single, Left, Base Frame, 2" Brickmould / Traditional, Exterior Black, Interior Black, **Glass:** All Sash: High Performance SmartSun Glass, No Pattern, **Hardware:** Black, **Screen:** Fiberglass, Full Screen, **Grille Style:** Grilles Between Glass (GBG), **Grille Pattern:** All Sash: Colonial 4w x 4h, **Misc:** None

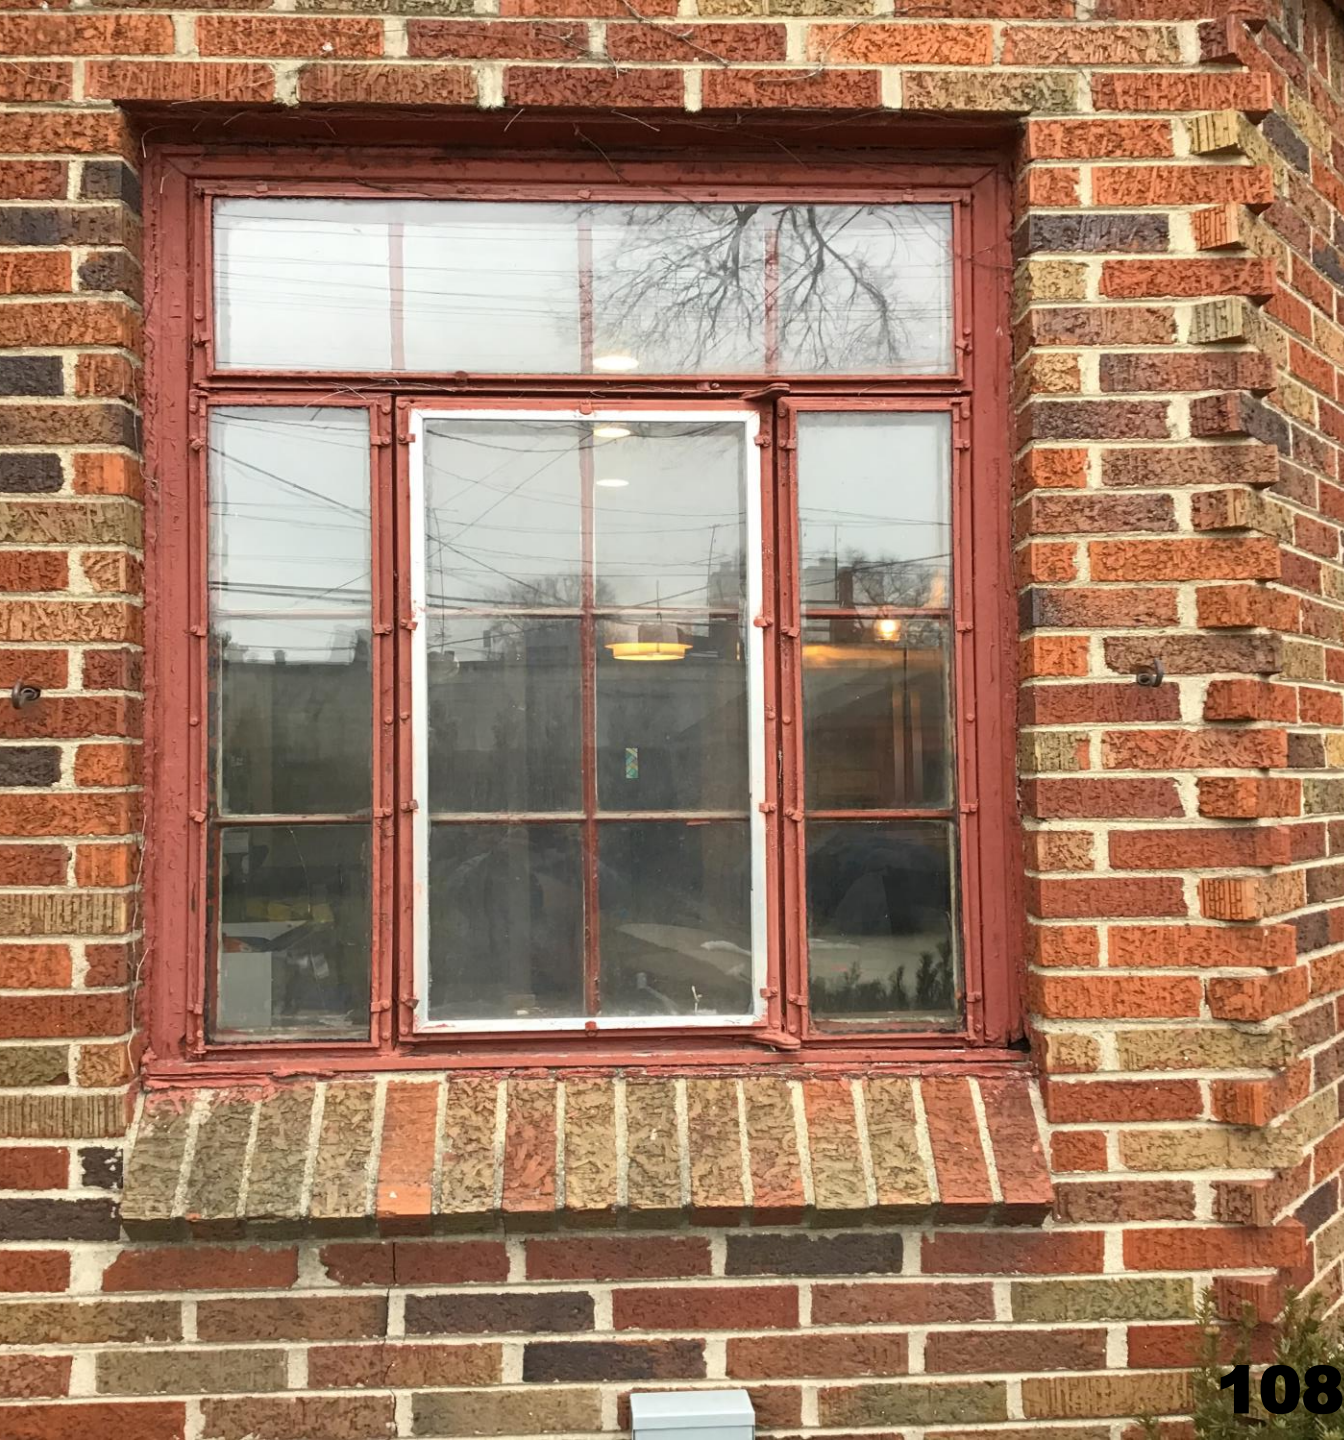
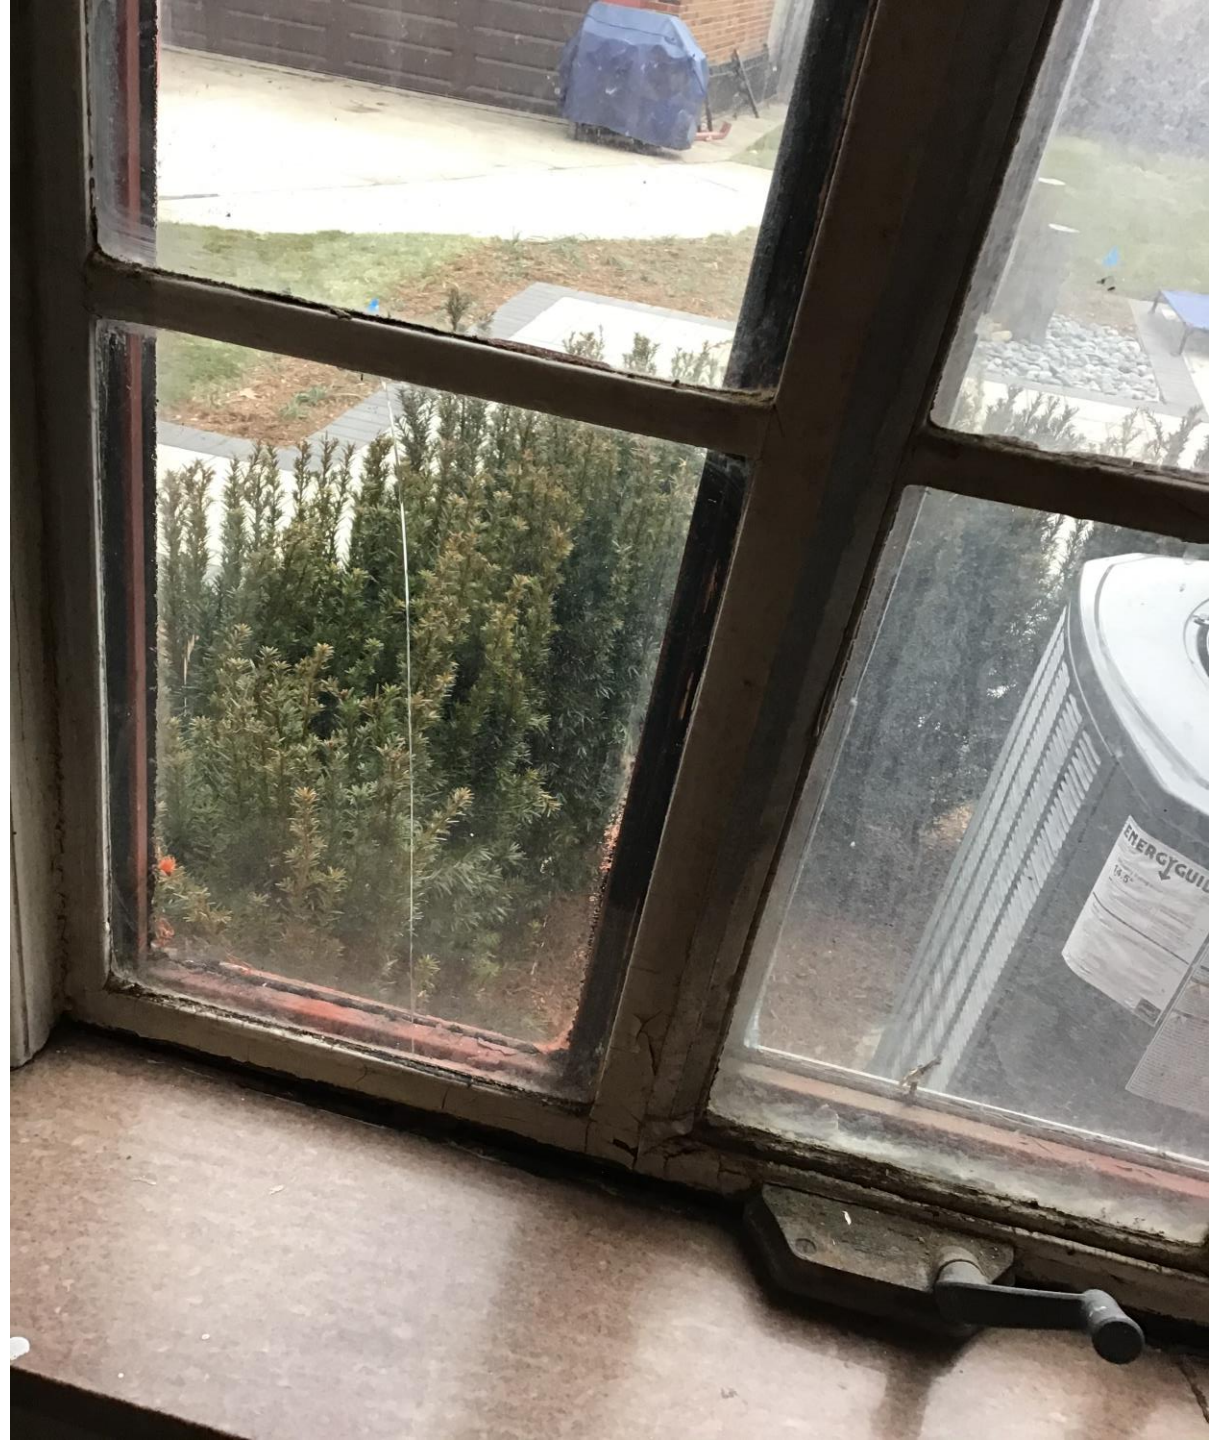
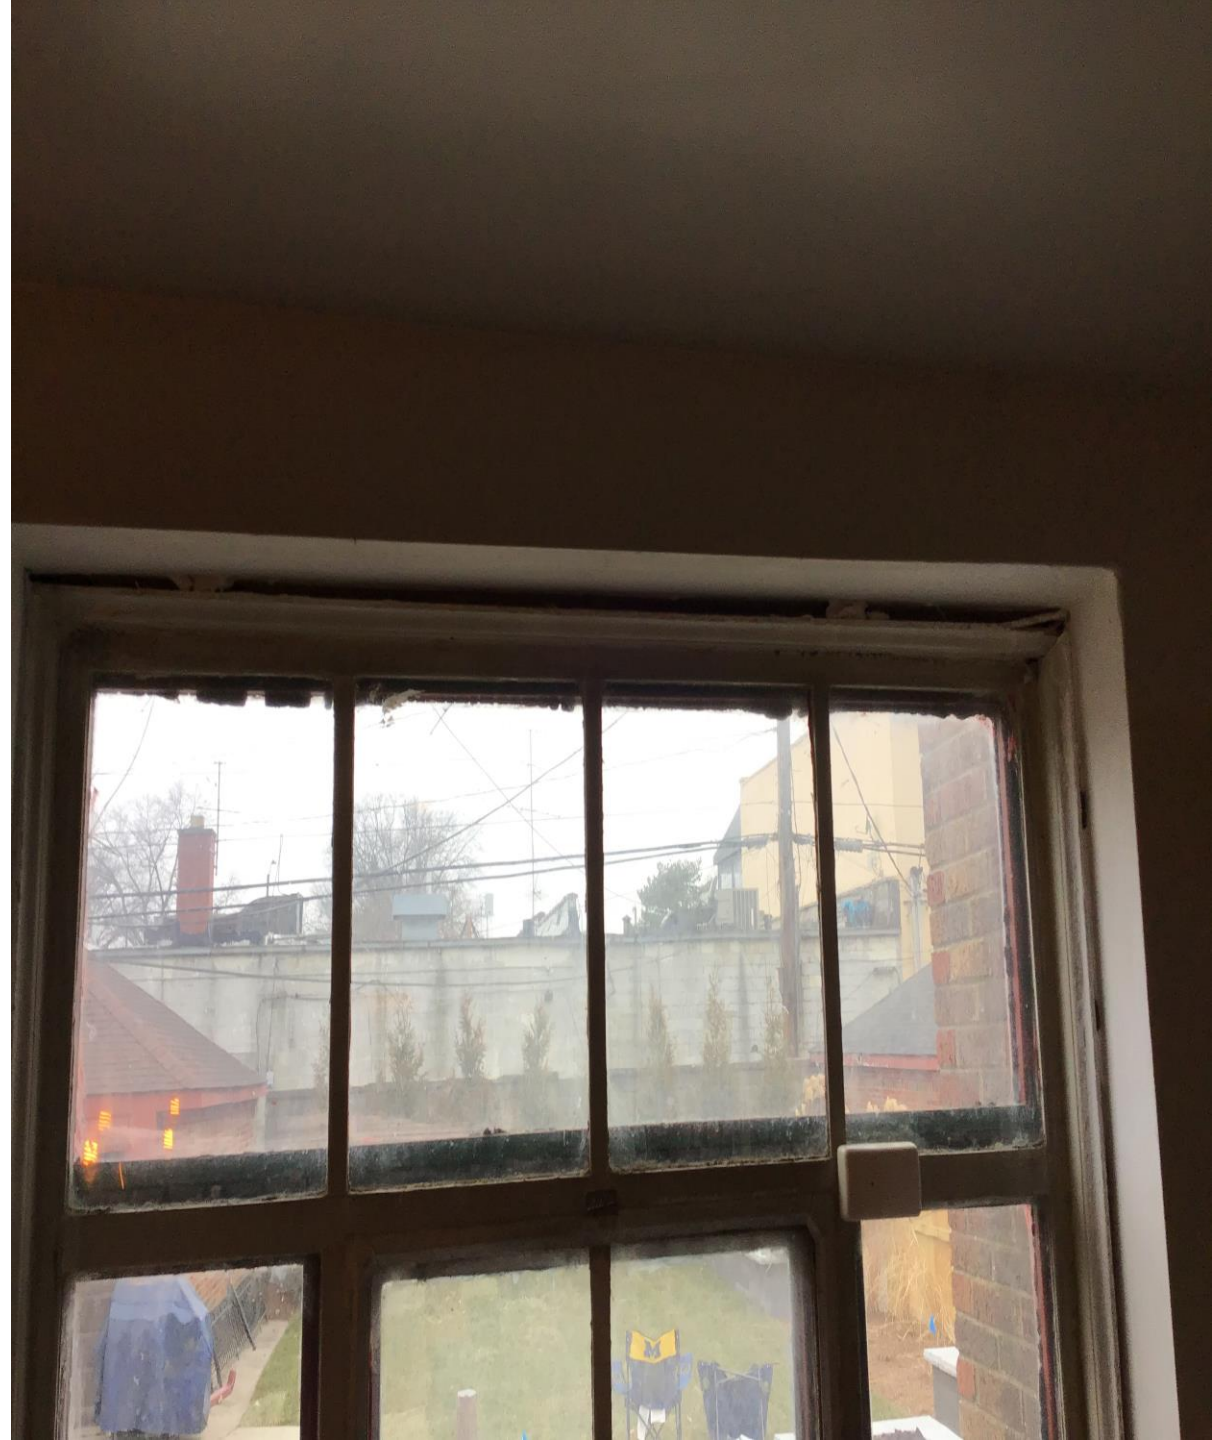
WINDOW OPENING 108

- Single Casement Window
- Window is in Kitchen
- Window doesn't open
- Exterior sill is rotted, can see through
- Interior sill is cracked
- Windowpane cracked
- Screen missing

Window: Casement, Single, Left, Base Frame, 2" Brickmould / Traditional, Exterior Black, Interior Black, **Glass:** All Sash: High Performance SmartSun Glass, No Pattern, **Hardware:** Black, **Screen:** TruScene, Full Screen, **Grille Style:** Grilles Between Glass (GBG), **Grille Pattern:** All Sash: Colonial 4w x 4h, **Misc:** None
