James Haskins
19365 Warrington Dr
Detroit MI 48221
Sherwood Forest District

Renewal by Andersen 37720 Amrhein Livonia, MI 48150

- Homeowner wants to replace all the windows around house except for one stained glass window unit
- Windows are original steel
- Renewal by Andersen windows are Fibrex (wood composite) material
- Total of 24 windows to be replaced
- Windows exterior color will be black if approved
- Most windows matching style except for bay windows – flankers changed to operable and middle window changed to fixed.
- Windows will match existing mutton bar “pattern”
- Homeowner unable to get quotes for repair

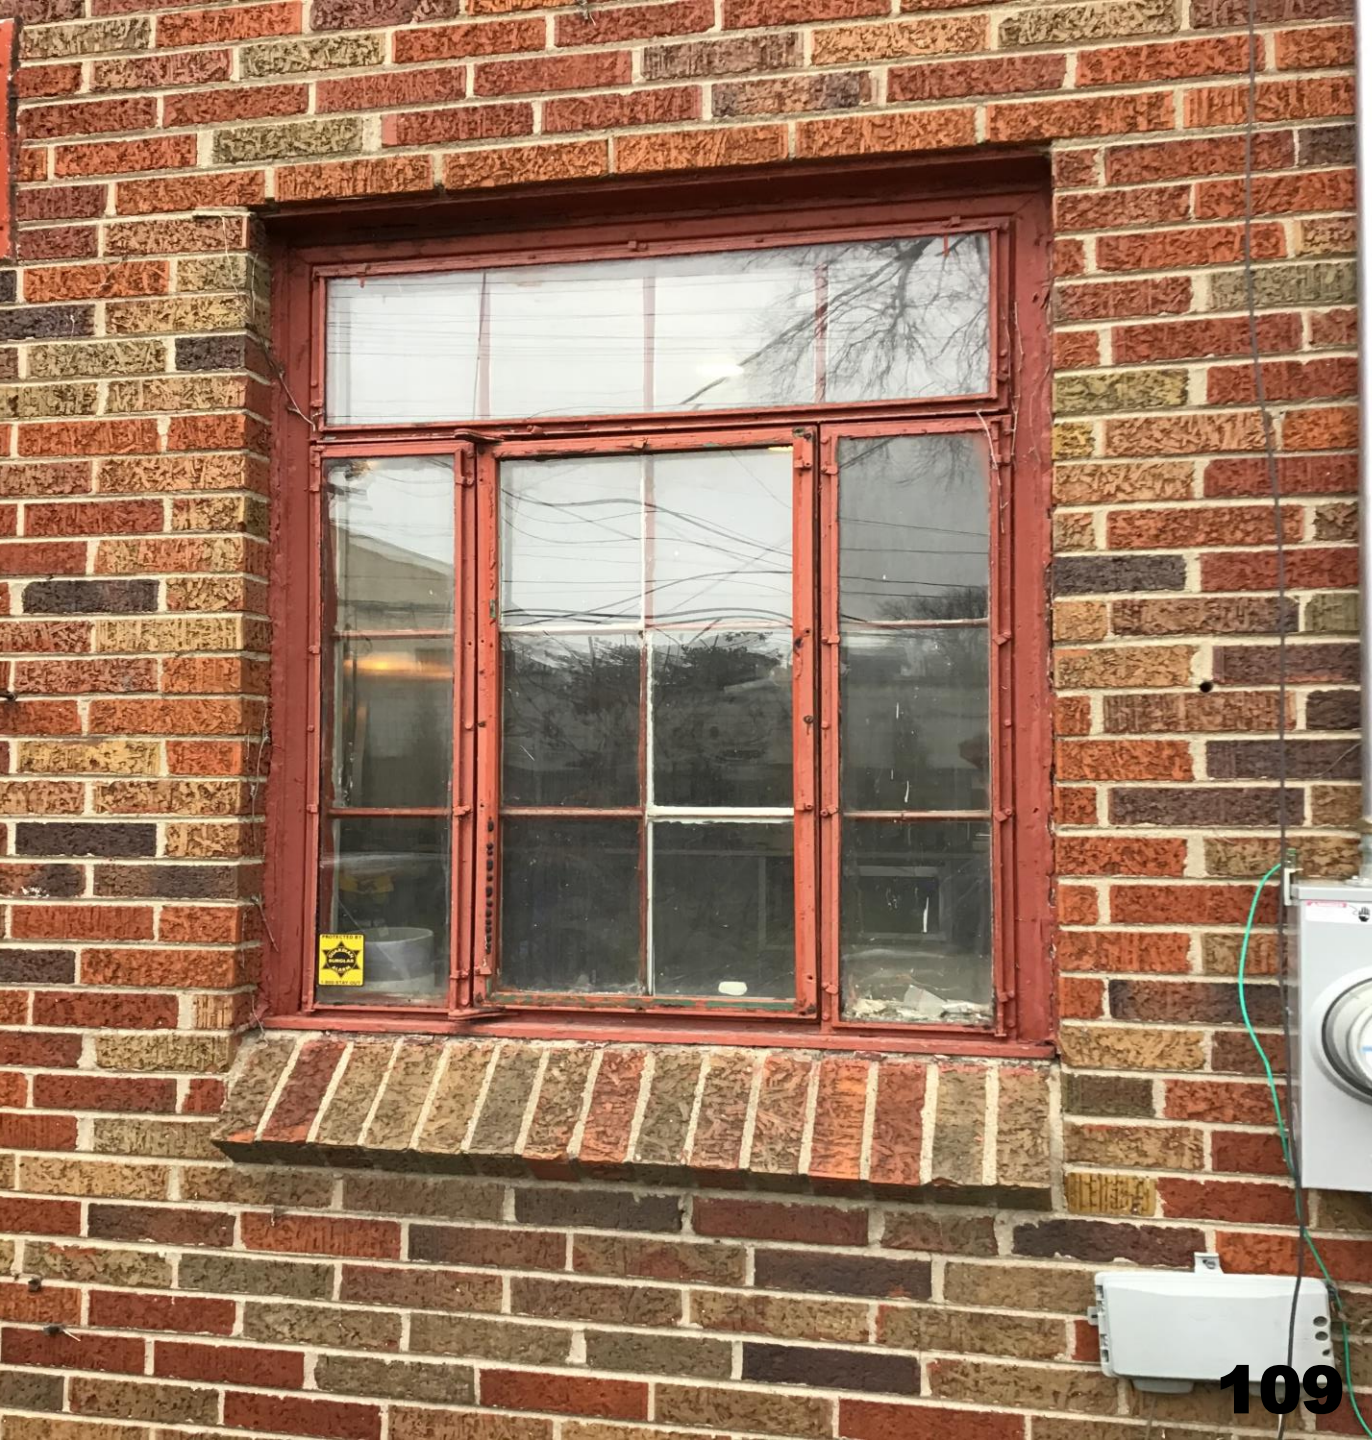
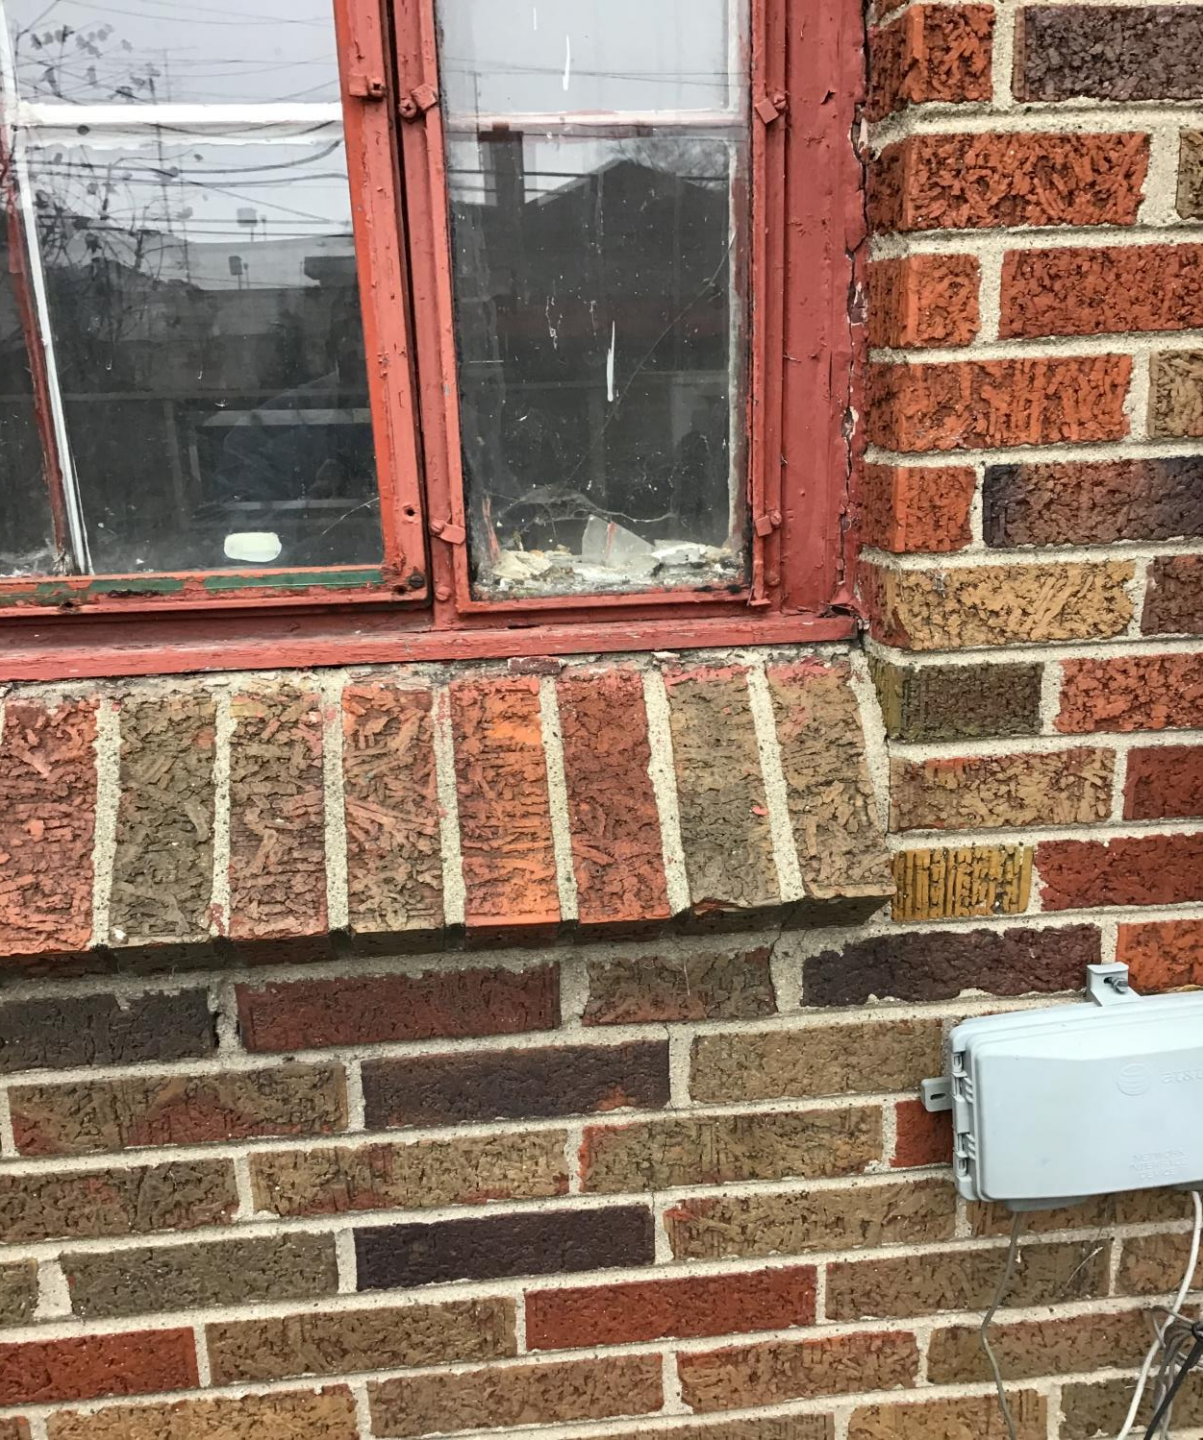
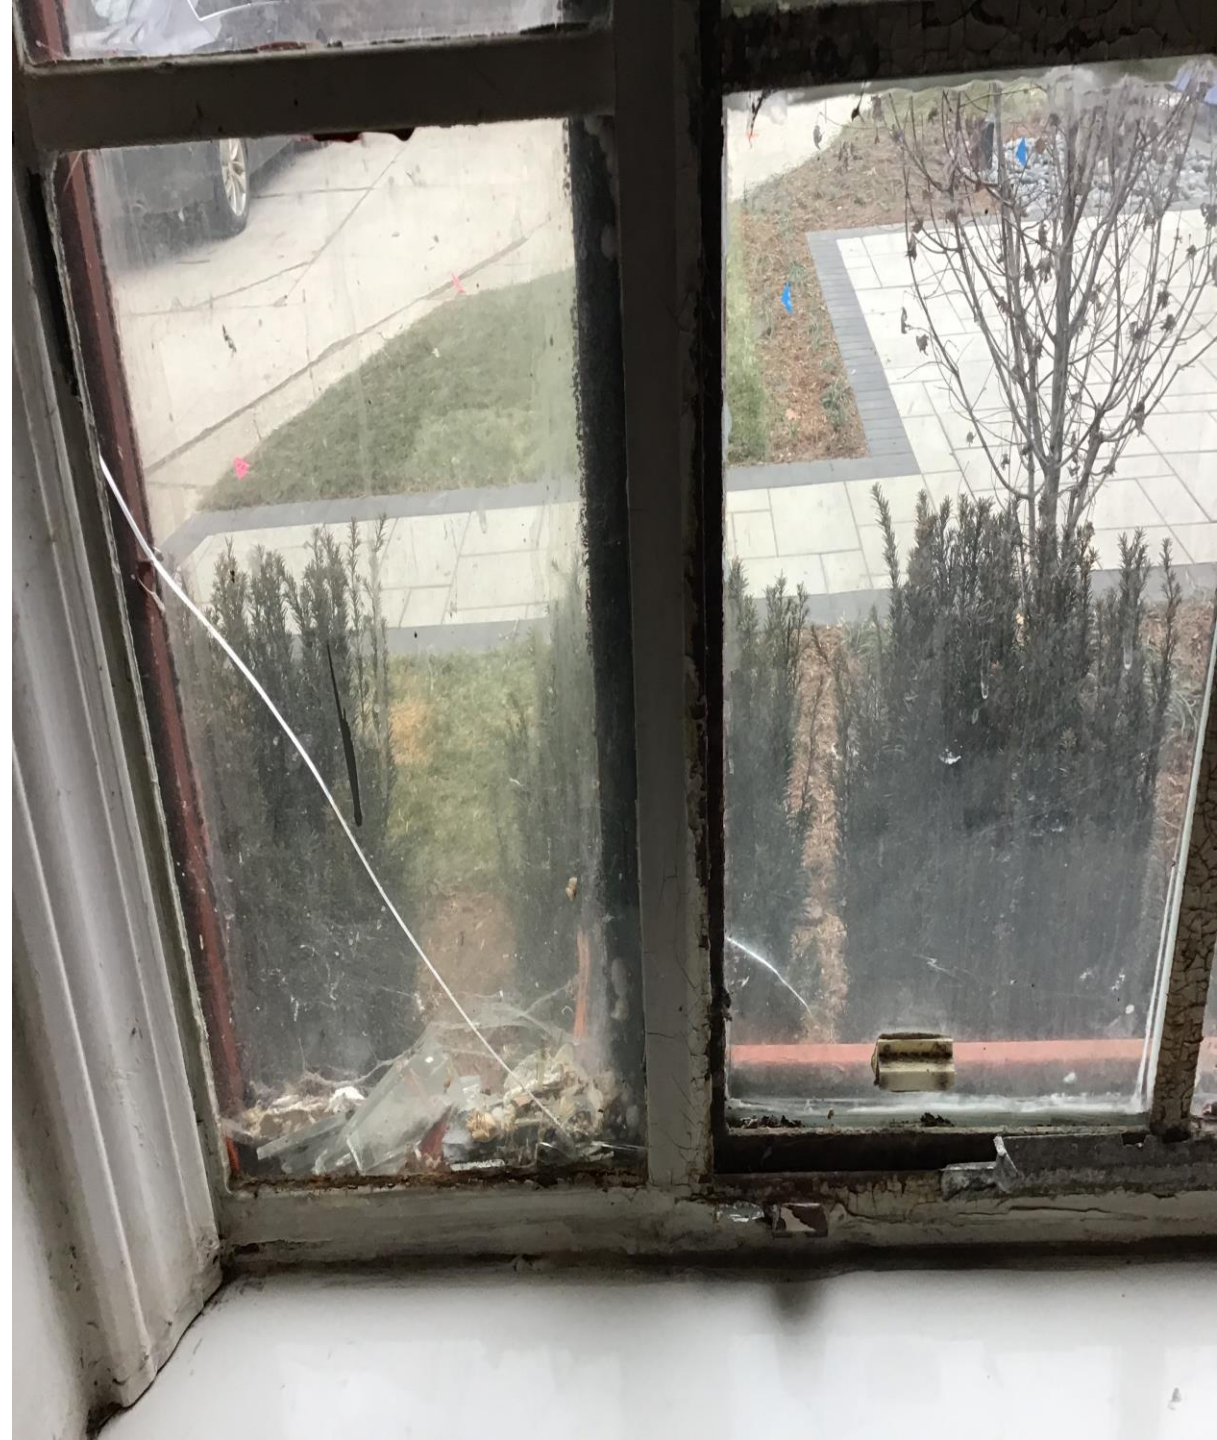
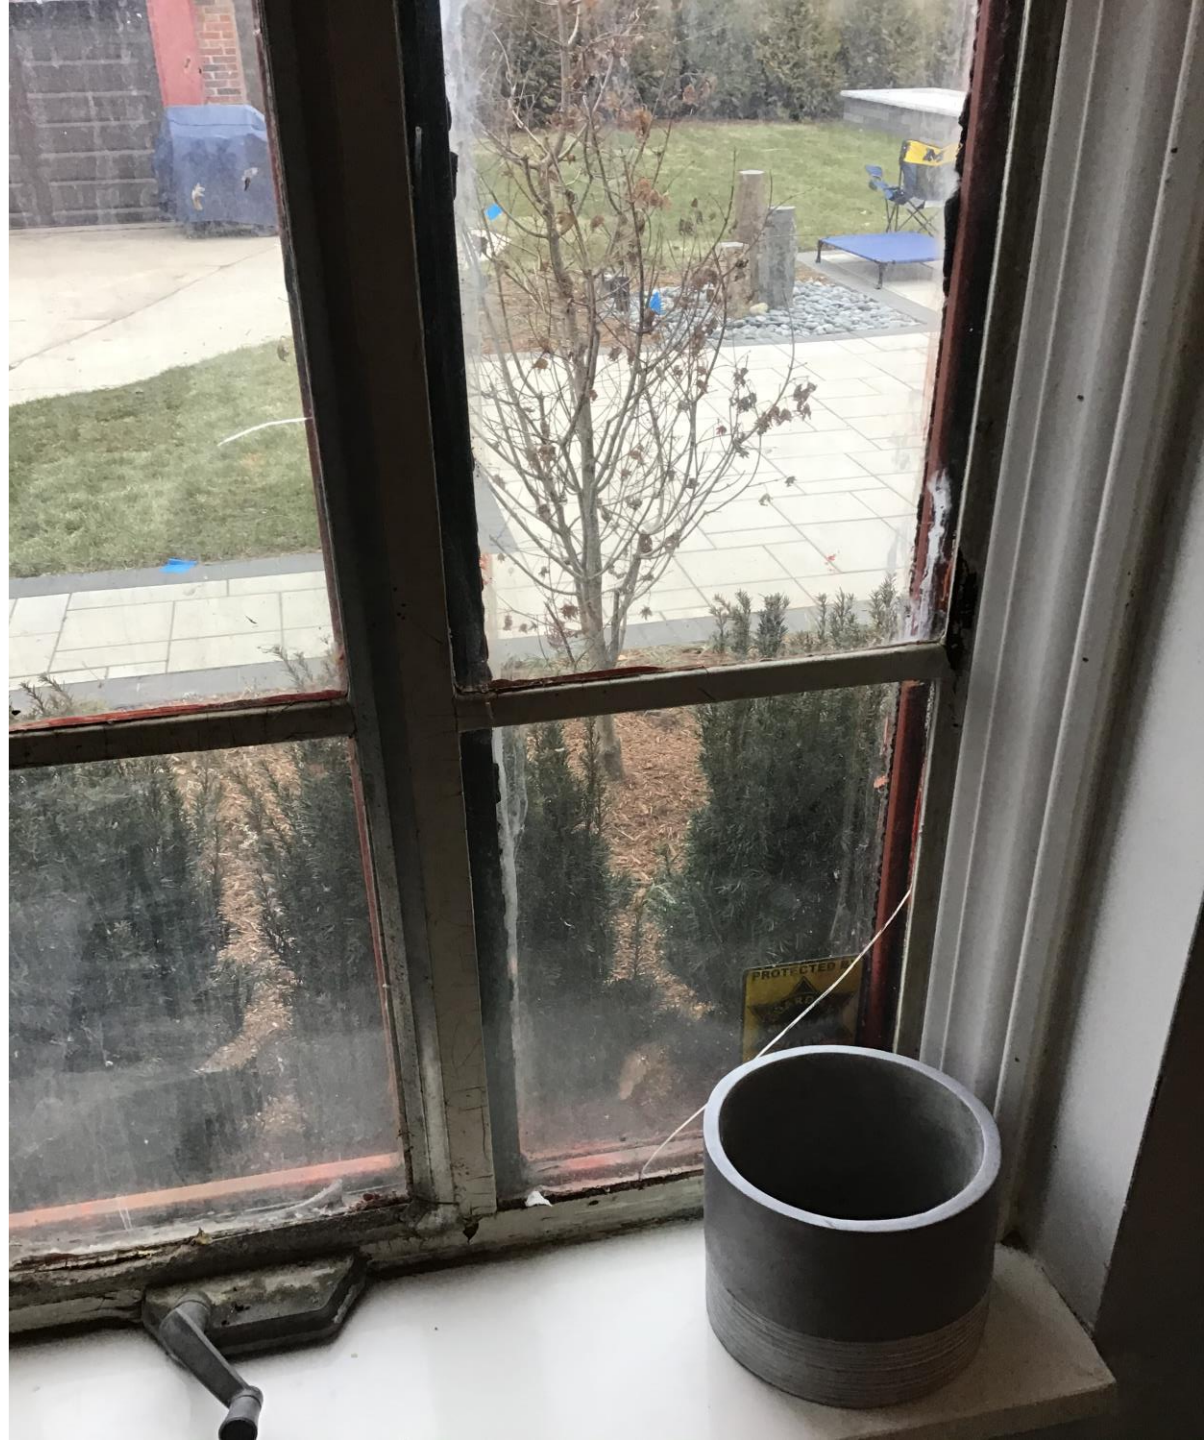
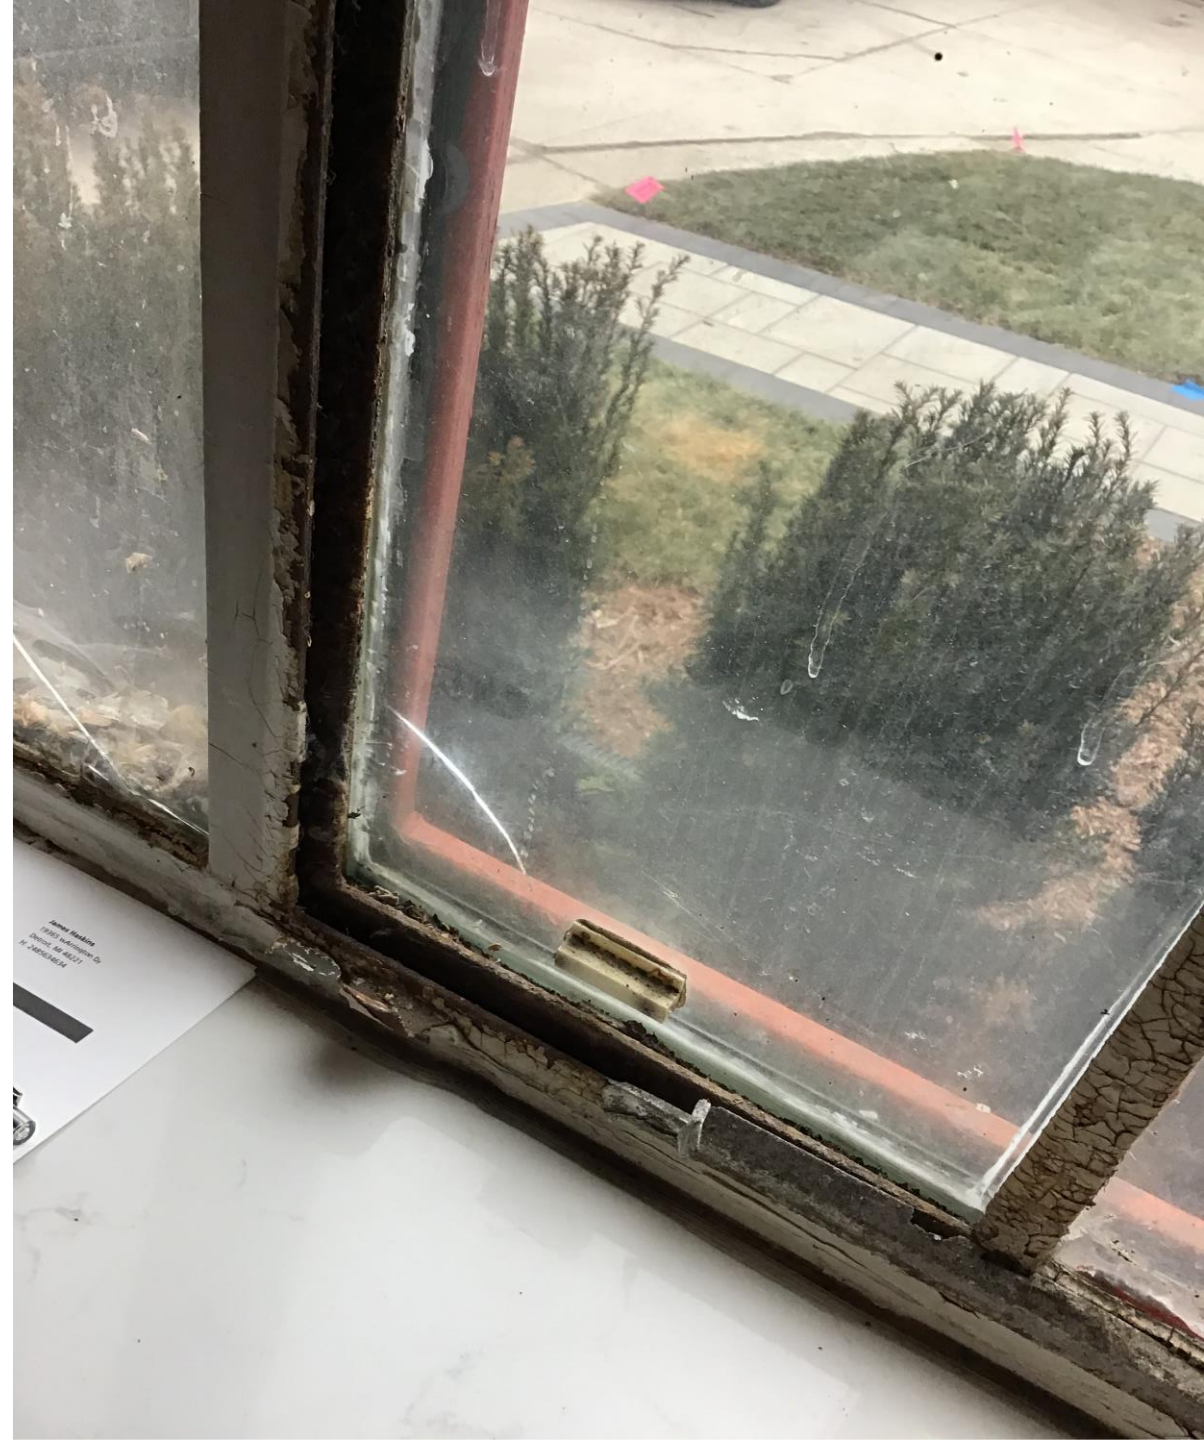
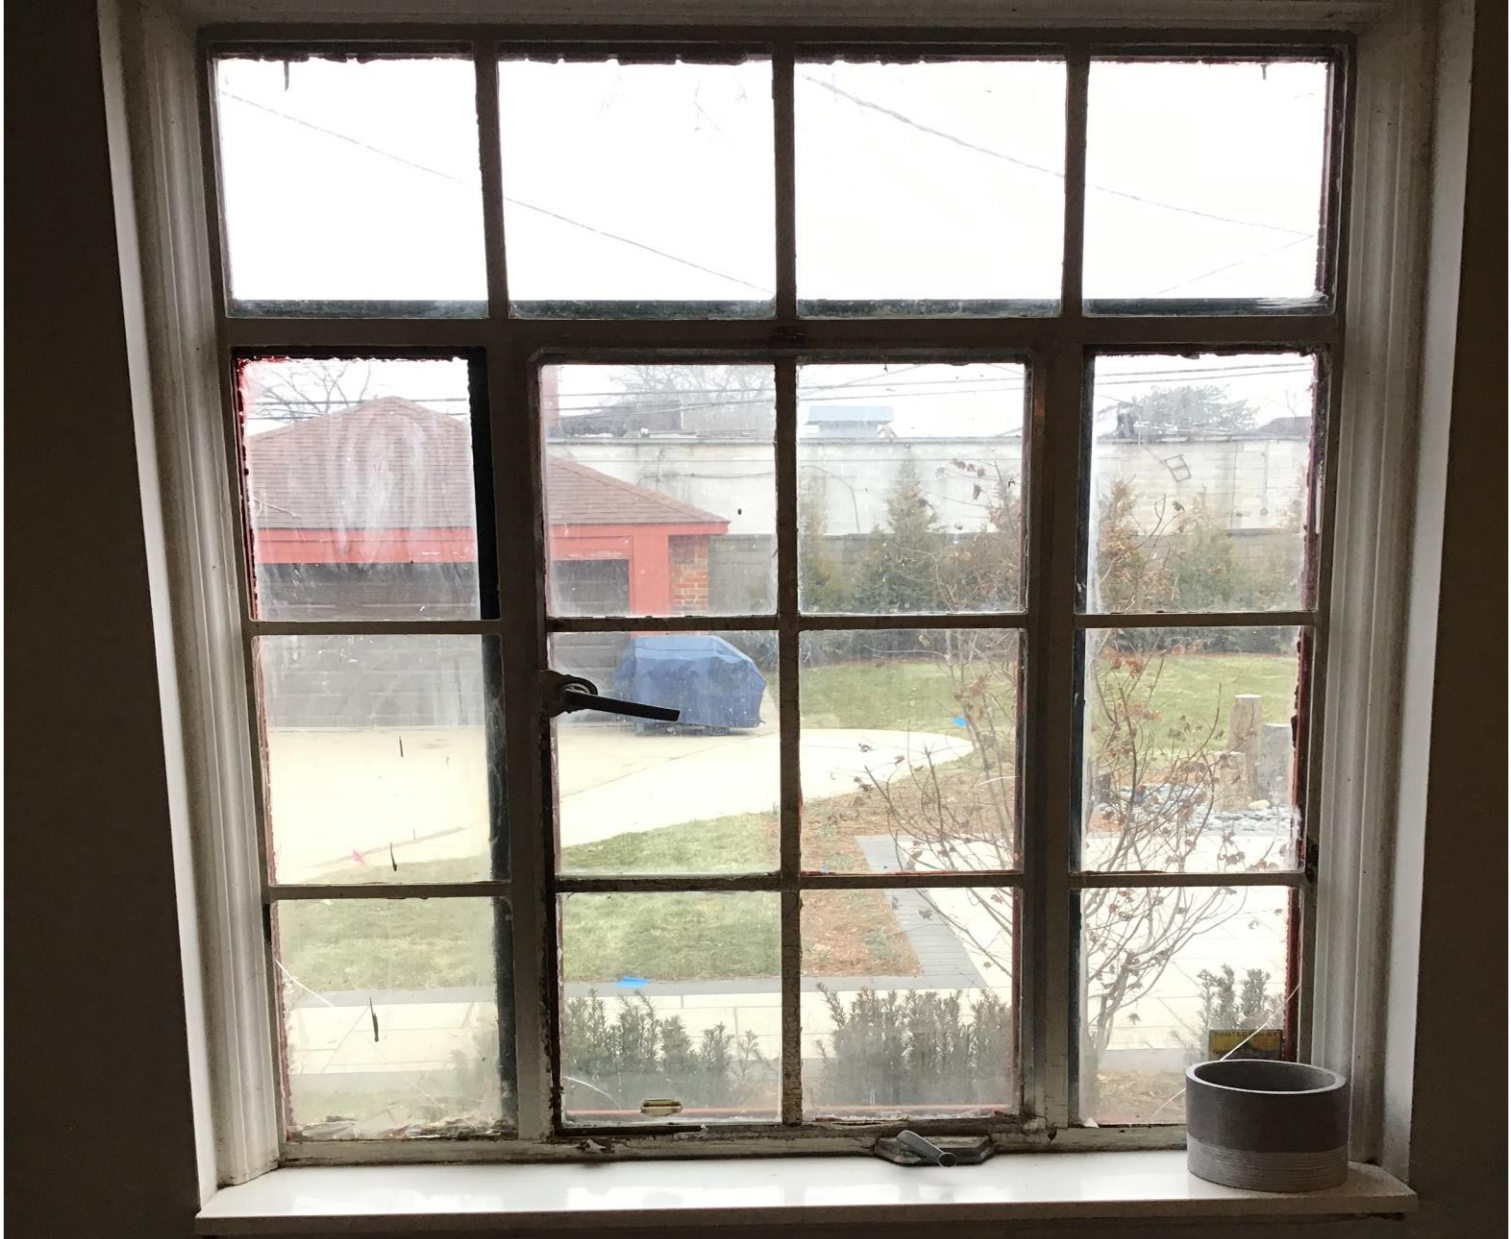
WINDOW OPENING 109 Kitchen - Back of House

- Single Casement Window
- Window is in Kitchen
- Window won't open
- Broken and cracked windowpanes

Window: Casement, Single, Right, Base Frame, 2"

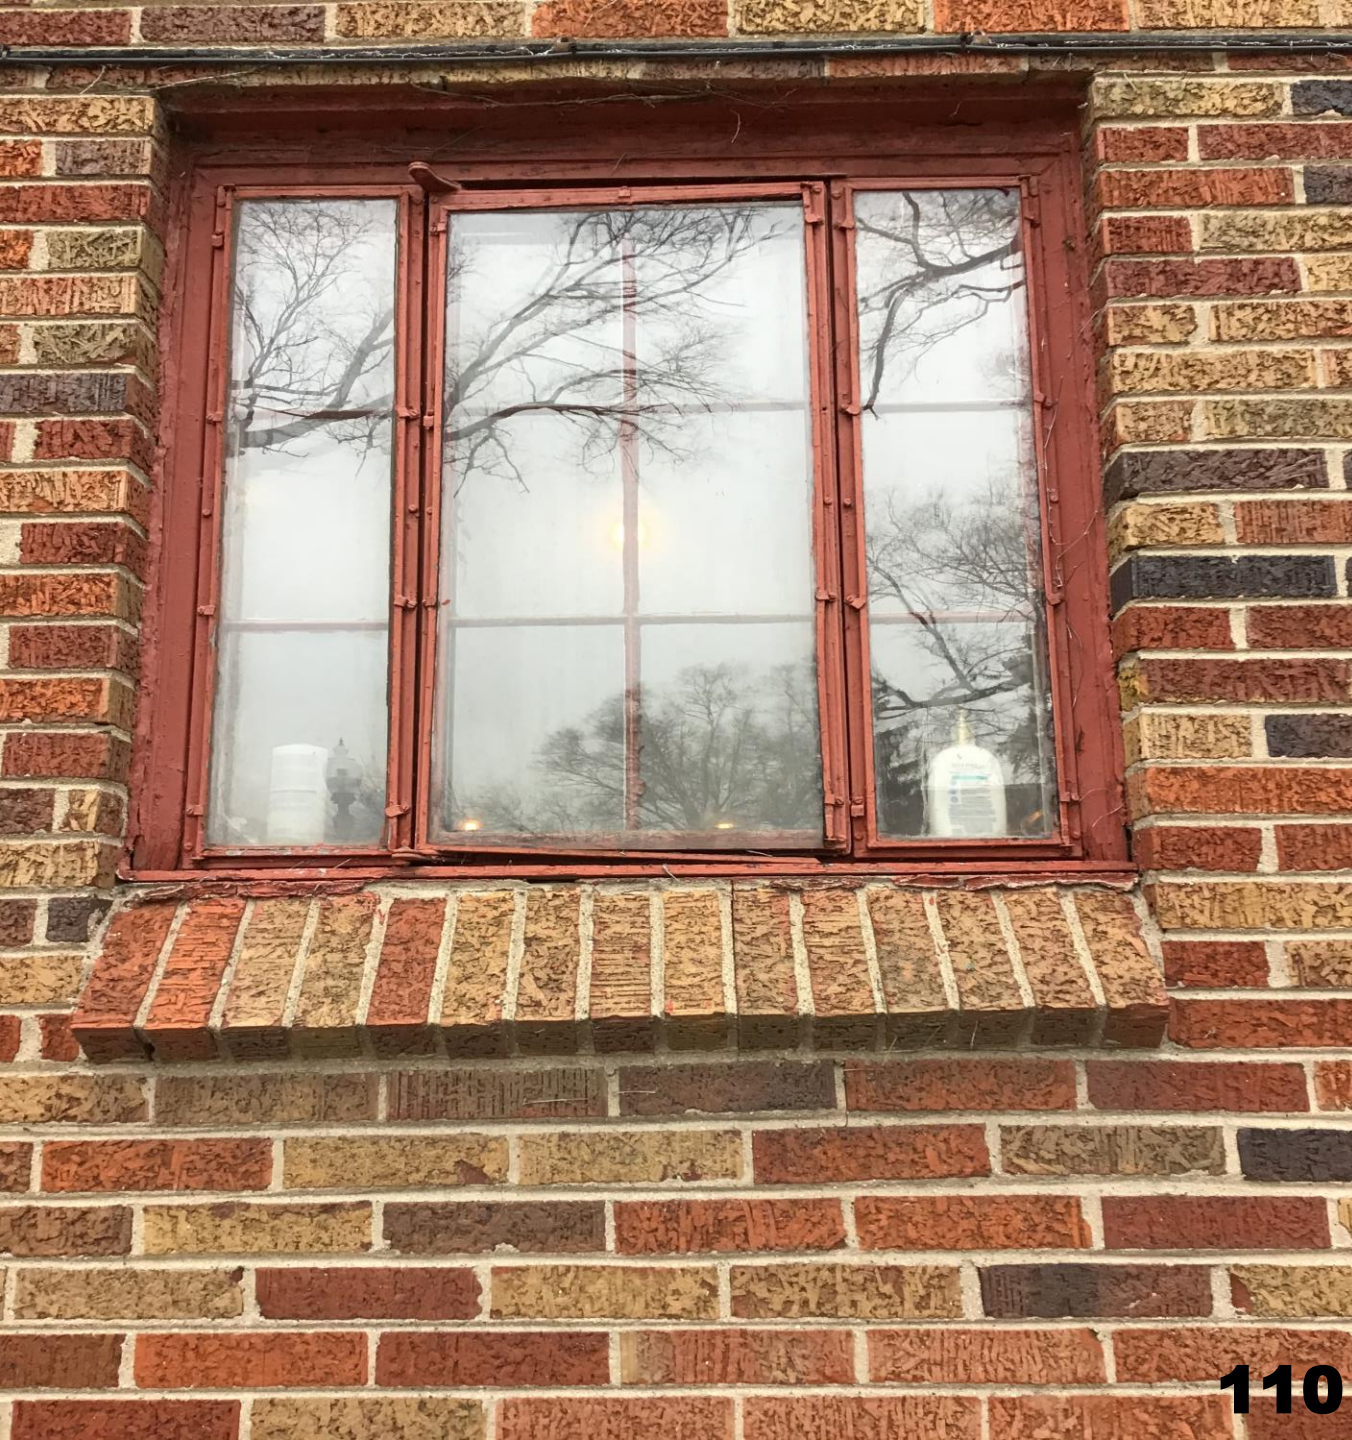
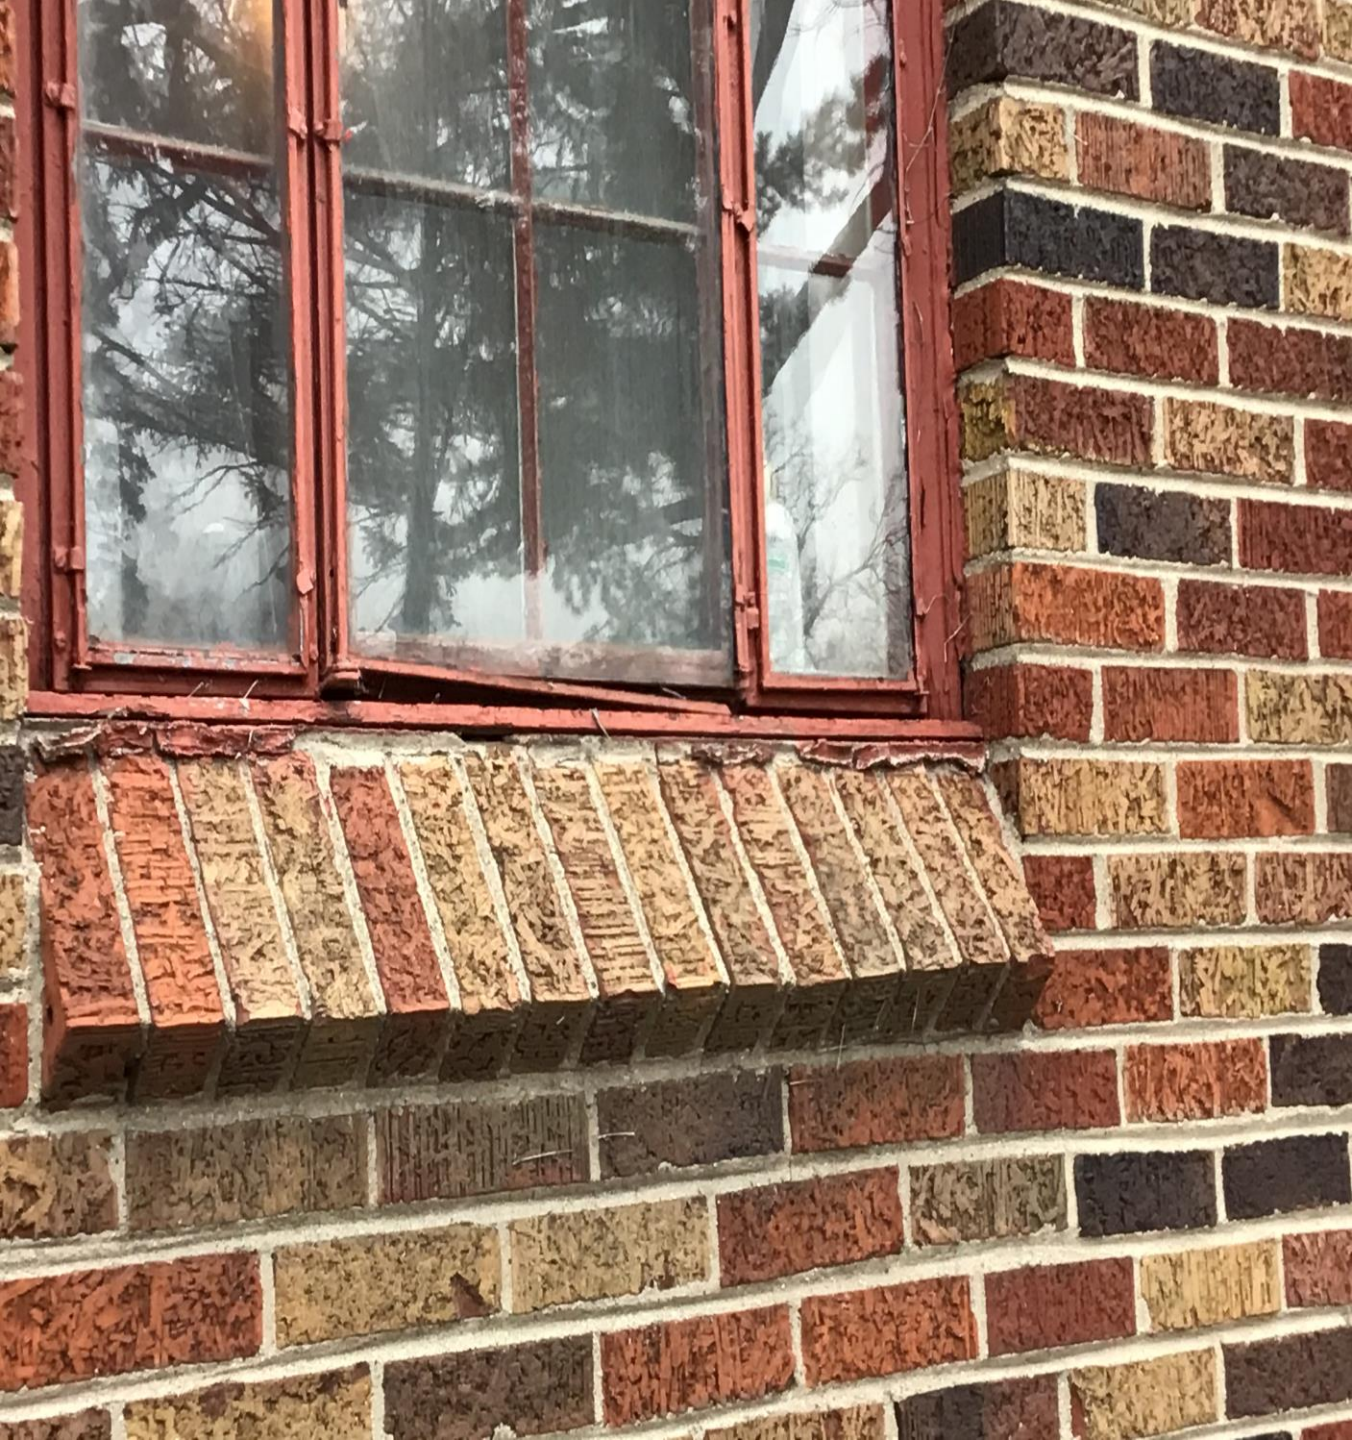
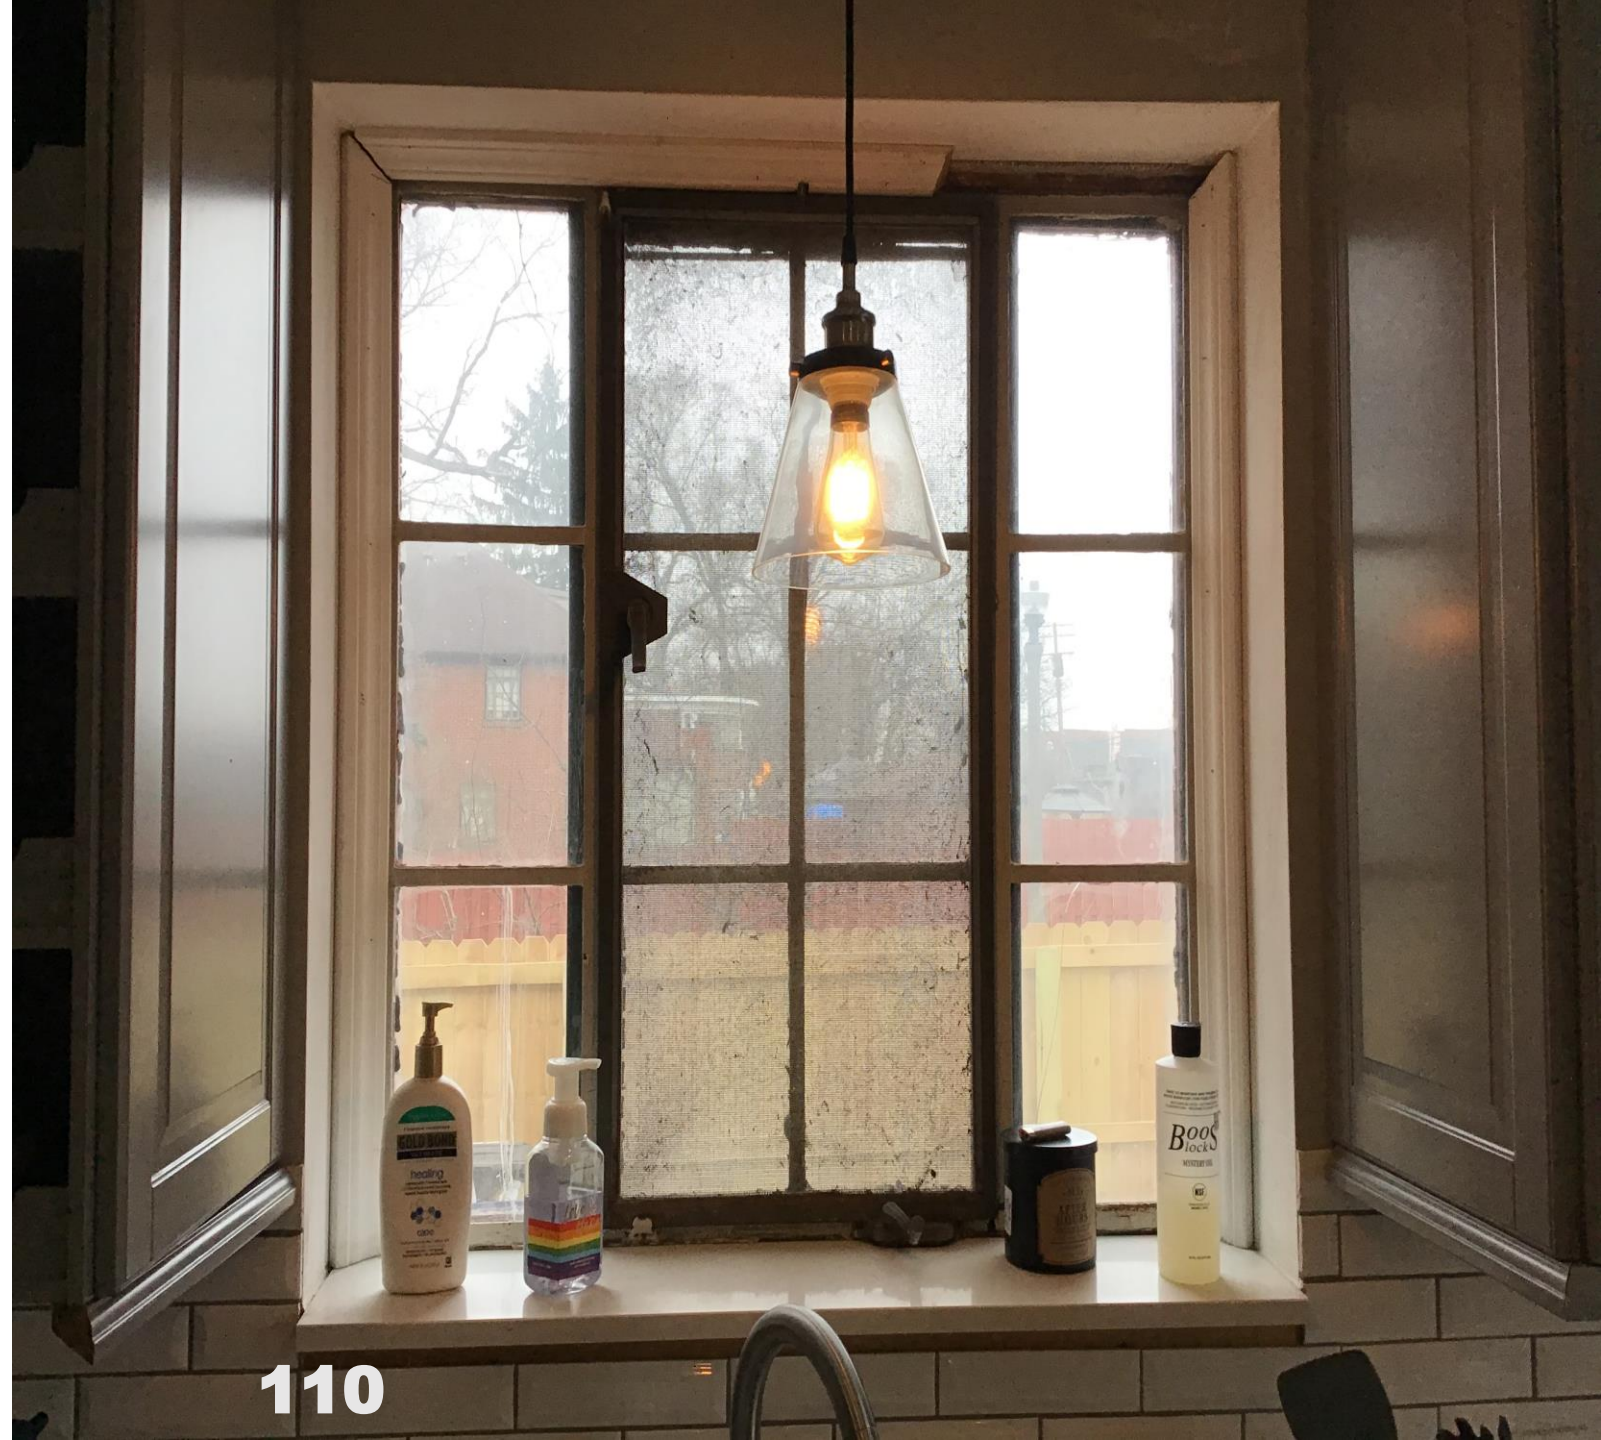
WINDOW OPENING 110 Kitchen – Left side of House

- Single Casement Window
- Window is in Kitchen
- Window won't open
- Exterior of window showing signs of rotting around frame and exterior window shows breakage
- Interior casing is missing/broken

Window: Casement, Single, Left, Base Frame, 2" Brickmould / Traditional, Exterior Black, Interior Black, **Glass:** All Sash: High Performance SmartSun Glass, No Pattern, **Hardware:** Black, **Screen:** TruScene, Full Screen, **Grille Style:** Grilles Between Glass (GBG), **Grille Pattern:** All Sash: Colonial 3w x 4h, **Misc:** None

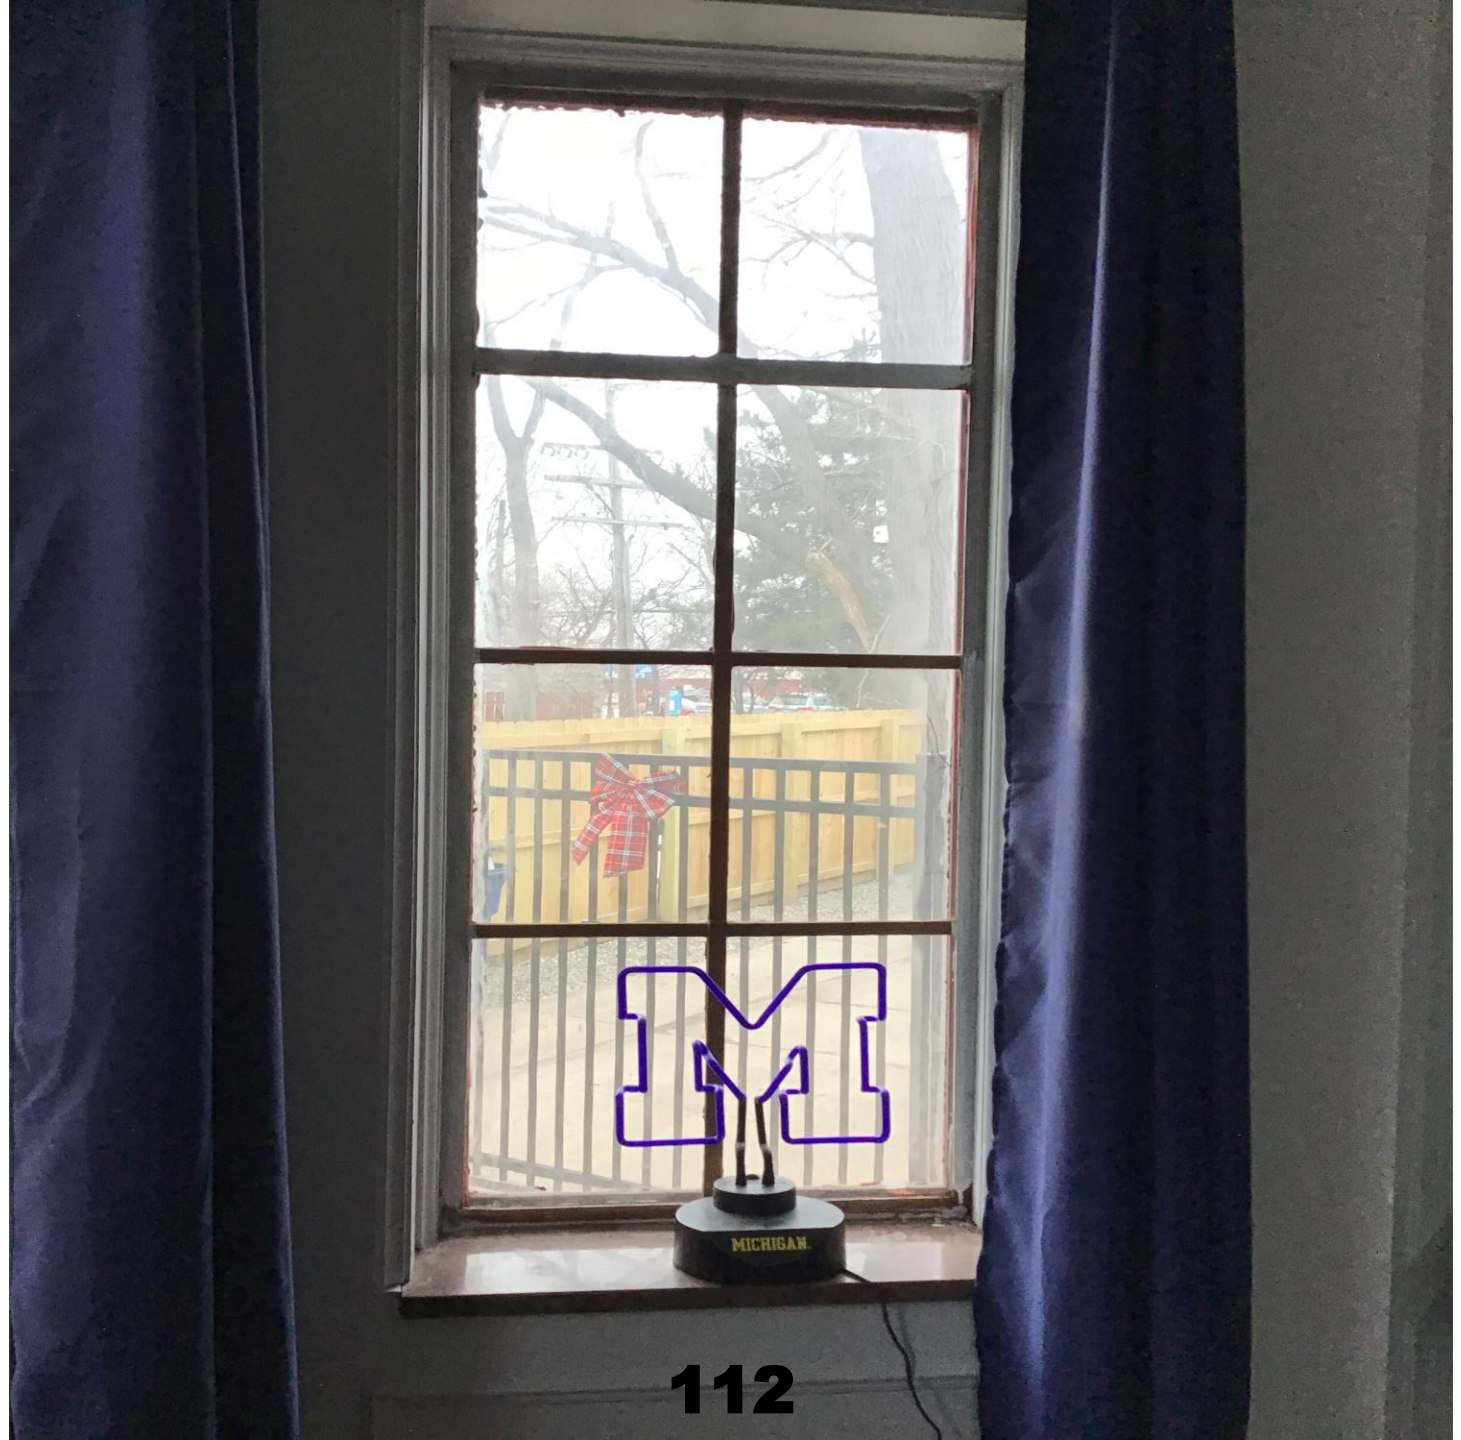
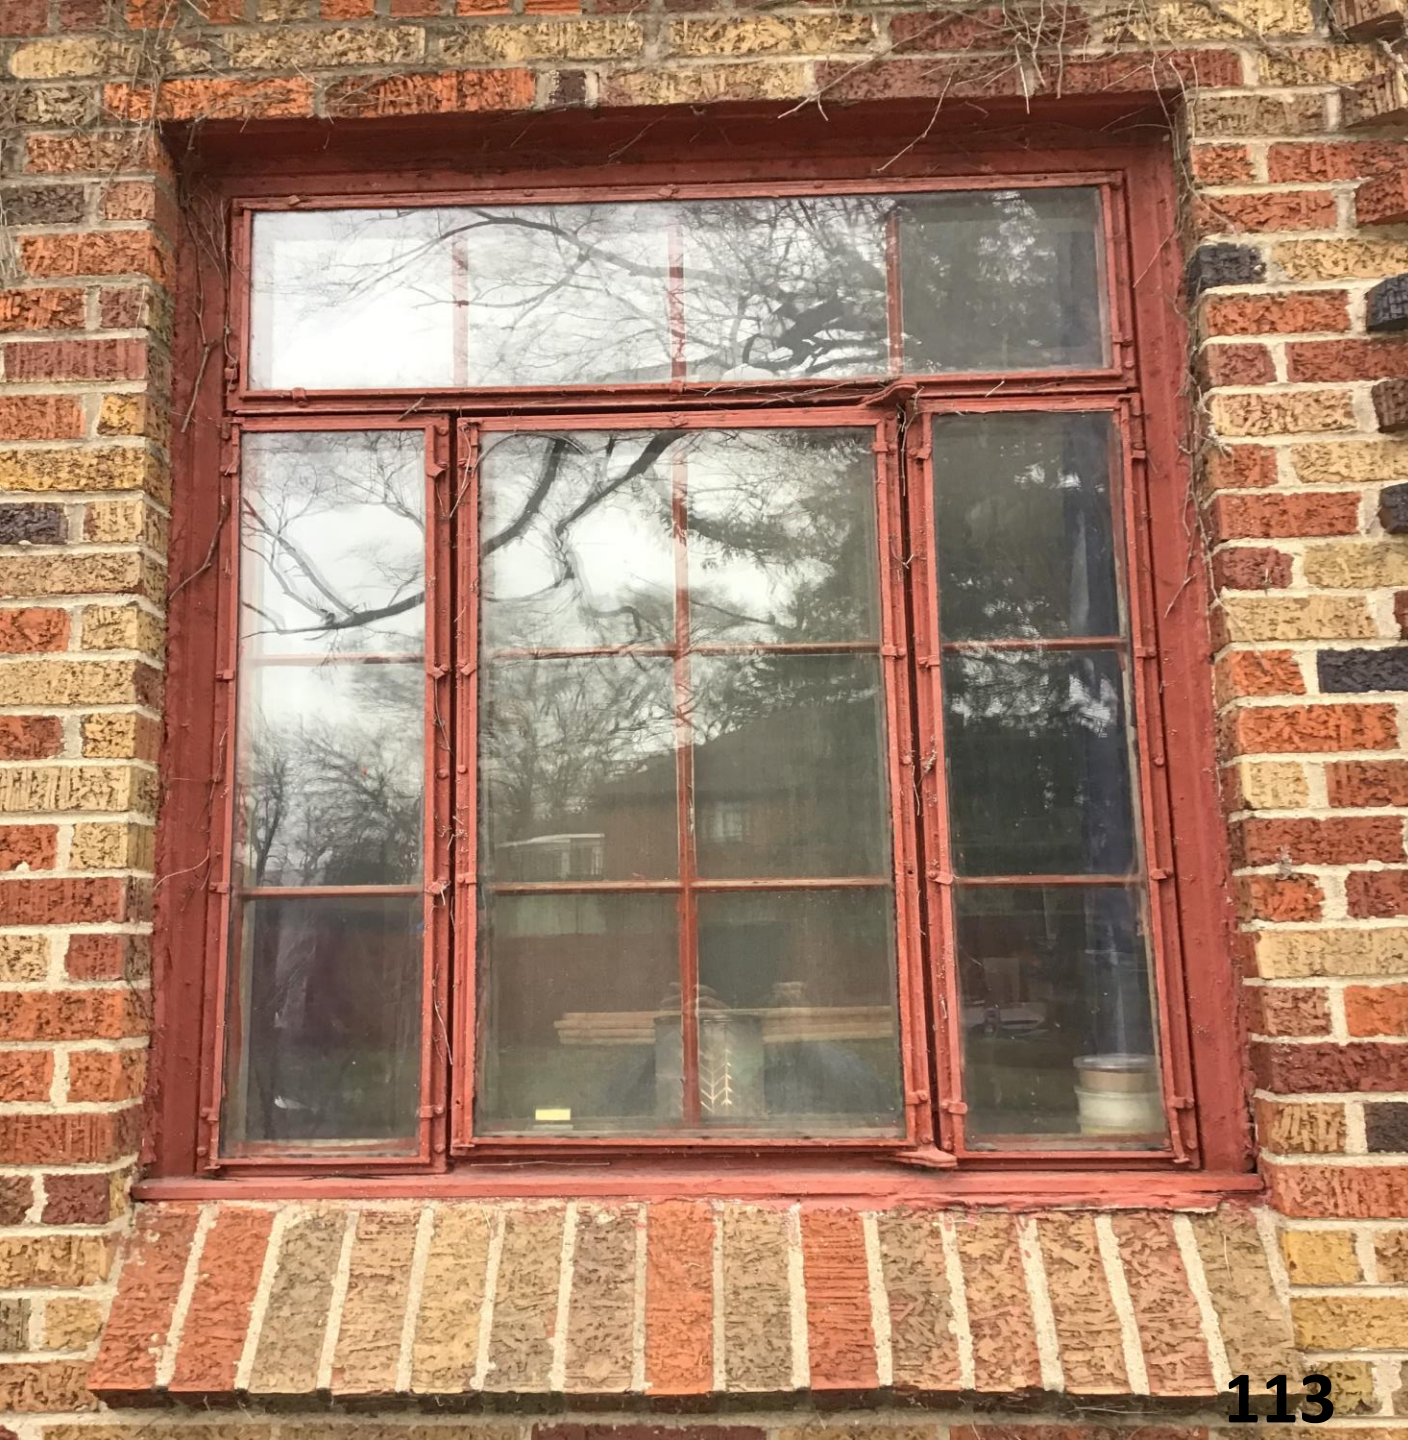
WINDOW OPENING 112 Office - Left side of House

- Fixed window – Steel casement
- Window is in an office
- Window doesn't open
- Ivy stuck between window and storm
- Exterior of window showing signs of rotting around frame

Window: Casement, Single, Left, Base Frame, 2" Brickmould / Traditional, Exterior Black, Interior Black, **Glass:** All Sash: High Performance SmartSun Glass, No Pattern, **Hardware:** Black, **Screen:** Fiberglass, Full Screen, **Grille Style:** Grilles Between Glass (GBG), **Grille Pattern:** All Sash: Colonial 2w x 4h, **Misc:** None
